# Manta Ray Viewing Boating Operations and Safety Assessment

*Prepared for the Hawaii Coral Reef Initiative Research  
Program (HCRI-RP) on September 6th, 2015*

**by Marine Science Consulting LLC**

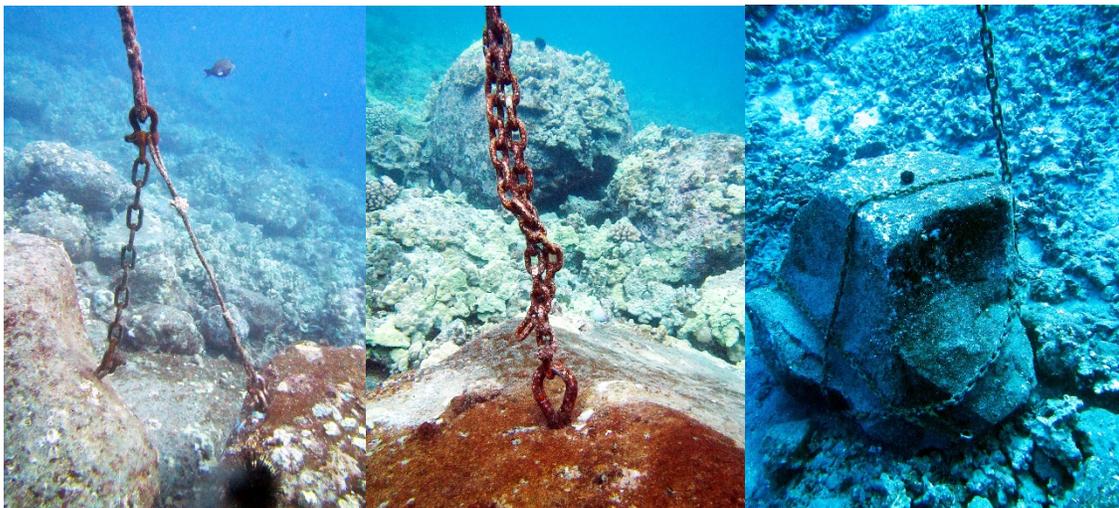
At Makako Bay, seven moorings with subsurface floats are used on a nightly basis (Figure 8, Table 1). Five are anchored using double pins, one (north inside) is anchored with a single pin, and one (north outside) is secured to a large boulder via chains (Figure 9). The north outside mooring is not a U.S. Army Corp of Engineers (USACE) permitted mooring. These moorings are located in close proximity and surround the circle of rocks known as the stone circle “campfire” where scuba divers place lights and sit on the seafloor to view manta rays (Figure 8). The campfire is the primary manta ray viewing site for scuba divers in Makako Bay.

Given the number of vessels compared to available moorings, at least 2-3 vessels simultaneously use each mooring on a nightly basis. The boats are attached end-to-end (“daisy chained”) to each other. Given that the number of vessels observed at Makako Bay during this study was well short of its peak activity, the number of vessels per mooring likely increases on busier days. Due to the limited number of moorings and space constraints, vessels also commonly anchor nearby (within 100 yards of the moorings). Some vessels, particularly smaller boats arriving after dark, do not moor or anchor but “live boat” throughout the duration of the night. These boats typically drop-off and pick-up snorkelers near the campfire and wait offshore in the interim.

Figure 9. Day-use moorings at Makako Bay: (left) middle outside with double pin anchor, (middle) north inside single pin anchor, and (right) north outside with chain anchor.

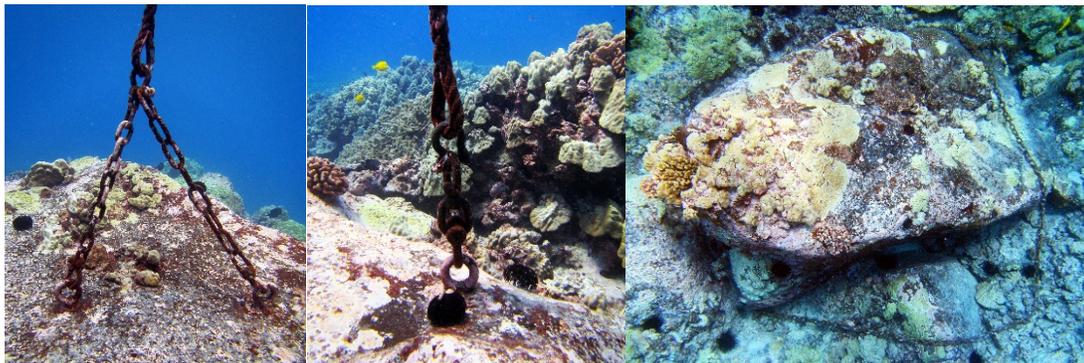
At Keauhou Bay, there are seven moorings but only four have subsurface floats. Three are anchored using double pins, one (inside north) is anchored with a single pin, and three (Aggressor north, Aggressor south, south chain) are anchored to large boulder via chains (Figure 10, Table 1). The three chain moorings do not have subsurface floats and are not USACE permitted moorings. Additionally, the south chain mooring is not secure and consists of a chain loosely looped over a boulder (Figure 11). The

Based observations, the four moorings with subsurface floats are regularly used by at least one vessel. Some vessels, arriving after dark, do not moor but instead drop anchors presumably due to their inability to locate available moorings. Boats have also commonly been observed live boating throughout the duration of the night. During busy nights, 3-4 boats were observed using each mooring simultaneously. Compared to the Makako Bay site, the vessels at Keauhou Bay are less centralized and more dispersed along the shoreline and anchoring is much more frequent. While not assessed within the scope of this study, the live coral cover was observed to be quite high throughout the area where anchoring was observed. Damage to live coral colonies is likely unavoidable when anchoring in this area, especially at night.

Figure 11. Day-use moorings at Keauhou Bay: (*left*) middle south with double pin anchor, (*middle*) inside north with single pin anchor, and (*right*) south chain which is only loosely wrapped around a boulder.
