Remaining Useful Life Determination for

Uncle Billy's Hilo Bay Hotel

Hilo, Hawaii

Final Report
June 2014

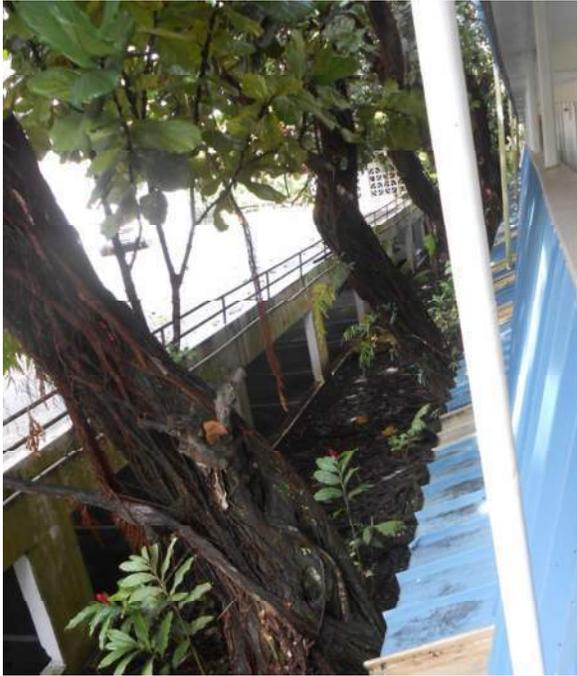
- Element No. G 1.a – The Ground to the West of the Kitchen Wing has risen due to trees planted along that Western face of the building. Walkways are showing signs of significant deformation due to the tree roots.
- Element No. S 5.a – Roof framing over the Shop & Lobby Wings is sagging.
- Element No. S 6.a – Fire escape stairways were observed to need significant repair and maintenance.
- Element No. E 1 – Electrical system, wiring & breakers are out dated. Continued use will require the upgrade of this system to meet current codes.
- Element No. U 2.a – Boiler system consists of 7 separate water heaters. Remaining useful life for this would be 3-5 years. Although not a necessary element to RUL, replacement of this element would be required with continued use.

Photo 1: DSCN0529 – Trees causing displacement of the ground floor of the Kitchen Wing

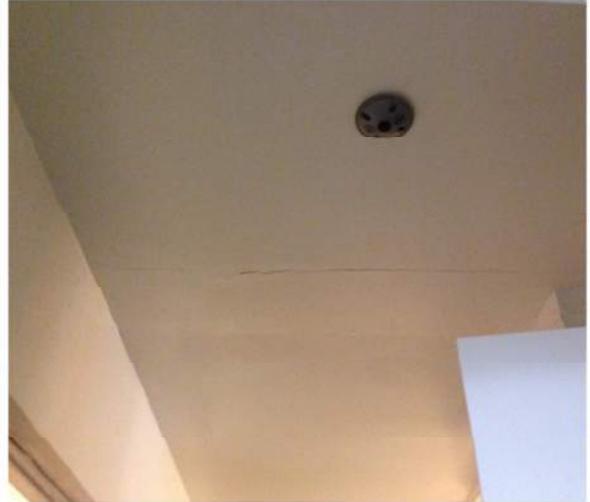
Photo 2: IMG_2528 – Cracking of ceiling finishes near the restrooms in the Lobby

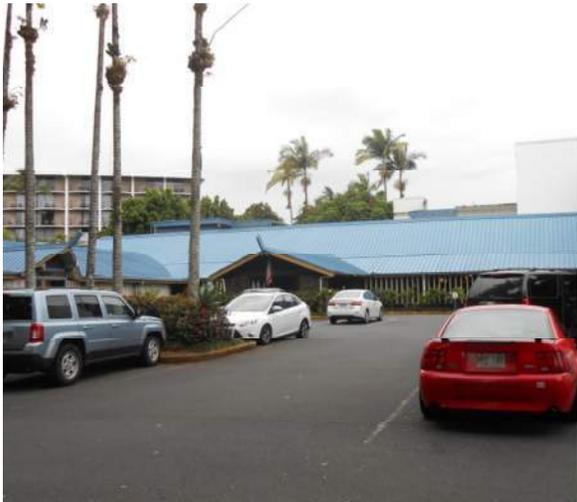
Element Code	Element	Location of Deficient Elements Noted:	Description of Finding:	RUL Weight: (1 High to 3 Low)	Estimated Age: If Available (Years)	Condition Rating: A to F	Estimated Useful Life (Years)	Remaining Useful Life (Years)	Photos Referenced:	Comments & Major Deficiencies Noted:
G1	Grounds - Settlement & Erosion	a. Kitchen Wing b. Lobby near Restrooms	a. Tree roots along West side lifting concrete walkway. b. Cracking through ceiling finishes in Lobby near restrooms.	2	43 -48	B	15	4 15	a. DSCN0529 b. IMG_2528	a. In need of tree or tree root removal and reconstruction of Walkway. b. Cause of cracking cannot be determined due to inaccessibility of area.
G2	Grounds - Drainage & Runoff	BUILDING GROUNDS	NO KNOWN PROBLEMS	N/A	N/A	N/A	N/A	N/A	N/A	N/A
G3	Grounds - Parking & Paved Areas	a. Parking Area	a. Parking with 50 or so stalls is inadequate for usage.	2	Unknown	C	15	10	a. DSCN0508, DSCN0519	N/A

Photo 3: DSCN0508– Parking Lot

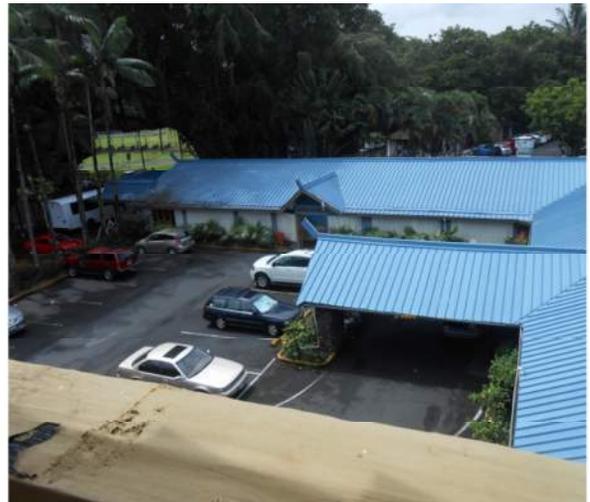
Photo 4: DSCN0519– Aerial view of Parking Lot

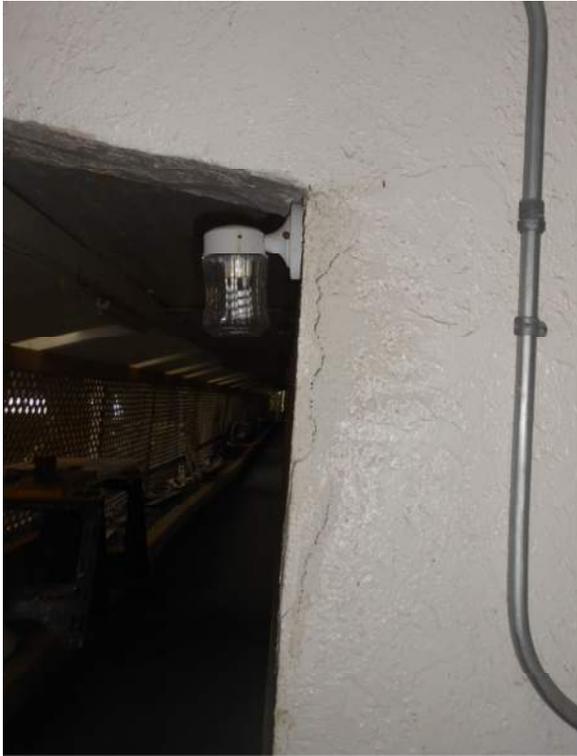
Photo 5: DSCN04888 – Crack with delamination at wall in Kitchen Wing

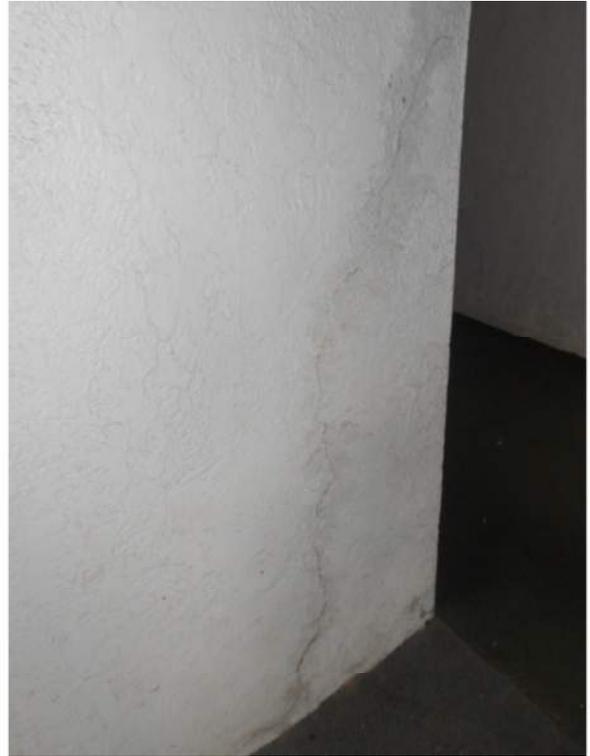
Photo 6: DSCN0490 – Crack with delamination at wall in Kitchen Wing

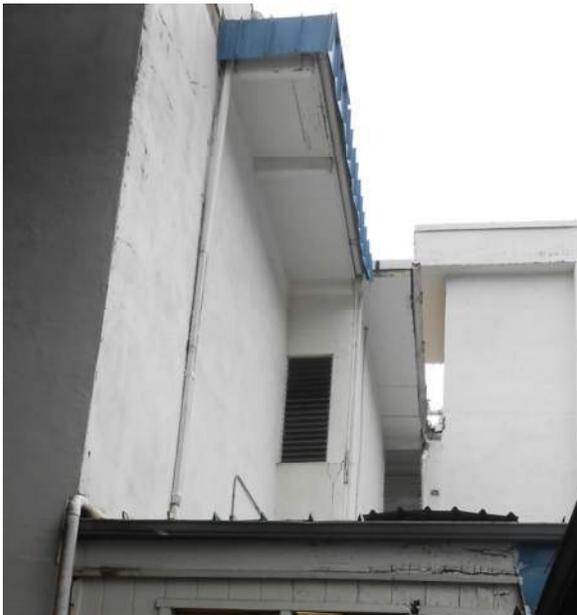
Photo 7: DSCN0496 – Cracking and spalling near elevator room

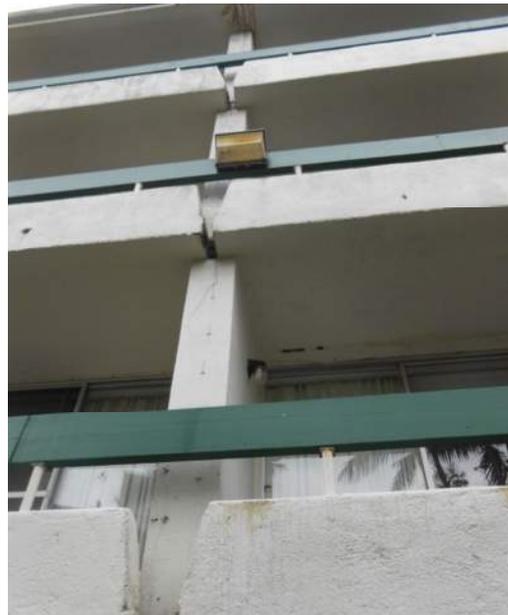
Photo 8: DSCN0501 – Cracking at Exterior Balcony Wall

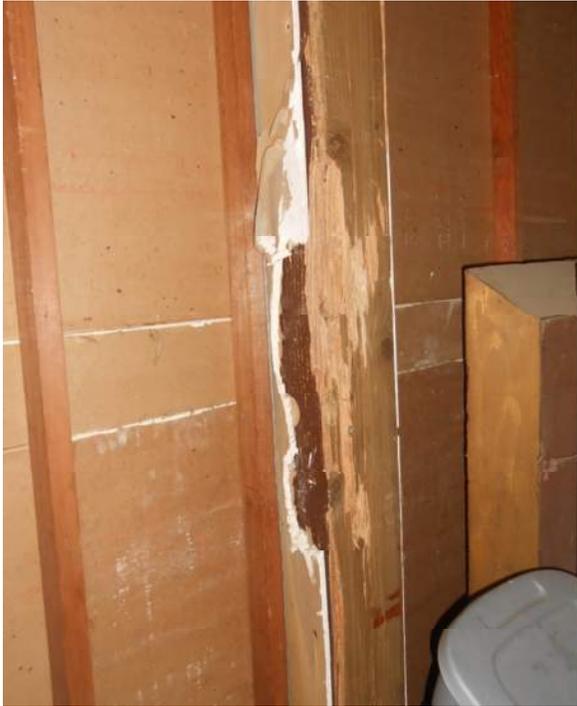
Photo 9: DSCN0487 – Termite damage in wood column in Electrical Room

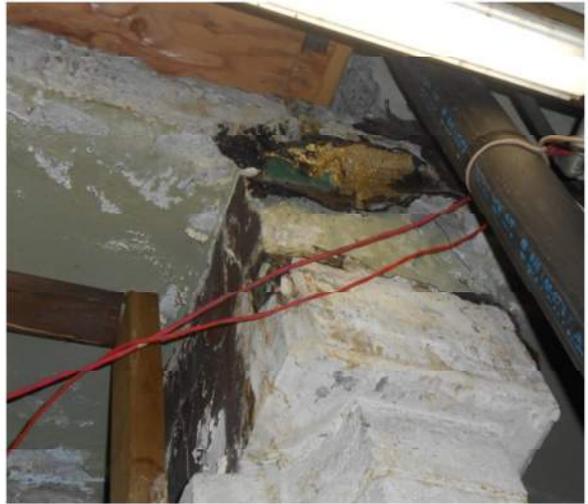
Photo 10: DSCN0486 – Cracking in beam at top of column in Electrical Room

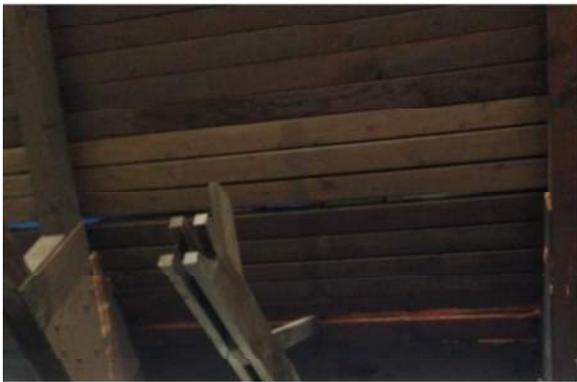
Photo 11: IMG_2561 – Termite damage in Lobby

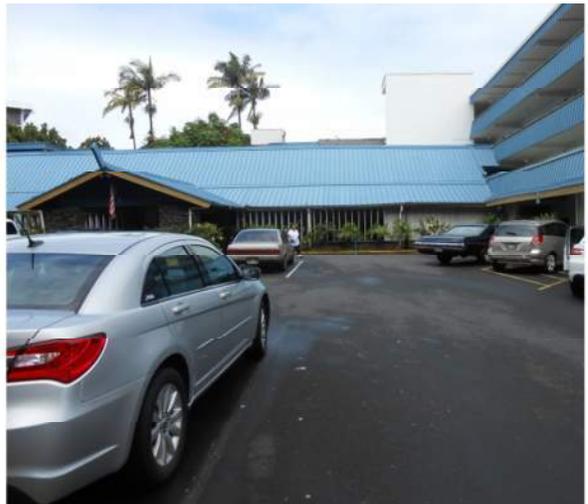
S5	Structural - Roof Framing	a. Lobby, Restaurant & Shop Wood Frame b. Kitchen, Main, Shop Buildings	a. Sagging noted with some termite damage. Collision damage at porte cochere roof. b. Cast in Place Concrete - Inaccessible.	2 N/A	43	D N/A	10 25	7 N/A	a. DSCN0511, DSCN0512	a,b. Repair & Rehab recommended with continued use.
S6	Structural - Stairs	a. Fire Escape Stairway	a. In need of maintenance and rehab.	1	43 -48	F	15	3	a. DSCN0491	a. Repair or Replacement needed.
S7	Structural - Balconies	a, b. Various locations throughout property	a. Ends of hollow core planks are exposed in a few locations and minor cracking and spalling of the concrete parapets and balcony slabs was observed. b. Minor deterioration of some wooden balcony rails.	2	43-48	C	25	15	a. IMG_2552 b. IMG_2555	a. Recommend repairing of cracks and spalls and patching the exposed ends of the hollow core planks with continued use. b. Routine repair and replacement of wooden railing components should be expected with continued use.

Photo 12: DSCN0511 – Sagging at roof areas

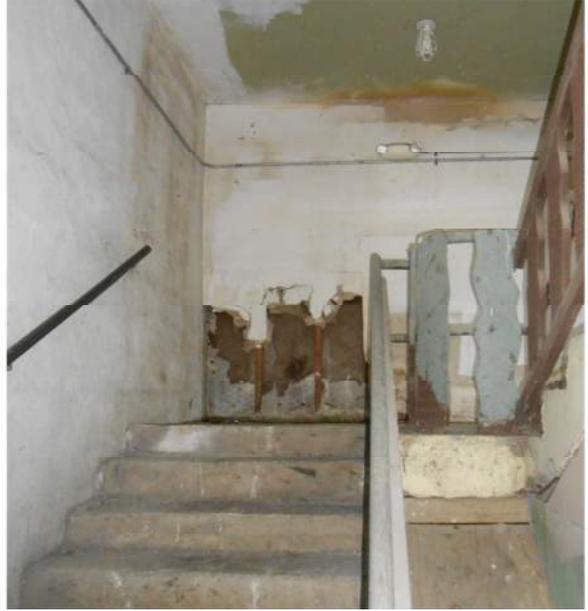
Photo 14: DSCN0491- Emergency Exit stairwell

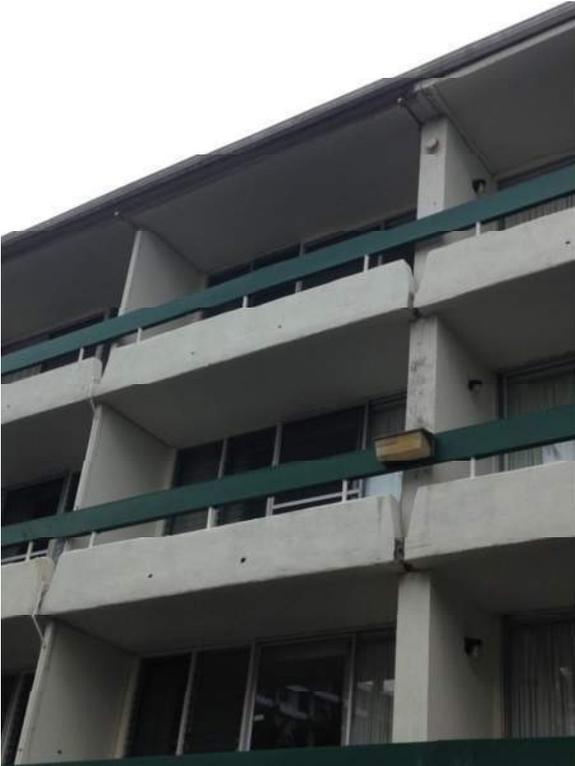
Photo 15: IMG_2552 – Area with exposed hollow core plank edges

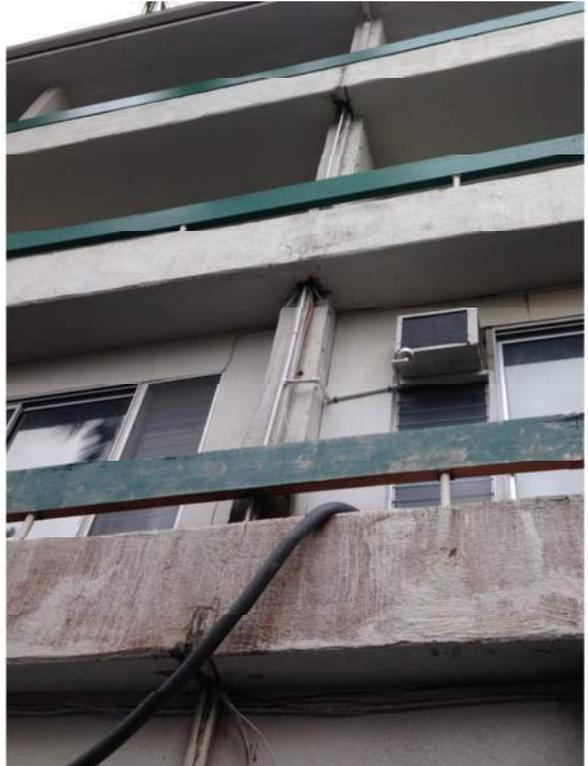
Photo 16: IMG_2555 – Deteriorating timber railing and balcony cracking

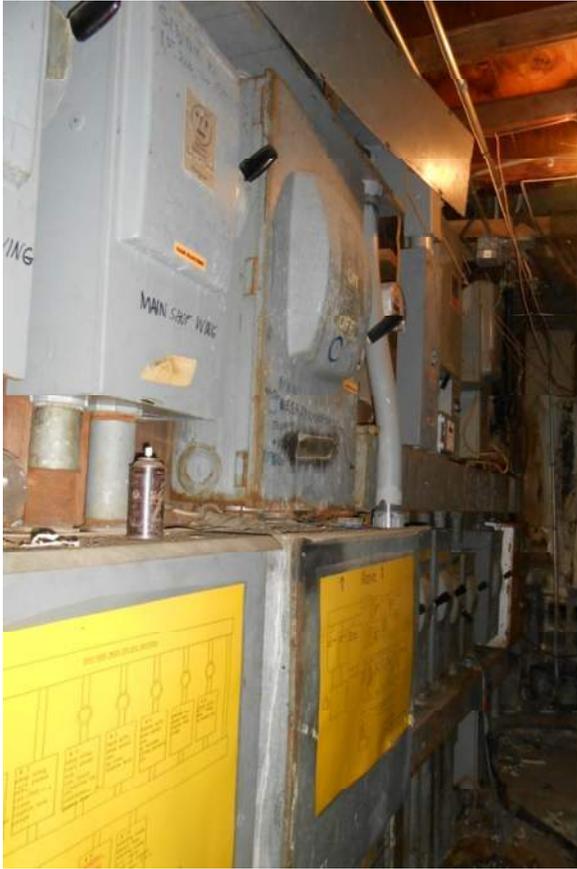
M2	Mechanical - Air Conditioning Ducts	NO CENTRAL AIR CONDITIONING	NOT APPLICABLE	N/A	N/A	N/A	N/A	N/A	N/A	N/A
U1	Utility - Electrical Power Supply	a. Main Power Supply w/ Transformer in Lobby Area	a. Operational and in satisfactory condition.	1	N/A	C	15	12	a. DSCN0483, DSCN0484	
U2	Utility - Heater & Flue, Commercial Size	a. Seven (7) Gas Water Heaters in various locations throughout the Hotel	a. Operational	2	3-10	D	10	5	a. IMG_2547	a. Necessary to assess condition of heaters and appropriate repair or replacement.
U3	Utility - Water Supply System	a. Meter & Main	a. Provided by County of Hawaii DWS.	2	N/A	C	20	15	N/A	N/A
U4	Utility - Wastewater System	a. Connection to Sewer System b. On site Lift Station - See Item P2 above	a. Provided by County of Hawaii Wastewater Division. Clay Pipe from facility to sewer system connection clay pipe, reported by Lessee to be in good condition observed recently through camera observation. b. See item P2 above.	2	N/A	C	N/A 15	N/A 15	N/A	N/A

Photo 17: DSCN0483 – Electrical Room

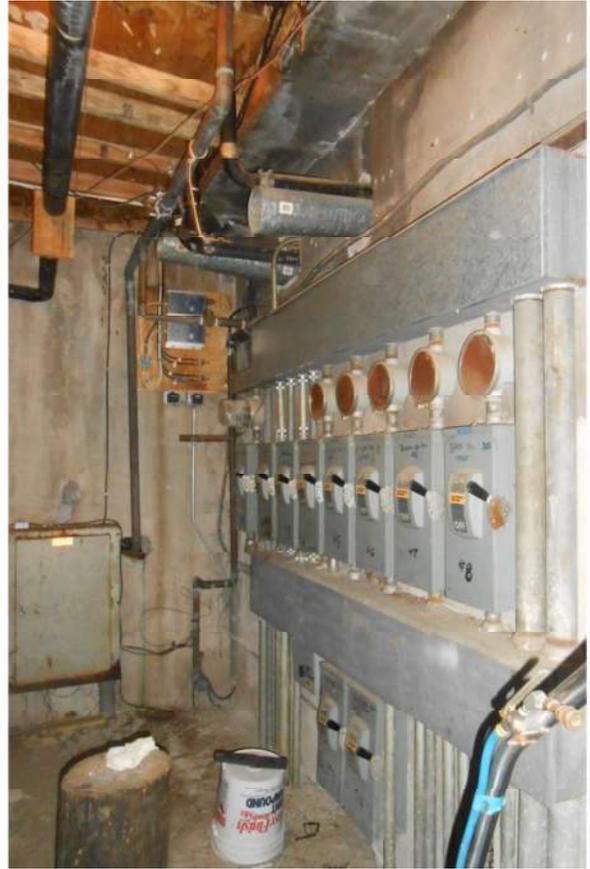
Photo 18: DSCN0484 – Electrical Room

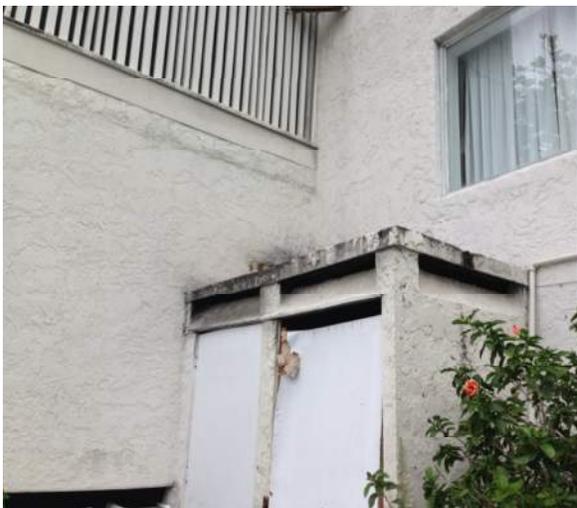
Photo 19: IMG_2547 – Gas Heater Enclosure

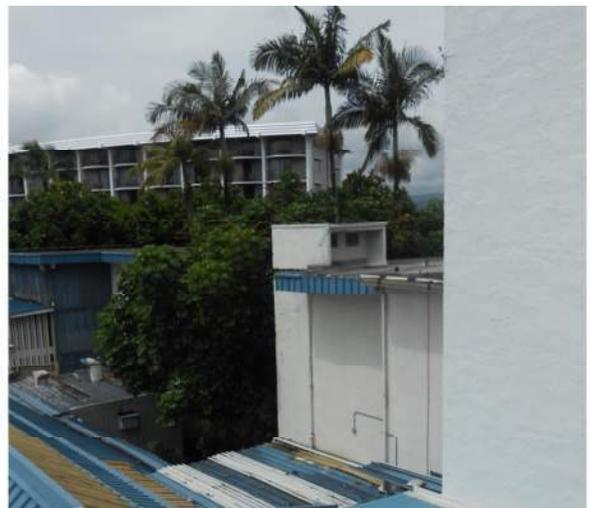
Photo 20: DSCN0522 – Elevator room

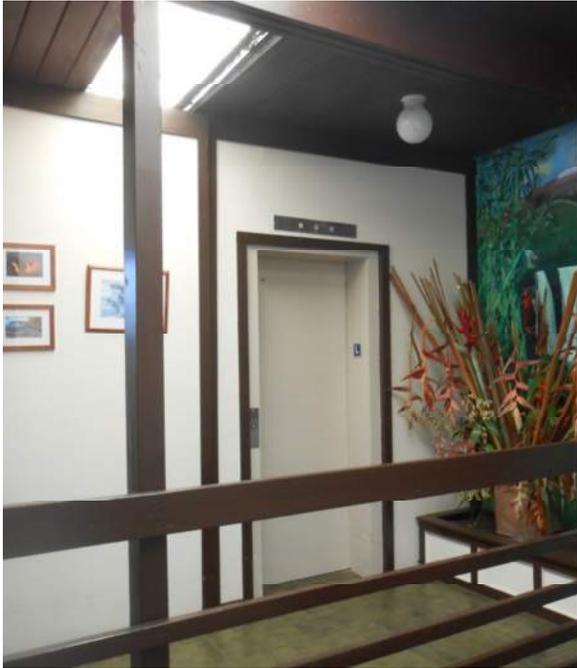
Photo 21: DSCN0524 – Elevator in Lobby

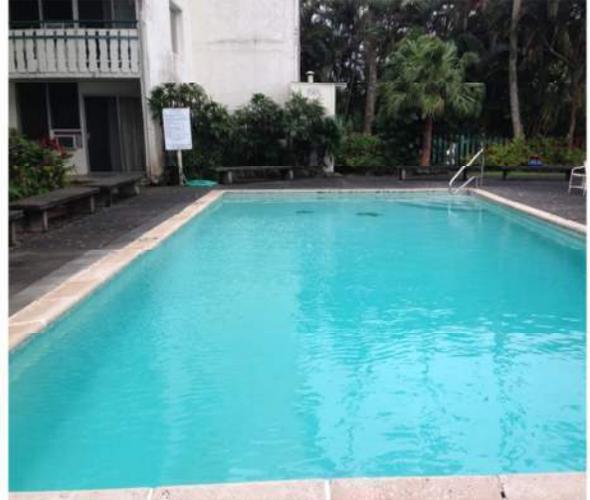
U5	Utility - Gas Supply System	GAS PROVIDED UP TO SERVICE METER BY THE GAS COMPANY	Provided by the Gas Company. No Known Problems.	2	N/A	C	15	15	N/A	N/A
O1	ADA COMPLIANT	BUILDING PHYSICAL PLANT	a. Compliant in most areas, have not yet installed pool lift.	1	N/A	D	N/A	N/A	N/A	a. ADA improvements needed with continued use.
O2	Elevator System	a. One (1) located in the Main Wing off of the Lobby Area	a. Operational	2	40+	C	15	15	a. DSCN0522, DSCN0524	N/A
O3	Fire Protection	a. Fire Alarm System b. Sprinkler System	a. Operational b. NONE	2	Unknown	C	15	10	N/A	N/A
O4	Swimming Pool	a. Makai between the Kitchen Wing and the Main Wing	a. Good condition including pumps & filters.	2	40+	C	20	15	a. IMG_2546	N/A

Photo 22: IMG_2546 – Swimming Pool
