Kuualii Fishpond Tsunami Damage Restoration

Anaehoomalu Bay, Waikoloa, South Kohala, Hawaii

Revision 1

October 2015

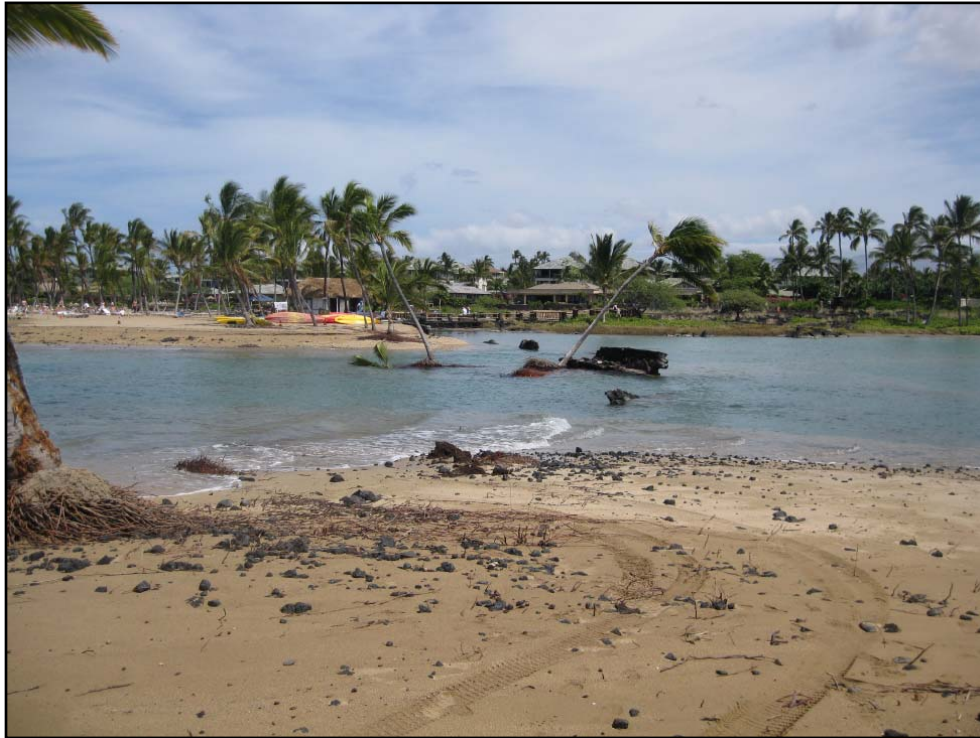
Figure 1-6 The Tsunami Breach at Waikoloa Beach, as Photographed 17 March, 2011

As shown on Figure 1-5, the tsunami created a wide breach all the way through the beach and the rock fishpond wall. Sand was both pushed into the pond on both sides of the breach, and moved directly offshore to form a mound immediately seaward of the breach. A survey made on March 21, three weeks after the tsunami, showed the breach to be about 100 feet wide at the mean lower low water (mllw) elevation. A detailed site topographic survey on April 12, 2011 showed the breach to be about 160 feet wide. The post-tsunami beach condition based on the April topographic survey is shown on Figure 2-1. During the three month period required to obtain all the necessary approvals for the emergency repair of the breach, wave action continued to enlarge the breach and scour sand from the remaining beach on both sides and move it into the pond. By the time the emergency repair was accomplished in the first week of August the breach was about 200 feet wide. The damage due to the immediate effects of the tsunami combined with the continuing damage during the permit phase of the emergency breach repair, resulted in the beach being significantly lower in elevation and narrower than it was pre-tsunami. The beach crest is presently about +3 feet mean lower low water (mllw). [Note: all elevations are referenced to the mllw datum.] The beach width above mean higher high water (mhhw) is presently about 50 to 70 feet along the southern half and 80 to 100 feet at the north end.

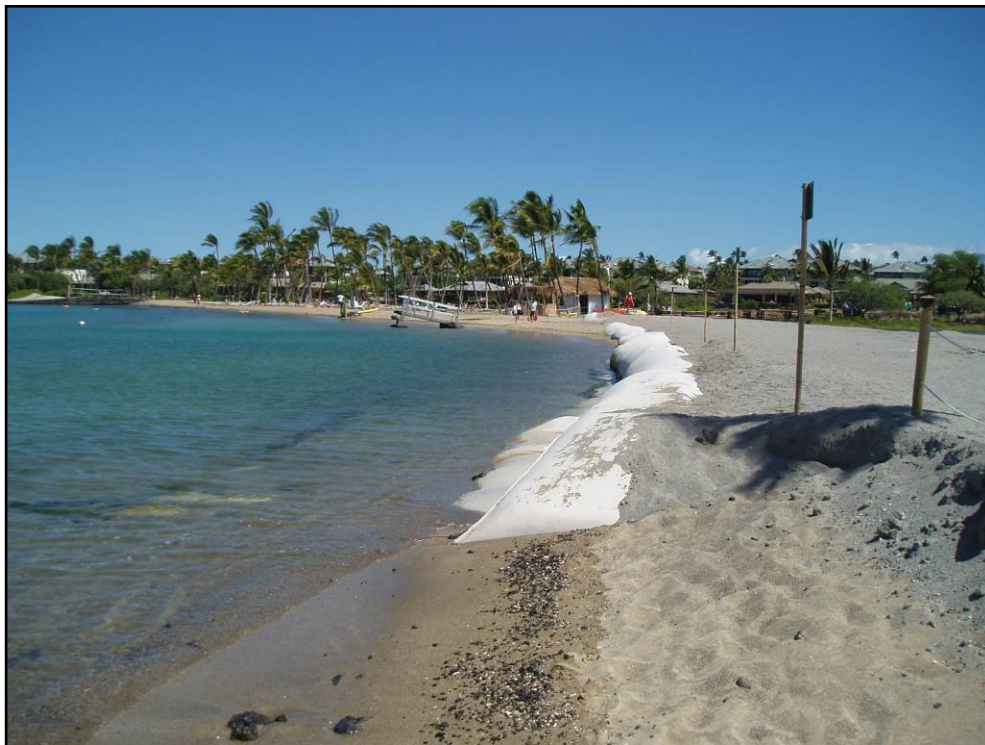
Figure 1-7 Temporary Repairs in the Tsunami Breach at Waikoloa Beach, as Photographed 20 September, 2011

The gap in the beach resulted in continuing sand infill into the pond by wave action. Various permits issued by the County, State and U.S. Army Corps of Engineers (USACE) during development of the resort require the maintenance and preservation of the pond, and thus a request for emergency repair of the beach was made by the WBA to the County Planning Department, the State Department of Land and Natural Resources (DLNR), and the USACE on March 28. After the final necessary approval was granted on July 7, repair work was initiated on July 25, and completed on August 3. The temporary emergency repair plan consisted of installing sand filled geotextile tubes to close the gap in the beach. The completed emergency repair work is shown on Figure 1-7. Plan and section views of the repair plan are shown on Figure 1-8. During the three month period required to obtain all the necessary approvals for the emergency repair work, wave action continued to enlarge the breach in the beach, scour sand from the remaining beach on both sides of the breach, and move sand into the fishpond. Consequently, when emergency repair work was finally able to start, the damage to the beach was considerably greater than it had been immediately after the tsunami. This resulted in the need for geotextile tubes with a total length of 240 feet to completely close the gap.

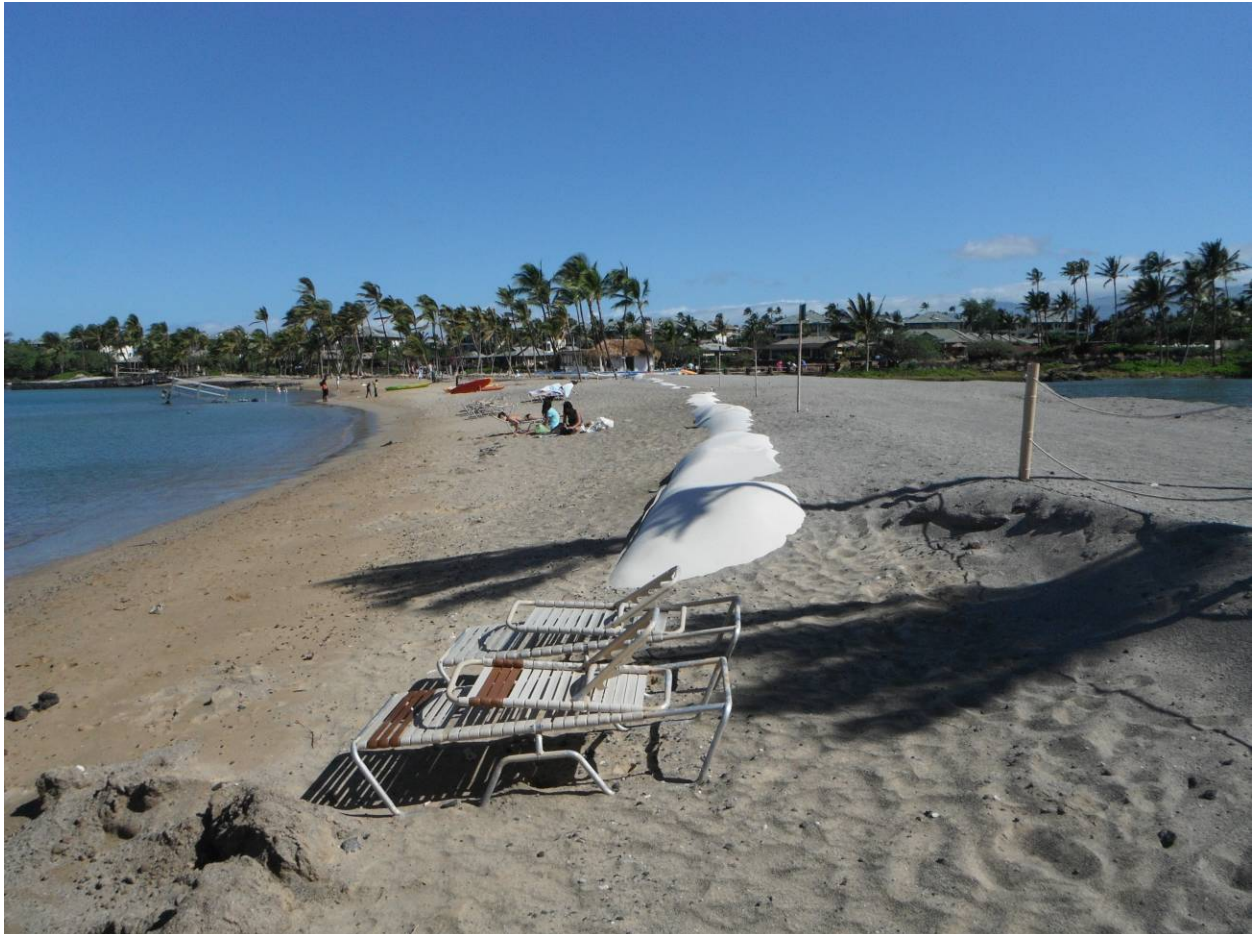
Figure 1-9 Temporary Repairs in the Tsunami Breach at Waikoloa Beach, as Photographed 14 March, 2012

Emergency repair work was accomplished as an intermediate step to protect the fishpond while this long-term, permanent repair/restoration plan for the pond and beach was developed and the necessary permits and approvals are pursued. Permanent repairs include rebuilding the fishpond wall, placement of wall support sand reclaimed from the pond, and berm restoration of the dry beach to its pre-tsunami condition. This report evaluates the repair and restoration needs, and presents a plan for the work. Only repair of tsunami related damage to the pond and beach is proposed at this time. However, due to the rapid recovery of the beach, as seen in Figure 1-9, it is also proposed that the emergency beach repair sand tubes be left in place and covered with sand until such time as they become exposed due to erosion. Since the tubes have been buried beneath the recovered beach, they are no longer impacting littoral processes, and removal would require extensive excavation within the newly recovered beach.

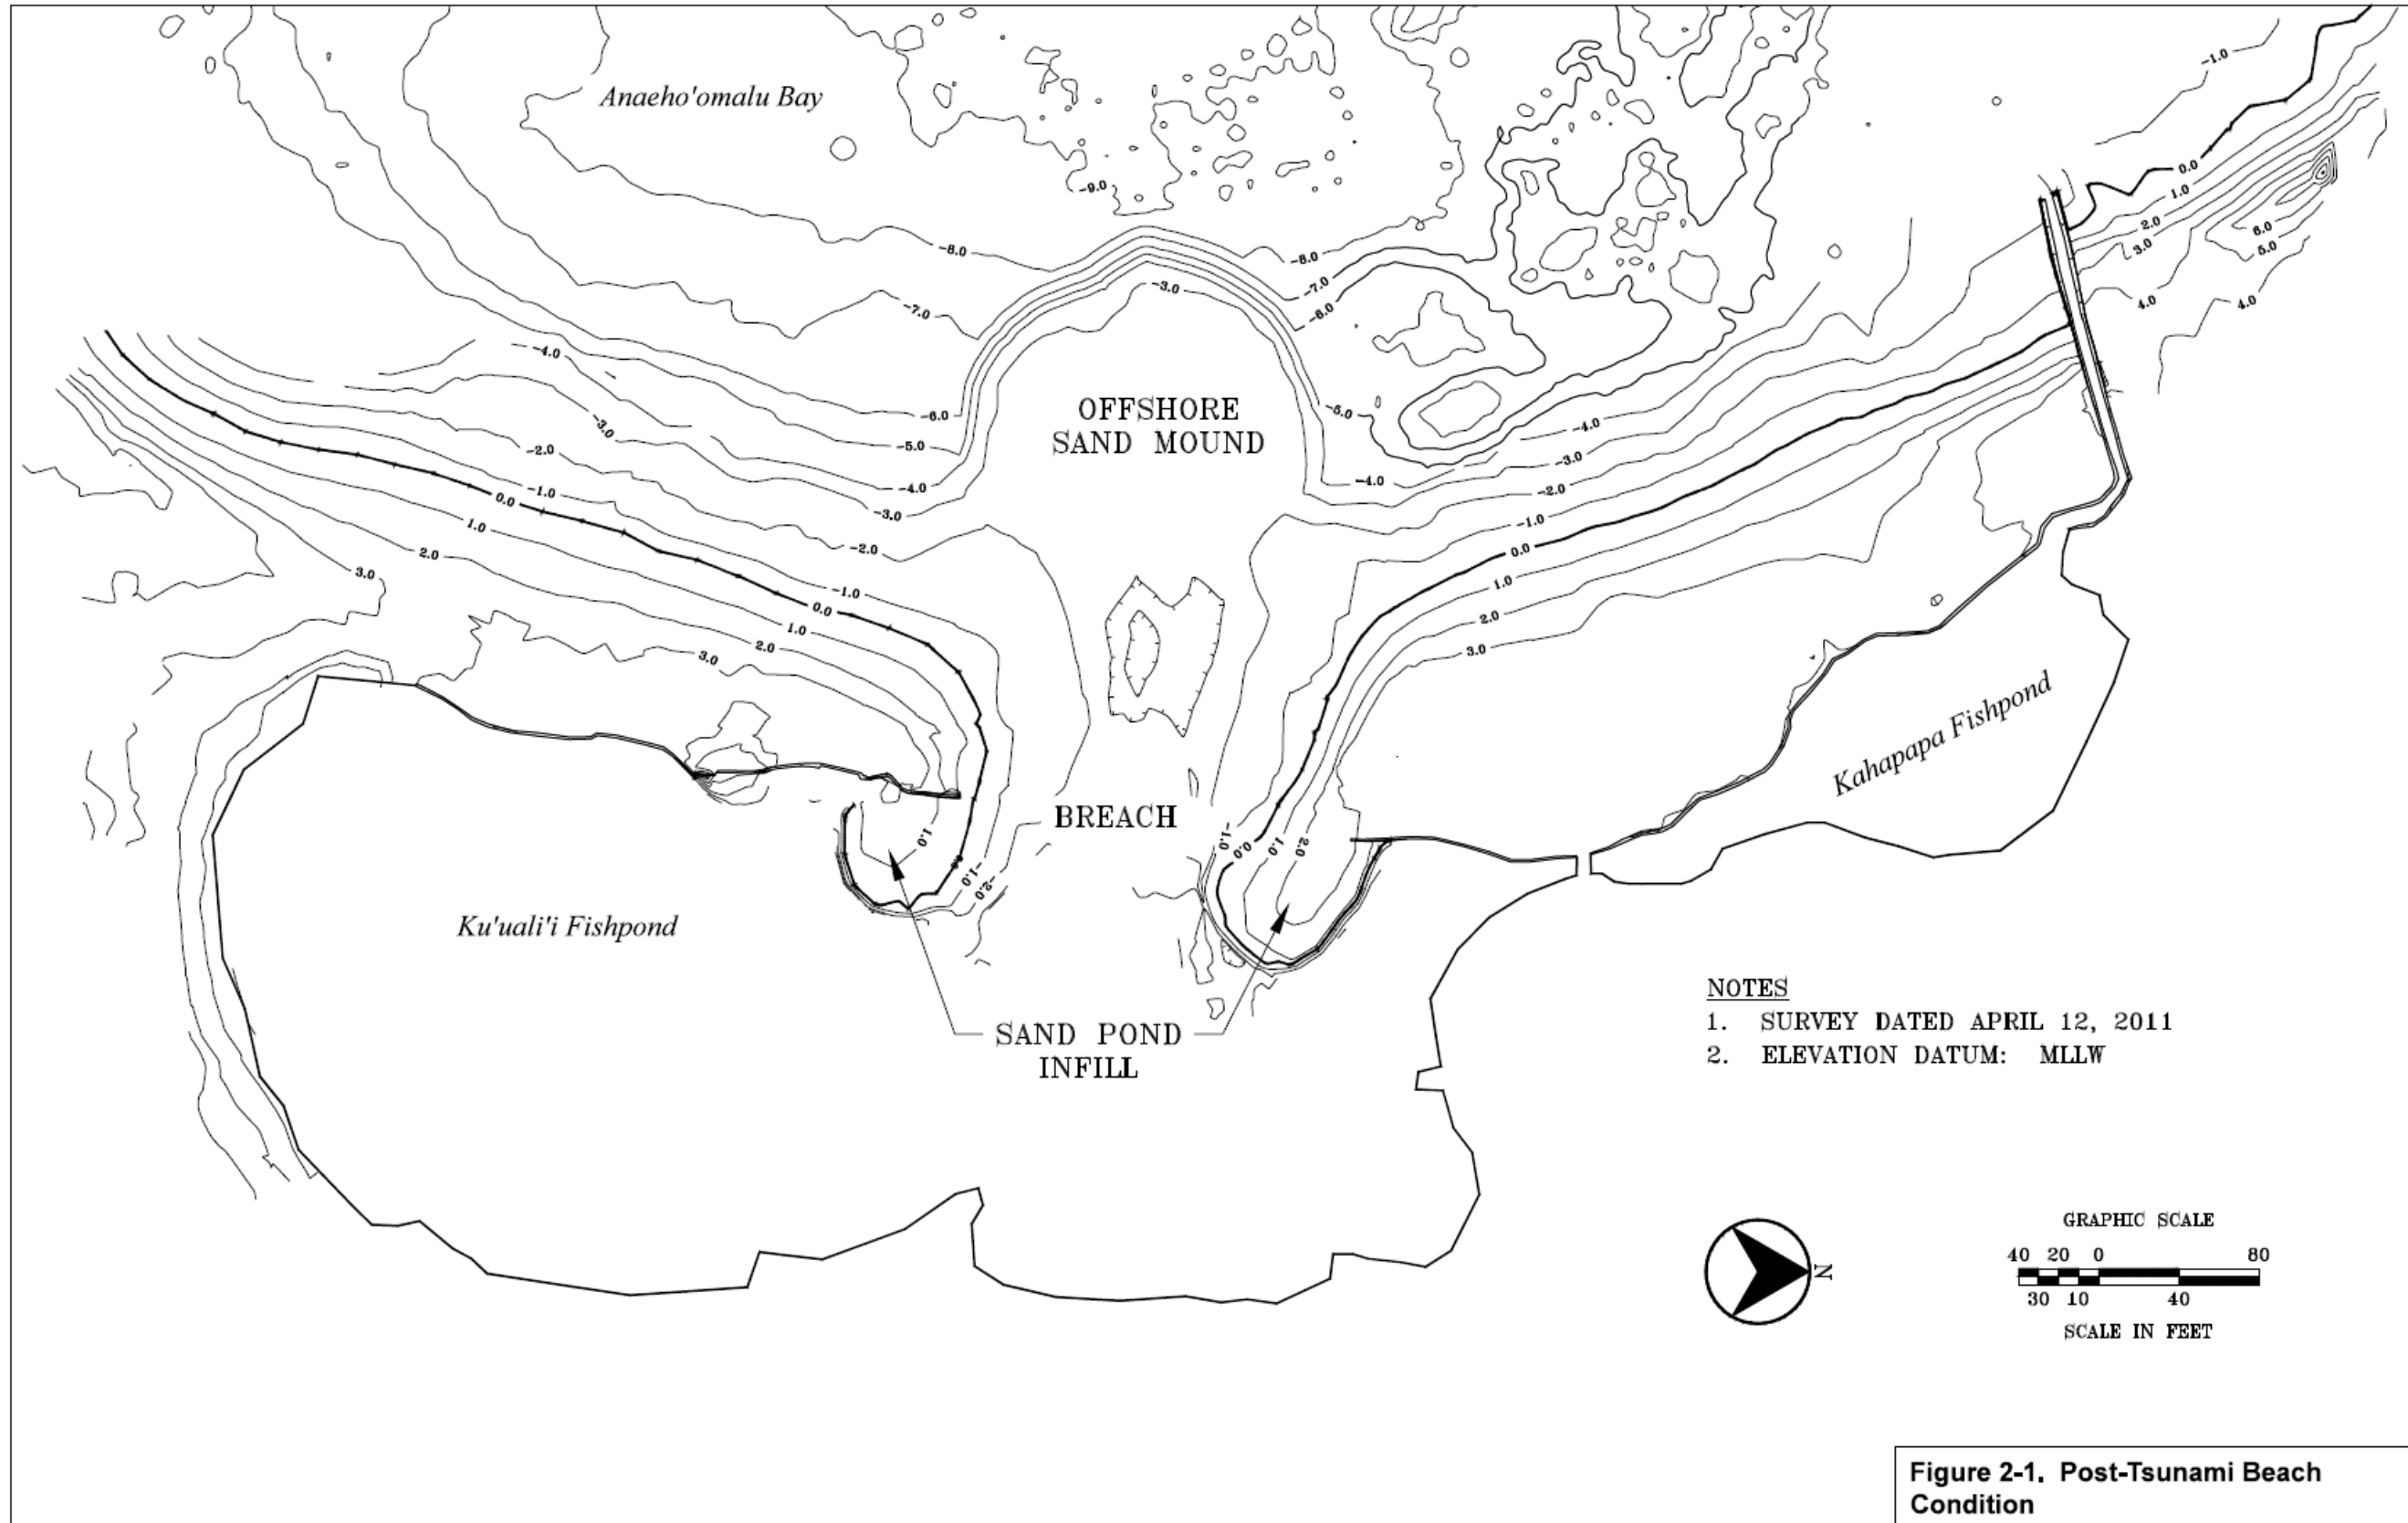
Figure 2-1 Post Tsunami Beach Condition

The pre-tsunami beach size and configuration has been estimated using the November 10, 2010 satellite image (Figure 1-4). Overlaying this on the post-tsunami topographic survey an estimated 9,000 cubic yards (cy) of sand was removed from the beach during creation of the breach and other tsunami damage. The majority of beach sand loss due to the tsunami occurred in the immediate vicinity of the breach; however sand loss lowered the beach crest elevation about 1-foot along virtually the entire length of the beach.

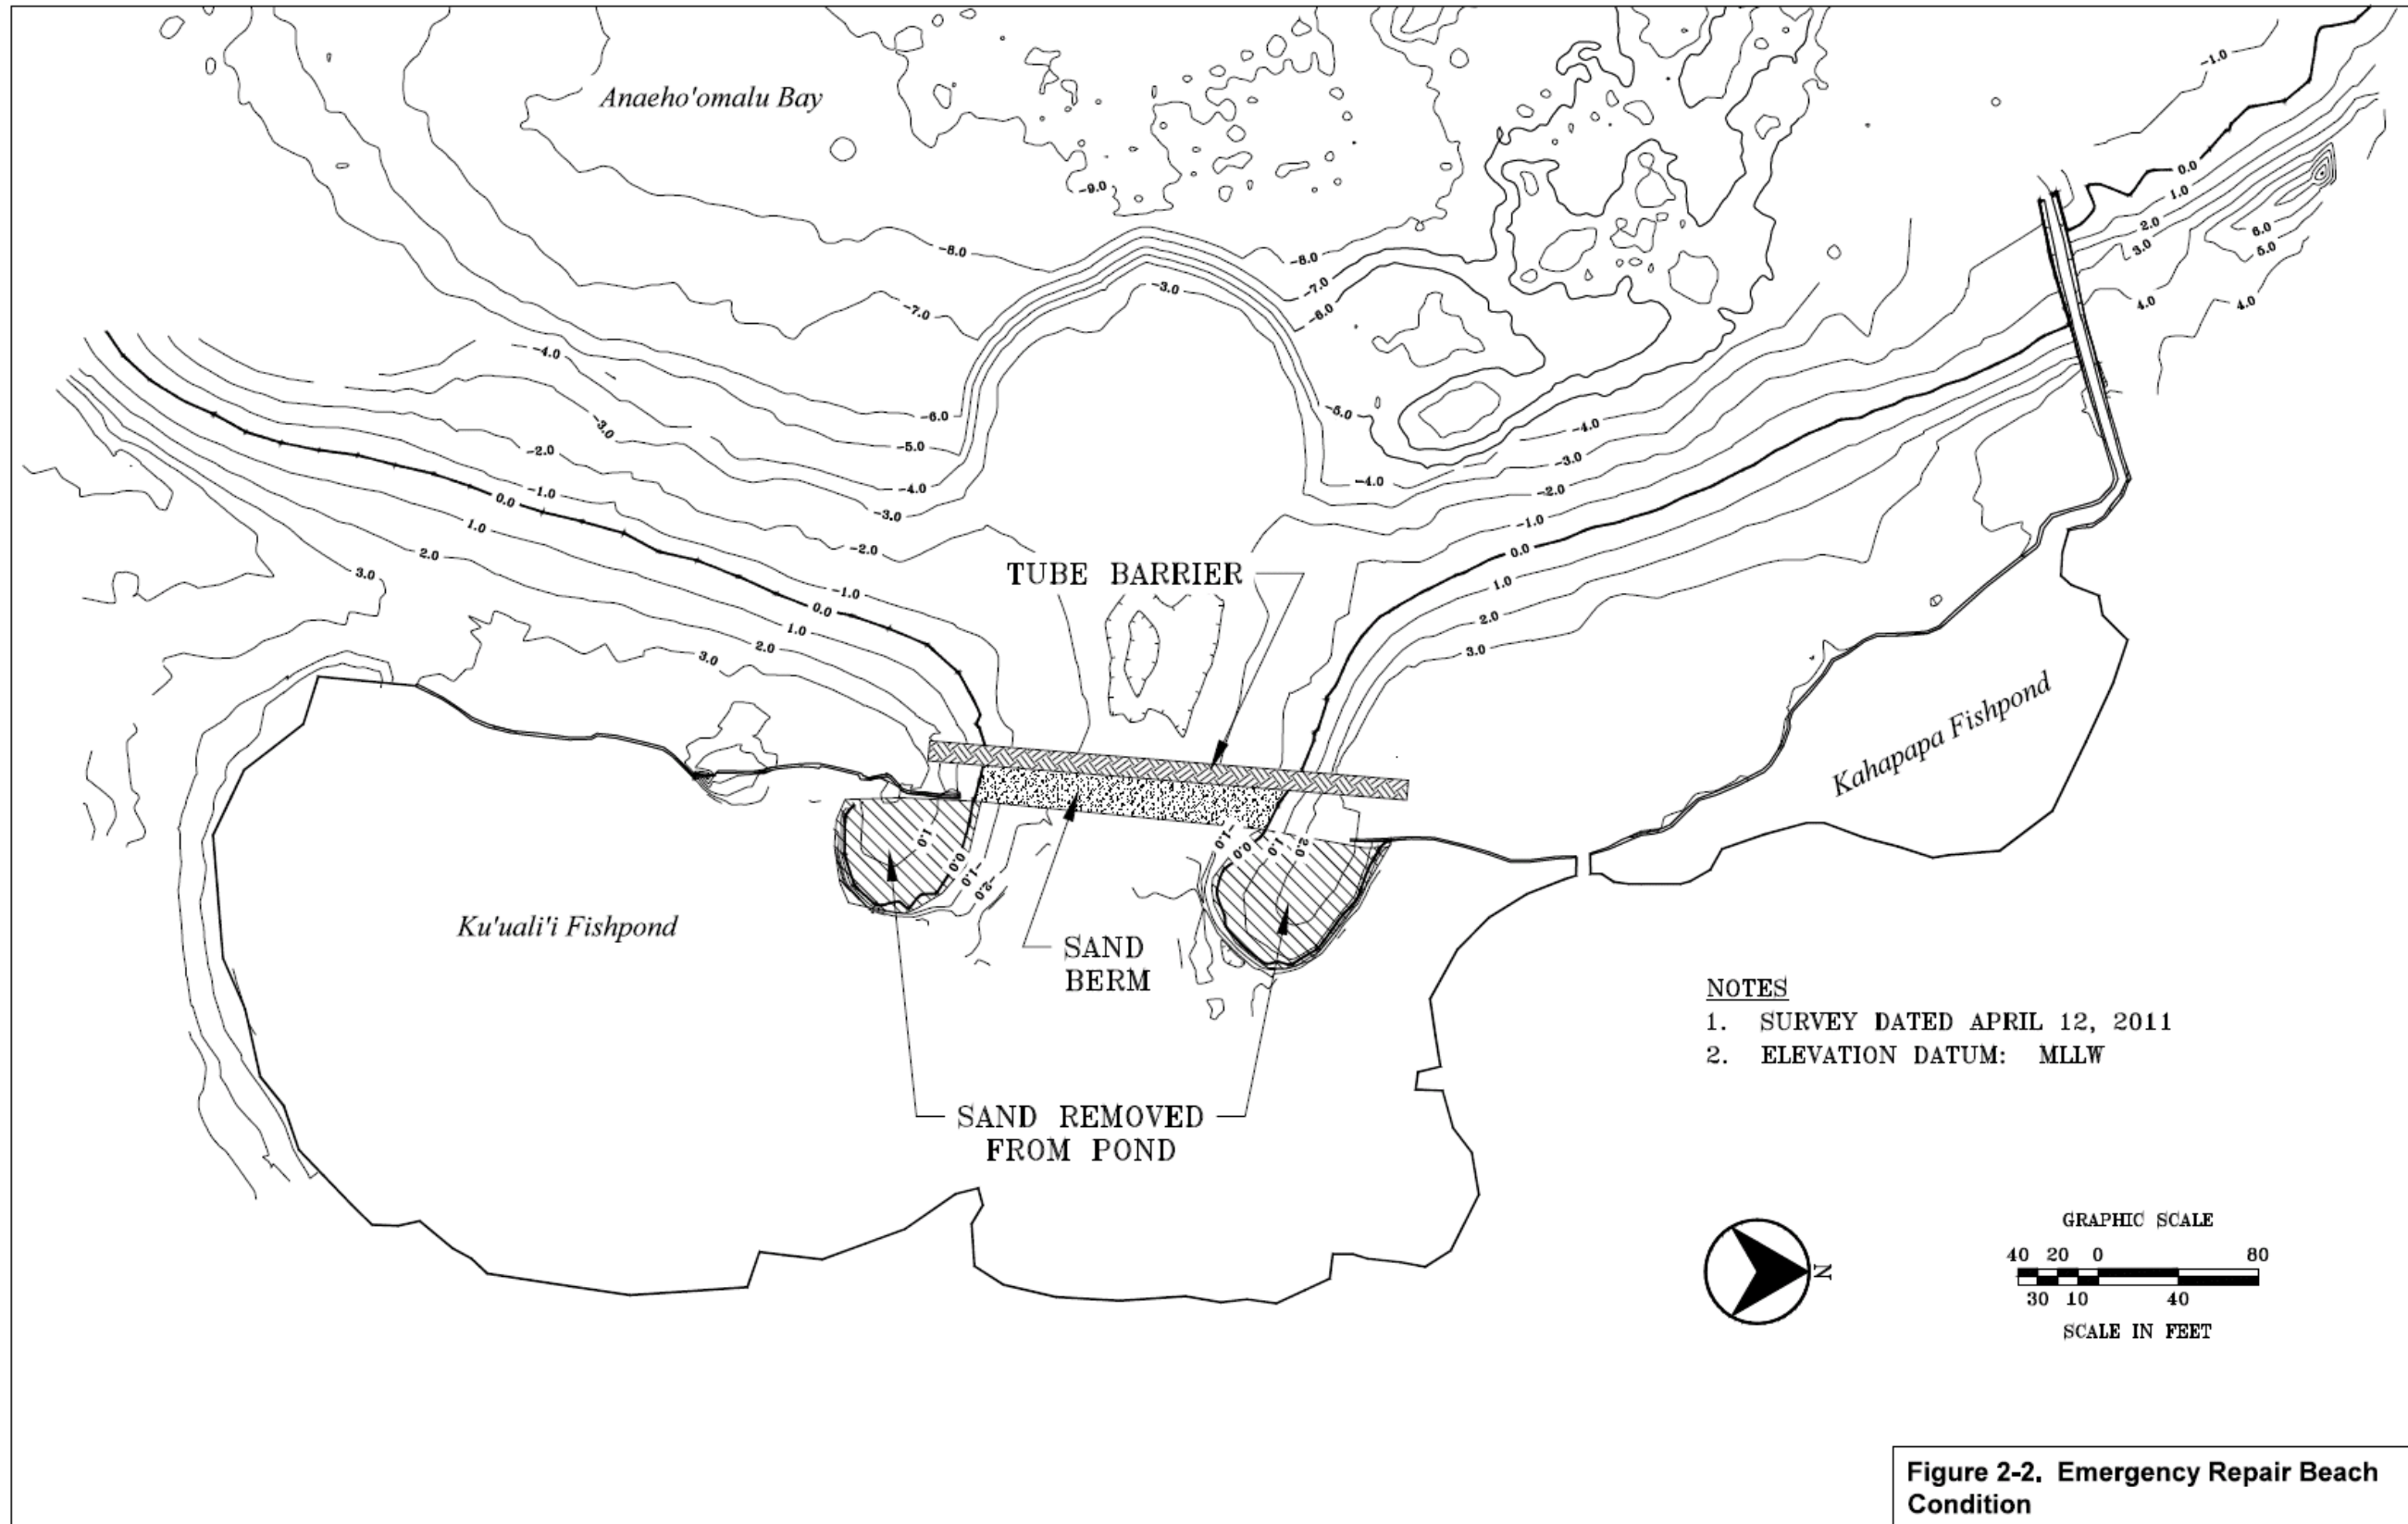
Figure 2-2 Emergency Repair Beach Condition

Emergency repairs used sand which had been pushed into the pond on either side of the breach to both fill the tubes and anchor them by creating a minor beach berm on their mauka side. Currently there are six (6) 120 foot long by 15 foot circumference sand filled tubes placed across the breach section to form a 240-foot-long barrier, stacked in a two tubes on the bottom and one on top configuration. Mauka of the tubes is an approximately 25 foot wide sand berm separating them from Kuualii fishpond. The post-emergency repair beach configuration is shown on Figure 2-2.

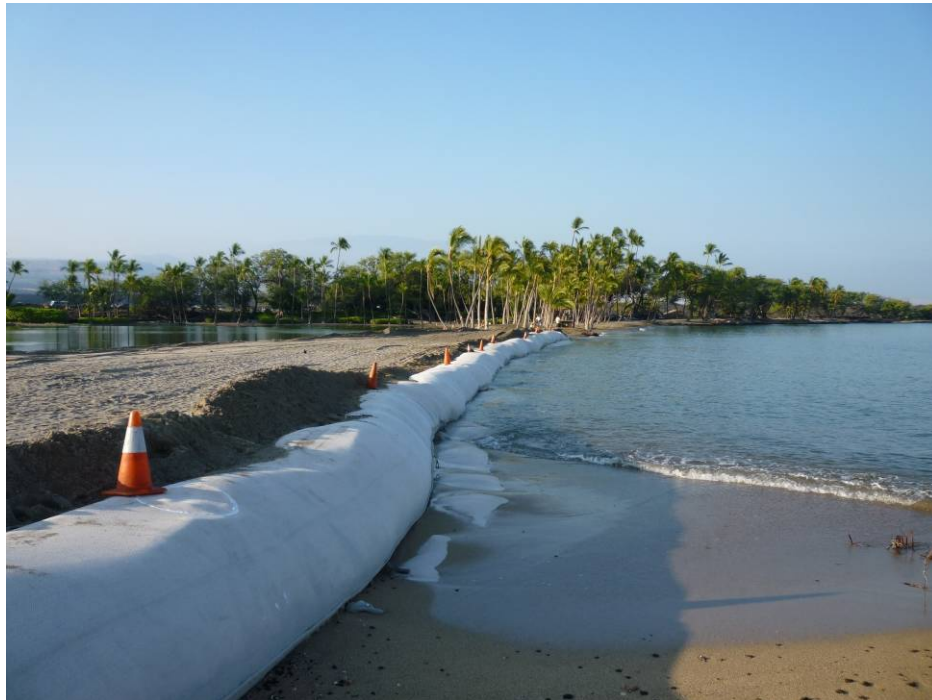
Figure 2-3 Post Emergency Repair, August 4, 2011

Following the emergency repair work the beach immediately began to repair itself, with sand accreting on and in front of the geotube barrier. Figure 2-3 and Figure 2-4 show the shoreline fronting the geotubes immediately post-construction (August 4, 2011), and seven months later on March 14, 2012. The bottom tubes are completely buried and only a portion of the top tube is visible, and a natural beach slope extends seaward of the tubes. A topographic survey update on February 25, 2012 shows that approximately 3,400 cy yards of the sand lost during the tsunami has returned to the beach, leaving a current net loss of 5,600 cy from pre-tsunami conditions. The February 25, 2012 survey is shown on Figure 2-5. The nearshore sand mound seaward of where the breach was located has diminished in volume; presumably some of this sand has been moved back on to the beach by wave action.

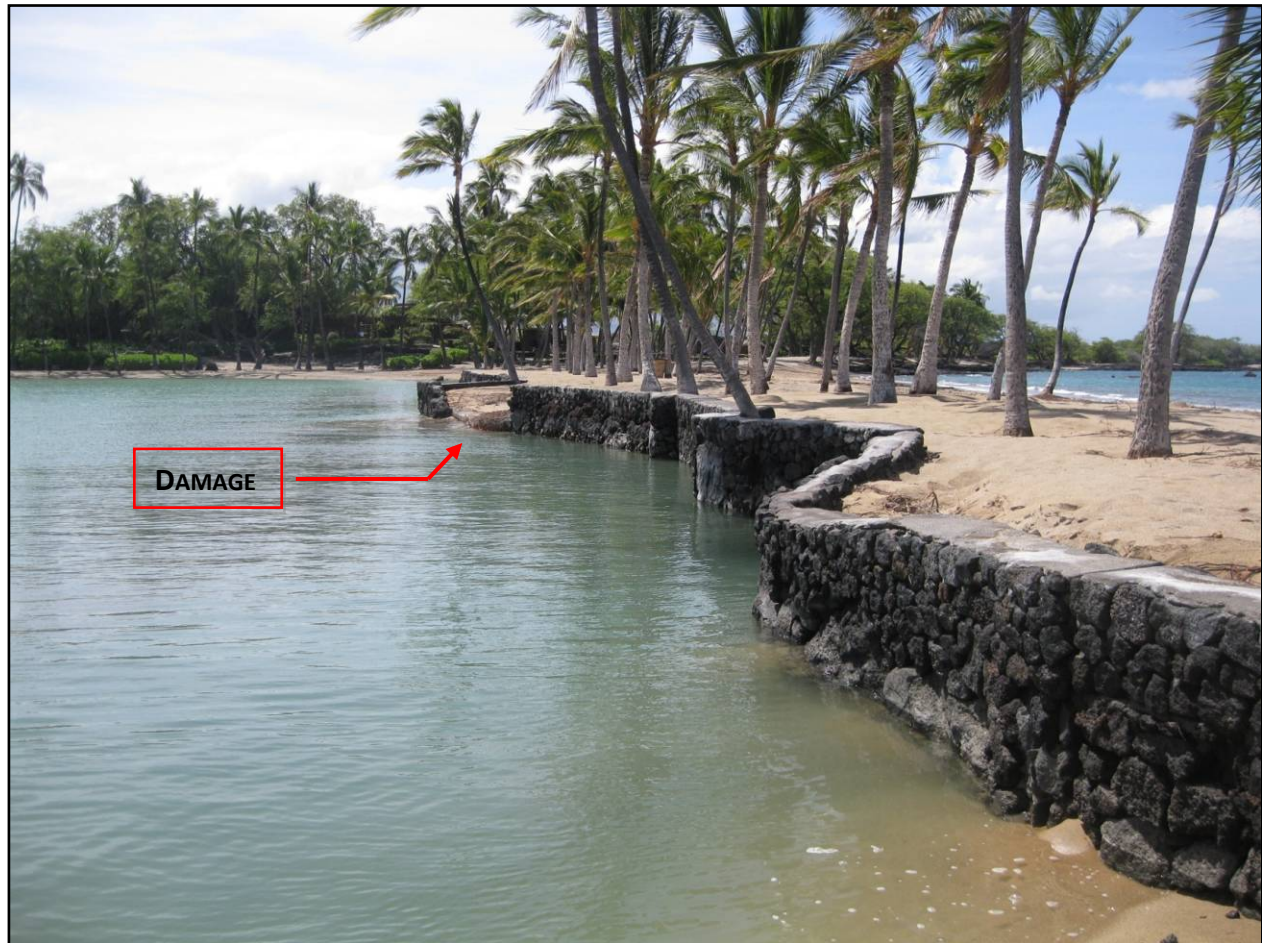
Figure 3-1 Existing Pond Wall

The existing pond wall is shown on Figure 3-1. It is not known exactly how the existing wall was constructed. Anecdotal information indicates that large boulders were placed first to form a stable mass, then the cemented stacked rock wall was constructed on top of the boulders. Evidence of this construction technique can be seen at some of the damaged wall locations. Approximately 220 linear feet of wall was completely destroyed by the tsunami, and other sections are now leaning and appear unstable. Given the extensive damage it is recommended that the entire wall be replaced. It is proposed to rebuild the wall in a manner similar to its original construction. The remains of the existing wall will be removed, and sand excavated from around it to expose the boulder foundation. Where boulders are not found, or have settled to a position below the low tide water level, additional boulders will be placed as necessary to create a stable mass. The top of this mass boulder foundation will be at approximately mean lower low water. A cemented stone wall (cement-rubble-masonry or CRM) will then be built on top of the boulder foundation, with a top elevation of +6 feet.

A typical wall section is shown on Figure 3-2. The wall would be of standard gravity wall design, and the first course of wall stone would be carefully placed to key it into the boulder foundation. The total wall length would be approximately 690 linear feet. The wall is designed to replicate the existing feature and tie in to the undamaged portions of the remaining pond walls.
