# South Kohala Stream Corridor Assessment Erosion Monitoring, and Recommendations

## **Final Report September 2014**

Prepared for:  
Hawaii Department of Land and Natural Resources  
Division of Aquatic Resources  
1151 Punchbowl St, Room 330  
Honolulu, HI 96813

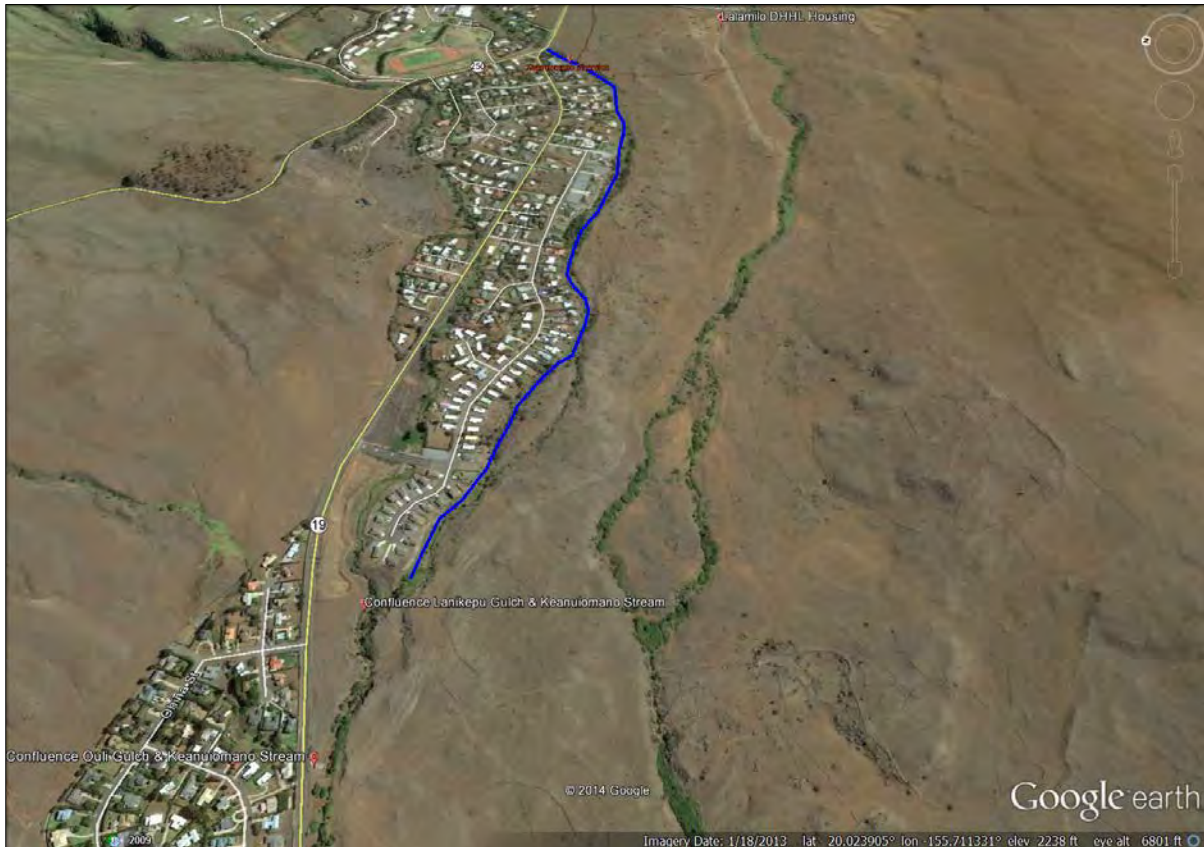
**Photo 12. Keanu'i'omanō Stream, nearby development**

Blue line depicts Keanu'i'omanō Stream; houses to the left and their OSDS close to stream.

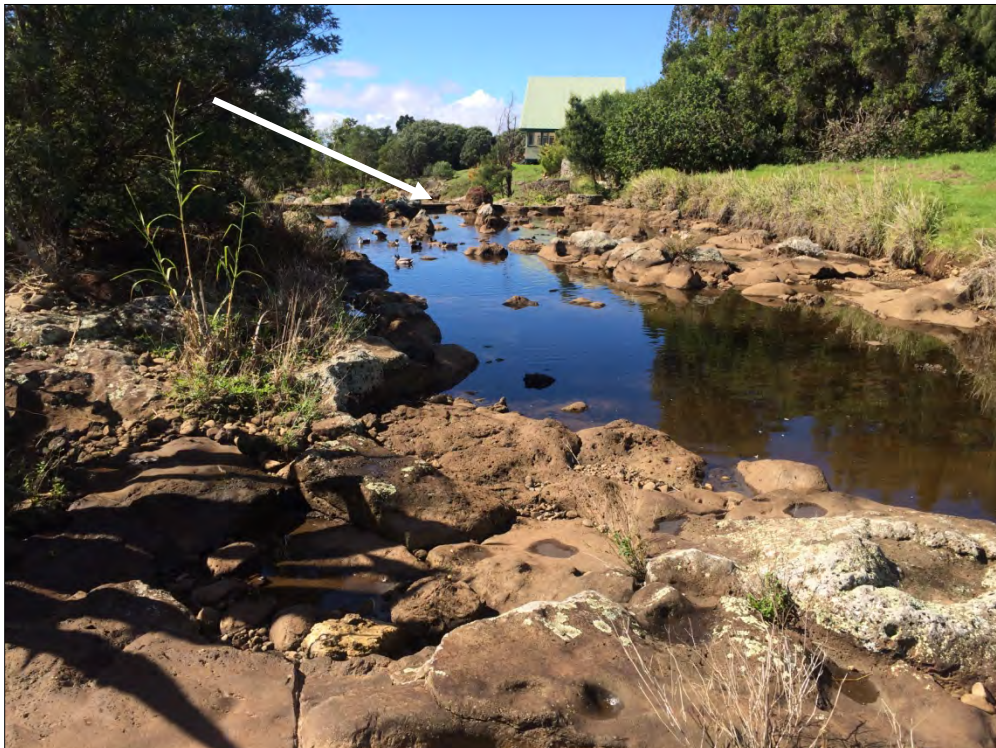
**Photo 13. Rock Dam on Keanu'i'omanō Stream**

Rock and mortar dam on stream near Waiaka Street.

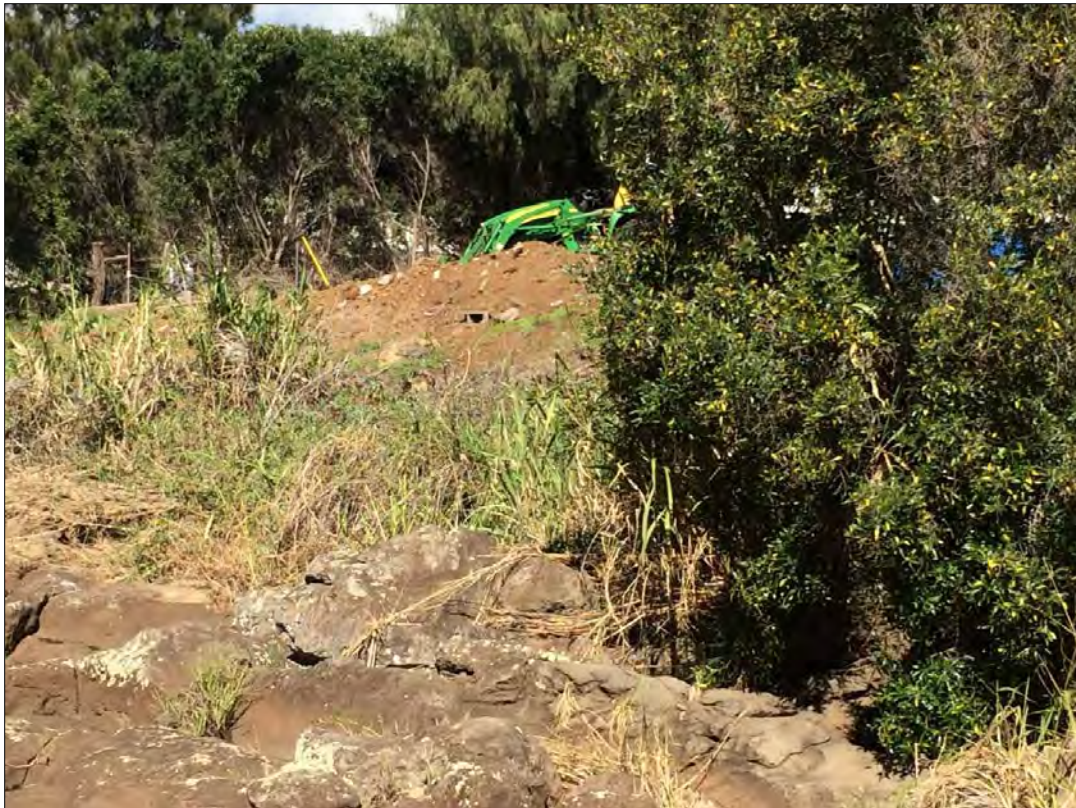
**Photo 15. Stream Encroachment**

Uncontained fill above Keanu'i'omanō Stream.

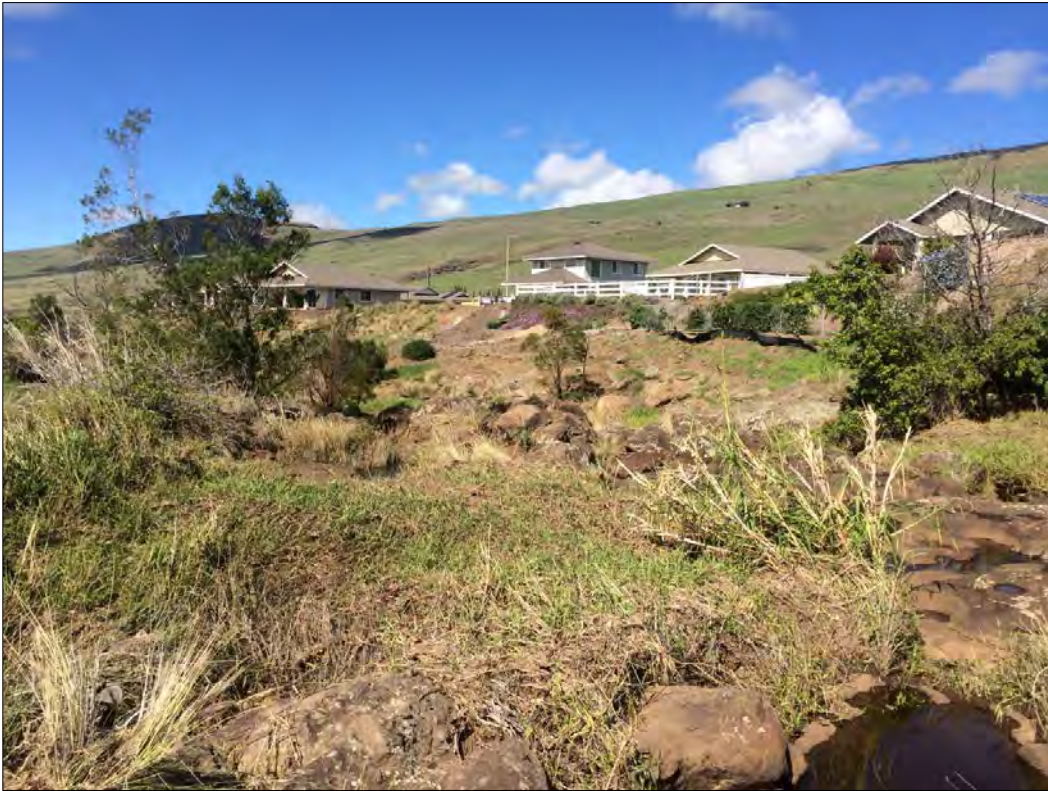
**Photo 16. Failing BMP along Stream**

Silt fence failing; fill material was observed in active channel.

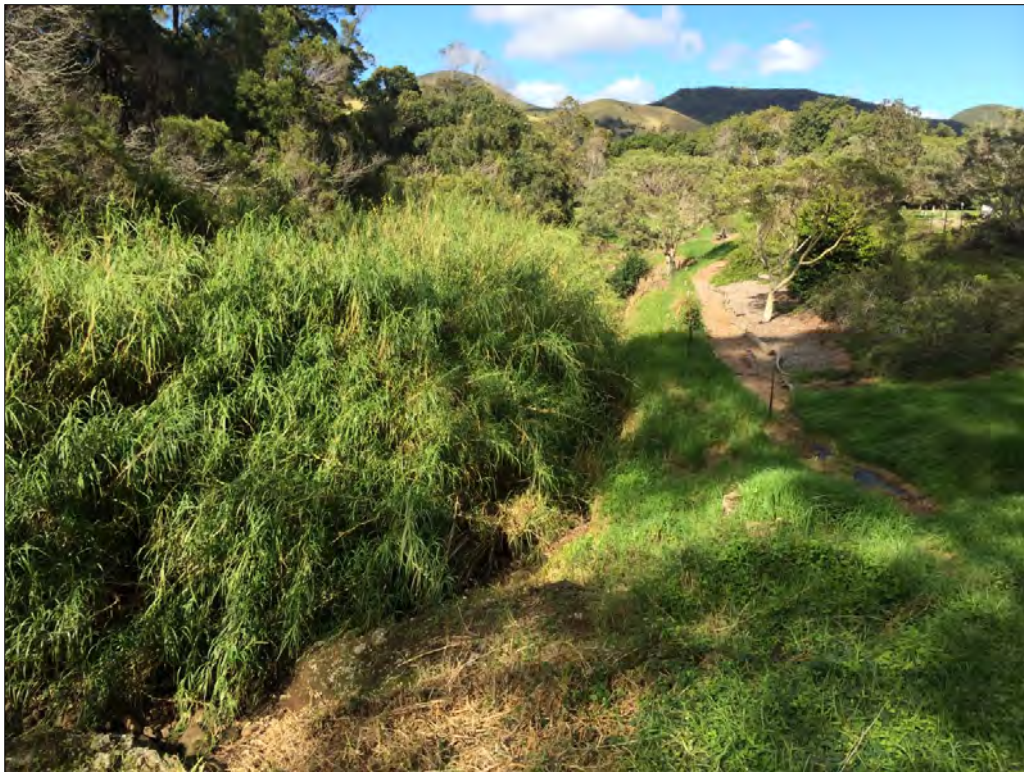
**Photo 17. Waikoloa Stream, channel blockage**

Section of Waikoloa Stream along trail below Waimea Nature Park.

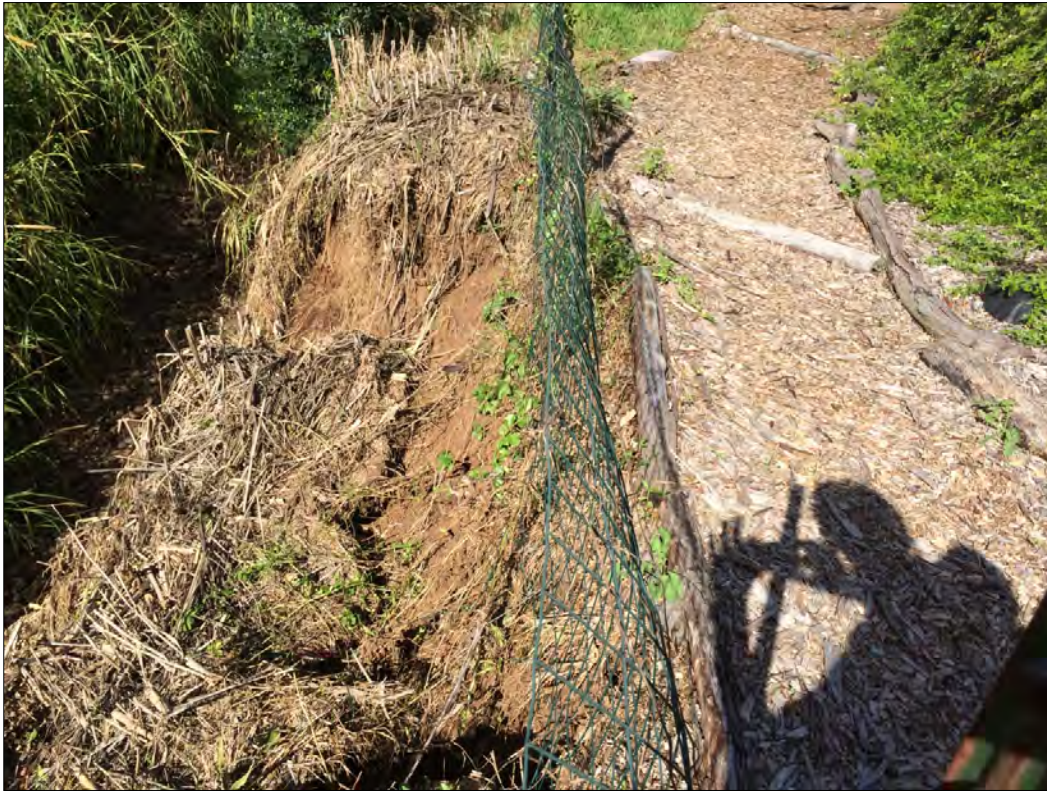
**Photo 18. Waikoloa Stream, failing stream bank**

Section of Waikoloa Stream bank within Waimea Nature Park.

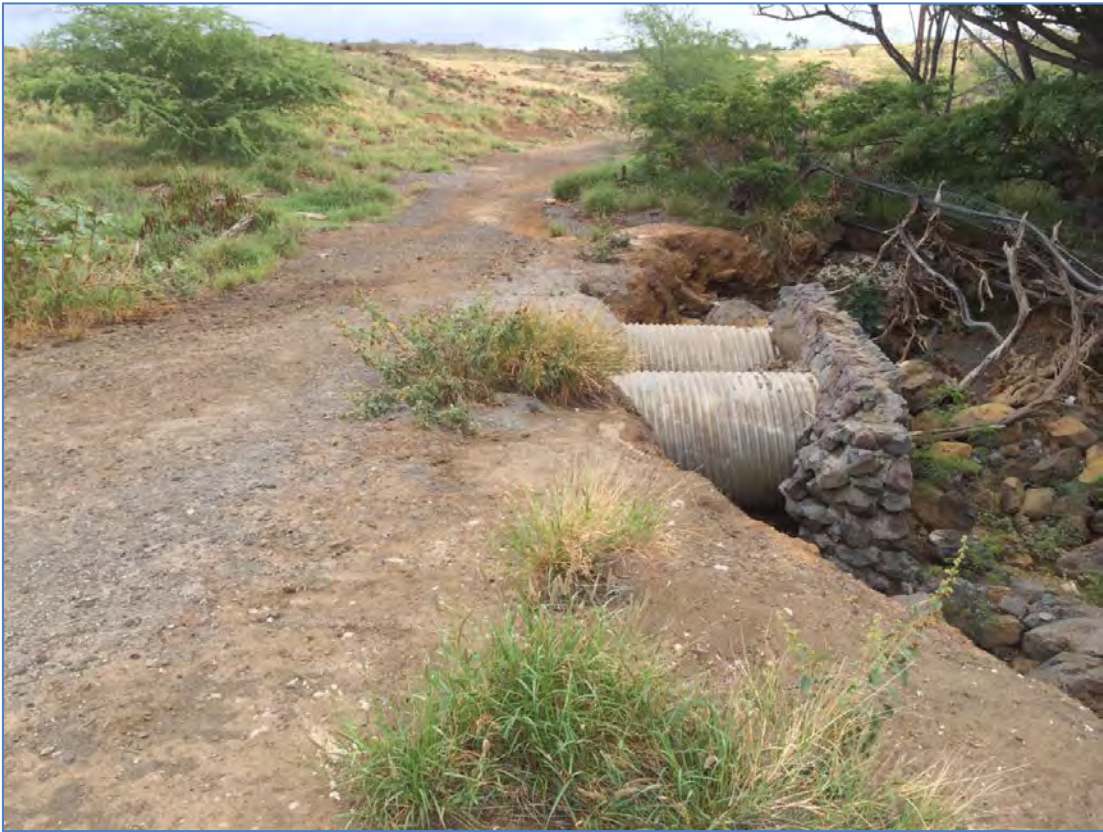
| Site ID | Issue | Location | Land Owner | Priority | Management Measures |
|---|---|---|---|---|---|
| 1PL | Road runoff / Erosion | Mau'u Mae Beach to Kukui Point | Queen Emma Foundation | Low | Road improvement with drainage system |

**Photo 1. 1PL, Road erosion near Mau'umae Beach**

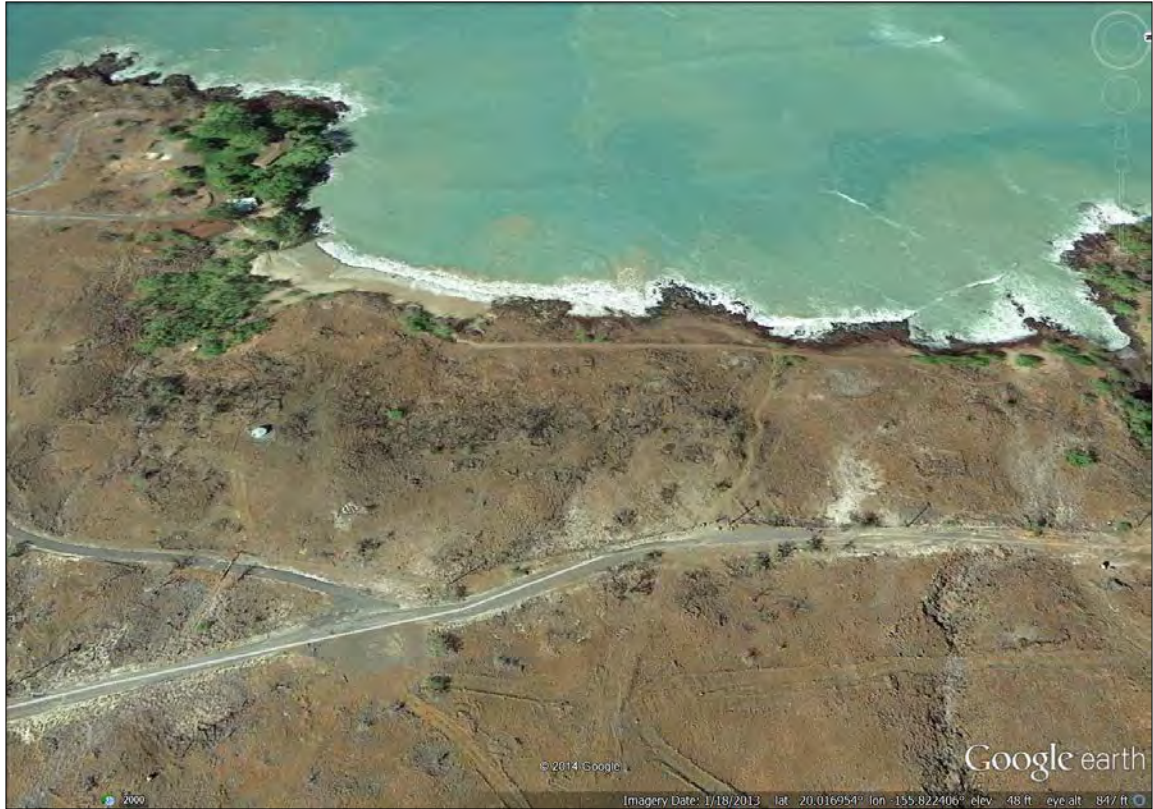
| Site ID | Issue | Location | Land Owner | Priority | Management Measures |
|---|---|---|---|---|---|
| 2PG | Burned area / Barren | Mau'u Mae Beach | Queen Emma Foundation | Low | Install ground cover, revegetate |

**Photo 2. 2PG, Burned area at Mau'umae Beach**

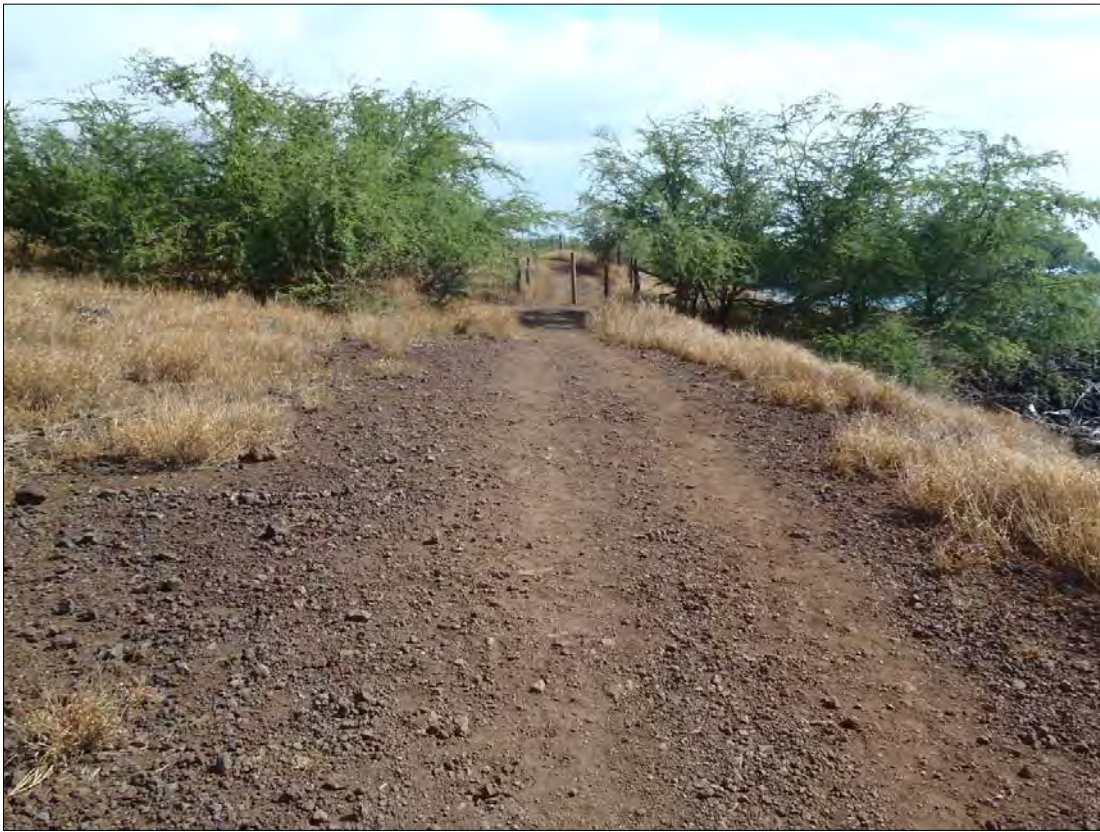
**Photo 3. 4PL, Trail erosion on trail leading to Mau'umae Beach**

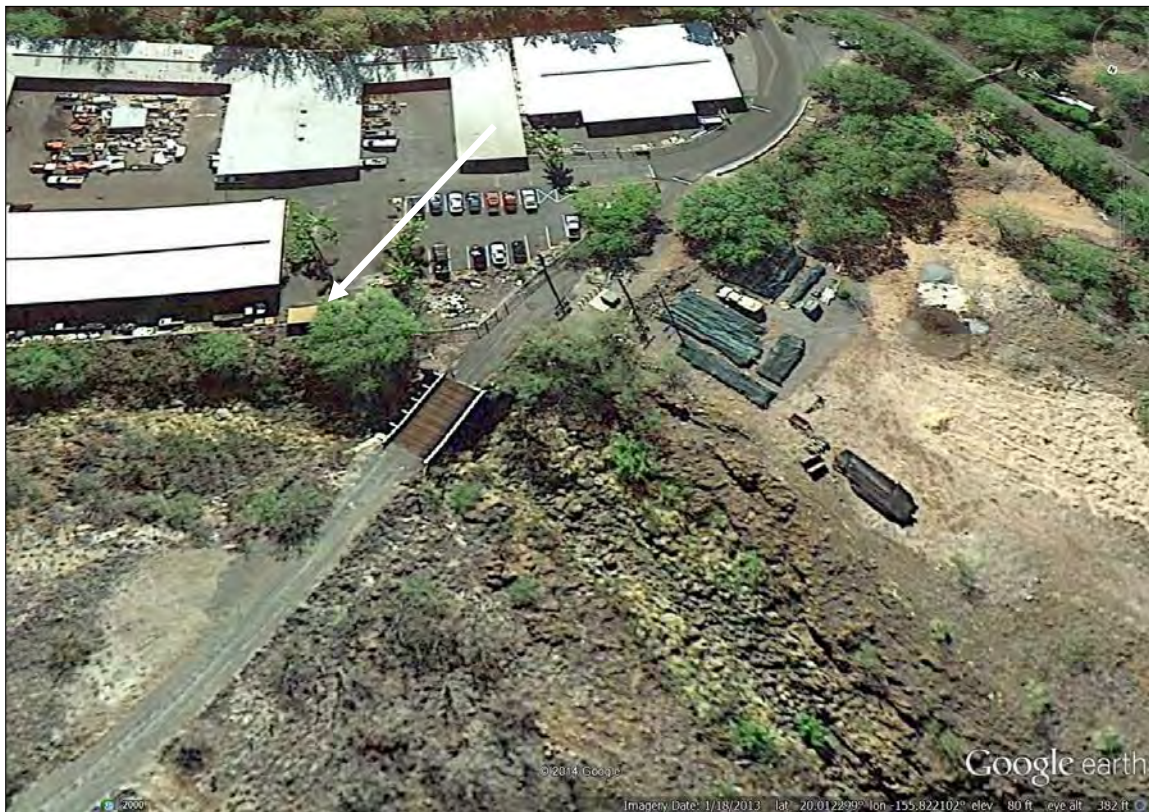
**Photo 4. 4PT, Maintenance yard runoff**

Edge of parking lot located on top of Wai'ula'ula Stream south bank.

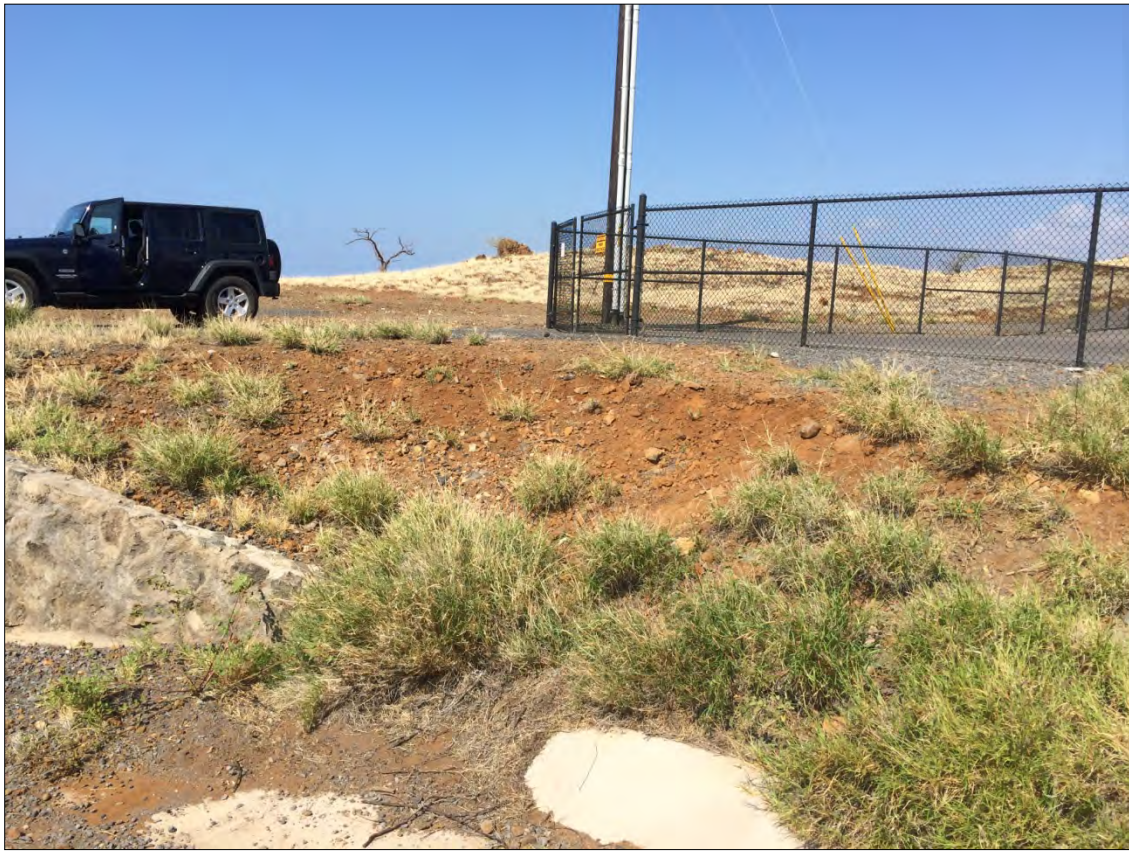
**Photo 5. 6PT, Runoff/Sediment**

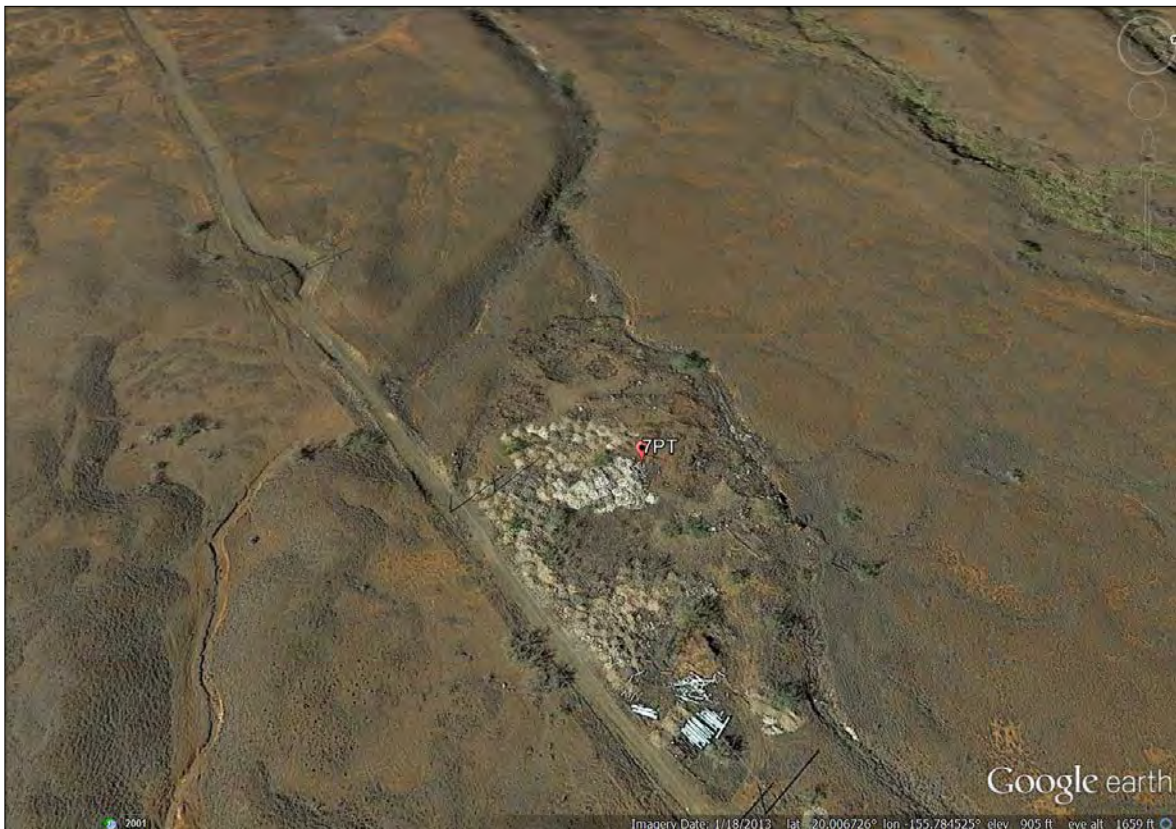
| Site ID | Issue | Location | Land Owner | Priority | Management Measures |
|---|---|---|---|---|---|
| 7PT | Dump | 1.15 miles east of shared property line of Mauna Kea Development and Mauna Kea Plantation Estates | Mauna Kea Development and Mauna Kea Plantation Estates | Low | Requires investigation to prepare recommended solution |

**Photo 6. 7PT, Rubbish Pile**

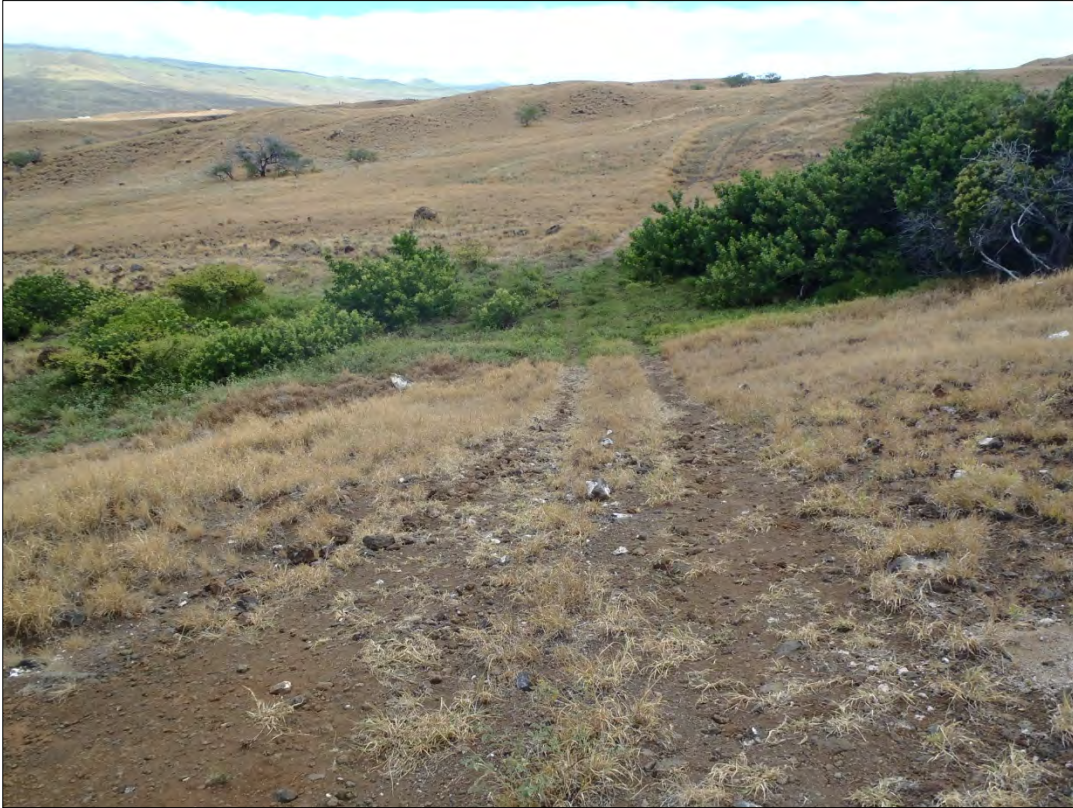
**Photo 7. 9PT, Dirt Road Crossing Channel**

Dirt road approach over southern branch of Waikoloa Stream, State Land

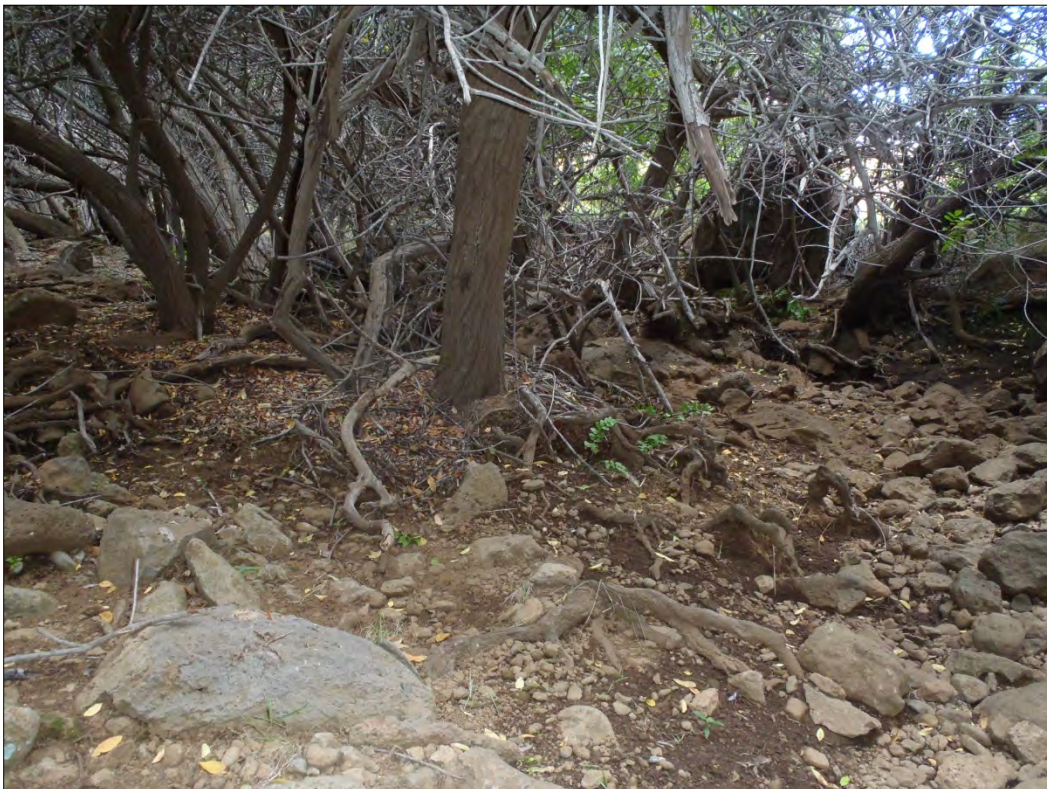
| Site ID | Issue | Location | Land Owner | Priority | Management Measures |
|---|---|---|---|---|---|
| 10PL | Degraded channel, sedimentation/erosion from cattle | Southern branch Waikoloa Stream above confluence with Keanu'i'omanō Stream | State of Hawaii | Low | Fencing |
| 11PL | Degraded channel, sedimentation/erosion from cattle | Middle branch Waikoloa Stream above confluence with Keanu'i'omanō Stream | State of Hawaii | Low | Fencing |

**Photo 8. 10PL & 11PL, General Landscape Image**

Channel on Waikoloa Stream branch, typical of accessible stream areas where cattle bed.

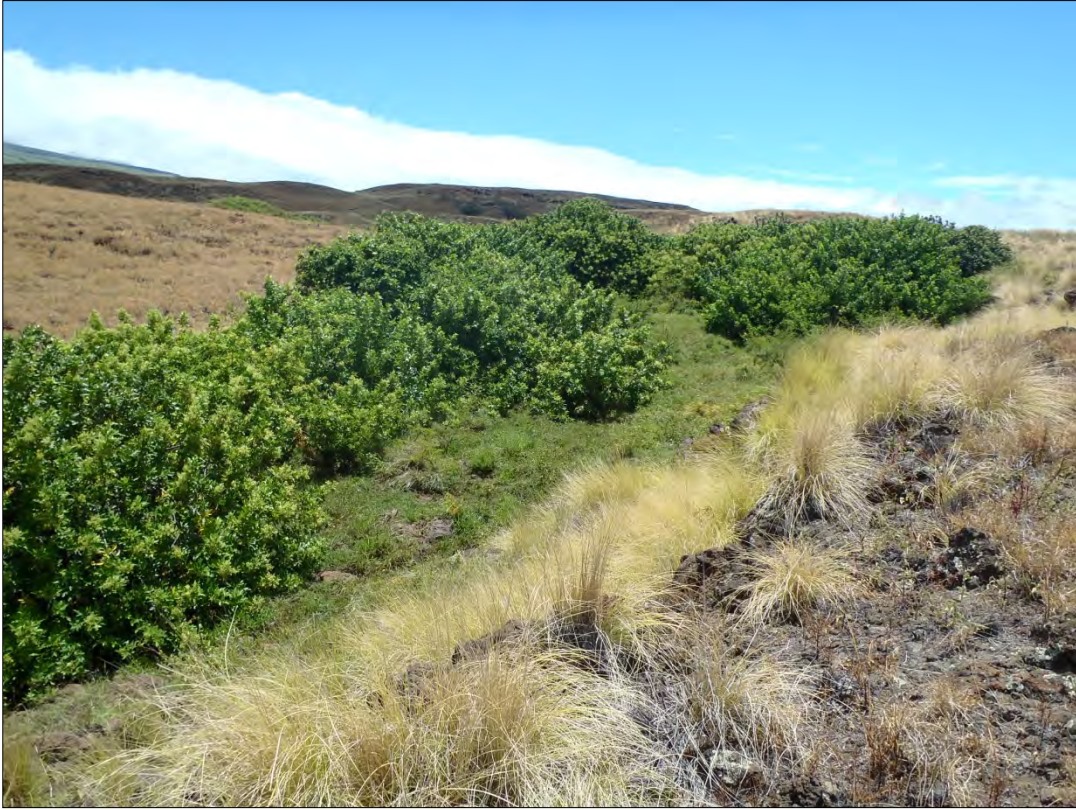
| Site ID | Issue | Location | Land Owner | Priority | Management Measures |
|---|---|---|---|---|---|
| 16PG | Stream damage by cattle | Waikoloa Stream downstream of DHHL-State parcel | State of Hawaii | Low | Fencing, bioengineering |

**Photo 9. 16PG, Typical Stream**

Representative image of stream zone within trees, varying degree of stream channel damage

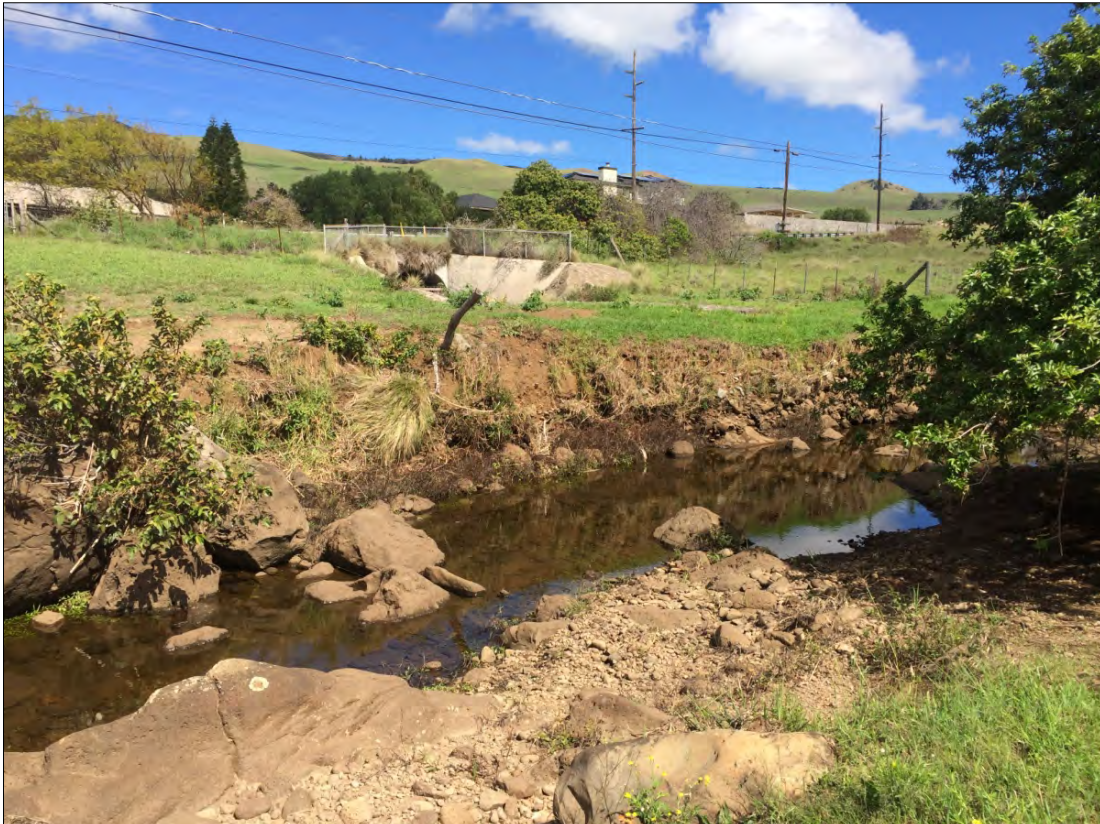
**Photo 10. 14PT, Ouli Gulch Outfall**

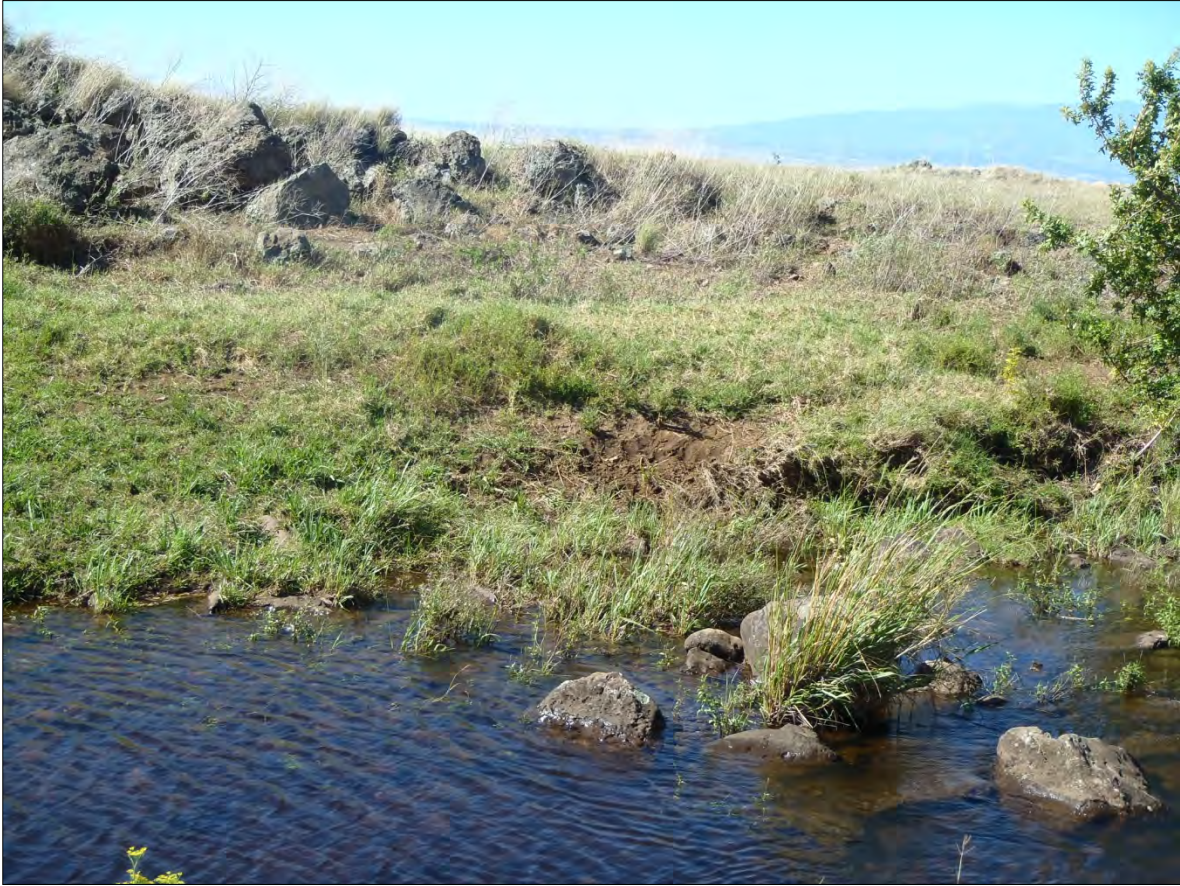
**Photo 11. 15PT, Bank Damage**

Keanu'i'omanō Stream access point by cattle at perennial pool

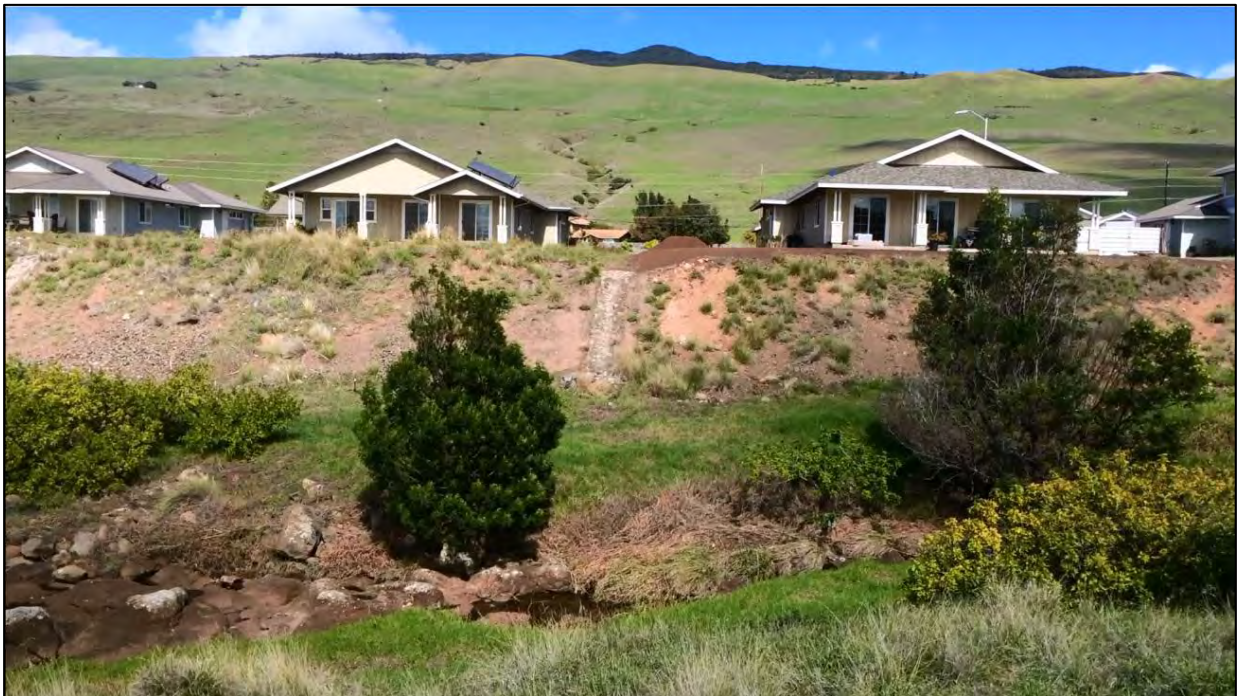
| Site ID | Issue | Location | Land Owner | Priority | Management Measures |
|---|---|---|---|---|---|
| 28PL | Exposed banks, sediment input | Waiaka Subdivision | Various UK | Medium | Stabilization using bioengineering practices |

**Photo 12. 28PL, Exposed Stream Banks**

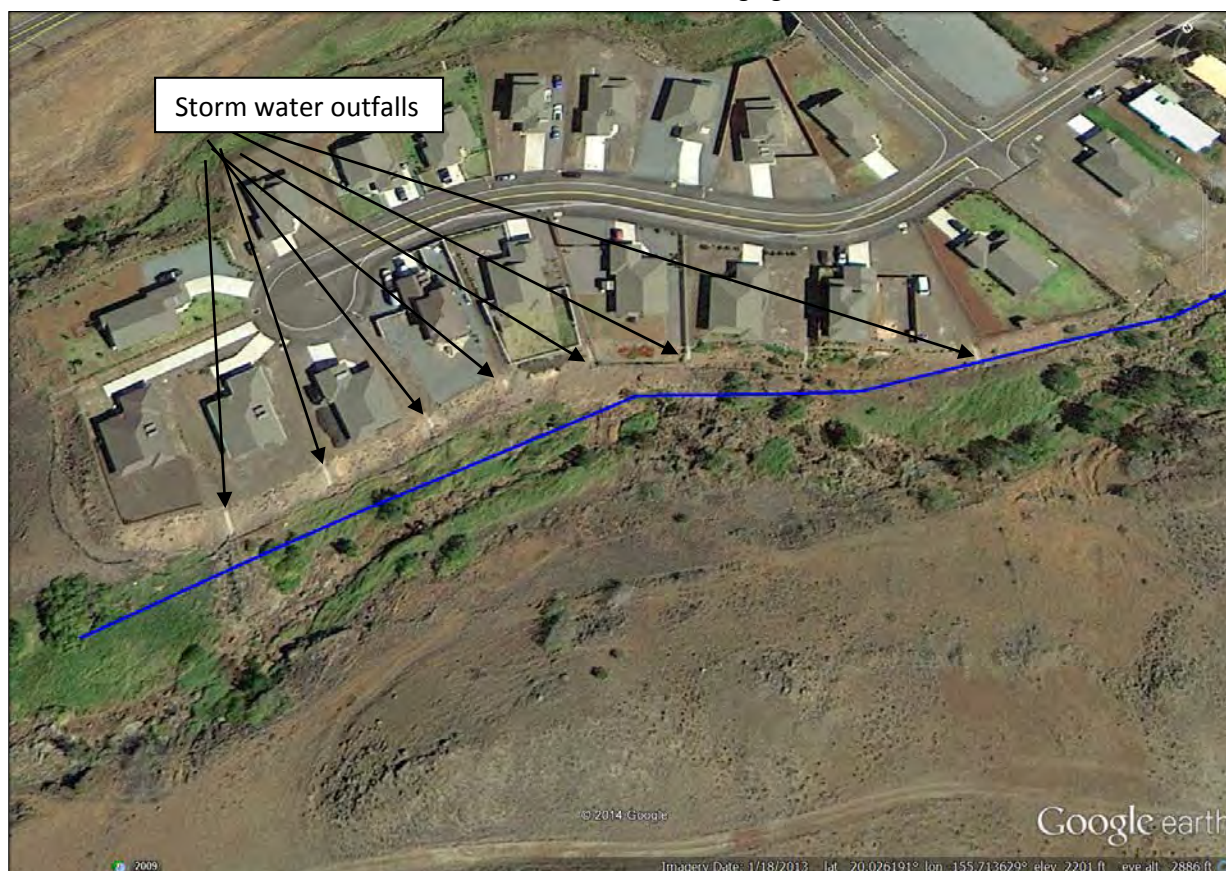
**Photo 13. 29PT, Storm Water Outfalls**

Waiakea subdivision home lots with rock mortar swales discharging onto bank of Keanu'i'omanō Stream

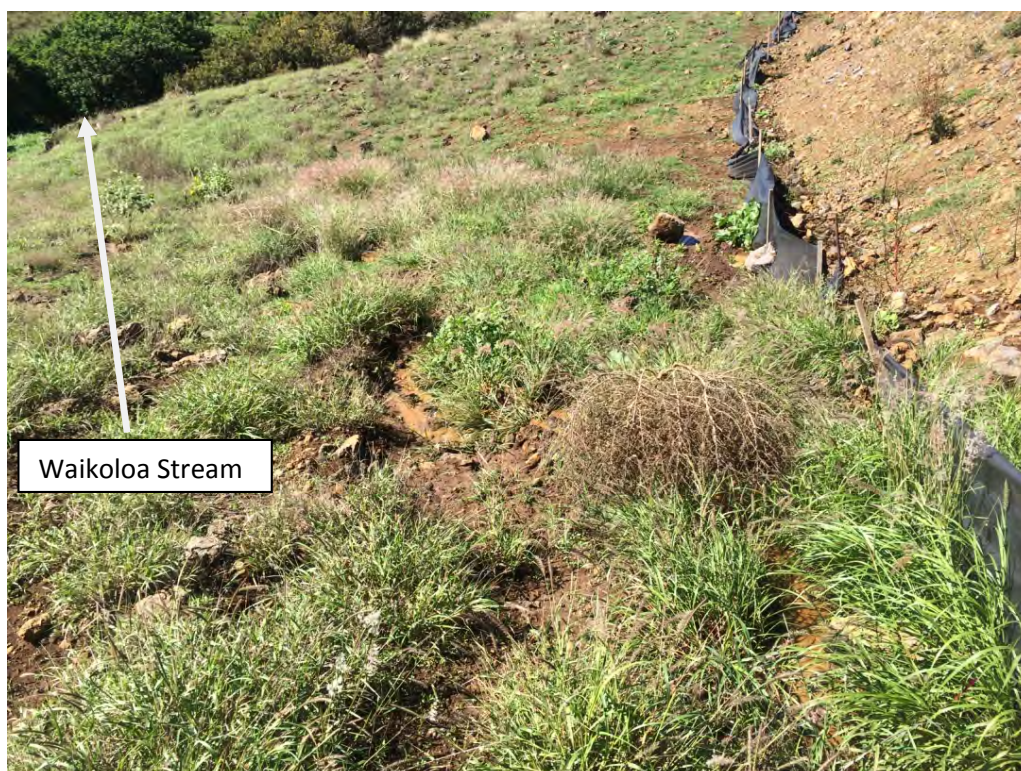
**Photo 14. 13PG, Waikoloa Stream - Sediment runoff from stock pile on DHHL land**

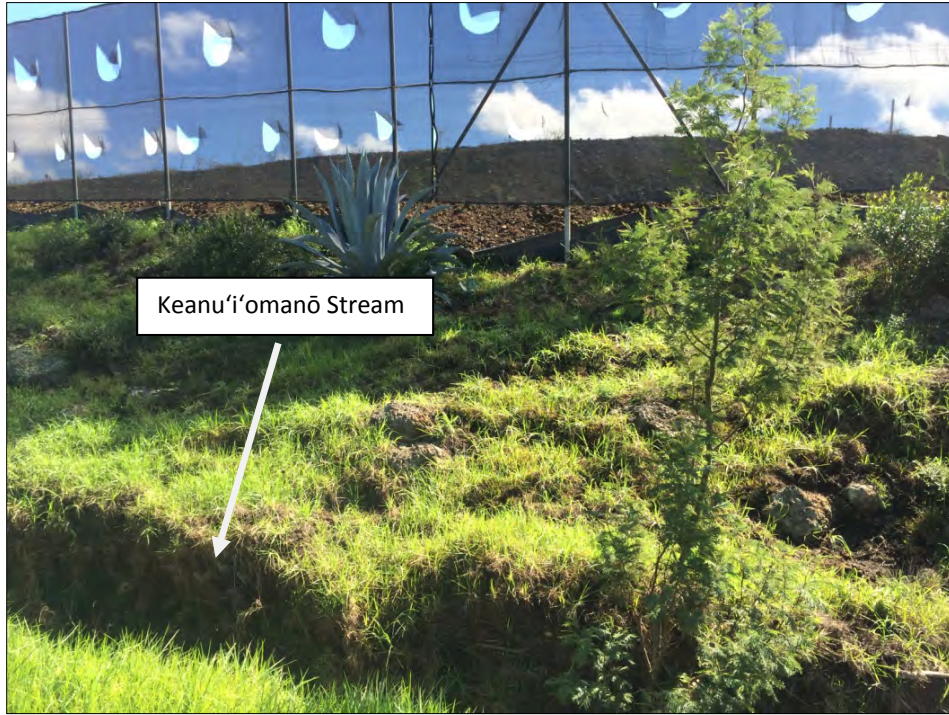
**Photo 15. 24PG, Cut and Fill Piles**

Cut and fill piles spilling onto floodway and stream from State DHHL Lalamilo development

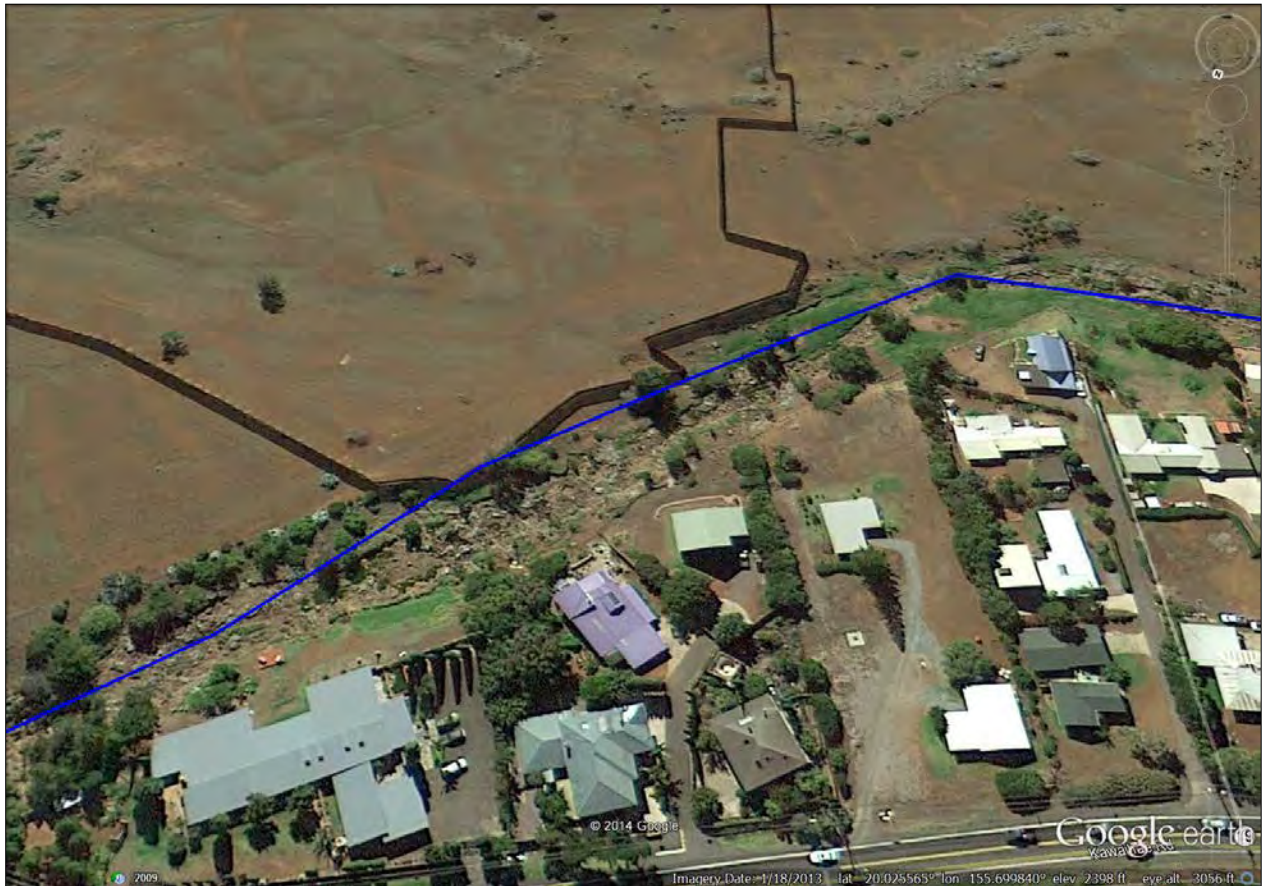
**Photo 16. 24PG, Aerial View of State DHHL Lalamilo Development**

Build out foot print within black fence area appears to encroach onto floodway along Keanu'i'omanō Stream

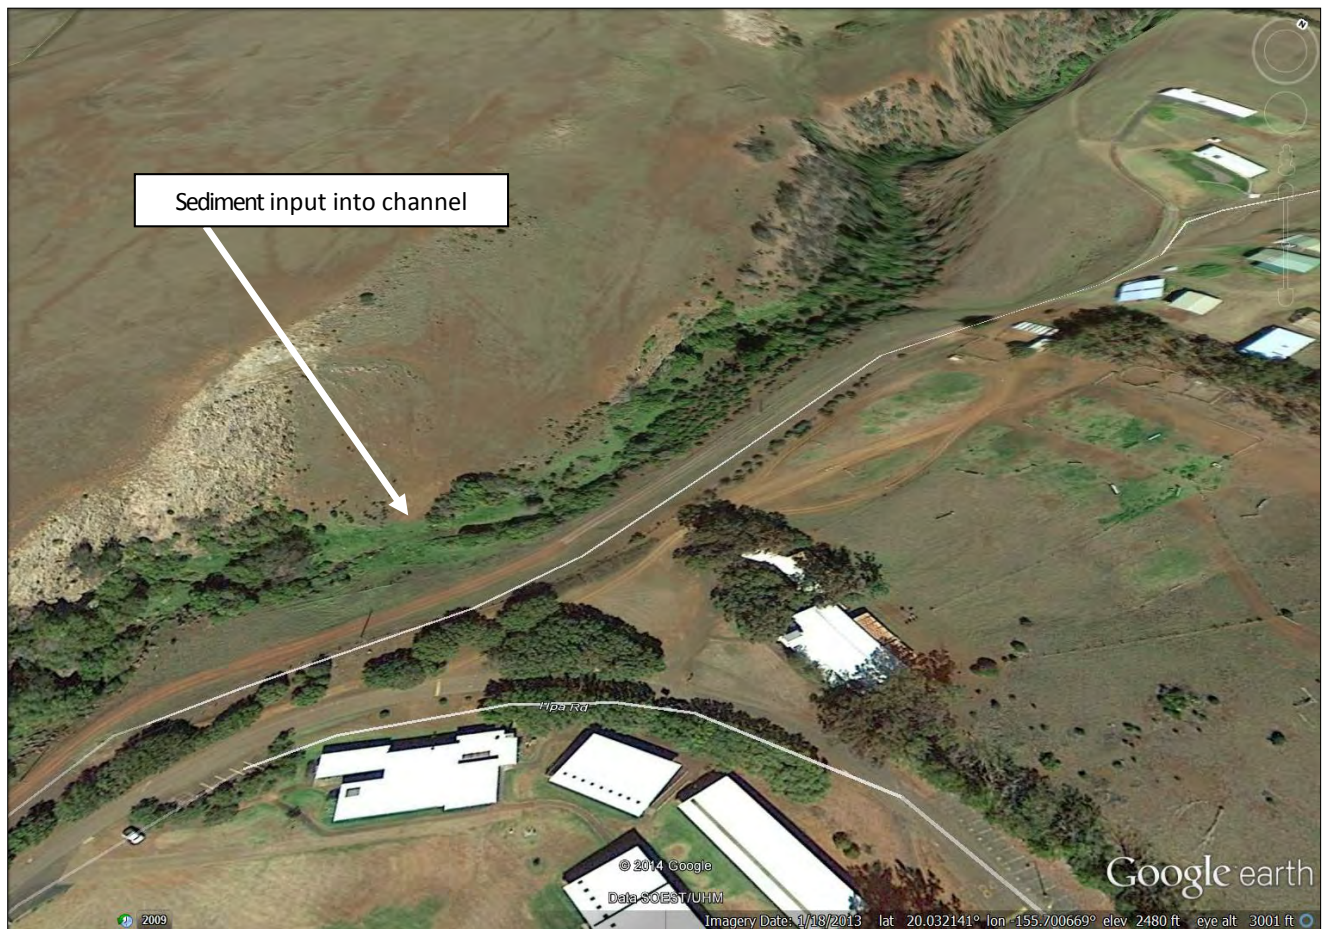
**Photo 17. 17PG, Eroding slope above Lanikepu Gulch on Parker Ranch**

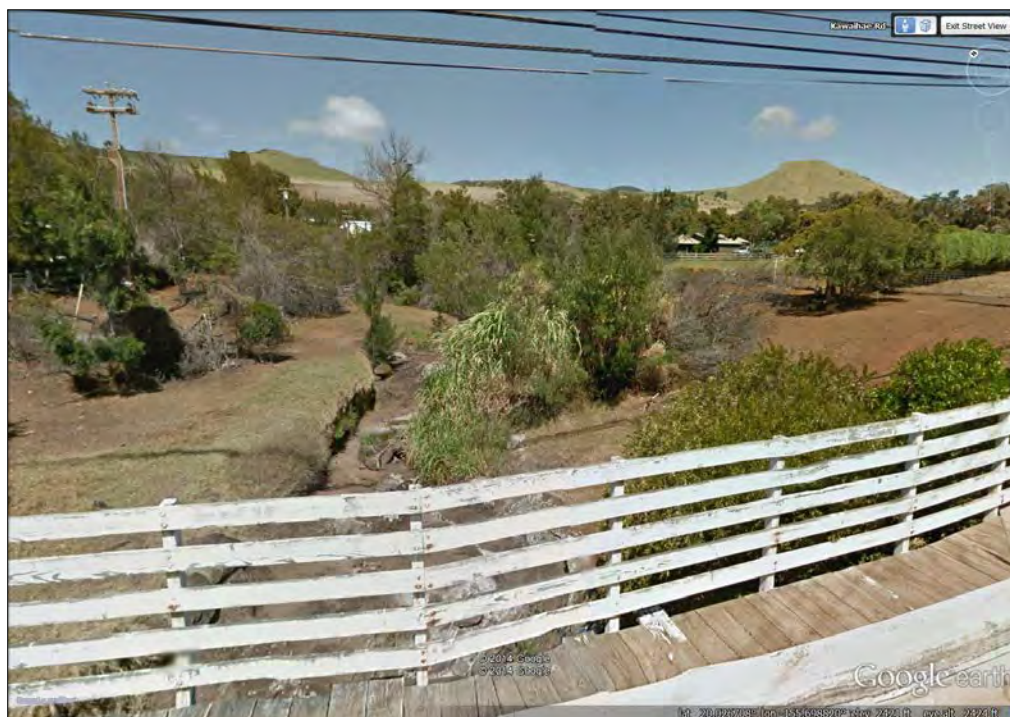
**Photo 18. 21PL, Keanu'i'omanō Stream**

Erosion and unstable bank of stream, zone used for pasture
