# South Kohala Stream Corridor Assessment Erosion Monitoring, and Recommendations

## **Final Report September 2014**

Prepared for:  
Hawaii Department of Land and Natural Resources  
Division of Aquatic Resources  
1151 Punchbowl St, Room 330  
Honolulu, HI 96813

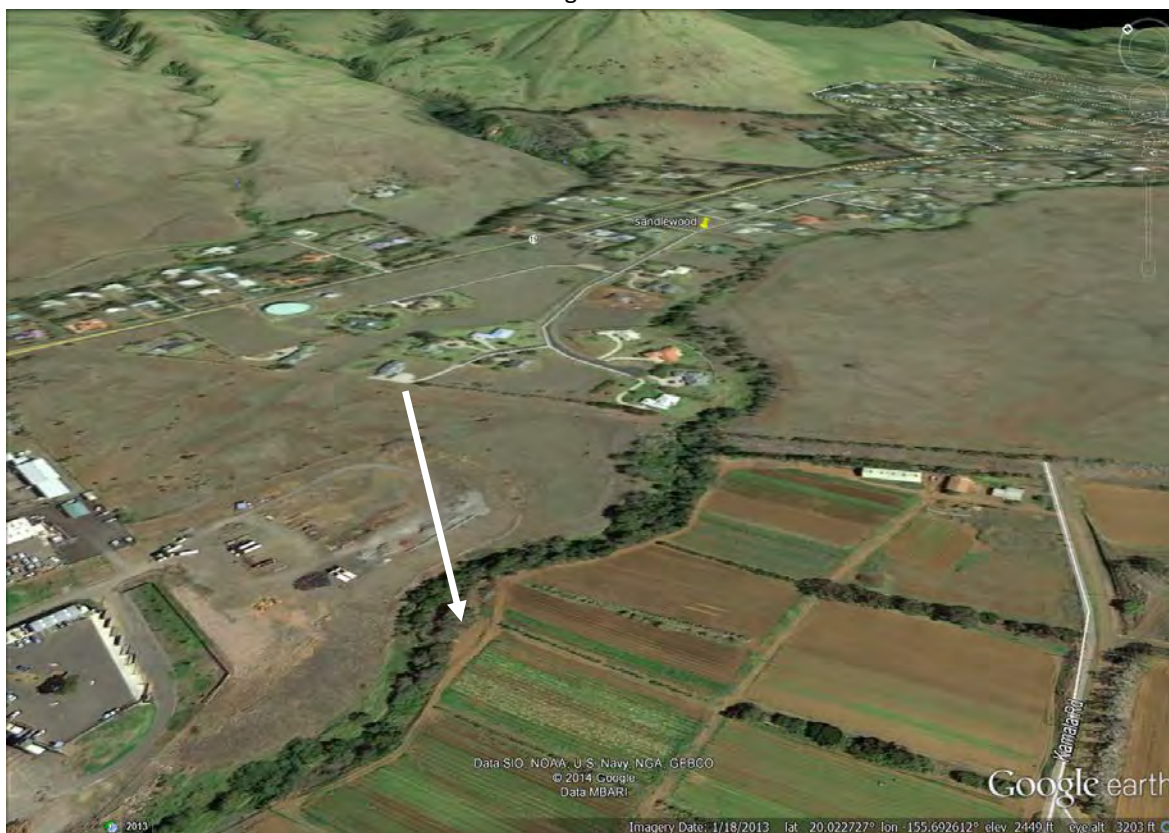
**Photo 19. 20PL, Lalamilo Farm**

Narrow buffer between edge of field and Waikoloa Stream

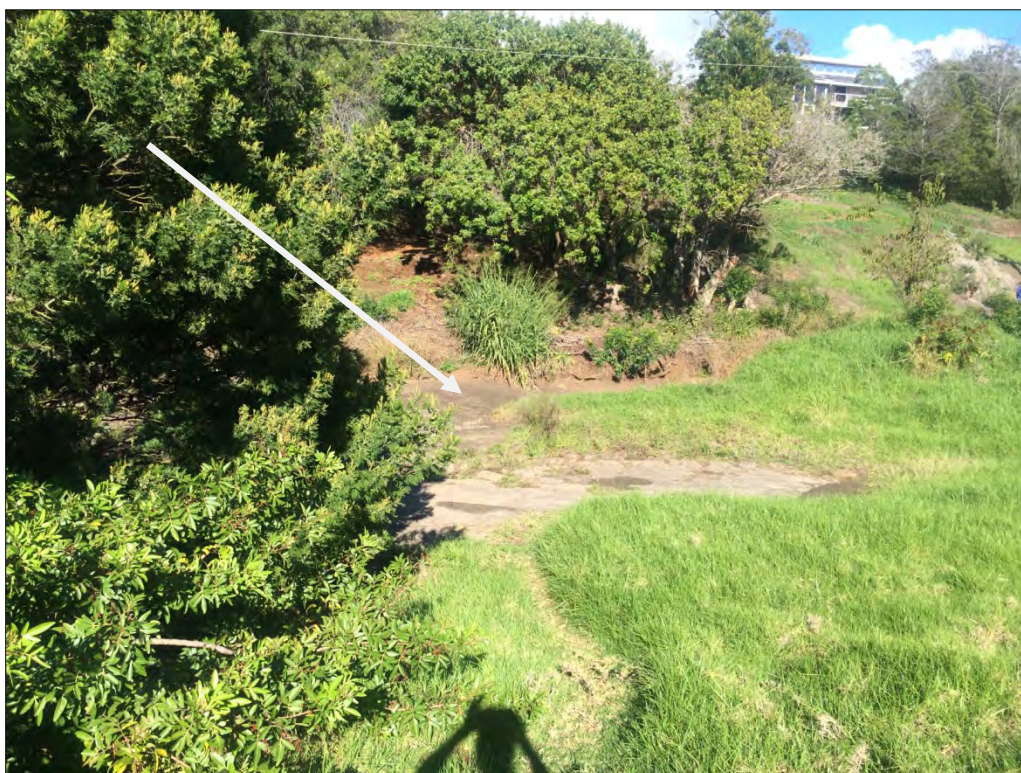
**Photo 20. 30PT, Waikoloa Stream - old stream ford**

Concrete ford instream creates possible fish barrier. Erosion and sediment input for approach roads into stream.

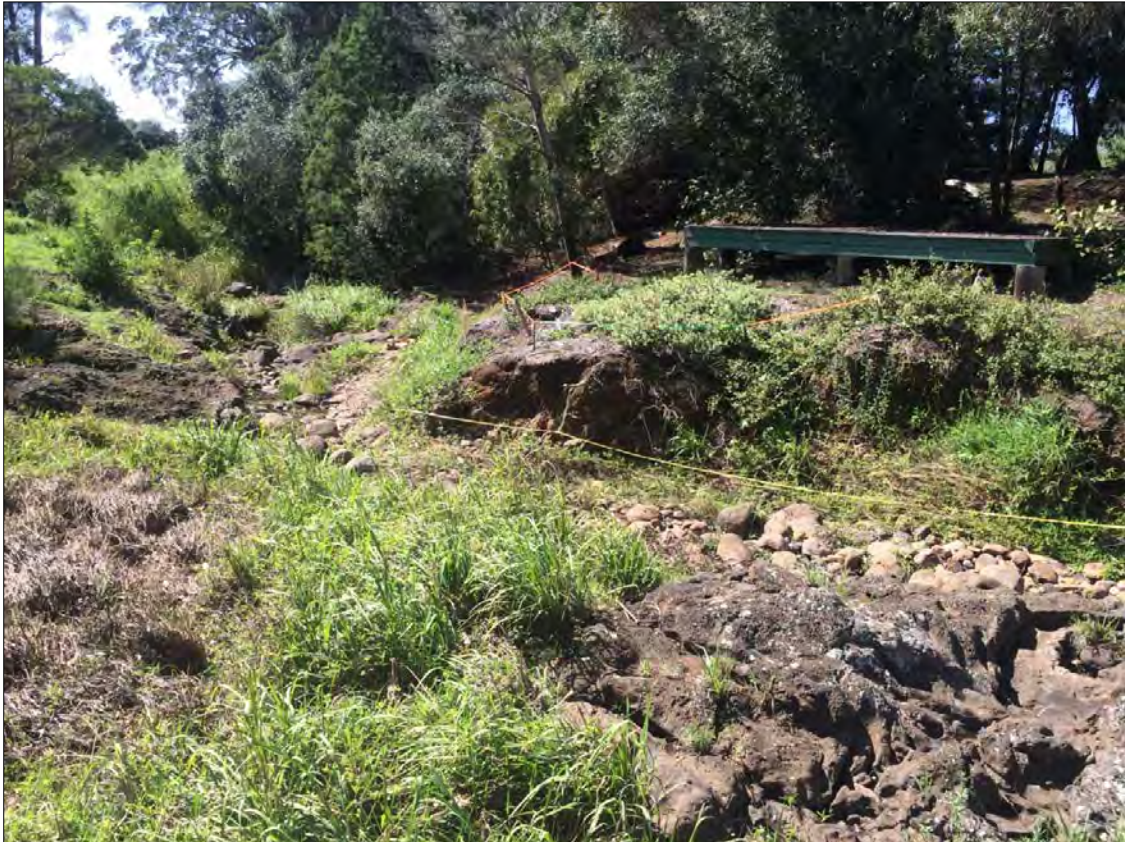
**Photo 22. 31PL, Waimea Nature Park - unstable banks**

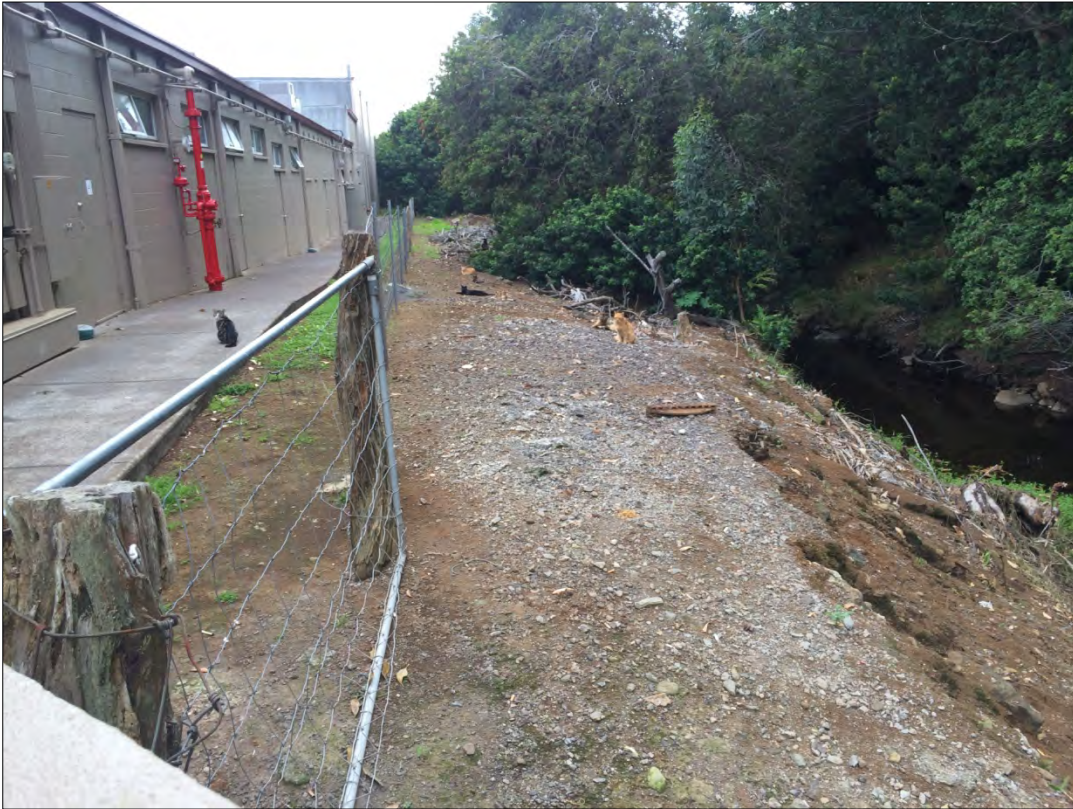
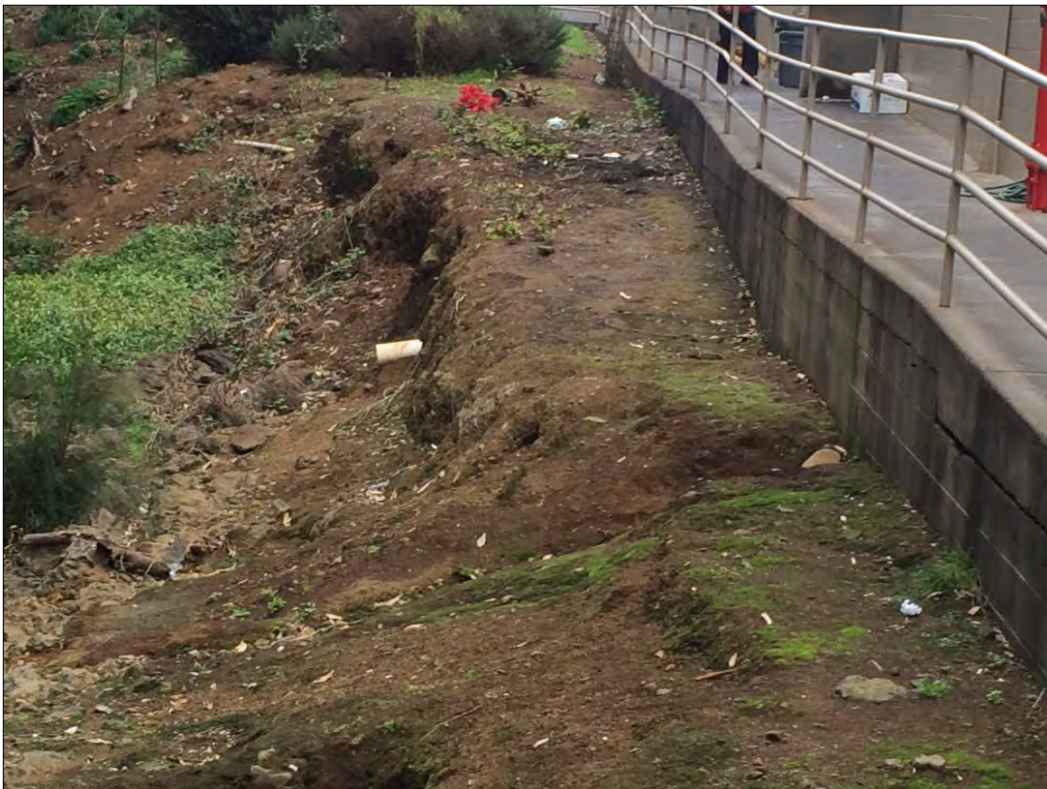
**Photo 23. 23PG, Waikoloa Stream - Waimea Shopping Center**

Multiple issues: degraded banks eroding, illicit discharge onto stream banks, feral cat colonies, bacteria loading into water, bare banks, parking lot runoff into stream.
