# **‘ĪAO VALLEY STATE MONUMENT FLOOD REPAIRS**

Public Informational Meeting  
Wailuku Community Center  
Tuesday, September 12, 2017  
5:00 pm to 7:00 pm

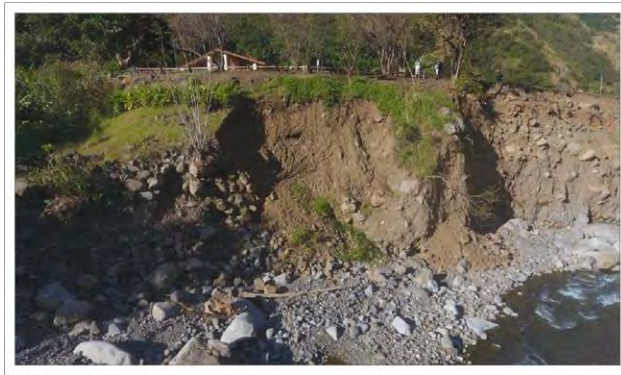
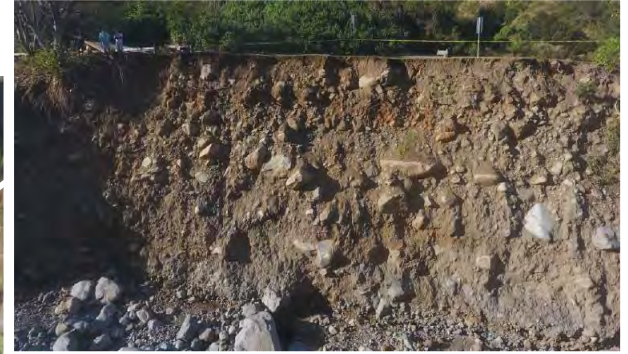
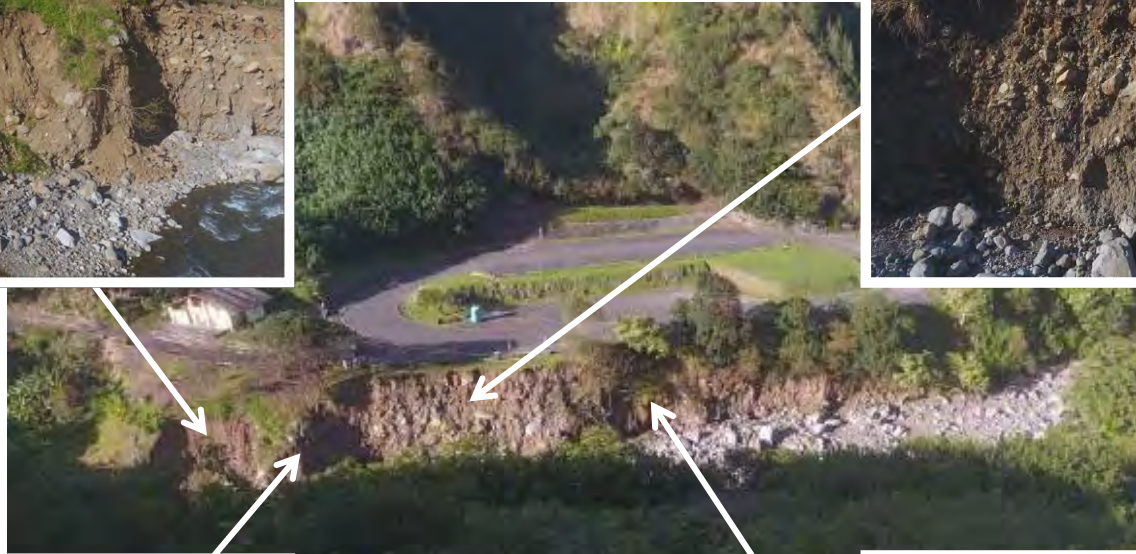
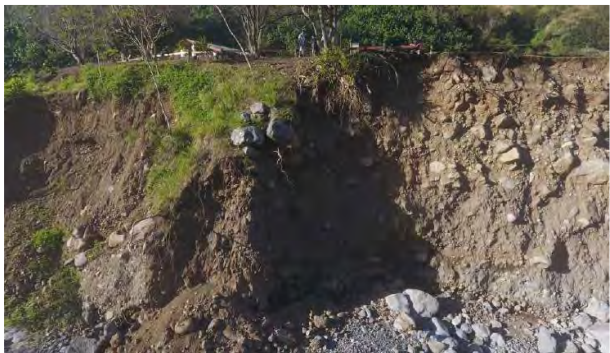
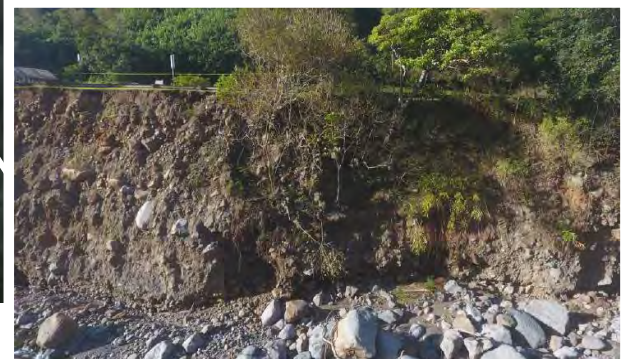
## POST-FLOOD SLOPE DAMAGE

Photos taken 1/16/17
