# Remaining Useful Life Determination for the

## Country Club Condominium/Hotel

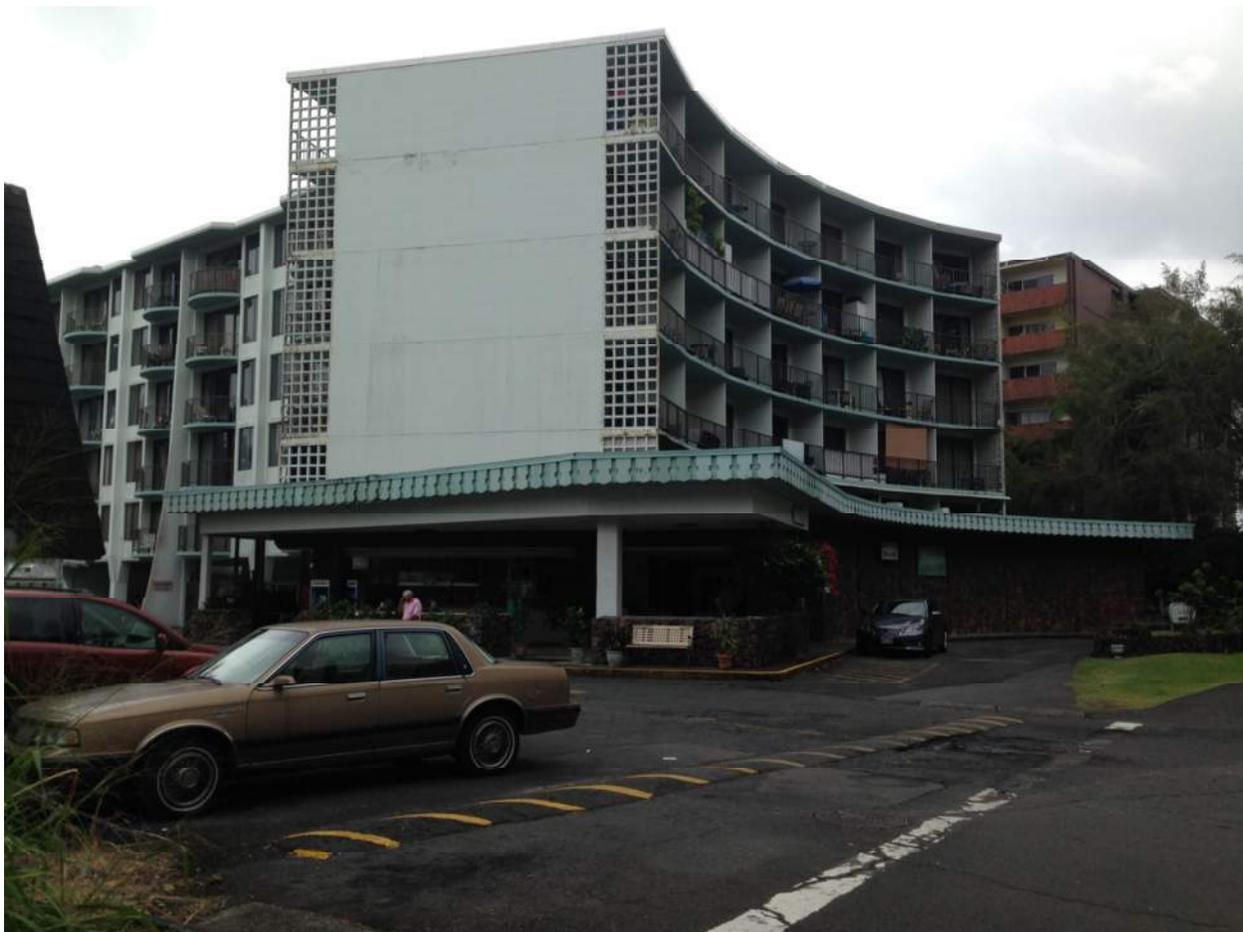
Country Club Condominium and Hotel located at 121 Banyan Drive, Hilo, Hawai‘i.

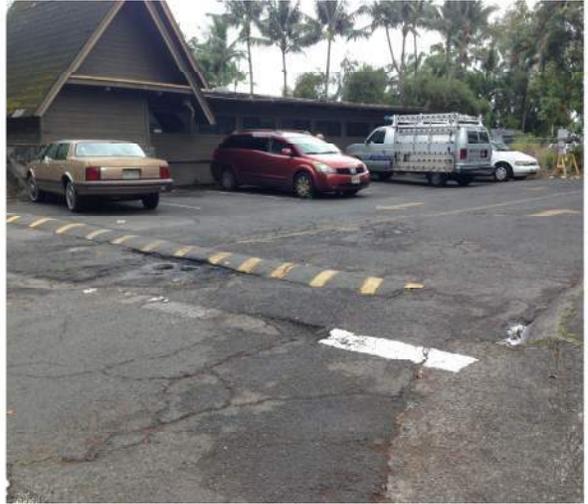
Photo 2: IMG\_2445 – Deteriorated pavement at entry parcel

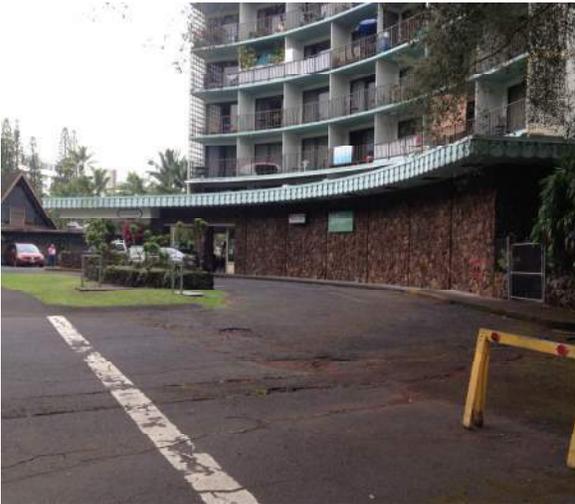
Photo 3: IMG\_2447– Deteriorated pavement at drop off area

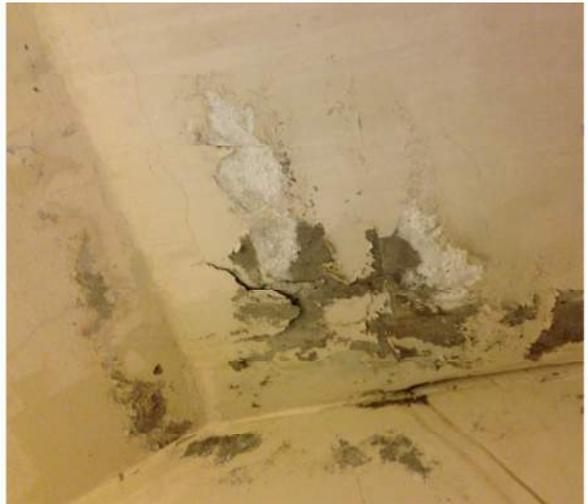
Photo 4: IMG\_2494– Concrete slab spalling and efflorescence in stairwell

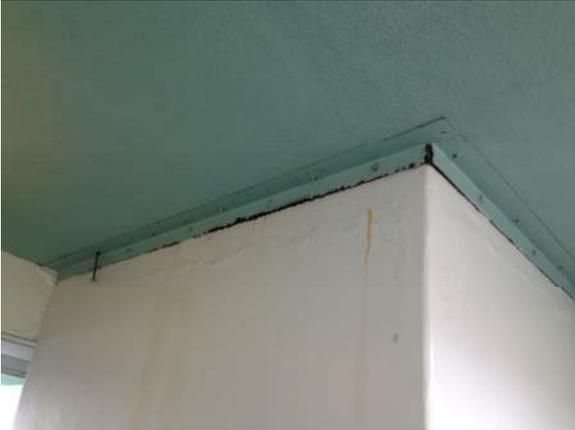
Photo 5: IMG\_2507 – Rusting and loose bolt at slab ledger

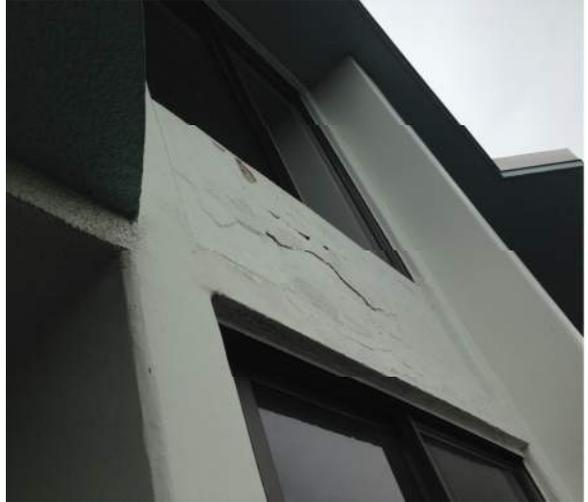
Photo 6: IMG\_2523– Spalling at Exterior Wall

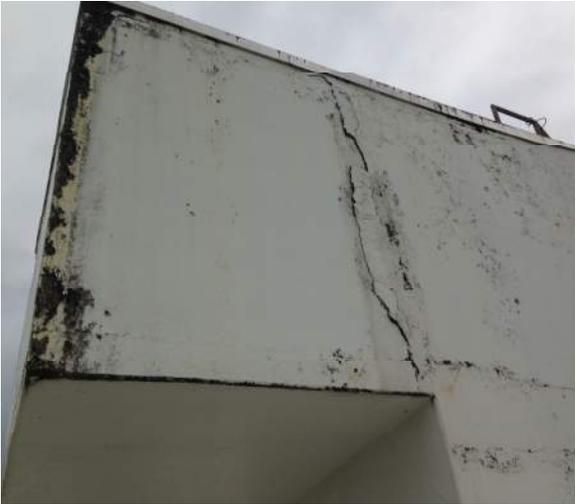
Photo 7: IMG\_2491 – Spalling and cracking at Elevator Room

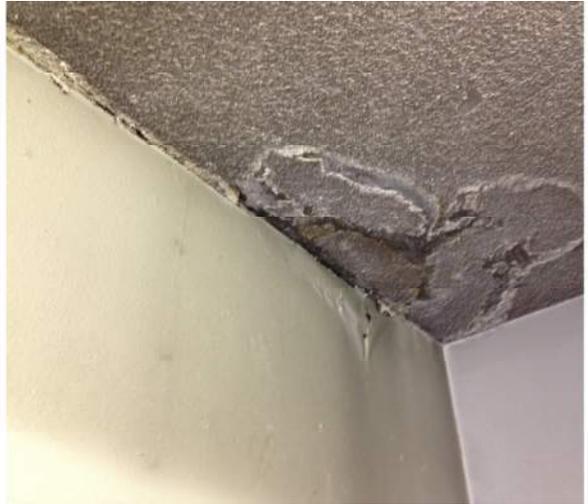
Photo 8: IMG\_2519 – Water Damage, cracking and efflorescence at ceiling

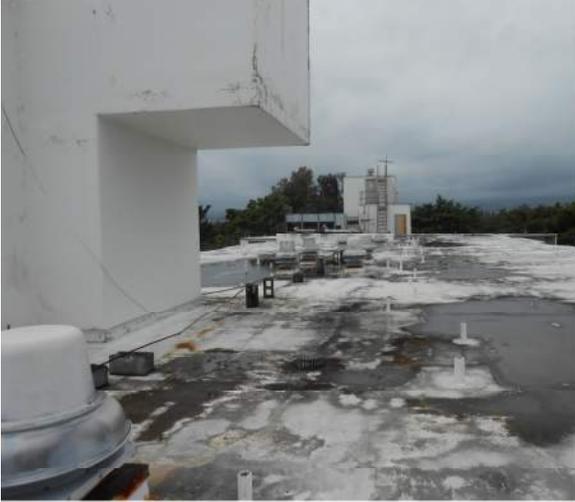
Photo 9: DSCN0465 – Roof treatment failure and ponding water

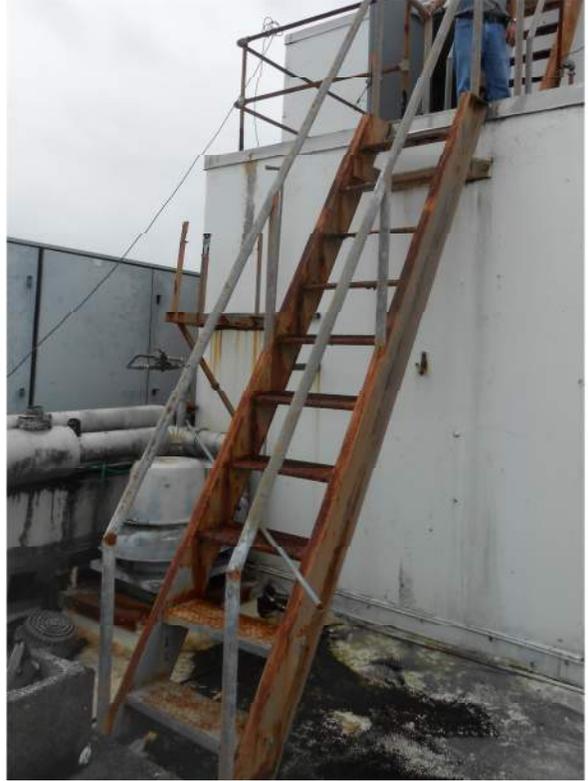
Photo 10: DSCN0471 – Roof stair rusting

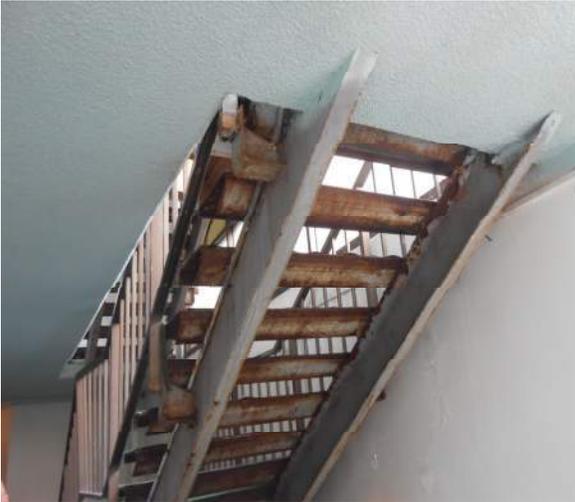
Photo 11: DSCN0481– Typical steel stair rusting

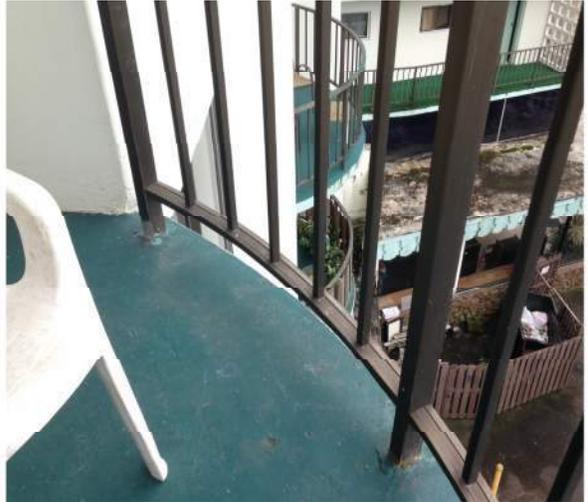
Photo 12: IMG\_2522 – Typical Balcony
