**Kō'ie'ie Fishpond  
2014 Progress And Monitoring Report**

Revised Conservation District Use Permit (CDUP) MA-3153, <sup>APPLICANT</sup> 2009. Revitalize Kō'ie'ie Fishpond for Educational, Cultural, Historical and Recreational Purposes.

The following progress and monitoring report is a summary of the findings and ongoing activities at the Kō'ie'ie Fishpond Revitalization Project for the period of January 1 to December 31, 2014.

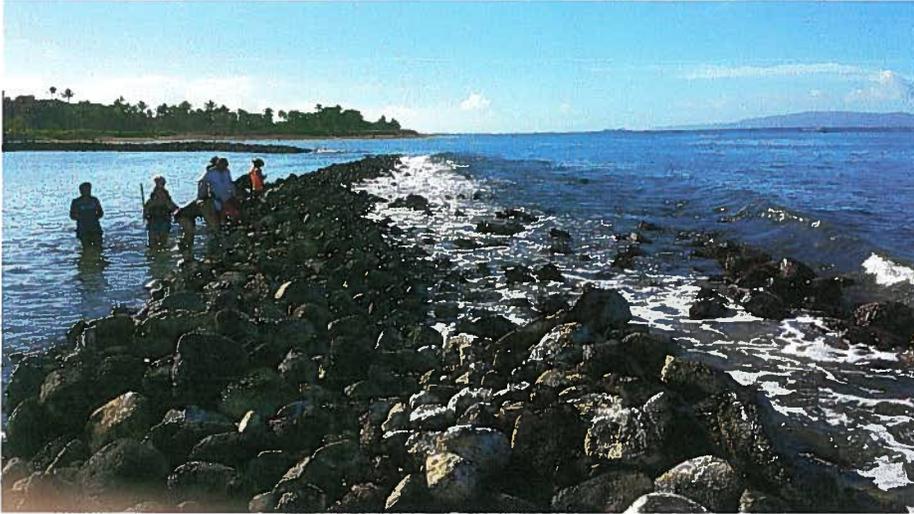
**Figure 1.** December 14, 2013  
Western wall section of wall under  
restoration. This area often received  
direct hits from southern surf.

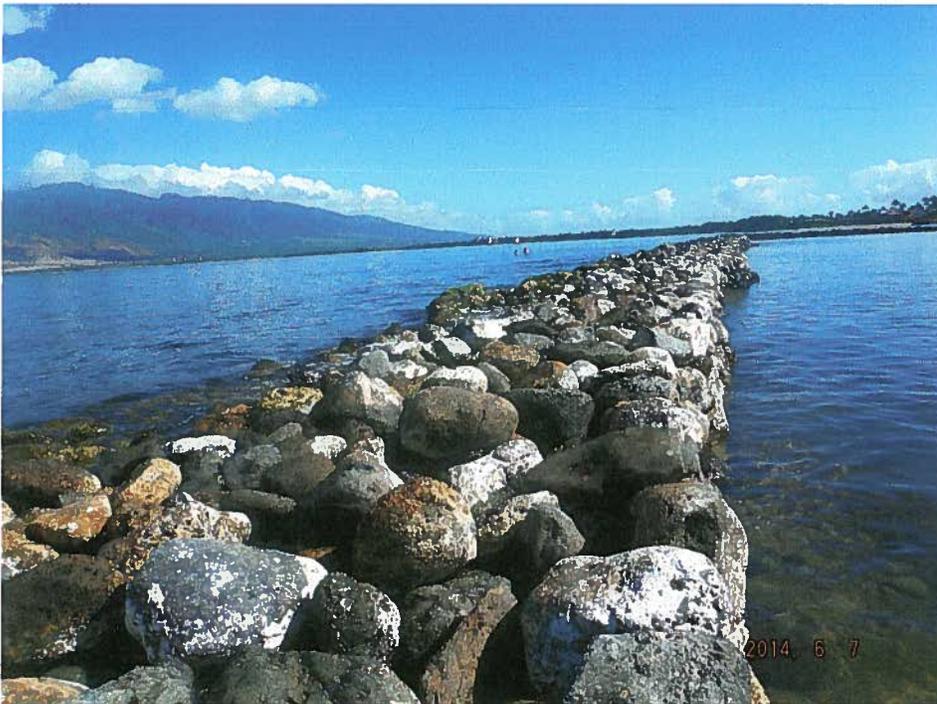
By mid-2014, a majority of the western wall was able to be restored by our crew despite these obstacles (Figure 2). Unfortunately, a series of strong southern swells heavily damaged the restoration work on the western wall by the end of the year.

**Figure 2.** June 7, 2014  
Western section of wall restored.

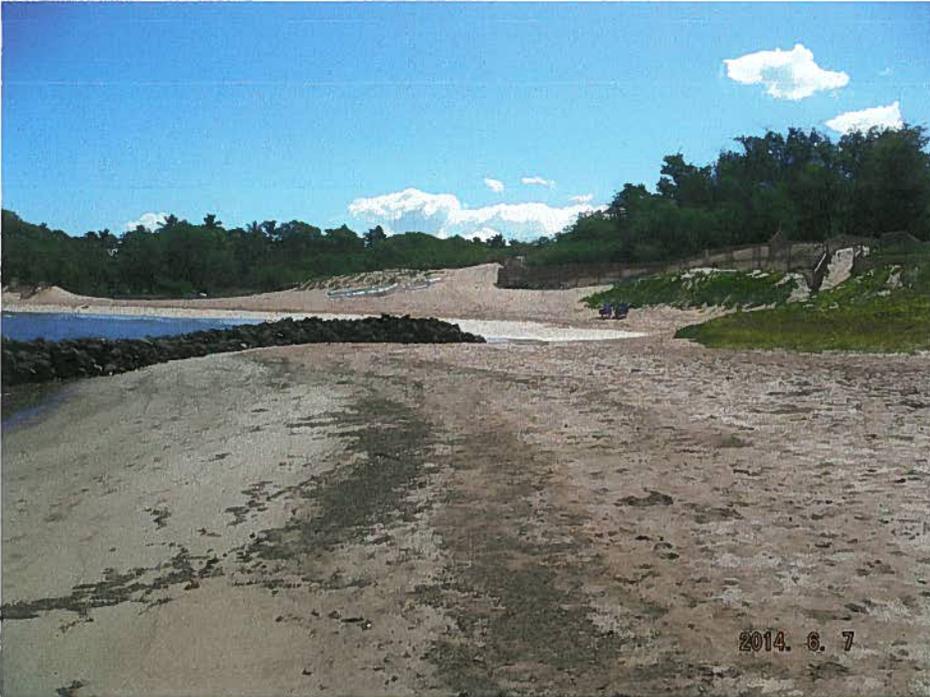
**Figure 3.** June 7, 2014  
Beach exposed during low tide in northern section of fishpond.

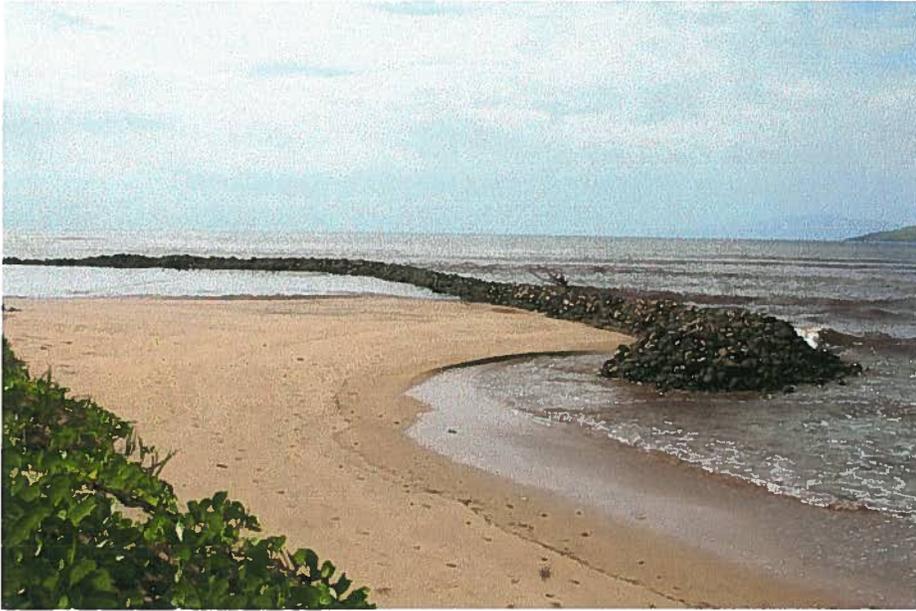
**Figure 4.** January 18, 2011  
Sand accretion along northern wall in 2011.

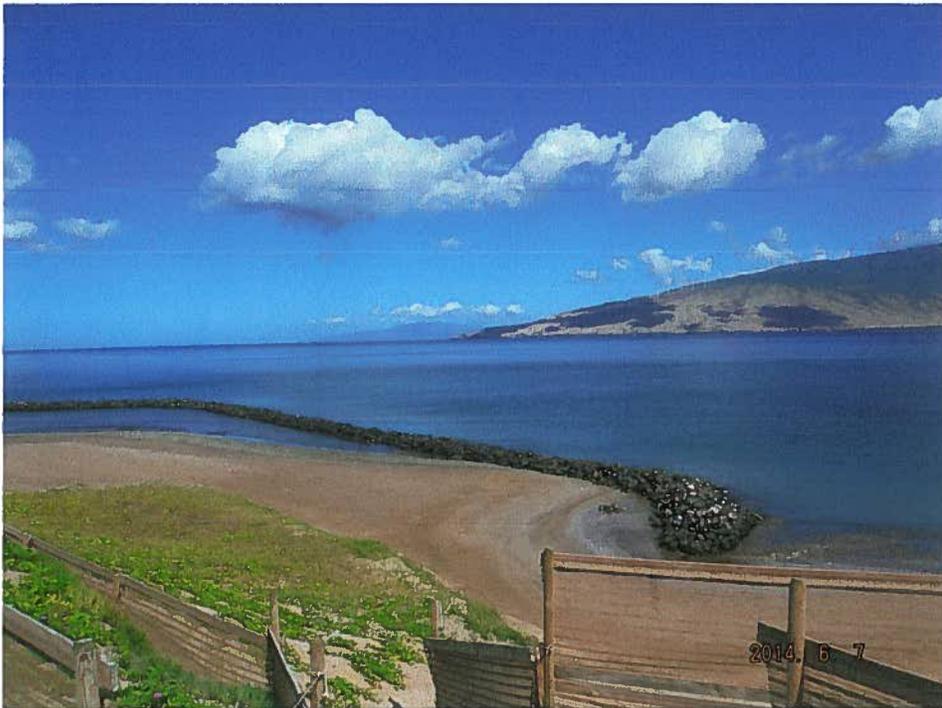
*Northern-end.* The northern wall section continued to be very shallow. This has been consistent with past years when sediment filled the northern section after floods and tsunami inundations. During low and extremely low tides, the depth averaged 0 to 2 feet deep. Figures 3 through 5 show comparisons of this area over time. The sand dune restoration project occurring along the northern end of the pond continued to be very effective in creating a high sand berm from the northern wall toward Kūlanihāko'i Stream (Figures 6 and 7).

**Figure 5.** June 7, 2014  
Accumulation of sand within northern wall area and northern beach area of Kalepolepo still remains very shallow since at least 2011.

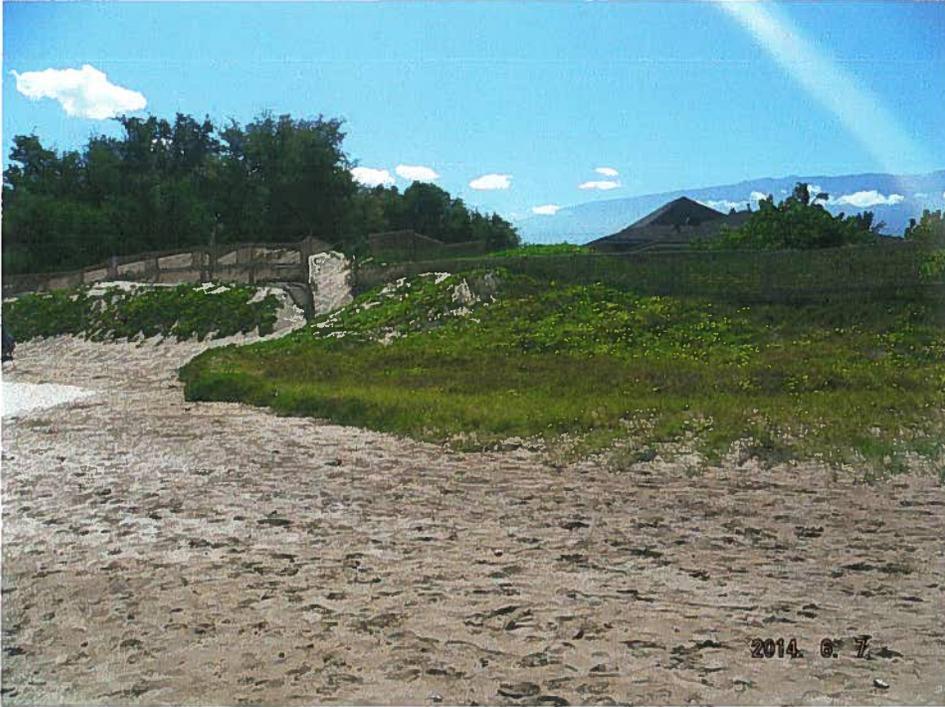
**Figure 6.** June 7, 2014  
Sand dune restoration just north of the  
Hawaiian Islands Humpback Whale  
National Marine Sanctuary building  
and across from the northern wall.

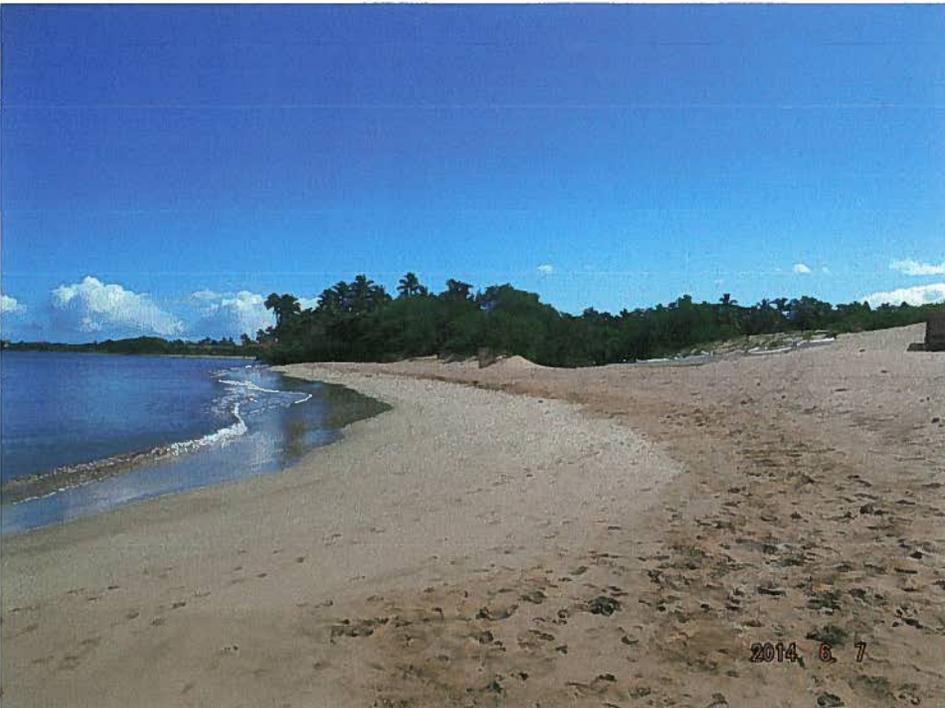
**Figure 7.** June 7, 2014  
Beach profile near Kūlanihāko‘i Stream  
with sand dune restoration project.

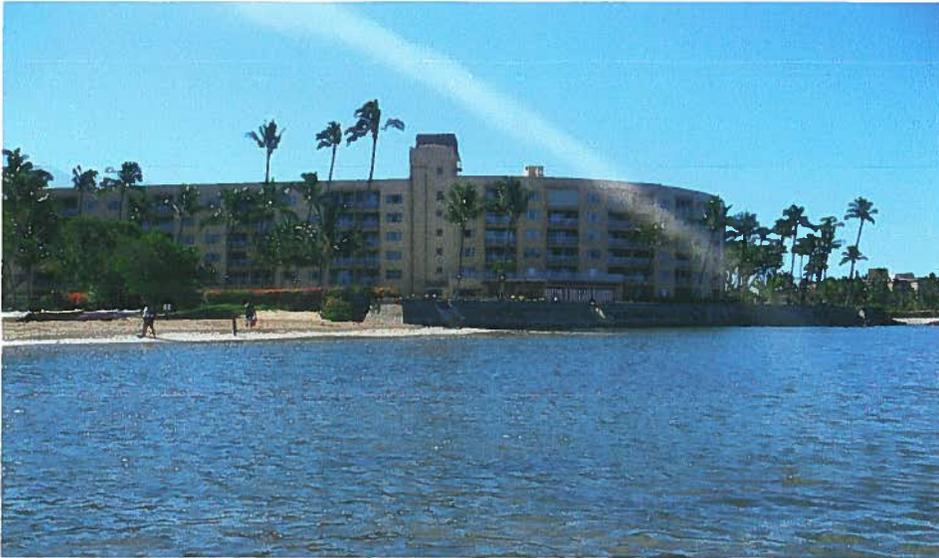
*Western section.* Like in previous years, the center area of the pond (away from any walls) continued to be shallow during most tides, averaging around 1 to 3 feet deep (Figure 8). The depth of the pond increased as one moved closer to the western wall section where the depth averaged 4 to 5 feet. In this particular wall section, water circulation, currents, and high impact from waves on the outer side of the wall tended to create a deeper depth near the interior side of the western wall. In addition, the beach from Kalepolepo Park and the area fronting the Whale Sanctuary, continued to have a very large accumulation of sand creating ample recreational space for visitors (Figure 9).

**Figure 8.** June 7, 2014  
The center of the fishpond tended to have a very shallow depth of approximately 1 to 3 feet.

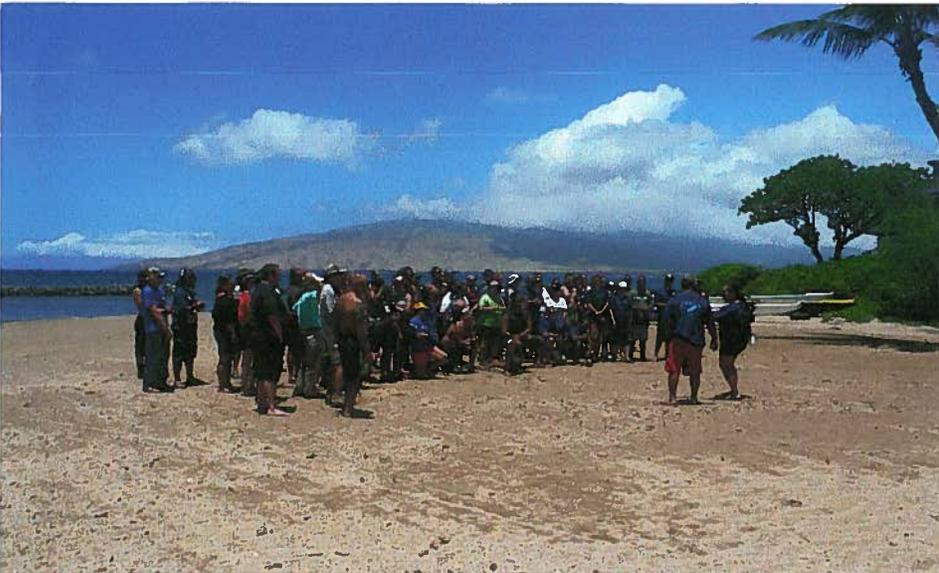
**Figure 9.** April 30, 2014  
A large beach area is utilized by recreational users throughout the year.

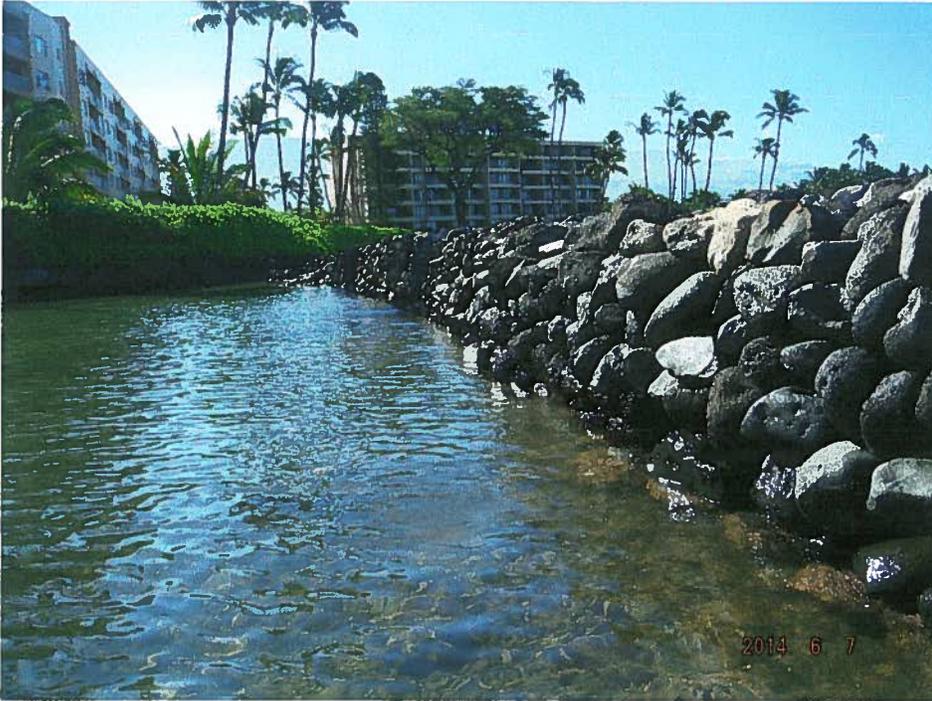
**Figure 10.** June 7, 2014  
At the south wall, the depth is very shallow at 0.5 to 3 feet deep.

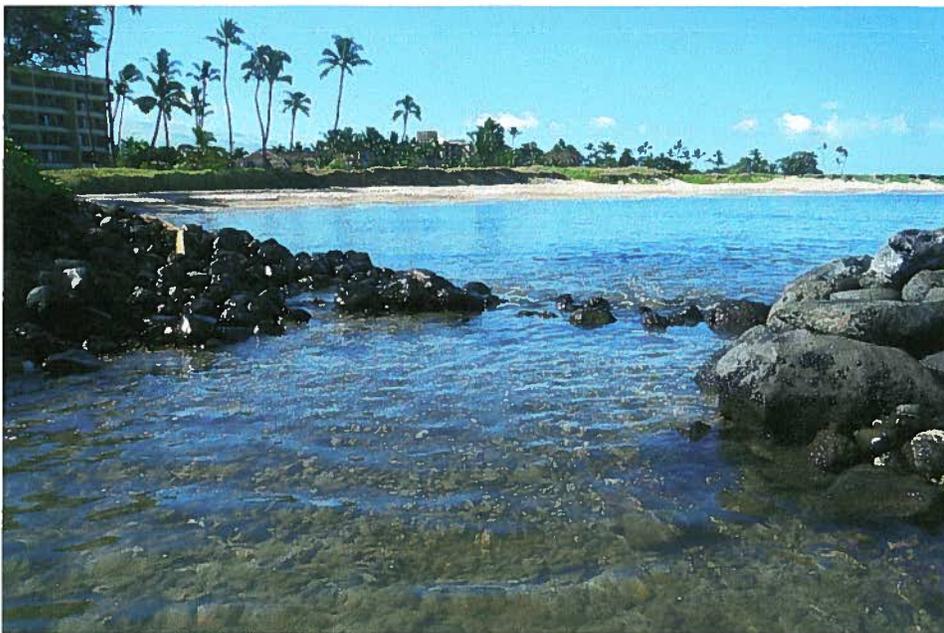
**Figure 11.** June 7, 2014  
Opening in south wall for beach access.

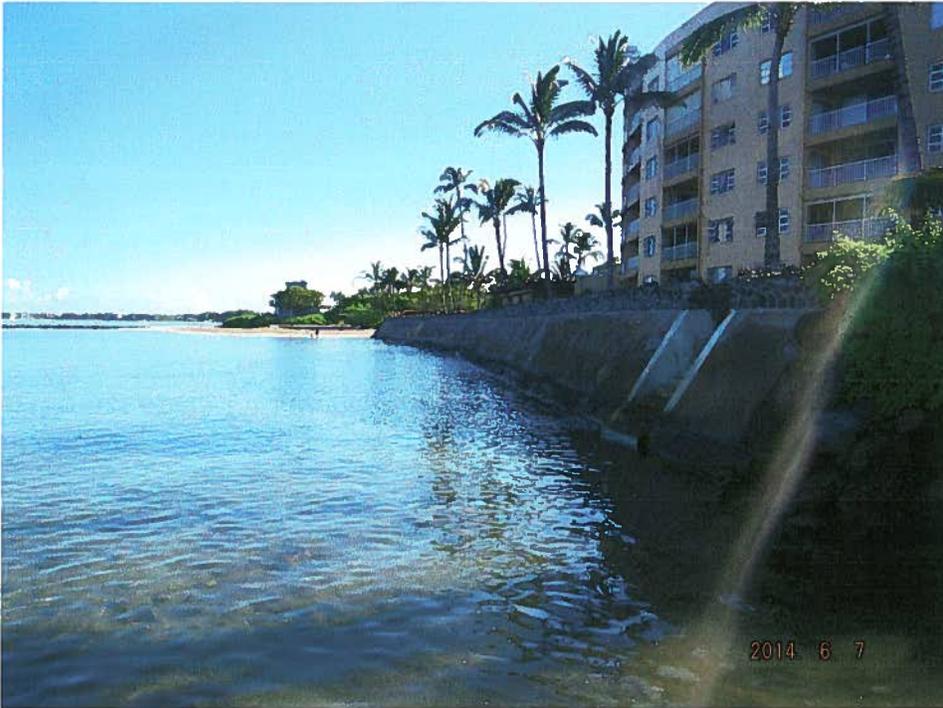
**Figure 12.** June 7, 2014  
Shallow depth at Menehune Shores  
seawall.
