Sugar Cove Berm Post Maintenance Effort #4 Monitoring

Sugar Cove, Spreckelsville, Maui, Hawaii

July 2023

Sea Engineering, Inc.
Makai Research Pier
Waimanalo, HI 96795

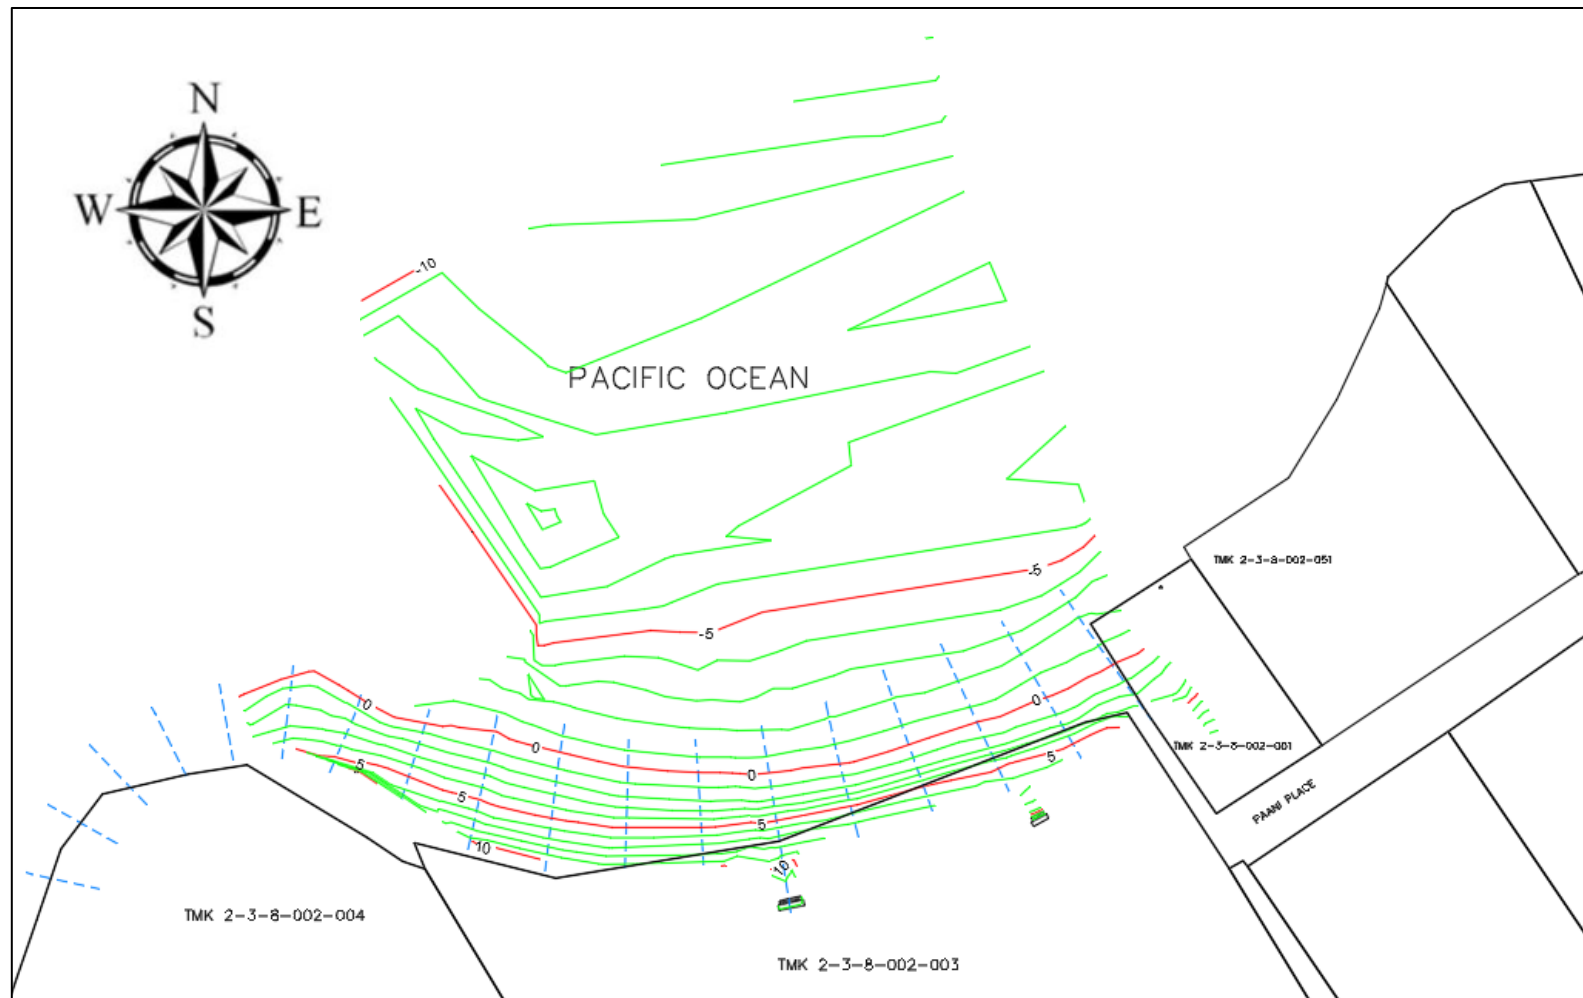
Figure 1-4. Post-Maintenance #4 topography at the project site, May 11, 2023 (LMSL datum, feet)

The elevation data presented was collected from the site visit to investigate beach condition on May 11, 2023. The sand beach fronting the parcel extends 35 to 80 feet from the 0-foot contour at local mean sea level (LMSL) to the seawall's backstop, from east to west respectively. Beach profiles in the western area (Transect 7), middle area (Transect 5), and eastern area (Transect 3) have active beach face, or foreshore, slopes of 1V:10H (Figure 1-5), 1V:10H (Figure 1-6), to 1V:12.5H (Figure 1-7), respectively. The berm crest in the profiles is approximately +8 feet in elevation on average.

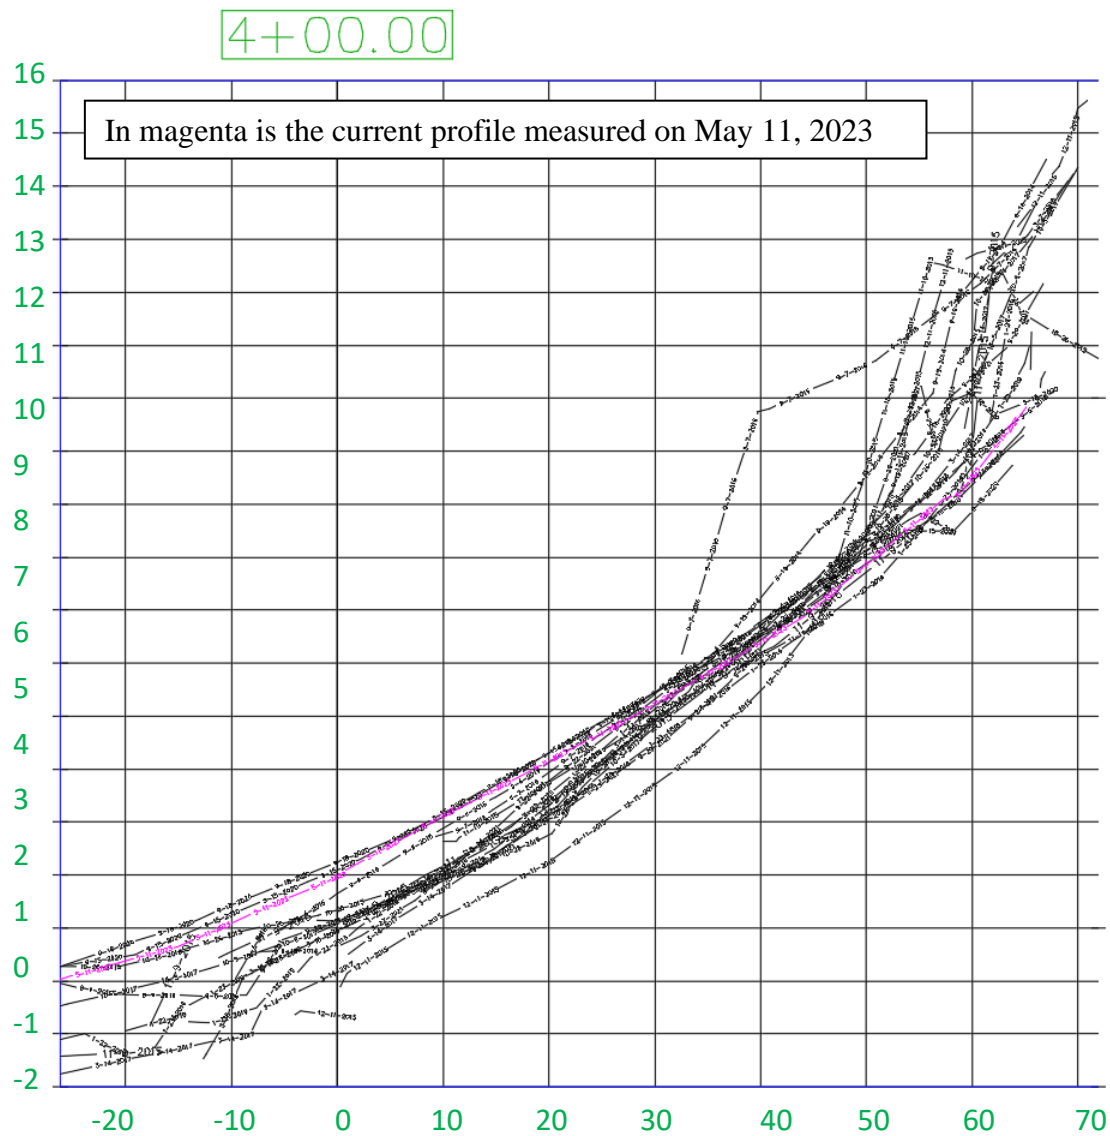
Figure 1-5. Topographic profiles at western end of Sugar Cover over 2014-2023 (LMSL Datum, feet)

Currently, the beach at Sugar Cove is deflated. A survey conducted on May 11, 2023 found the beach berm at Transects 7 and 3 to be under +10 ft in elevation (Figure 1-5 and Figure 1-7). Additionally, beach width from the accessway to the beach toe at Transect 5 was approximately 75 ft. The slopes at the three transect locations were found to be 1V:10H at Transect 7, 1V:10H at Transect 5, and 1V:12.5H at Transect 3, indicating that the beach is losing sand and becoming flatter. These three triggers indicate that the beach has become unstable and would benefit from nourishment efforts.

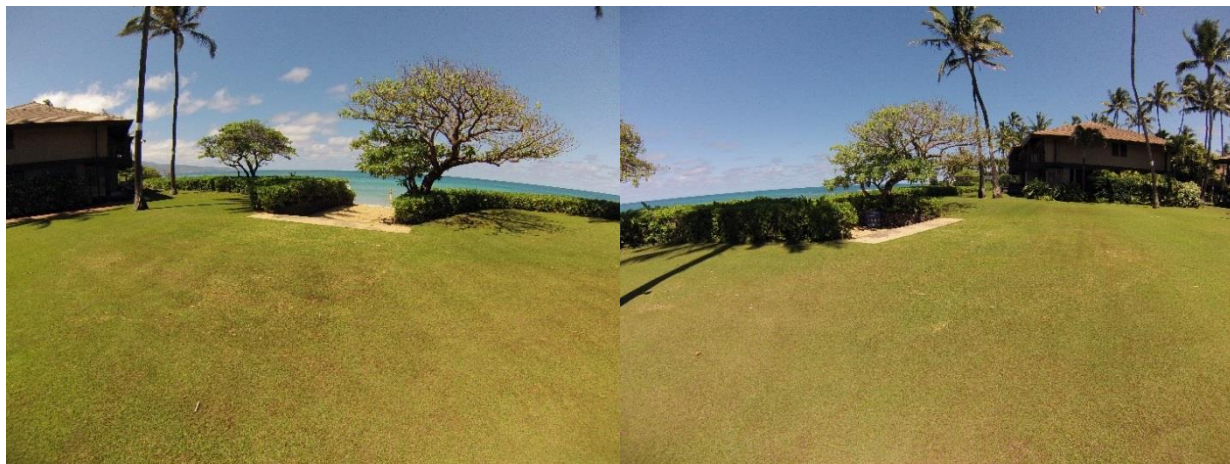
Figure 1-11. Typical backshore conditions at the site

Backshore conditions at the project are typified by a coastal lawn bordered by a naupaka hedge on the makai side. The Hayashi seawall is located beneath and makai of the naupaka hedge, extending seaward beneath the restored sand beach. Dwellings are built in the coastal lawn, adjacent to the mauka side of the Hayashi seawall.

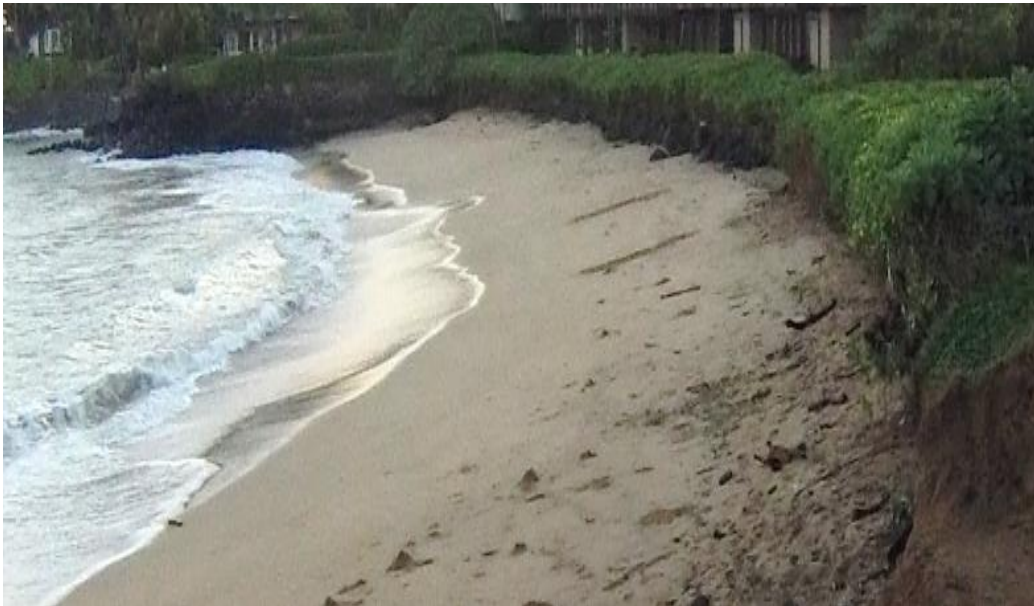
Figure 4-6. Beach condition prior to placement (November 9, 2015, Maintenance #1)

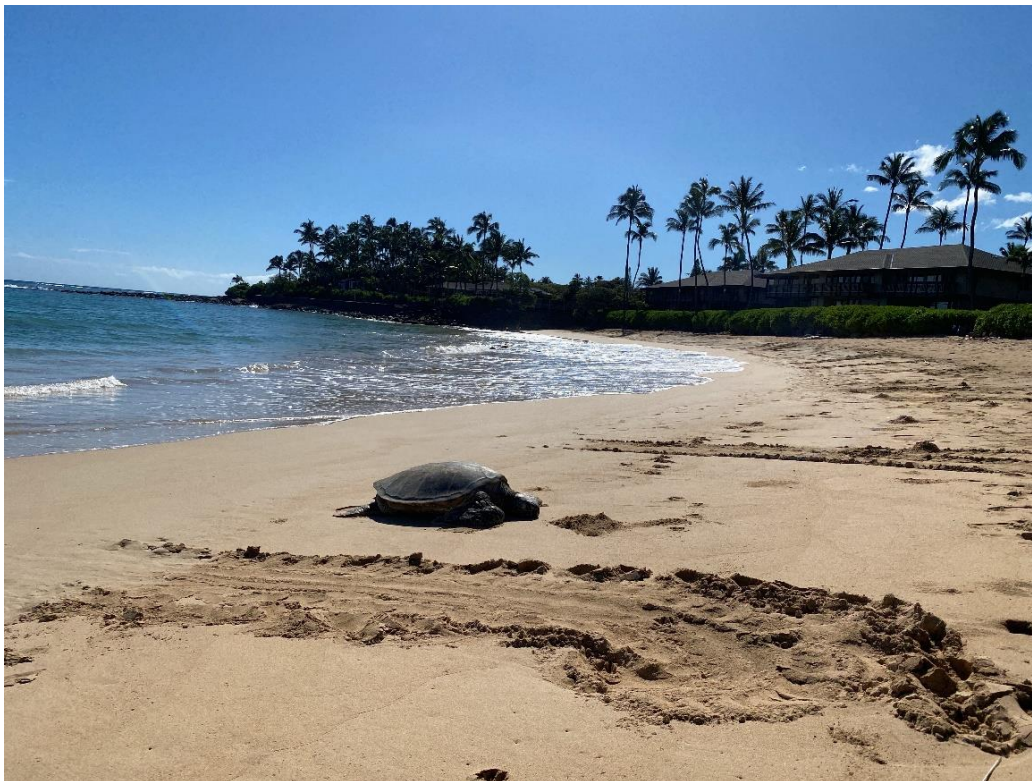
Figure 8-39. Sea turtle observed on the beach at Sugar Cove on May 11, 2023

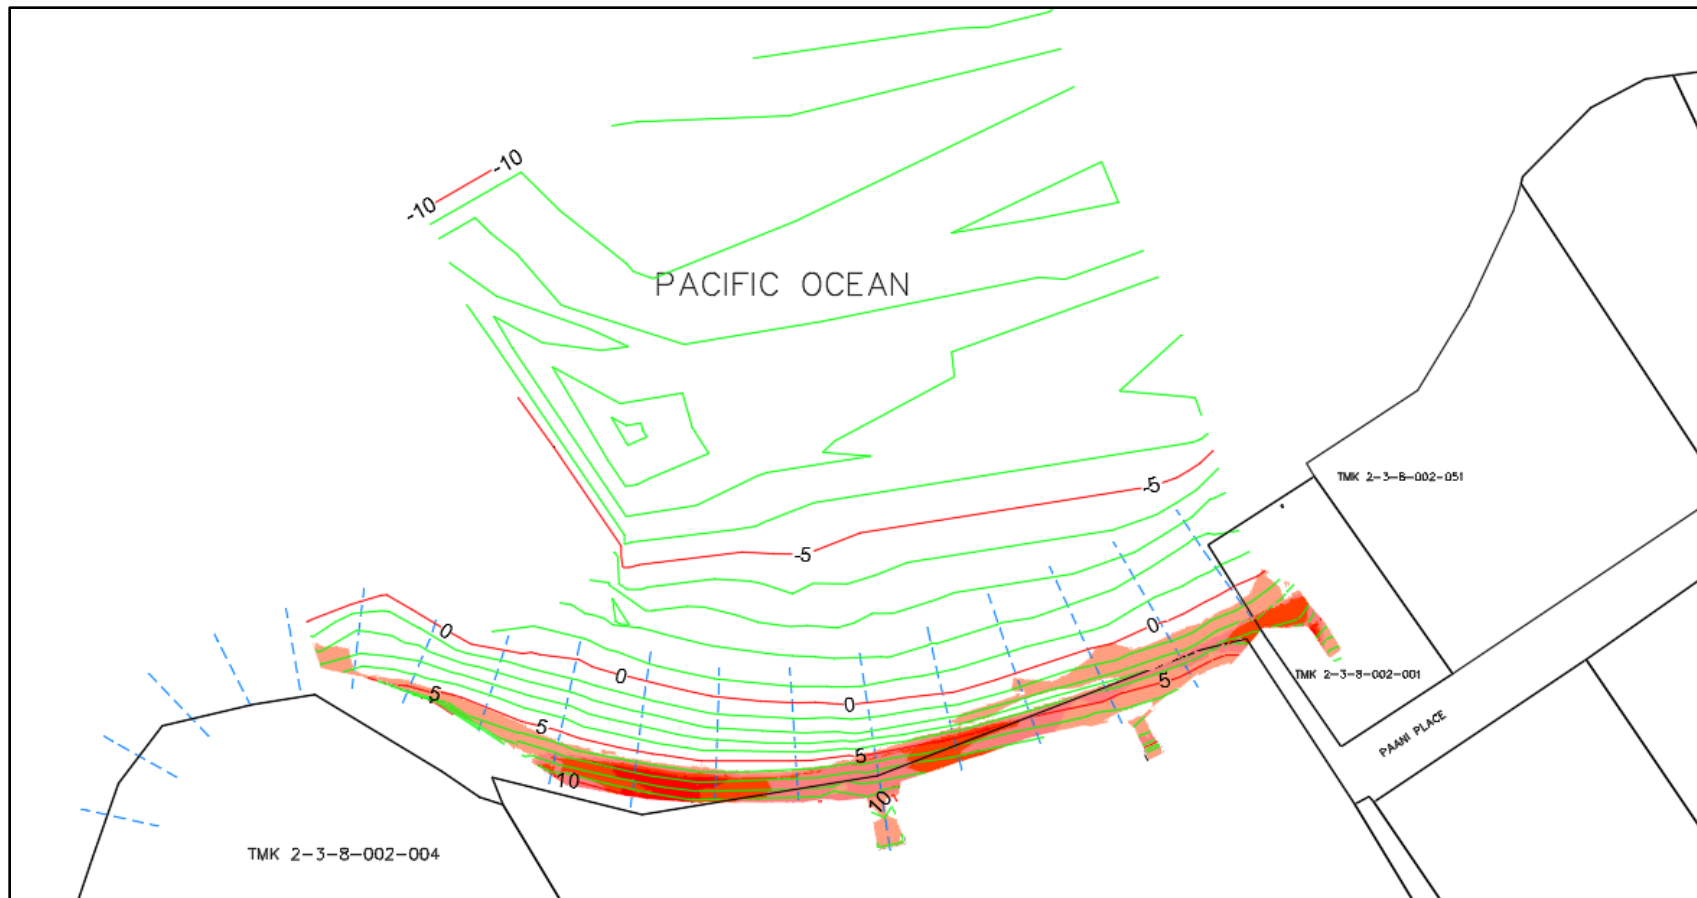
Figure 8-90. May 11, 2023 topo-bathymetric conditions showing sand losses since September 29, 2021 in shades of red
