Sugar Cove Berm Maintenance Effort 6-Month Interim Report

Sugar Cove, Sprecklesville, Maui, Hawaii

July 2018

Job No. 25411

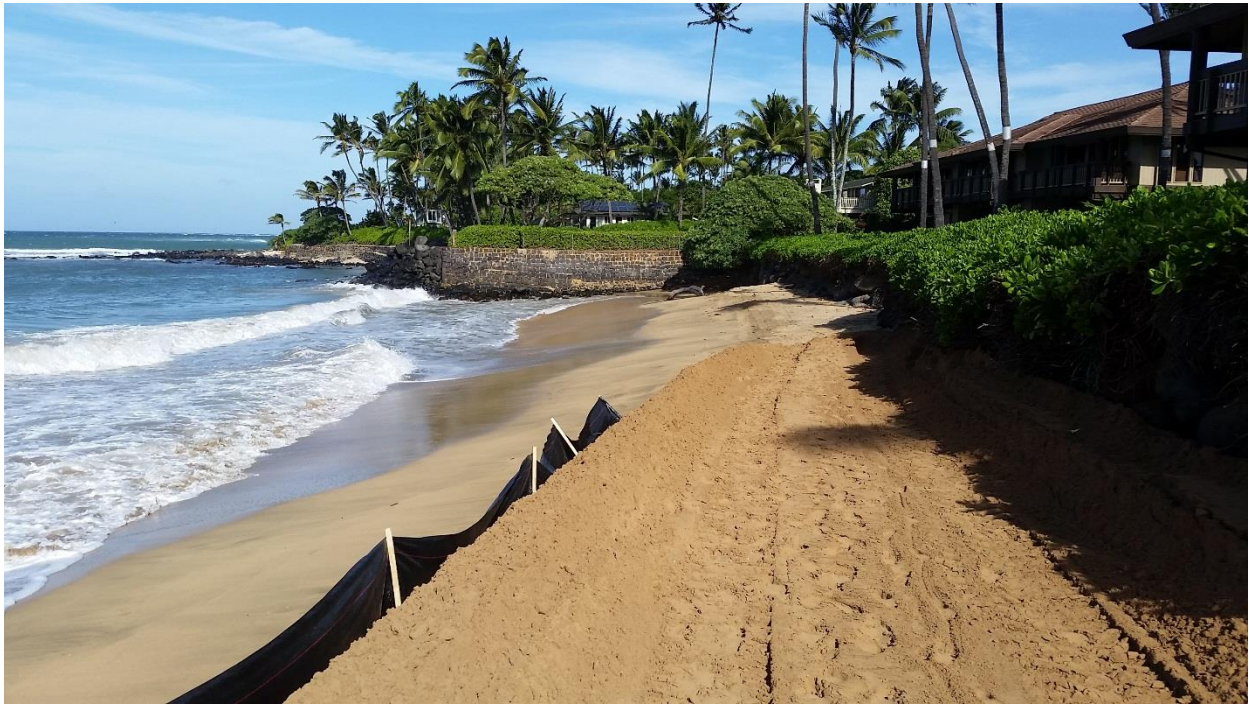
Figure 4-5 Graded sand with finished makai slope and silt fencing ending near Transect 3 (Maintenance #1).

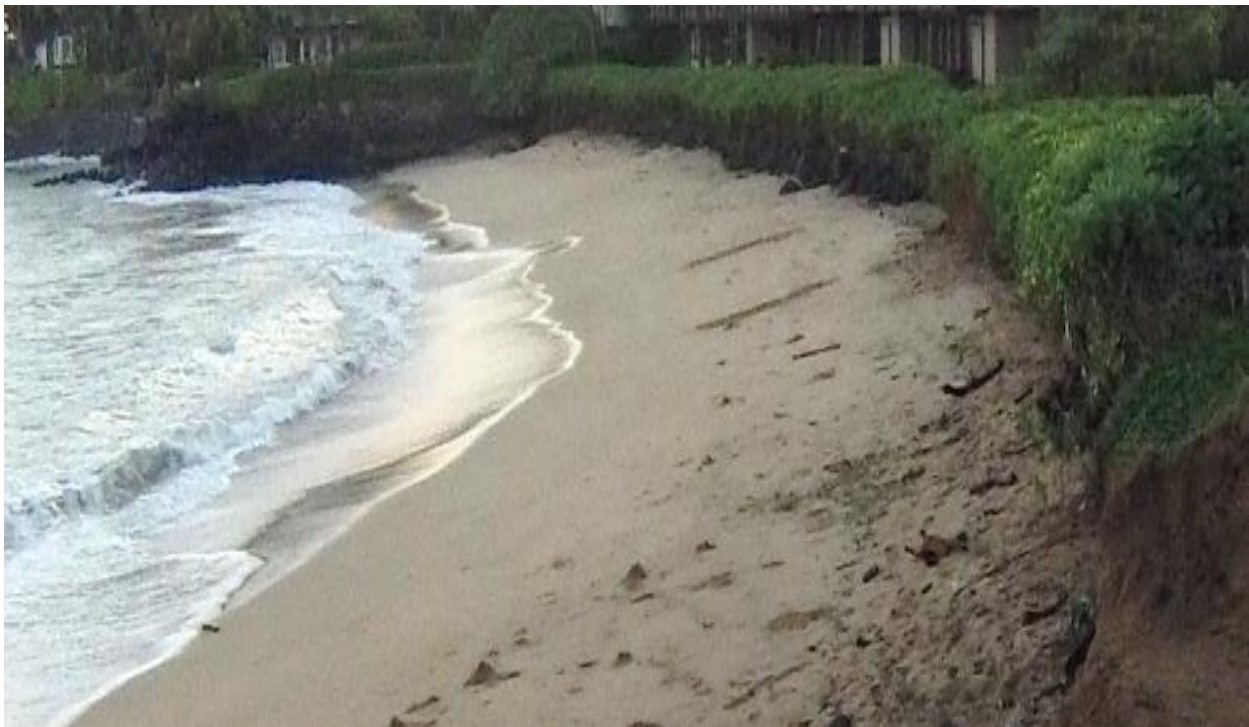
Final Grade: The upper portion of the berm maintenance sand was placed atop the low elevation berm (Figure 4-6) on the beach profile, and was graded to a nearly horizontal plane (Figure 4-7). The makai face of the material was graded to as gentle a slope as was possible, given the already deflated and narrow beach profile. 60 ton of sand was placed in the County of Maui beach access to cover the pre-existing irregular grade (Figure 4-8), including a 3-foot-tall ledge (Figure 4-9). The final grade in the access was a smooth slope from the top of the access path to the beach berm (Figure 4-10).

Figure 4-6 Beach condition prior to placement on November 9, 2015 (Maintenance #1).

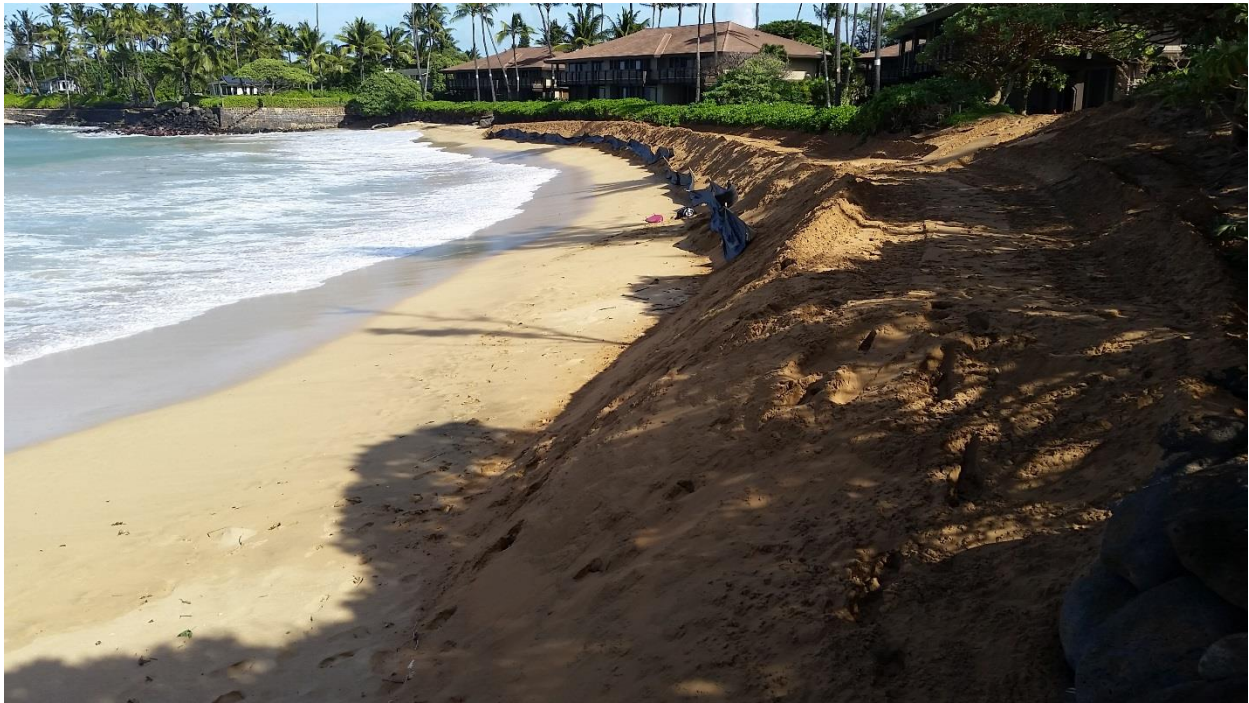
Figure 4-7 Beach and berm condition after placement (November 10, 2015, Maintenance #1).

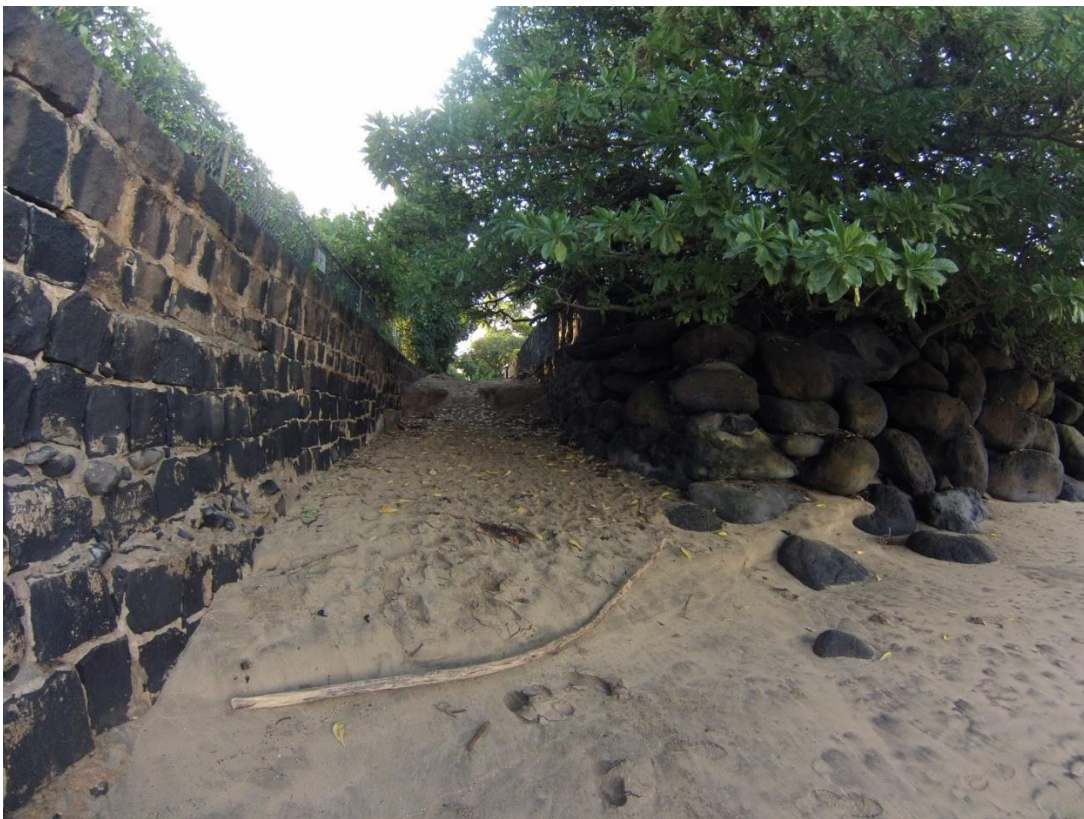
Figure 4-8 County of Maui beach access path prior to sand placement (Maintenance #1).

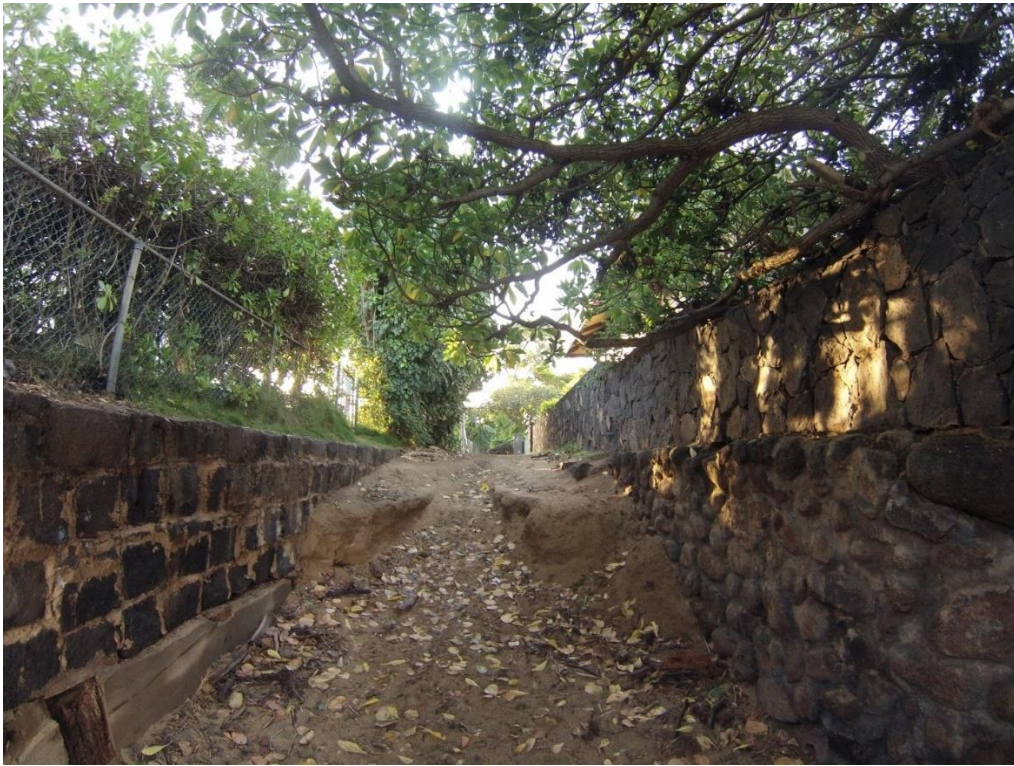
Figure 4-9 Three-foot scarp in County of Maui beach access path (Maintenance #1).

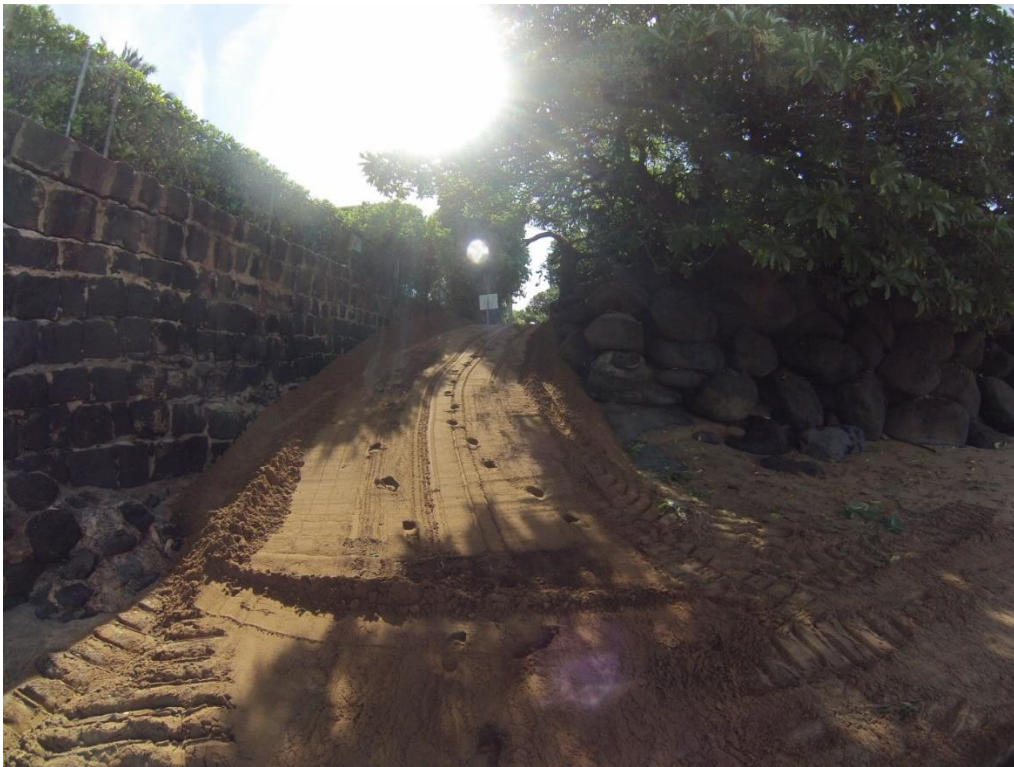
Figure 4-10 County of Maui beach access path with graded maintenance sand (Maintenance #1).

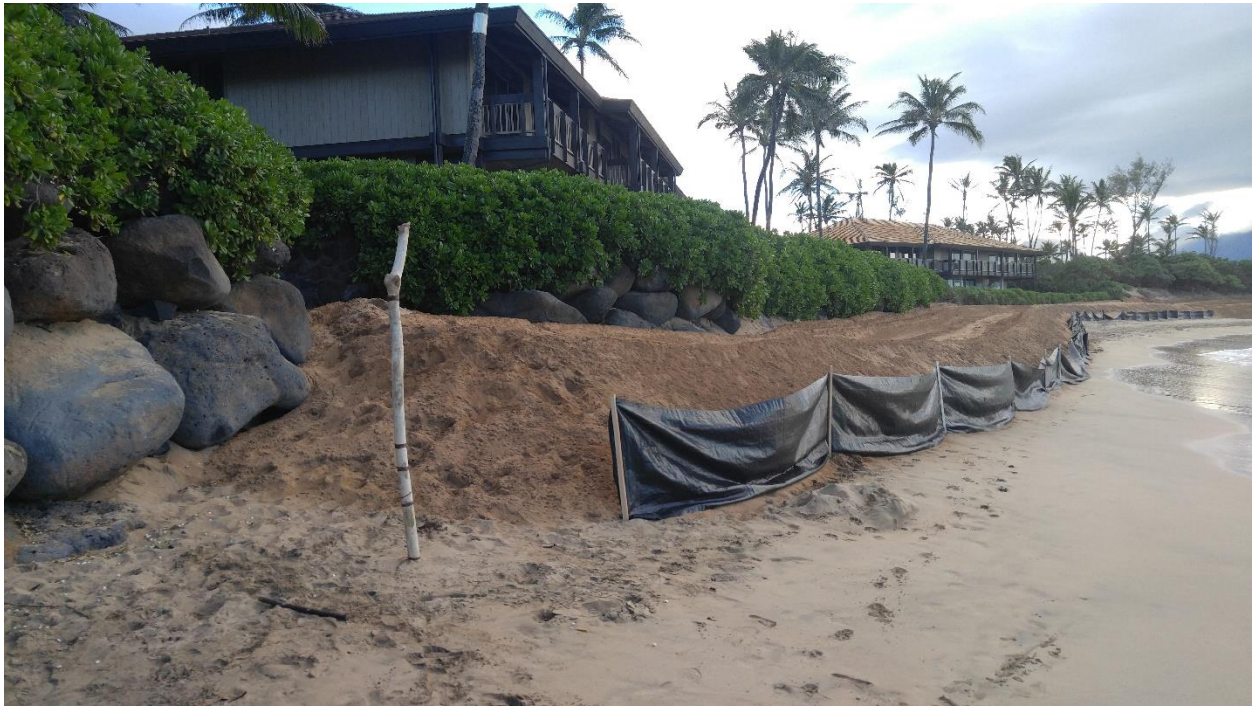
Figure 5-3 Graded sand with finished makai slope and silt fencing ending near Transect 3 (Maintenance #2).

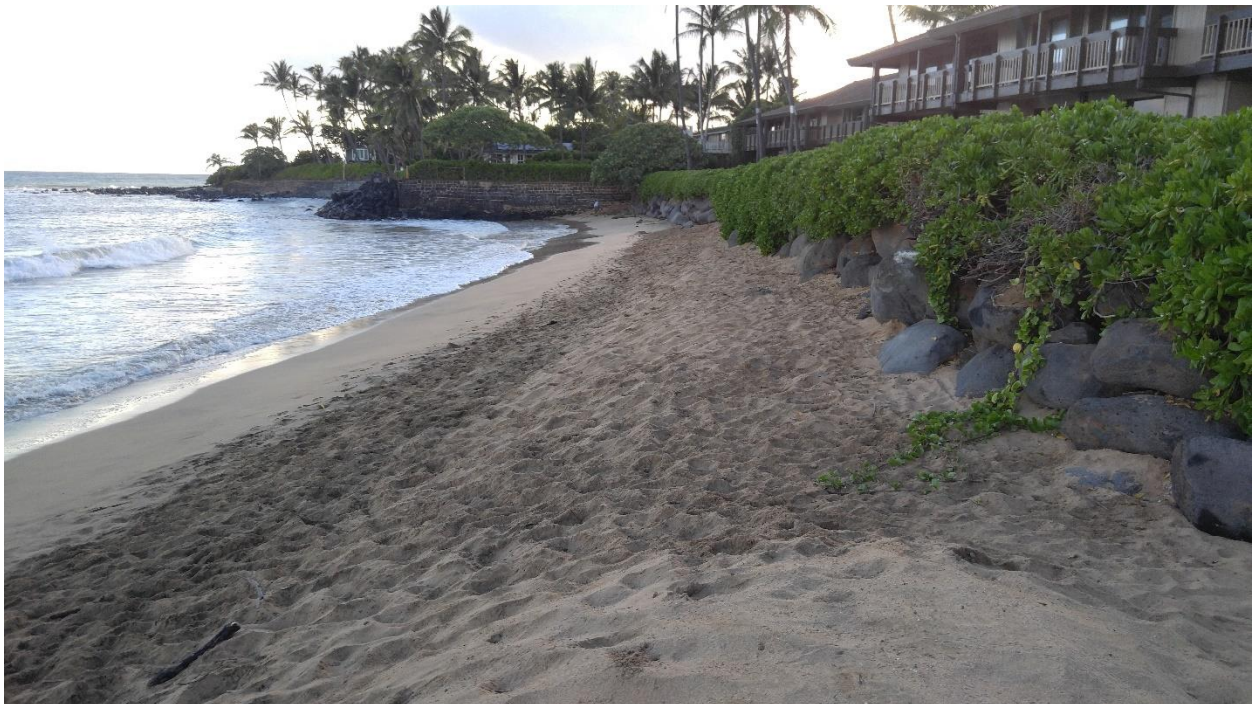
Final Grade: The upper portion of the berm maintenance sand was placed atop the low elevation berm (Figure 5-4) on the beach profile and was graded to a nearly horizontal plane (Figure 5-5). The makai face of the material was graded to as gentle a slope as was possible, given the already deflated and narrow beach profile.

Figure 5-4 Beach condition prior to placement on September 6, 2016 (Maintenance #2).

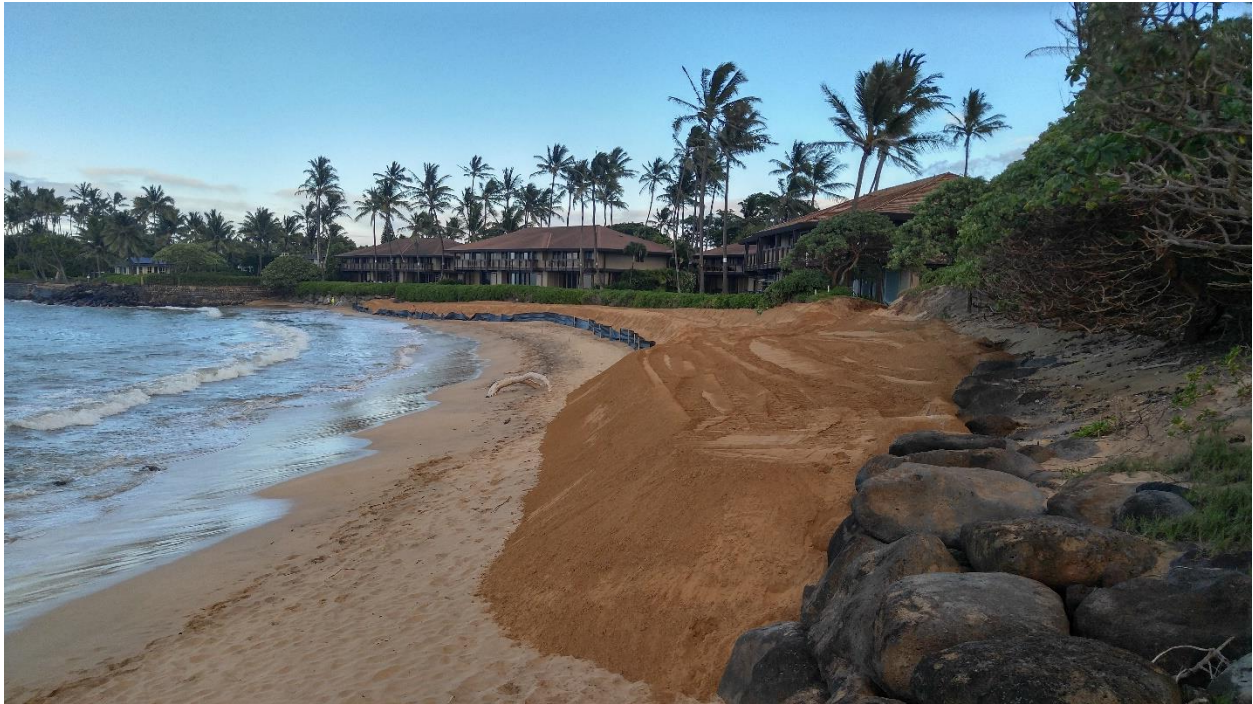
Figure 5-5 Beach and berm condition after placement on September 7, 2016 (Maintenance #2).

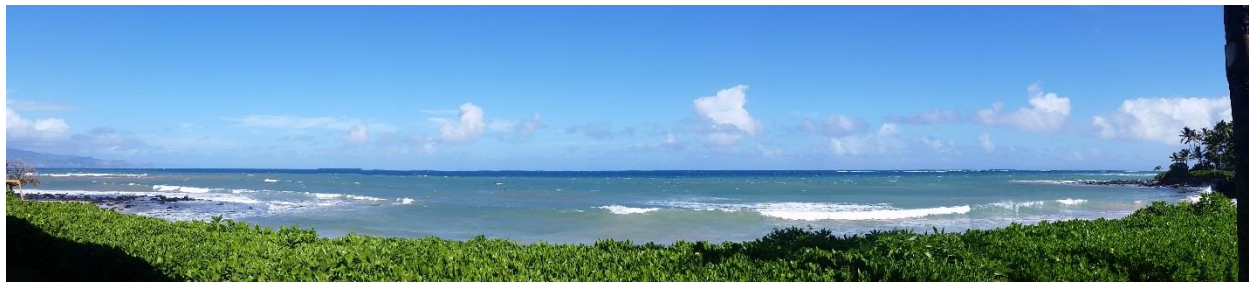
Figure 7-11 Water quality conditions at Sugar Cove, 10:15 on November 09, 2015.

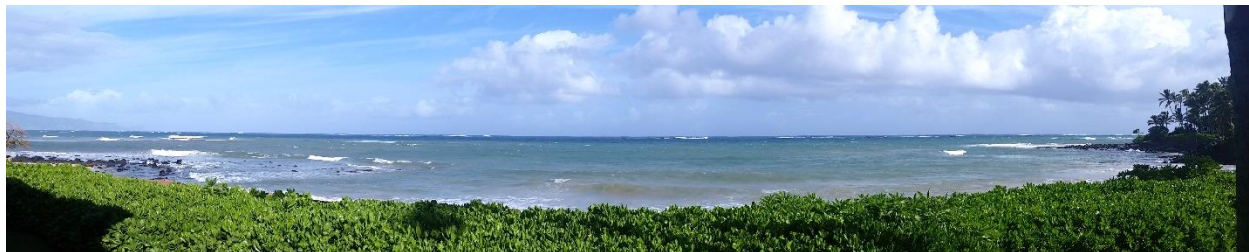
Figure 7-12 Water quality conditions at Sugar Cove, 09:12 on November 10, 2015.

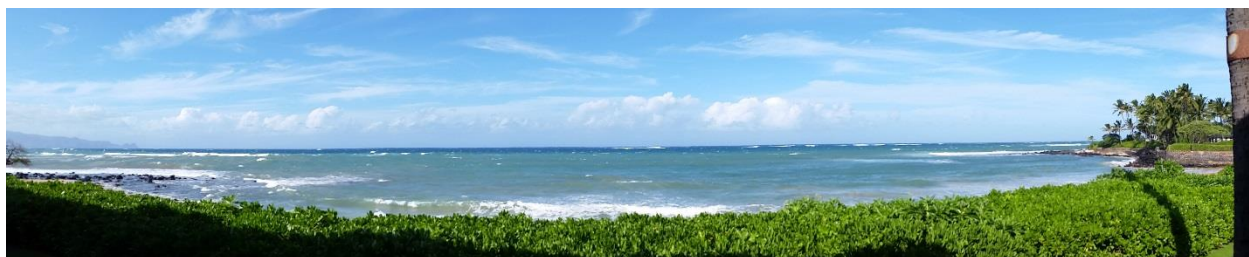
Figure 7-13 Water quality conditions at Sugar Cove, 14:48 on November 10, 2015.

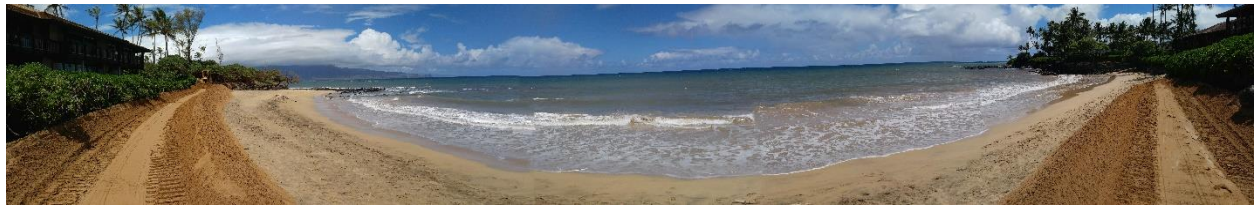
Figure 7-14 Water quality conditions at Sugar Cove, 11:15 on September 06, 2016.

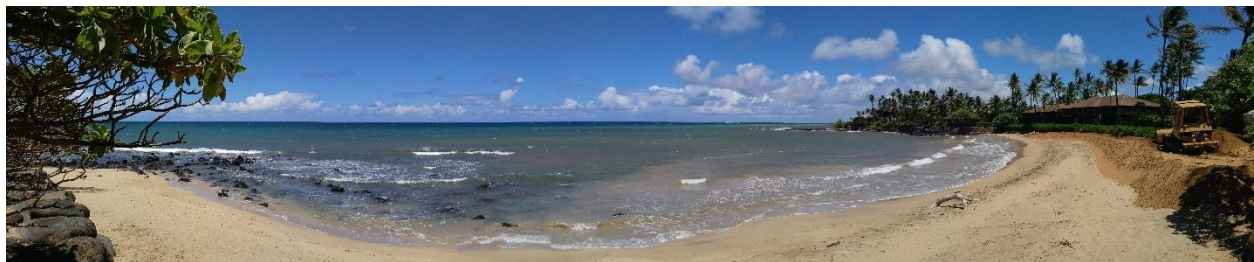
Figure 7-15 Water quality conditions at Sugar Cove, 17:50 on September 6, 2016. End of work day.

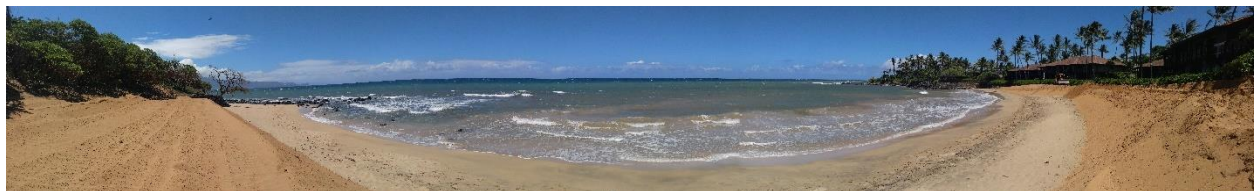
Figure 7-16 Water quality conditions at Sugar Cove, 16:15 on September 7, 2016.
