MEMORANDUM

PROJECT: Kauai Kailani Beach Restoration (Project No. 201752)

SUBJECT: Preliminary Completion Report for Category II Small-Scale Beach Nourishment Seaward of Kauai Kailani Condominiums at 4-856 Kūhiō Highway, Kapa'a, Kaua'i, TMK: (4) 4-3-009:041

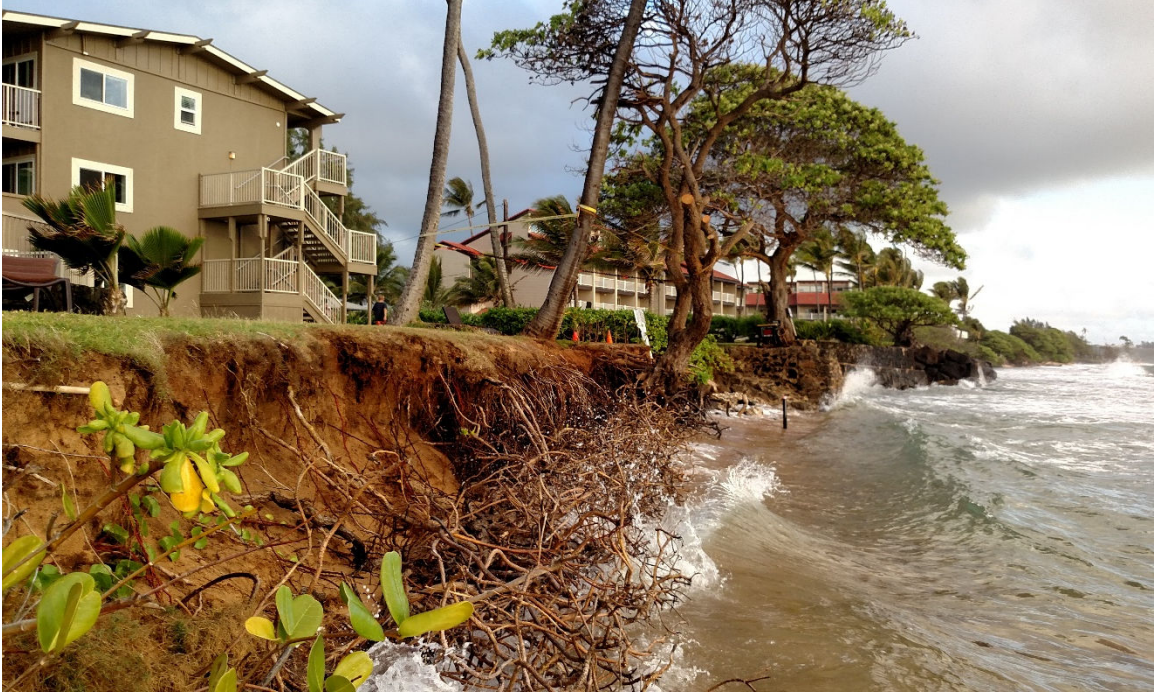
Figure 1. Photograph taken before construction, on October 21, 2016, showing the pre-existing extent of shoreline erosion at the Condominiums, facing north

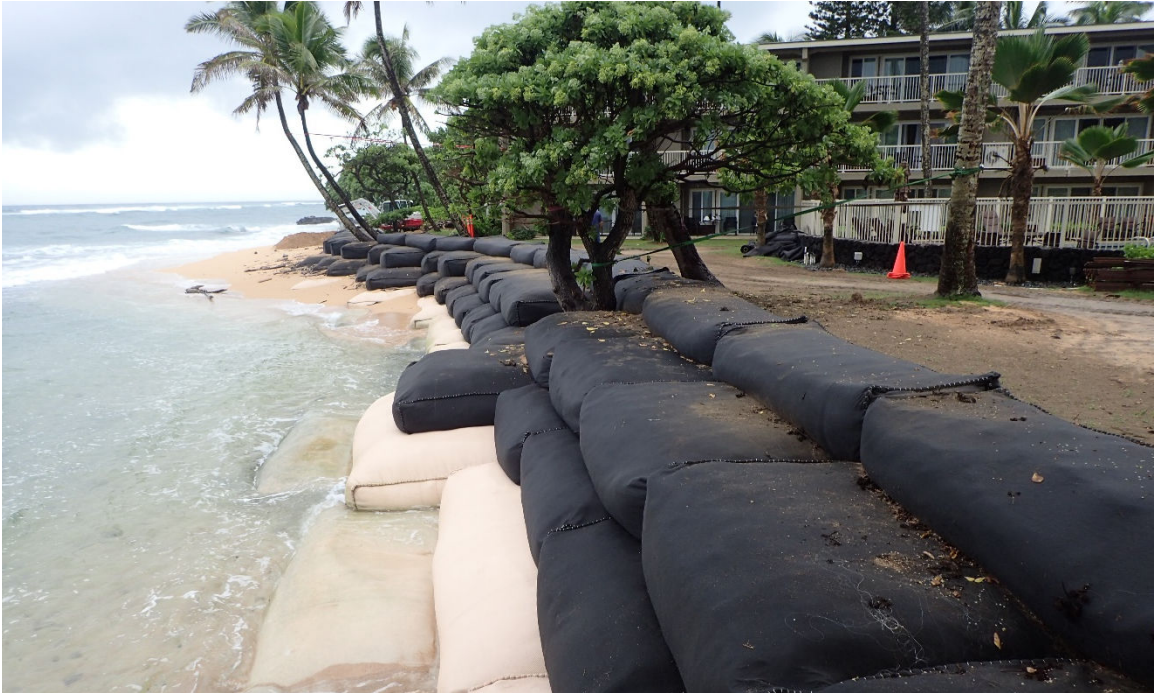
Figure 3. Photograph taken before construction, on October 20, 2020, showing pre-existing sandbag shoreline protection fronting the Condominiums, facing south

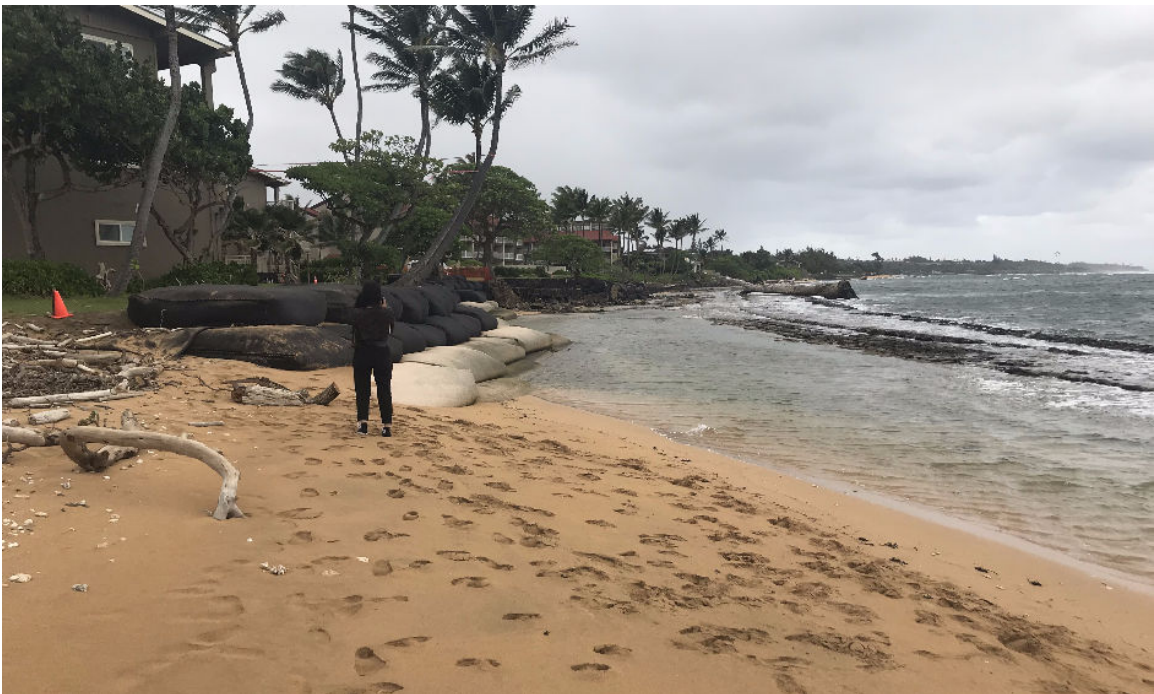
Figure 4. Photograph taken before construction, on January 18, 2021, showing southern end of pre-existing sandbag shoreline protection fronting the Condominiums, facing north

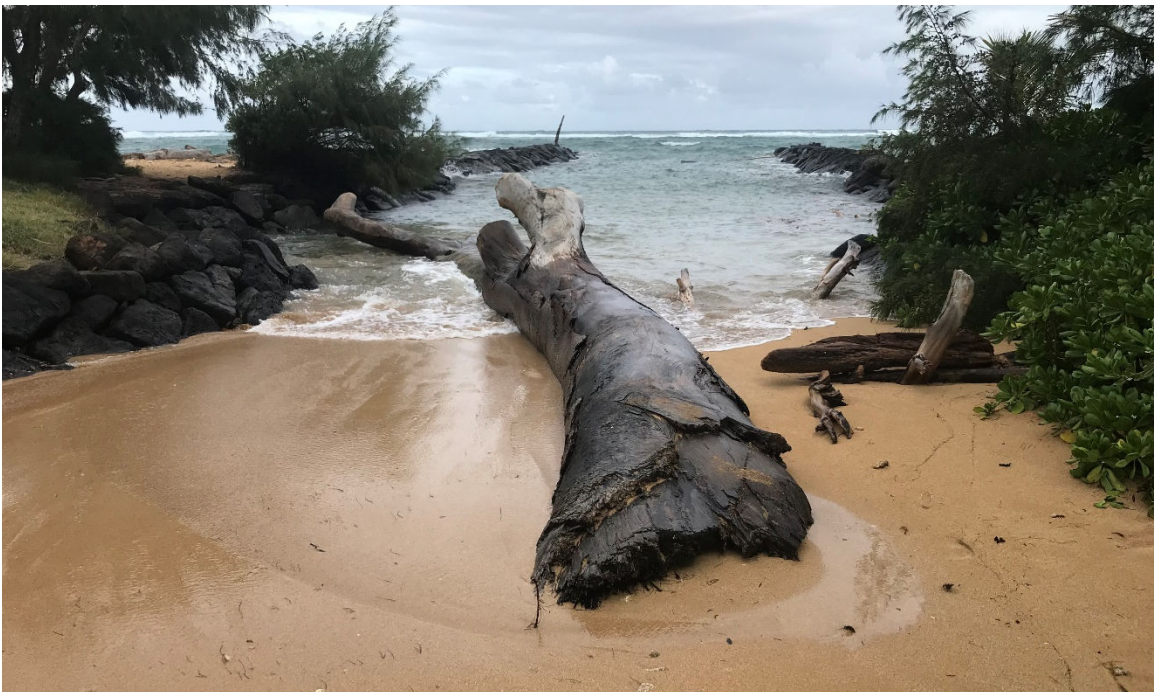
Figure 6. Photograph taken before construction, on August 1, 2018, showing sand accumulation at the eastern end of Waipouli Drainage Canal, facing east

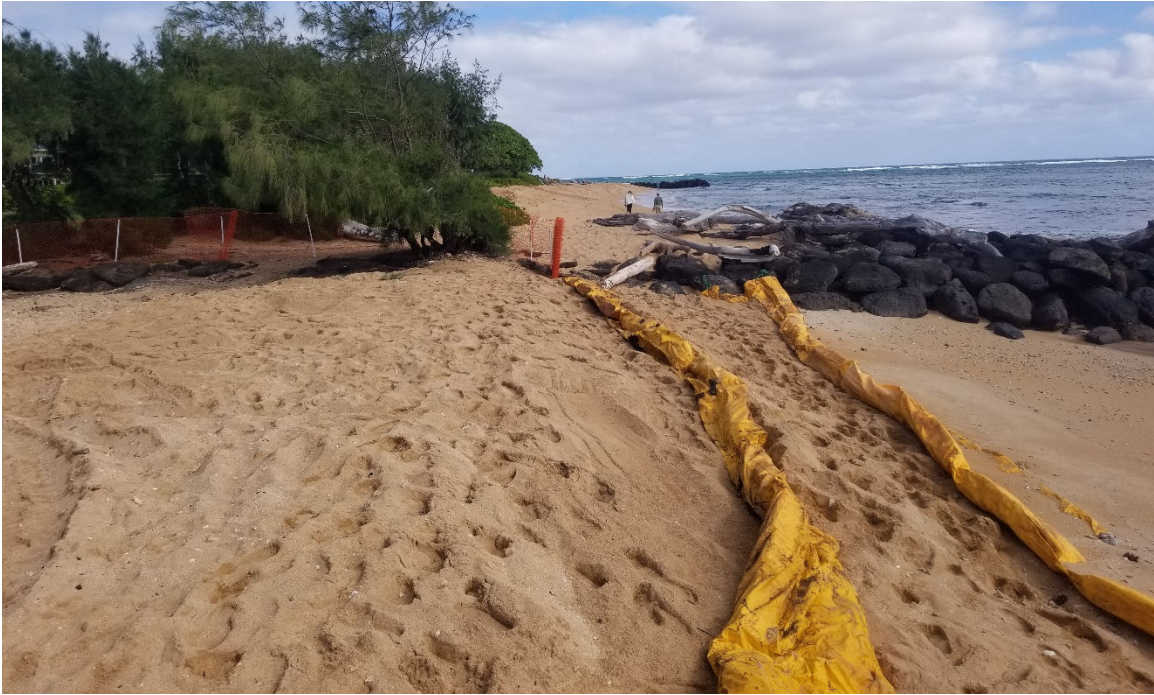
Figure 7. Photograph taken during construction, on February 1, 2023, showing sand plug and silt curtain BMPs at the eastern end of Waipouli Drainage Canal, facing north

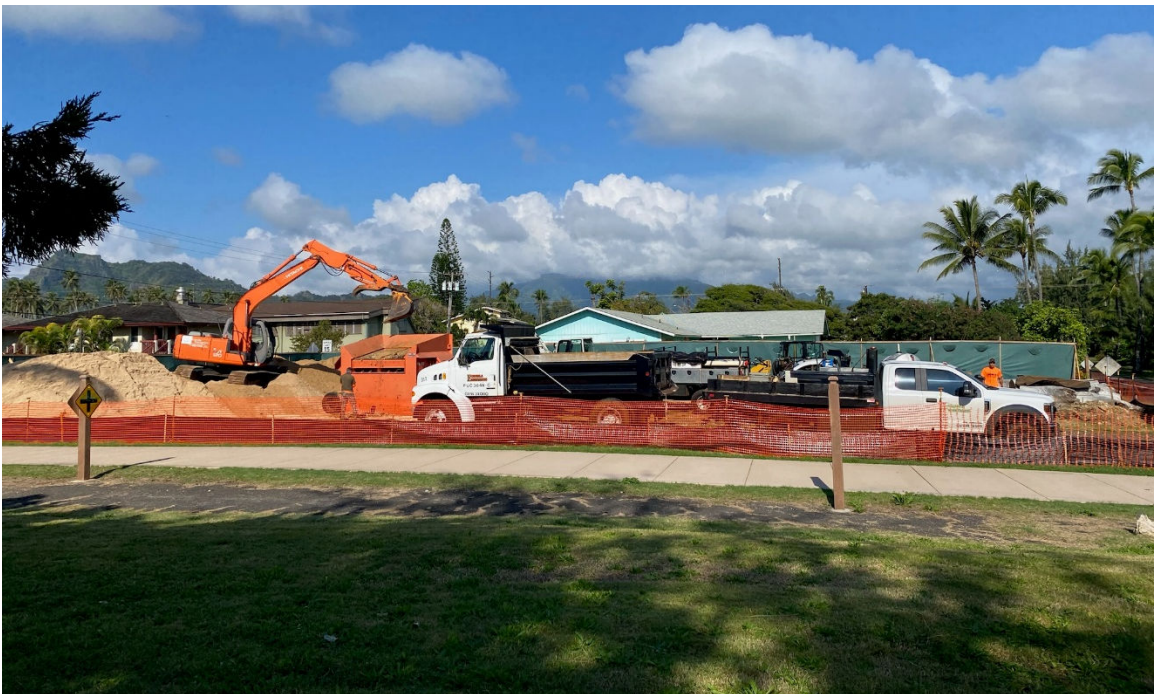
Figure 8. Photograph taken during construction, on February 8, 2023, showing temporary sand stockpiles being screened for coral fragments, with geotextile foundation fabric, fiber roll and silt fence BMPs

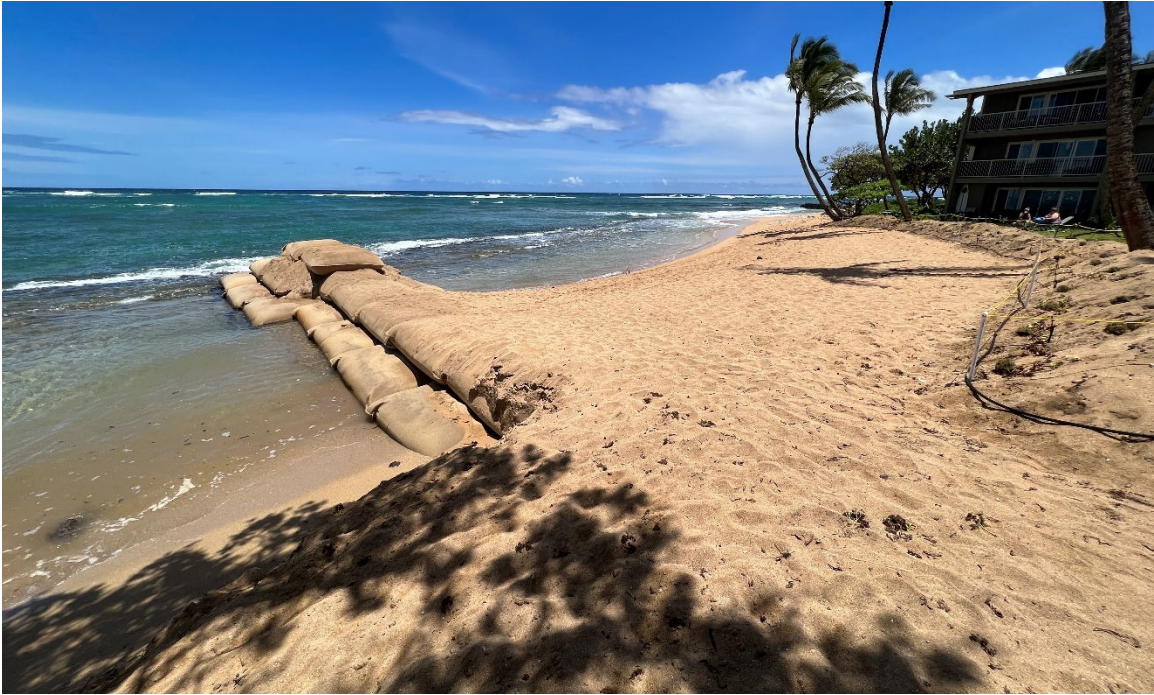
Figure 13. Photograph taken during construction, on May 17, 2023, showing sandbag groin, beach nourishment and unvegetated sand berm, facing south

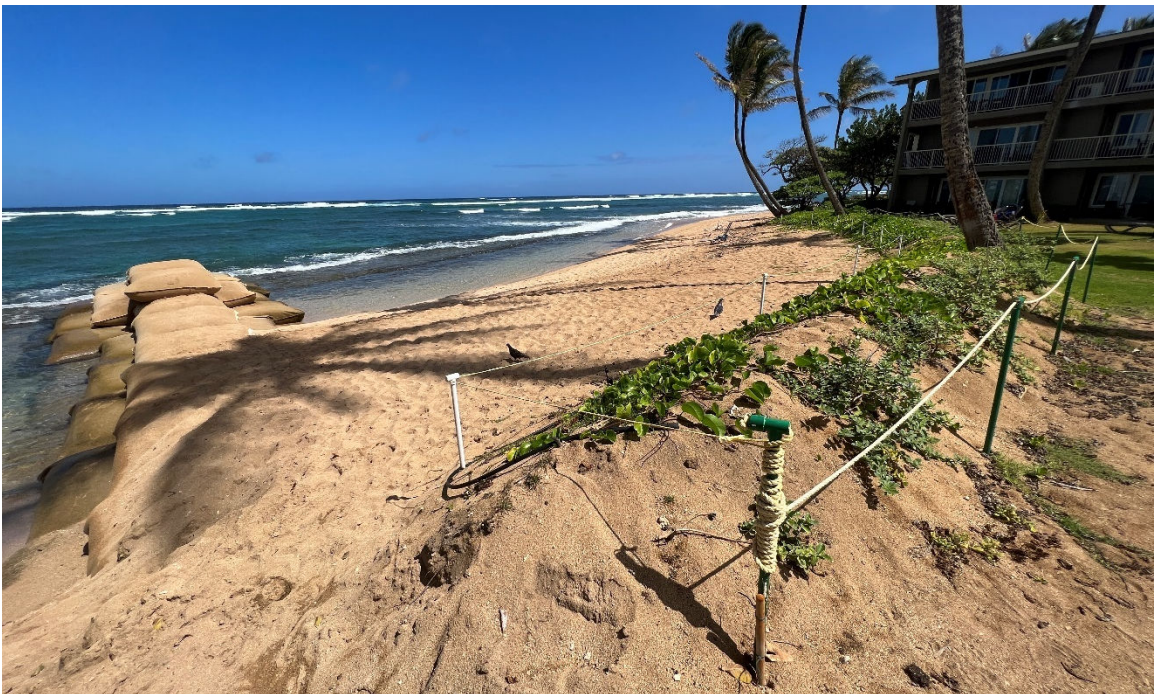
Figure 14. Photograph taken during vegetation establishment, on August 29, 2023, showing sandbag groin, beach nourishment and partially vegetated sand berm, facing south

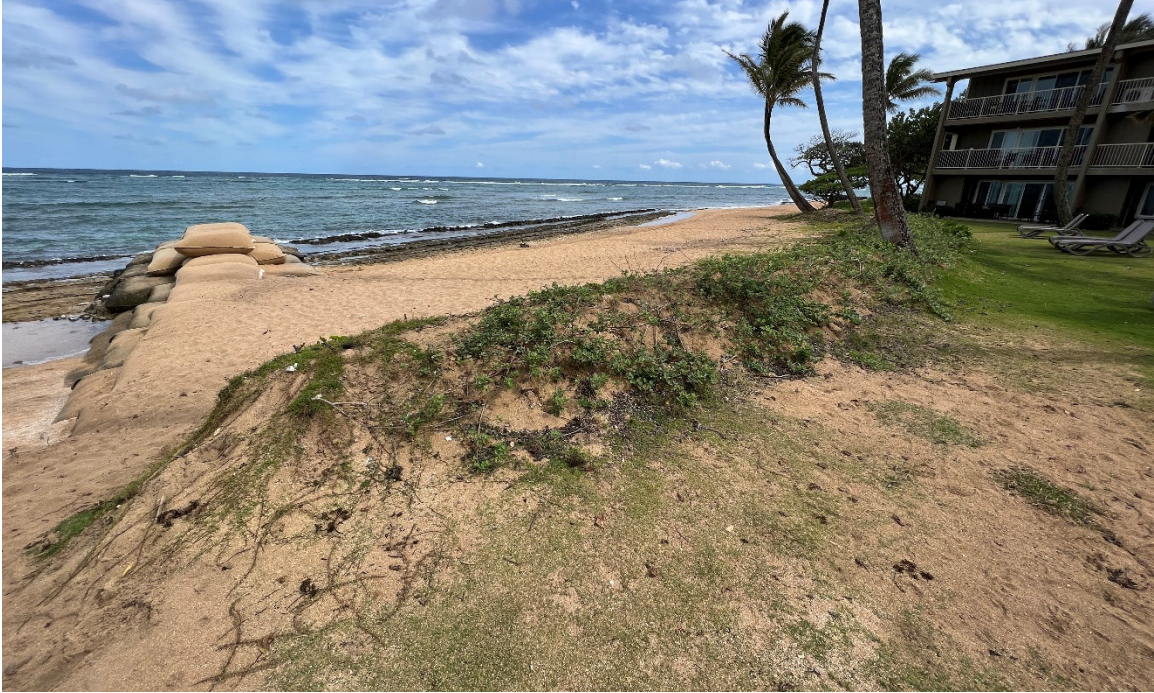
Figure 15. Photograph taken after vegetation establishment, on March 19, 2024, showing sandbag groin, beach nourishment and vegetated sand berm, facing south

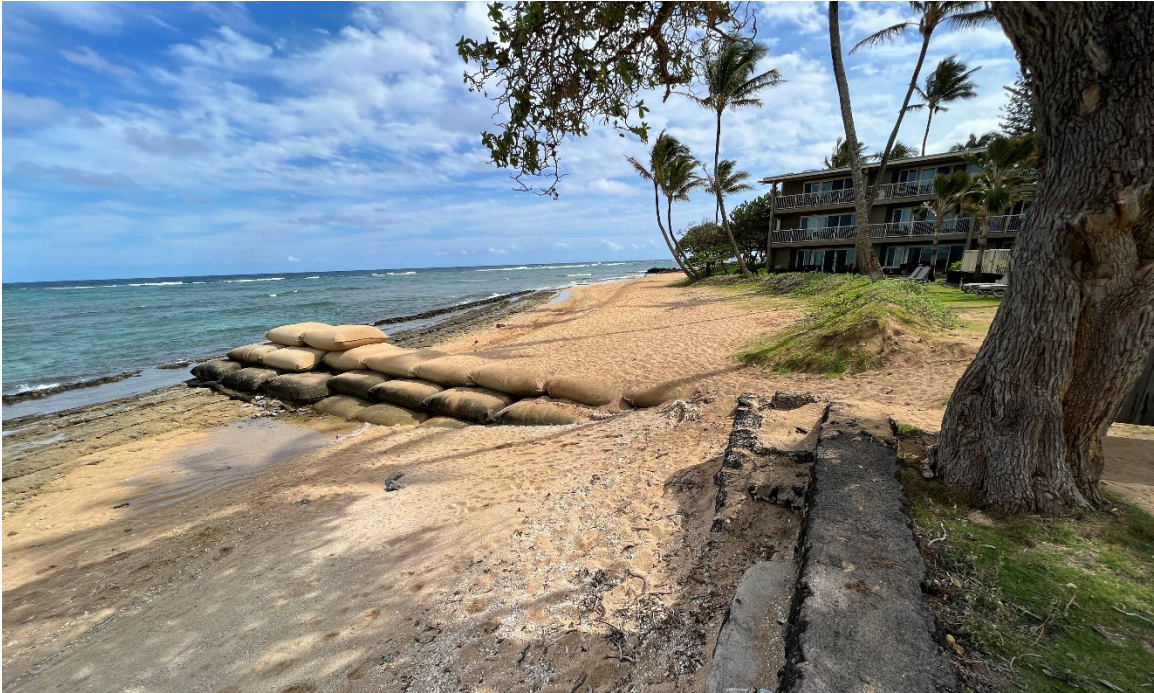
Figure 16. Photograph taken after vegetation establishment, on March 19, 2024, showing sandbag groin and beach nourishment abutting adjacent property to the north, facing south

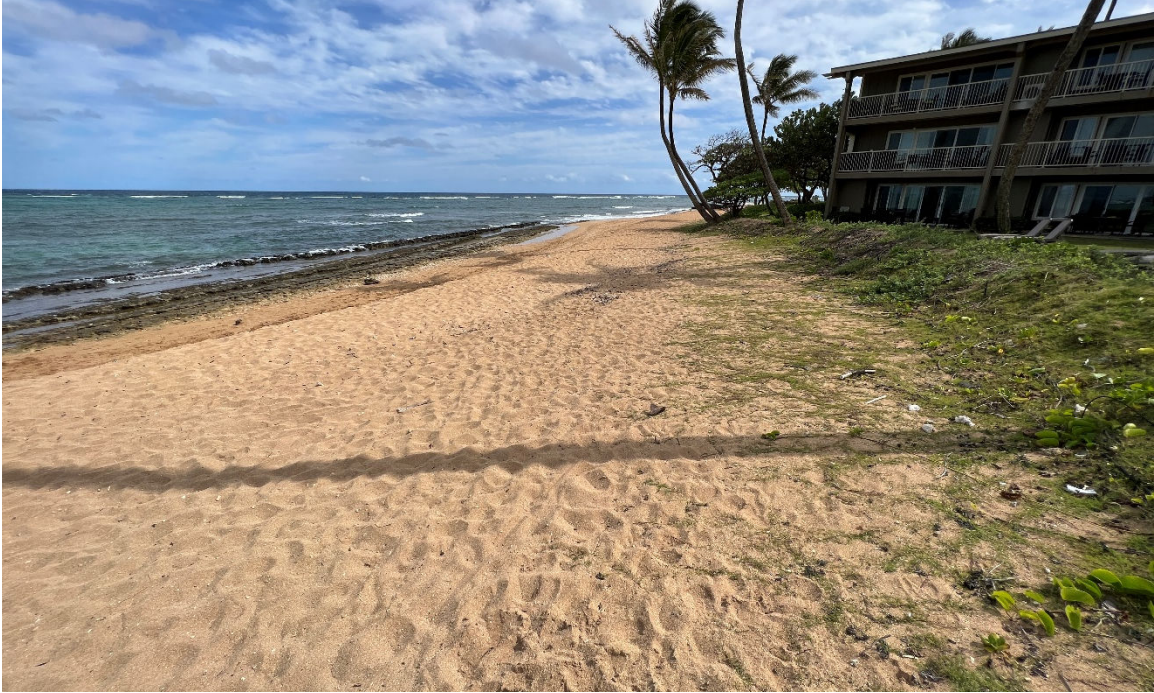
Figure 17. Photograph taken after vegetation establishment, on March 19, 2024, showing beach nourishment and vegetated sand berm, facing south

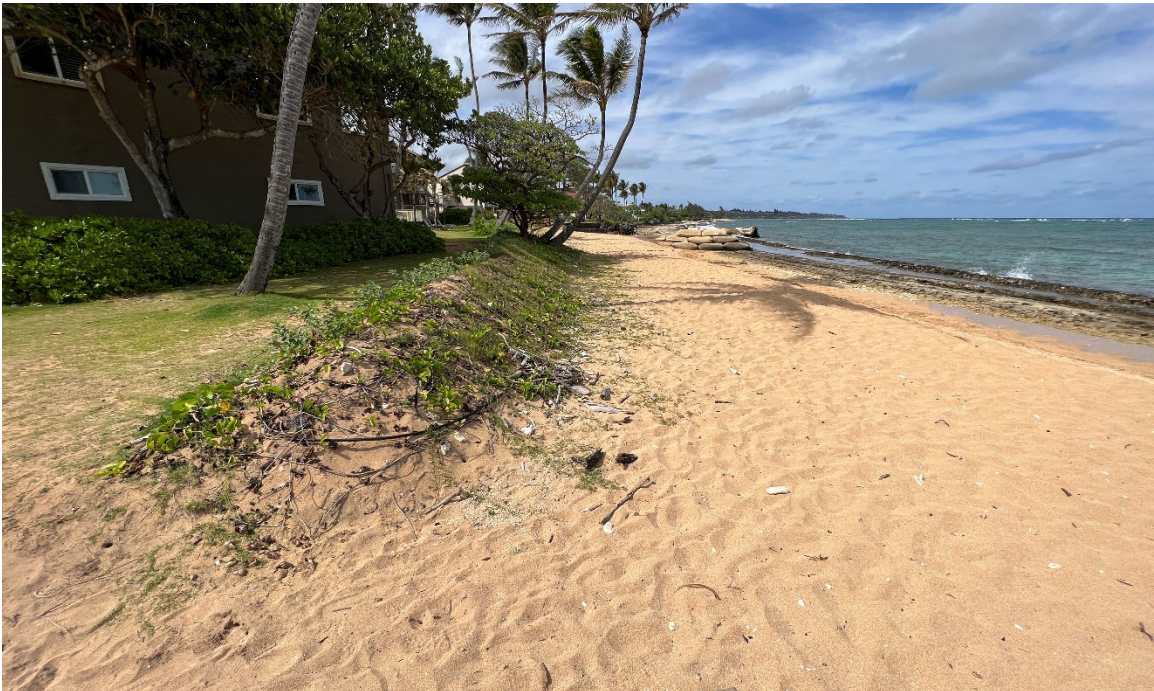
Figure 18. Photograph taken after vegetation establishment, on March 19, 2024, showing sandbag groin, beach nourishment and vegetated sand berm, facing north

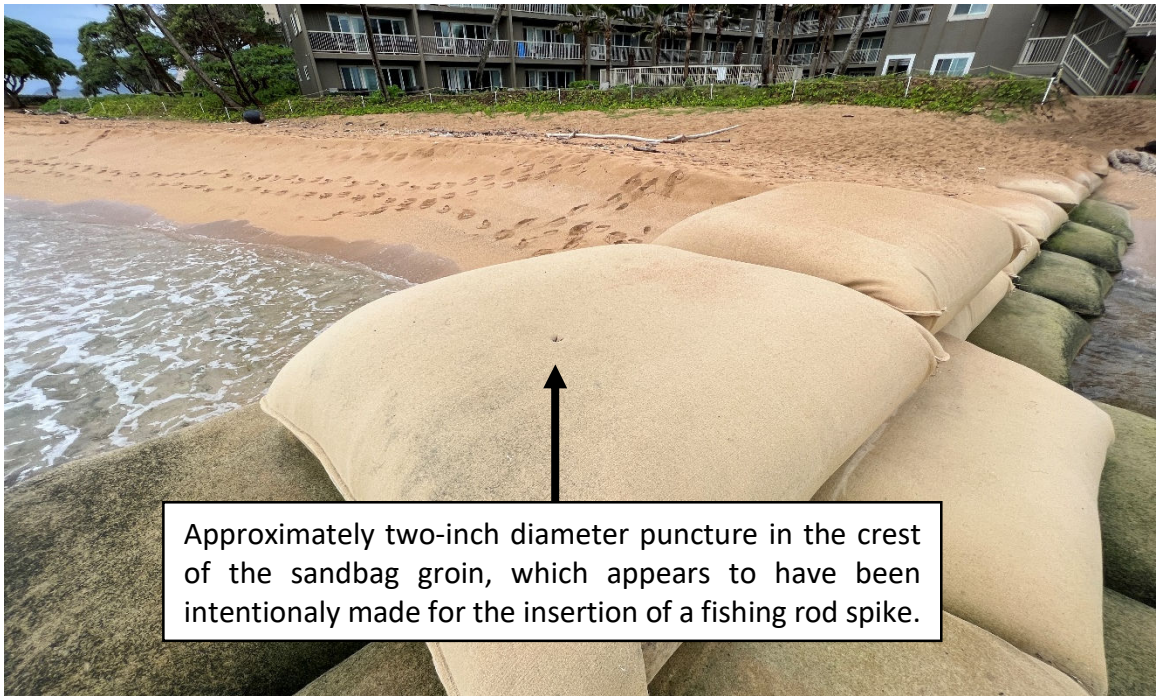
Observations and photographs of the project were made during periodic site inspections. Photographs taken during the inspections before, during and after construction are included in Attachment A as Figures 1 through 21. The only observed damage to the groin's geotextile containers since construction is a small puncture in the geotextile fabric at the seaward-most crest of the groin (Figure 19). Photographs of the project beach profile and the sandbag groin taken during a recent site inspection are provided in Figures 20 and 21.

Figure 19. Photograph taken on November 30, 2023, showing minor damage that was observed to one of the groin's geotextile containers
