Sugar Cove Berm Maintenance Effort #6 Monitoring

Sugar Cove, Spreckelsville, Maui, Hawaii

March 2025

Sea Engineering, Inc.
504 N. Nimitz Hwy
Honolulu, HI 96817

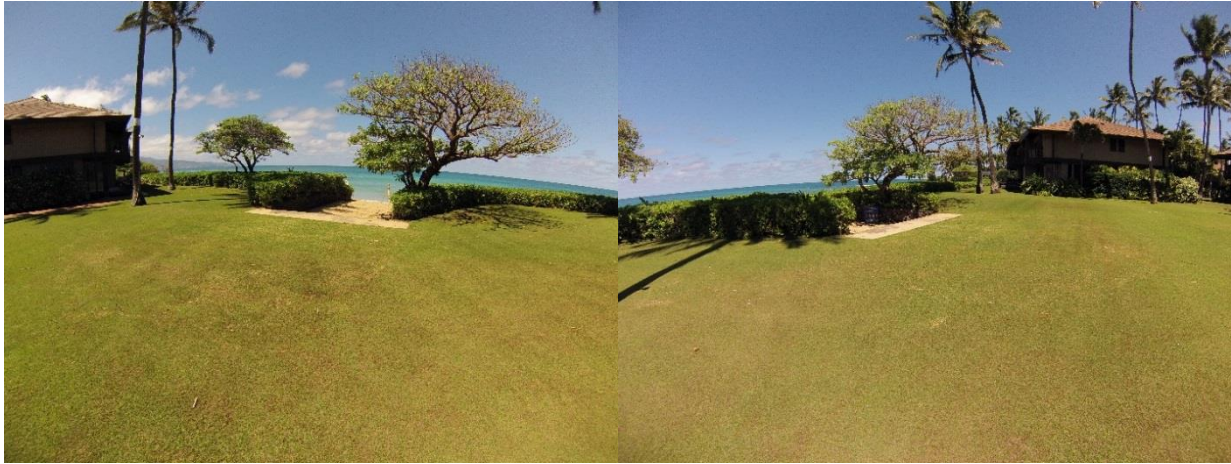
Figure 1-10. Typical backshore conditions at the site

Backshore conditions at the project are typified by a coastal lawn bordered by a naupaka hedge on the makai side. The Hayashi seawall is located beneath and makai of the naupaka hedge, extending seaward beneath the restored sand beach. Dwellings are built on the coastal lawn, adjacent to the mauka side of the Hayashi seawall.

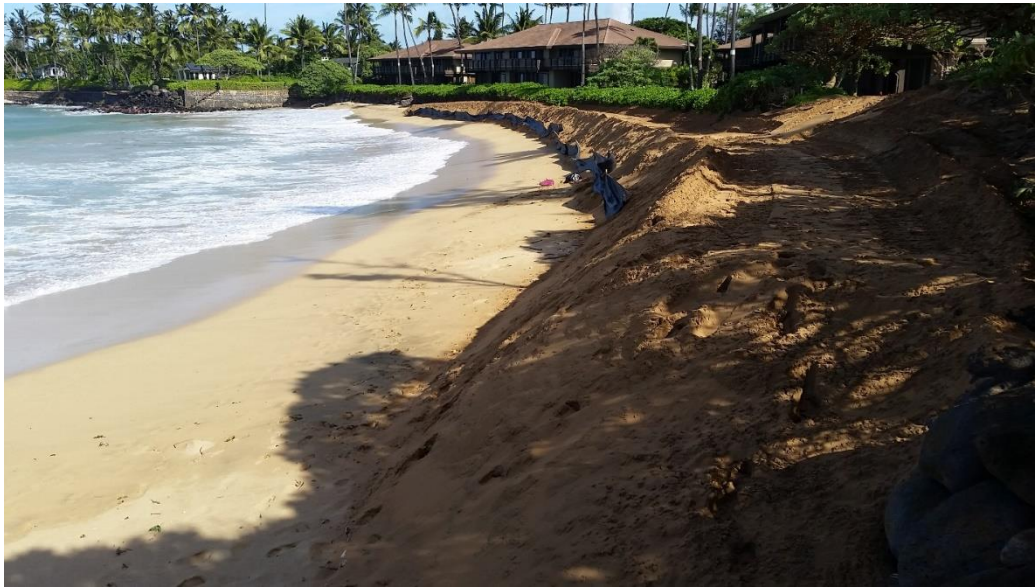
Figure 4-7. Beach and berm condition after placement (November 10, 2015, Maintenance #1)

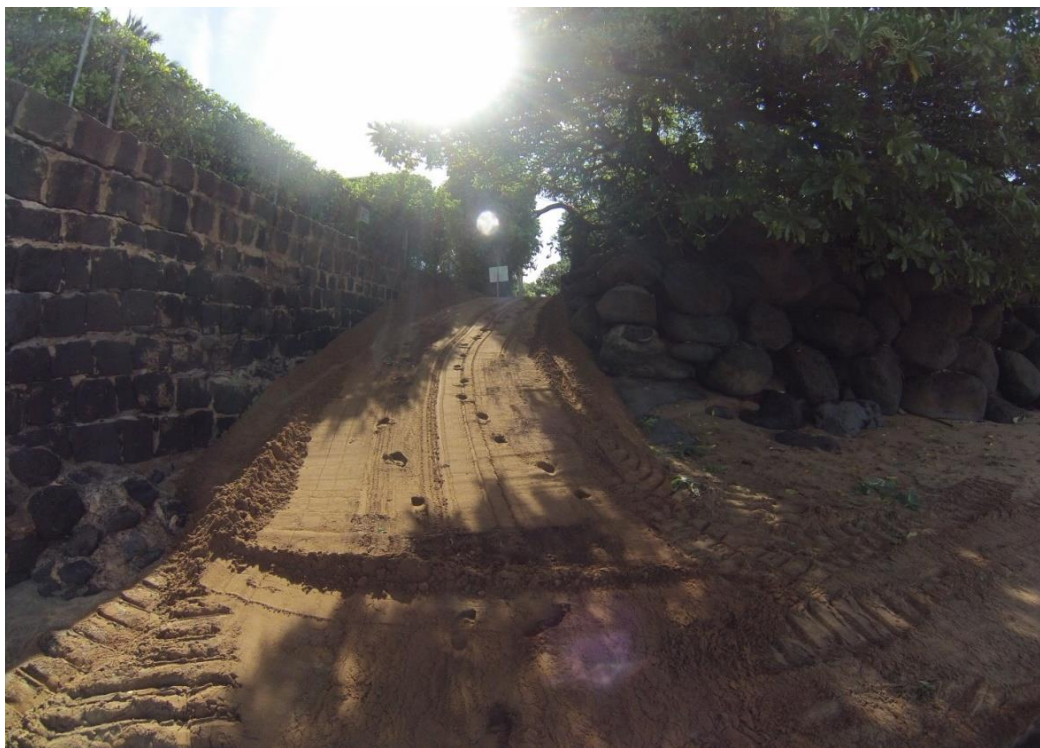
Figure 4-10. County of Maui beach access path with graded maintenance sand (Maintenance #1)

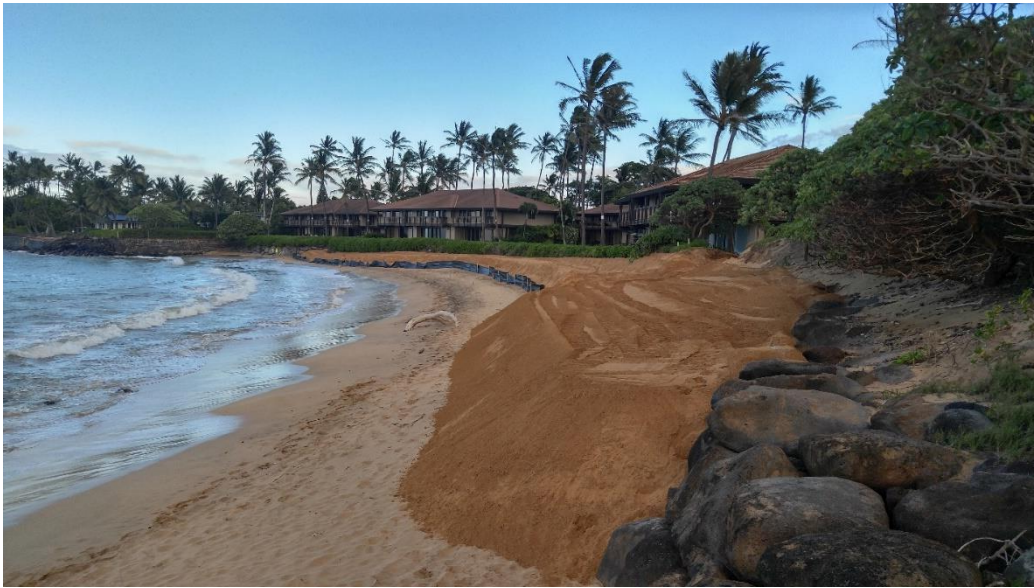
Figure 5-5. Beach and berm condition after placement on September 7, 2016 (Maintenance #2)

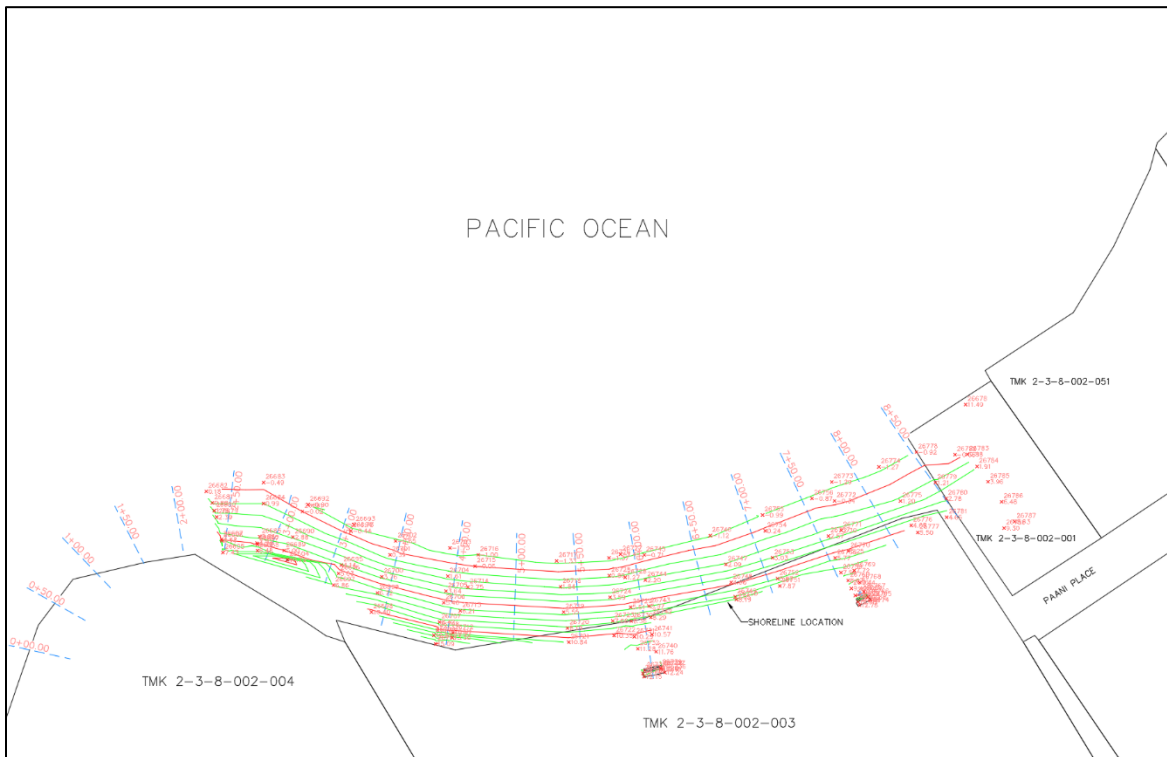
Figure 10-117 April 23, 2024 topographic conditions prior to maintenance #6

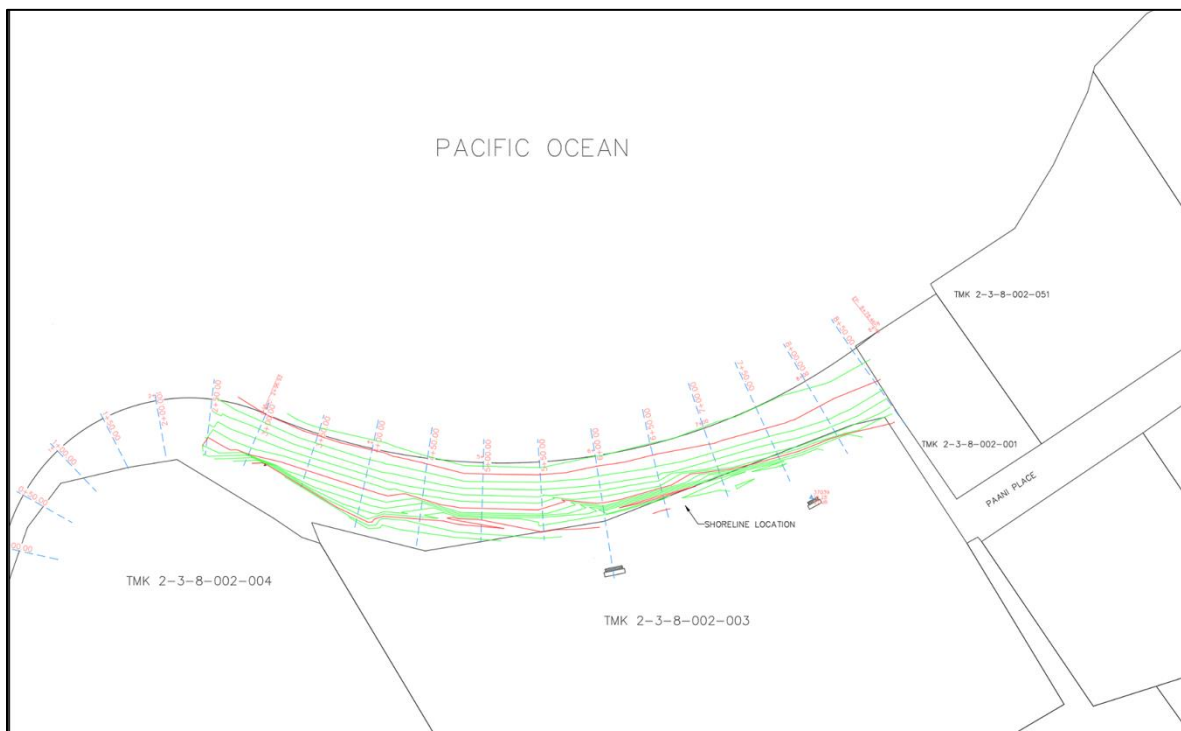
Figure 10-118 April 25, 2024 topographic conditions immediately following maintenance #6
