SUBJECT: PETITION TO REMOVE HISTORIC PROPERTY "FALLS OF CLYDE"
FROM HAWAII REGISTER OF HISTORIC PLACES PER HAR §13-198-10(1)

THE FOUR-MASTED IRON SHIP *FALLS OF CLYDE*: EVALUATION OF LOSS OF INTEGRITY AND RECOMMENDATION FOR DELISTING FROM THE NATIONAL REGISTER OF HISTORIC PLACES

James P. Delgado, Ph.D.

May 10, 2023

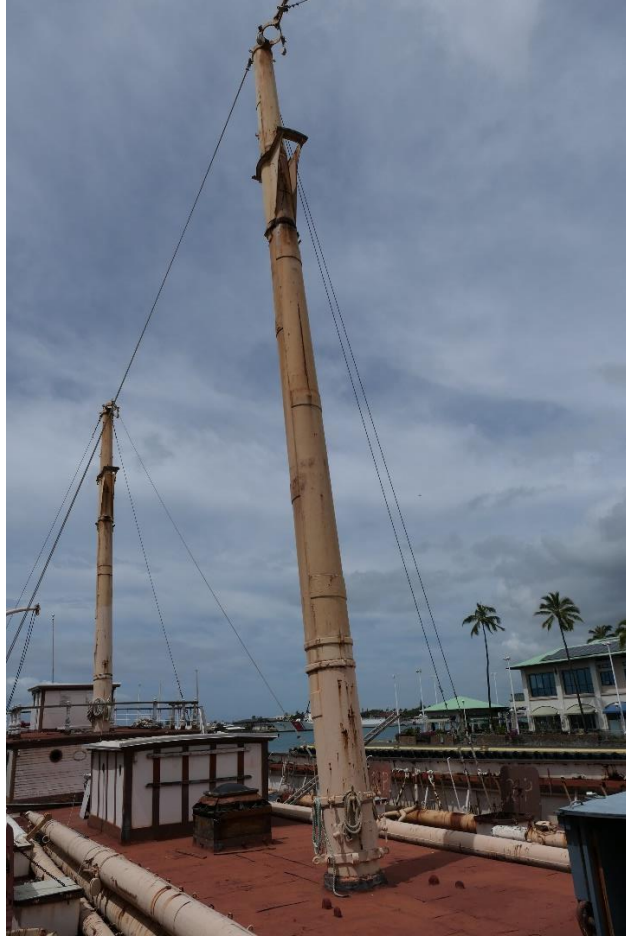
The vessel is now, in 2023, a partially flooded hulk, with the topmasts, topgallant masts, yards, booms and gaffs stowed in a deteriorated condition on the weather deck. There is no running rigging; only some of the standing rigging that supports the lower masts. The existing down-rigged condition of the vessel no longer reflects or represents a sailing vessel. The masts are corroding; “bare poles” in sailing parlance.

Figure 3: Condition and status of standing rigging for the mizzen and jigger masts (Joseph Lombardi).

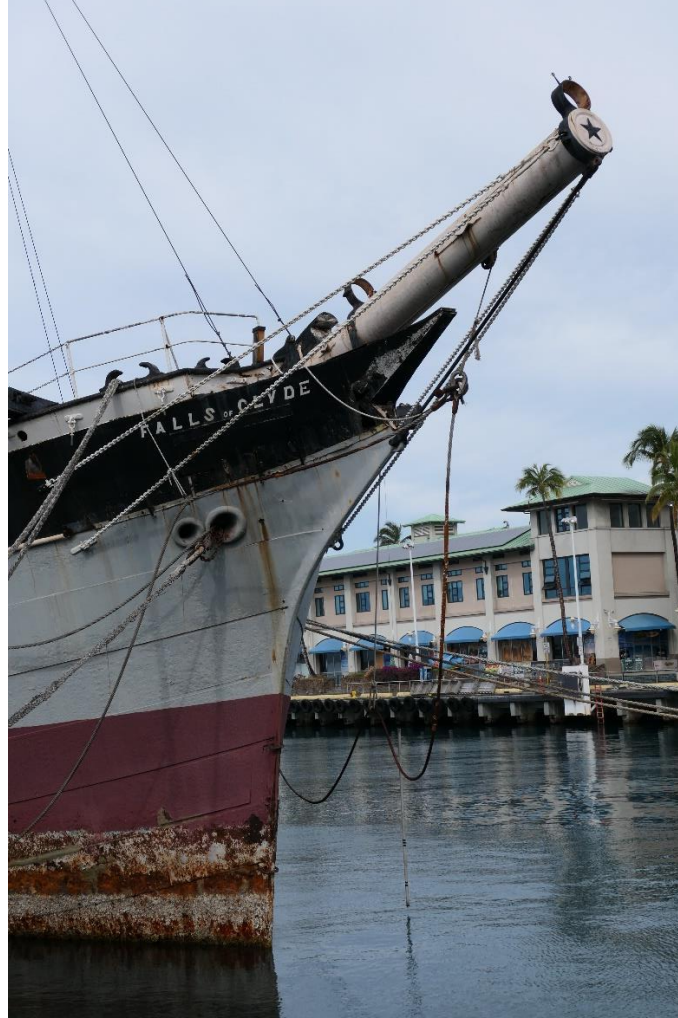
The bowsprit, a key feature of the vessel and its rigging, was rigged to balance the upward pull of head stays and the downward pull of bobstays; these were key to maintaining taut support for the masts. The bowsprit, now also down-rigged, is missing its outer jibboom, jibboom head, martingale and associated rigging, such as the outer jibboom guys, fore-royal stay, fore-topgallant-stay, flying jibboom downhaul, outer jib-stay, fore-royal-stay, outer-martingale-stay, martingale stay, and martingale backstays. The bowsprit, supported by its inner-bowsprit guys, are about to fail; *“The forward wrought iron margin of the deck is badly corroded and provides support for the guy wires of the bowsprit. This will give way shortly with catastrophic failure of bowsprit to follow”* (Lombardi 2023: 35).

Figure 4: Bowsprit and guys (Joseph Lombardi).

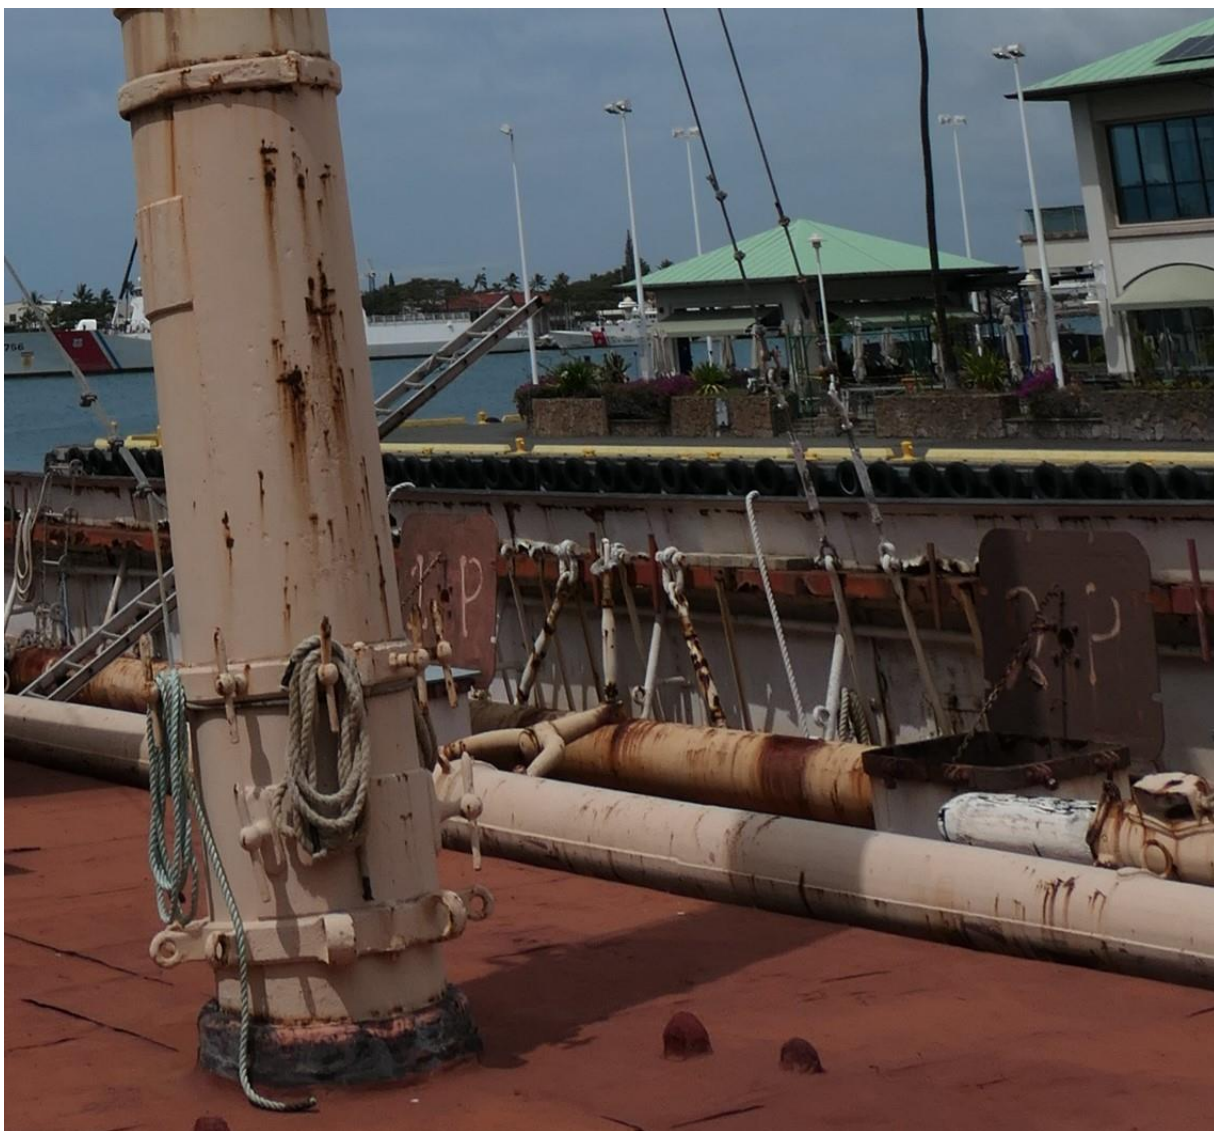
Figure 5 is a close-up view of Figure 3 and shows the port chainplates that supported the standing rigging for the mast. This is where the masts will need to be cut, and it is also an area where the loss of integrity is apparent even now, before the removal of more of the masts and rigging.

Figure 5: Chain-plates on the port side with minimal rigging for the mizzen-mast (Joseph Lombardi).

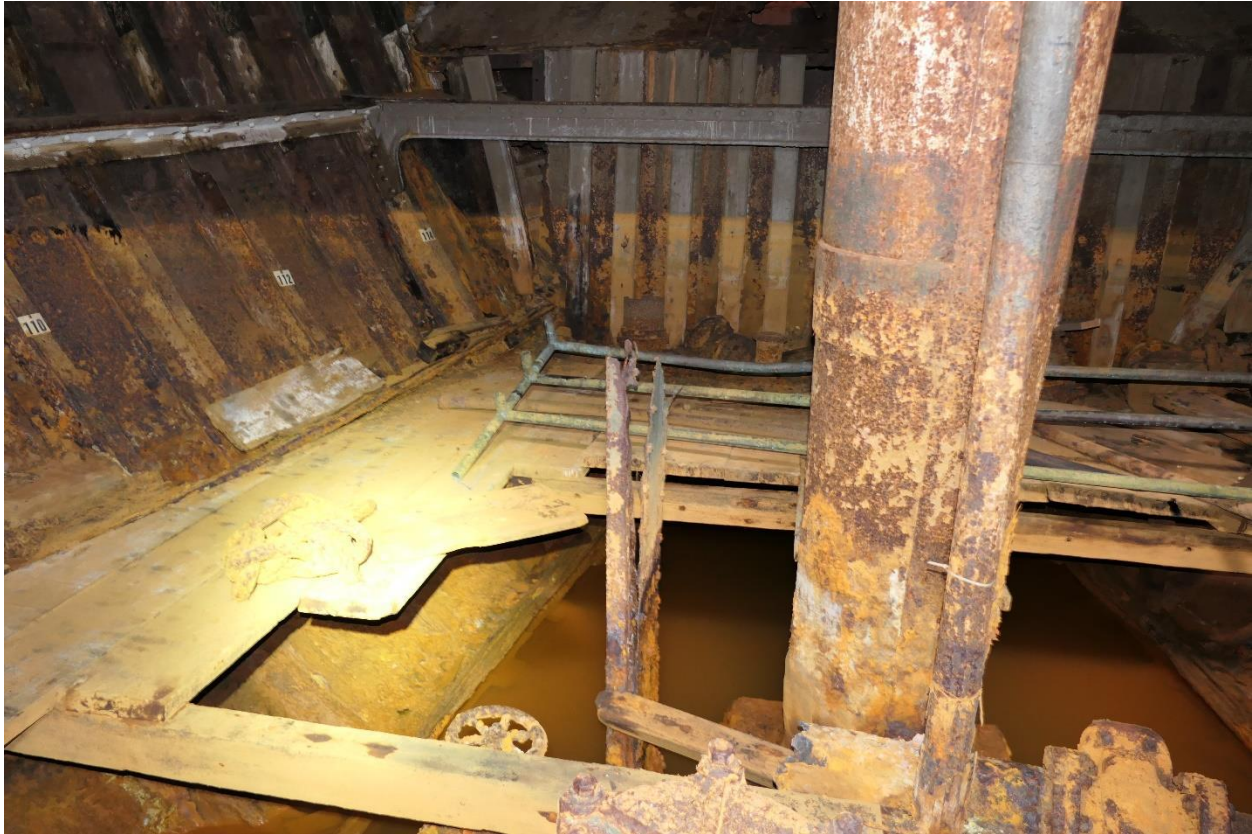
Compounding the untenable nature of the structural integrity of the masts is the fact that the masts are all attached to the ship's keel, and the *"bases for the masts at the keel are badly corroded and exerting additional stress on the hull itself"* (Lombardi 2023: 48). The marine survey recommends *"that these four spars be cut down to the maindeck level before move of ship"* (Lombardi 2023: 48).

Figure 6: Corroded base of the foremast in the bilge, March 2023 (Joseph Lombardi).

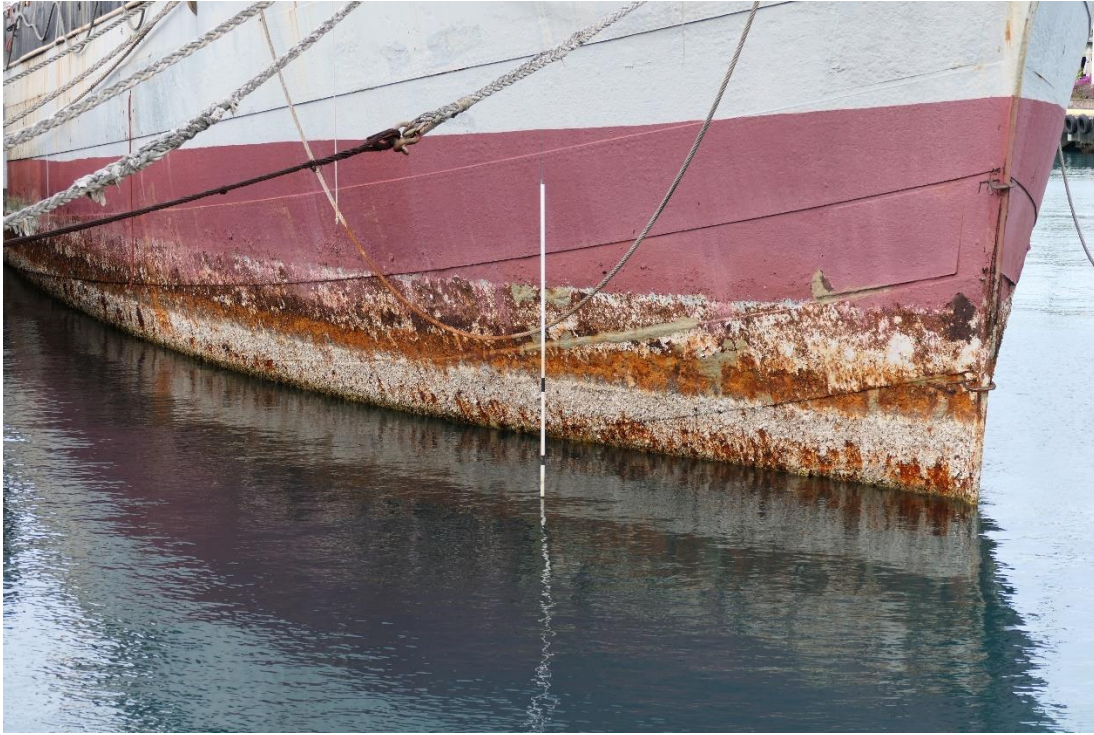
The hull has holes that are the result of corrosion and wastage of the metal. Many of the iron rivets have failed, with heads missing as well as the body of the rivet as it passes through iron hull plating or attaches stanchions, knees, gussets and other fittings to the hull and decks. The exterior hull is leaking through holes both above and below the waterline, and the level of corrosion on the hull below the waterline has grown “rusticles” of corrosion byproduct that is also seen on shipwrecks. In addition to corrosion caused by seawater, the main (weather) deck is no longer watertight, and its leaking has also compromised and caused the failure of the deck below it. The failure of both decks to repel water has led to the loss of structural integrity for the decks to the extent they are no longer safe to walk on. This has also allowed water from rain as well as hull leaks to accumulate in the hold, flooding the lower level of the vessel.

Figure 7: Condition of the lower hull, March 2023 (Joseph Lombardi).

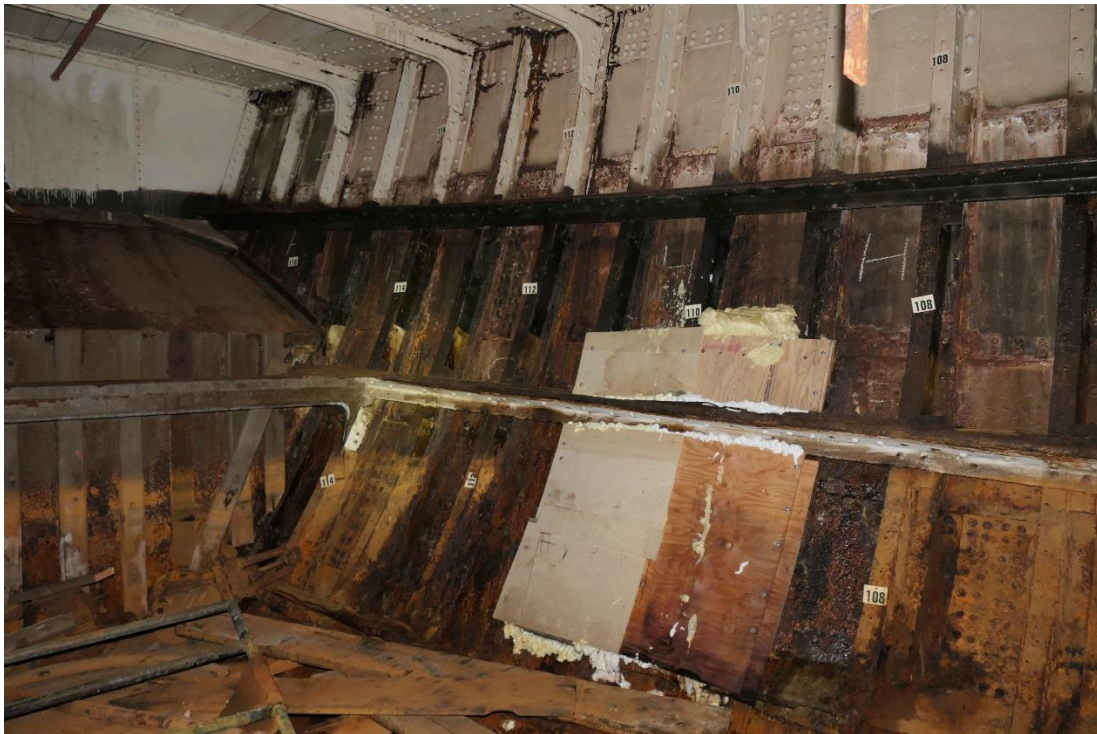
Figure 8: Larger patches cover area where the hull is leaking more substantially, but the loss of up to fifty percent of hull plating thickness in many areas, lost rivets, and rainwater entering through the decks have essentially made *Falls of Clyde* a floating wreck (Joseph Lombardi).

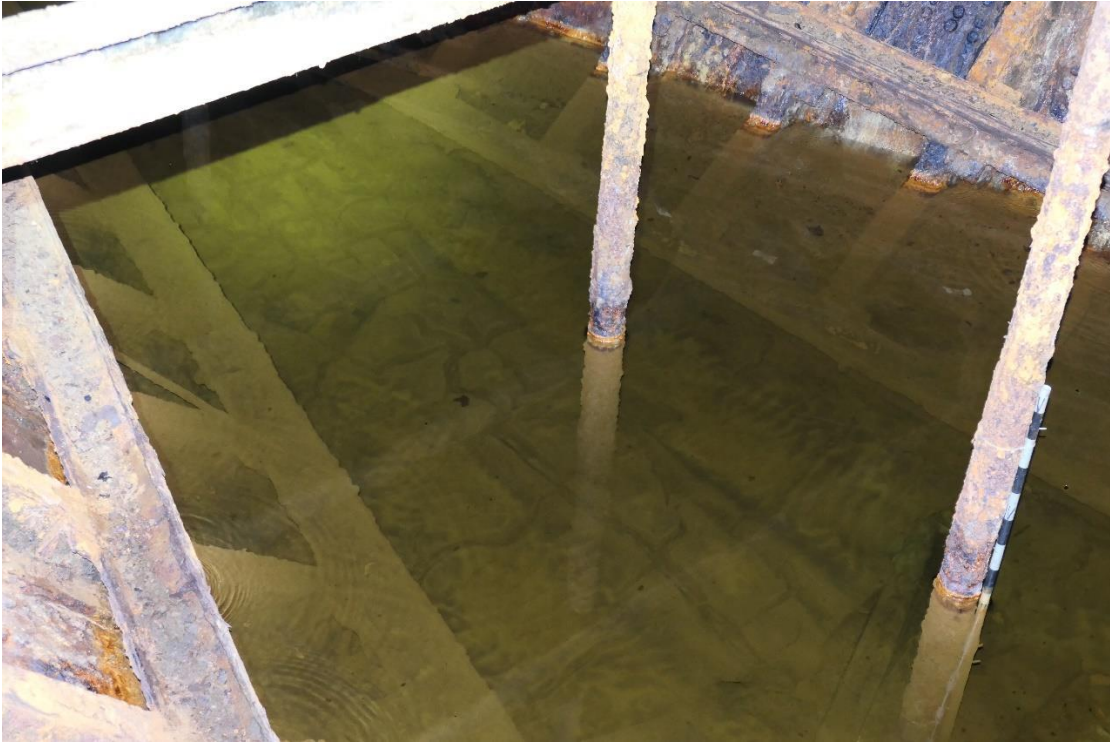
Figure 9: Water in the hold, March 2023 (Joseph Lombardi).

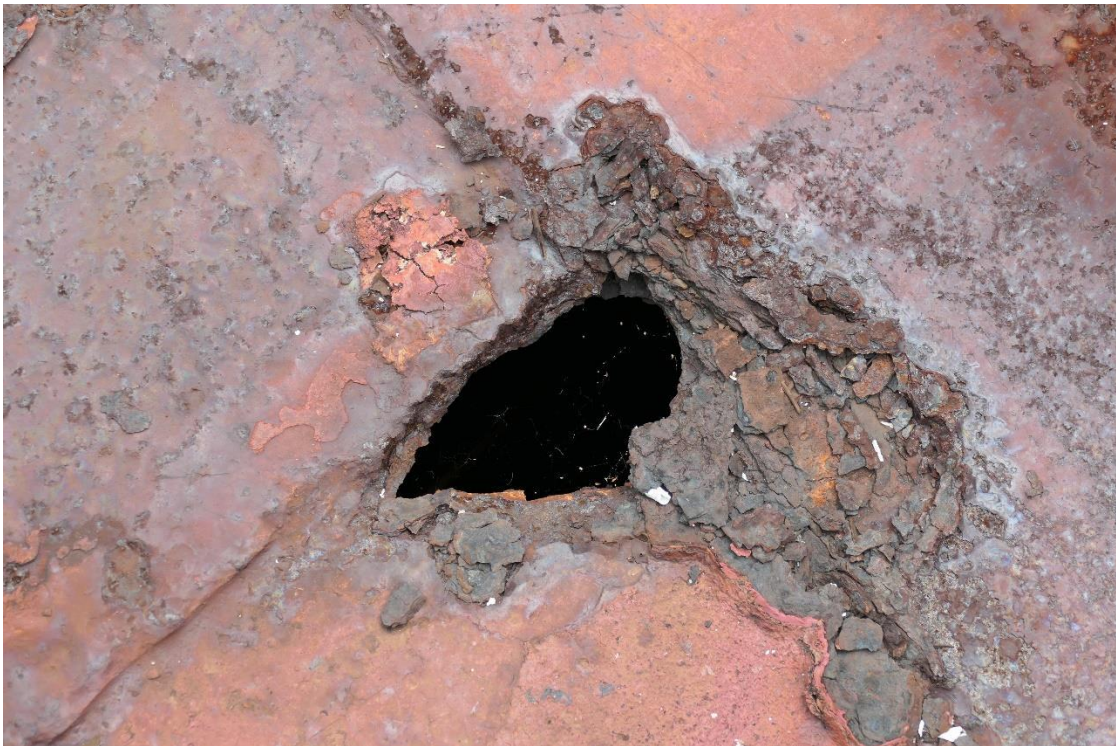
Figure 10: Corrosion has reached the level of complete loss of structural integrity in a number of areas in the hull and decks (Joseph Lombardi).

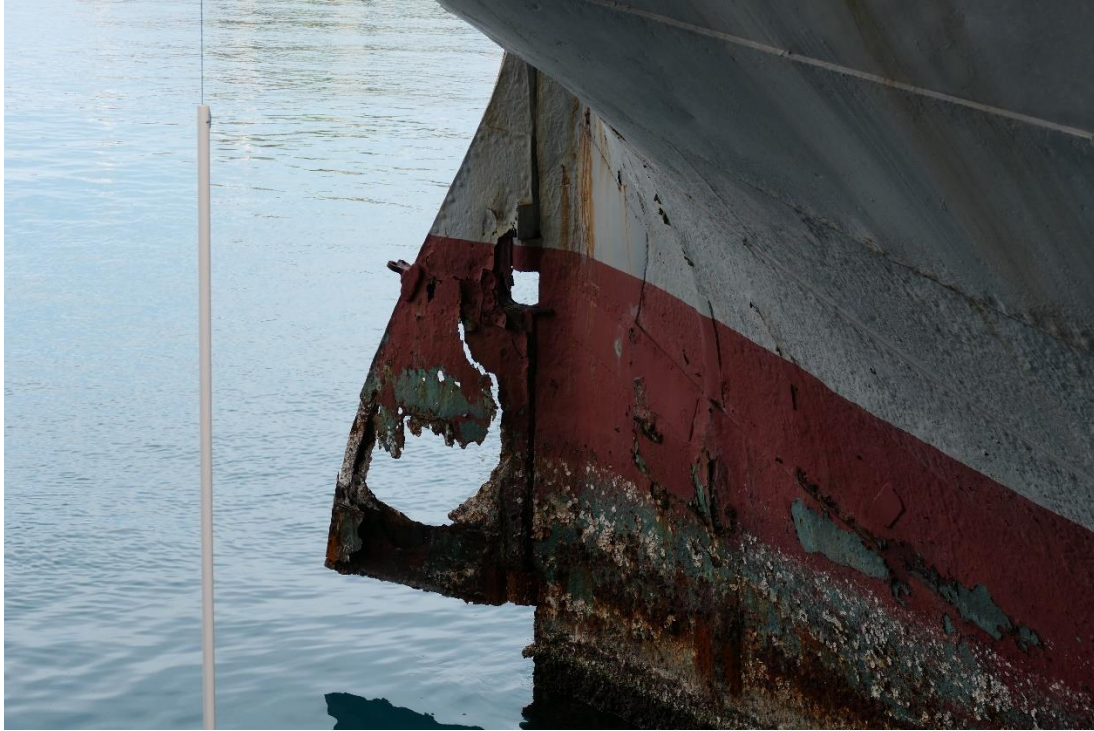
Figure 11: Condition of the rudder, March 2023 (Joseph Lombardi).

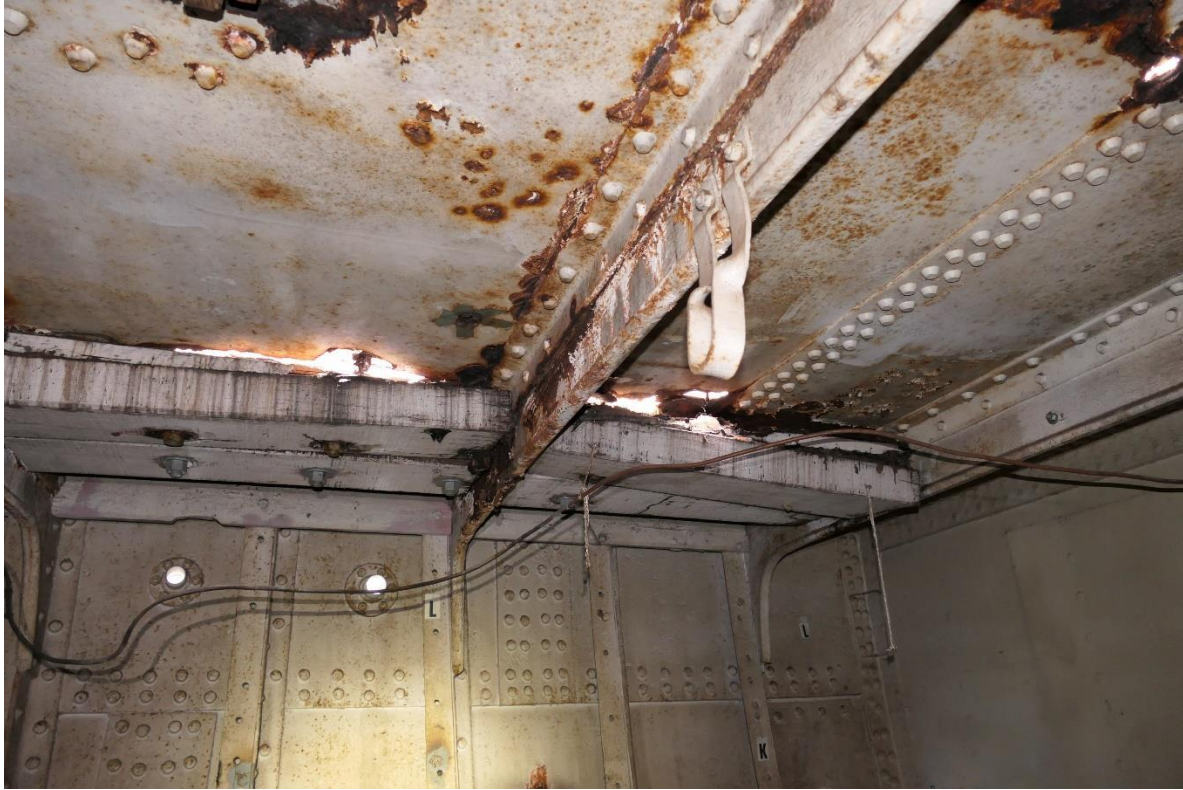
Figure 12: Corrosion has opened holes that have accelerated corrosion inside the ship as well as outside of the vessel (Joseph Lombardi).

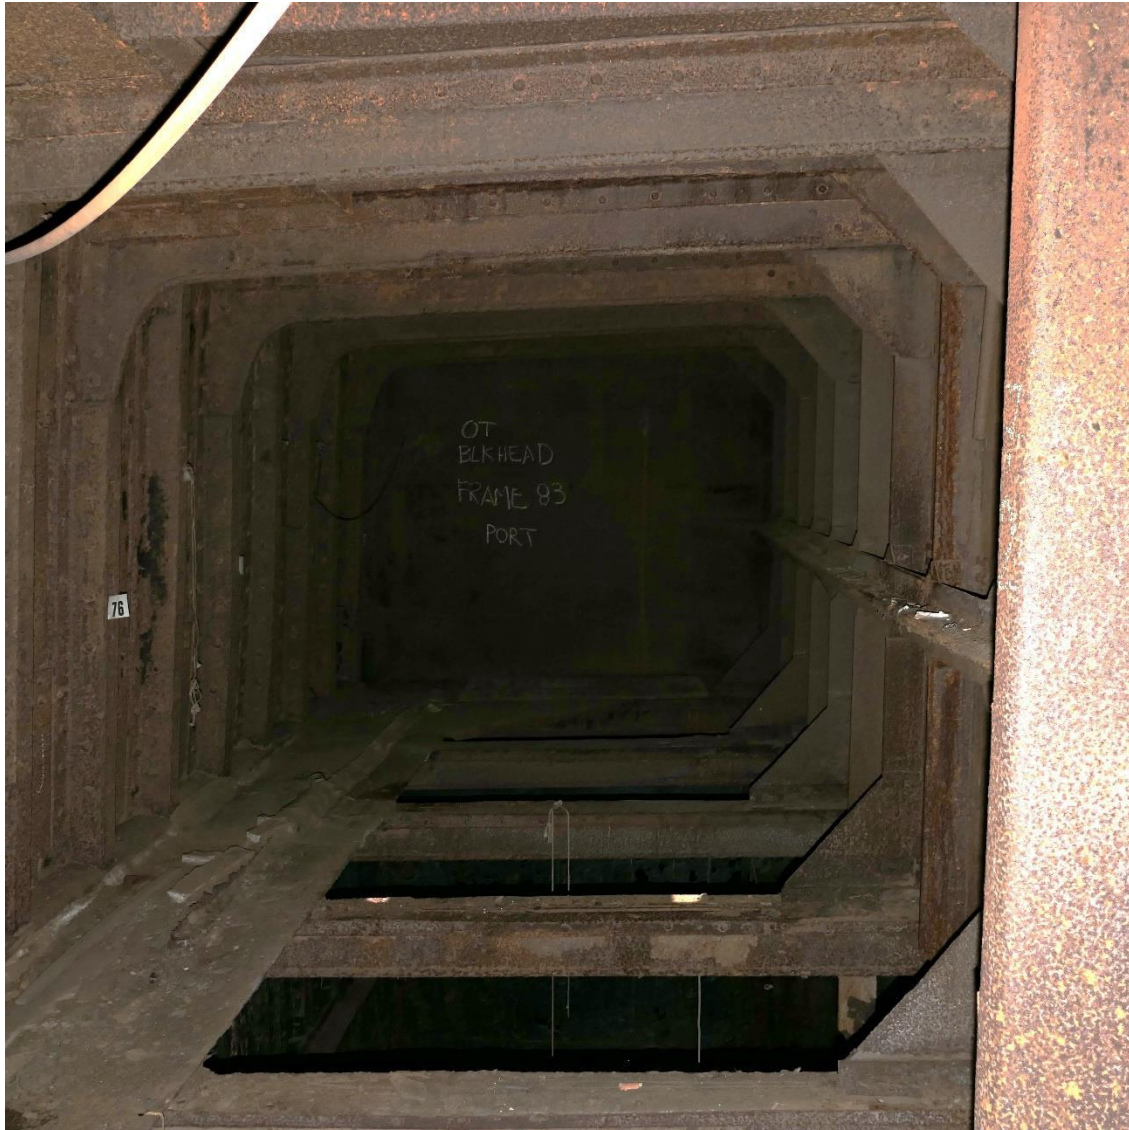
Figure 13: Interior of one of the tanks (Joseph Lombardi).

The ten riveted steel bulk liquid cargo tanks are all flooded with two to three feet of water, and have corroded to the point of not being able to be restored; replacement of much of the physical structure of the tanks would be necessary, especially with as much as 80 (eighty) percent wastage; the physical condition poses a significant hazard to access and work in the area; *“Entry into Tanks is dangerous to personnel due to wasted access ladders and wasted intermediate platform that are structurally unsafe”* (Lombardi 2023: 78):

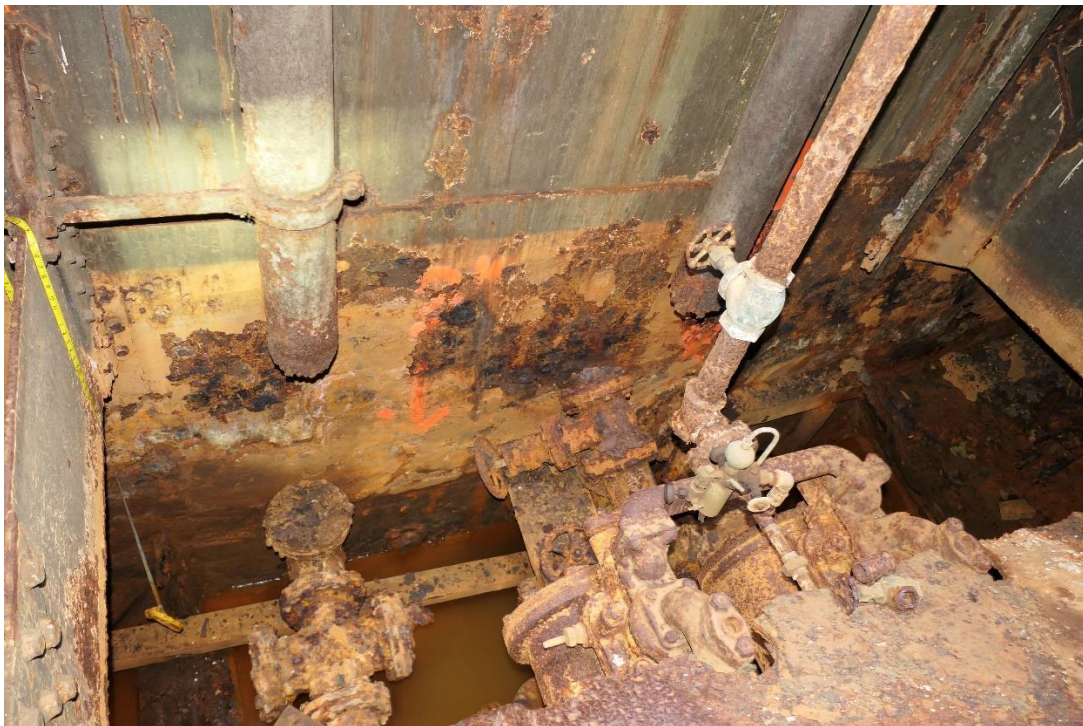
Figure 14: Corroded machinery and piping in 2023 (Joseph Lombardi).

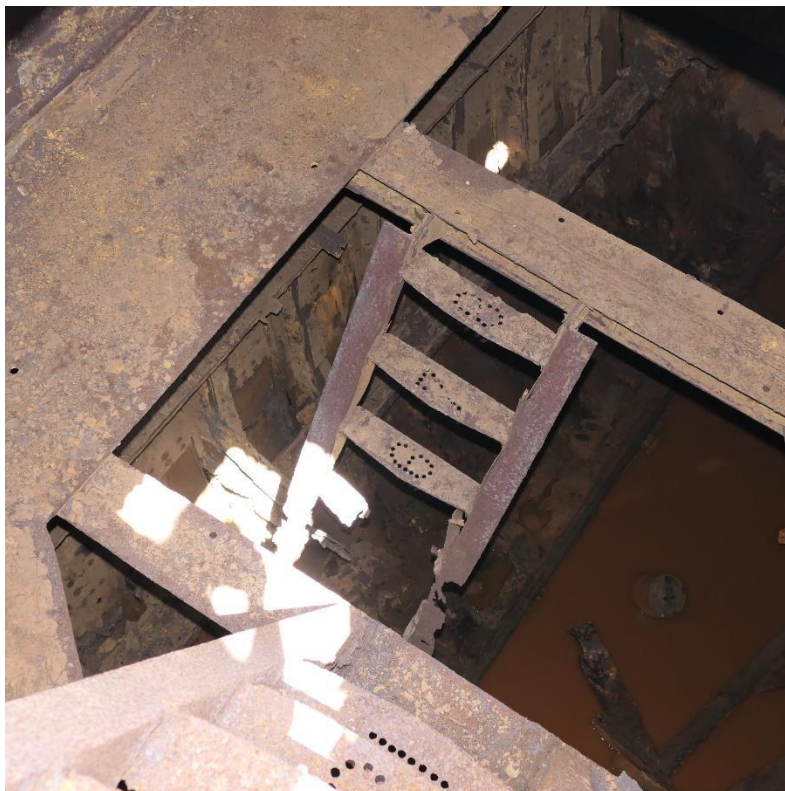
Figure 15: Corroded and partially flooded tank (Joseph Lombardi).

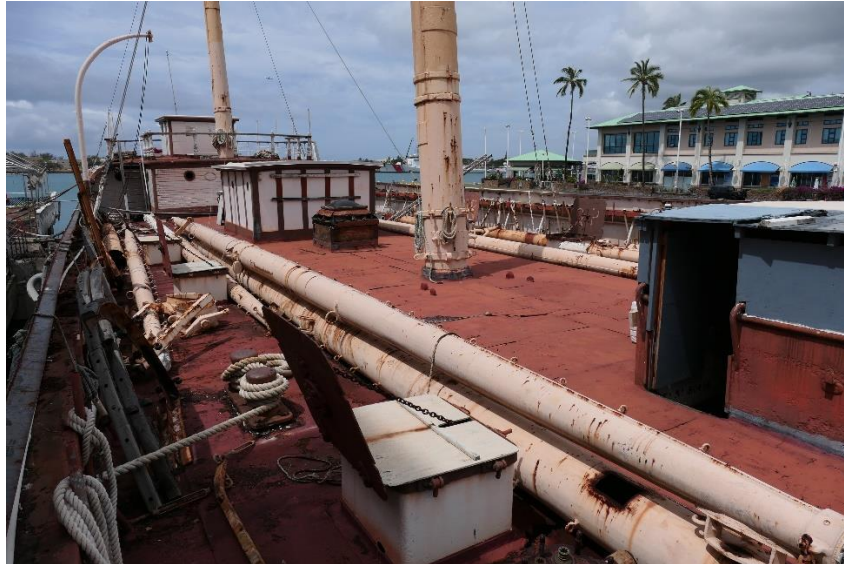
The other elements of *Falls of Clyde* that were present were the main deck with the ship's deck house, decking, and the deck equipment. The decks, which had not been restored, but were in fair condition and had their historic appearance in 1988, were given a protective covering of plywood which has now completely failed, as has the decking beneath it; *"The plywood sheathing over the wooden decking on main deck has failed; the underlying deck is unsafe for personnel"* (Lombardi 2023:5).

Figure 16: Main deck and aft deckhouses, spars stowed on deck in March 2023 (Joseph Lombardi).

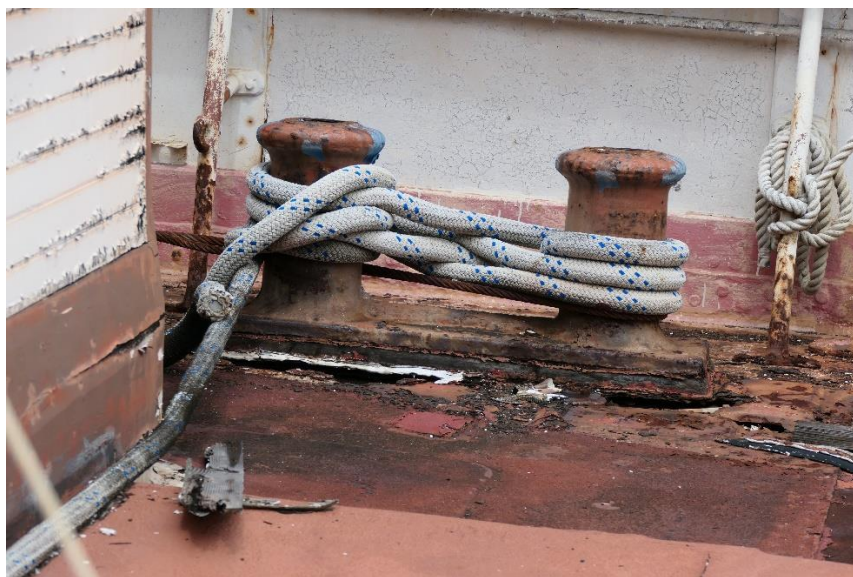
If the vessel could be saved, which the hull condition indicates cannot be done, the entire deck would need to be replaced. The various fittings on the deck have failed or are failing due to corrosion. *"The vessel's bitts, bollards, chocks and mooring hardware are in need of structural support and in many cases are in danger of carrying away"* (Lombardi 2023: 5).

Figure 17: Bitts that have corroded and are detaching from the deck; this is one example of many (Joseph Lombardi).

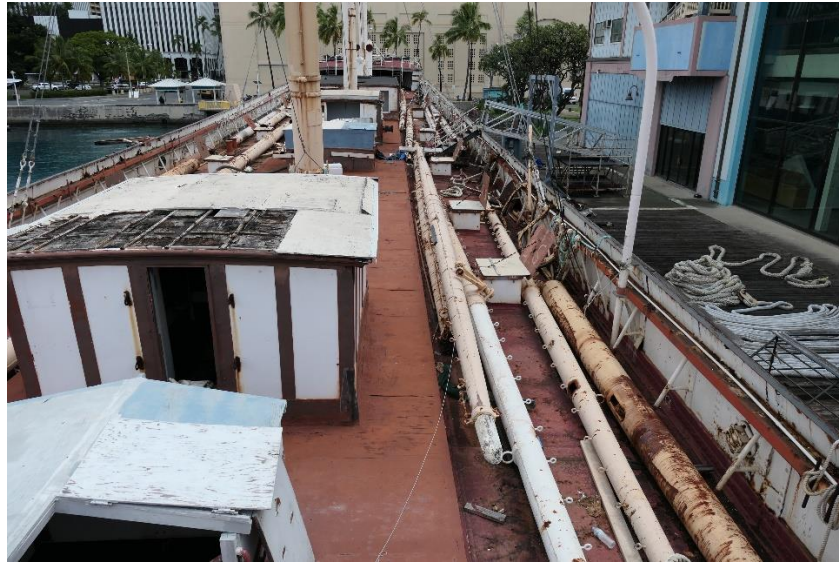
Figure 18: The corroding, dry-rotted and crowded decks of the ship are in danger of collapse and a hazard to anyone who boards the vessel (Joseph Lombardi).

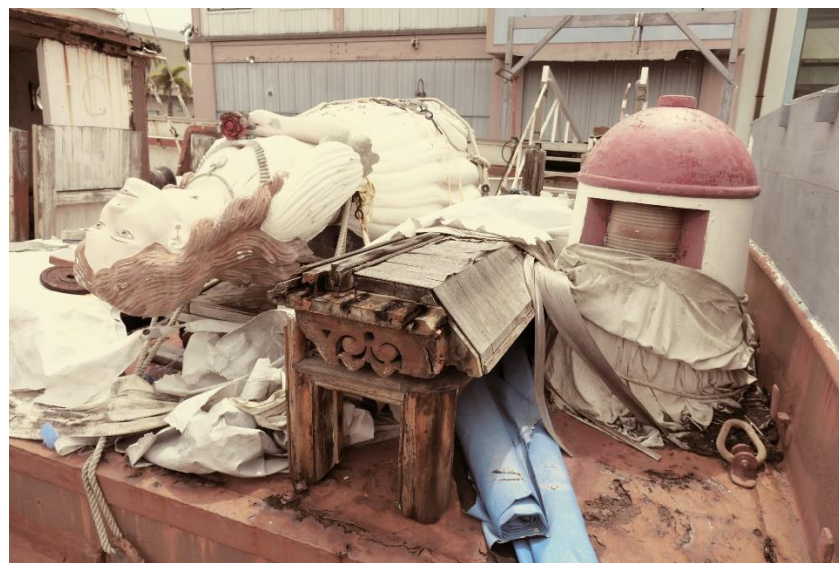
Figure 19: Significant artifacts are exposed on the deck and deteriorating, including the ship's figurehead, the running lights, and the ornate woodwork that covered the steering mechanism on the poop deck (Joseph Lombardi).

The condition of the figurehead is unknown, but its open storage in tropical conditions does not bode well for its preservation. This artifact and others that are significant aspects of the ship should be immediately removed, assessed, and if needed, conserved and placed in museum for conservation, and climate-controlled storage and/or display.

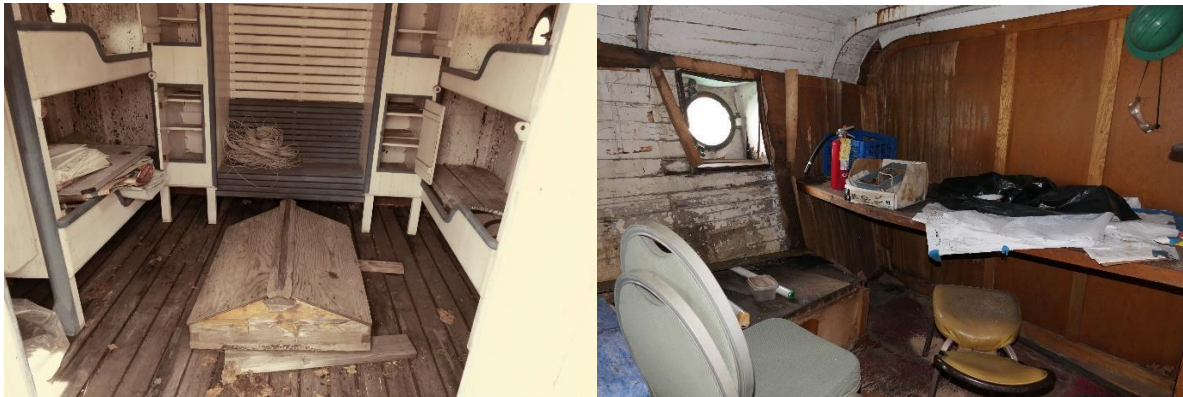
Figure 20: Condition of interior spaces, 2023 (Joseph Lombardi).

These spaces are now open to weather, with freshwater leaks, resulting in dry rot, and filled with rotting furniture and gear. The marine survey in March 2023 noted that the *"varnished wooden veneer in the main salon is delaminating due to rainwater making its way below decks. The ceiling is also collapsing due to rot. Much evidence of rain making its way below deck. Portholes to port have been removed (stolen). Much mildew in all cabins with rot present. Vermin have also used these spaces to enjoy their cruise! Side ports, windows and doorways open to the weather decks throughout"* (Lombardi 2023: 49). The joinery has been severely compromised, and the qualities inherent in the joinery which caused it to be originally listed have been lost or destroyed.

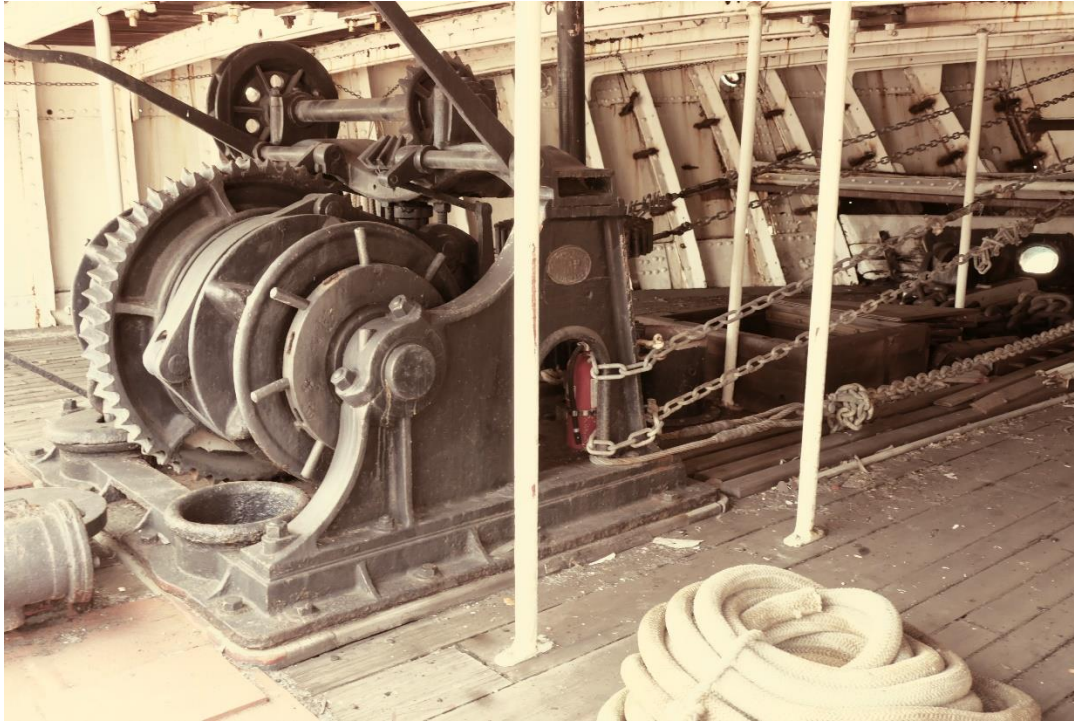
Equipment on the deck includes the Napier patent windlass original to the ship, the Murray Brothers patent steam apparatus, and the Krough Manufacturing steering gear. The windlass is in fair condition, but the margin plates that support the apparatus are corroded and delaminating. The windlass is an important artifact that could and should be saved for museum display or storage, but it will require conservation and probable repair.

Figure 21: The windlass under the leaking forecastle deck, 2023 (Joseph Lombardi).

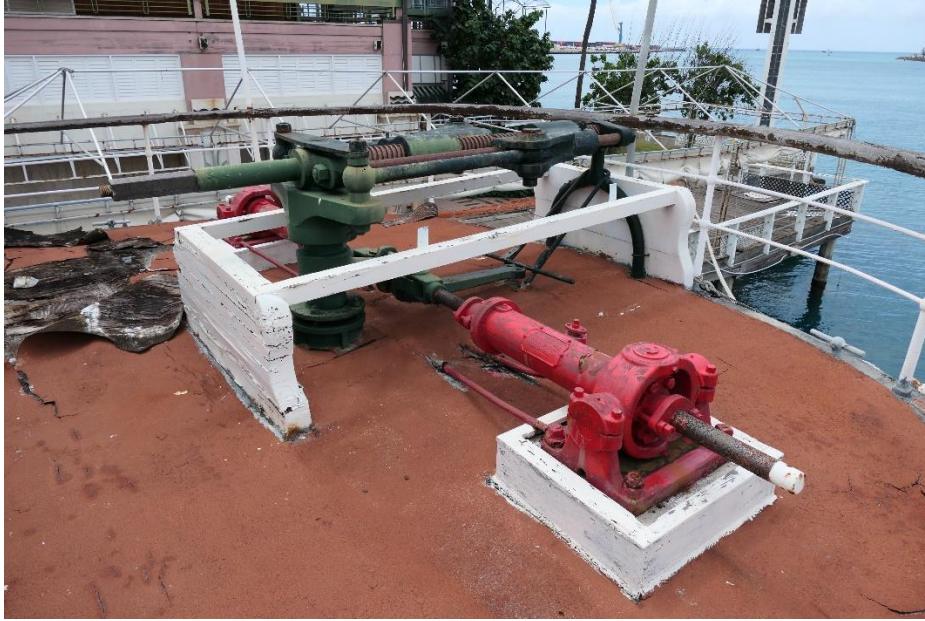
The iron and bronze steering apparatus as surveyed in March 2023 *“is intact although the beautiful, varnished teak cabinetry was removed and stored on main deck in a very deteriorated condition.... The poop deck stanchions and railings are failing with the underlying wrought iron bases no longer riveted as these have failed. The fiberglass sheathed fir deck has failed with rotted plywood substrate throughout”* (Lombardi 2023: 47). It is also a significant artifact that could and should be removed and saved for museum display or storage; it is also potentially at more imminent risk because the *“steering flat is slowly collapsing on the fantail due to the weight of the steering gear and degradation of the vessel’s structure”* (Lombardi 2023: 6). As noted, the woodwork that covered it, stored exposed on the open deck, has deteriorated and may not be savable. Fortunately, the ship’s wheel, a significant artifact, has survived because it was stored below deck in the pump room.

Figure 21: The Krough Manufacturing Co. steering apparatus on the decayed, collapsing poop deck (Joseph Lombardi).

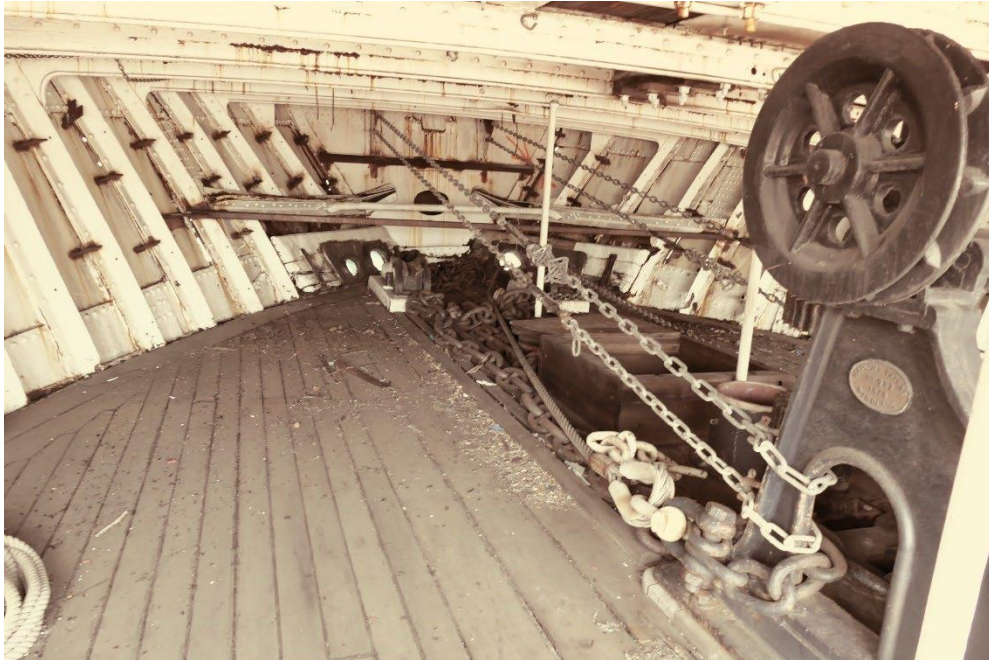
**Chains installed in 2008 to support forward collision bulkhead.
Transverse steel beams welded across space to pull side shell plating in.**

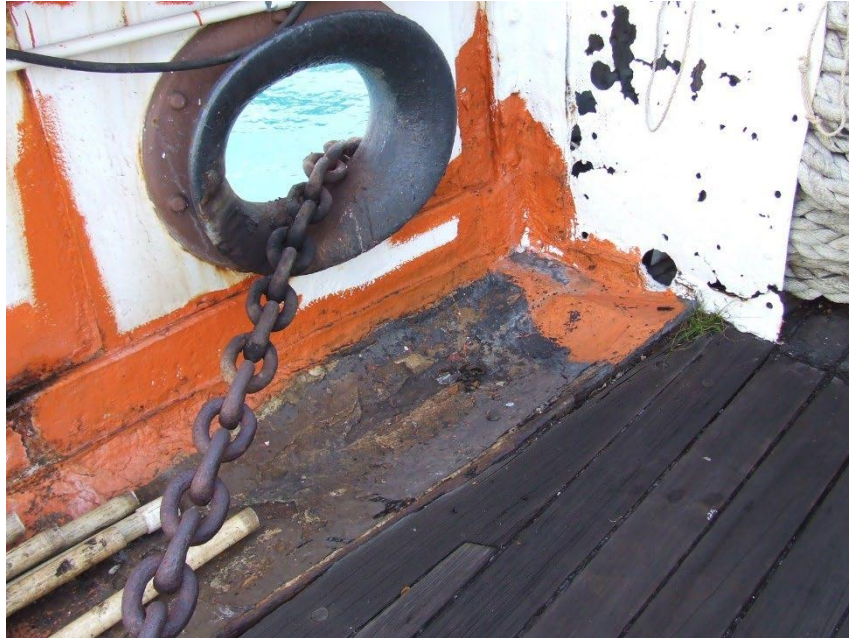
The waterways (both port and starboard) have had concrete poured to facilitate water runoff; this concrete is causing corrosion to the substrate.

Concrete in waterways causing degradation to substrate. Notice wasted plating in right portion of photo.

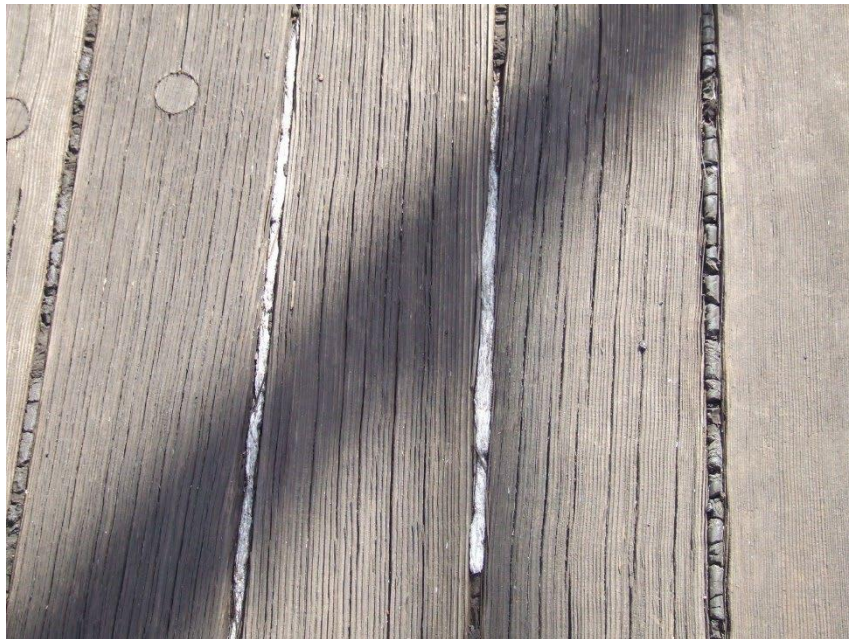
The wooden deck aft of the forecastle has failed caulking, failed mechanical fasteners and rotted planks. The underlying iron substrate requires replacement as does the wood deck.

Wasted caulking on wooden decking, notice exposed cotton.

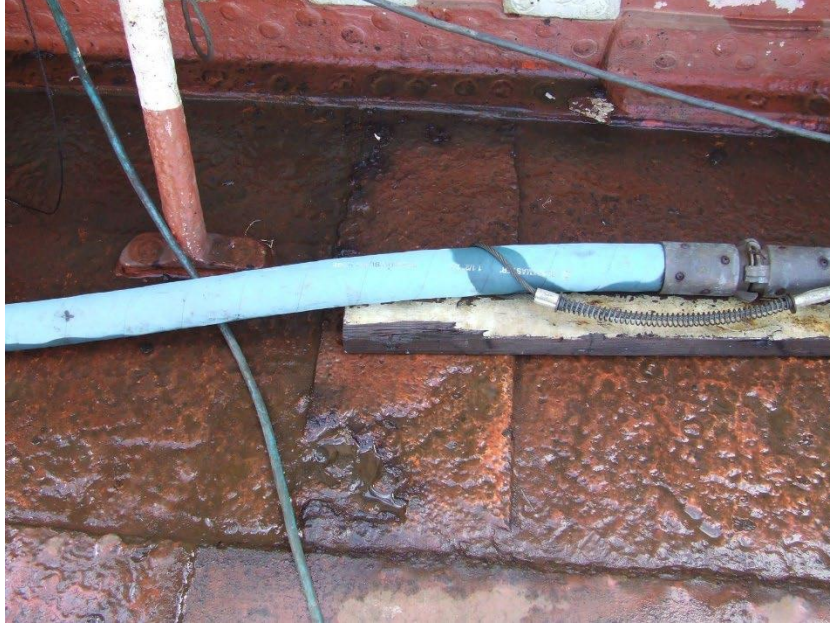
Riveted butt straps in waterways badly corroded with wasted rivet heads both port and starboard..

Wasted riveted butt straps connecting deck plating in waterways to port.

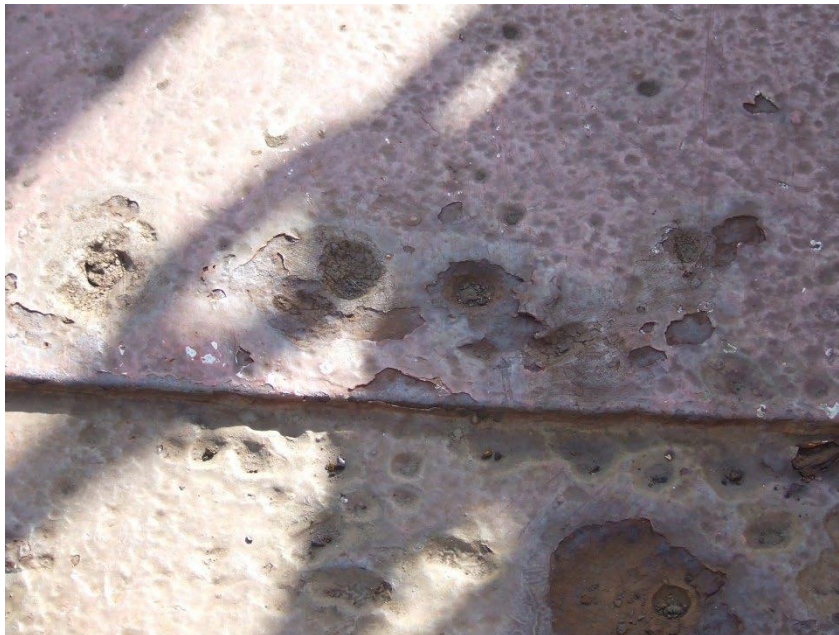
The wrought iron deck (3/8"+) is heavily pitted in many areas; pitting exceeds 70% of original thickness of material.

Typical pitting action on maindeck, showing failed paint system.

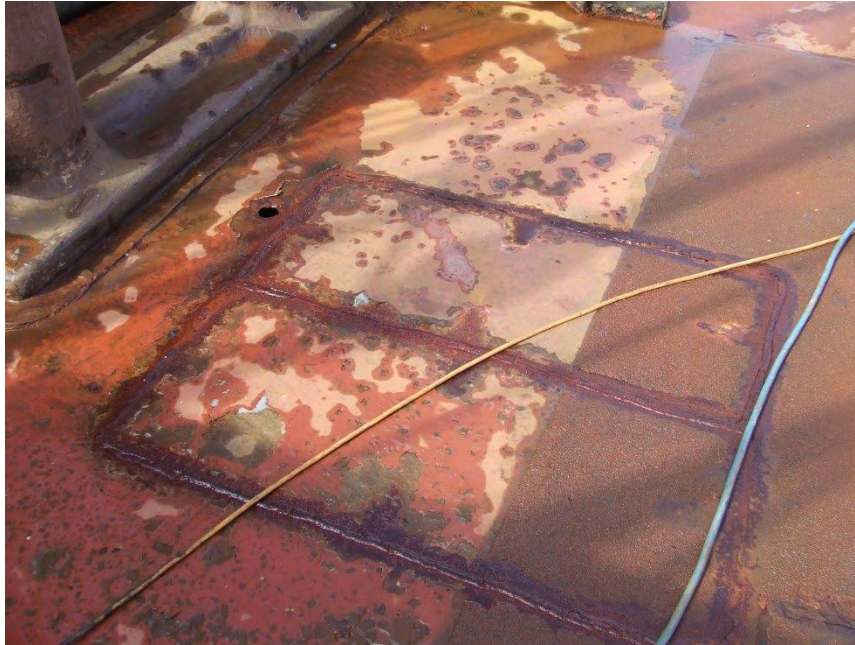
Weldments made to access ports are failing and are a real danger to museum personnel.

Welded access hatches with failed weldments on main deck.

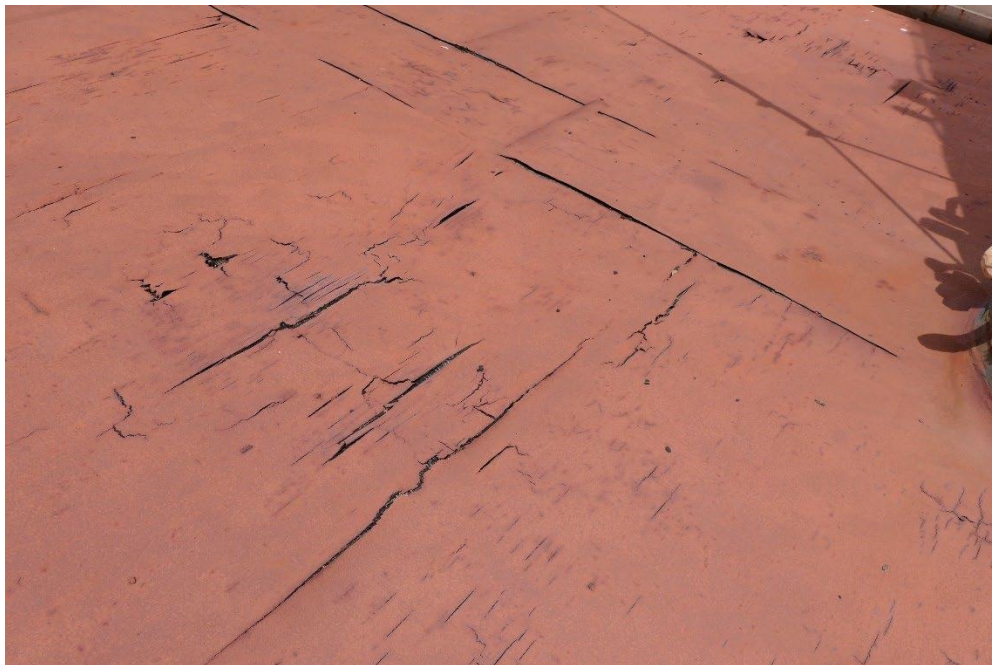
Plywood sheathed with fiberglass is over fir decking de-laminated with underlying plywood badly rotted throughout..

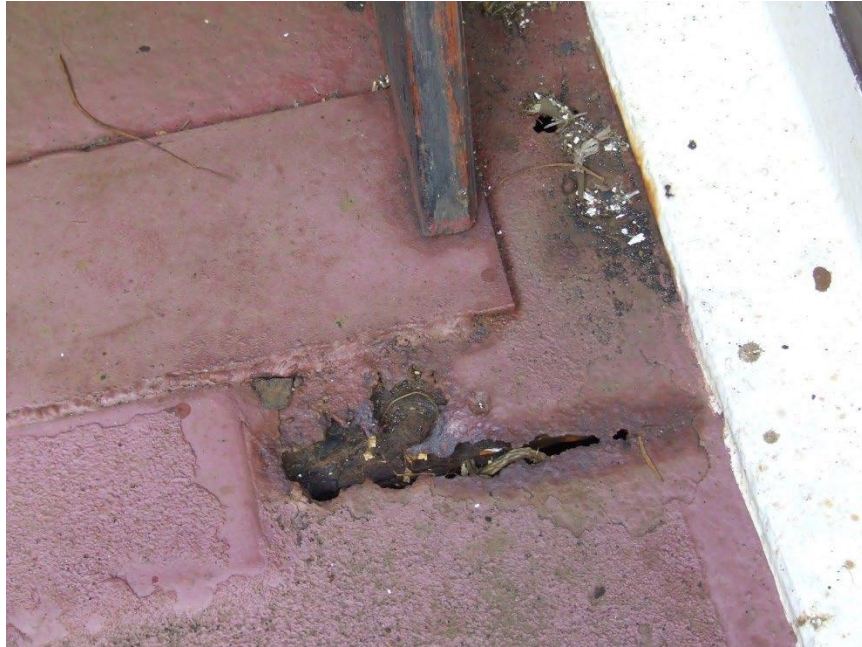
Wasted deck at foot of ladder aft to starboard.
