SUBJECT: PETITION TO REMOVE HISTORIC PROPERTY "FALLS OF CLYDE"
FROM HAWAII REGISTER OF HISTORIC PLACES PER HAR §13-198-10(1)

THE FOUR-MASTED IRON SHIP *FALLS OF CLYDE*: EVALUATION OF LOSS OF INTEGRITY AND RECOMMENDATION FOR DELISTING FROM THE NATIONAL REGISTER OF HISTORIC PLACES

James P. Delgado, Ph.D.

May 10, 2023

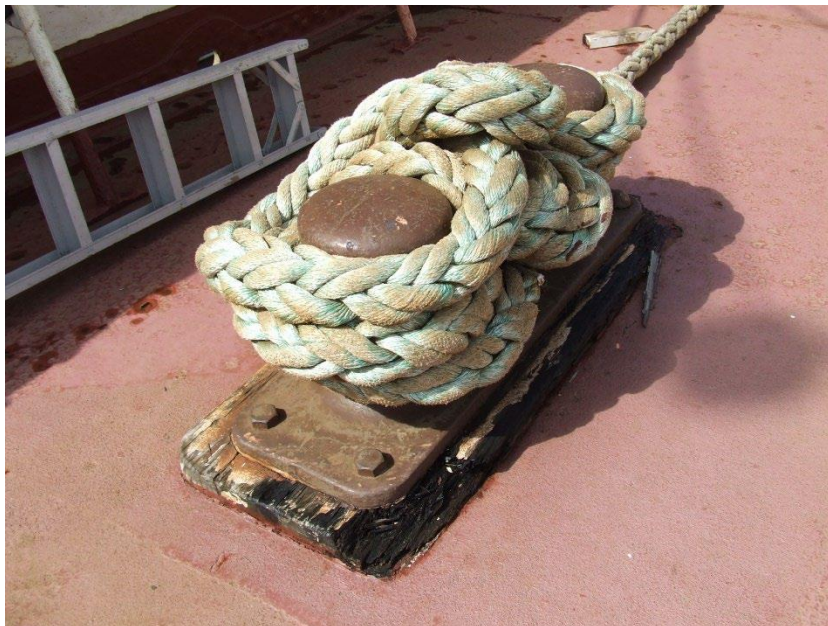
Wasted wooden base to double bitts securing stern line of vessel.

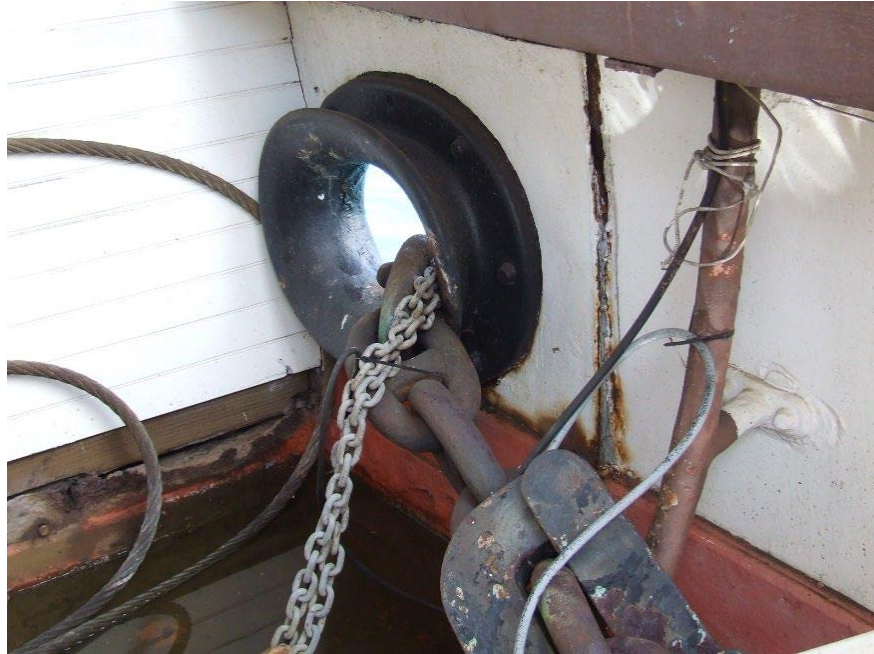
Wasted side shell plating in danger of giving away under strain from anchor rode; port side aft maindeck.

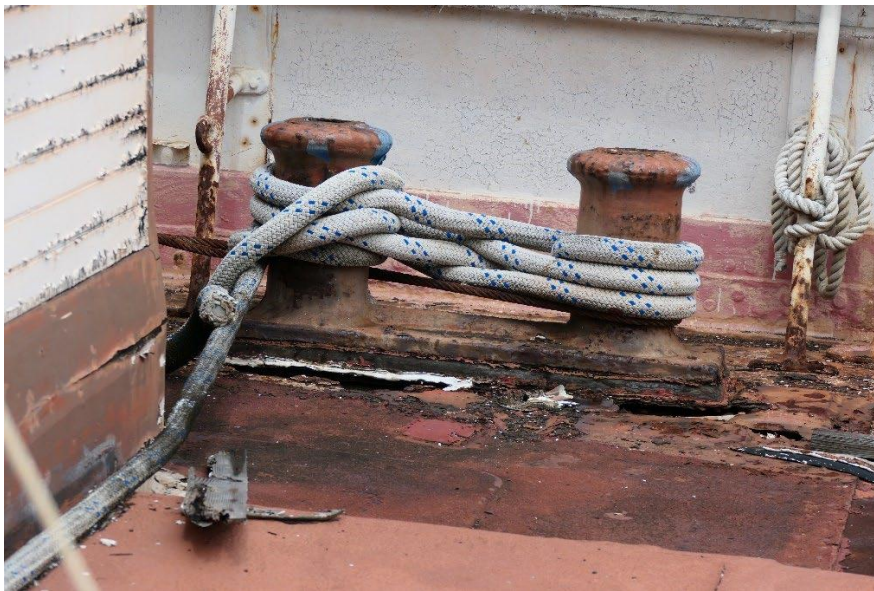
Wasted double bitts, fir foundation and deck badly corroded and rotted. Unsafe, yet still securing vessel under load.

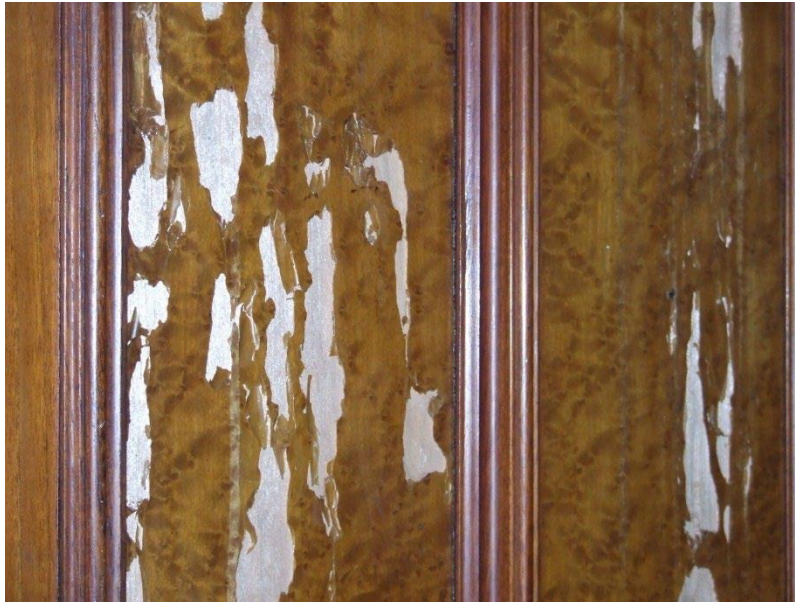
Delaminated veneer in main salon.

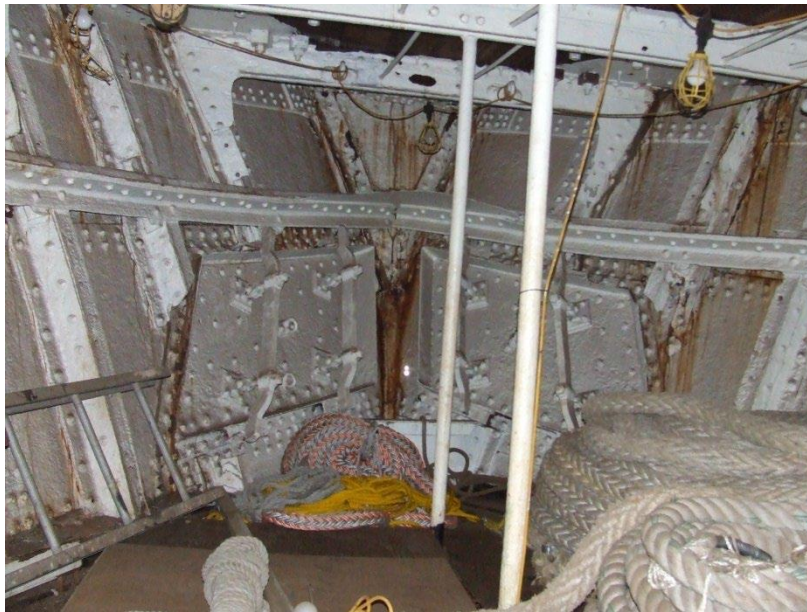
Shell plating is holed in many places within this space.

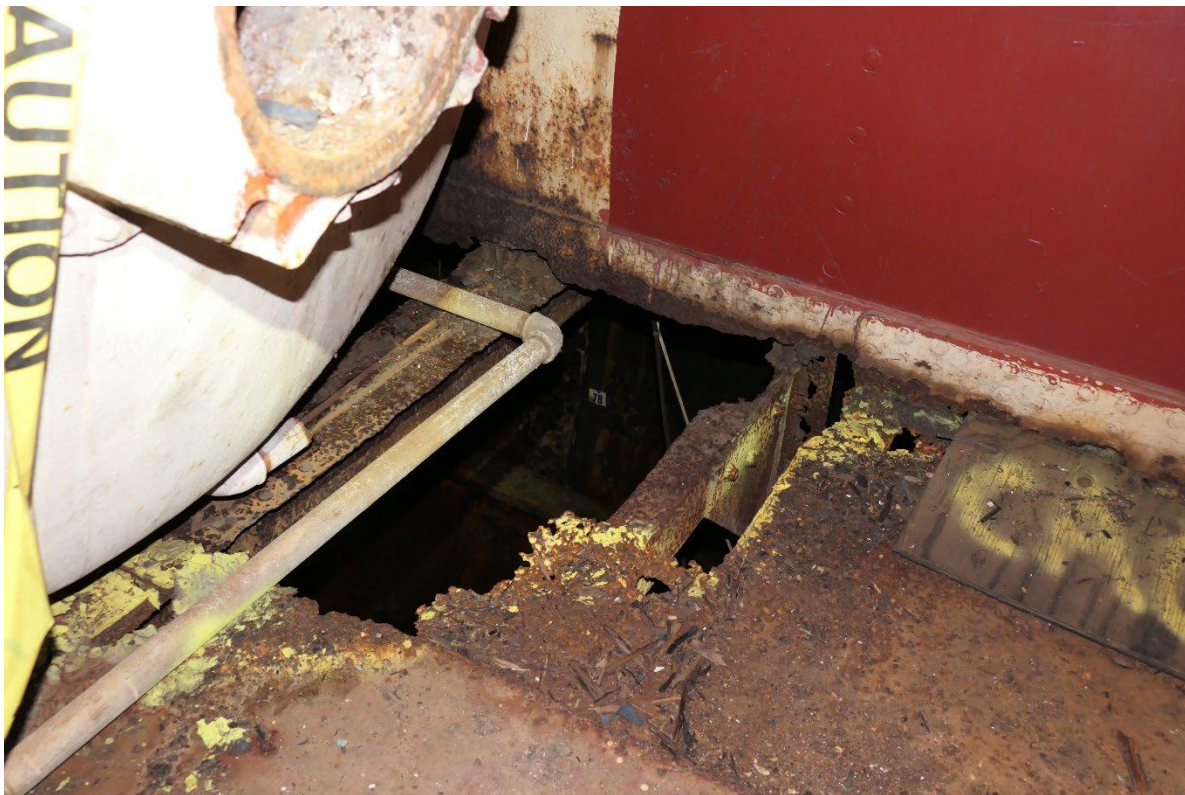
Boiler-room, holed plating to port under boiler.

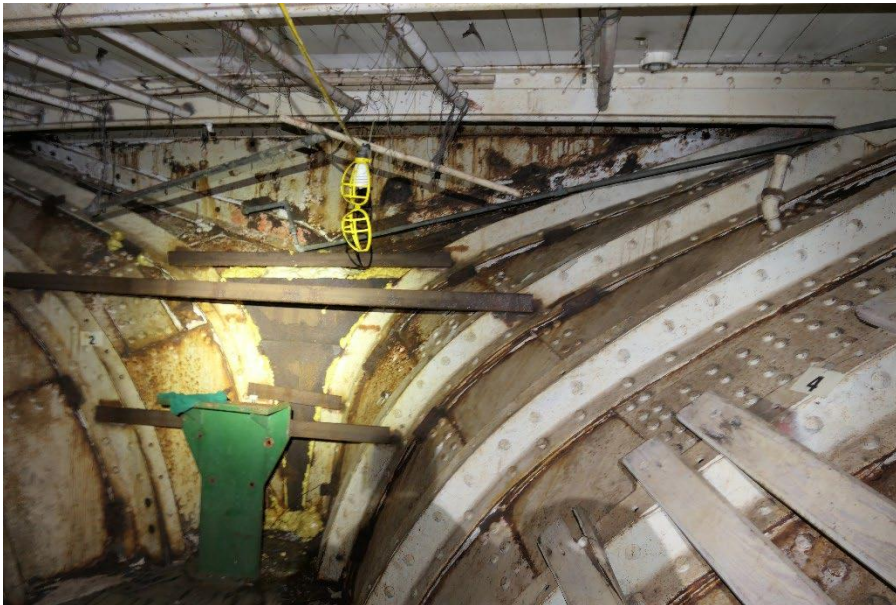
Storeroom at stern, looking aft.. Shell plating separated from frames on both sides leading forward.

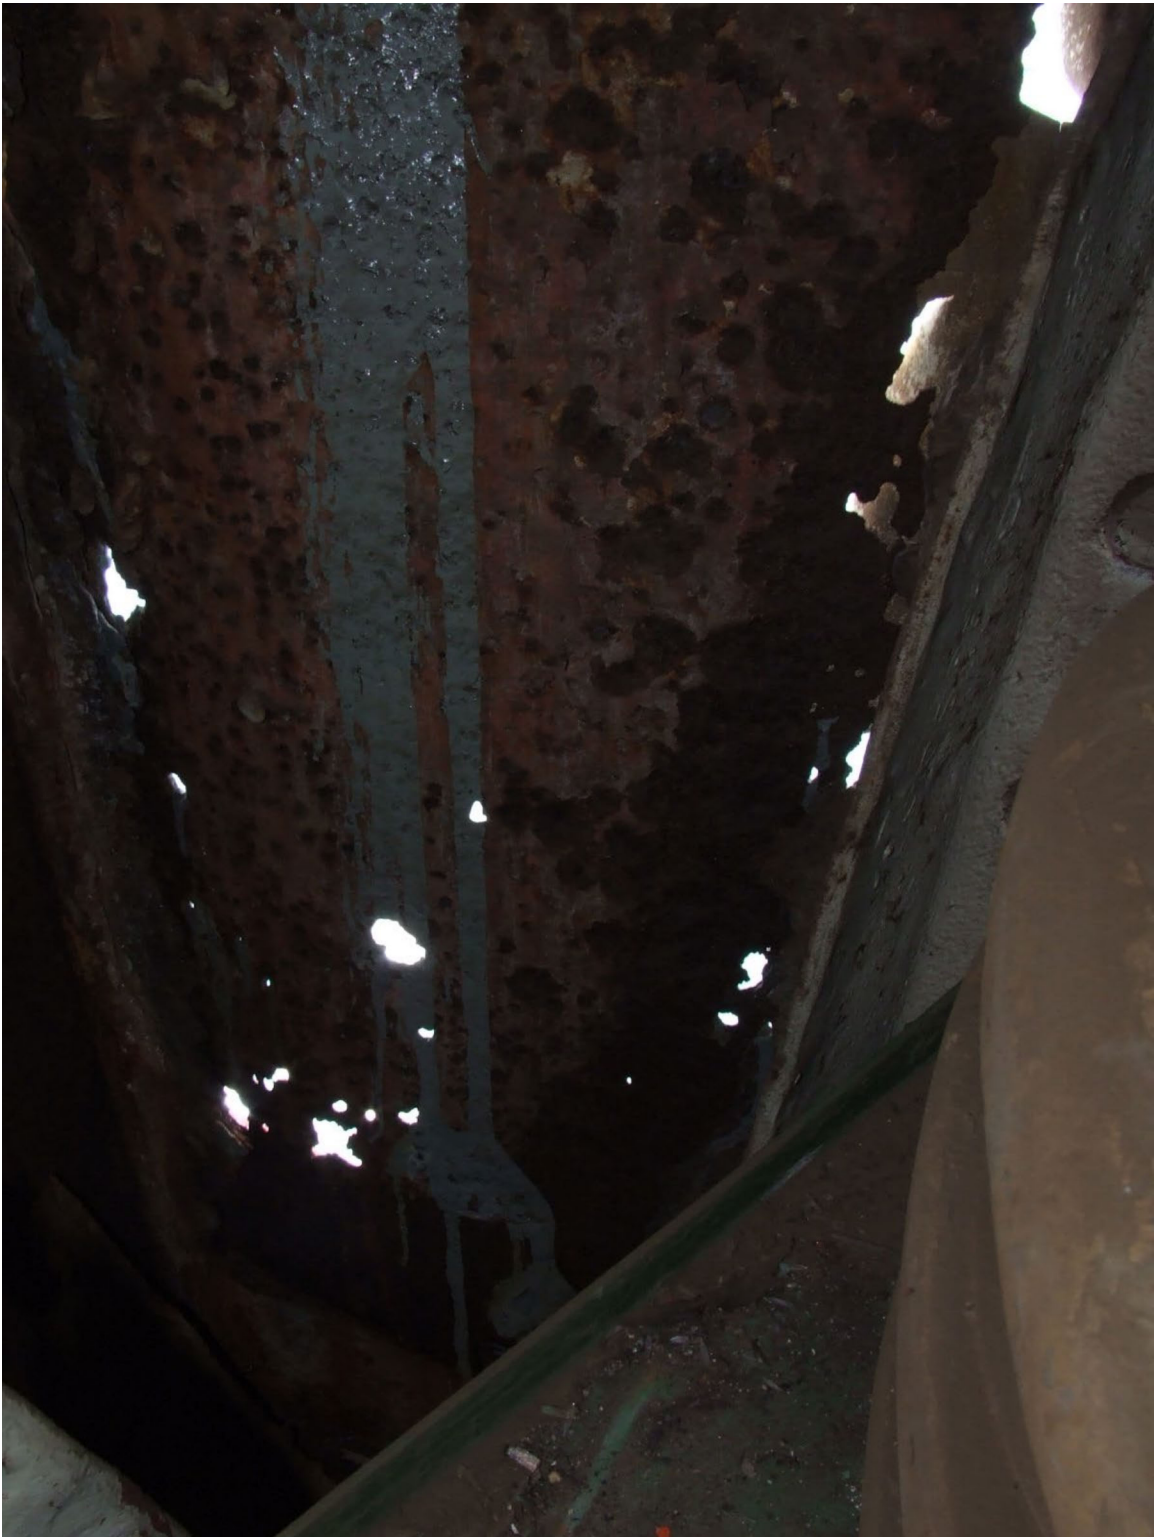
Holed shell plating just above waterline to port of stern casting. Nothing left to repair.

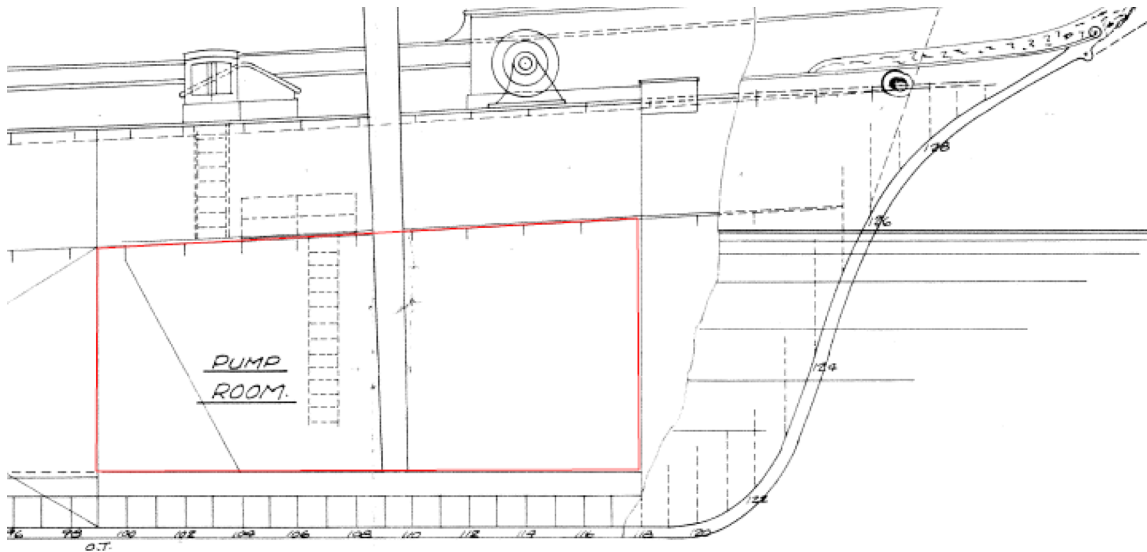
This space contains the tattered remnants of the pair of steam pumps and associated piping utilized to load and discharge the cargo. The space contained 2'+ of standing water at time of survey.

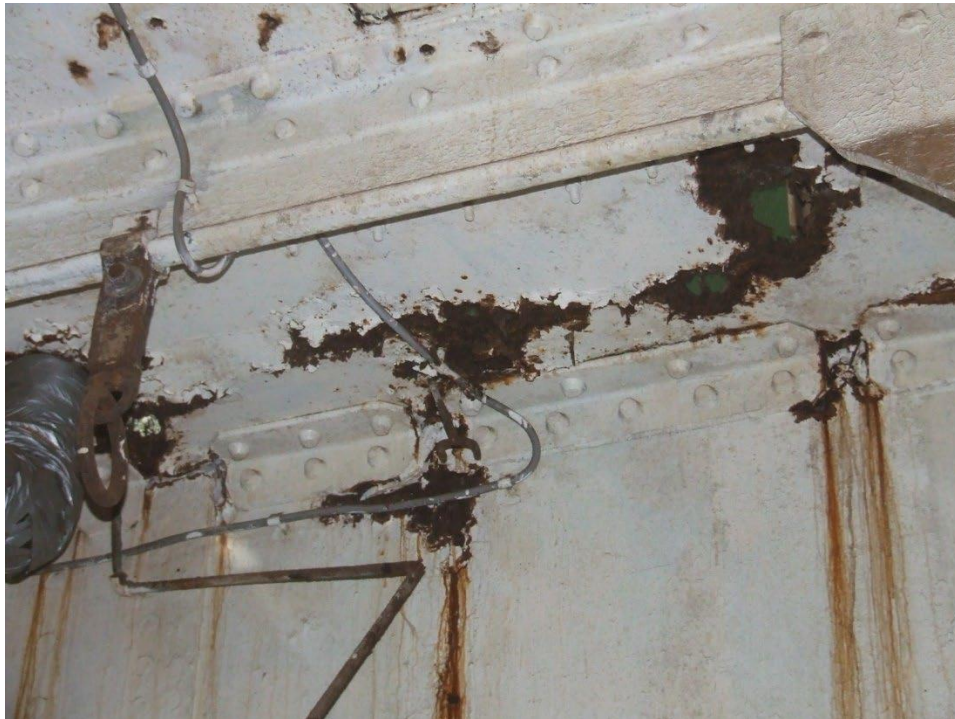
Wasted deck flange on aft bulkhead.

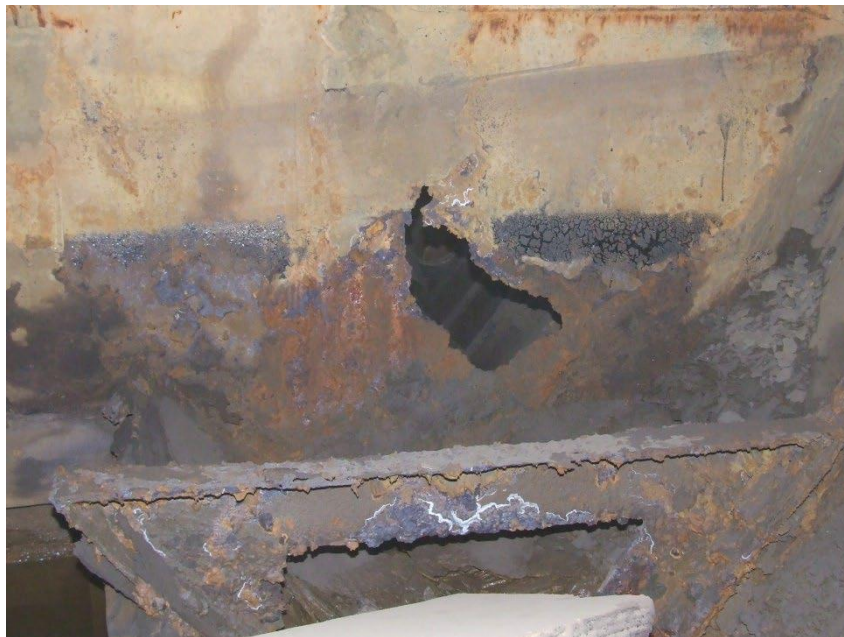
Holed main aft bulkhead into Tank #1 port.

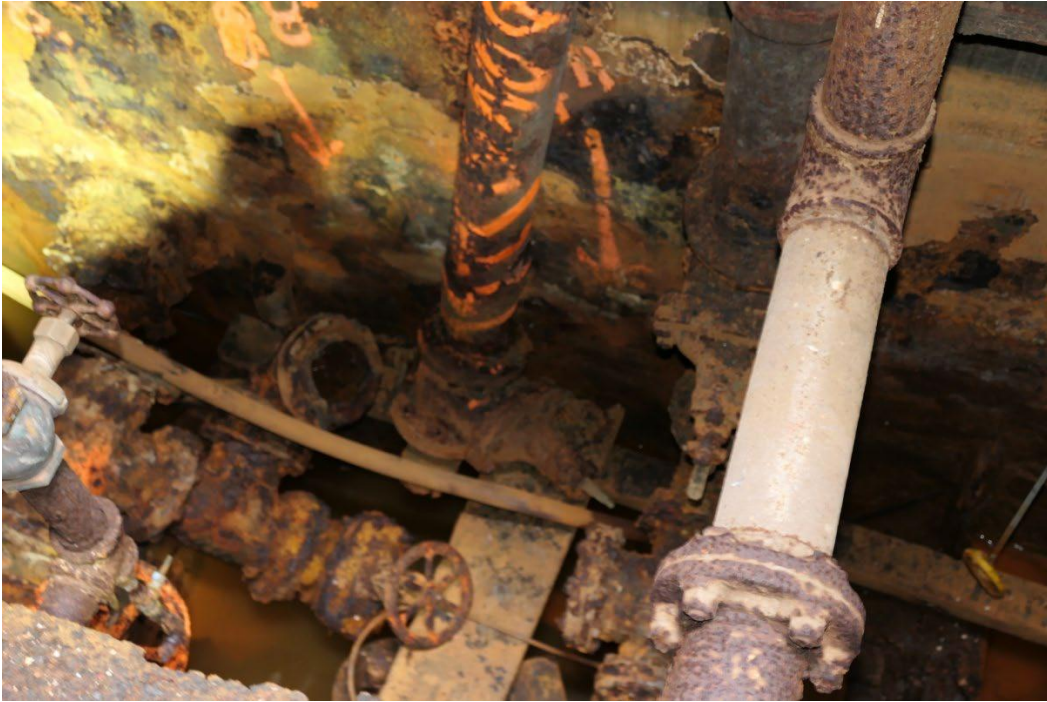
Piping manifold aft of dual steam pumps, showing broken sections in bilges,

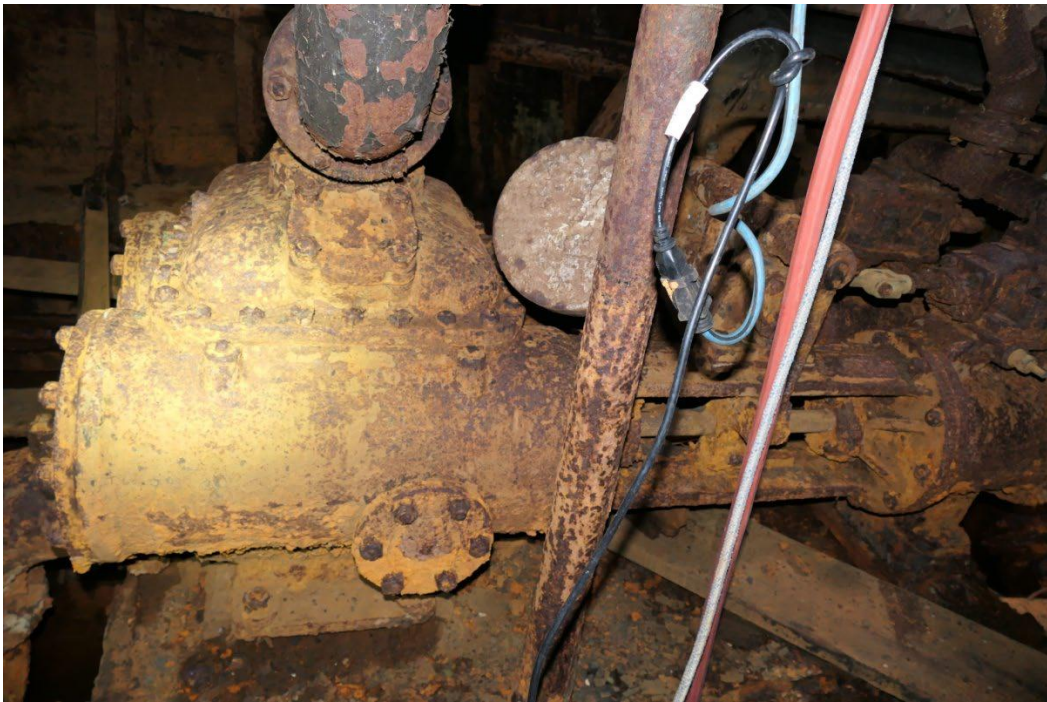
Main steam pump, totally wasted with rust/scale.

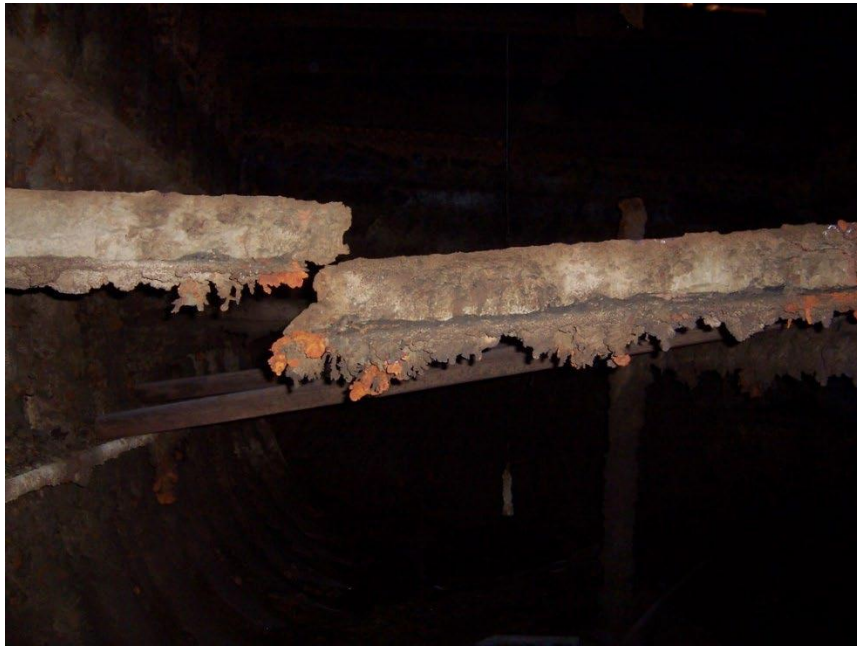
Tripped or broken horizontal support in Tank #3 starboard.

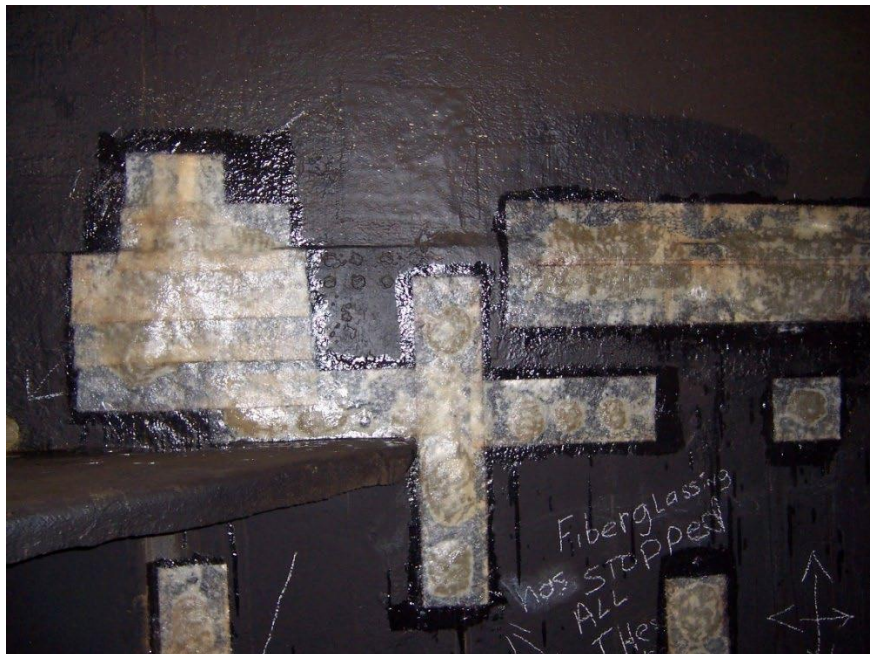
Patched bulkhead in Tank #3.

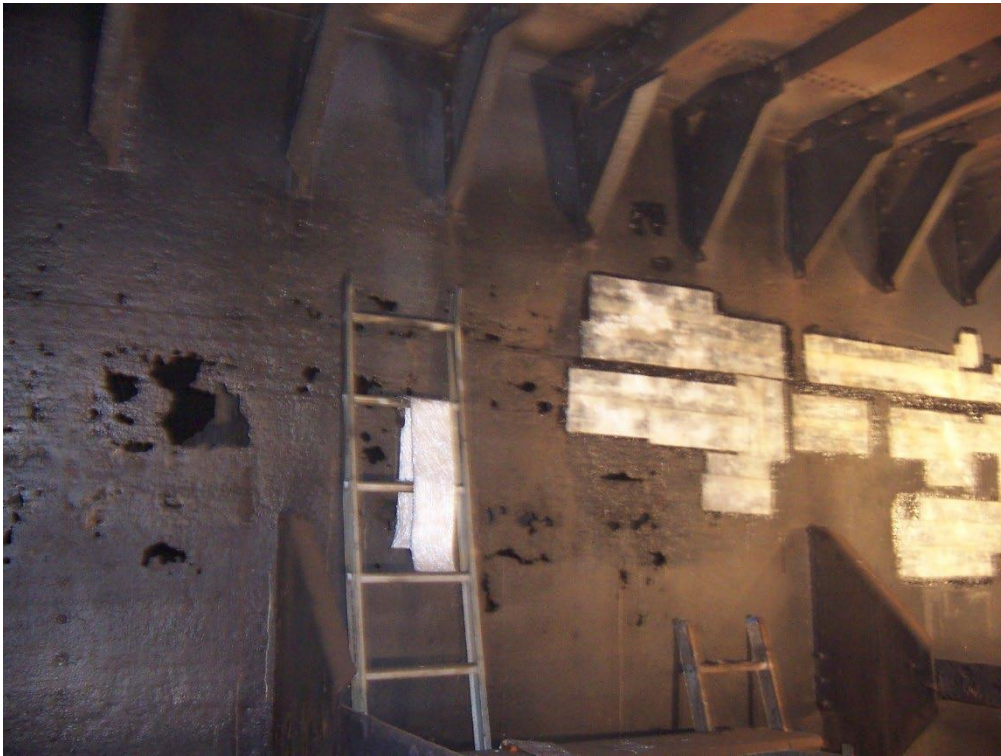
Wasted transverse bulkhead, indicative of conditions found throughout tank system. Bulkheads are Swiss cheese.

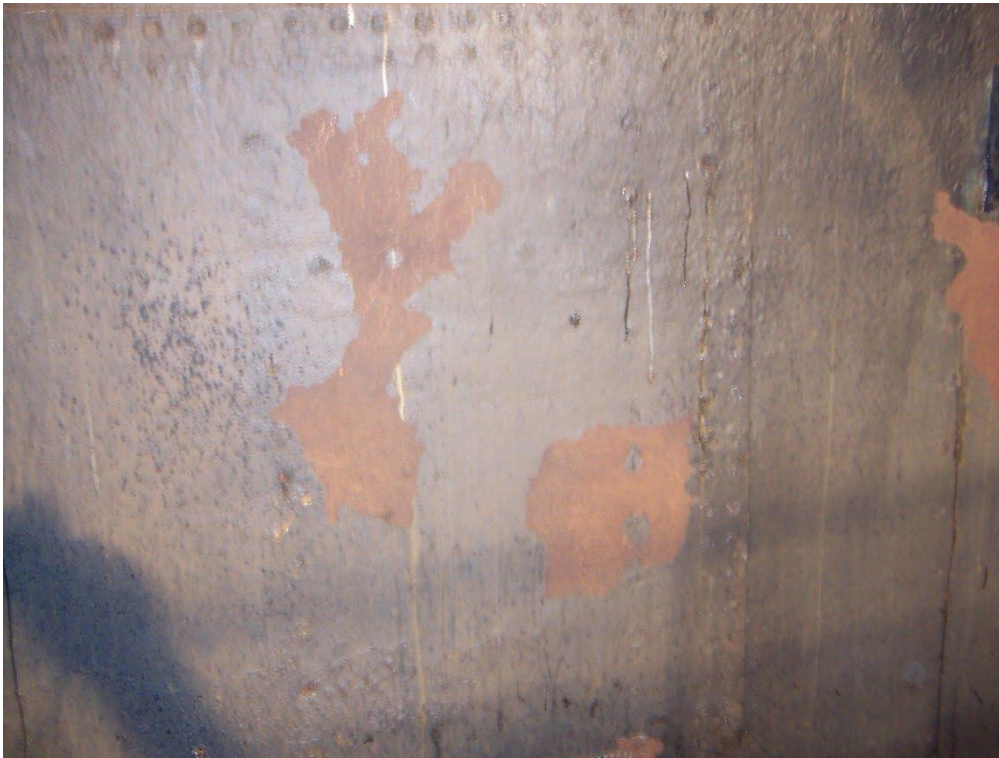
New paint system failure on bulkhead.

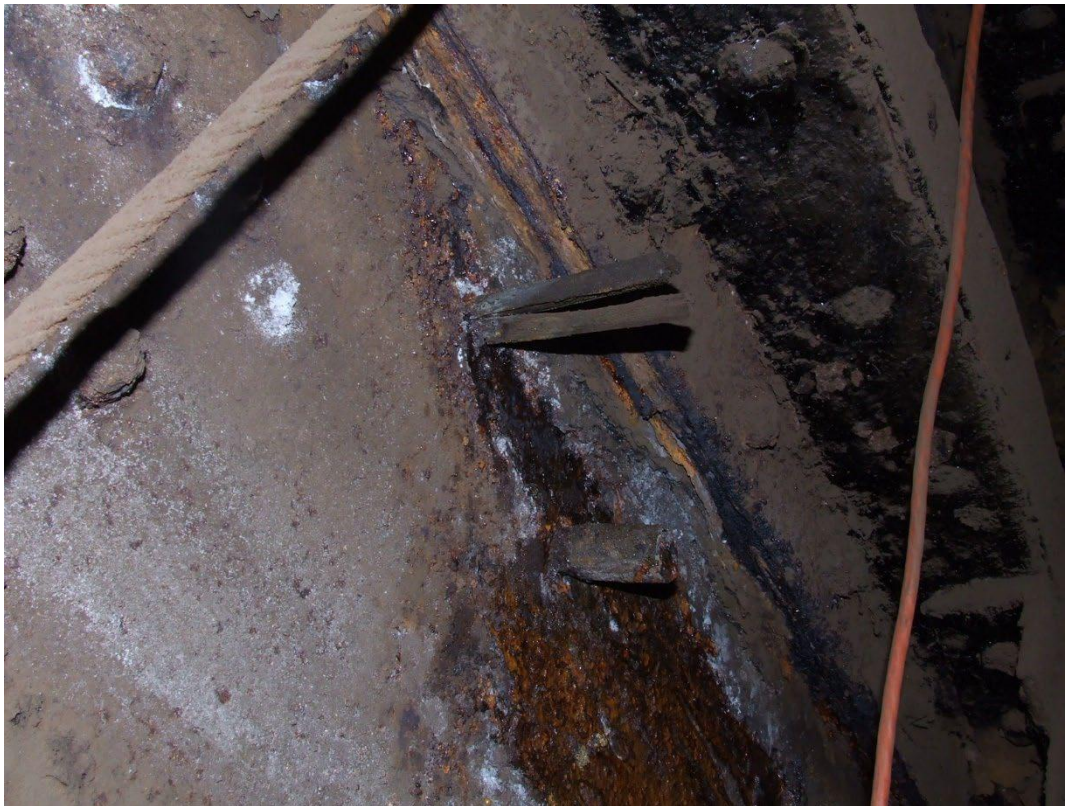
Wooden plugs keeping the ocean out.

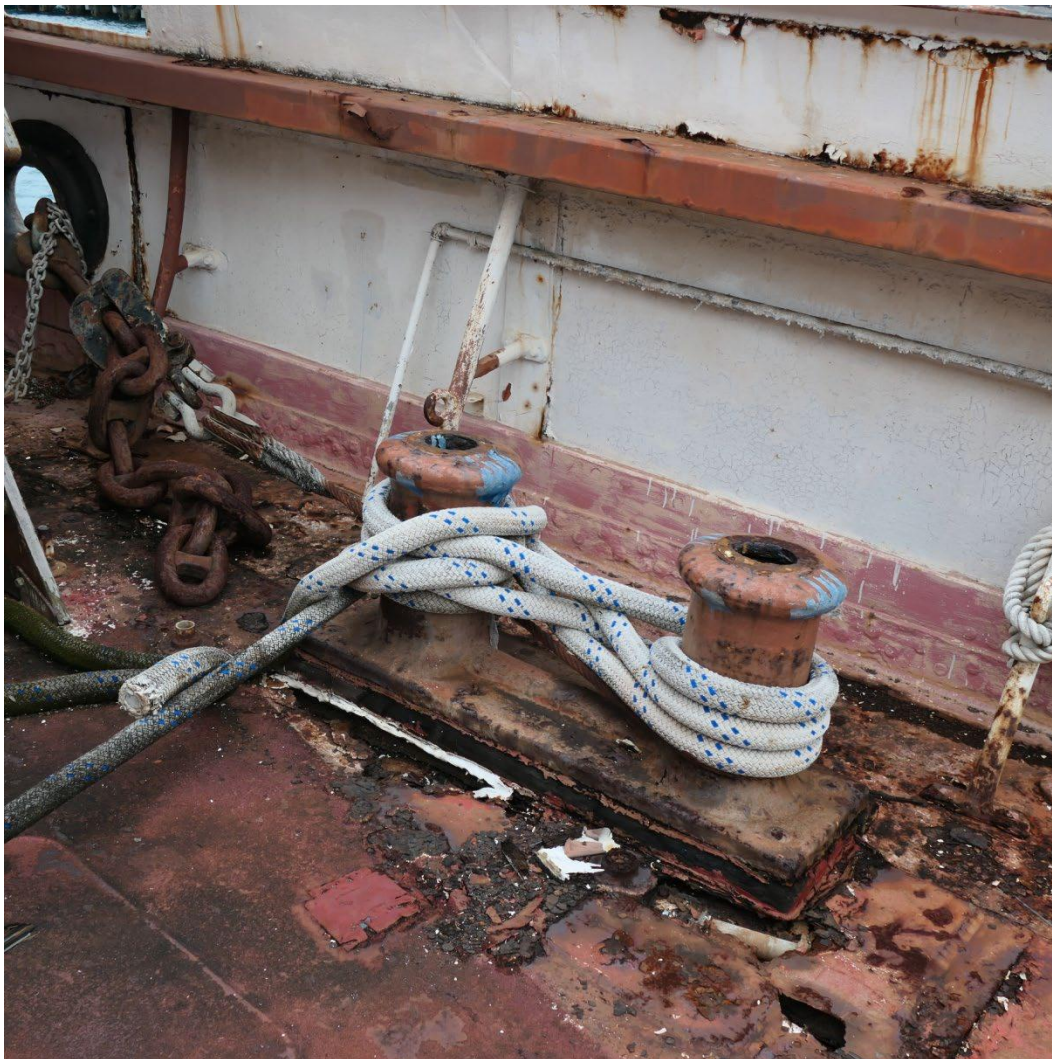
**Double bitts made up with line and chain. Load of chain pulling bulwark in around chock.
Double bitts pinned to rotted laid deck and iron substrate. Absolute junk....**

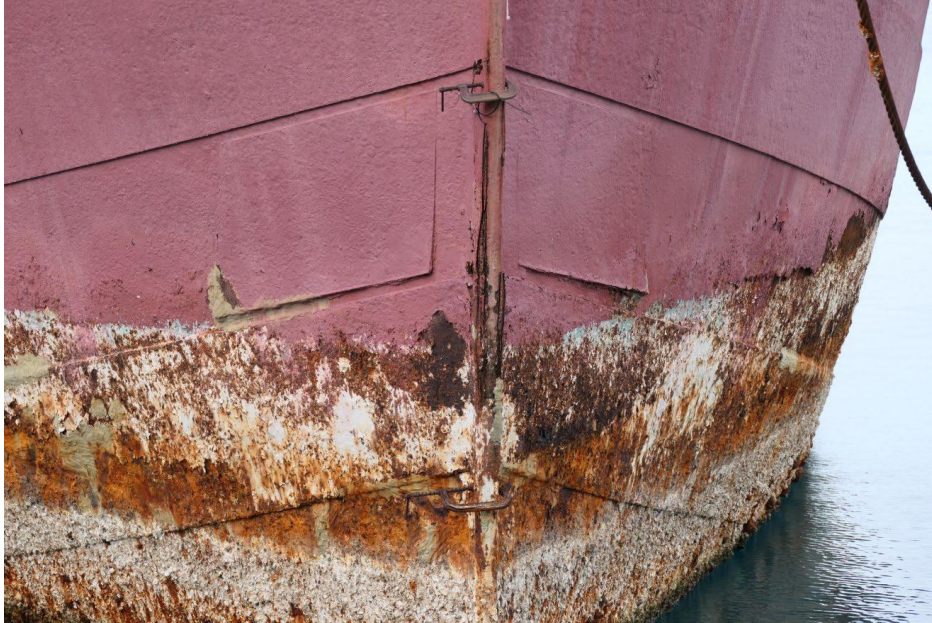
The entire hull has rusticles protruding from the iron hull. These corrosive nodules form with the unprotected iron hull in salt water. When they break off, and they will, a perfect hole is formed.

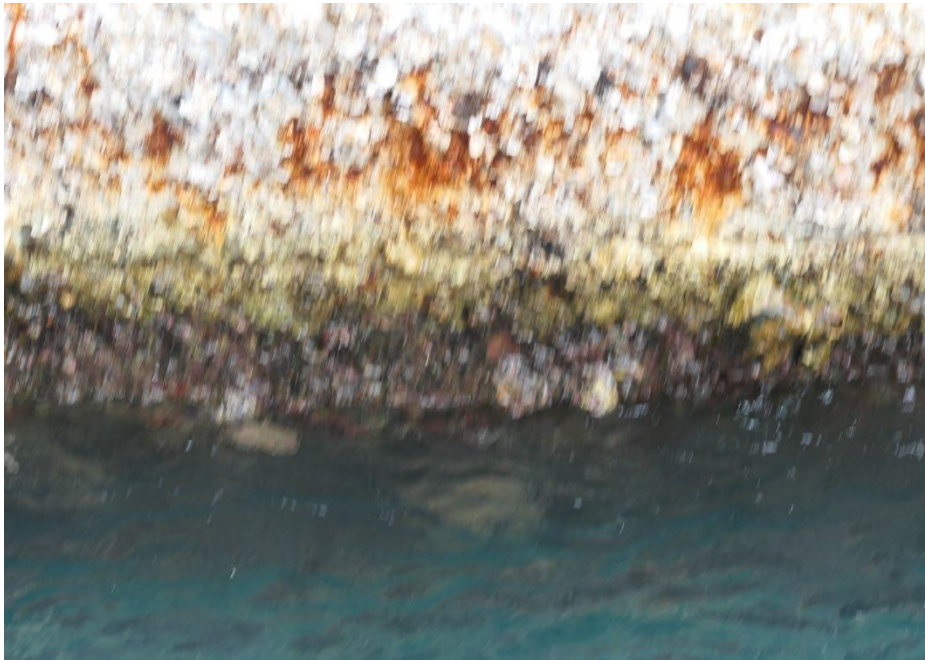
Rusticles formed at the waterline of FOC. Endemic to the entire hull bottom of FALLS OF CLYDE.

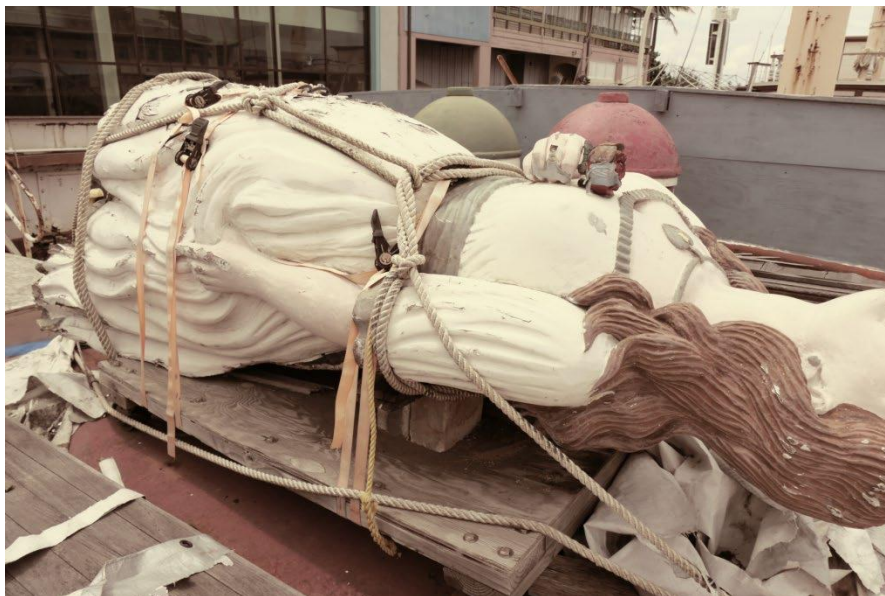
Figurehead laying on deck unprotected; figurehead is starting to rot and has termites.

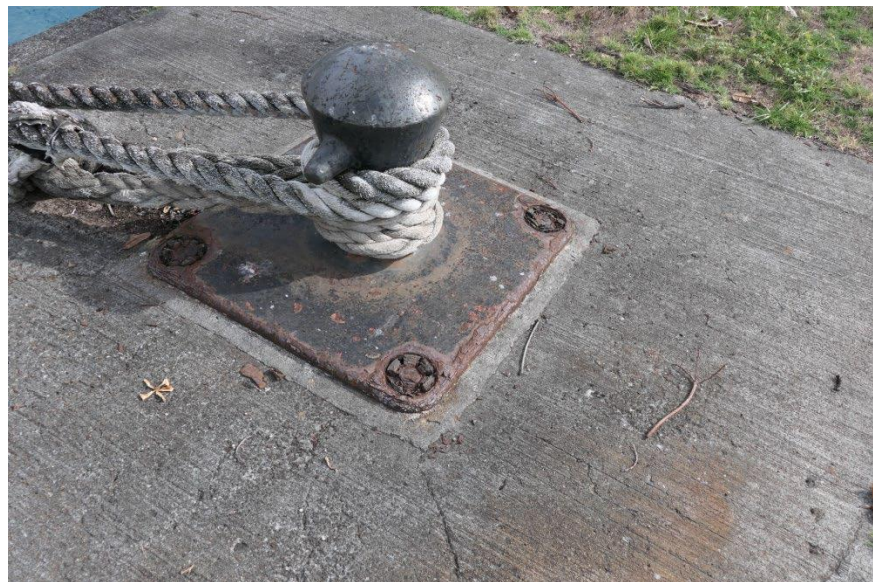
Typical mooring bitt on quay wall with severely deteriorated pins.
