# STATE OF HAWAII DEPARTMENT OF LAND AND NATURAL RESOURCES

Subject: Enforcement Action against TWOL, LLC for Stony Coral and Live Rock

Damage Resulting from the October 10, 2017 CFV *Pacific Paradise* Grounding within the Waikiki-Diamond Head Shoreline Fisheries

# CFV *Pacific Paradise* Injury Report Waikīkī – Diamond Head Fisheries Management Area, October 10<sup>th</sup>, 2017 – December 7<sup>th</sup>, 2017

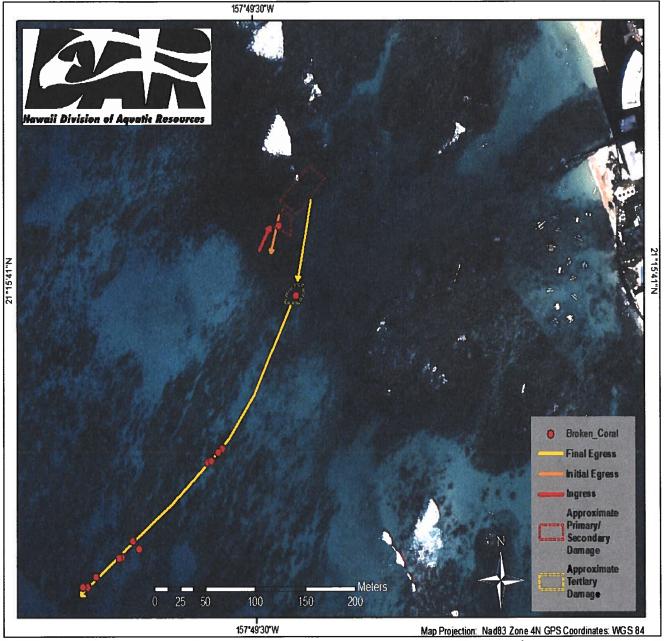
Figure 2. CFV *Pacific Paradise* Grounding site, depicting the ingress, primary/secondary impact, egress path, tertiary impact, and documented broken coral colonies.

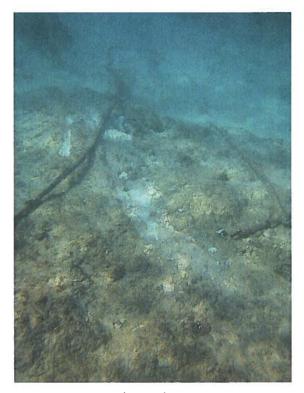
Figure 9. Tertiary (egress) scar.

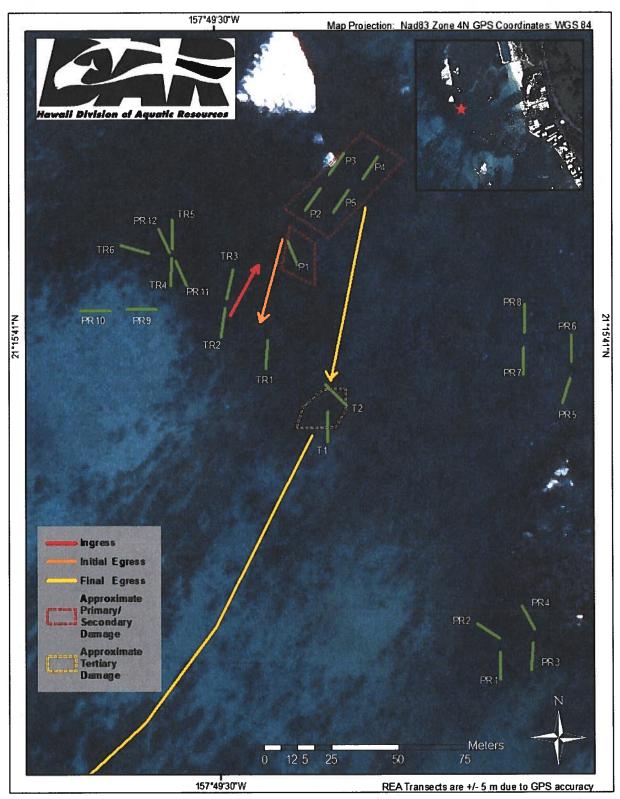
Figure 12. CFV *Pacific Paradise* Grounding site, depicting the primary/secondary impact, ingress, egress path, tertiary impact, and subsequent Rapid Ecological Assessment (REA) transects. (P = Primary/Secondary Impact Sites, PR = Primary/Secondary Reference Sites, T = Tertiary Impact Sites, TR = Tertiary Reference Sites).

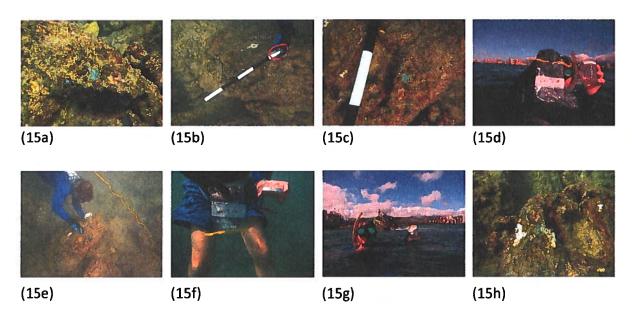
Figure 15a – 15h. Photographs demonstrating the sequence of collecting paint scraping. (a – paint scrape of unaltered evidence; b – paint sample wide angle view with 0.5 m scale bar; c – close up view; d – evidence collection jar and bag with a unique identification code; e – DAR diver collecting sample from substrate; f – paint chip placed into sample bag with same sample code; g – paint chip in the sample jar and place in the labeled sample bag; h – post-evidence collection photograph to demonstrate that the sample pictured above came from that site).

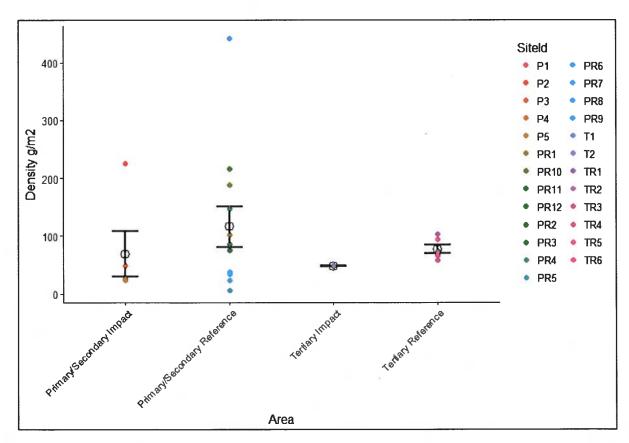
Mean fish density was lower at damaged impact sites (primary/secondary impact site = 69.4 g/m², tertiary impact = 48.0 g/m²) than at non-impacted reference sites (primary/secondary reference sites = 116.4 g/m², tertiary reference sites= 77.1 g/m²) (Figure 16). Species diversity was similar between reference and impact sites. In the primary/secondary impact site, the yellowfin goatfish ( $Mulloidichthys\ vanicolensis$ ) made up the bulk of the biomass (Table 1). While the brown surgeonfish ( $Acanthurus\ nigrofuscus$ ) was second, but made up the bulk of the biomass in the other three survey area.

Figure 16. Fish density (g/m²) at primary/secondary impact site, primary/secondary reference sites, tertiary impact site, and tertiary reference sites. Each point represent density for each transect surveyed. Center circle shows the mean density estimated for each area with standard error bars.

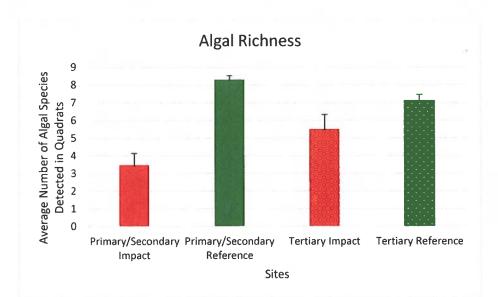
Figure 17. Algal richness at primary/secondary impact site (solid red bar, n=5), primary/secondary reference sites (solid green bar, n=12), tertiary impact site (red bar with white dots, n=2), and tertiary reference sites (green bar with white dots, n=6). Bars represent the average number of algal species or algal functional group detected within quadrats at each of the four sites. Error bar depicts standard error.

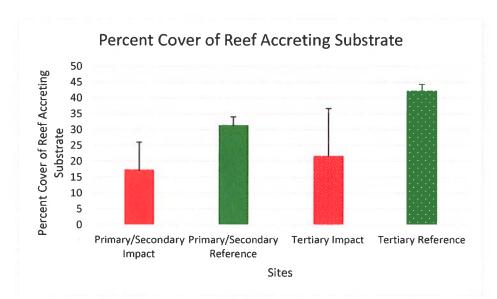
Figure 18. Percent cover of reef accreting substrate at primary/secondary impact site (solid red bar, n=5), primary/secondary reference sites (solid green bar, n=12), tertiary impact site (red bar with white dots, n=2), and tertiary reference sites (green bar with white dots, n=6). Bars represent the average percent cover of reef accreting substrate at each of the four sites. Error bar depicts standard error.

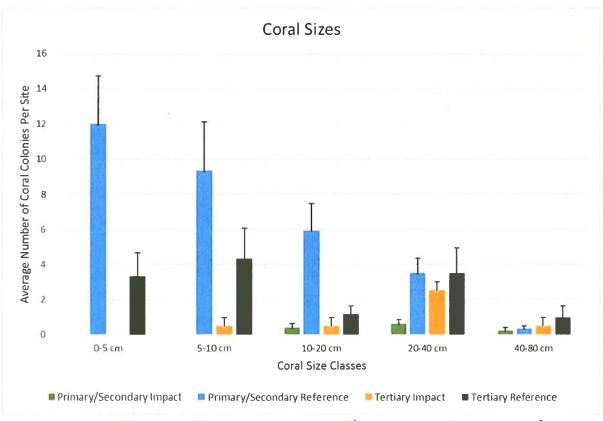
No corals in the size ranges 0-5 cm and 5-10 cm were documented in the primary/secondary impact sites, whereas this size class had the most colonies in reference sites. The average number of coral colonies ( $\pm$  standard error) at each site were: primary/secondary impact ( $0.24 \pm 0.09$  colonies, 0.001 colonies/m²), primary/secondary reference ( $6.22 \pm 0.99$  colonies, 0.01 colonies/m²), tertiary impact ( $0.80 \pm 0.33$  colonies, 0.008 colonies/m²), tertiary reference ( $2.67 \pm 0.56$  colonies, 0.009 colonies/m²) (Figure 19).

Figure 19. Average coral colonies by size classes at primary/secondary impact site, primary/secondary reference sites, tertiary impact site, and tertiary reference sites. Error bars represent the standard error.
