**HONOLUA BAY / LIPOA POINT
EROSION AND SEDIMENTATION
STORMWATER MANAGEMENT REPORT**

**HONOAPILANI HIGHWAY
TMK (2) 4-1-001:010
MAUI COUNTY, HAWAII**

July 9, 2018

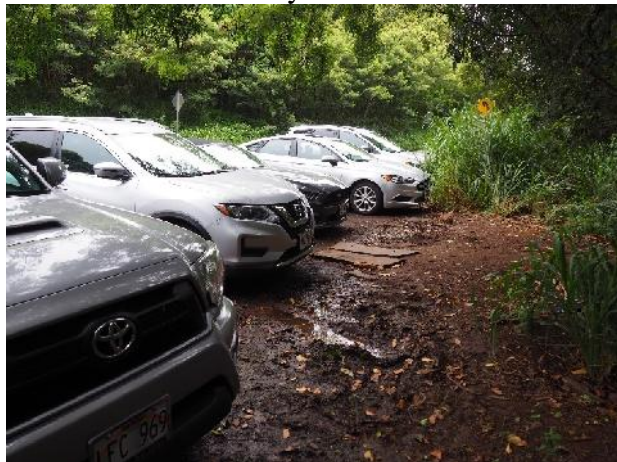
While portions of the main parking area along Honoloua Highway are paved or covered with gravel, large sections are exposed dirt and mud that flow freely into Honoloua Stream during rain events. Here, bare muddy soil deposits are continually disturbed by vehicles pulling into and out of the parking area. Muddy tire tracks, rills, and small channels leading to Honoloua Stream were observed.

Unimproved Parking with Disturbed Soils

The parking areas along Honoapiilani Highway should be updated with Low Impact Development (LID) techniques so that vehicles no longer come in contact with loose and muddy soils. This can be done in a variety of ways including by extending the pavement to include the entire parking area, resurfacing the parking area with pervious concrete or asphalt, installing pervious pavers in those areas that are now bare ground, and with the installation of bioswales with vegetation makai of the parking area to catch sediment and water originating from the parking area before it reaches Honoloua Stream.

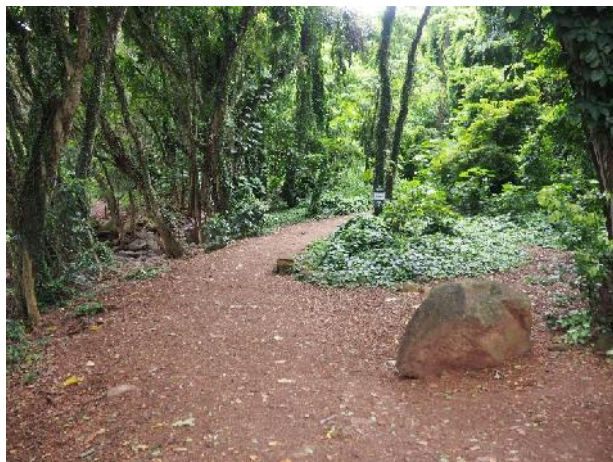
The dirt walking path leading to Honoloua Bay follows the northern bank of the stream. The path consists of bare ground with exposed roots, rills, and channels sloping directly into the adjacent stream with little to no vegetative buffer to prevent sediment from entering the stream. This trail has high use by tourists throughout the year. Many additional side trails have been cut into the riparian zone near the highway as tourists make their way from undesignated overflow parking areas towards the main walking path, further exacerbating erosion in this area.

Dirt Trail Sloping to Honolua Stream

Currently, little to no shrub and ground cover exists along the dirt trail leading to Honoloua Bay. At a minimum, the northern bank of Honoloua Stream should be planted with appropriate vegetation to slow sheet flow from the access trail and capture any resulting sediment. In addition, this trail can be elevated by the installation of a boardwalk or paved with pervious concrete or asphalt.

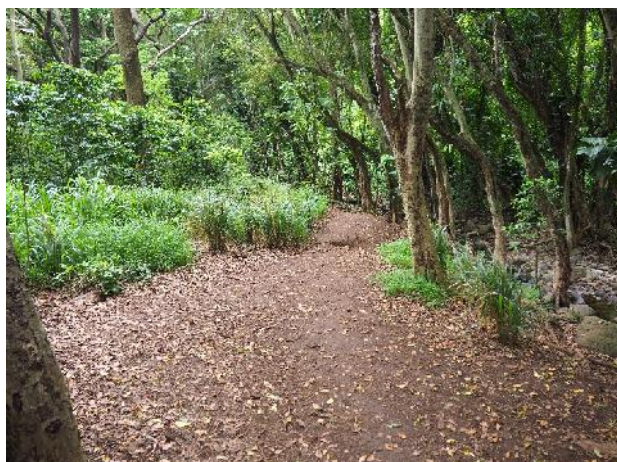
Dirt Trail with Little to No Groundcover

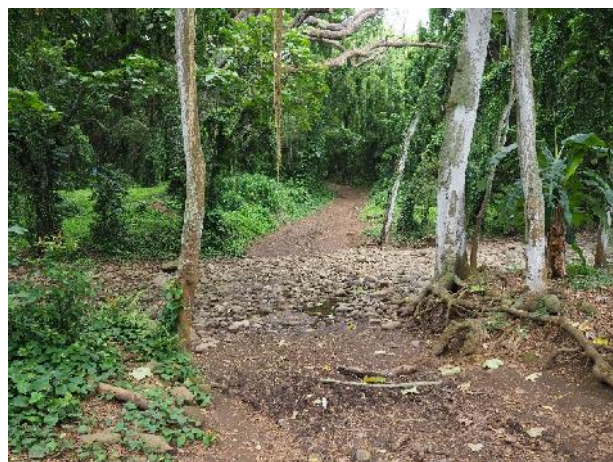
In addition, a dirt road crosses the stream channel near the cobble beach. Here, the banks of the stream have been undermined. Exposed tree roots, muddy sediment deposits, and undercut banks are evident at this road crossing. The dirt road leading to this crossing slopes down toward the stream from a secondary parking area along Honoapiilani Highway. Rills and channels are evident in the road and provide an additional source of sediment to the stream and ultimately to the stream outfall into Honoloua Bay approximately 200 feet to the northwest.

Road Crossing Honolua Stream

The dirt road crossing Honolua Stream should be elevated using culverts or pipe arches to protect the stream bottom and stream banks. These culverts must be sized to handle current and storm flows of water. Consultation with the West Maui Soil and Water Conservation District technicians or appropriate engineers should be conducted to assist with proper installation of culverts. Failure to properly size a culvert can lead to washed out roads and serve to increase erosion.

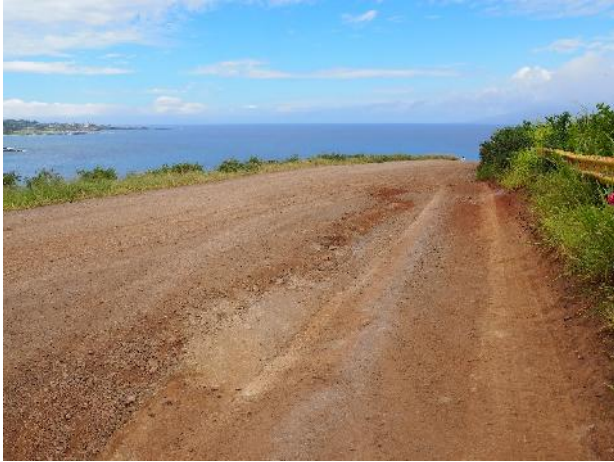
Deep rills and long uninterrupted channels are evident throughout the driveway as it drops approximately 80 feet, heading north from Honoapiilani Highway towards Lipoa Point. Further evidence of erosion is provided by the exposed fragments of black plastic used historically for agricultural practices. Failed water bars, kickouts, and undermined swales can be observed throughout the driveway.

Rills and Channelization

-) Grade Existing Driveway Away from Cliff – The existing dirt driveway should be graded so that water is forced to flow away from the cliff edge and Honolua Bay and towards Kulaokaea.
-) Water Bars – If the driveway is to remain in place, water bars should be installed for every six feet of elevation drop or as appropriate to further divert water away from the cliff and Honolua Bay northeast towards Kulaokaea.
-) Bioswales – Water collected by driveway grading and water bars should be collected in a bioswale paralleling the driveway. This swale should be planted with vetiver, native grasses and shrubs, or other vegetation deemed appropriate to slow the movement of stormwater and sediment. In addition, this swale can be fortified with geotextiles or geo webbing to further protect against rills, channelization and loss of sediment.
-) Kickouts and Detention Basins – In order to capture water and sediment diverted into

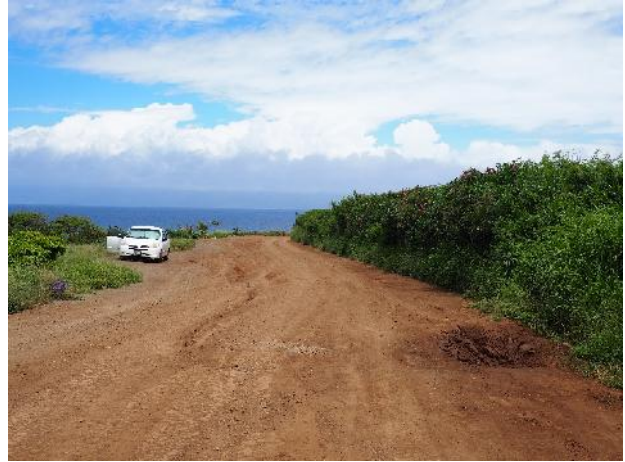
Failed Water Bars

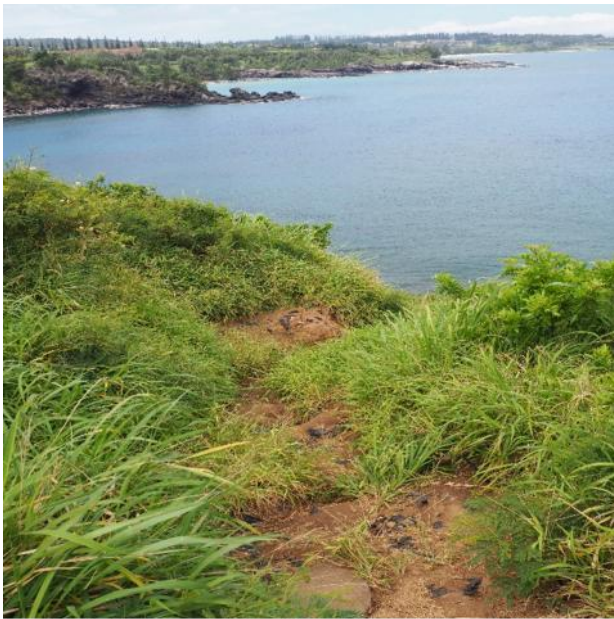
In addition, many steep makeshift trails have been cut into the cliff leading from this dirt driveway down to Honoloua Bay by surfers, fisherman, and tourists alike. Erosion and sediment transport from the dirt driveway are facilitated by these trails. Scouring is evident along many of these pathways. Exposed fragments of black plastic can also be observed along these trails, providing further evidence of erosion in these areas.

Makeshift Access Trail to Honoloua Bay
Showing Erosion

- J) Designate Appropriate Access Trails to Ocean – Currently, several access trails exist leading from the dirt driveway down to Honoloua Bay. These trails have been haphazardly cut into the cliff wall by surfers and fishermen accessing the water. Trails should be optimized to maximize user access to popular areas, and minimize storm water flow through the use of known trail best management strategies including the use of switchbacks, water bars, kickouts, etc. Additional trails should be decommissioned and replanted with native vegetation and/or vetiver to discourage their continued use.

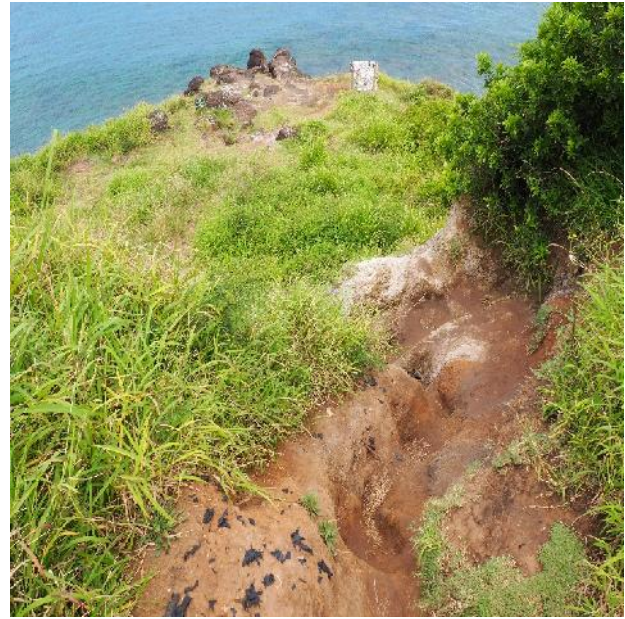
Makeshift Access Trails to Honoloua Bay
Showing Scouring

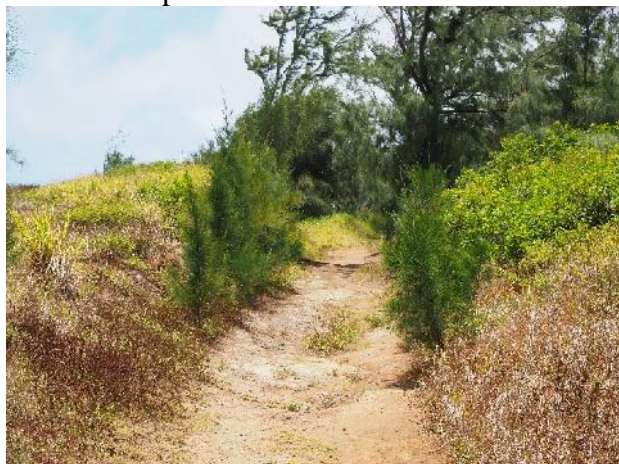
Along the numerous dirt roads in this area, rills and channelization are evident. Soil deposits were observed where these roads turn or run into vegetation. Storm water falling on these highly compacted soils builds speed and, using the roads as a conduit, flows down slope toward the ocean. These uninterrupted flows cause additional erosion to the roads and surrounding landscape and deliver sediment laden storm water to the ocean.

Agricultural Dirt Road

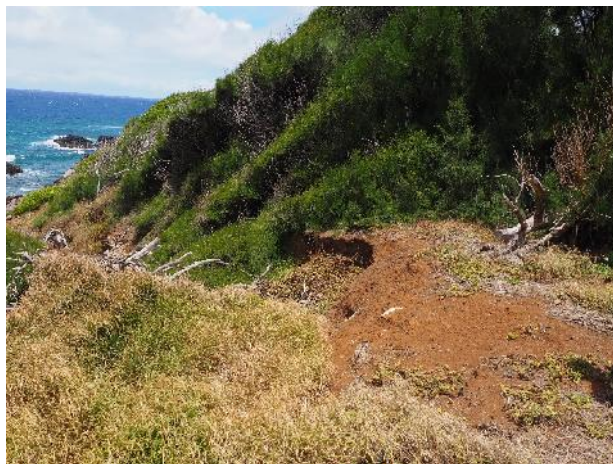
Head Cut and Debris in Flow Way

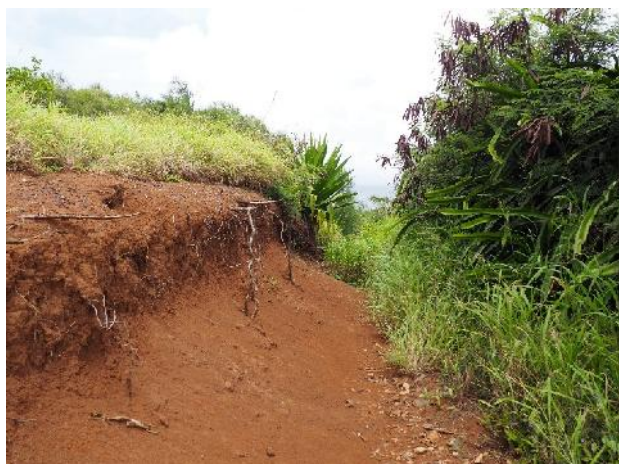
Soils Erosion and Sediment Deposits

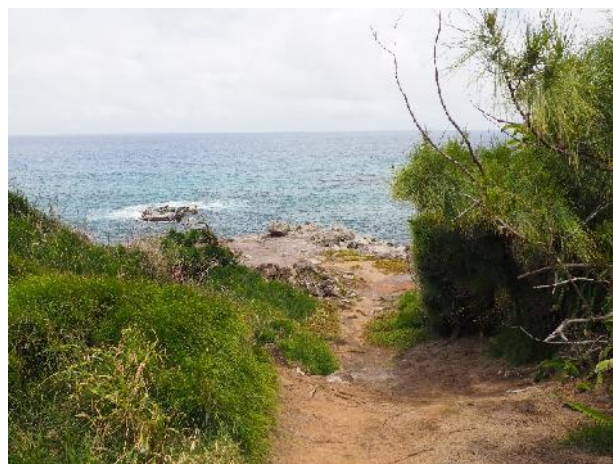
At the top of the coastal cliffs where Kulaokaea drops toward the ocean, various old roads and hiking trails drop to the tidal pools and coastal areas below, acting as discharge channels. These flow ways contain stream cuts, undercut banks, exposed roots, and large piles of sediment deposits and other debris, all indicators of high flow volumes during storm water events.

Dirt Road Leading to Ocean

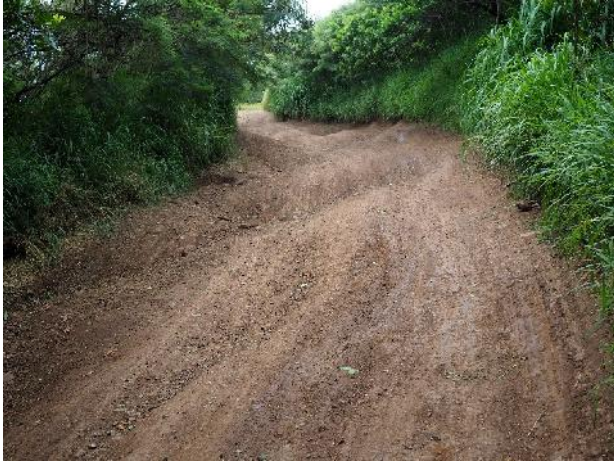
The steep 4x4 driveway from Honoapiilani Highway down to “Windmills Beach” is highly eroded. Rills and deep channelized cuts are found throughout the dirt driveway as it makes its way down the campground area. Like the abandoned agricultural roads associated with Kulaokaea, this dirt driveway is highly compacted and provides a conduit for storm water to quickly flow downhill towards the ocean, exacerbating erosion. In addition, the steep hill just east of this 4x4 driveway leading down from the highway to the camping area is largely devoid of vegetation. A makeshift hiking trail has been created on this hill by pedestrians avoiding the 4x4 driveway entrance to “Windmills Beach”. Instead, these individuals park in a small turnoff along the highway and hike down the hill.

4x4 Driveway from Honoapiilani Highway to Terrace
“Windmills Beach” and Campsites

The 4x4 driveway is quite steep in grade but few modifications to its footprint are possible due to the limited room along the hill leading from Honoapiilani Highway. The driveway is currently bare ground but could be improved with gravel, permeable concrete or asphalt. In addition, a swale should be cut paralleling the 4x4 driveway. Water bars should be placed in high frequency along the driveway, directing water into the swale and eventually into the detention basin recommended above.

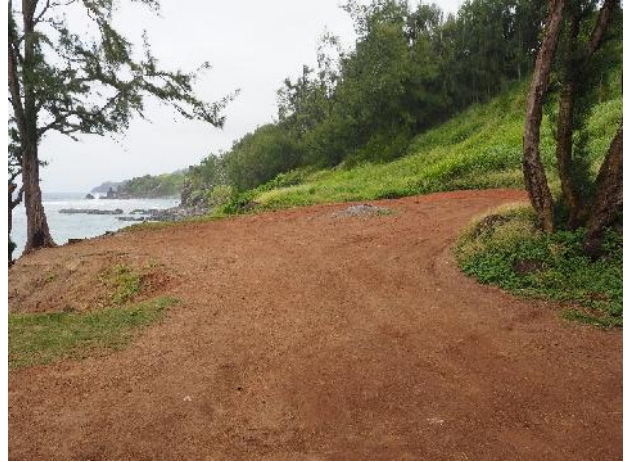
The clay capped level embankment used for camping has a dirt driveway through its center. Vehicles driving over this area have caused the driveway to become severely compacted, leaving the soils highly impermeable and promoting additional runoff to the shoreline below.

Dirt Driveway and Campsites Along Clay

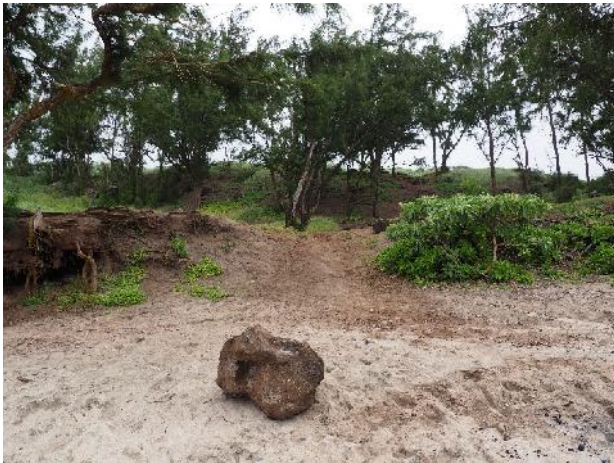
Naupaka grows along the embankment where it meets the shoreline and acts to stabilize soils in this area. Where Naupaka is absent due to camper trails for accessing the beach, rills, channels, exposed tree roots, undercut banks, and large sediment deposits are present.

Beach Access from Campsites

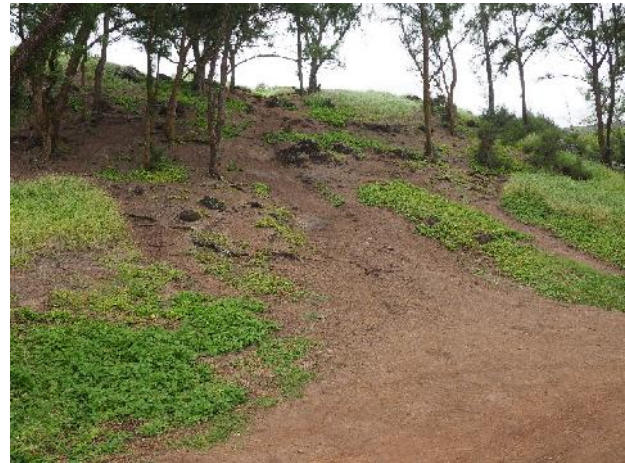
Hill Leading from Honoapiilani Highway to Campsites at “Windmills Beach”
