STATE OF HAWAII
DEPARTMENT OF LAND AND NATURAL RESOURCES
Division of Aquatic Resources
Honolulu, Hawaii 96813

Subject: Enforcement Action against John Joseph Barry III and Avalanche Adventures Corp. for Alleged Stony Coral and Live Rock Damage Resulting from the May 28, 2021 *Avalanche* Anchoring Incident Within the Waters of the Kaloko-Honokōhau Fish Replenishment Area / Netting Restricted Area, Hawai'i Island.

Incident Report: DAR, DOBOR, DOCARE, NPS response to report of coral damage due to vessel anchoring within the Kaloko-Honokōhau National Historic Park

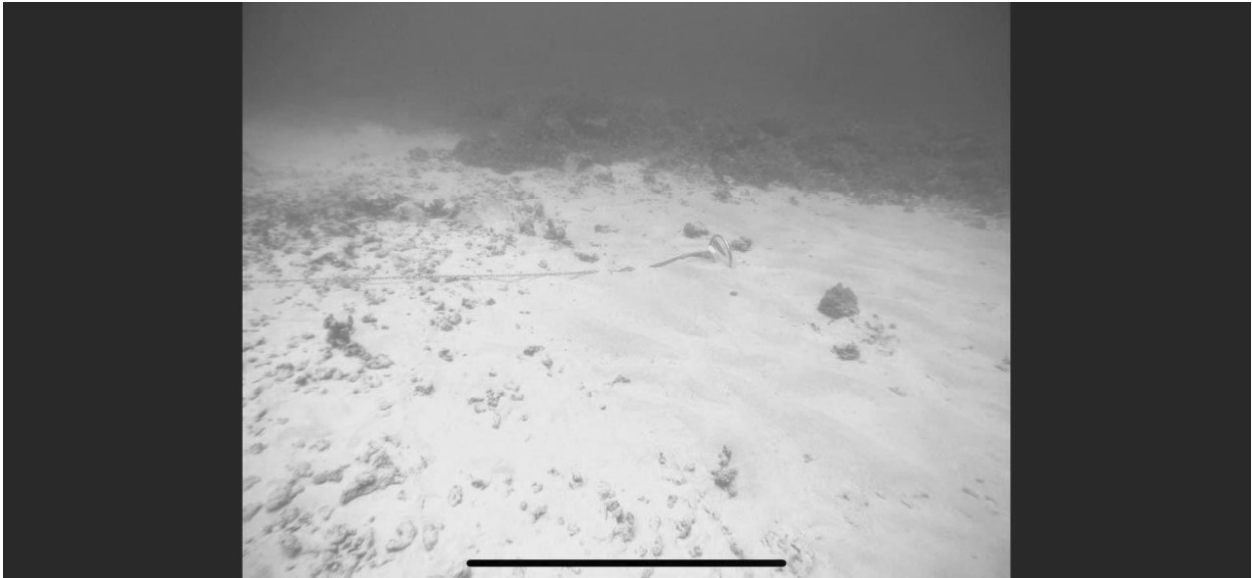
Figure 2: Anchor situated in sand patch. Image posted to social media.

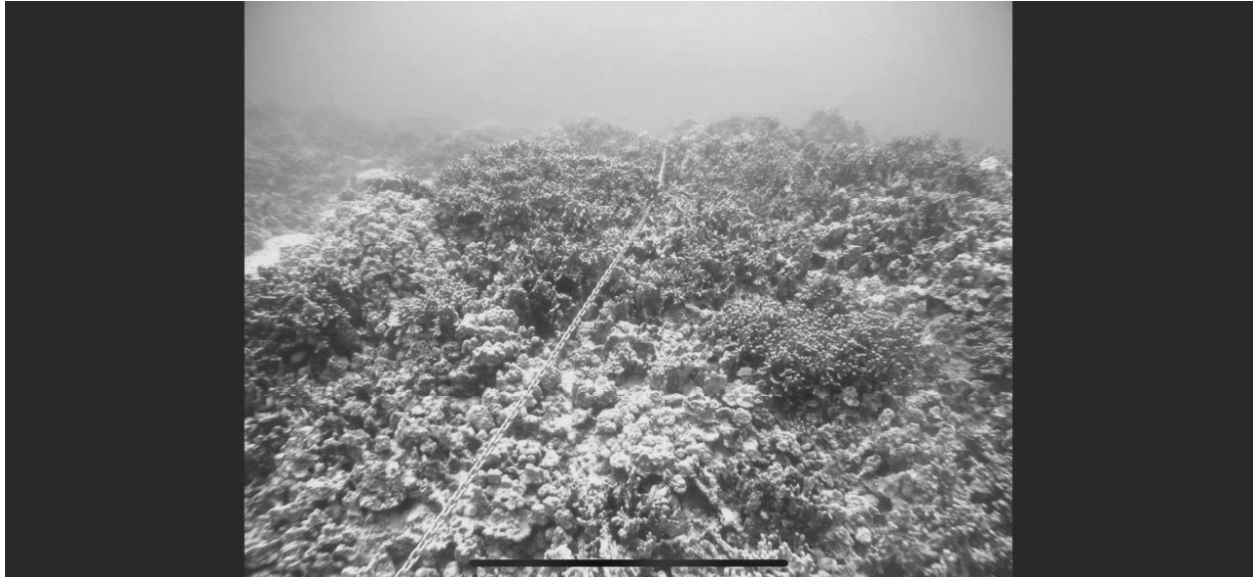
Figure 3: Anchor chain laying on live coral. Image posted to social media.

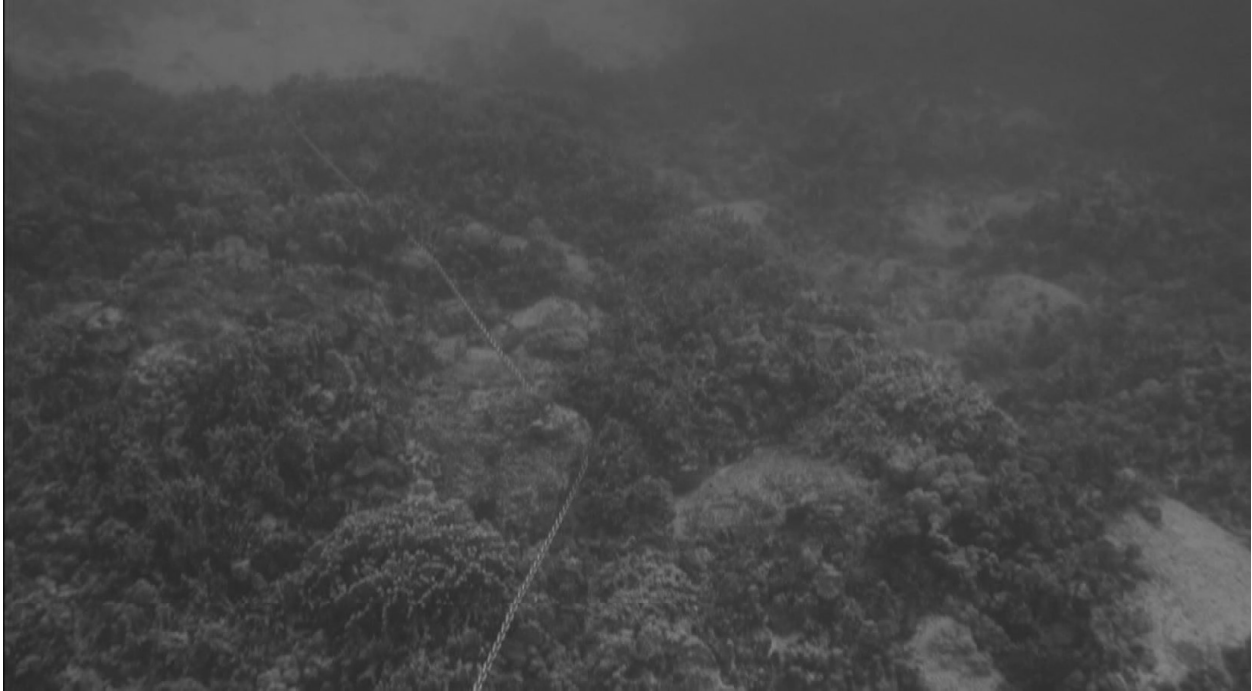
Figure 4: Anchor chain laying across section of reef with high coral cover. Image extracted from video footage taken by C. Teague.

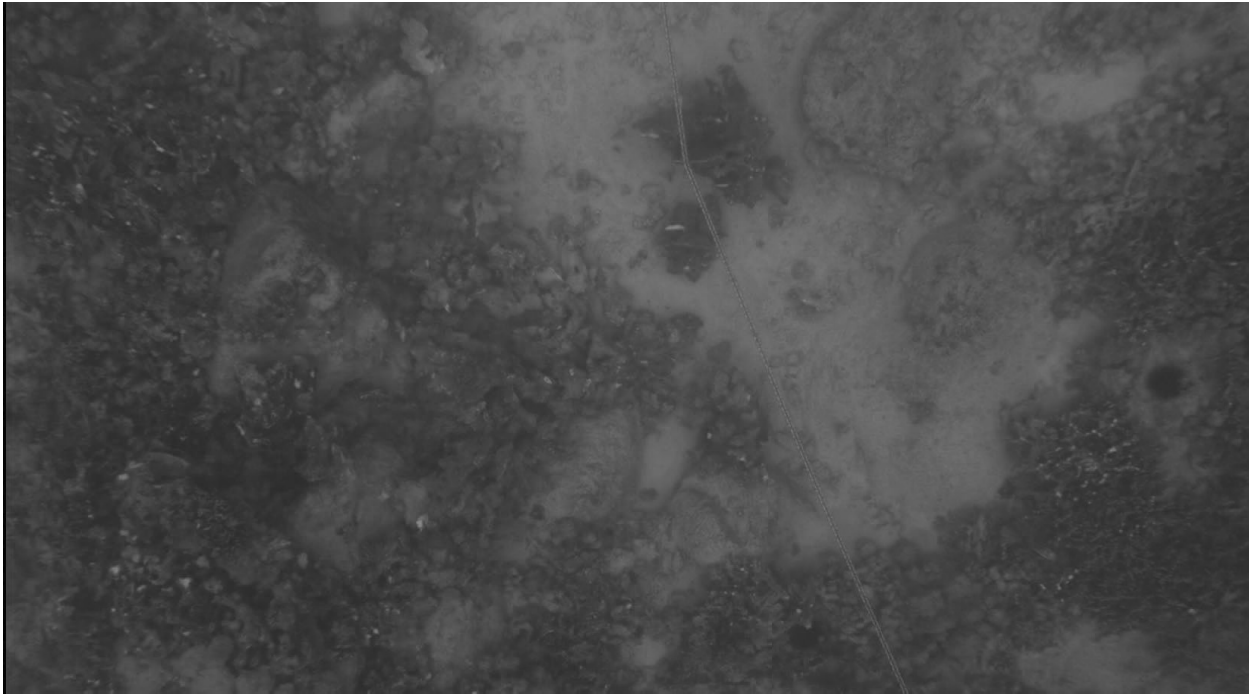
Figure 5: Anchor chain laying over section of reef. Light spots of coral in this image are indicative of recent damage. Additionally, the chain is caught on a colony of *Porites lobata* that has been dislodged. Image extracted from video footage taken by C. Teague.

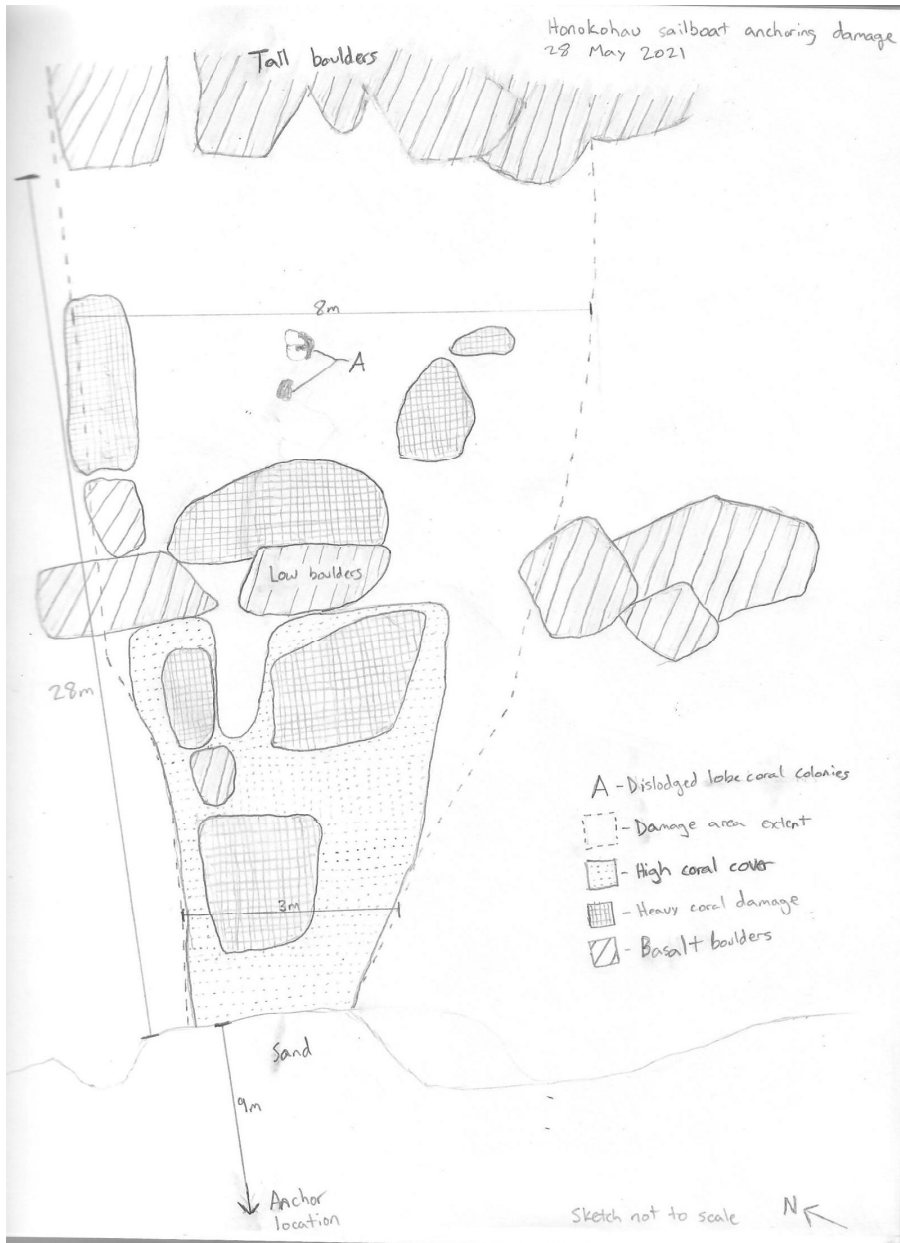
The overall amount of damage to this section of reef was extensive. The affected area was wedge shaped, with the damage extending along 28 meters of reef (Figure 6). This "wedge" was 8m at the widest and 3m at the narrowest. Coral breakage began at the reef immediately adjacent to the sand patch where the anchor was located and extended due east towards a line of large basalt boulders. Coral cover was highest in the western portion of the area, however impacted colonies were spread relatively evenly across the affected area.

Figure 6: Site overview depicting large boulders, the extent of the damaged area, and areas with particularly heavy coral damage.

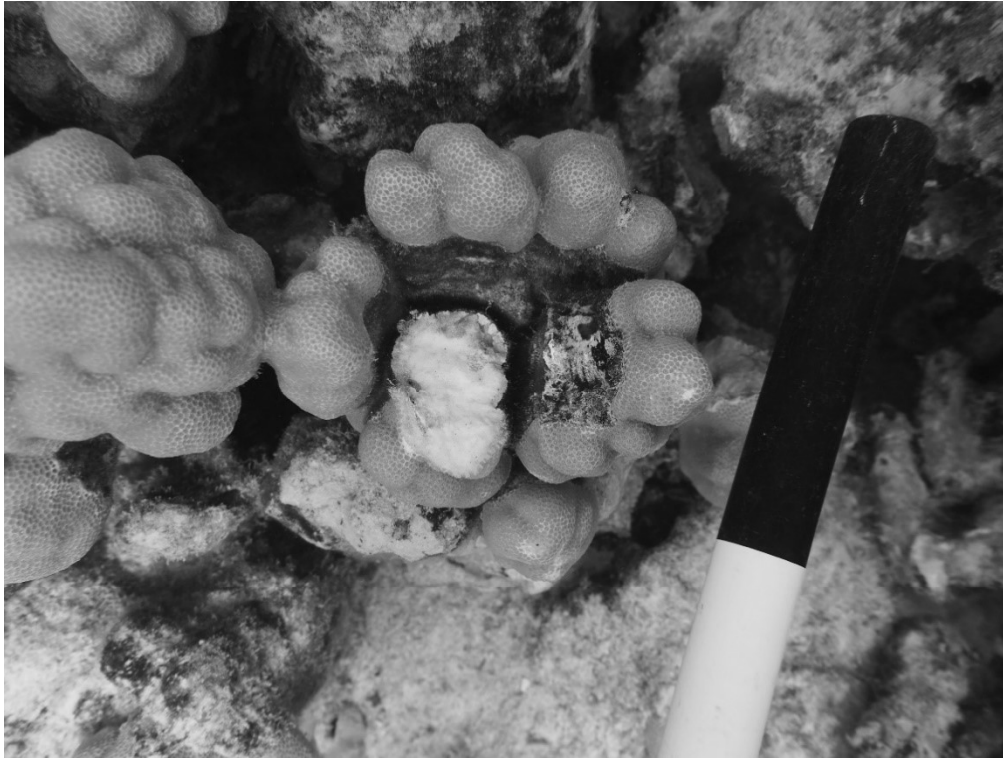
Figure 7: Example of a small (< 5 cm) breakage of a *Porites lobata* colony. Scale bar shown has 10cm increments.

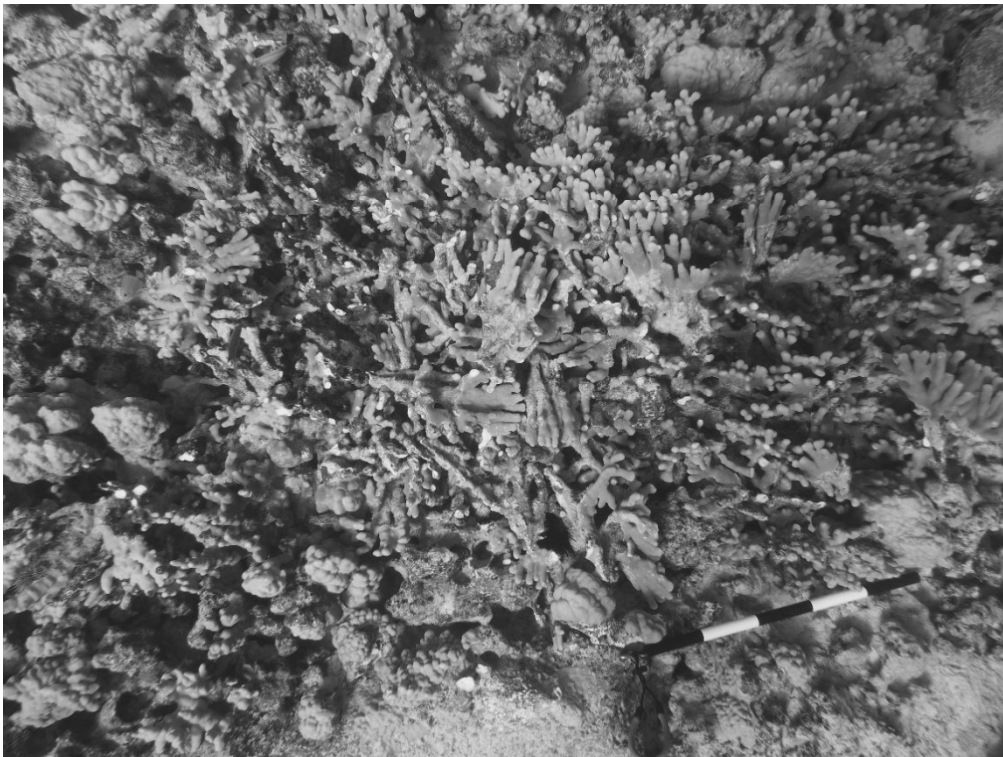
Figure 8: Example of a large swath of damaged *Porites compressa* bed. Scale bar is 50cm long with 10cm increments.

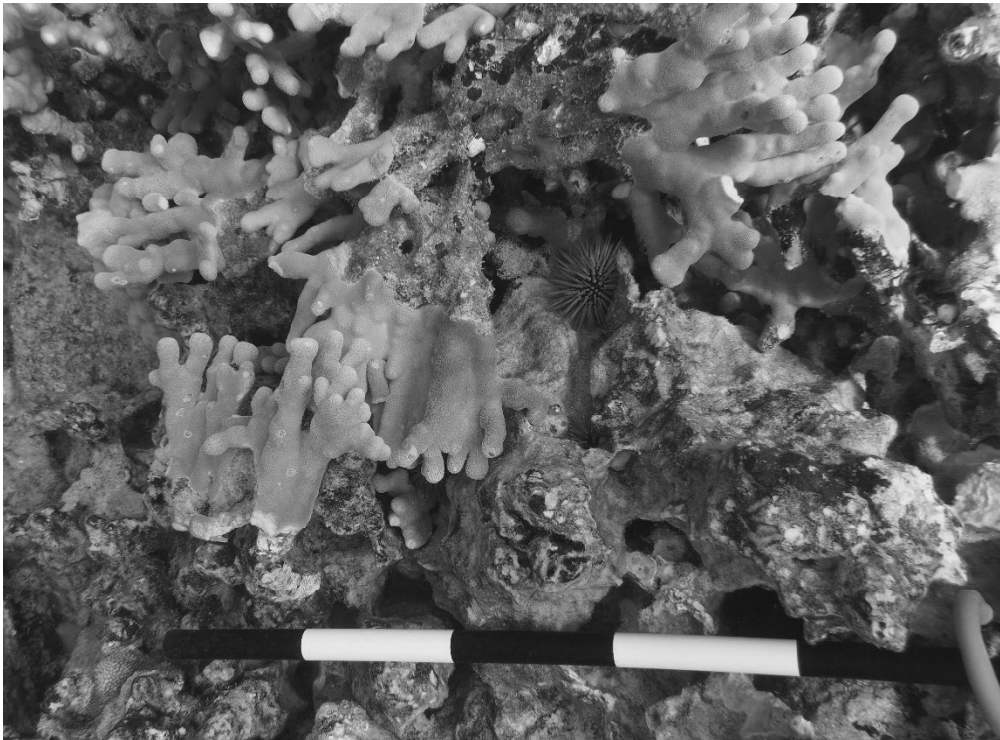
Figure 9: Closeup of damaged *Porites compressa* colonies. Note that the branches are laying on their sides. Undamaged, upright corals provide necessary habitat for fishes and invertebrates.

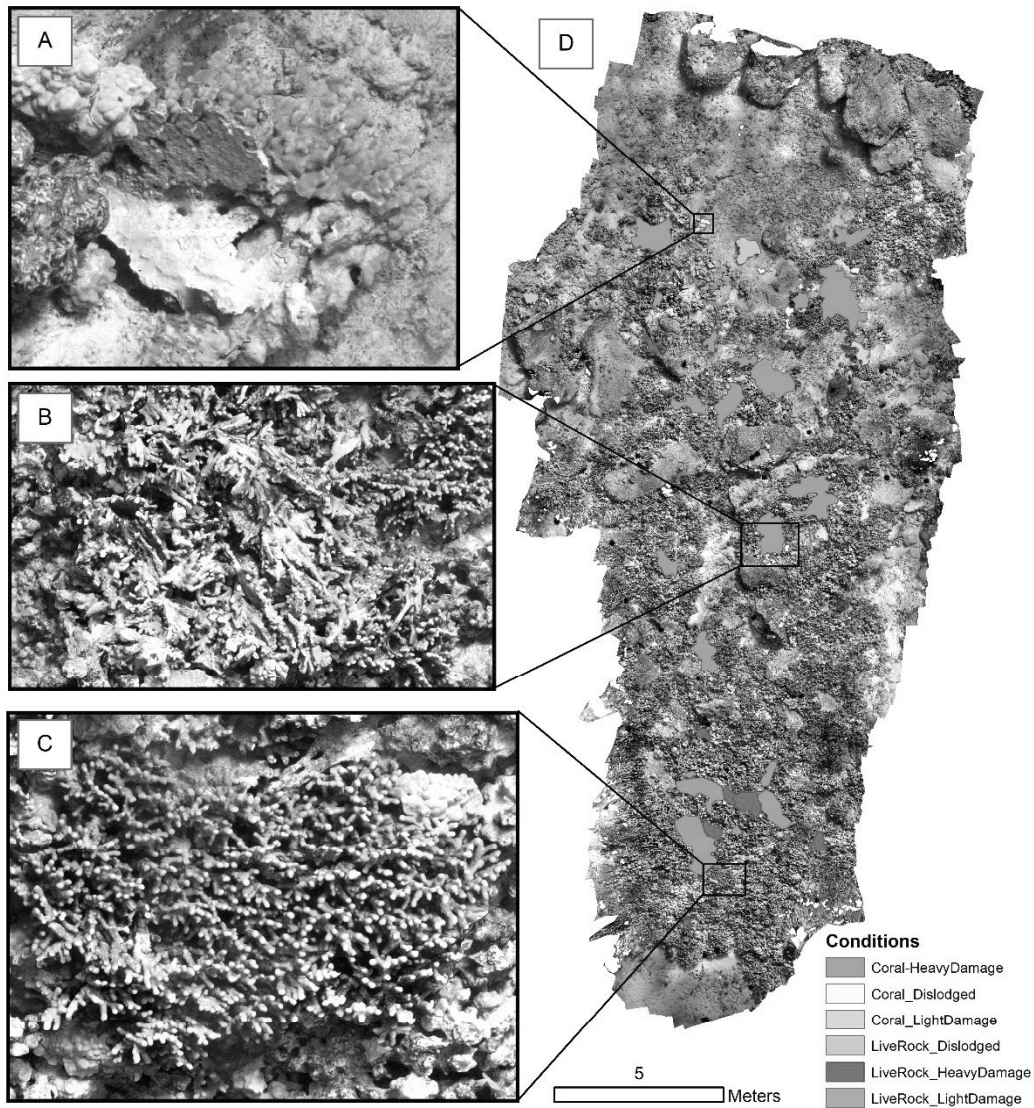
Areas of heavy damage, light damage, and dislodged coral/live rock visible in the orthomosaic were manually annotated to show the distribution of impacted resources (Figure 10D). The heavy damage classification describes instances of severe loss of habitat structure, and light damage describes scarring, abrasion, or small breakage points that did not result in a visible, substantial change of habitat structure. Coral and live rock classified as dislodged describes intact structures that are no longer attached to the substrate and were frequently overturned or on their side.

Figure 10: Orthomosaic of anchor damage site on June 1, 2021. A) A mounding *Porites lobata* colony broken and on its side with inner white skeleton exposed. B) A colony of *Porites compressa* with heavy damage and most branches broken and laying on their side. C) A relatively healthy colony of *Porites compressa* intact with upright branches and a small section of light damage on the lower left. D) View of entire anchor damage survey area with impacted areas of live rock and coral highlighted.

DAR staff will revisit this site in the future and repeat the photogrammetry survey. The annotated orthomosaic, in addition to the DEM, will serve as a basis of comparison to track the recovery success of damaged colonies.

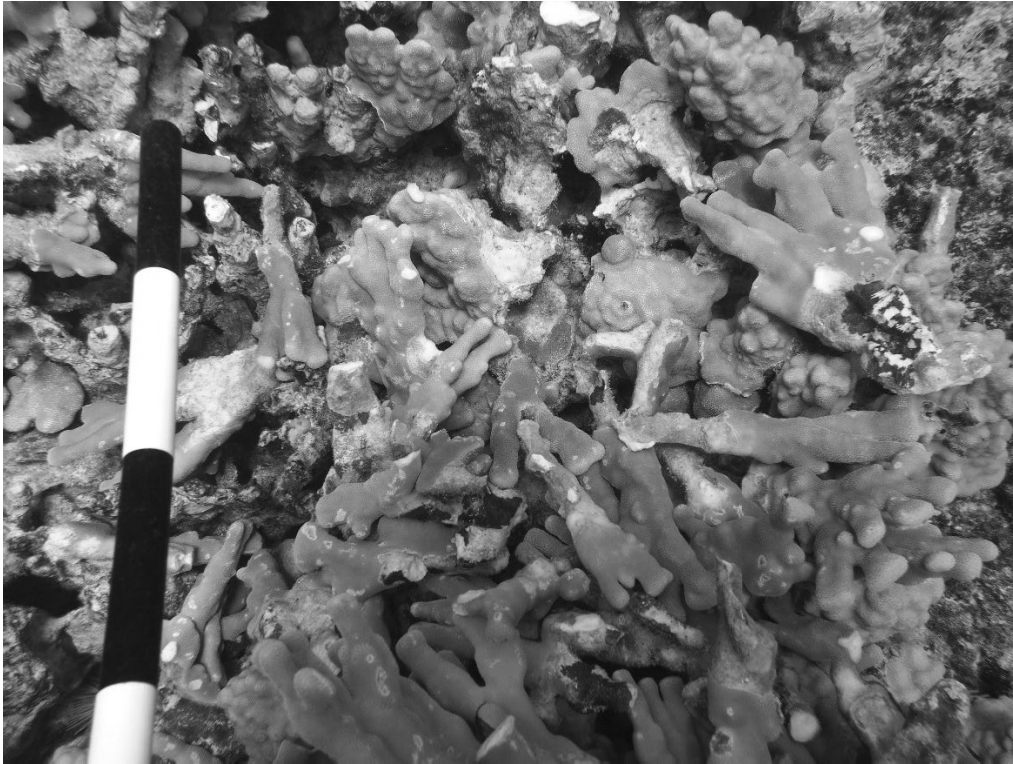
Figure A1: Closeup of a damaged *Porites compressa* colony.

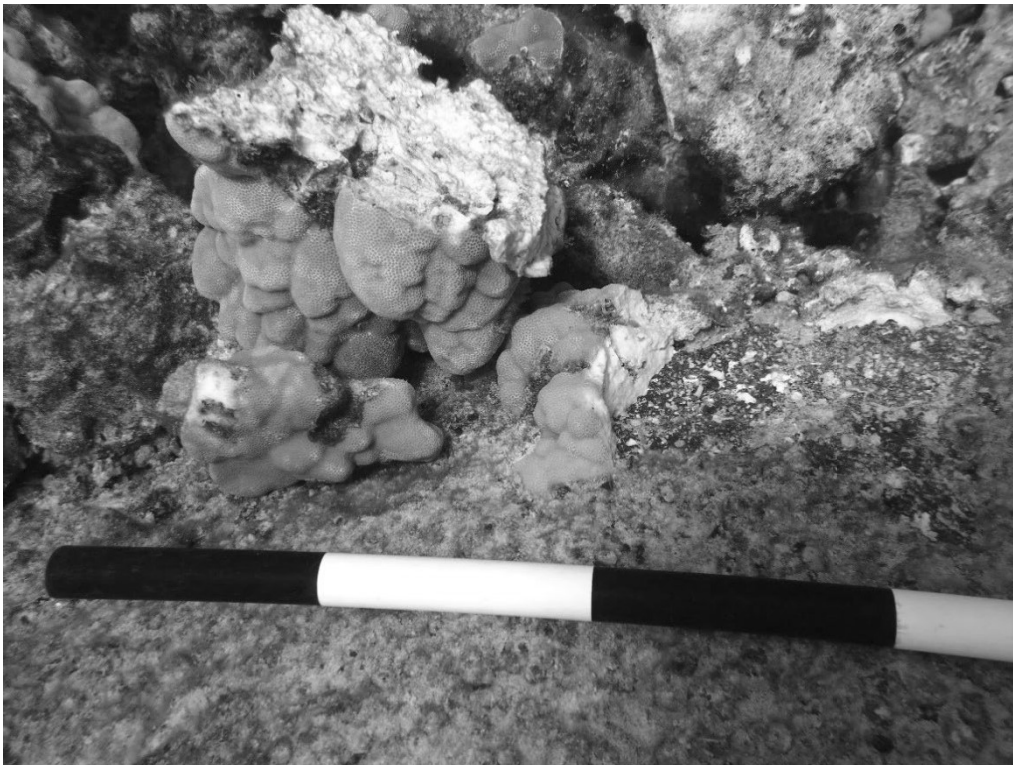
Figure A2: Dislodged section of *Porites lobata*.

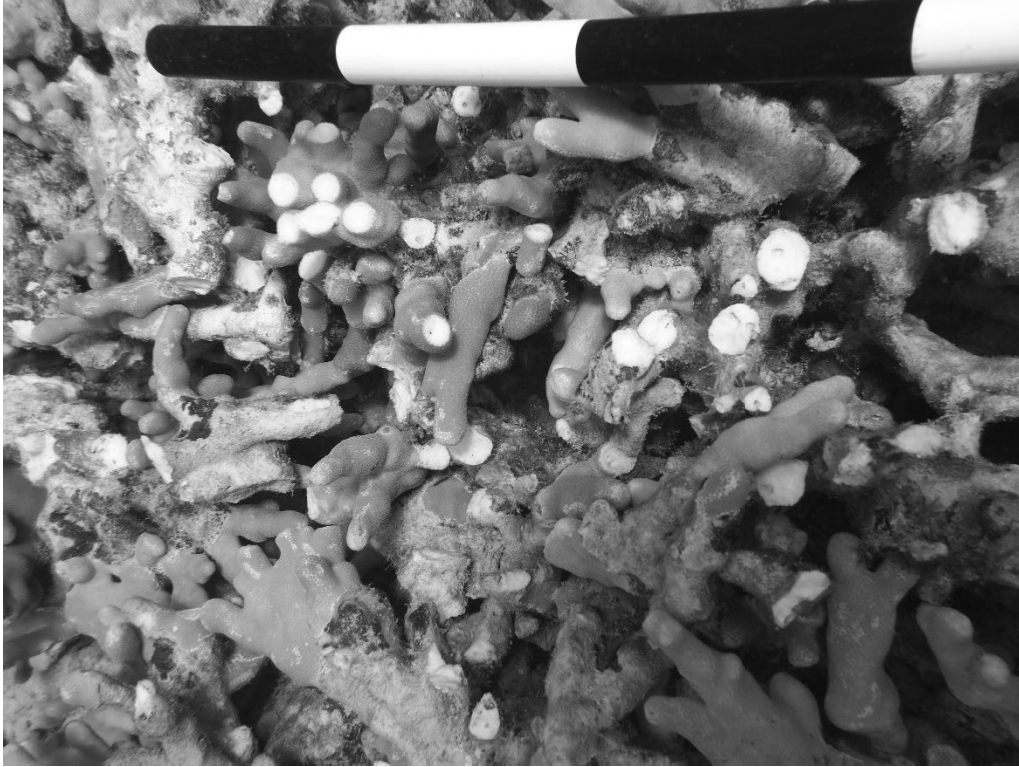
Figure A3: Colony of *Porites compressa* with numerous breakages.

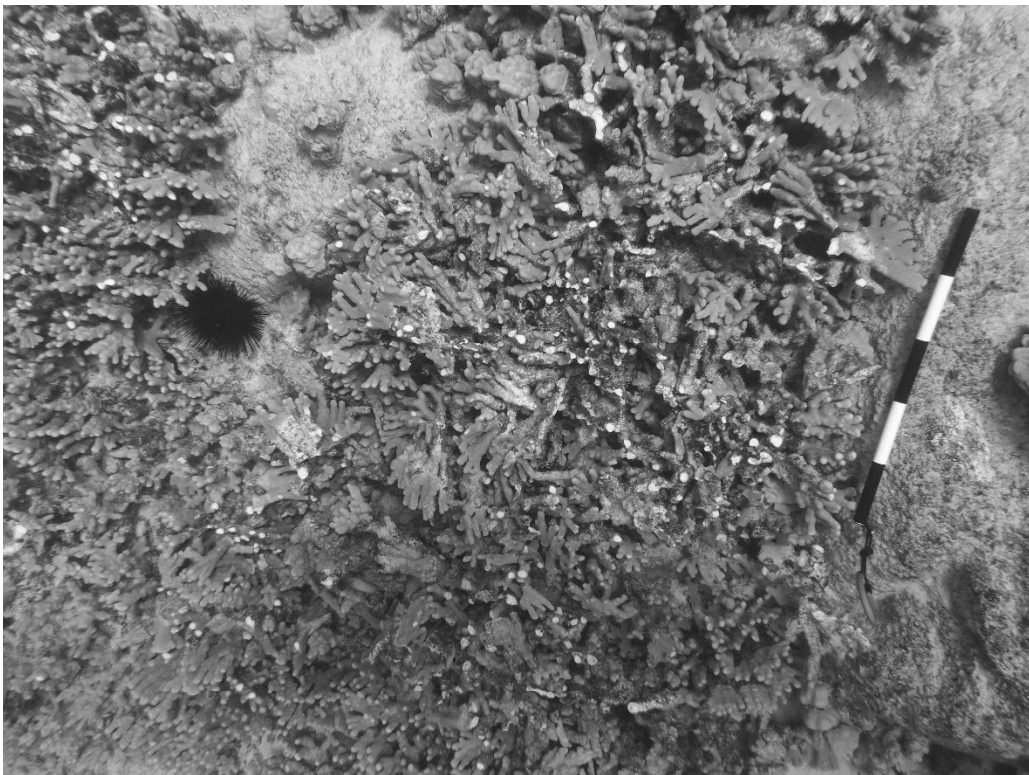
Figure A4: Large swath of *Porites compressa* showing many individual breakages

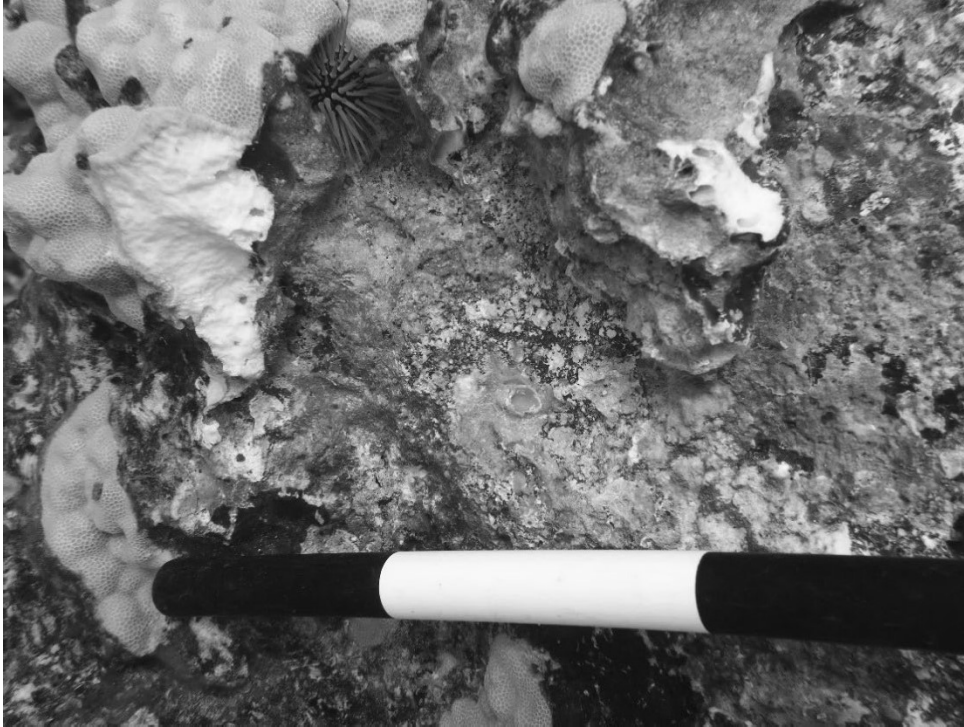
Figure A5: *Porites lobata* that has been sheared off. Visible bright white skeletal material is indicative of recent damage.

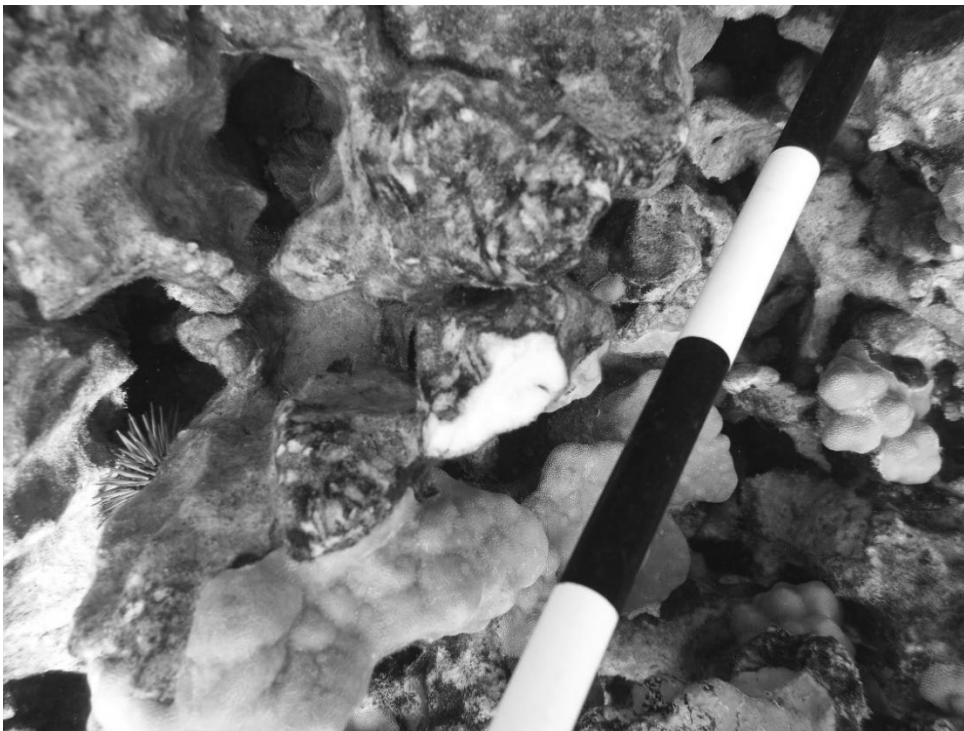
Figure A6: Live rock damage. Bright white section shows portion of a dead coral that has been sheared off. Note the scars from parrotfish bites on the undamaged sections. These reefs are important foraging grounds for parrotfishes which contribute to the long-term health of coral reefs.
