**Subject:** Enforcement Action against Anthony Hodgson and 2G Vessel Owner Limited for Alleged Stony Coral and Live Rock Damage Resulting from the September 29-30, 2021 *Endless Summer* Anchoring Incident within the Kailua Bay Fisheries Management Area, Island of Hawaii.

# *Endless Summer* anchor damage: multi-agency response and injury assessment, Kailua Bay Fisheries Management Area

## Field investigative report

**Division of Aquatic Resources**

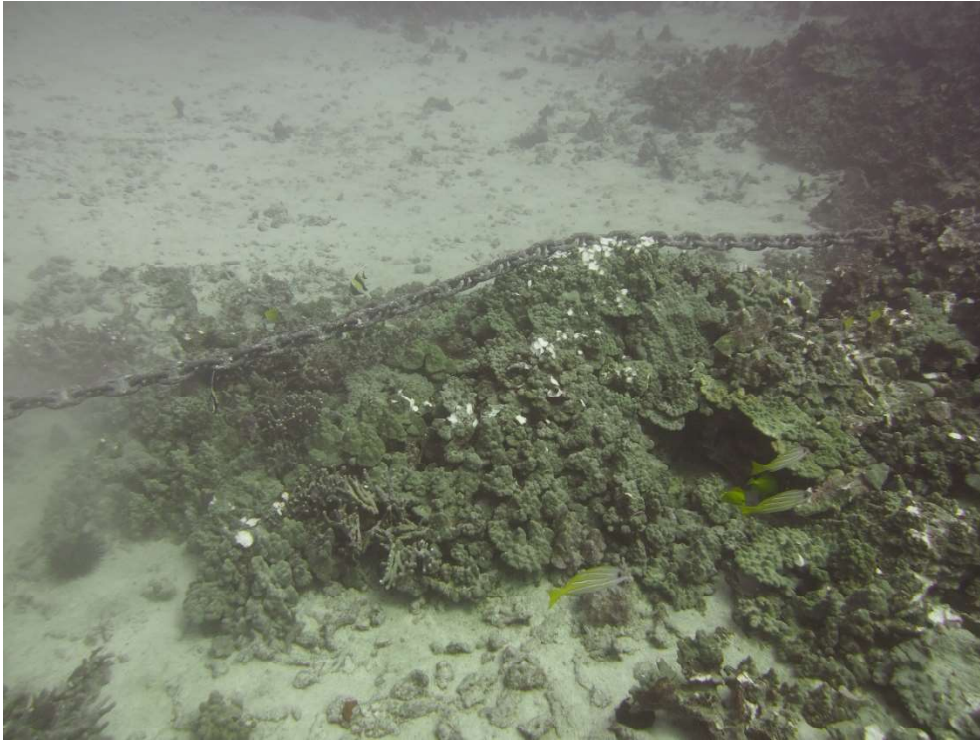
PUGH and TEAGUE descended into the water, following *Endless Summer*’s anchor chain to a depth of approximately 26 meters (85 feet) where the anchor chain met the seafloor. The divers observed the chain lying across and scraping a large colony of *Porites lobata* coral. The chain extended along the seafloor, and the divers observed the chain wrapped around several smaller coral colonies and lying across a large area of coral reef. The divers observed the anchor chain cinching and demolishing multiple colonies of coral as the chain pulled and tightened from the vessel’s movement at the surface.

Figure 4: Anchor chain draped over a large lobe coral (*Porites lobata*). Divers observed the chain bobbing up and down on top of this coral actively causing tissue and structural damage.

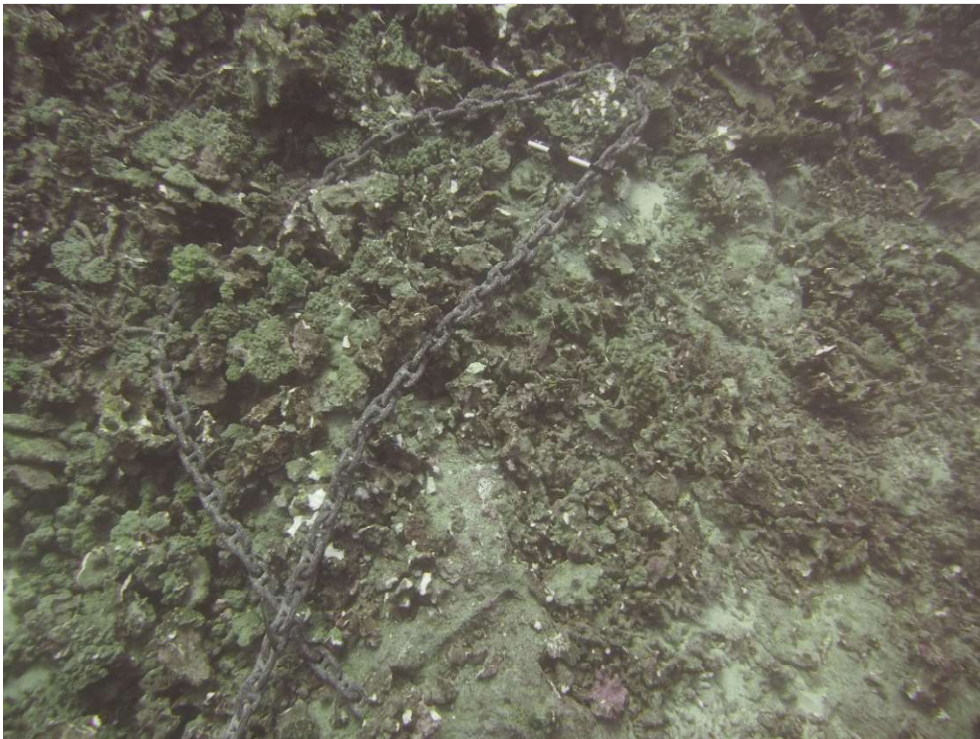
Figure 5: Segment of chain wrapped around numerous coral colonies. Many of these colonies were dislodged moments later as the loop cinched closed. The black and white scale bar in the upper middle is 50cm long with 10cm increments.

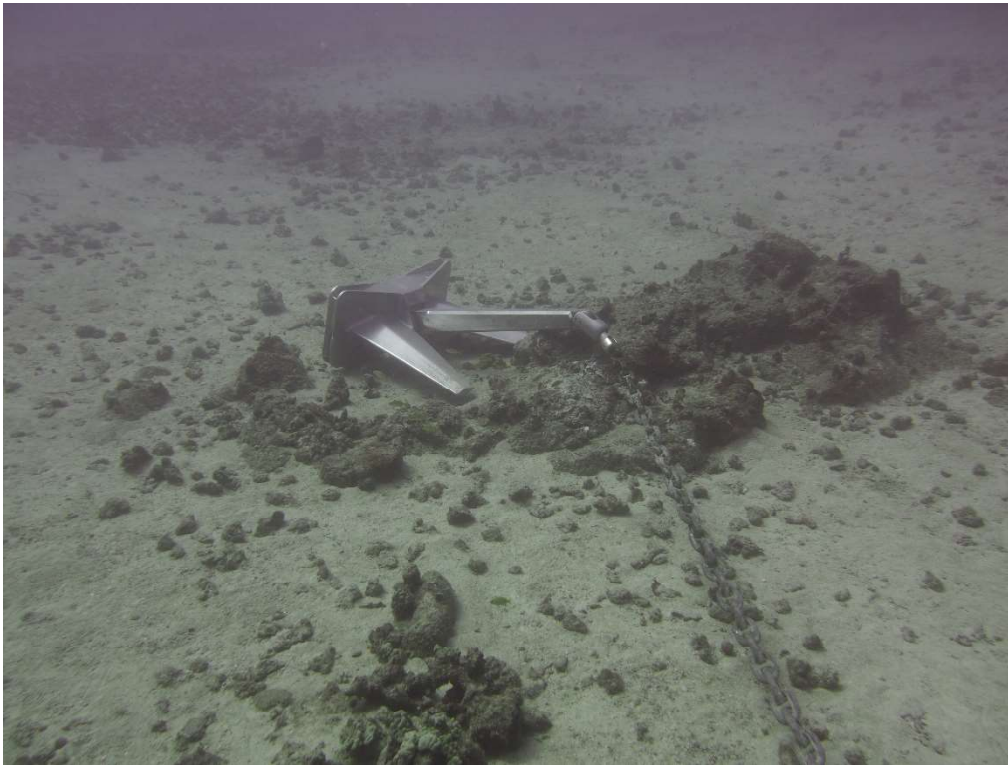
PUGH and TEAGUE followed the anchor chain westward into deeper water. They observed the chain lying over approximately 20 additional meters of live coral before the substrate turned into a mixture of sand and cobble. The anchor was located in this region at the end of the chain at a depth of approximately 29 meters (95 feet).

Figure 6: Anchor at a depth of ~29 meters snagged on a piece of low-lying reef.

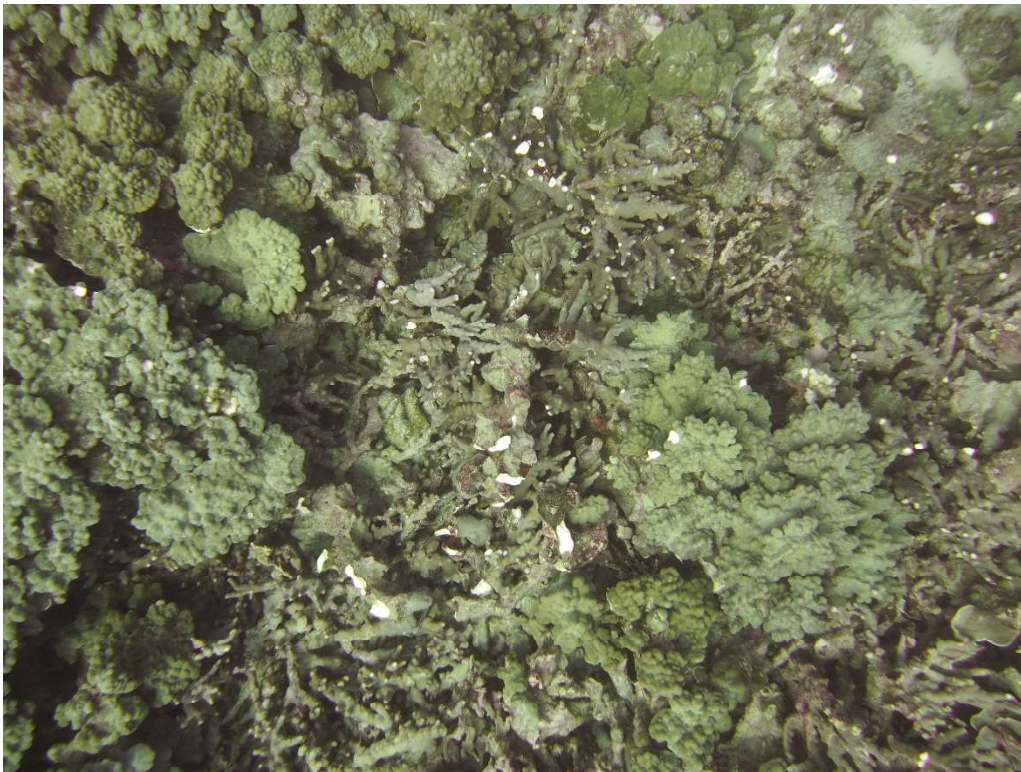
Figure 7: Section of damaged reef. Bright white spots are indicative of recent coral damage.

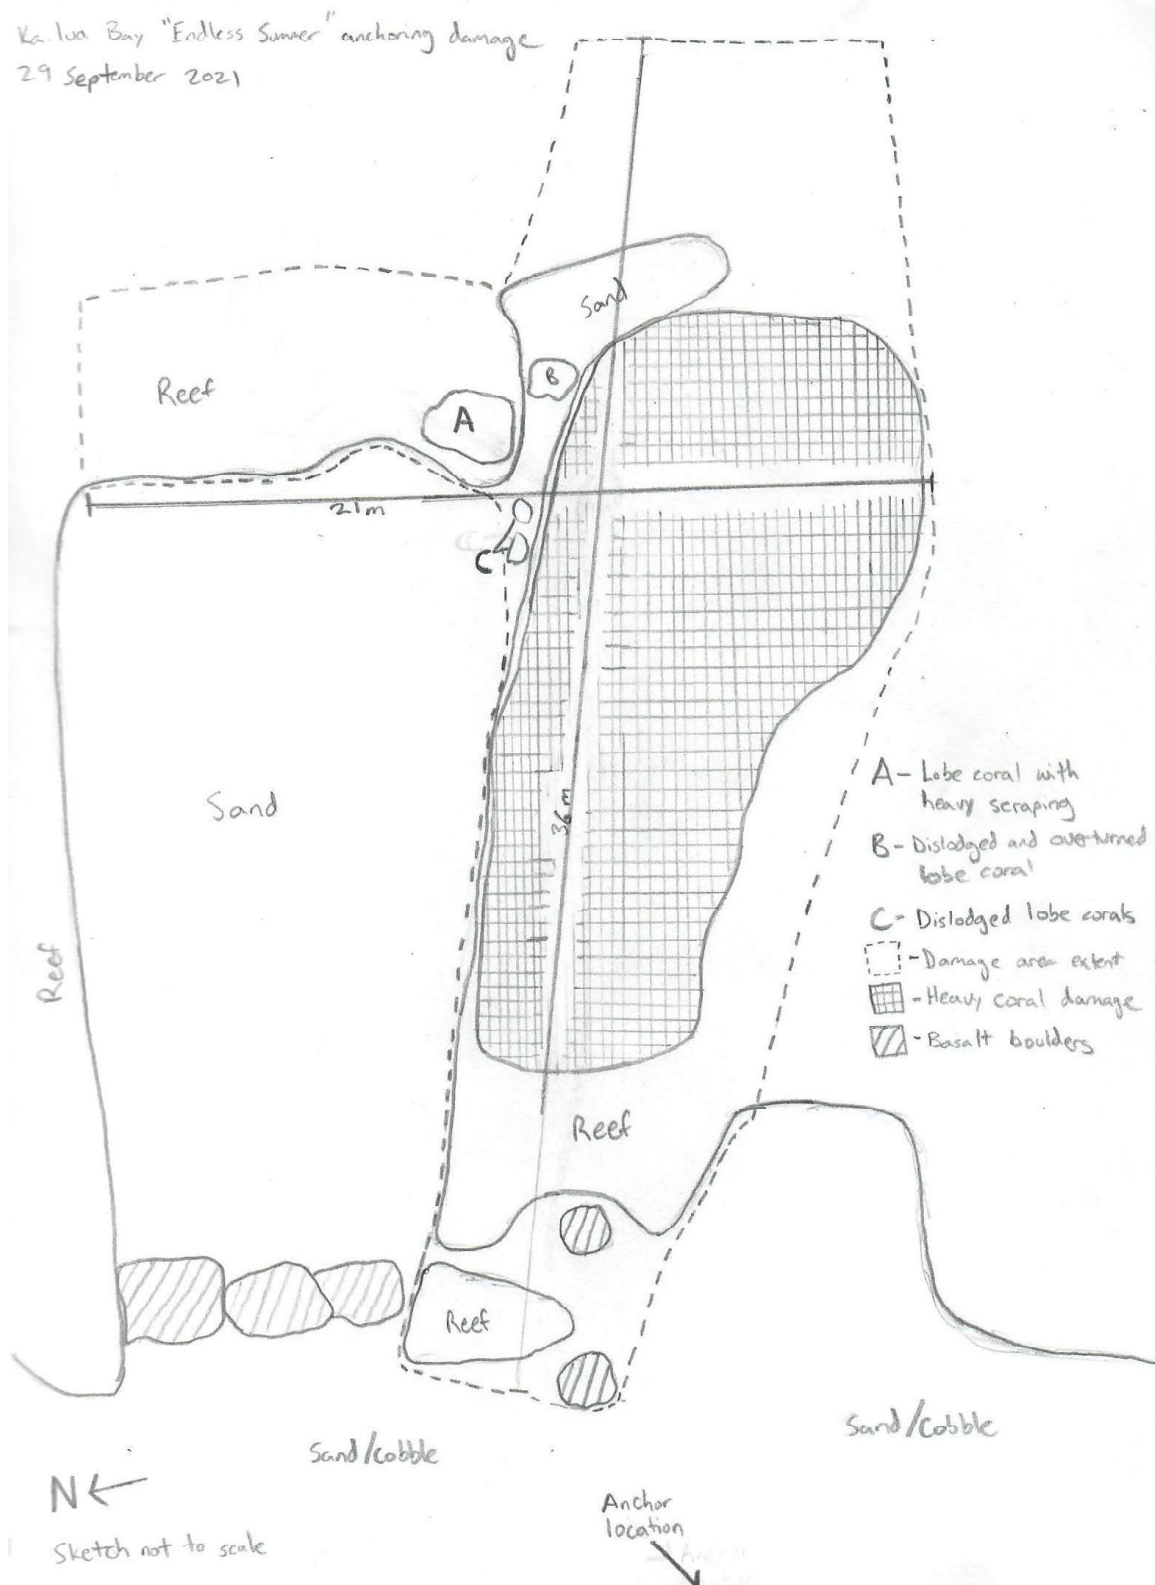
The reef in the damaged area contained a high level of live coral coverage. The dominant coral species were *Porites lobata* (lobe coral), *P. compressa* (finger coral), and *P. monticulosa* (plate-and-knob coral). Other species were also present, though at lower densities. The damage was spread over a broad swath of this reef with the majority concentrated along the reef bordering a sand patch. The affected area measured 36 meters at the longest axis and 21 meters at its widest. The heaviest level of damage was found at the center of the site, south of the sand patch (Figure 8).

Figure 8: Site overview sketch depicting the main reef areas, a large sand patch along the northern edge of the damage area, and a large area of particularly heavy coral damage at the center of the site.

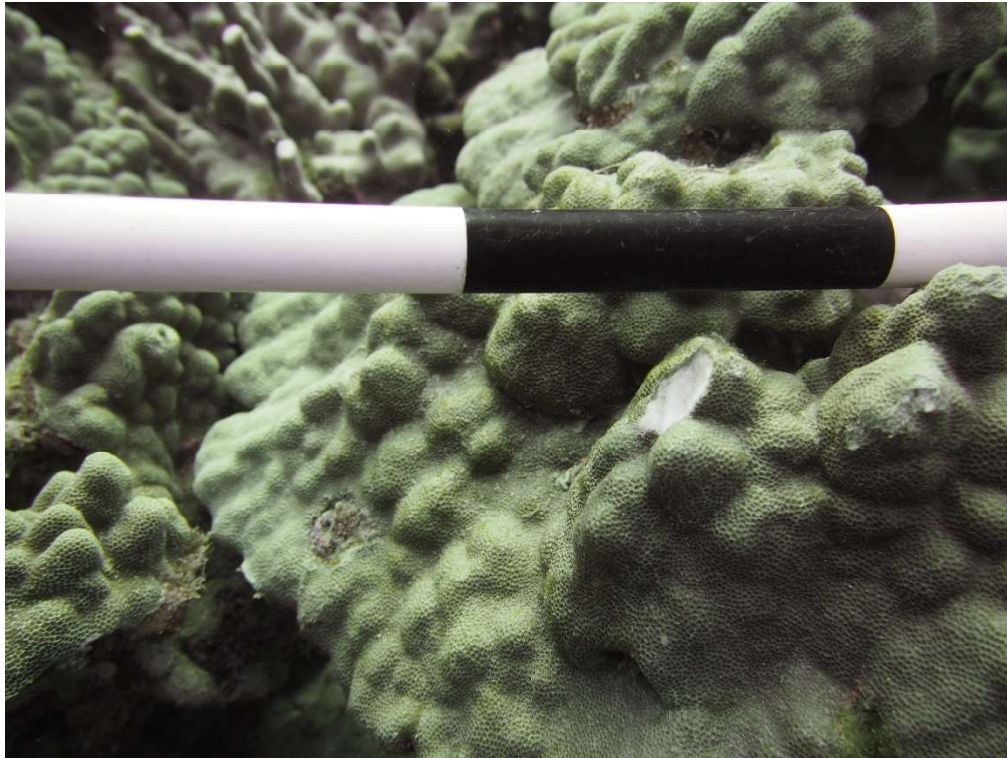
Figure 9: *P. lobata* colony showing a single point breakage indicated by the patch of white coral skeleton below the black portion of the scale bar. The black and white scale bar segments measure 10cm.

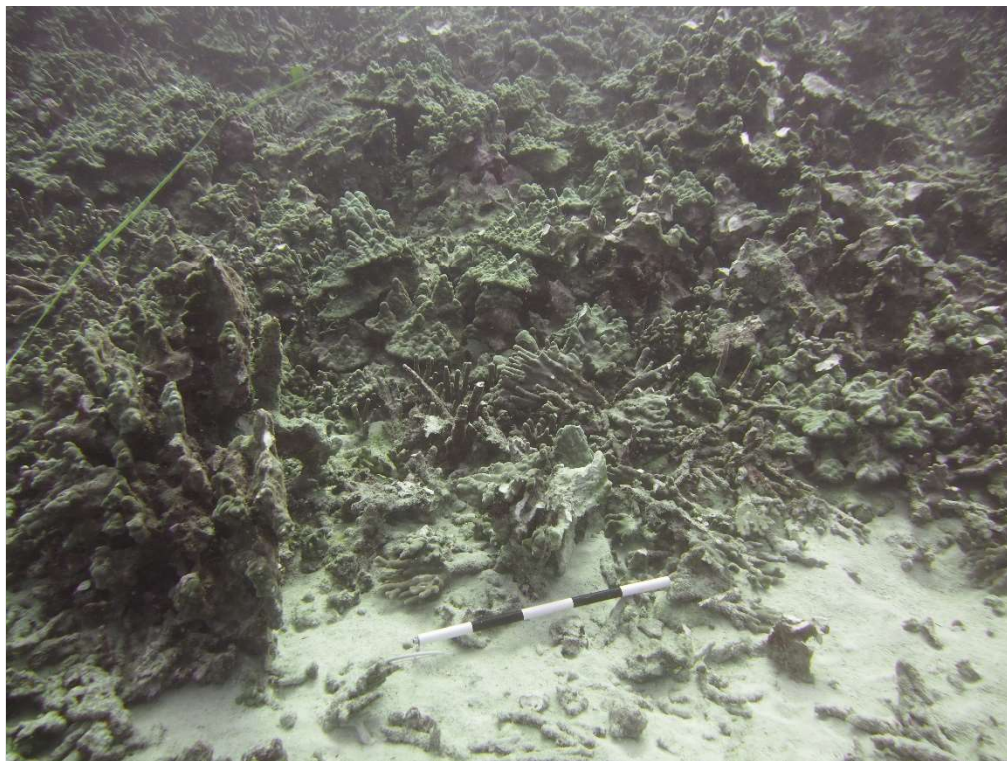
Figure 10: *P. compressa* colony with severe structural damage. Scale bar is 50cm long with 10cm increments.

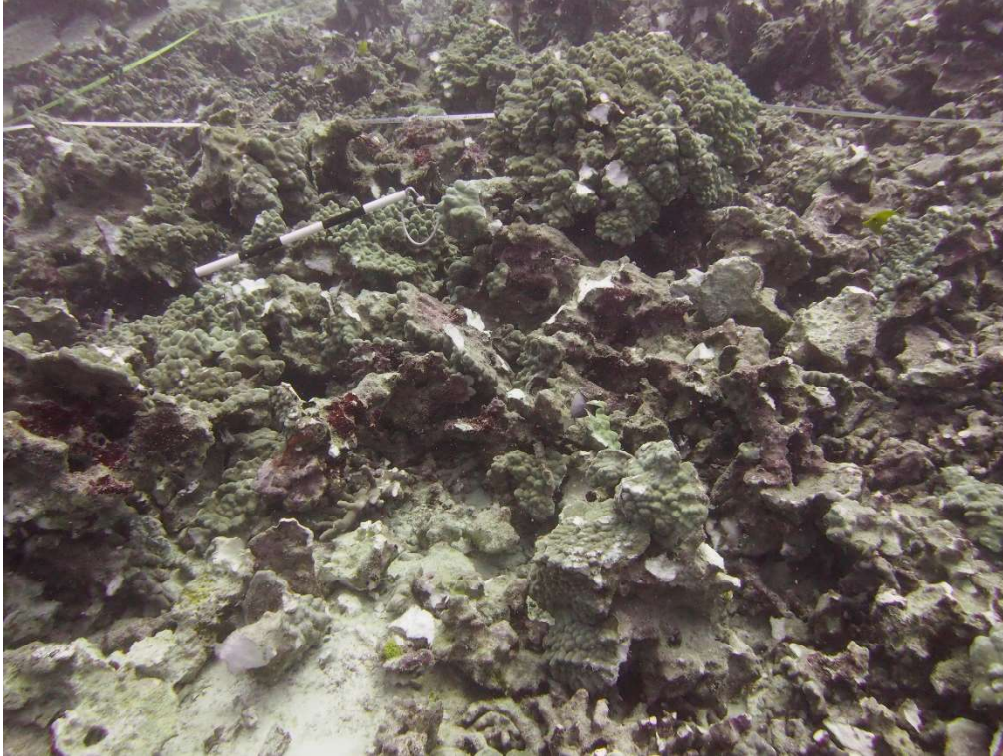
Figure 11: Cluster of numerous *P. lobata* colonies that were dislodged after a loop in the anchor chain cinched closed around them.

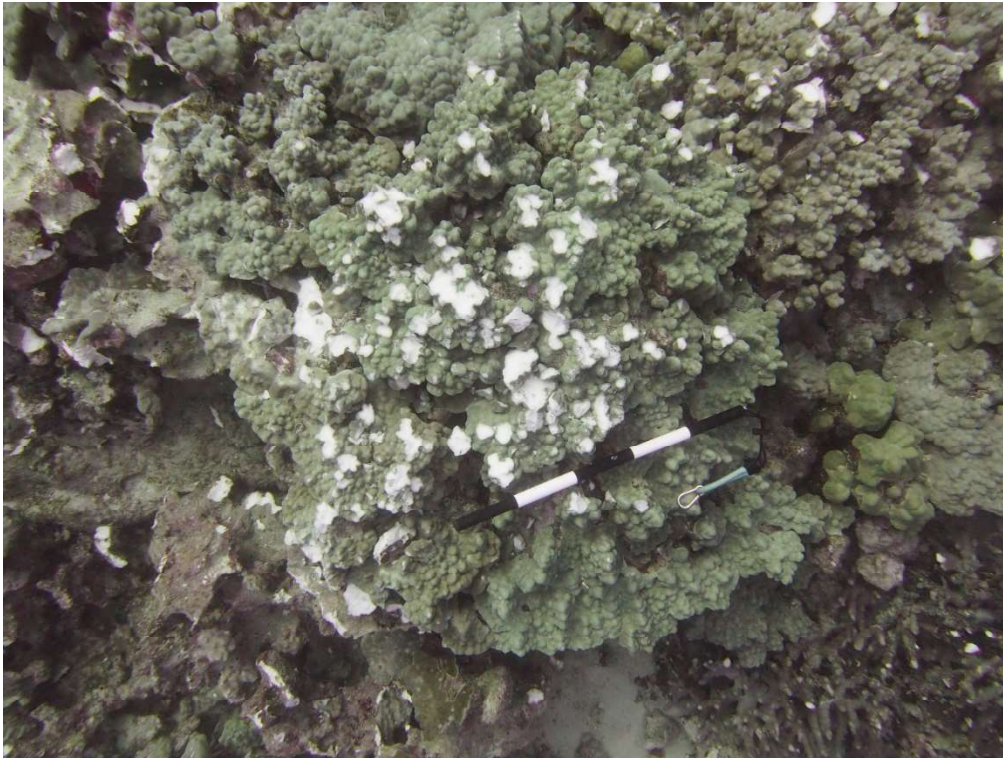
Figure 12: Large *P. lobata* colony that sustained structural damage and extensive abrasion due to the anchor chain "bobbing" up and down on the colony.

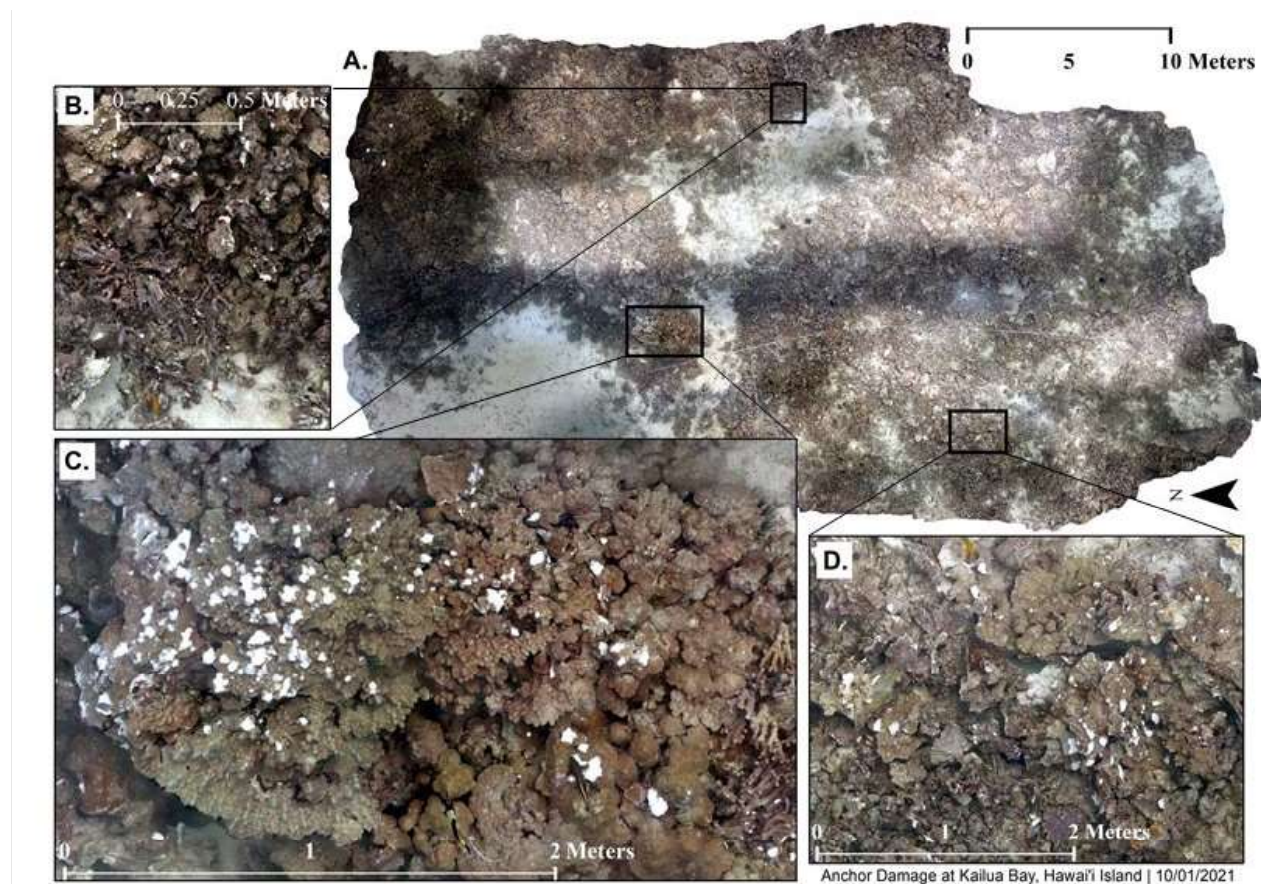
Figure 13: Photogrammetry model (orthomosaic image) of a portion of the overall anchor damage extent. Imagery for the model was taken on Oct. 1, 2021, one day after the anchor was removed from the reef. Orthomosaic imagery shows: A) an overall view of a large area of reef heavily damaged from the event, B) a close-up of broken *P. lobata* and *P. compressa* colonies, C) two large mounding coral colonies with severe abrasion from the anchor chain, and D) multiple large *P. lobata* colonies broken into loose fragments.

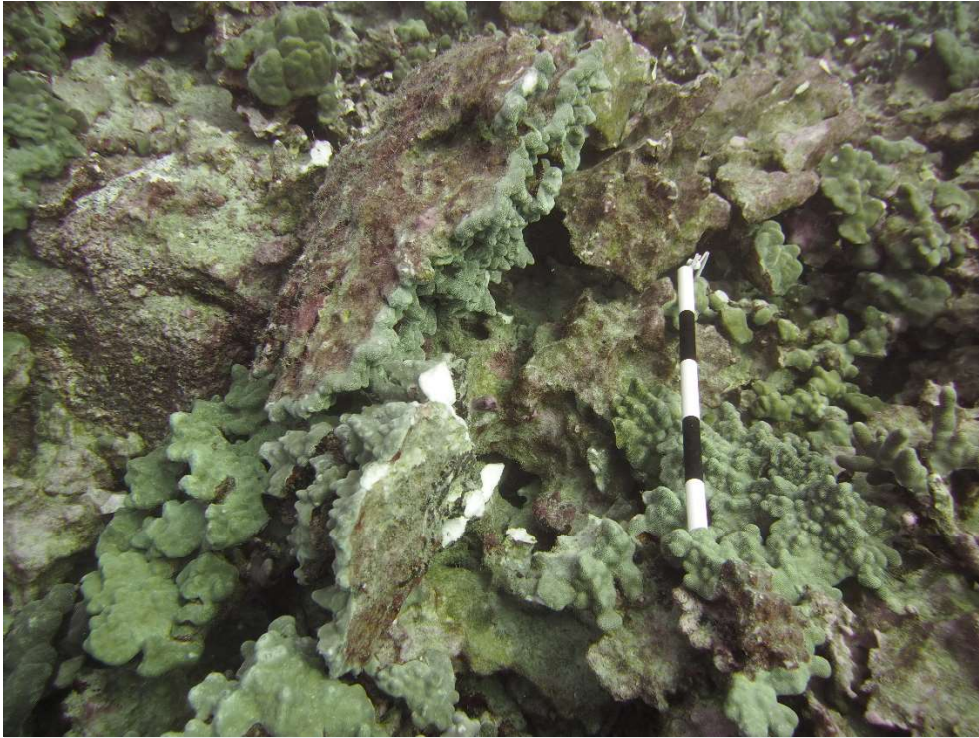
Figure A1: Several *P. lobata* colonies that were dislodged and overturned on the reef. Note the difference in the orientation of live tissue between separate colonies as well as the visible bright white skeletal material, both of which are indicative of recent damage.

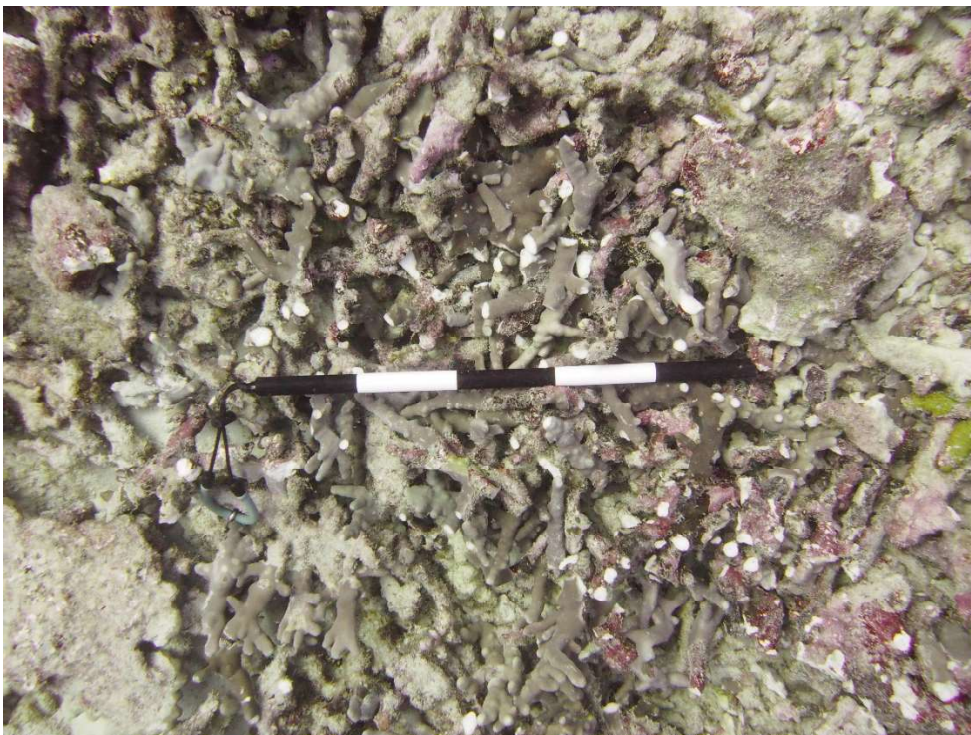
Figure A2: Patch of damaged *P. compressa* showing numerous individual broken "fingers".

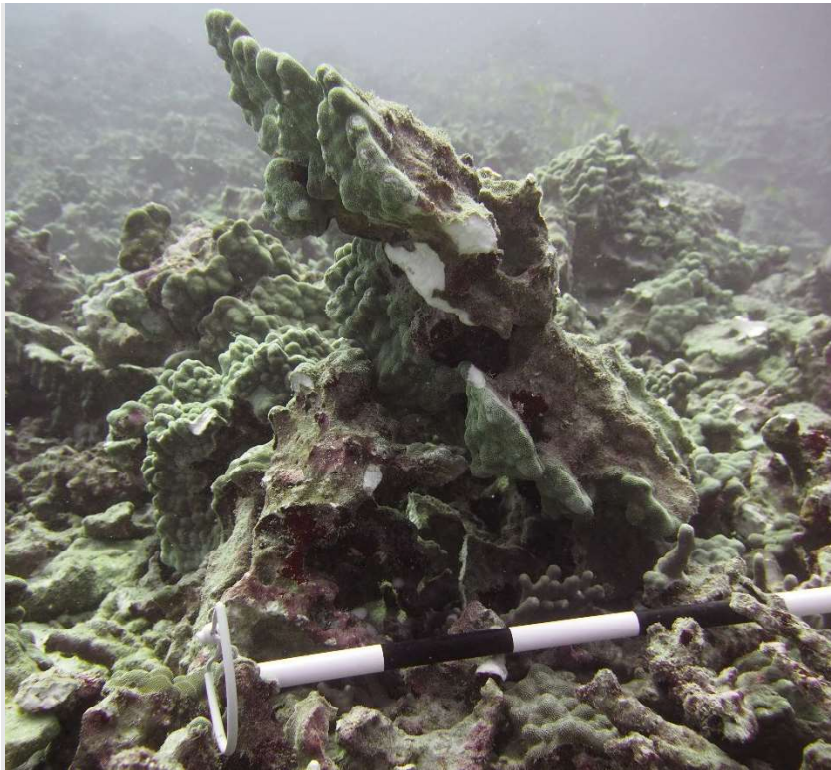
Figure A3: Overturned ~50cm *P. lobata* colony. Many of the broken colonies observed were between 20 and 80cm.

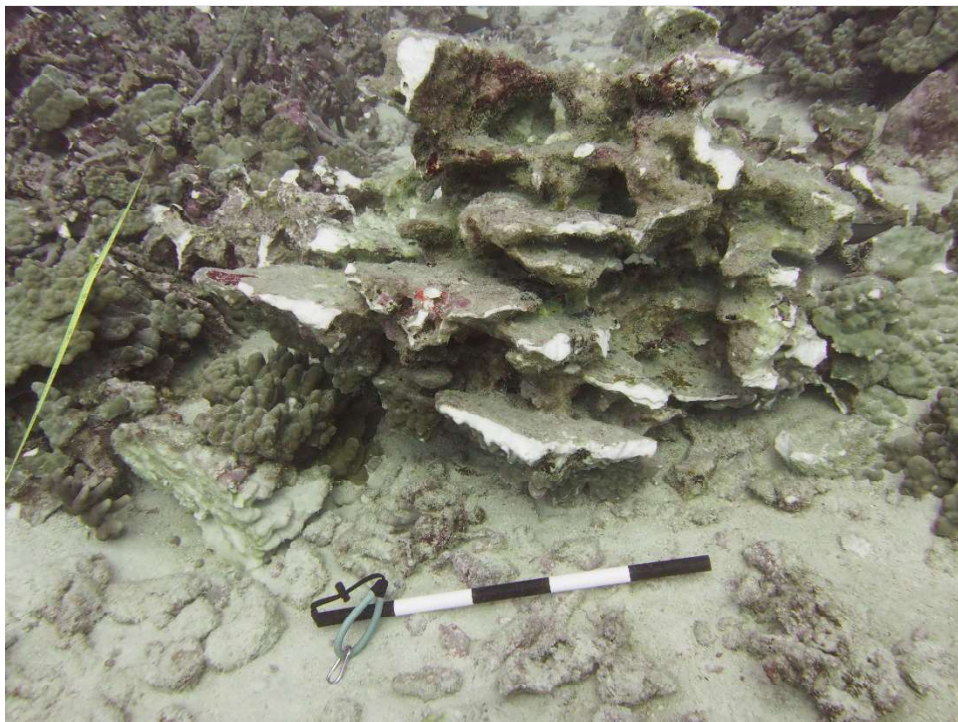
Figure A4: Large (>50cm) *P. lobata* colony that was dislodged and overturned in a small sand patch. Divers successfully righted this colony such that the live tissue was oriented upwards.

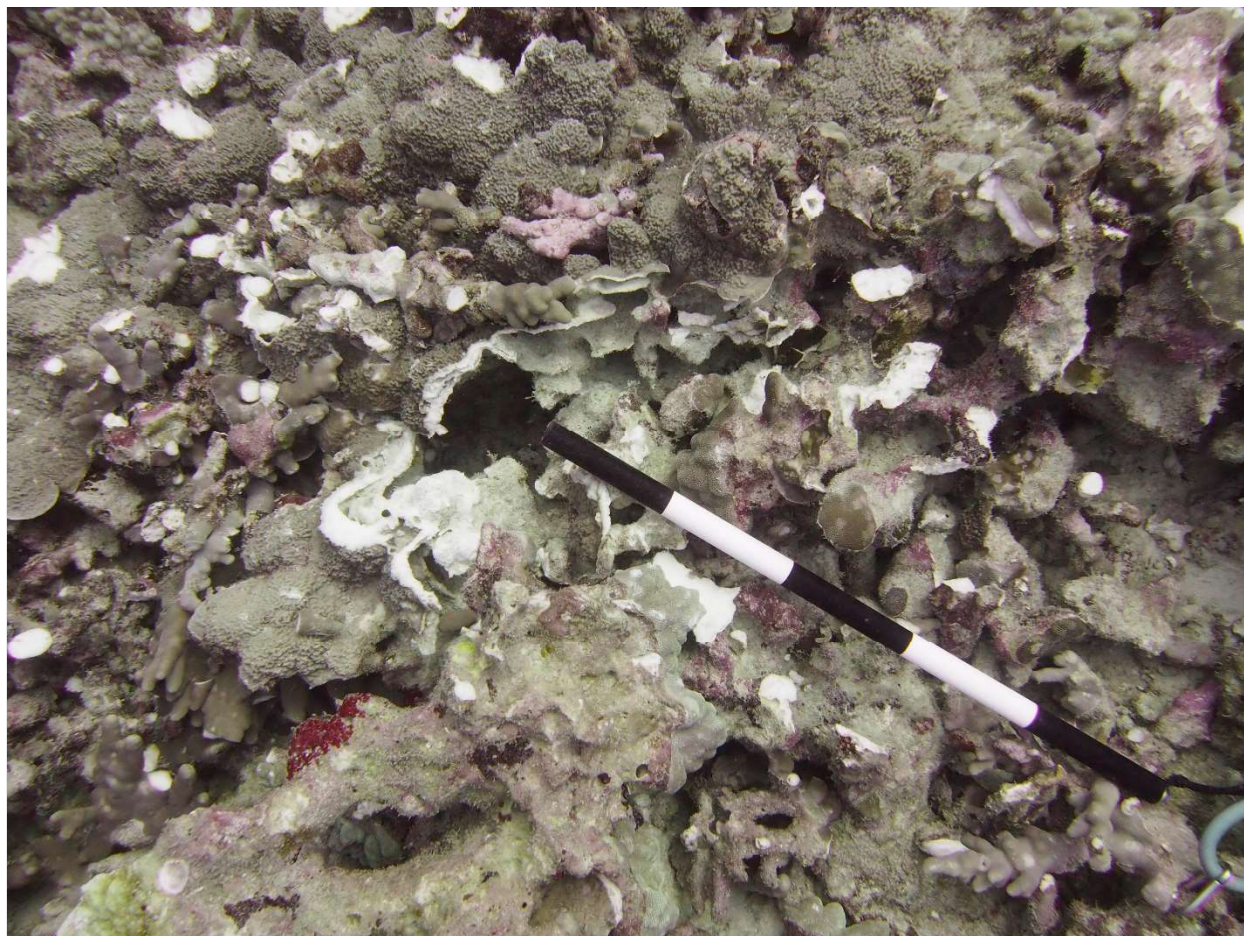
Figure A5: *Porites monticulosa* colony with multiple distinct breakages. This was one of two massive (>160cm) *P. monticulosa* colonies that sustained damage.
