State of Hawaii
DEPARTMENT OF LAND AND NATURAL RESOURCES
Engineering Division
Honolulu, Hawaii 96813

STAFF REPORT

Regarding: Dam Safety Enforcement Action on Puu O Hewa Dam (KA-0107) for Failure to Comply with Notice of Deficiency Issued November 2, 2022, and to make a finding of violations sufficient to support a specified fine on the owner, Eric A. Knudsen Trust.
Koloa, Kauai, Tax Map Keys (4) 2-7-002: 01

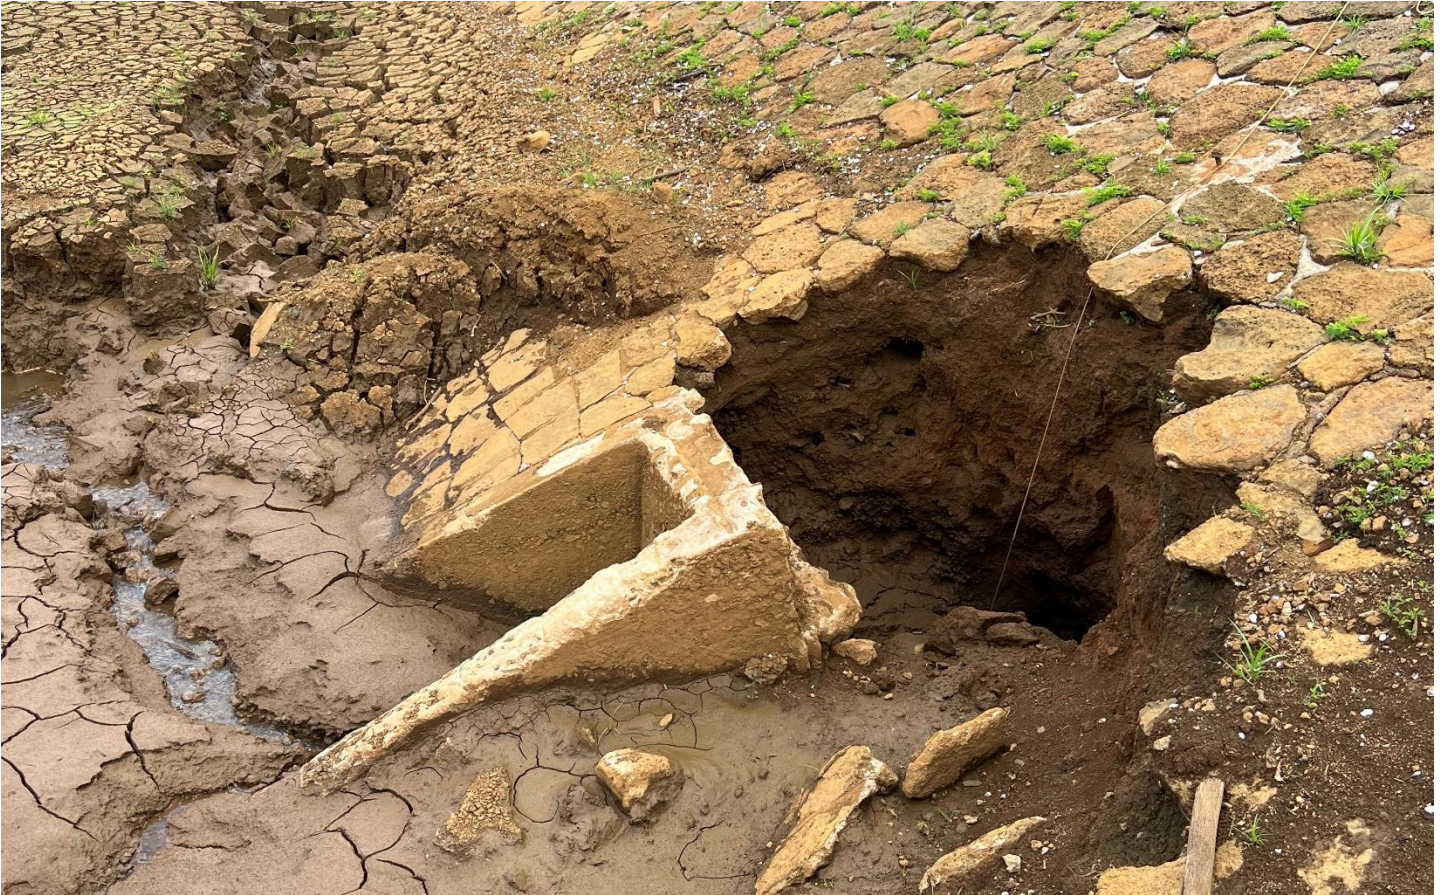
While there are other long standing safety issues for this dam (see Attachment A), the notice of deficiency (NOD) issued by the Department of Land and Natural Resources (Department) on November 2, 2022, was specifically meant to address a more urgent safety issue due to the outlet structure being compromised. Over time, the outlet had gotten blocked with silt, rocks, and other debris, preventing the release of water from the reservoir. This is a highly dangerous situation, because it means that there is no way to control the water level in the reservoir which could result in the potential overtopping and failure of the dam in a large storm event. When the NOD was issued, the operator and lessee at the time was Green Energy, and in an attempt to clear the outlet, they excavated a large area over the outlet intake. (See Figure 2). While they succeeded in removing a large boulder that was blocking the outlet, allowing some water to pass through, the current condition of the outlet remains of high concern because the outlet capacity is limited due to the extensive silt blockage (See Figure 3). Additionally, the sinkhole / dugout area right above and behind the original outlet intake (and the condition of the outlet pipe) are risk factors for leakage/preferential flow outside the outlet pipe, increasing the risk of failure of the dam.

Figure 2 (above) shows the excavation around outlet intake and the lack of protection from internal erosion

As discussed in the emails listed above, based on the inspection on 9/7/2022, the condition of the outlet is of high concern because the outlet capacity is limited due to the silt blockage. Additionally, the sinkhole / dugout area right above and behind the original outlet intake (and the condition of the outlet pipe) are risk factors for leakage/preferential flow outside the outlet pipe, increasing risk of failure of the dam.

3. **By 1/27/2023:** Send the Department a set of plans approved by a licensed Engineer to address the emergency remediation of the outlet and sinkhole. This can be a full permit package with notation describing which portions of work will be done as emergency work (i.e. before the permit is acquired), or a limited package addressing only the emergency portion of the work. A proposed schedule of work should be included with the plans.

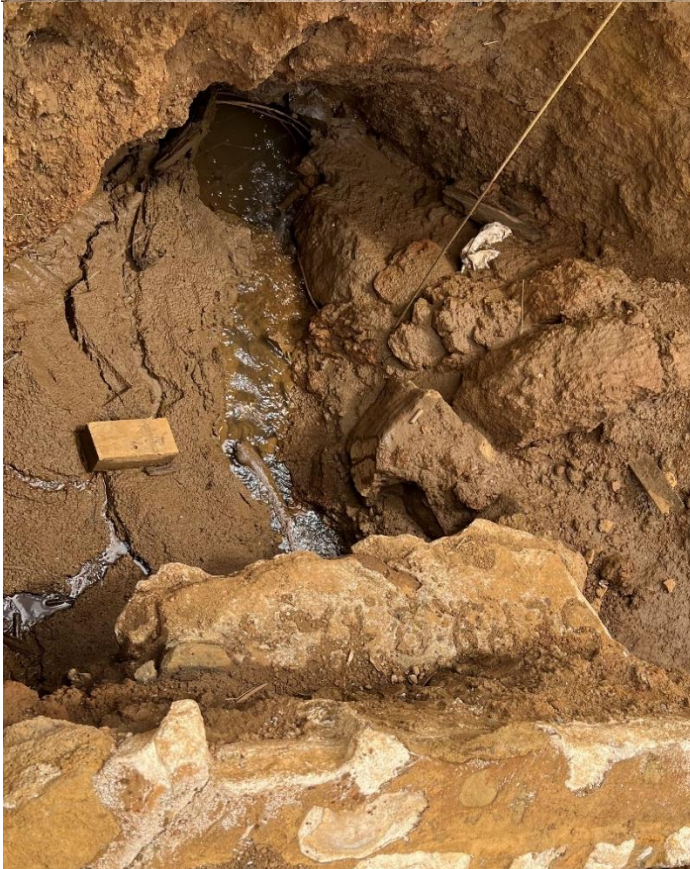
Figure 3 (left) shows the level of siltation in the outlet channel, significantly decreasing the flow through the outlet
