STATE OF HAWAII  
DEPARTMENT OF LAND AND NATURAL RESOURCES  
Division of Aquatic Resources  
Honolulu, Hawaii 96813

**Subject:** Enforcement action against Kapalua Kai Sailing, Inc. for stony coral and live rock damage resulting from the *Hula Girl* grounding incident on January 31, 2025, inside the Honolua-Mokulē‘ia Bay Marine Life Conservation District, island of Maui.

EXHIBIT C –  
HULA GIRL GROUNDING –  
DAMAGE ASSESSMENT  
FINAL REPORT

# **Hula Girl Grounding Honolua Bay MLCD, Maui Damage Assessment**

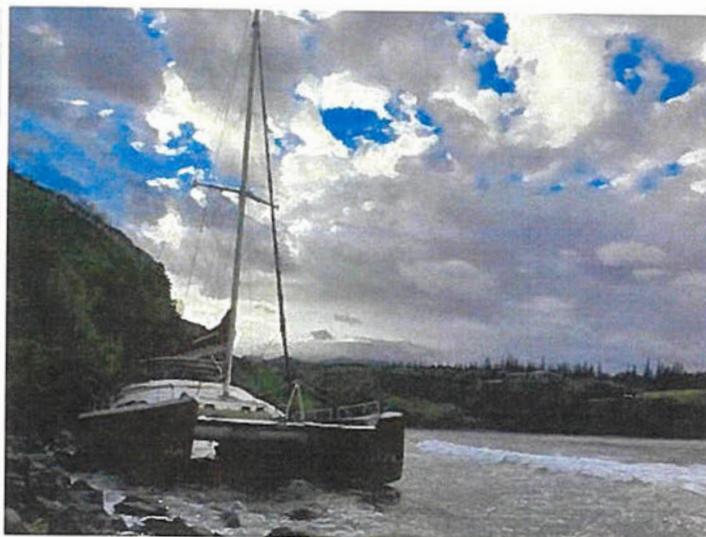
3 Photo depicts said vessel grounded on shore.

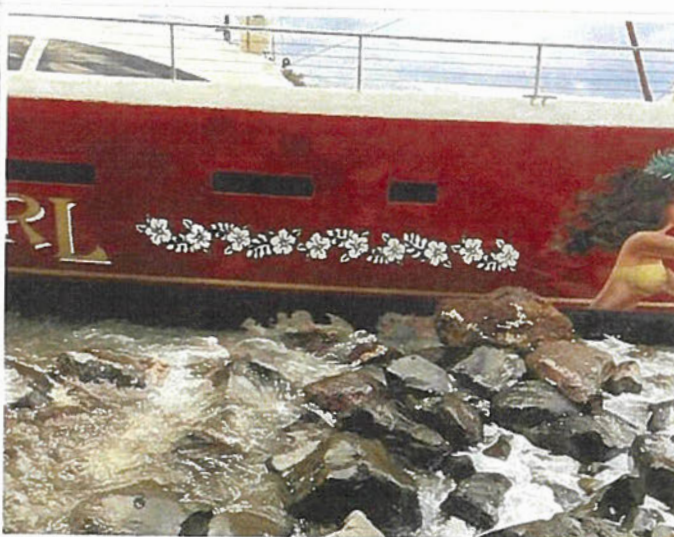
4 Photo depicts damage to said vessels Starboard Hull.

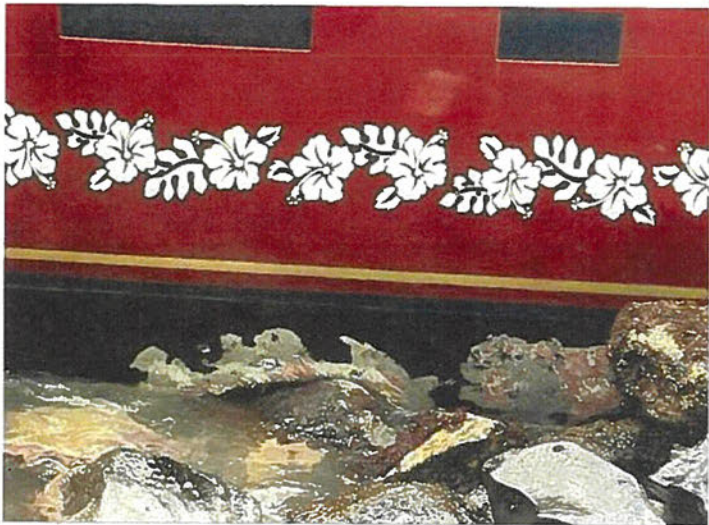
5 Photo depicts damage to said vessels Starboard Hull.

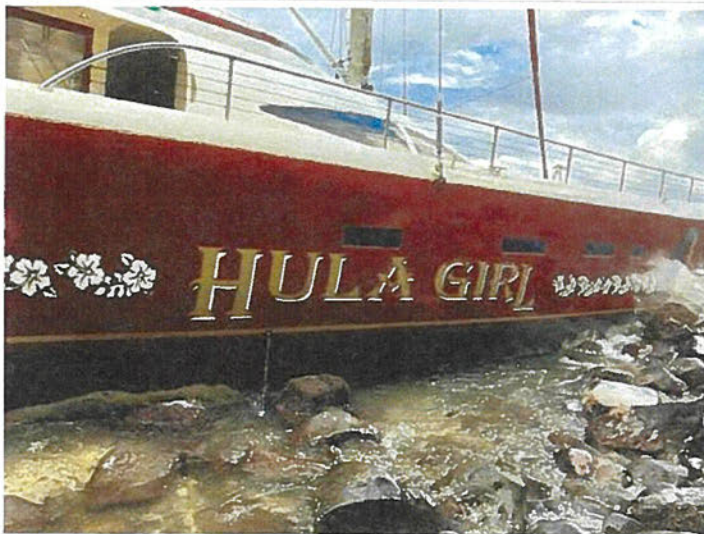
7 Photo Depicts damage to said vessels Starboard Hull.

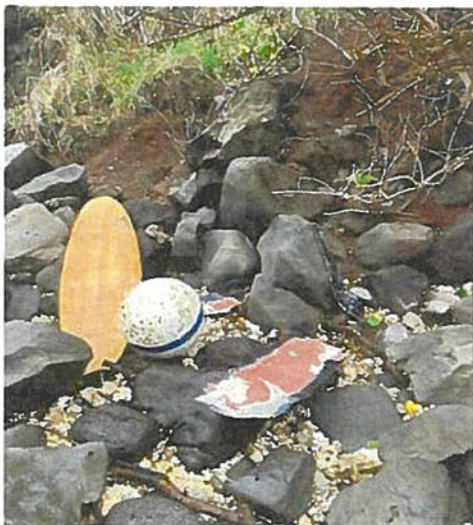
**11** Photo depicts debris on shore including Honolua Bay mooring ball and parts of said vessels Starboard Hull.

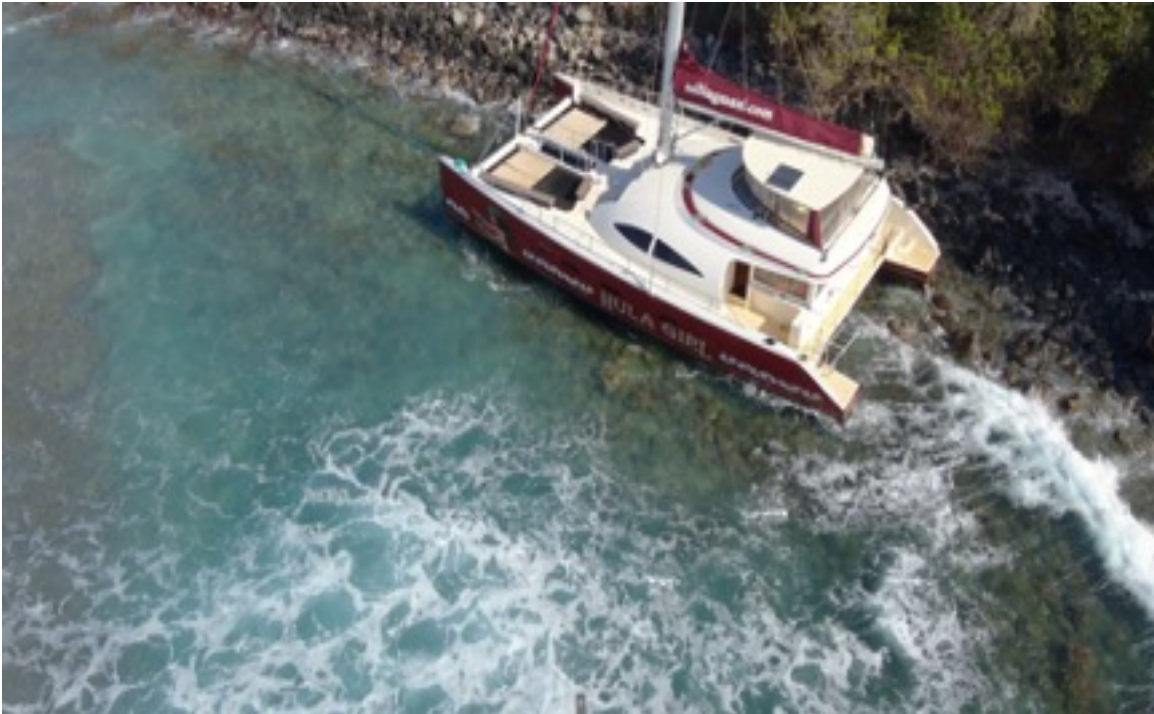
**The Vessel “Hula Girl” shown grounded on the rocky shoreline within the Honolua Bay Marine Life Conservation District (MLCD).**

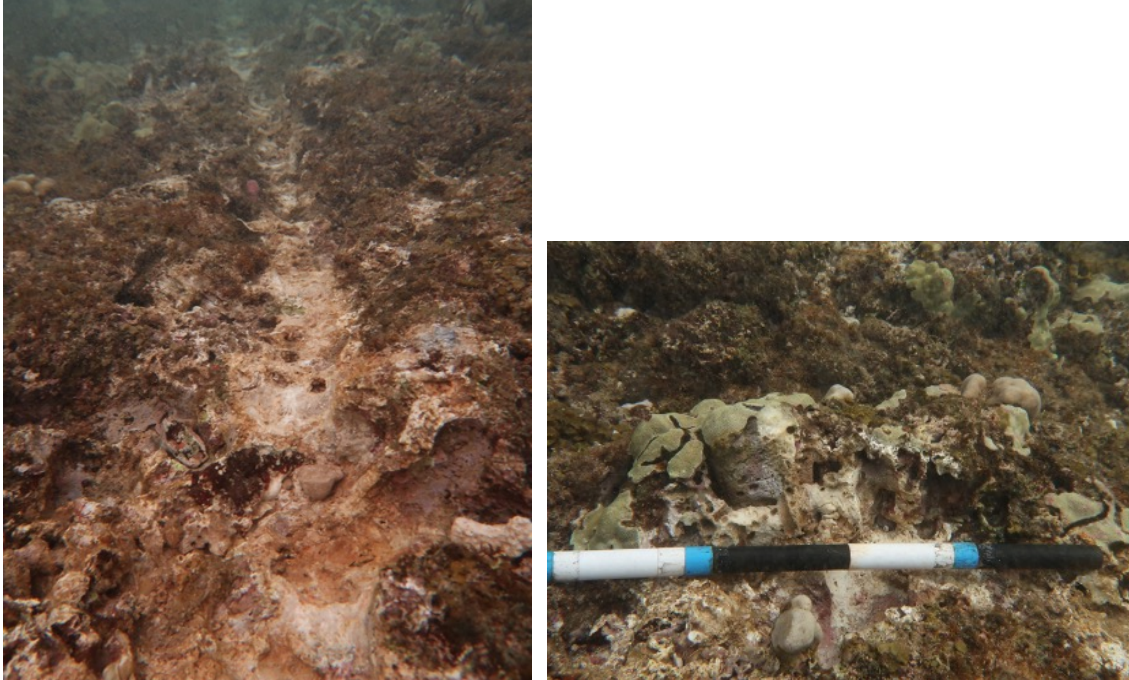
**Examples of damage to live rock habitat and corals from the salvage operation.**

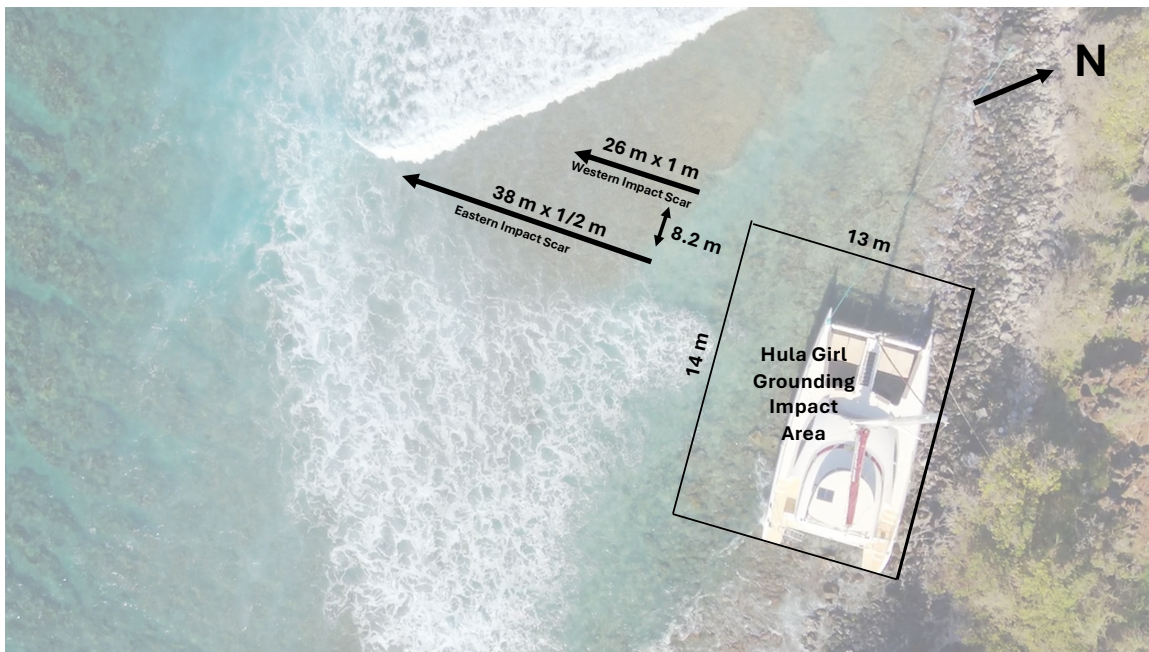
**Figure 1: Detailed map of the impacted area. The map shows the Initial Grounding impact area, and the two salvage scars.**

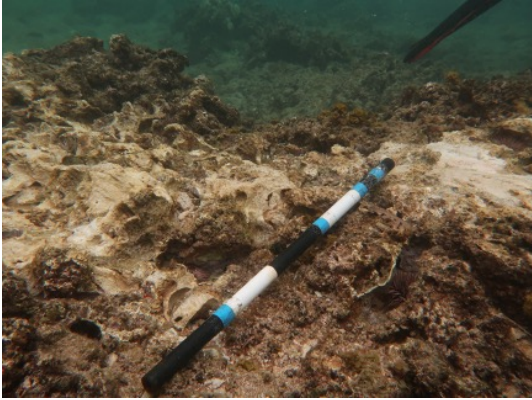
patchy and mostly limited to scraps on basalt boulders and some smashed carbonate hard bottom. In this area, we documented specific impacted areas, and these measured out to a total of 3 square meters of damage to carbonate hard bottom with turf algae on it. We also documented a total of five dislodged or otherwise damaged live coral colonies (4 - *Porities lobata* and 1 - *Pocillopora meandrina*) (Figures 2 – 4).

**Figure 2: Damaged calcified pavement with turf algae habitat in the deeper water Next to the grounding site.**

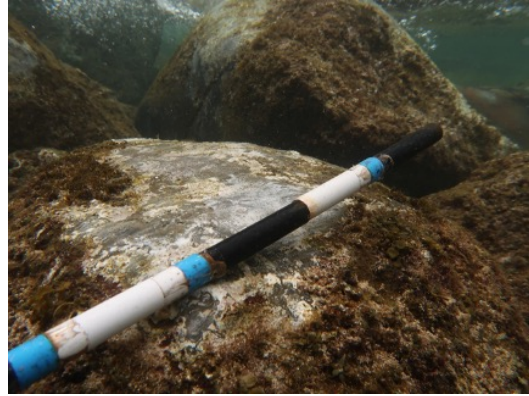
**Figure 3: Scraped boulder habitat where the the Hula Girl was grounded.**

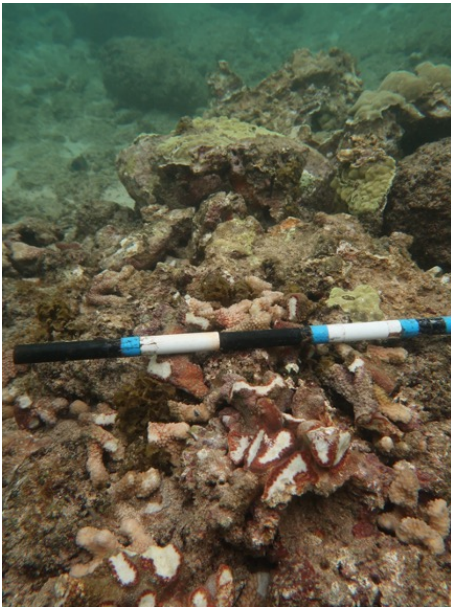
**Figure 4: Damaged *P. lobata* and *P. meandrina* in the deeper water Immediately next to the grounding site.**

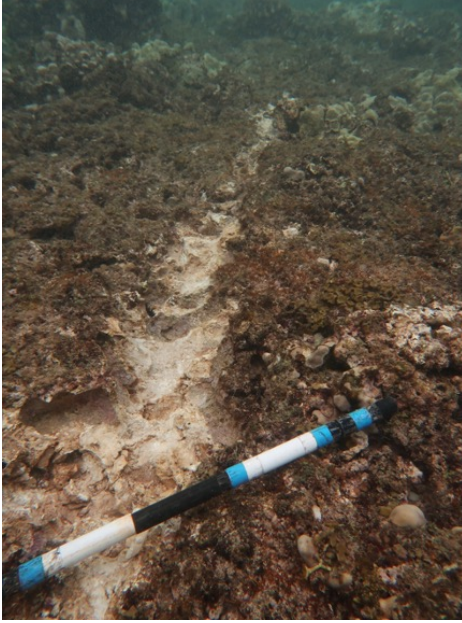
The final removal of the Hula Girl occurred on Friday, March 14, 2025. This salvage operation pulled the vessel out over a section of very shallow carbonate pavement habitat covered with macro algae (composed mostly of the brown algae *Turbinaria ornate*). The two hulls of the vessel were dragged over this very shallow habitat resulting in two parallel impact scars that were very distinct and separated by 8.2 meters. The scar on the eastern side was 38 meters long by approximately  $\frac{1}{2}$  meter wide (19 square meters) and the western side scar measured out at 26 meters long by approximately 1 meter wide (26 square meters) (Figure 5). In addition to the damage to live rock, there were some live corals damaged or dislodged from this habitat as well. We located and documented a total of 31 impacted coral colonies damaged in and/or around these two impact scars (20 - *Pocillopora meandrina*, 9 - *Porities lobata*, and 2 - *Pavona duerdeni*) (Figure 6).

**Figure 5: A section of the eastern salvage scar on the flat pavement habitat covered with macro algae (*T. ornate*).**

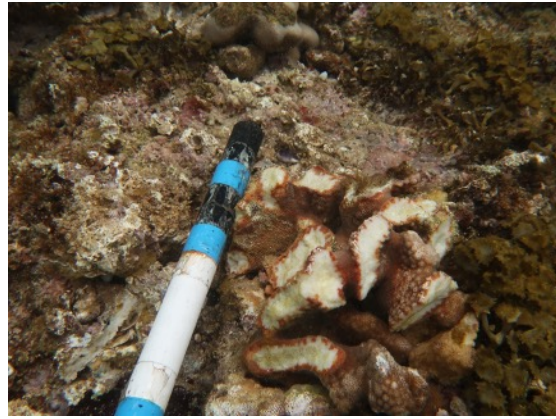
**Figure 6: An example of a damaged coral colony (*P. Meandrina*).**
