Tantalus-Round Top Drive Corridor Management Plan

Honolulu Ahupua'a, O'ahu, Hawai'i

Prepared By:
Planning Solutions, Inc.

December 2019

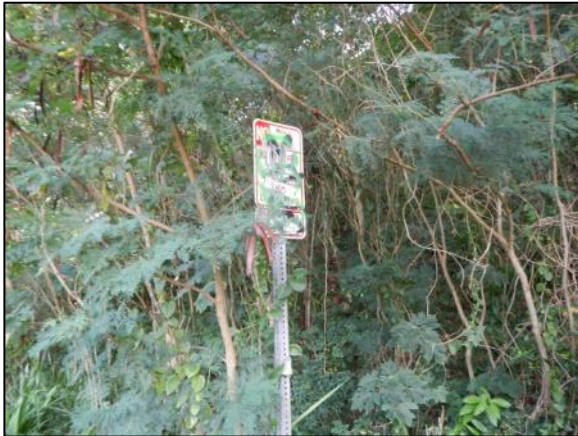
Sign obscured by vegetation and graffiti.

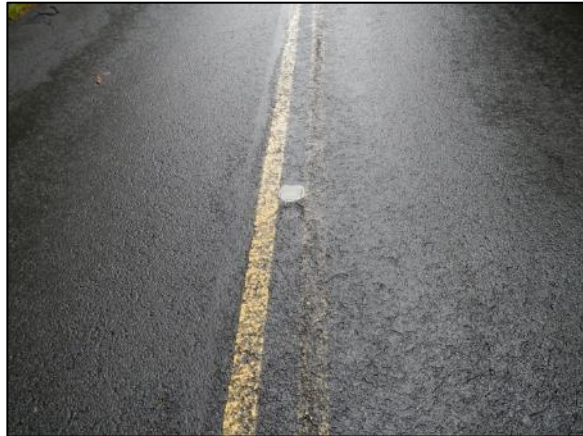
Reflector missing from roadway centerline.

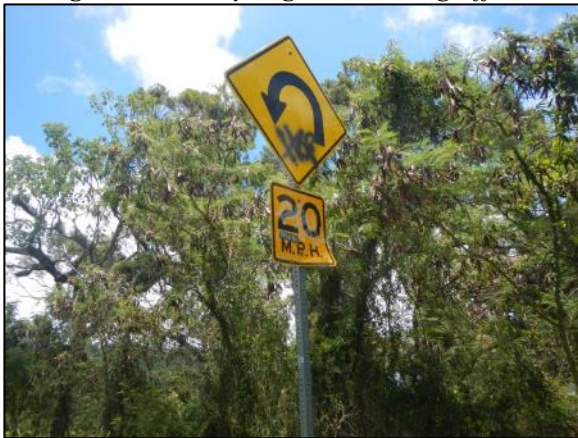
Sign defaced by graffiti.

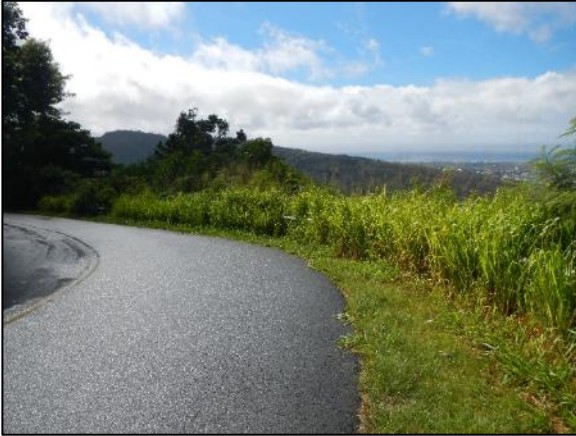
Tall grass has completely obscured the guardrail.

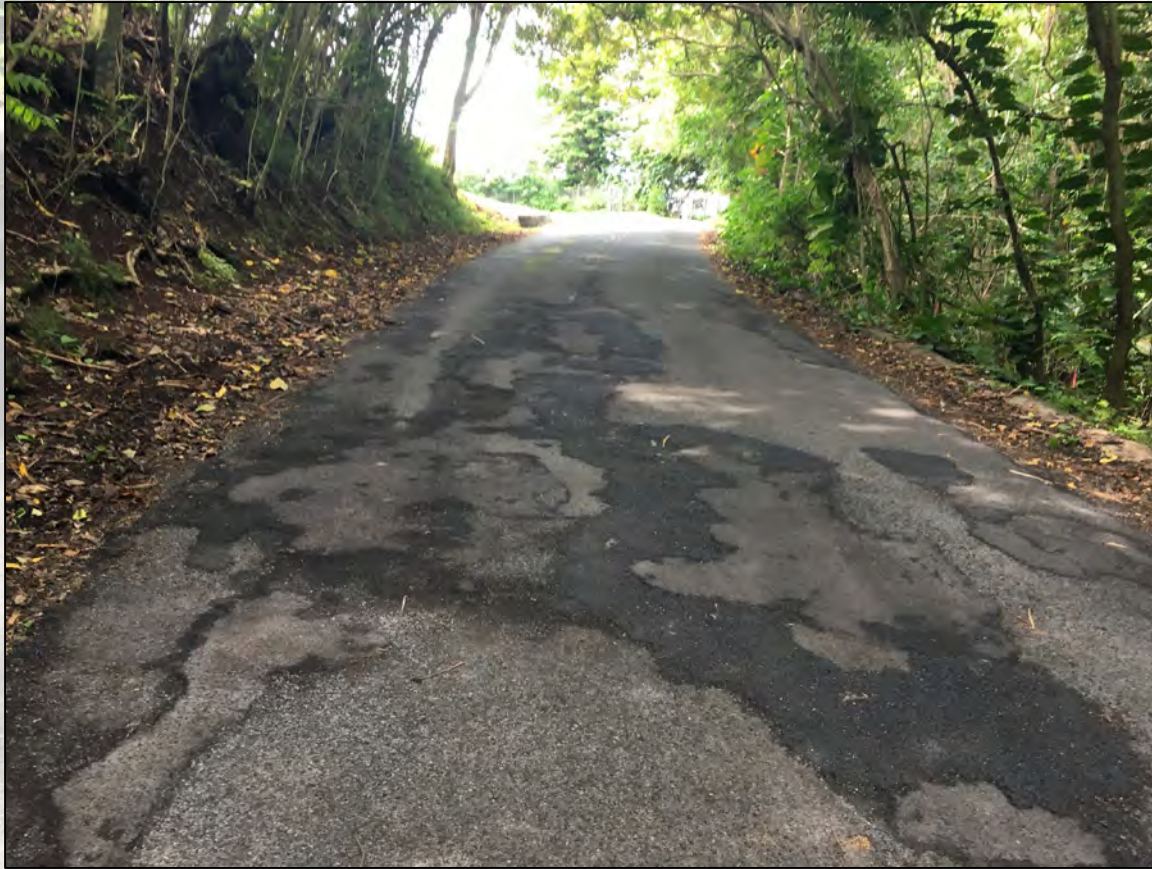
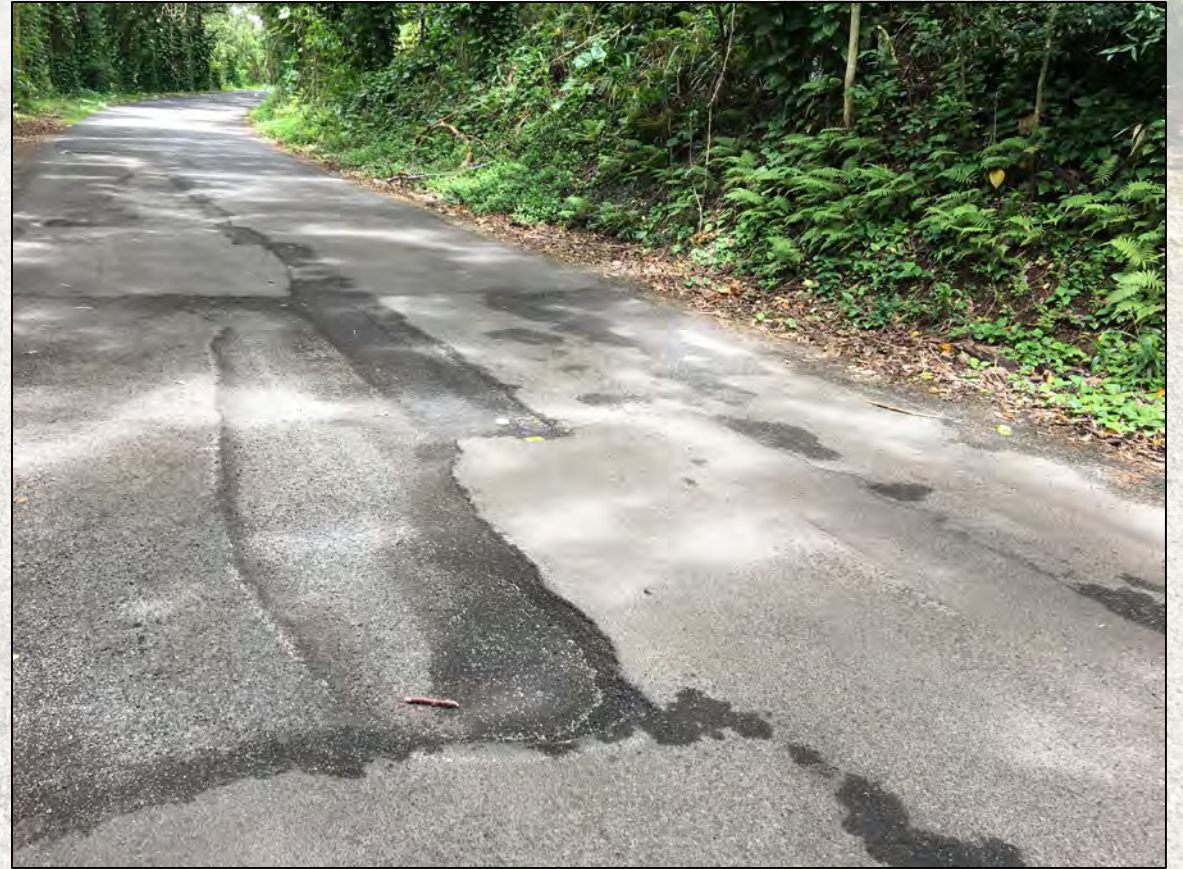
Systematic Breakdown of the Road Surface

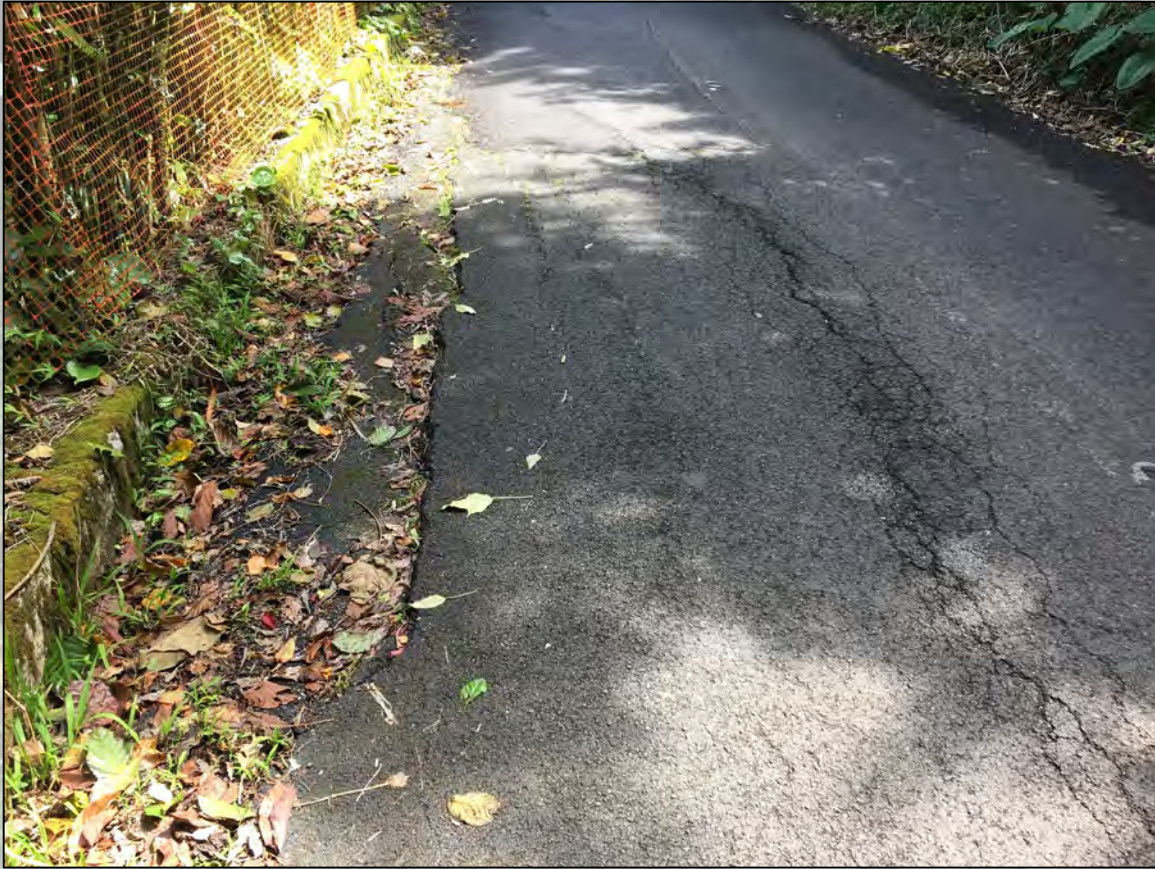
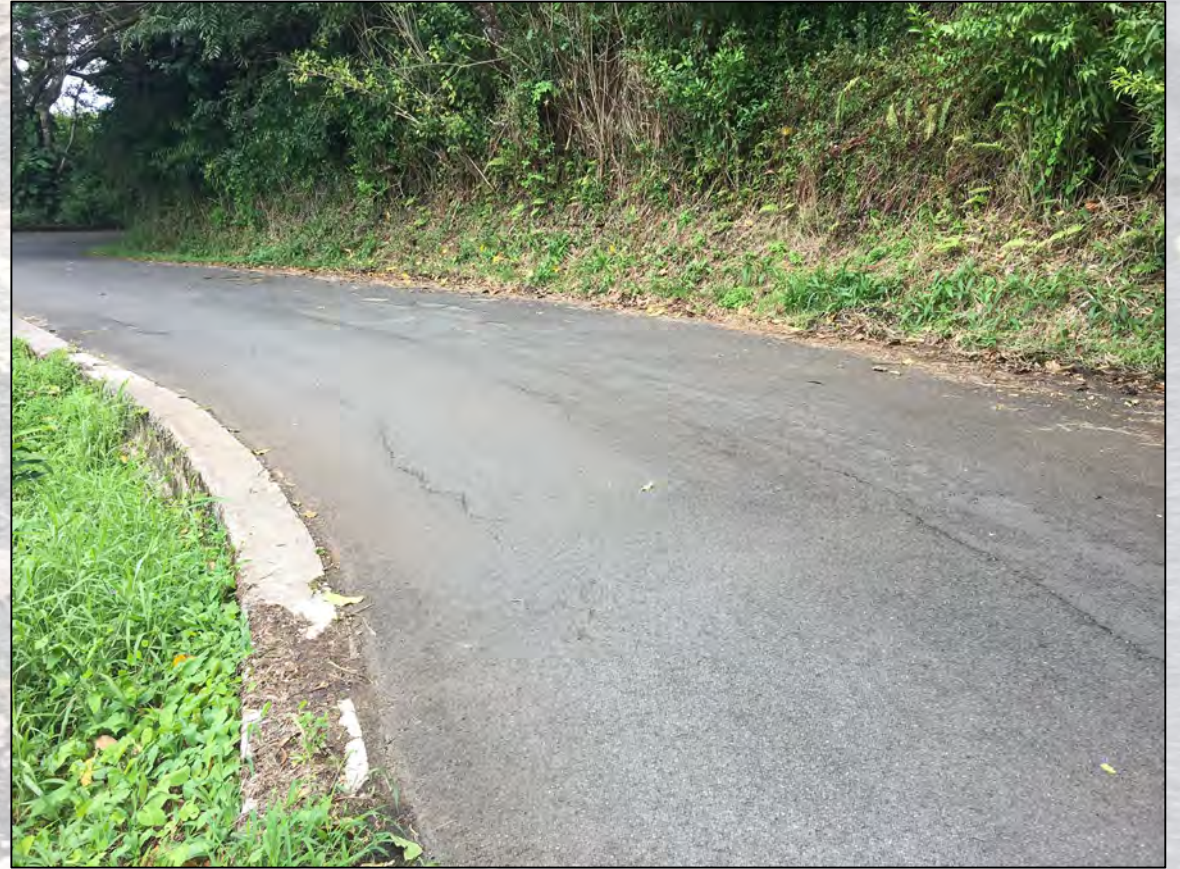
Erosion and Subsidence Beneath the Roadway

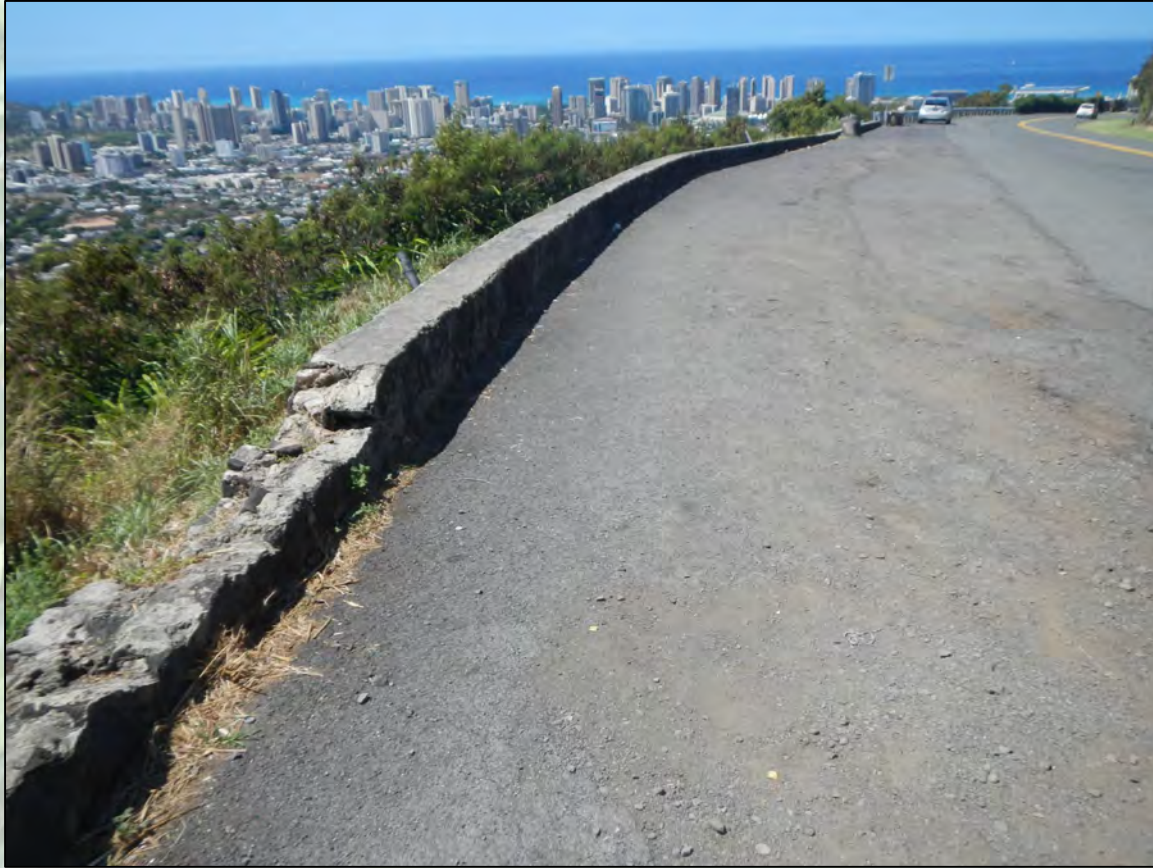
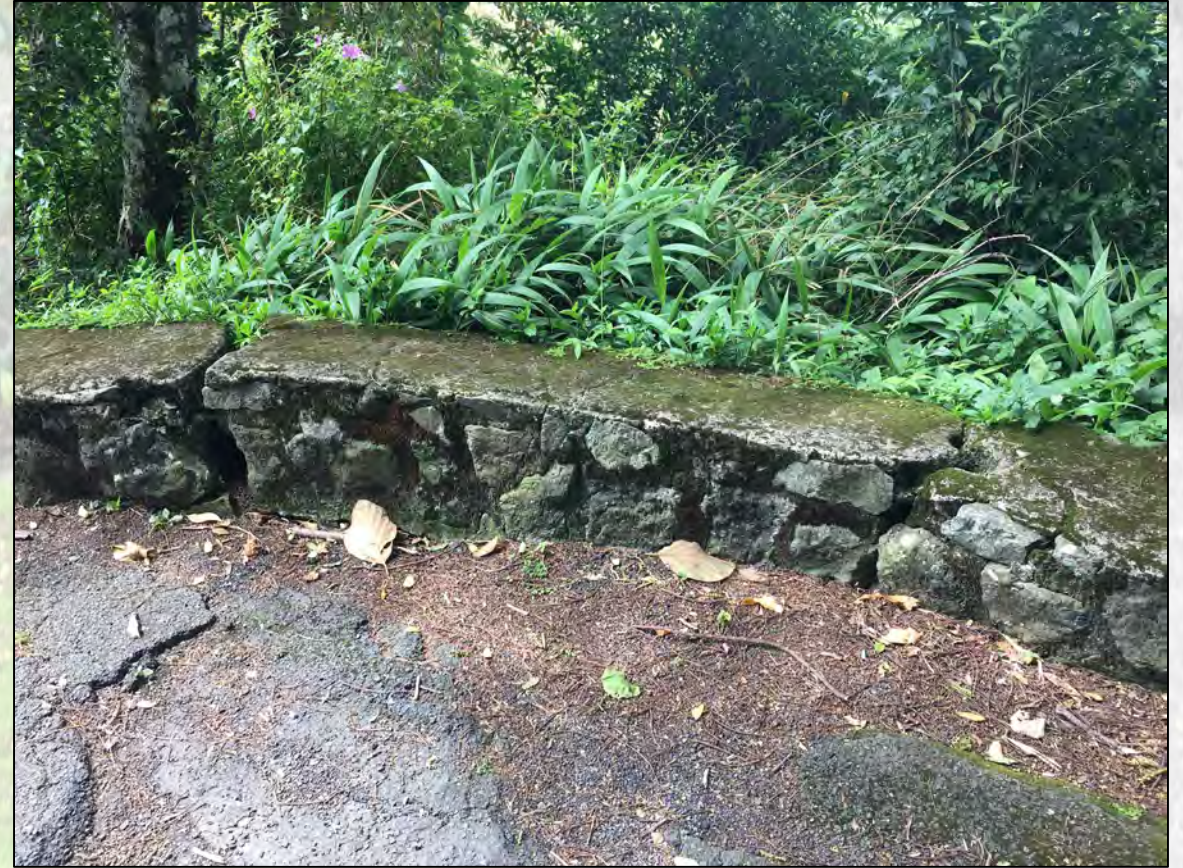
Deterioration of Retaining Walls

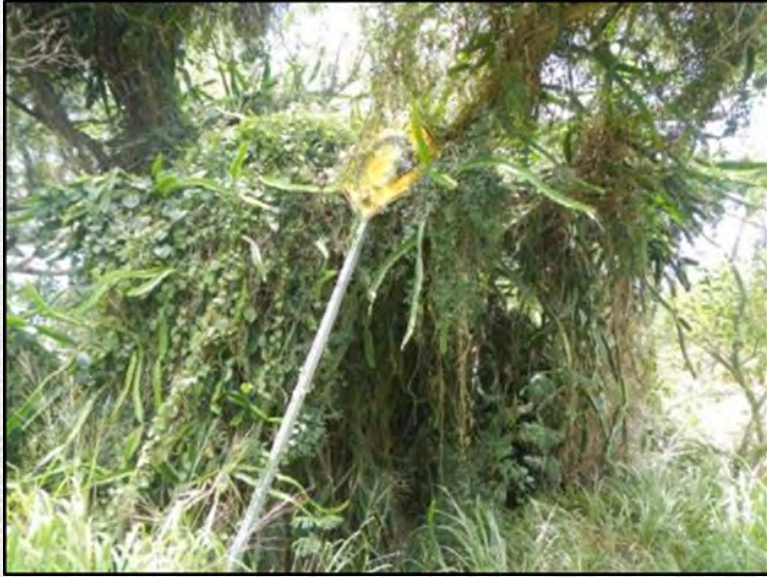
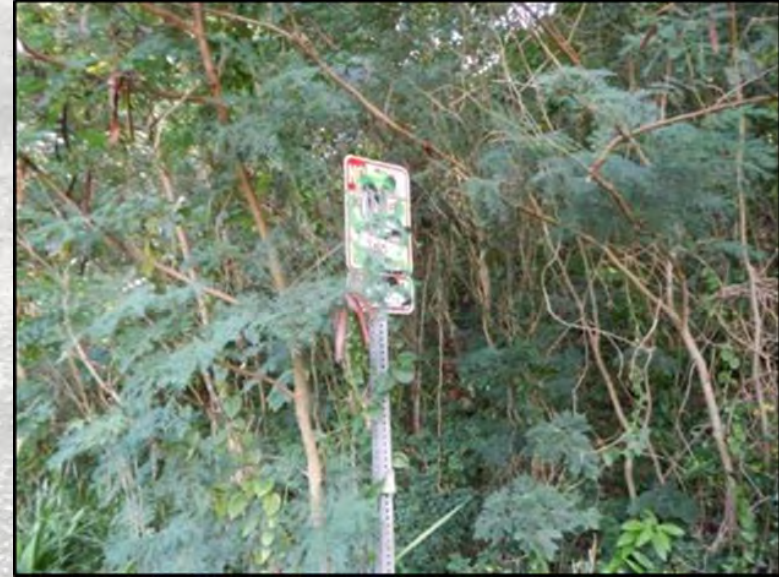
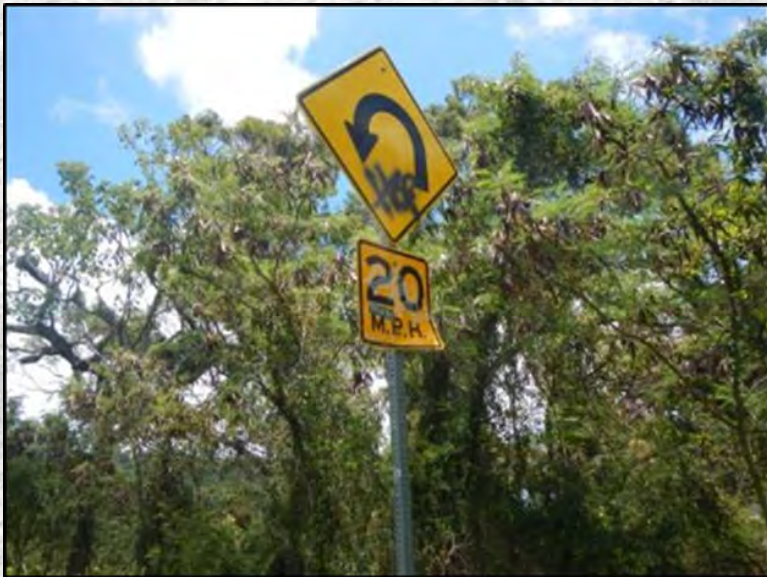
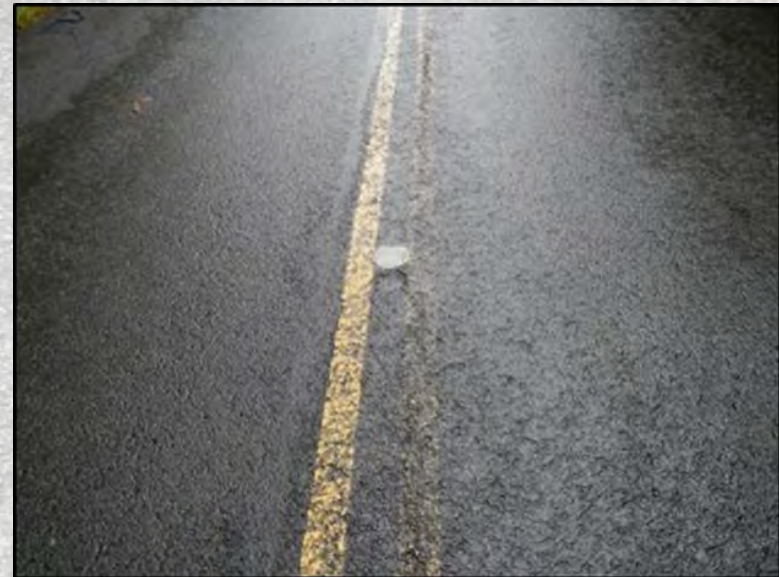
Signage, Striping, & Reflector Issues

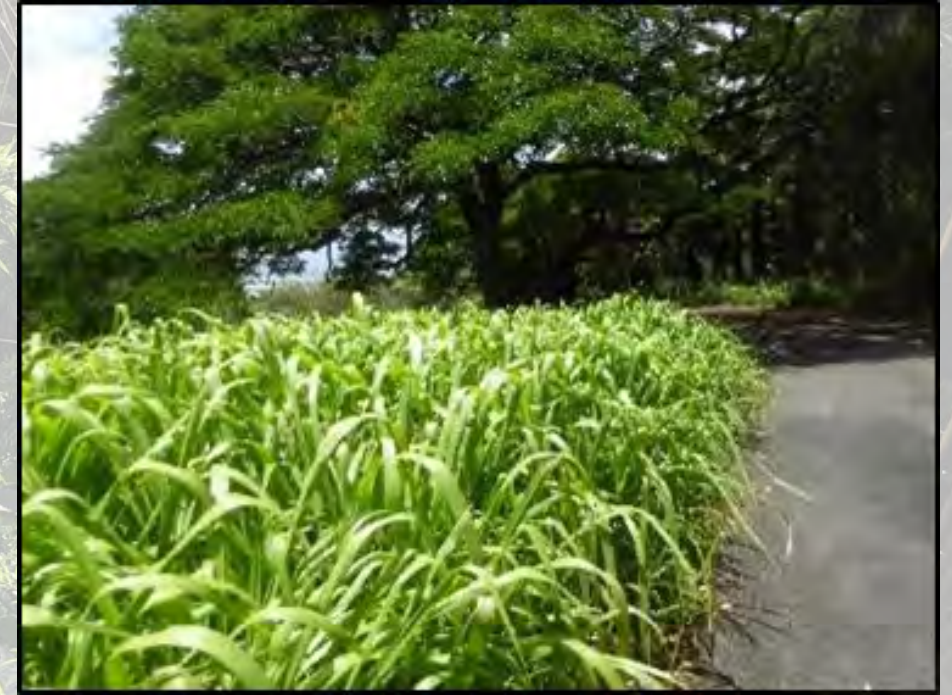
**Overhanging Vegetation Restricting
Vertical Clearance**

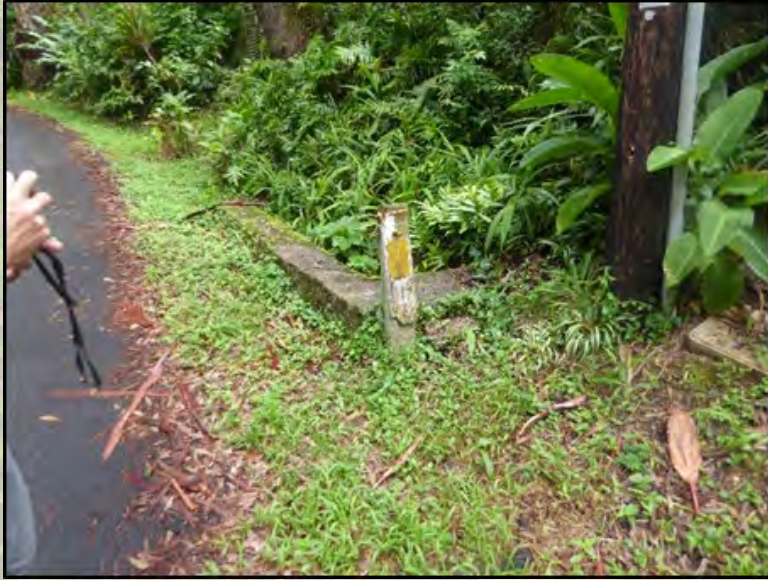
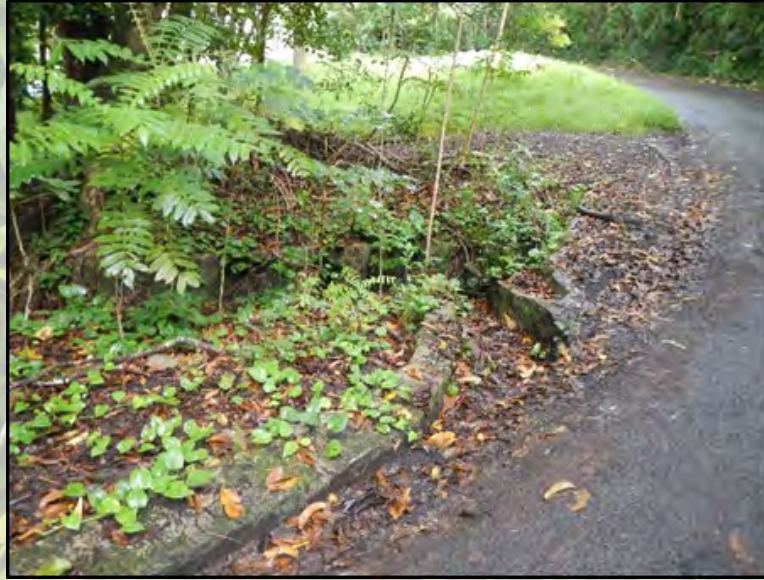
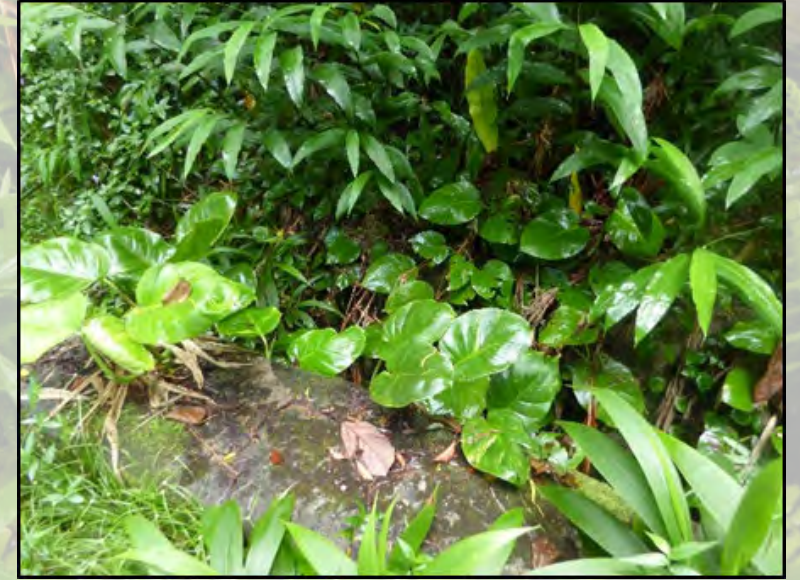
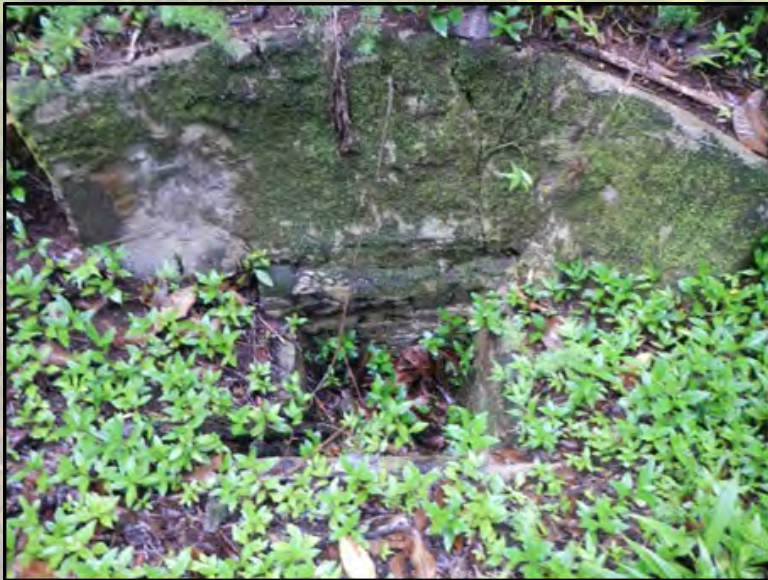
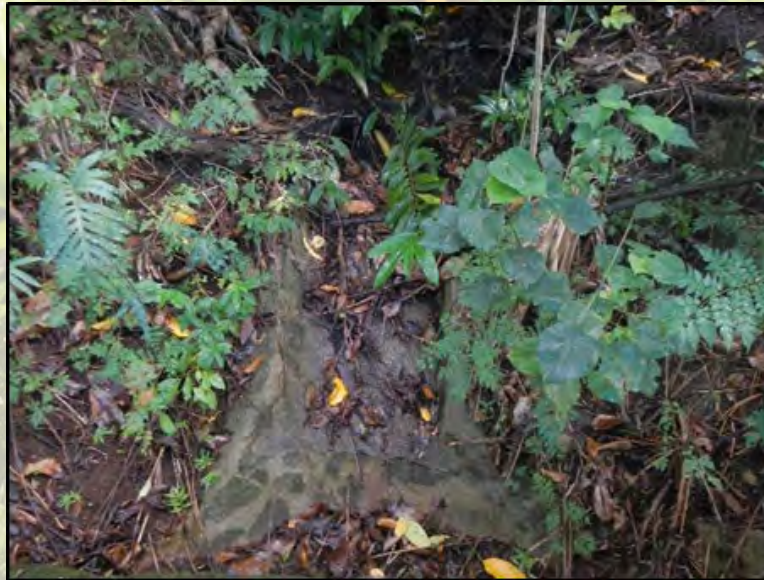
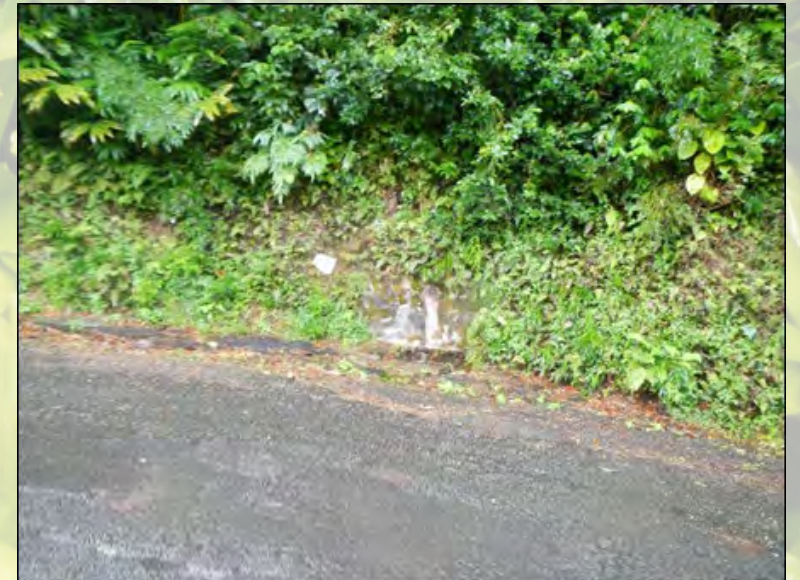
Drainage Issues
