Emergency Improvements in the Vicinity of 3708 Nu'uanu Pali Drive CDUA

Attachment 6: Existing Condition Photos

Existing Condition Photographs
Repairs in the Vicinity of 3708 Nuʻuanu Pali Drive

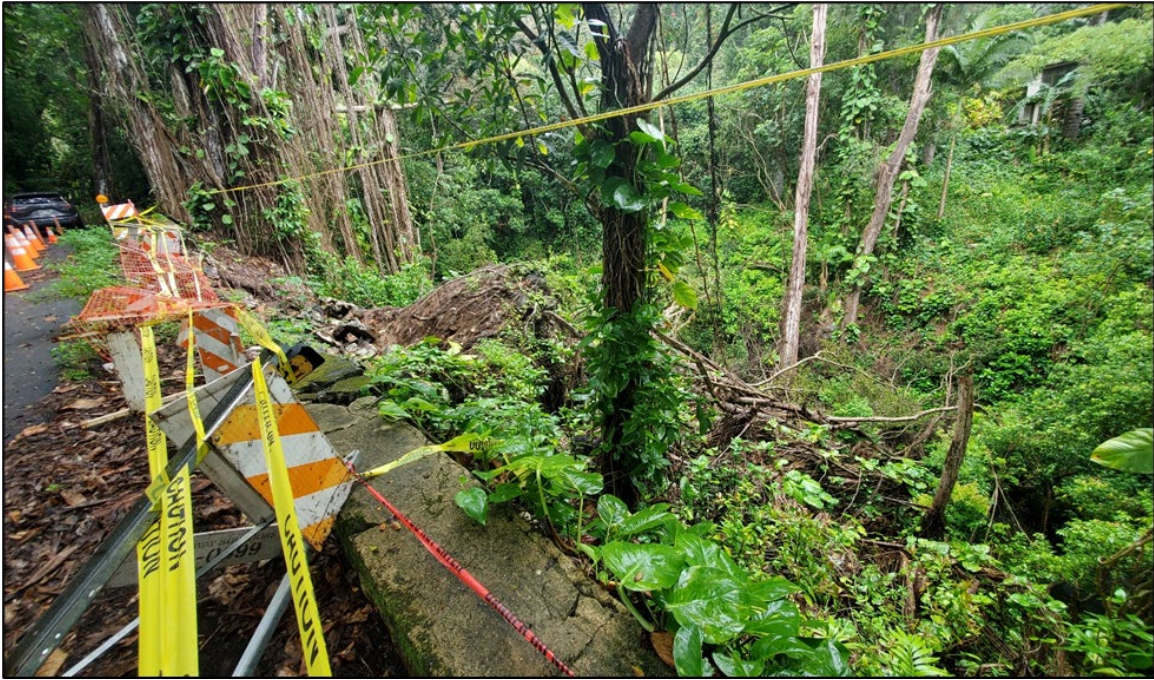
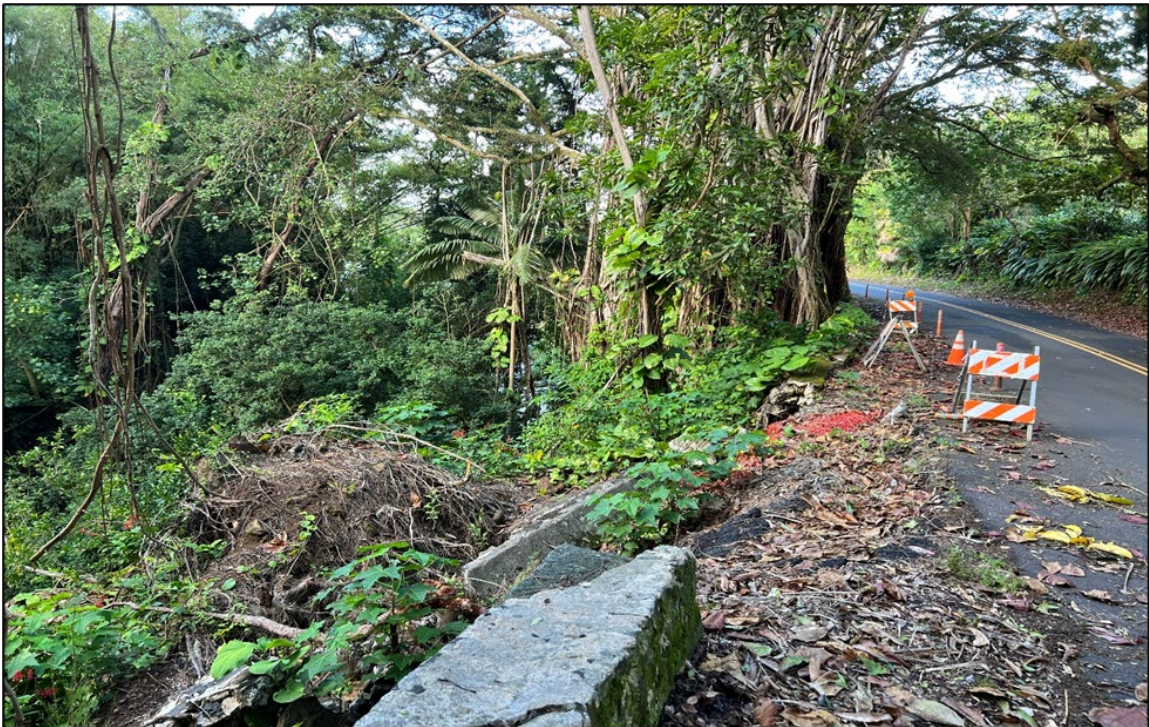
Four sections of rock wall along Nu'uuanu Pali Drive have been damaged. An approximately 55-foot-long section of rock wall was damaged by an approximately 80 foot-tall Chinese banyan tree (*Ficus microcarpa*) that uprooted and collapsed in 2021 (Photos 1

Photo 1. Uprooted Chinese banyan tree that damaged an approximately 55-foot-long section of CMR wall, view looking east.

Photo 2. Uprooted Chinese banyan tree tree that damaged an approximately 55-foot-long section of CMR wall, view looking west.

The approximately 55-foot-long section of rock wall that was damaged by the banyan tree that uprooted will be cleared. The slope below the edge of the roadway will be excavated to a depth of approximately 15 feet and an approximately 5-foot to 15-foot tall reinforced concrete soil nail wall will be constructed. To support the wall, 15-foot-long soil nails will be drilled into the slope under the roadway and embedded in 8-inch diameter holes. The area behind the wall will be regraded and stabilized with hydroseed and turf reinforcement matting. The top of the soil nail wall will be at the same grade as the roadway. The soil nail wall will be colored to match the surrounding environment. A new concrete barrier with rock veneer will sit on top of the soil nail wall. Cross-section views of this work are shown on the Construction Plans, Drawing Nos. CP301 to CP303. The existing rock wall along this section of the road is approximately 1 % -feet tall. For public safety the new concrete barrier will be 2 % -feet tall, but will match the original wall in form, color, and texture. The new barrier will not obstruct any views along the scenic roadway.

Where the existing rock wall collapsed a concrete barrier with rock veneer will be constructed. The other sections of rock wall that have been damaged by tree roots or other causes will be protected in place and a new rock wall will be constructed in front of the existing rock wall on the roadway side. The new concrete barrier with rock veneer and new rock wall will match the original rock wall in form, color, and texture.

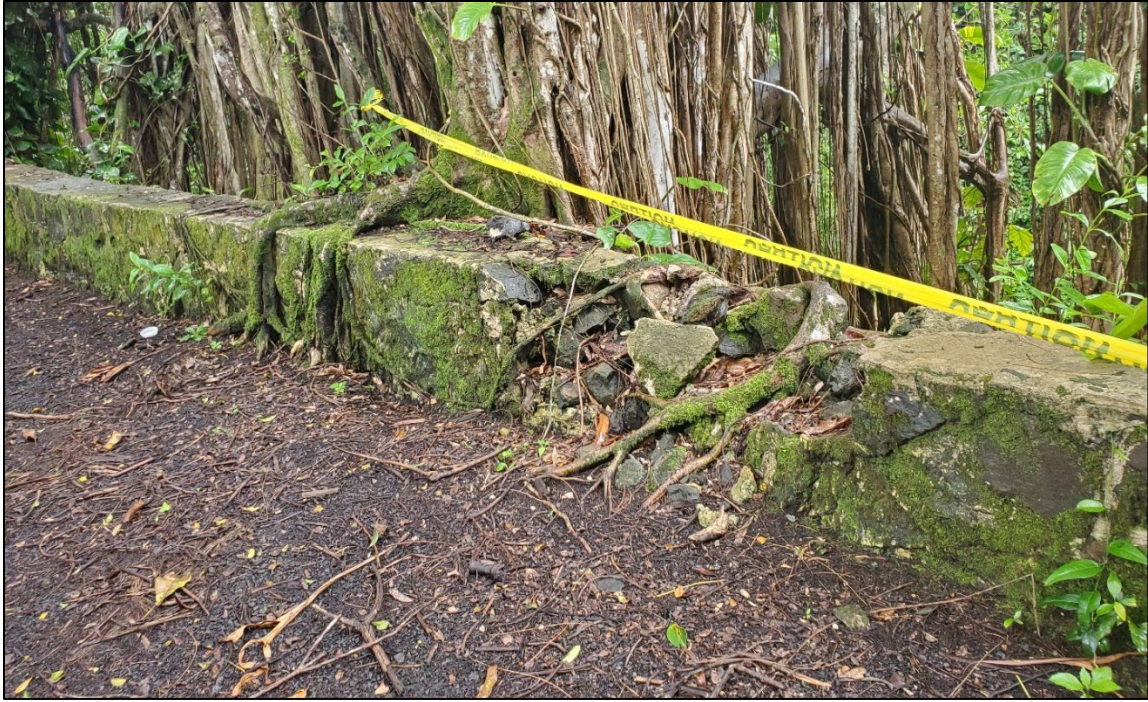
and 2). At three other locations, small sections of rock wall have been damaged by tree roots or other causes (Photos 3 to 5).

Photo 3. Small section of CRM wall damaged by Chinese banyan tree roots.

The other three damaged sections of rock wall will remain in place. A new approximately 80-foot-long by 2 % -foot-tall section of rock wall will be installed in front (on the roadway side) of the existing 1 % -foot-tall rock wall (see Construction Plans, Sheet 6). The excavation for the foundation of the new rock wall will be approximately! % -feet below grade (see Construction Plans, Drawing No. S3.1).

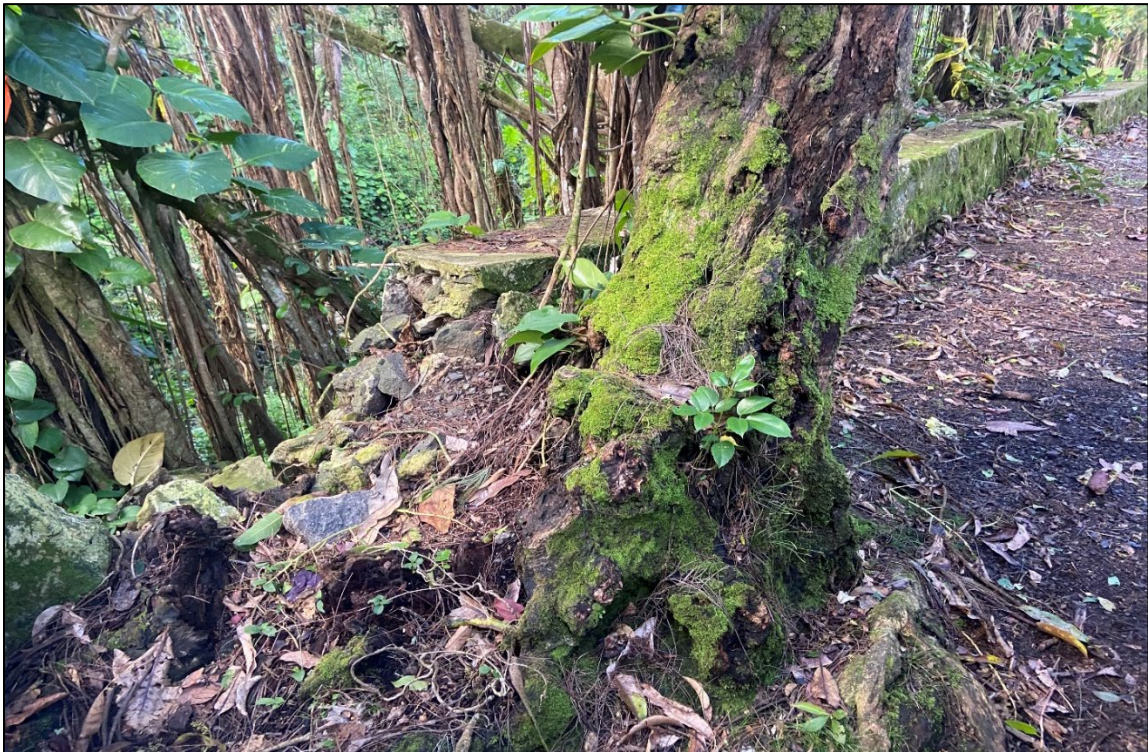
Photo 4. Small section of CRM wall damaged by Chinese banyan tree roots and an ironwood tree growing on the roadway side of the CRM wall.

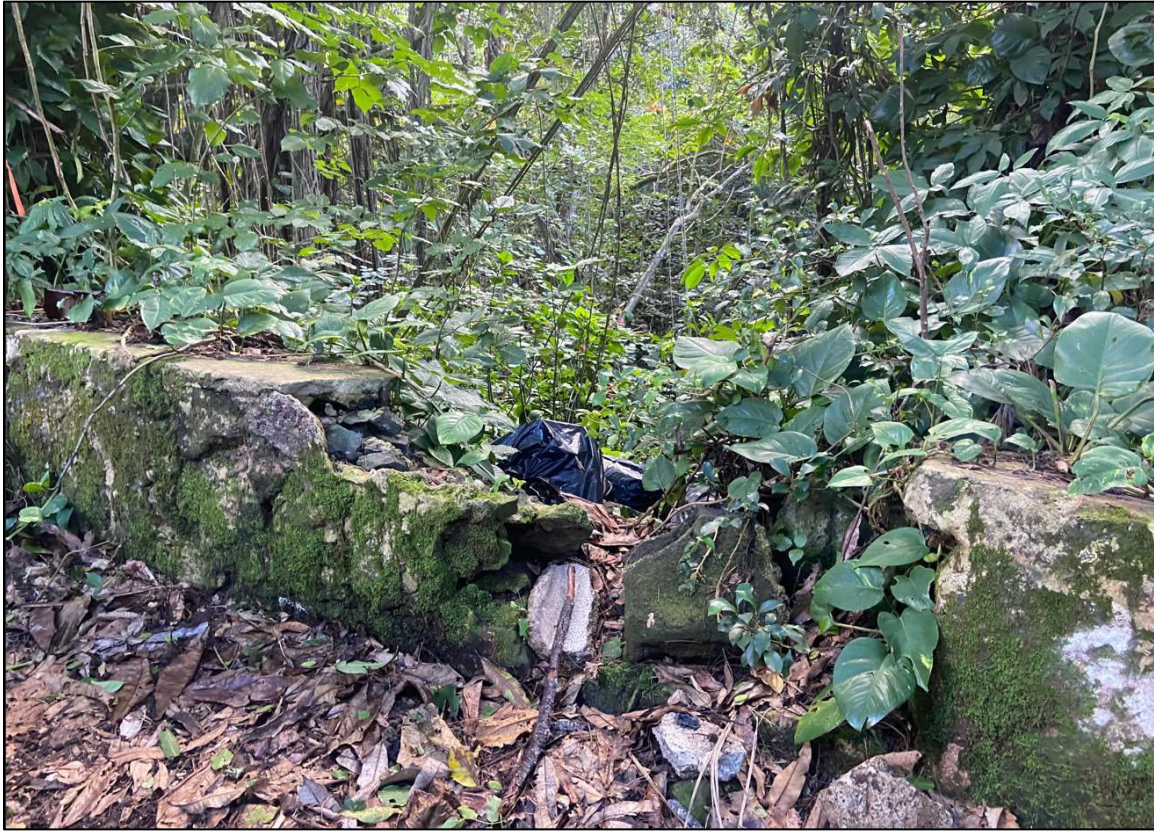
Photo 5. Small section of damaged CRM wall.
