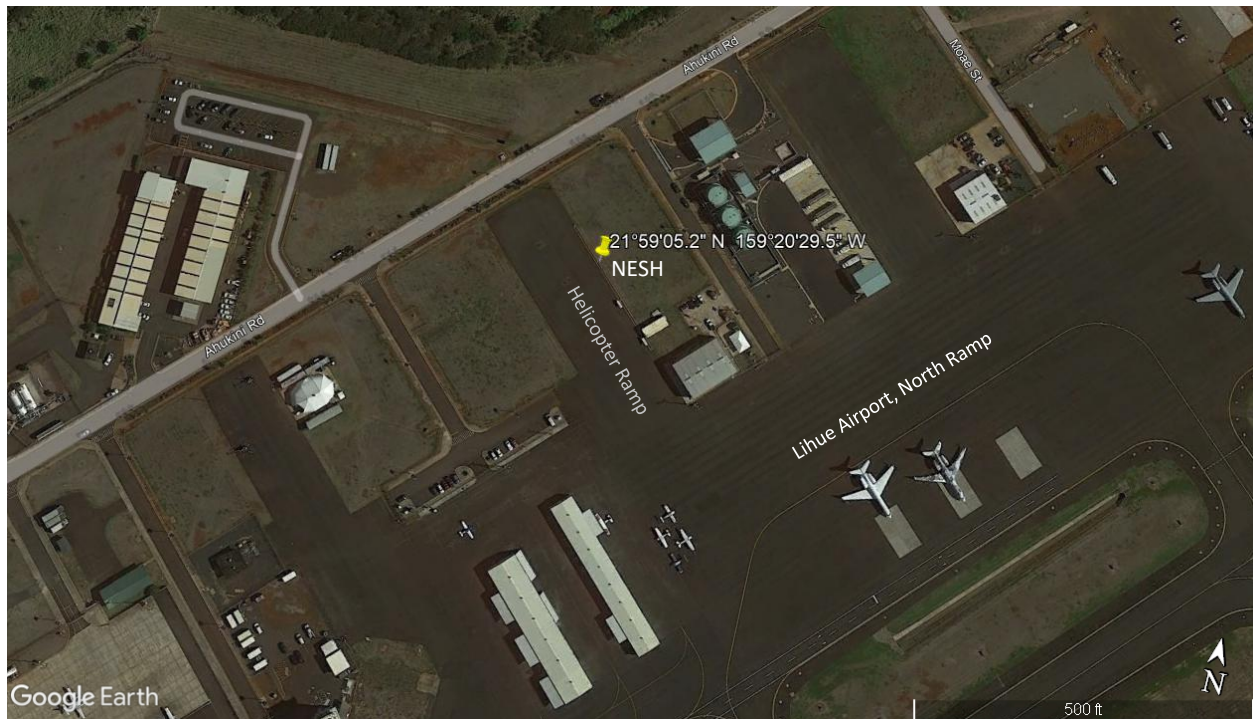
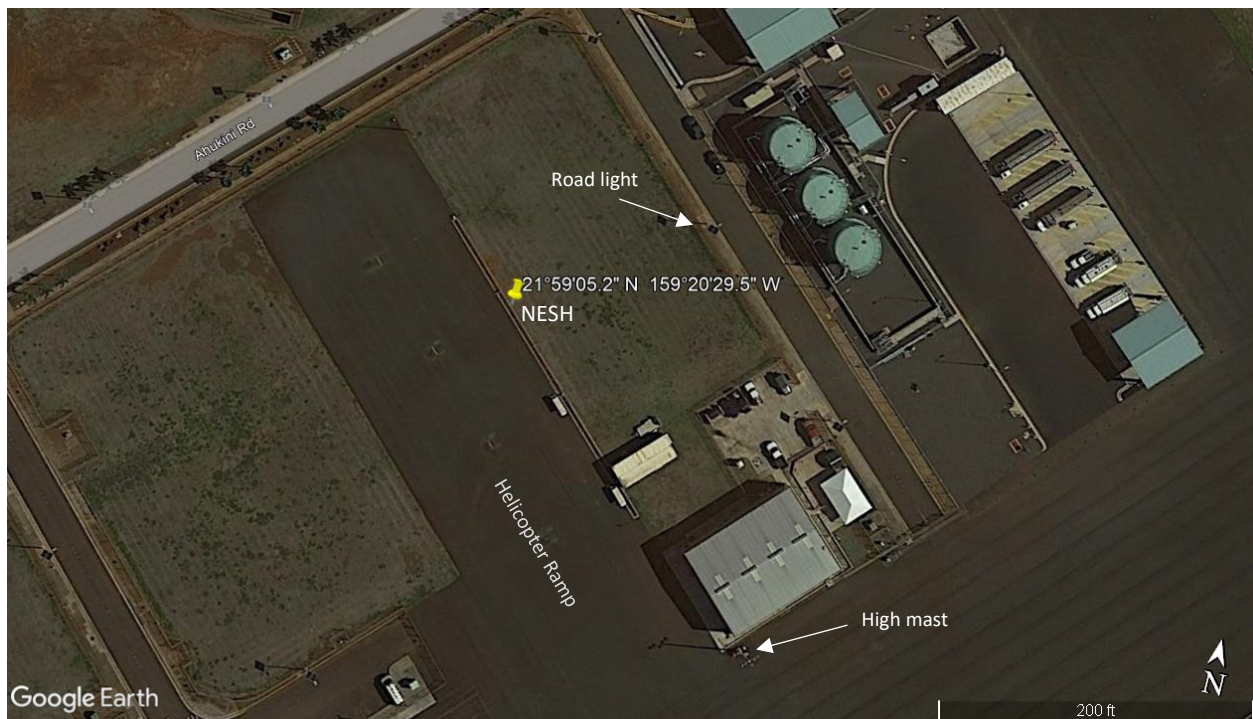
Light disorientation probably contributed to the grounding.

General overview of the Lihue Airport North Ramp and vicinity of grounded Newell's shearwater discovery (top); additional vicinity infrastructure and 2 nearby facility light features are shown below.

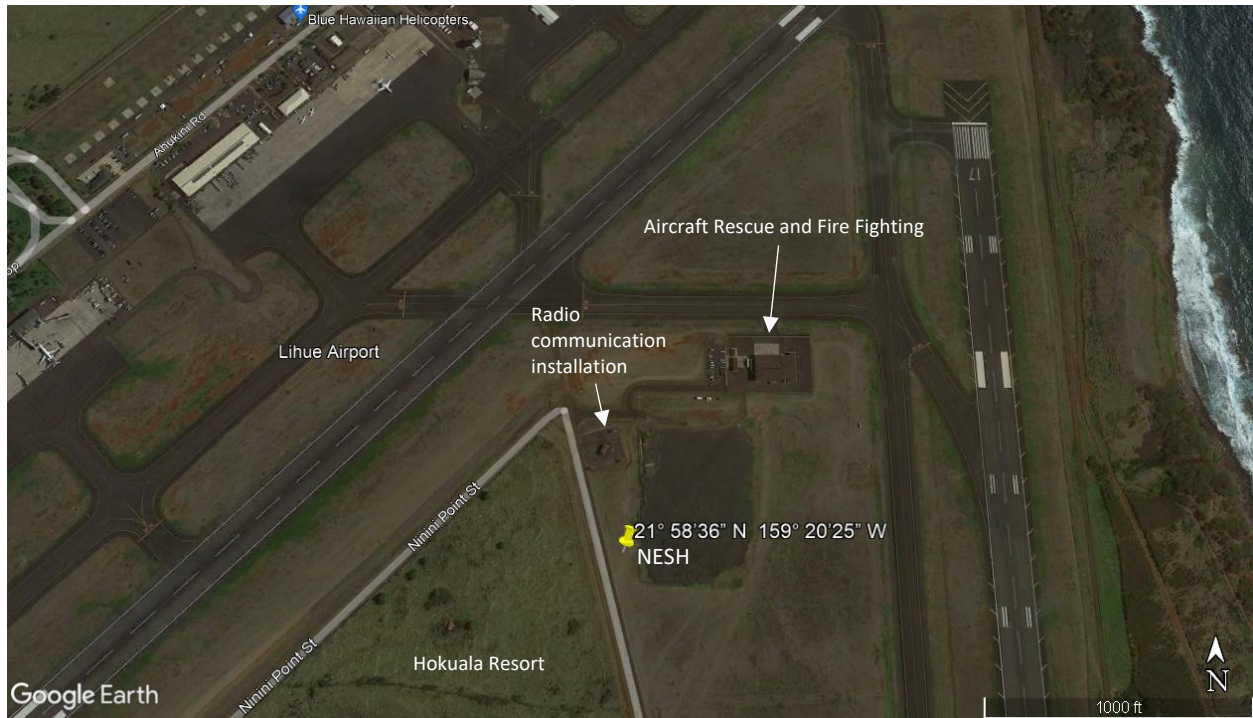
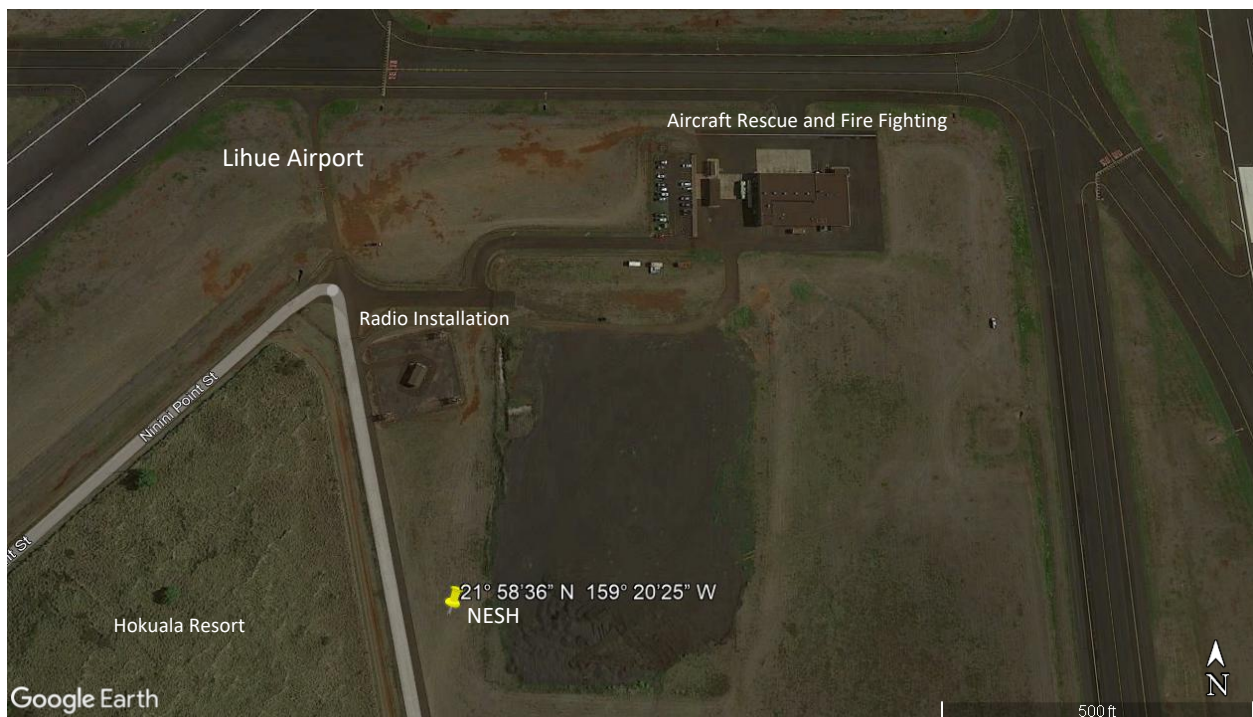
Light attraction and disorientation may have contributed to the seabird becoming grounded.

Broad view of the area (above) within the Lihue Airport AOA and closer view (below) show the location where a Newell's shearwater was discovered alive and rescued on October 19, 2022.

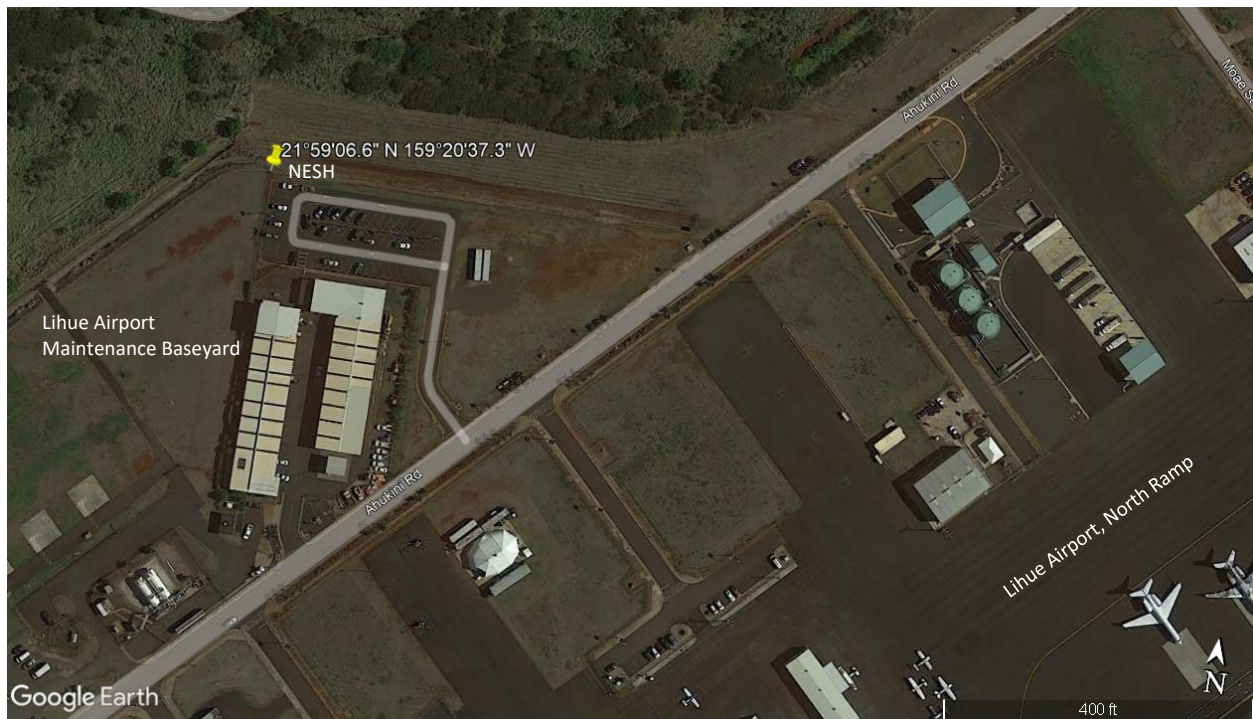
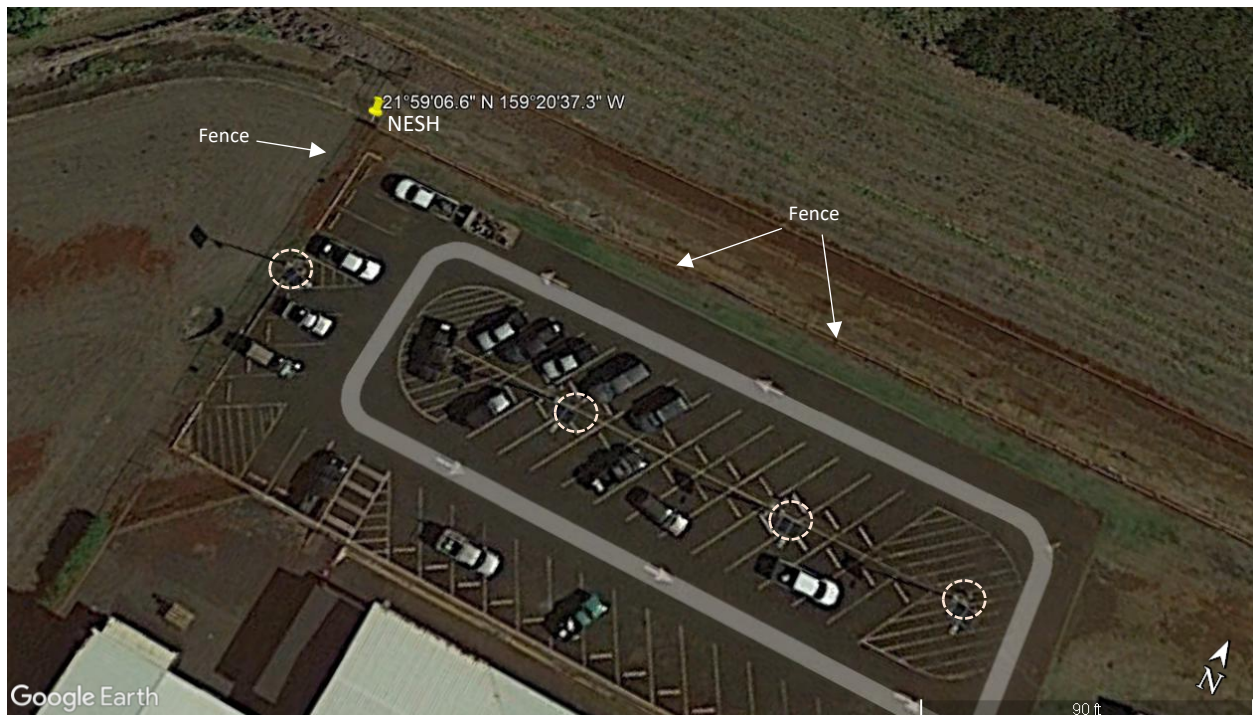
These two images show the vicinity overview of the Maintenance Baseyard (above) and details of the infrastructure in and around the parking area relative to the location where the Newell's shearwater was discovered on October 22, 2022. The parking lot pole-mounted lights are located within the dashed ovals.

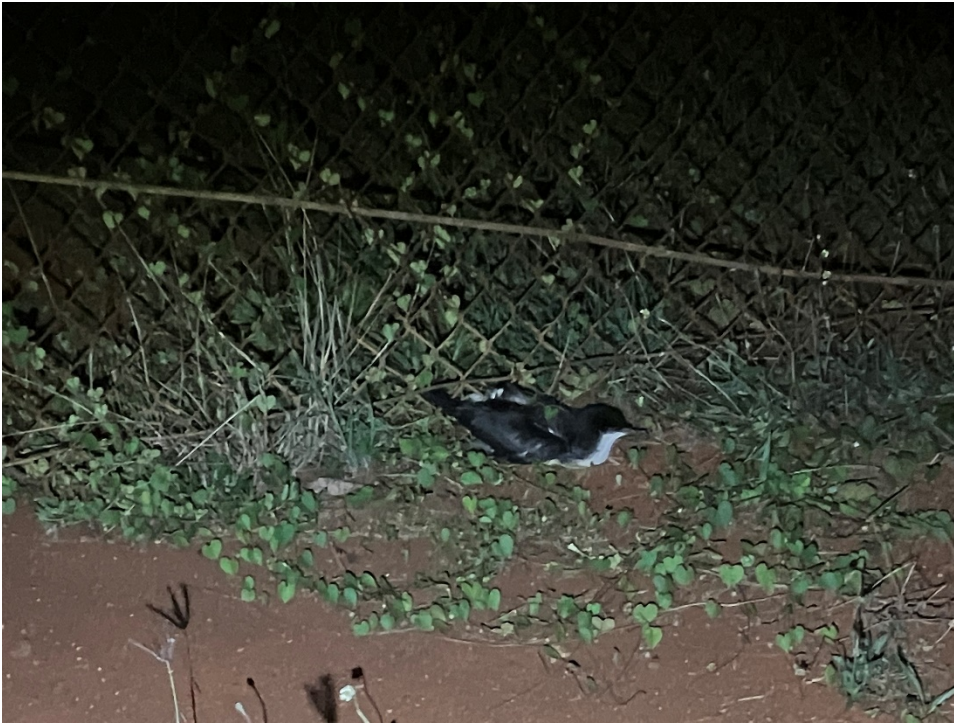
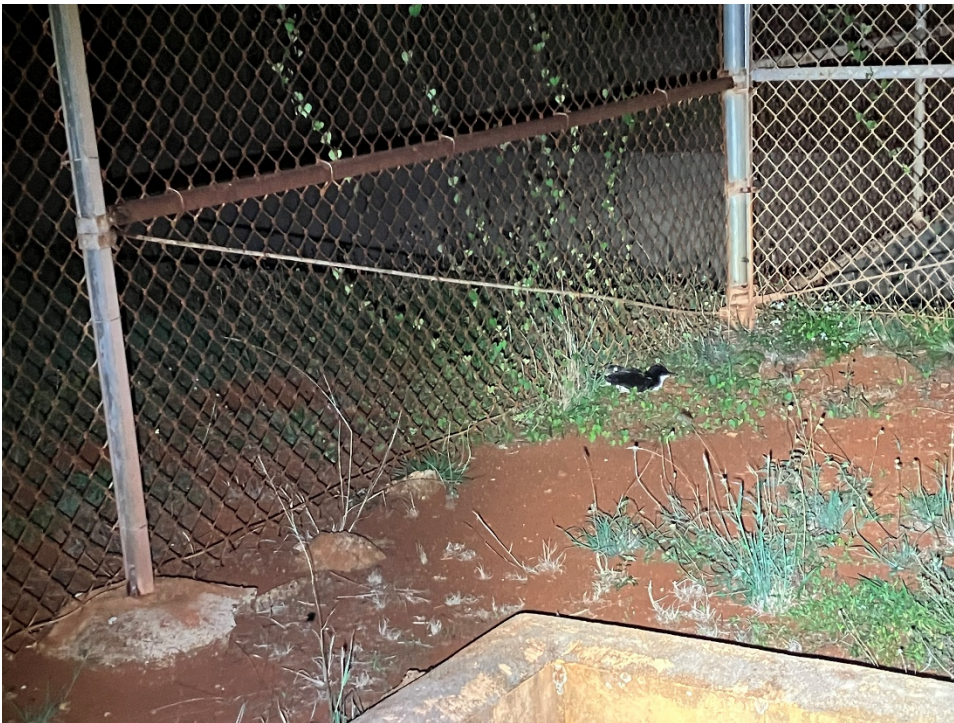
The seabird was alive and exhibited responsiveness when it was discovered. However, it appeared to be fouled by the foot or segment of the wing on the lower margin of the fence; this may have caused or been associated with injury but extent is unknown.

Injury was not confirmed in the field but is likely and may have been complicated by interaction with the base of the fence.

Two photos taken of the Newell's shearwater discovered at the Lihue Airport Maintenance Baseyard in the corner of the perimeter fence adjacent to the parking area on October 22, 2022.

☒ FOUND INJURED AS DESCRIBED: Left wing appears injured.

The shearwater was discovered by H. T. Harvey & Associates trained biologist and searcher, Alex Henry. Mr. Henry contacted airport security dispatch and communicated his discovery and requested the assistance of USDA-Wildlife Services. Wildlife Services responded and proceeded to place the shearwater in a secure carrier and subsequently transported the seabird to the Lihue Fire Station SOS Aid Station.

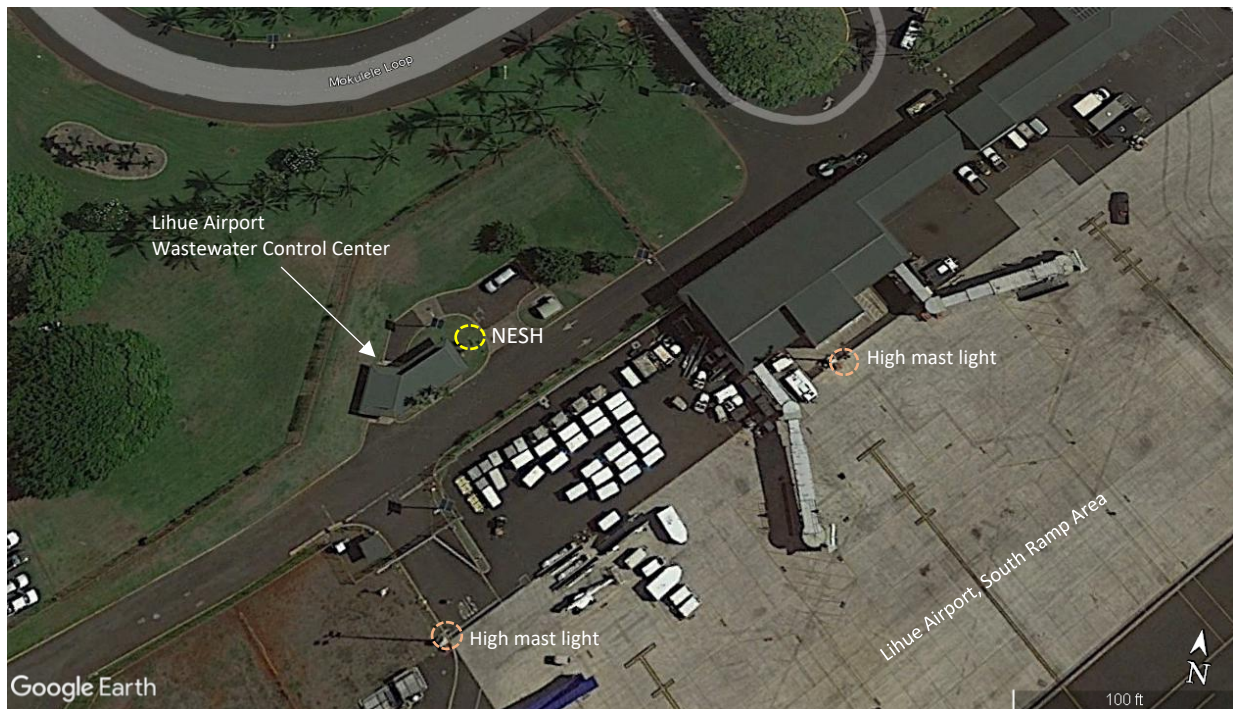
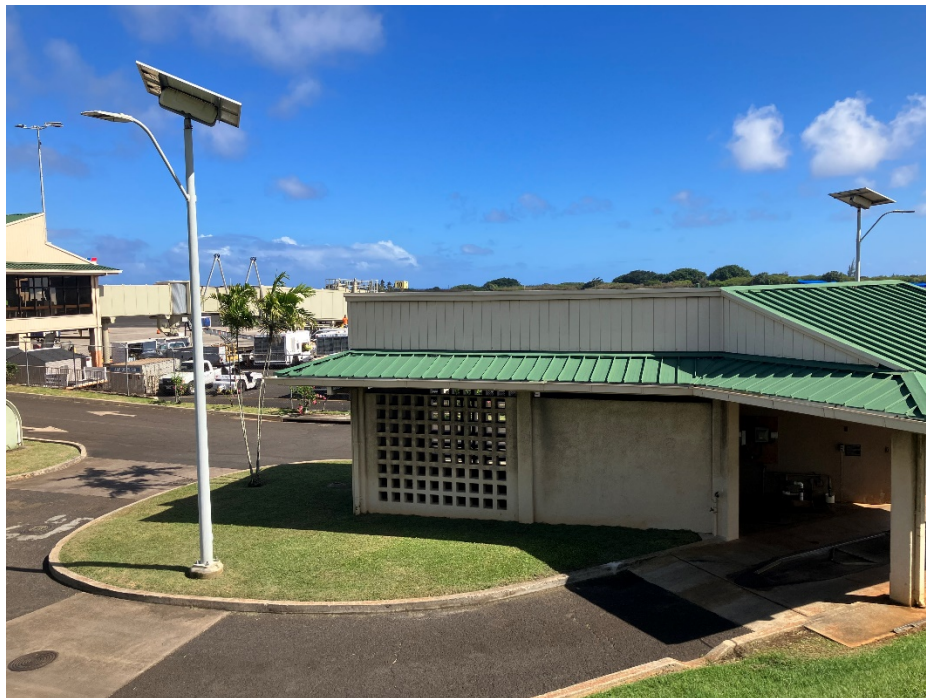
Overview showing the prominent features in the area where a grounded Newell's shearwater fledgling was discovered and rescued by USDA-Wildlife Services (top) and at Lihue Airport on October 22, 2022. The two figures below provide details of the immediate vicinity and surrounding infrastructure.

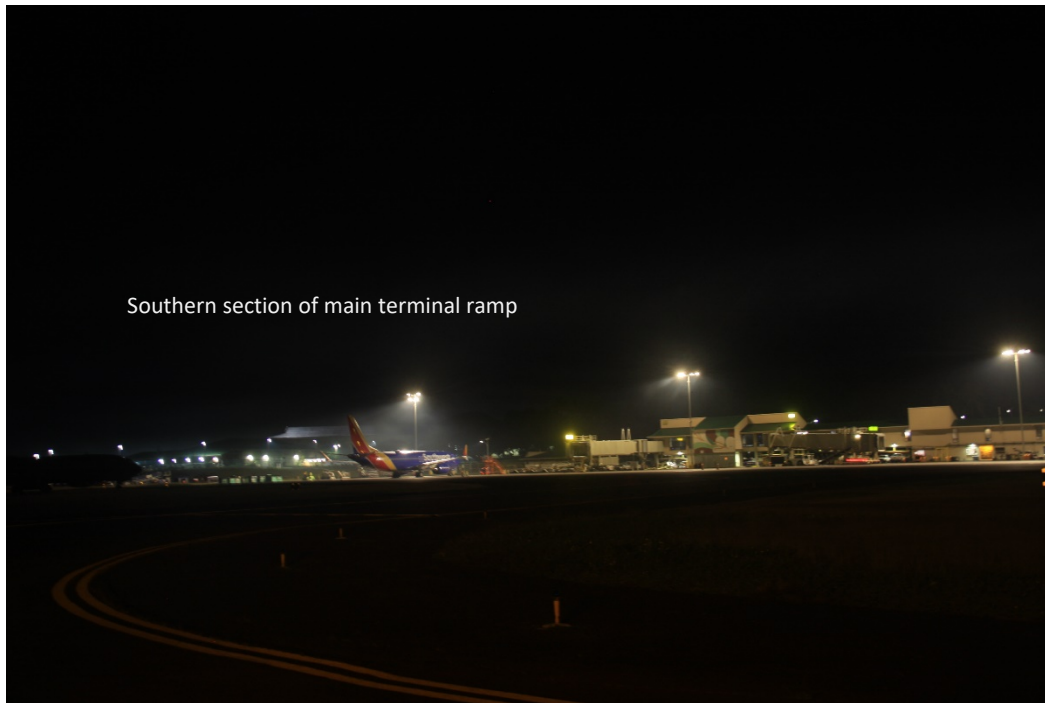
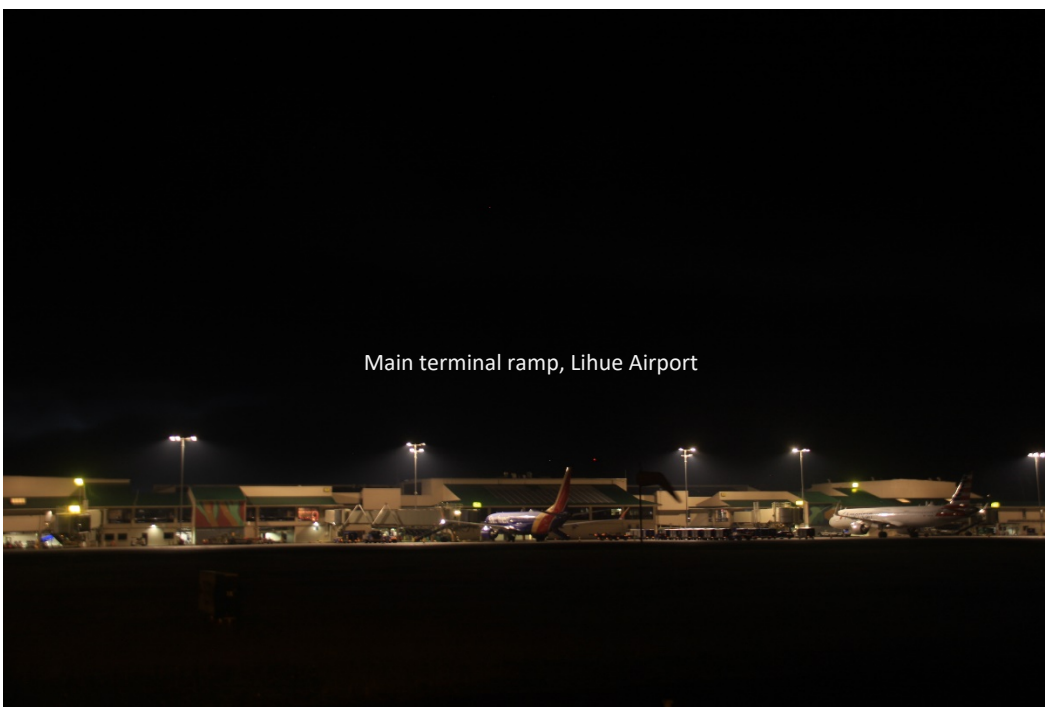
Photo 1 (top) and 2 (below). Aircraft and lighting infrastructure along the main terminal ramp at Lihue Airport during normal operational conditions.

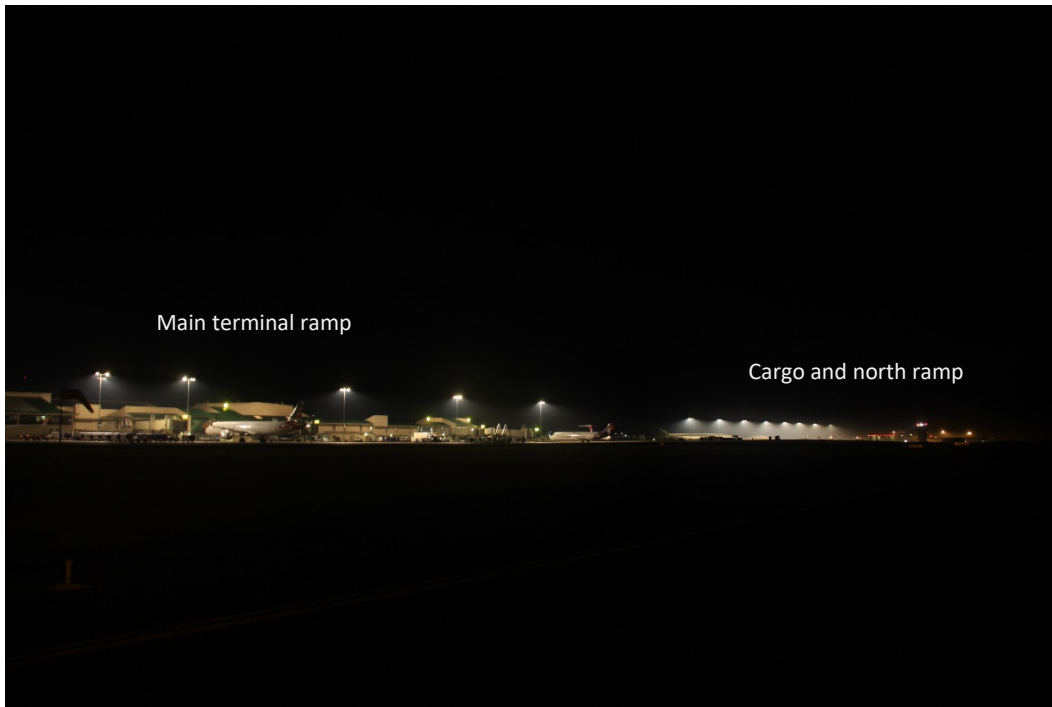
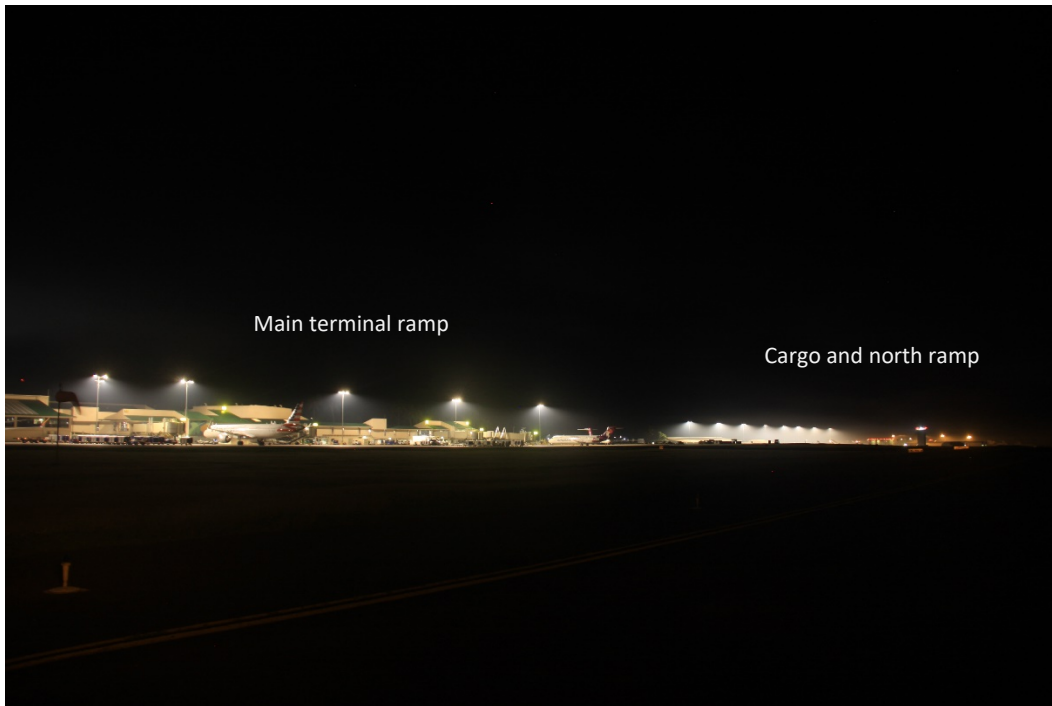
Photo 3 (top) and 4 (bottom). These images show the northern portion of the main terminal ramp and adjacent cargo ramp lighting at Lihue Airport in operational setting. High mast full cut off fixtures facilitate the direction of light at a downward angle.

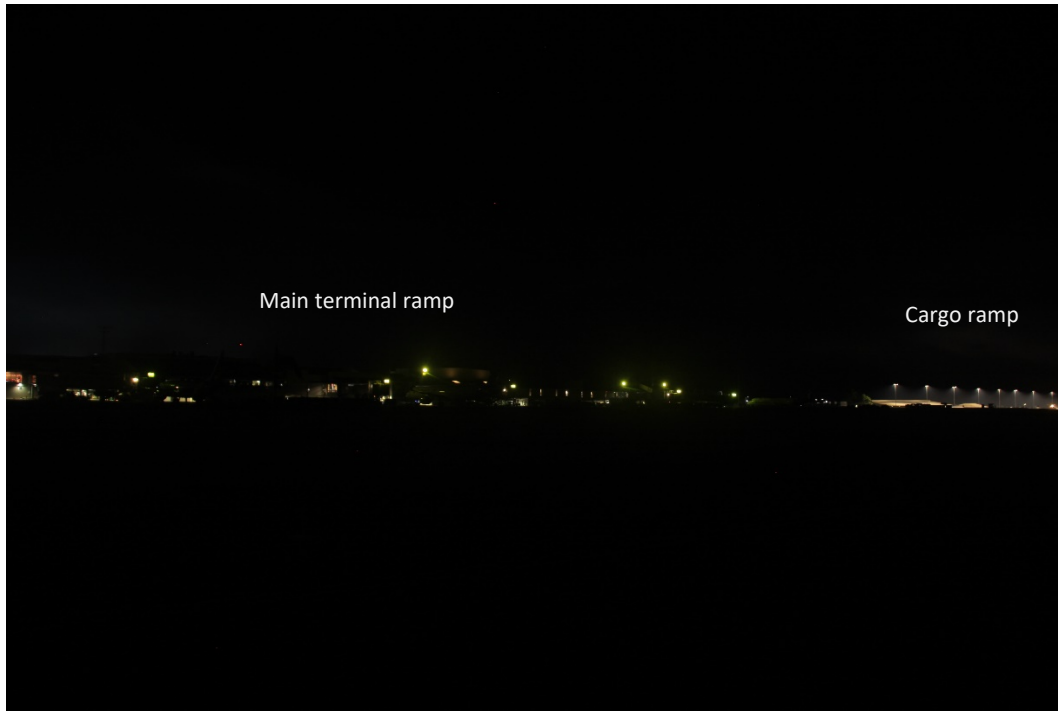
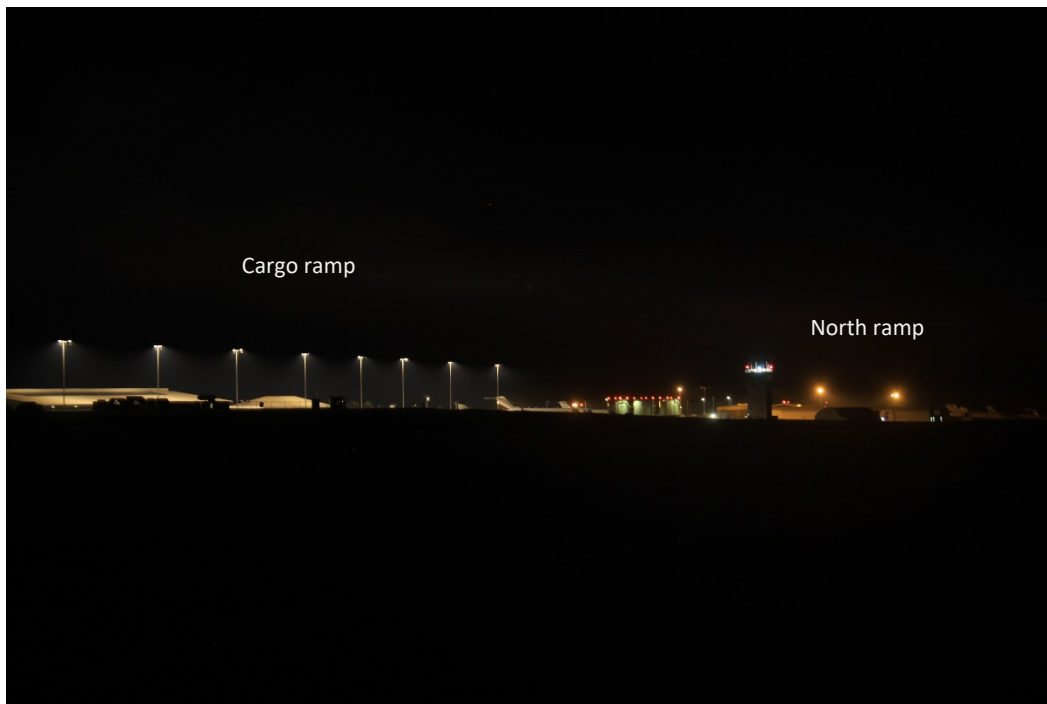
Photo 5 and 6 (top and below). Main terminal with high mast light complex off. As a minimization measure, this condition exists each night during the seabird fallout season for several hours during night and early predawn hours at Lihue Airport. Cargo and Life Transport remain operational.
