Downed Seabird Search and Monitoring Routes at HDOT Nawiliwili Harbor Facilities

Kauai Seabird Habitat Conservation Plan (4065-04)

January 2022

NAWILIWILI HARBOR

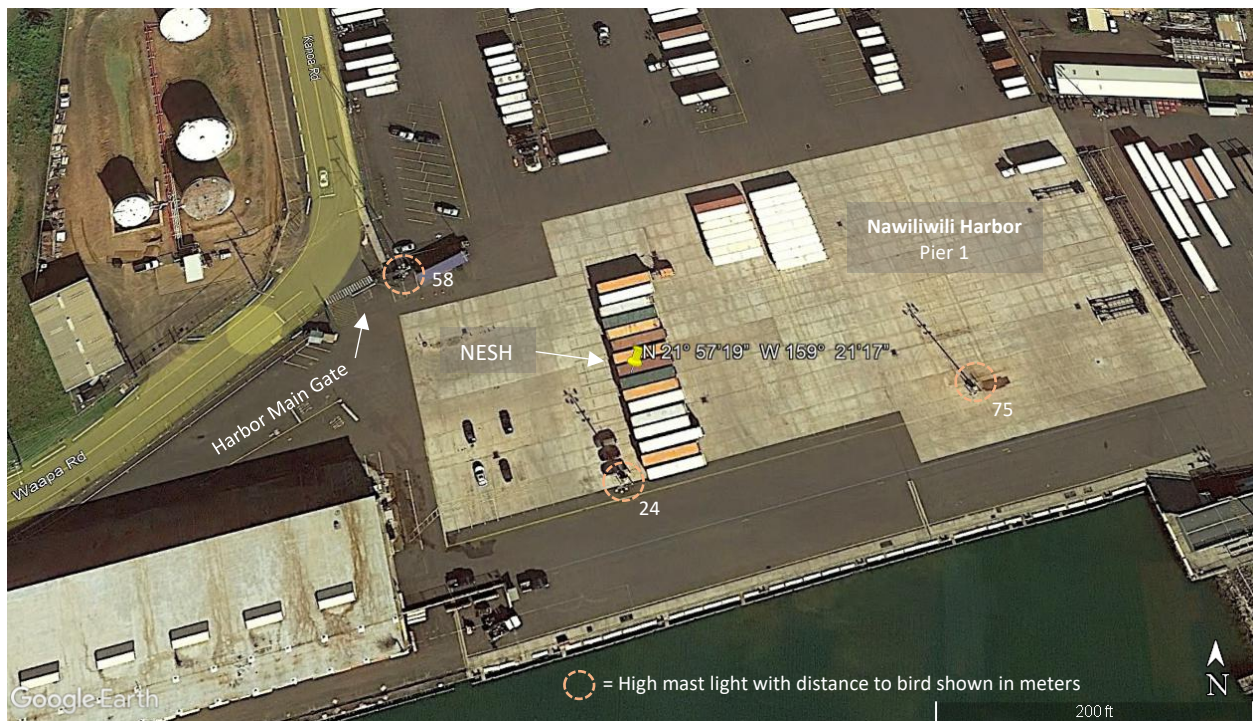
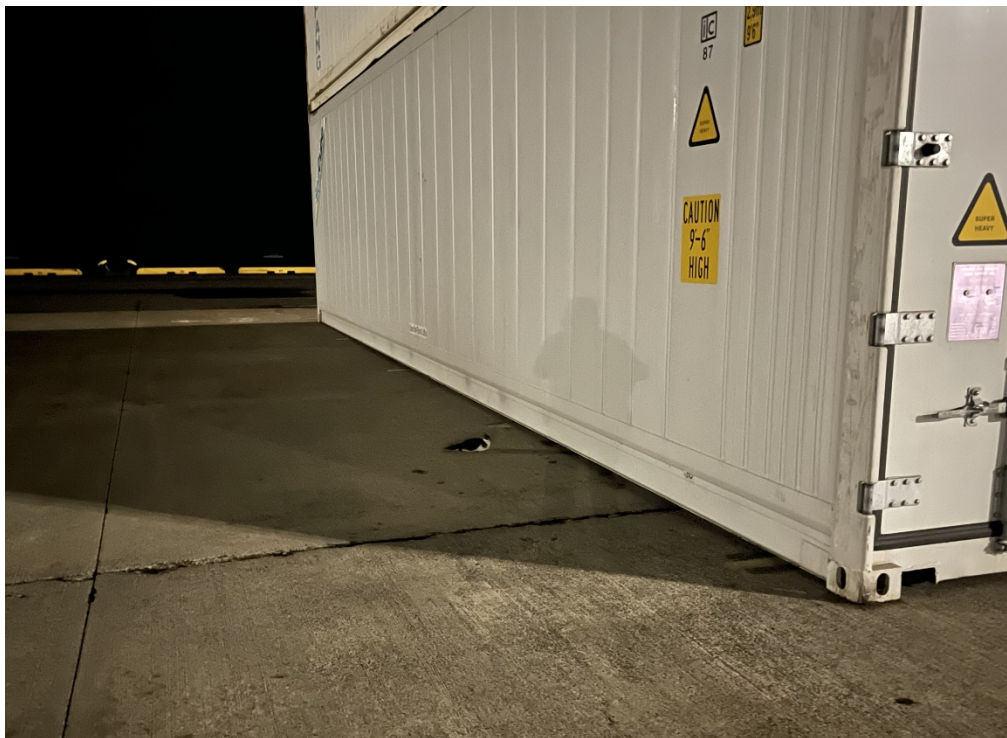
The top image provides an overview of features present in the vicinity of a grounded Newell's shearwater discovered at Nawiliwili Harbor, Kauai on October 26, 2022. In the image below the shearwater can be seen in a resting position next to a row of shipping containers.

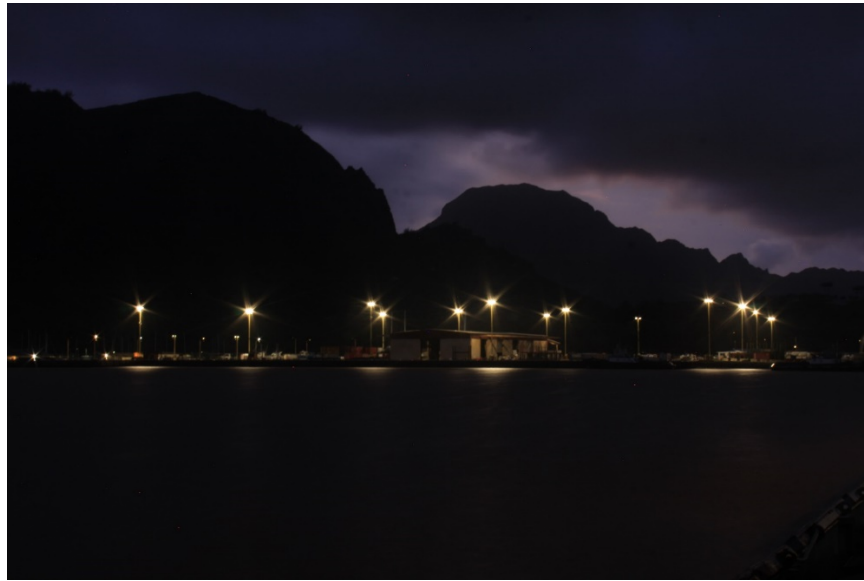
Photo 1. Pier 3 (Young Brothers) yard seen shortly after sunset with majority of high mast lights in operational setting following the departure of tug and barge. These lights are programmed to initiate a dimming sequence down to security level (15% capacity) over the course of about 20 minutes after operations conclude.

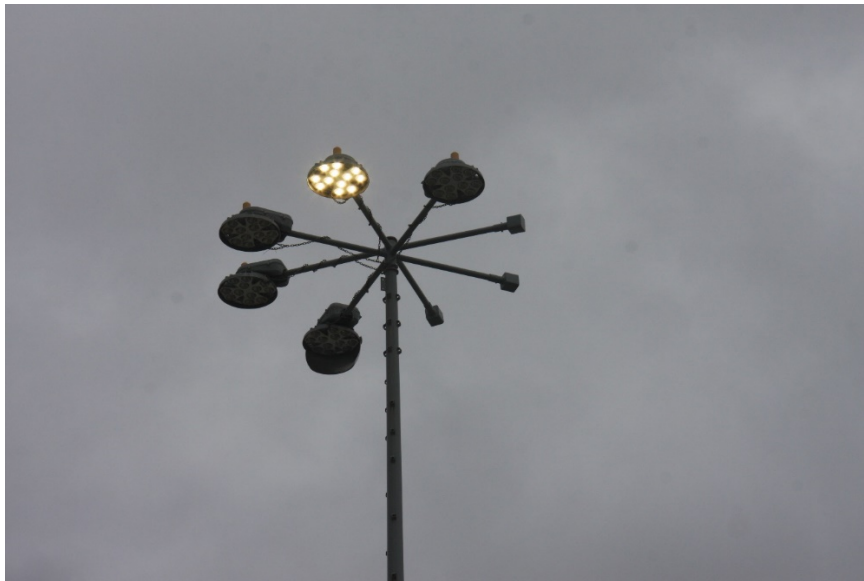
Photo 2. High mast light at Pier 1 (Matson yard) operating in a security setting – no operations, full minimization level.

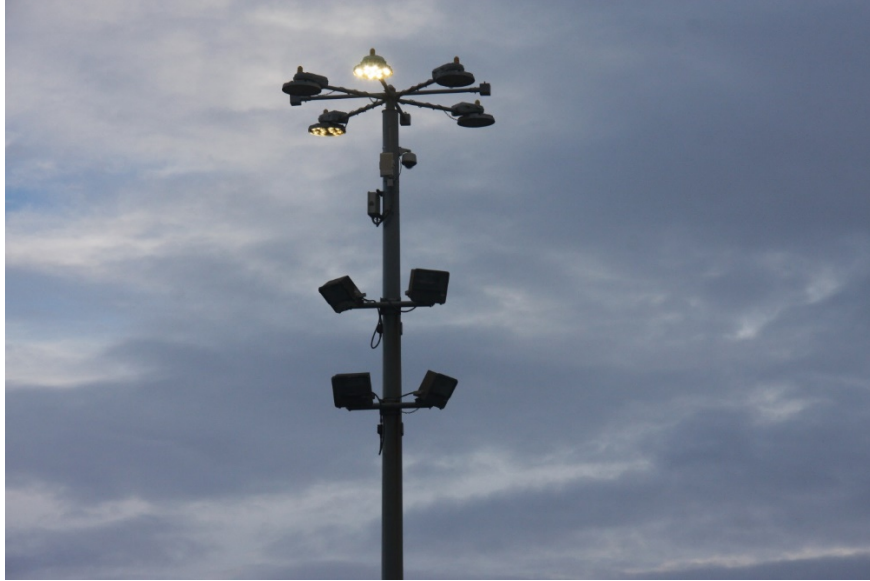
Photo 3. High mast light in security setting on Pier 1 next to the Superferry ramp at Nawiliwili Harbor, Kauai.

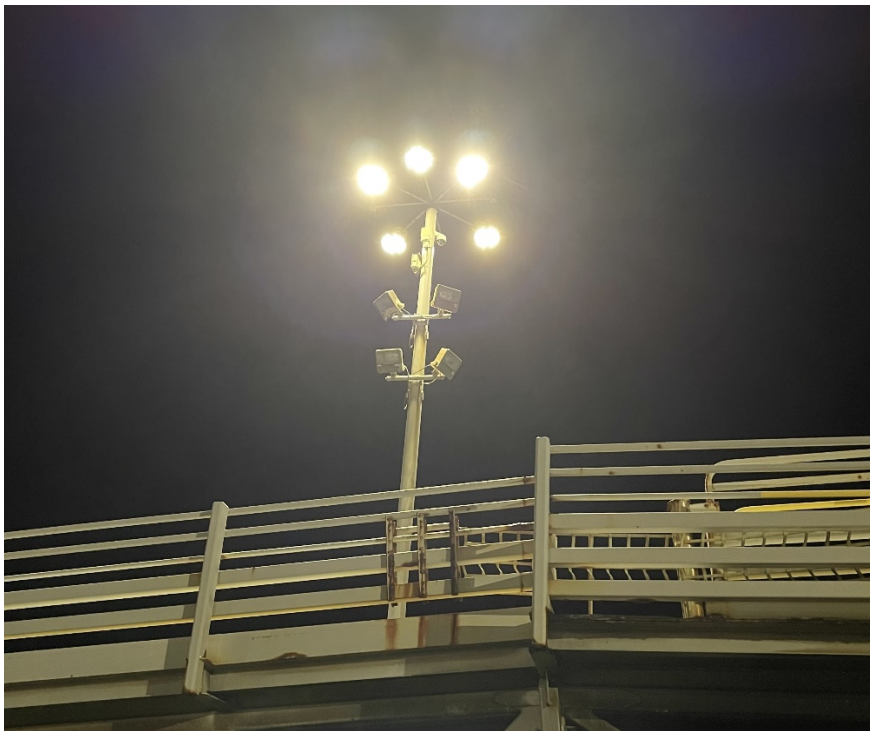
Photo 4. High mast light fully illuminated in operational setting on Pier 1, Nawiliwili Harbor.

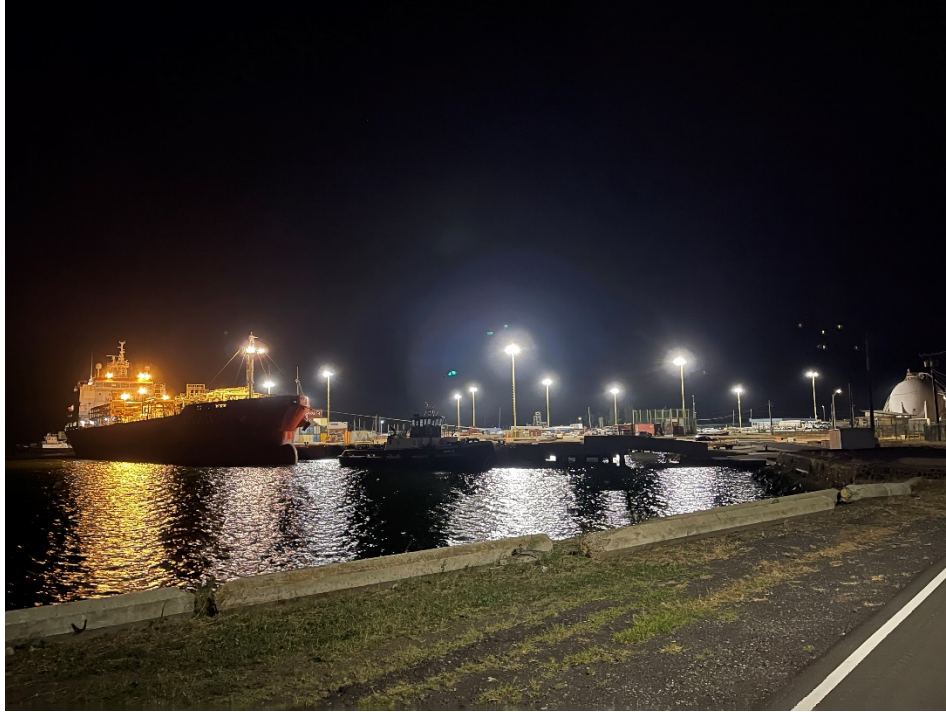
Photo 5. Fully operational lighting conditions at Pier 3 (Young Brothers yard) during liquid bulk cargo operations at Nawiliwili Harbor.

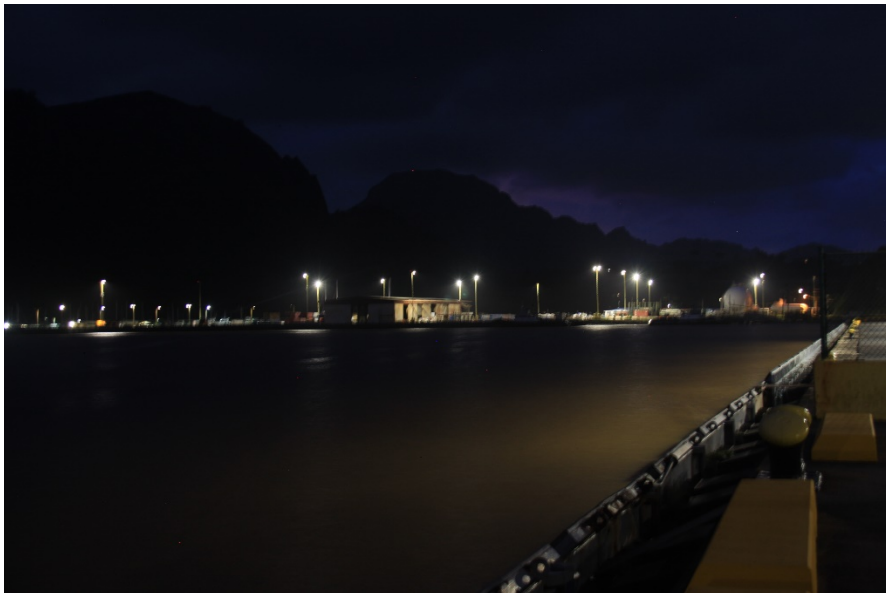
Photo 6. Lighting conditions at Pier 3 (Young Brothers yard) during non-operational security conditions when all high mast lights are reduced to 15% illumination level.
