Downed Seabird Search and Monitoring Routes at HDOT Port Allen Facilities

Kauai Seabird Habitat Conservation Plan (4065-04)

January 2022

APPENDIX 2
DOWNED WILDLIFE INCIDENT REPORTS

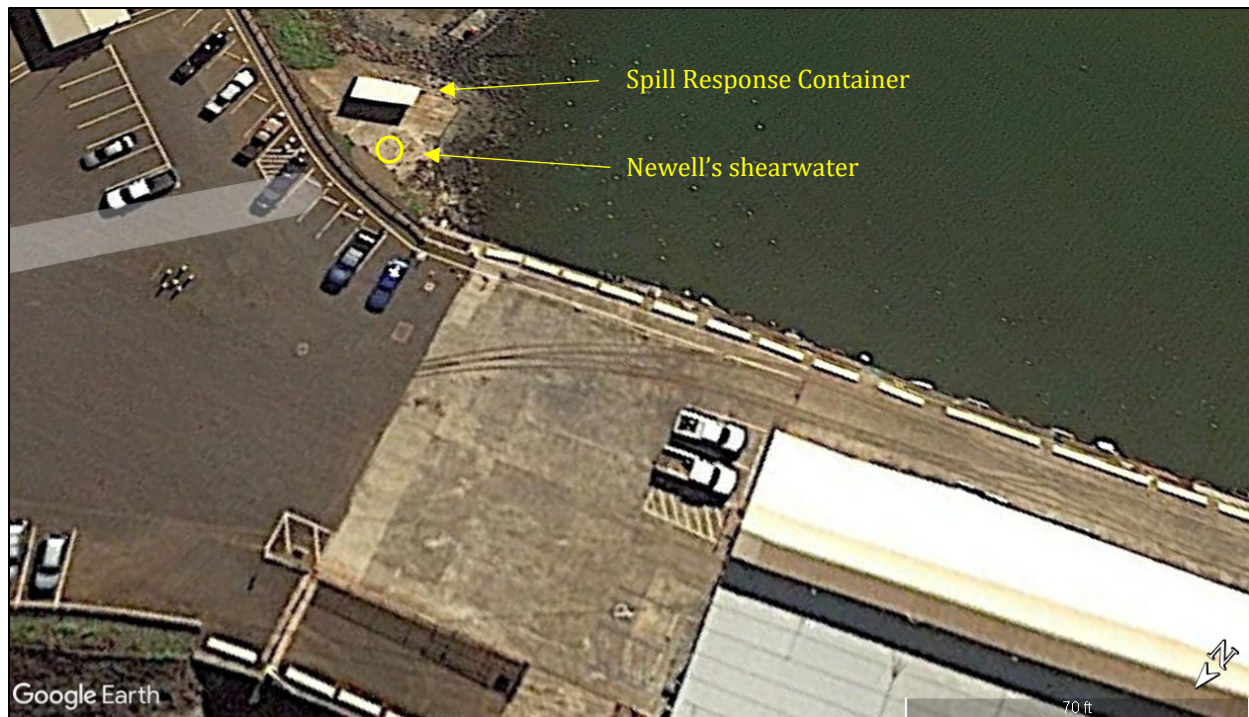
Location of Newell's shearwater found at Port Allen Harbor (HDOT) on September 29, 2022.

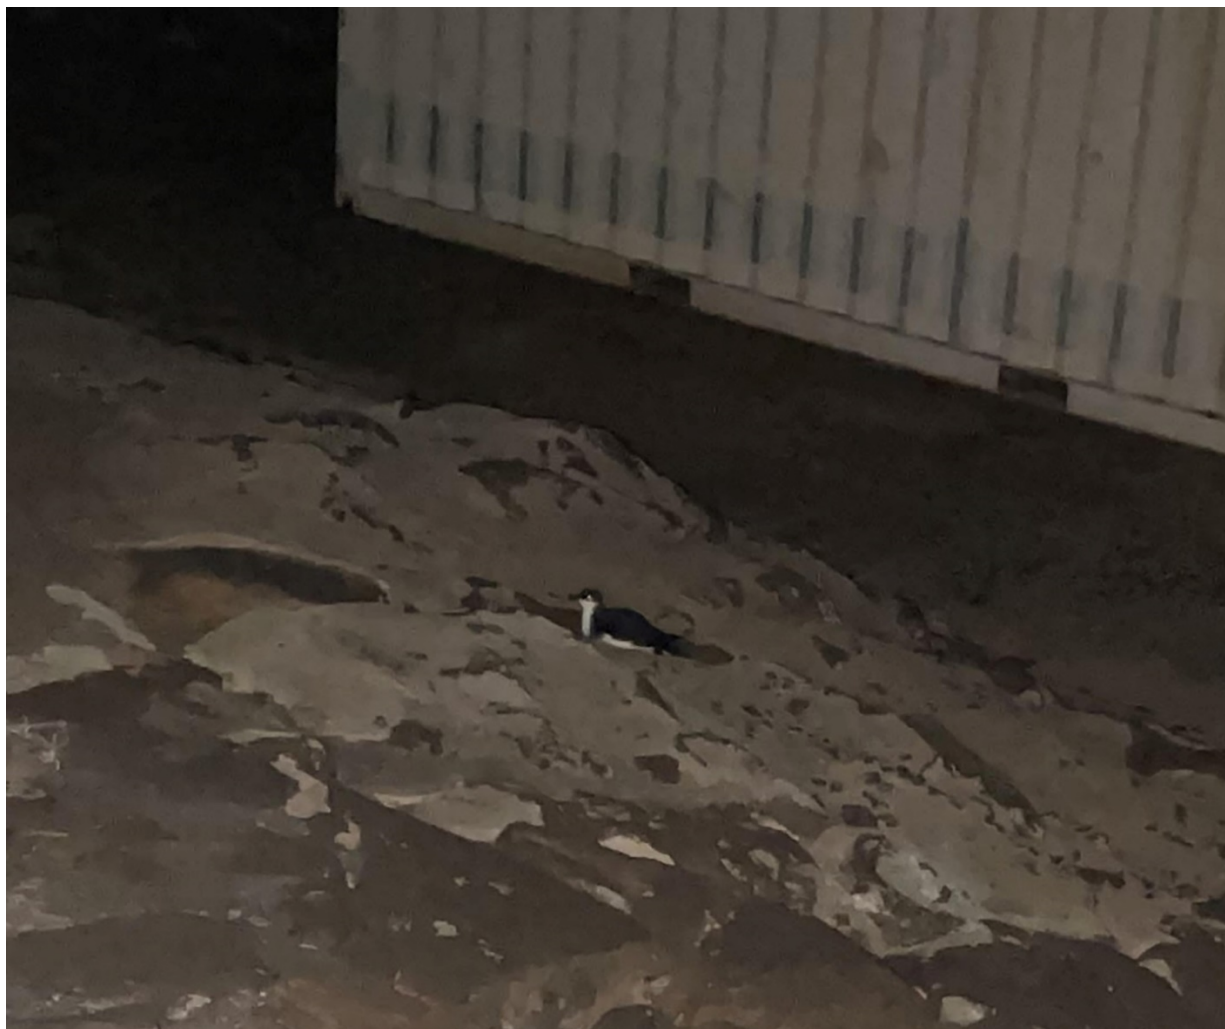
Condition appeared healthy and alert; no apparent injuries were observed.

View along the hardened revetment upslope of the spill response container with Newell's shearwater in the foreground at HDOT Port Allen Harbor, Kauai, September 29, 2022.

HDOT searcher and monitoring ecologist, Mitchell Craig, identified the downed shearwater and initiated proper rescue and response procedures which included delivery of the shearwater to SOS at its new base of operations in upper Wailua.

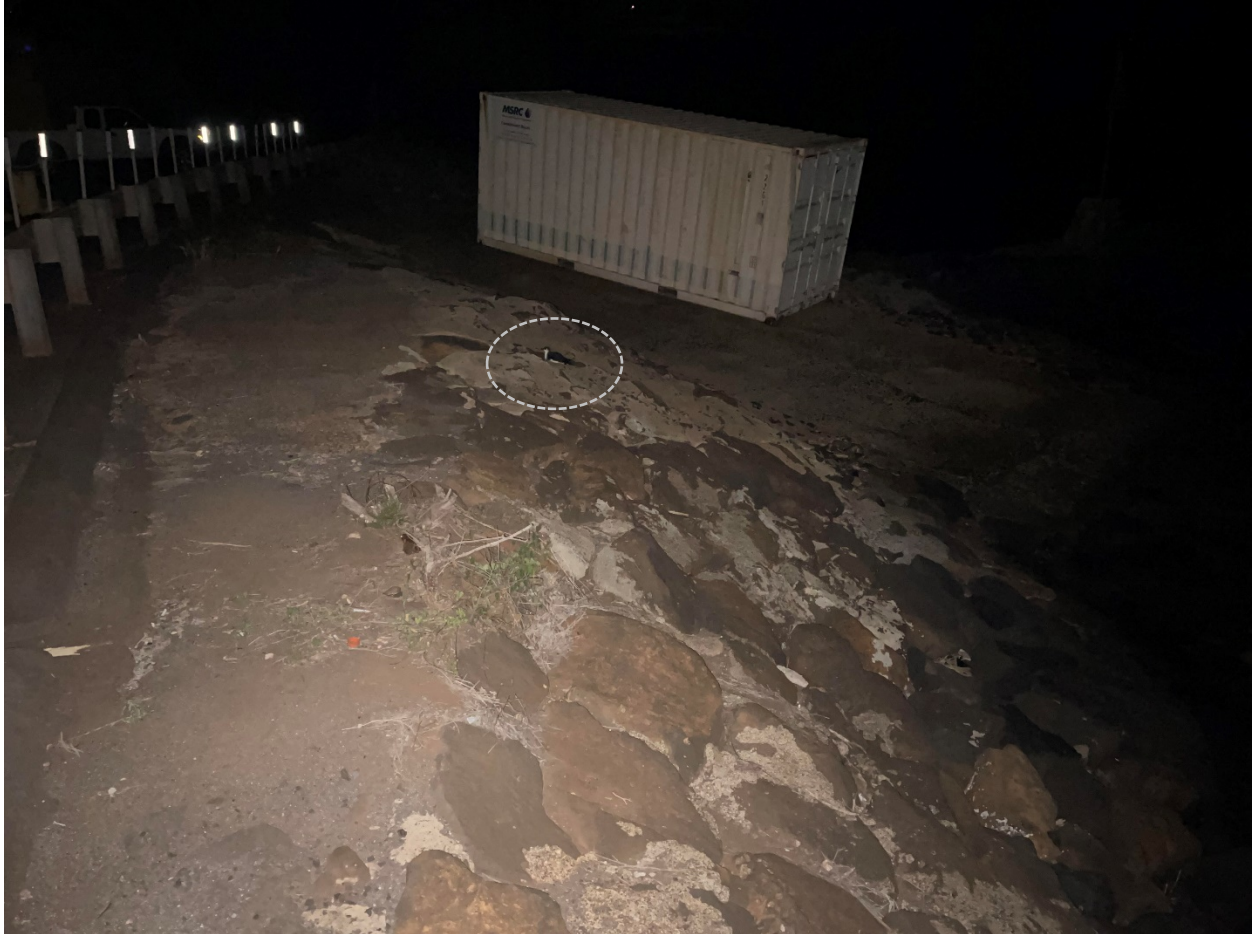
Broad view of the location and surrounding landscape at the discovery site. The reflective markers at the left run along the boundary of the parking area, upland from the shoreline below.

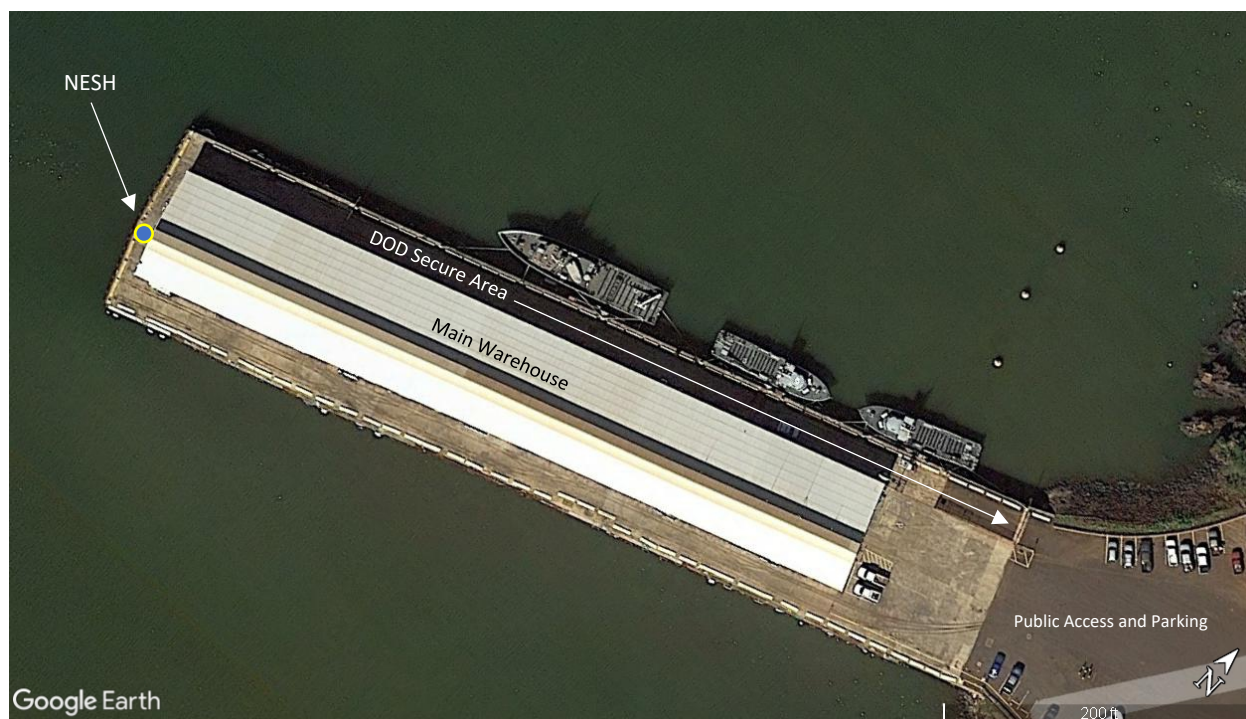
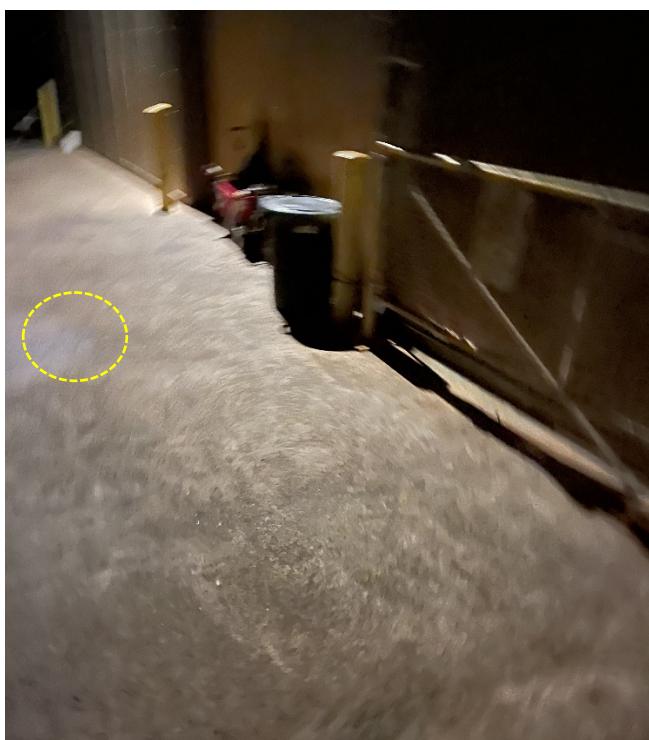
Overview of HDOT's Port Allen Harbor showing relevant features at the facility (top) and at the location where a Newell's shearwater was discovered (shown my oval, below) on October 25, 2022.

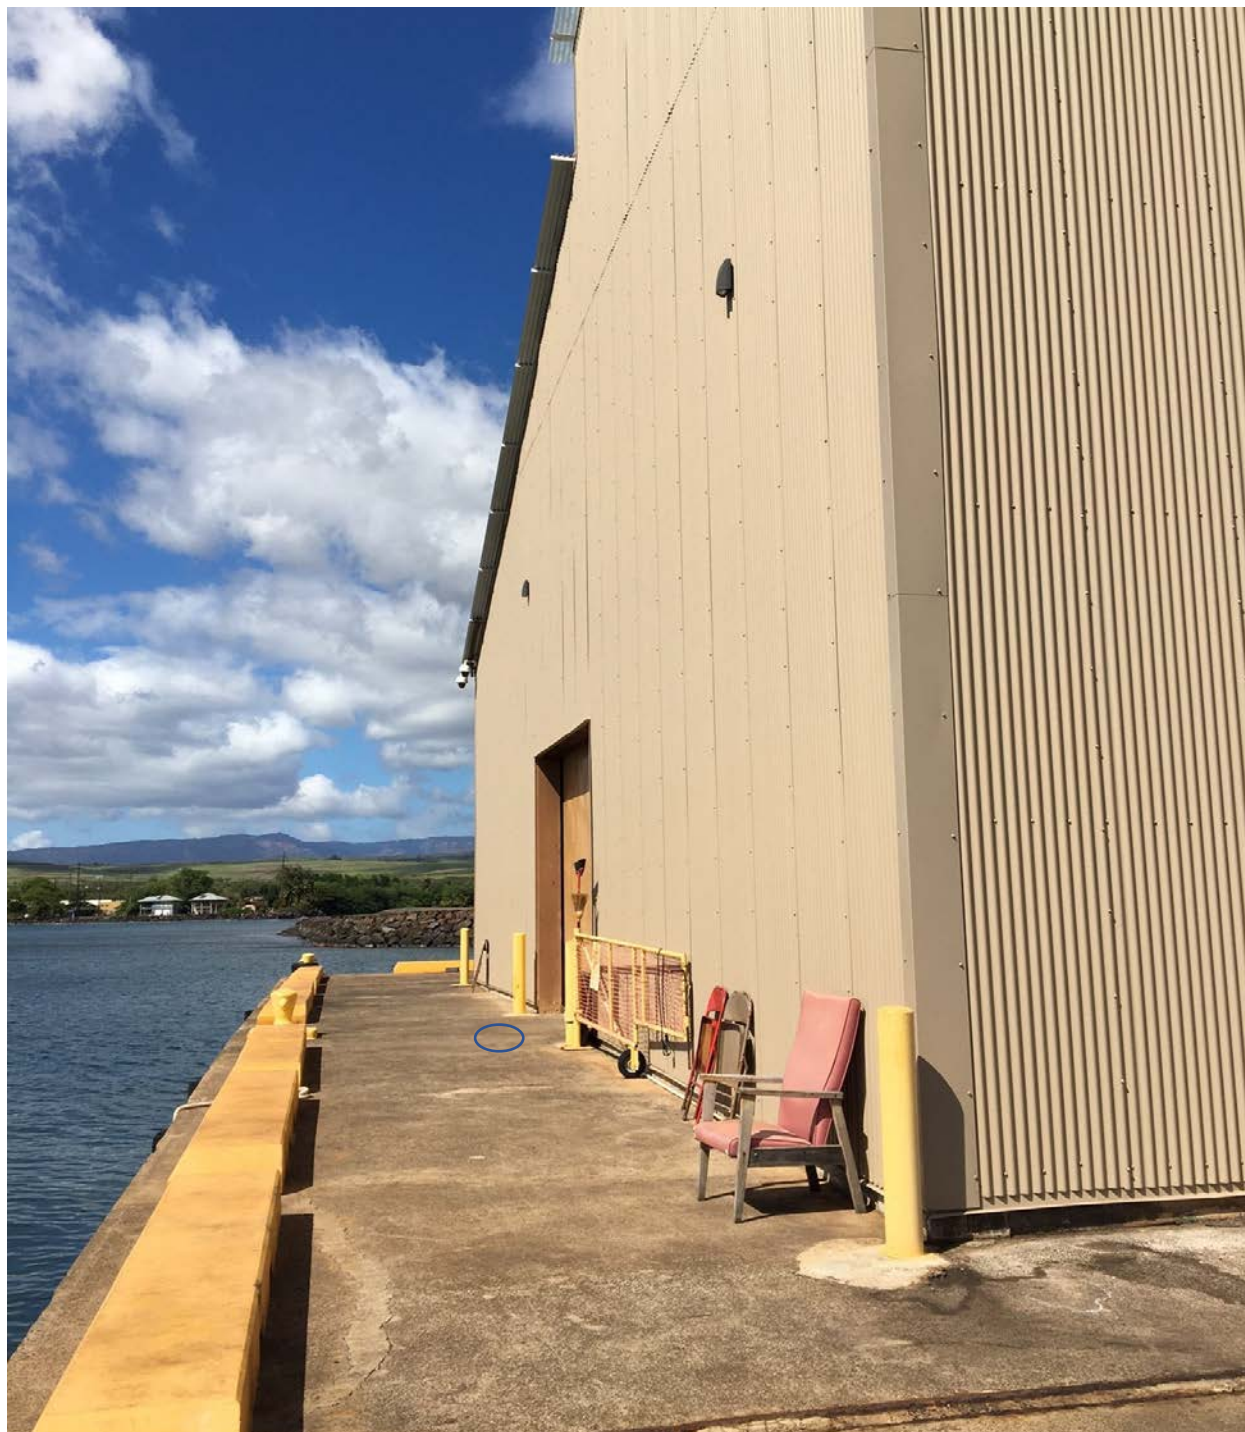
The seabird was alive and exhibited normal responsiveness when handled; left eye may have been irritated.

Uncertain as to the direct cause of any injuries. A fisherman nearby claimed that the bird had hit the side of the warehouse moments before the trained searcher arrived on scene. Unclear as to whether this is related to apparent eye trauma.

View of the general layout on the west side of the Port Allen Harbor pier. Note the oval indicating the approximate location where the shearwater was discovered near the base of the warehouse.

Secured the seabird inside the rescue carrier and transported to the Kalaheo Fire Station and placed securely in the SOS Aid Station.

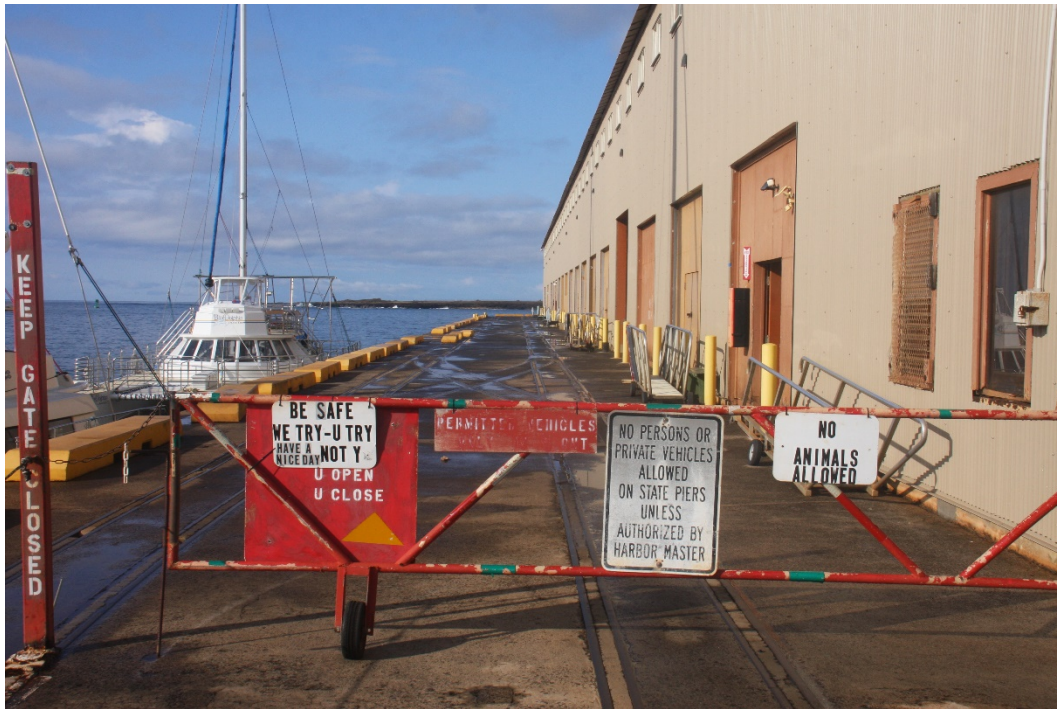
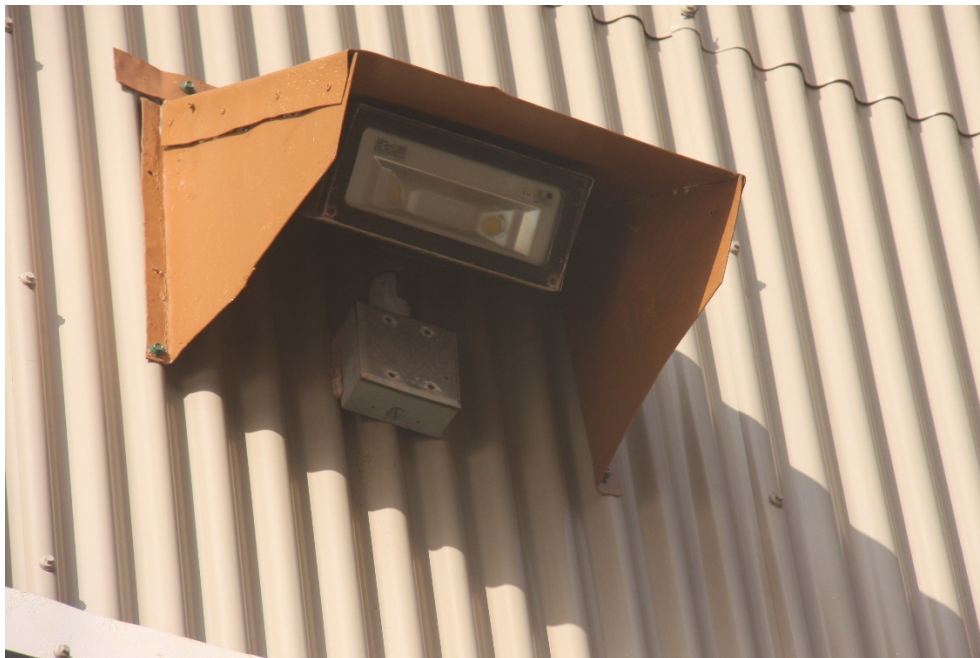
Photo 1 (above) presents a view along the south side of the main warehouse and pier at Port Allen Harbor with the newly installed siding and paint. Photo 2 (below) provides a view of the shielding that was installed on the main warehouse light in 2022.

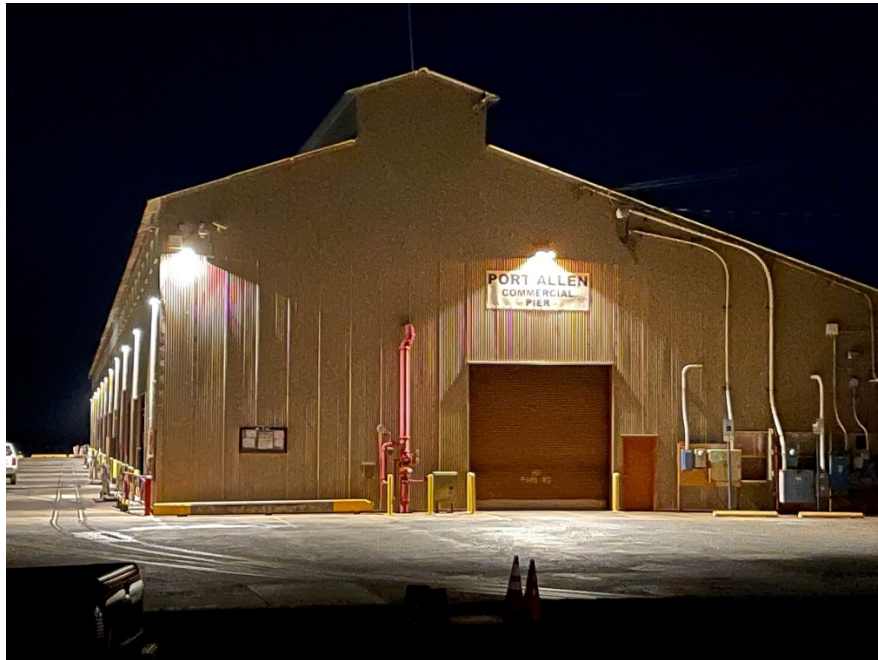
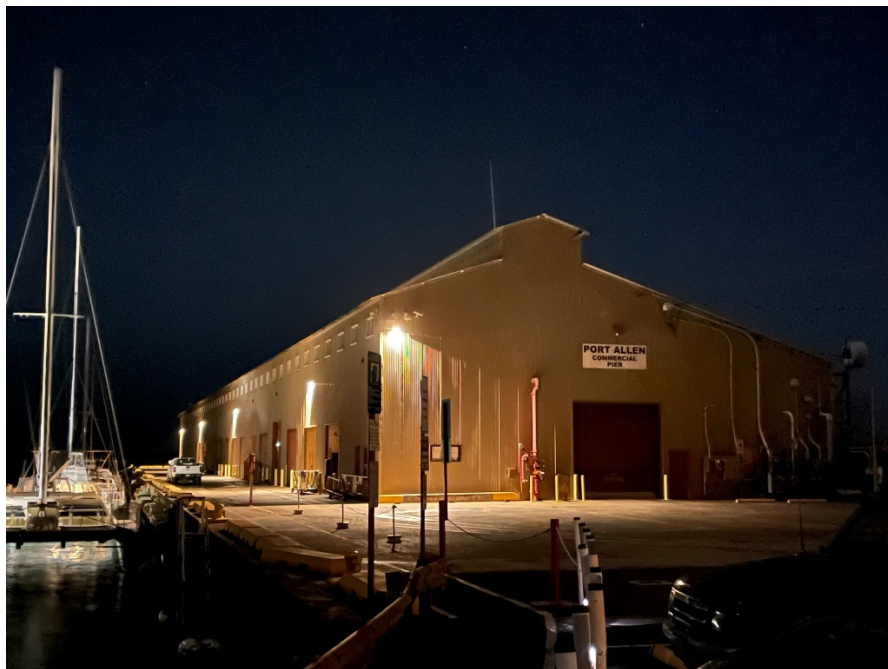
Photo 3 (above) captures the general light conditions with newly installed shielding on the main warehouse light prior to 20:30 at Port Allen Harbor; photo 2 (below) provides a contrasting light regime after 20:30 when the main warehouse light has dampened and every other wall-mounted light has also been turned off.
