KSHCP Participant Annual Report - Base Form

| Reporting Year | 2023 | Participant Name | Hawaii Department of Transportation | | |

KSHCP 2023 -- Summary of Take of Covered Seabirds Documented at Nawiliwili Harbor, Kauai

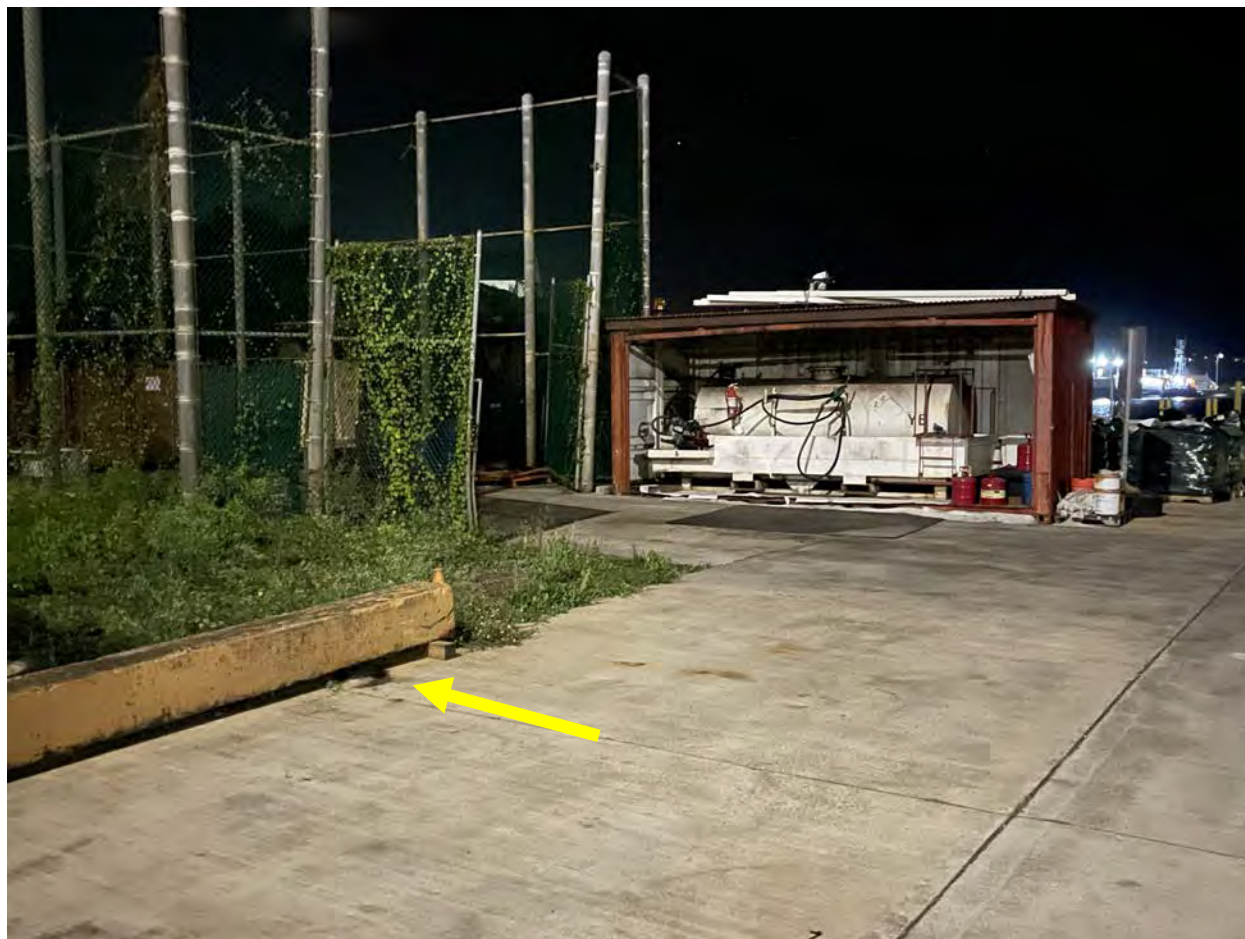
Newell's shearwater (*Puffinus newelli*) discovered by monitoring personnel at Nawiliwili Harbor on the evening of October 9, 2023.

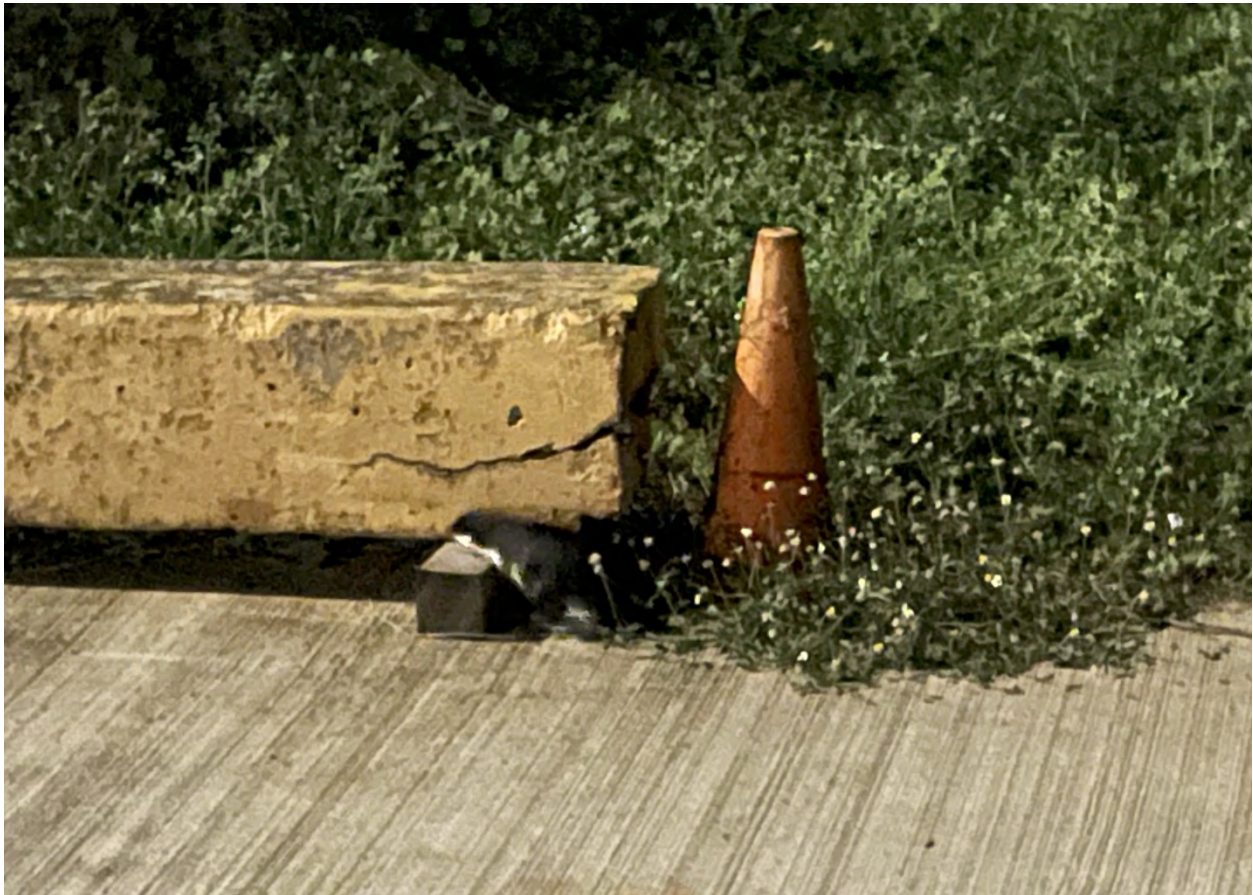
This energetic Newell's shearwater, probably a hatch year fledgling, was discovered during routine searches to locate and rescue seabirds that are grounded seasonally due to light attraction disorientation.

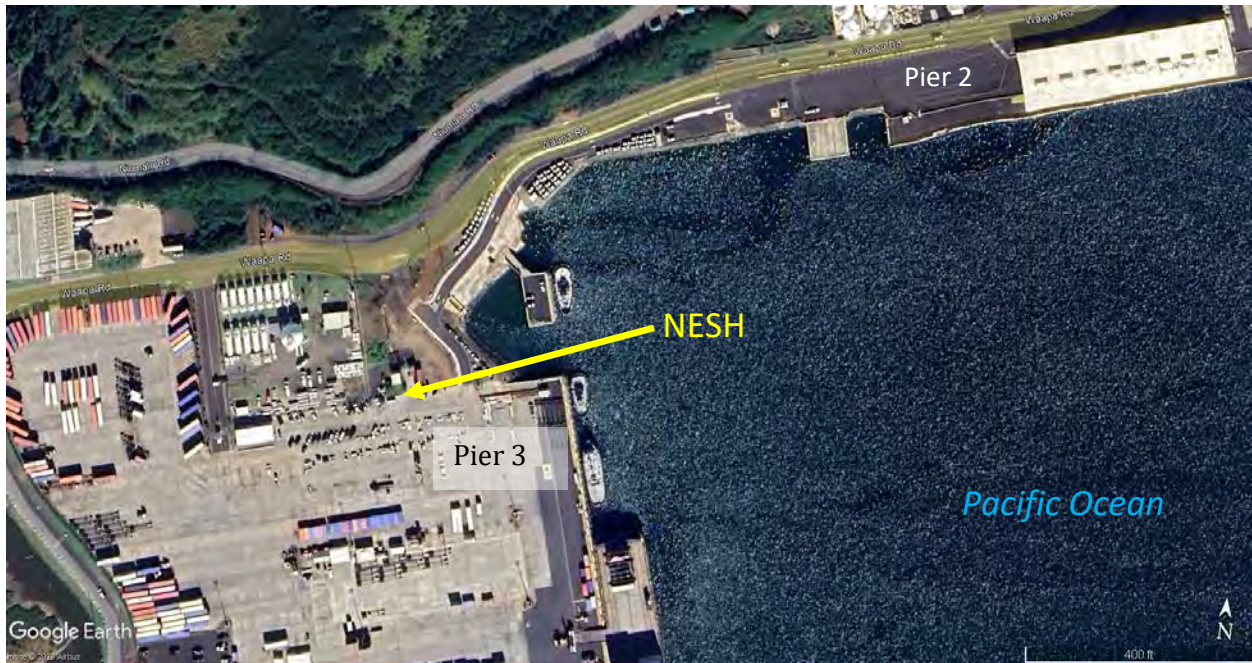
Overview of harbor facilities and infrastructure where the Newell's shearwater was discovered at Nawiliwili Harbor on October 9, 2023.

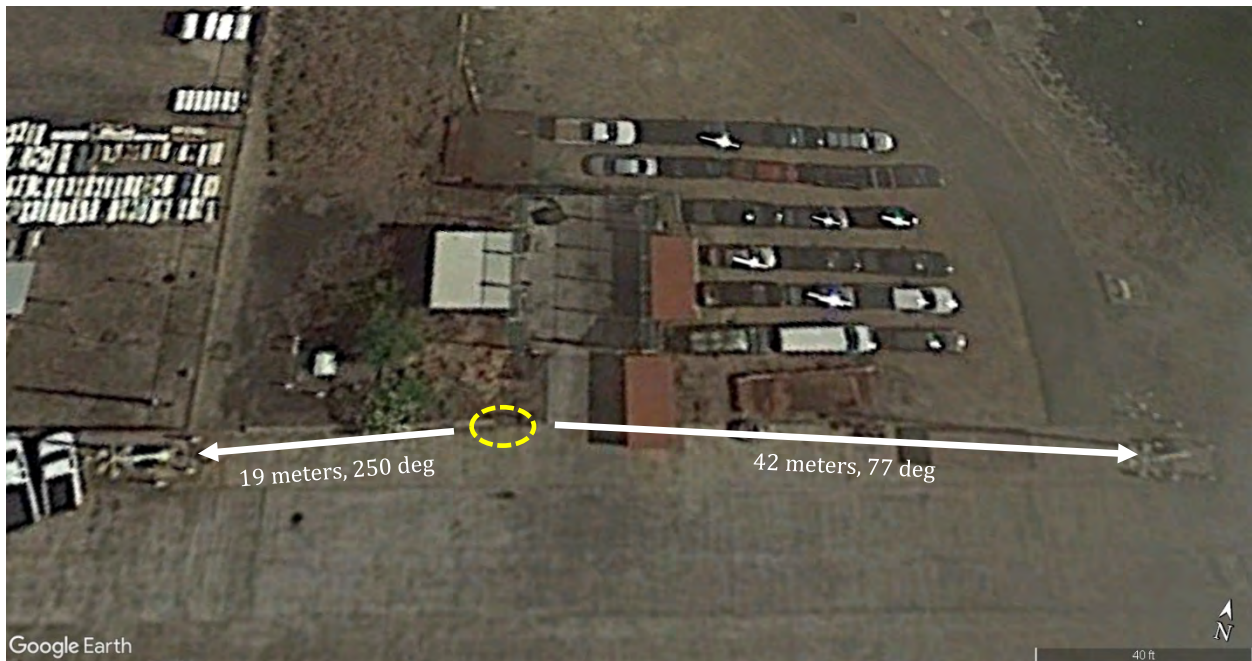
Shearwater discovery location and distance and direction to nearest high mast lights.

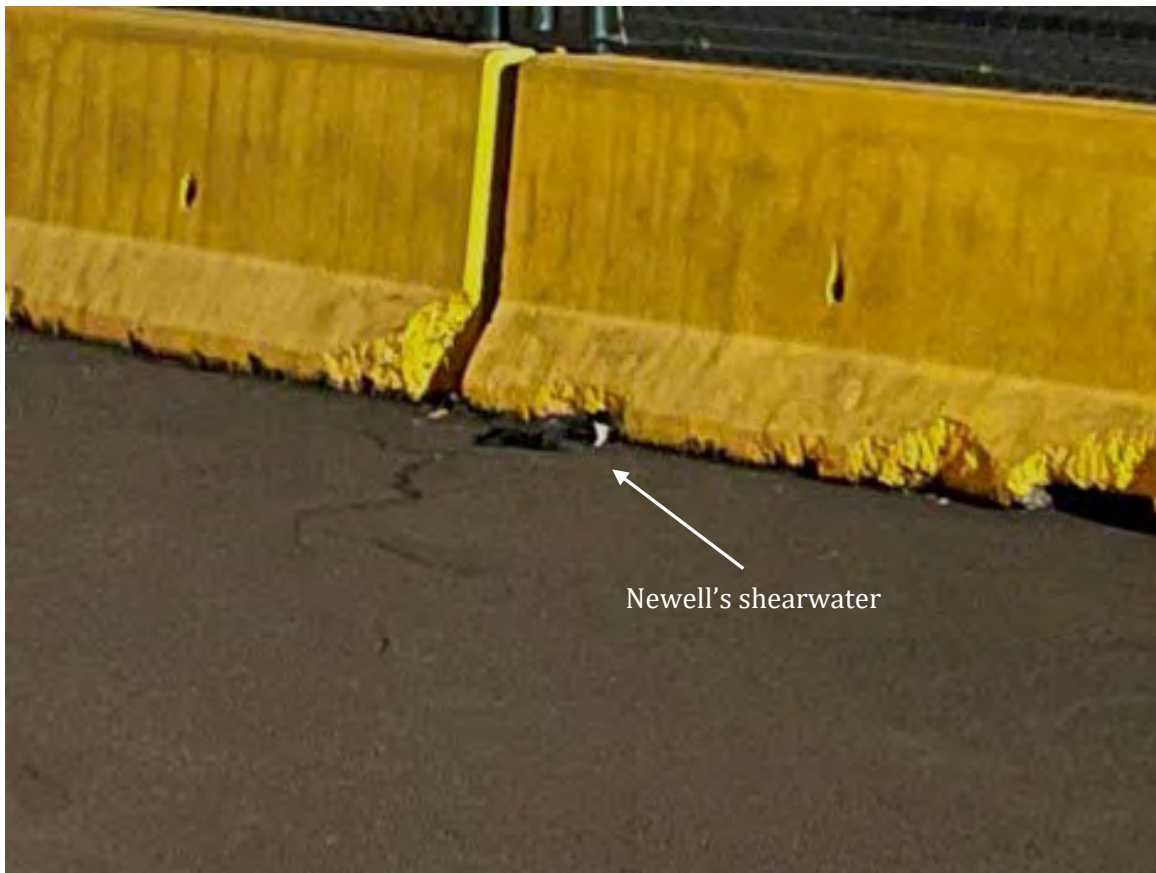
Newell's shearwater (presumably a fledgling) discovered during routine seabird light attraction fallout monitoring at Nawiliwili Harbor, island of Kauai, October 14, 2023.

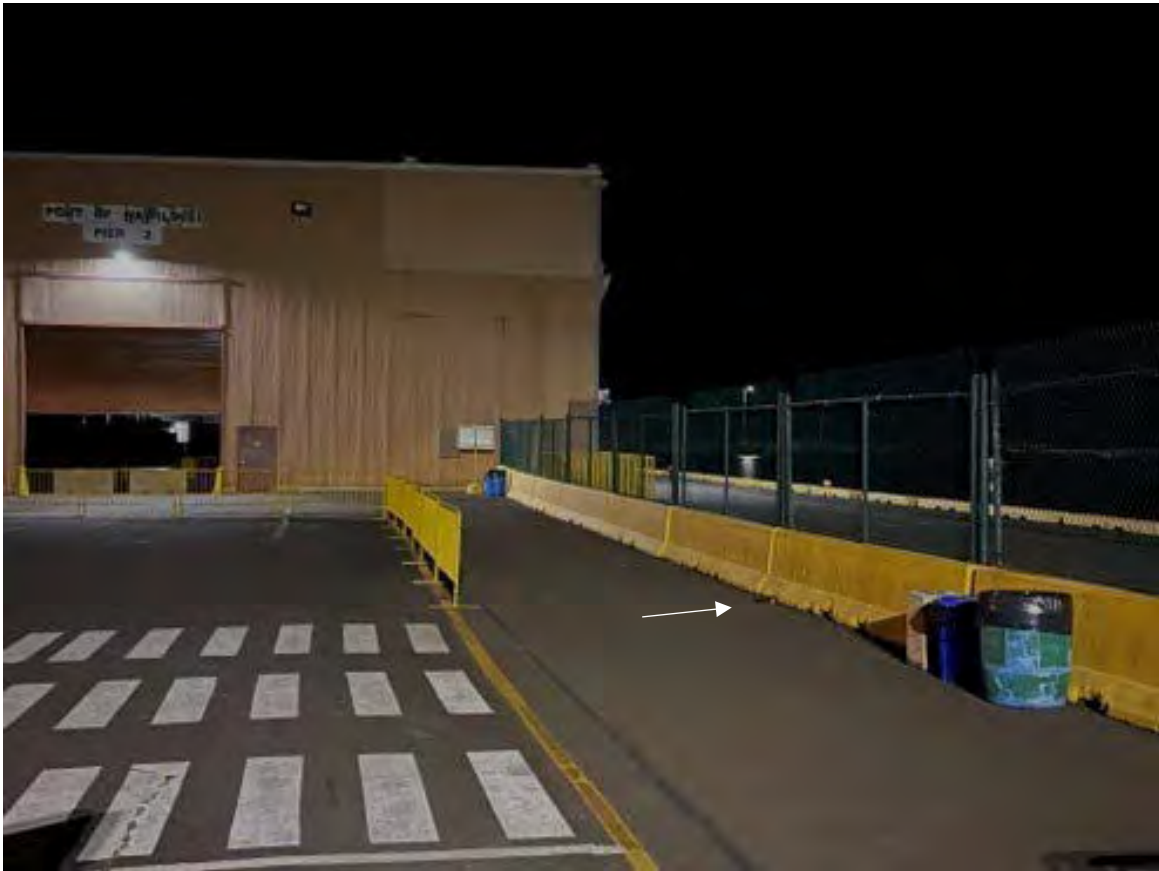
A grounded Newell's shearwater can be seen along the edge of a security barrier WSW of the Pier 2 warehouse at Nawiliwili Harbor, October 14, 2023.

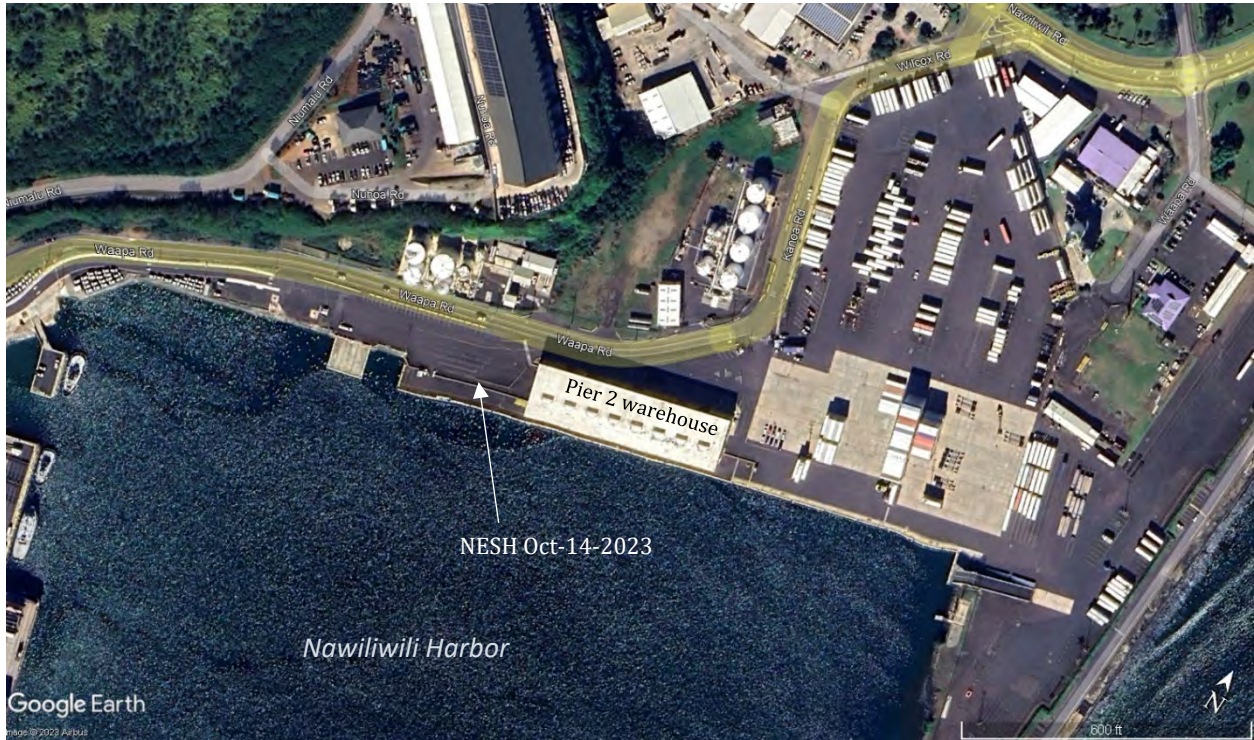
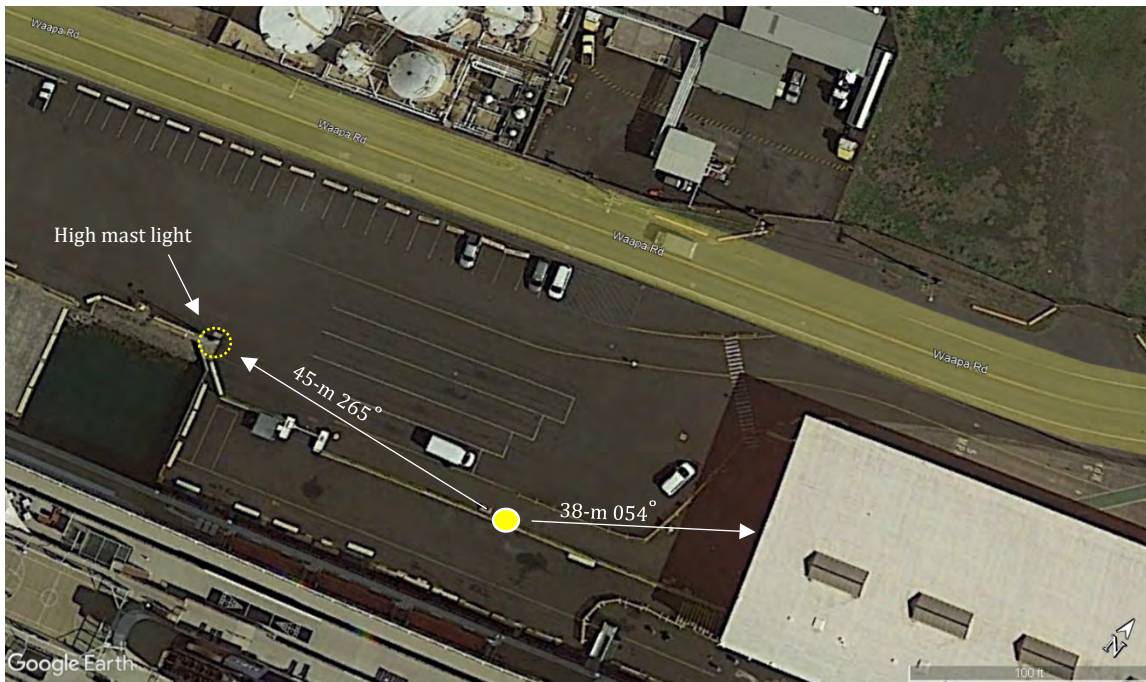
Wide view image showing vicinity infrastructure of Nawiliwili Harbor, port facilities, and location of Newell's shearwater (above); closer view of the shearwater grounding area and distance to nearest lights (below).

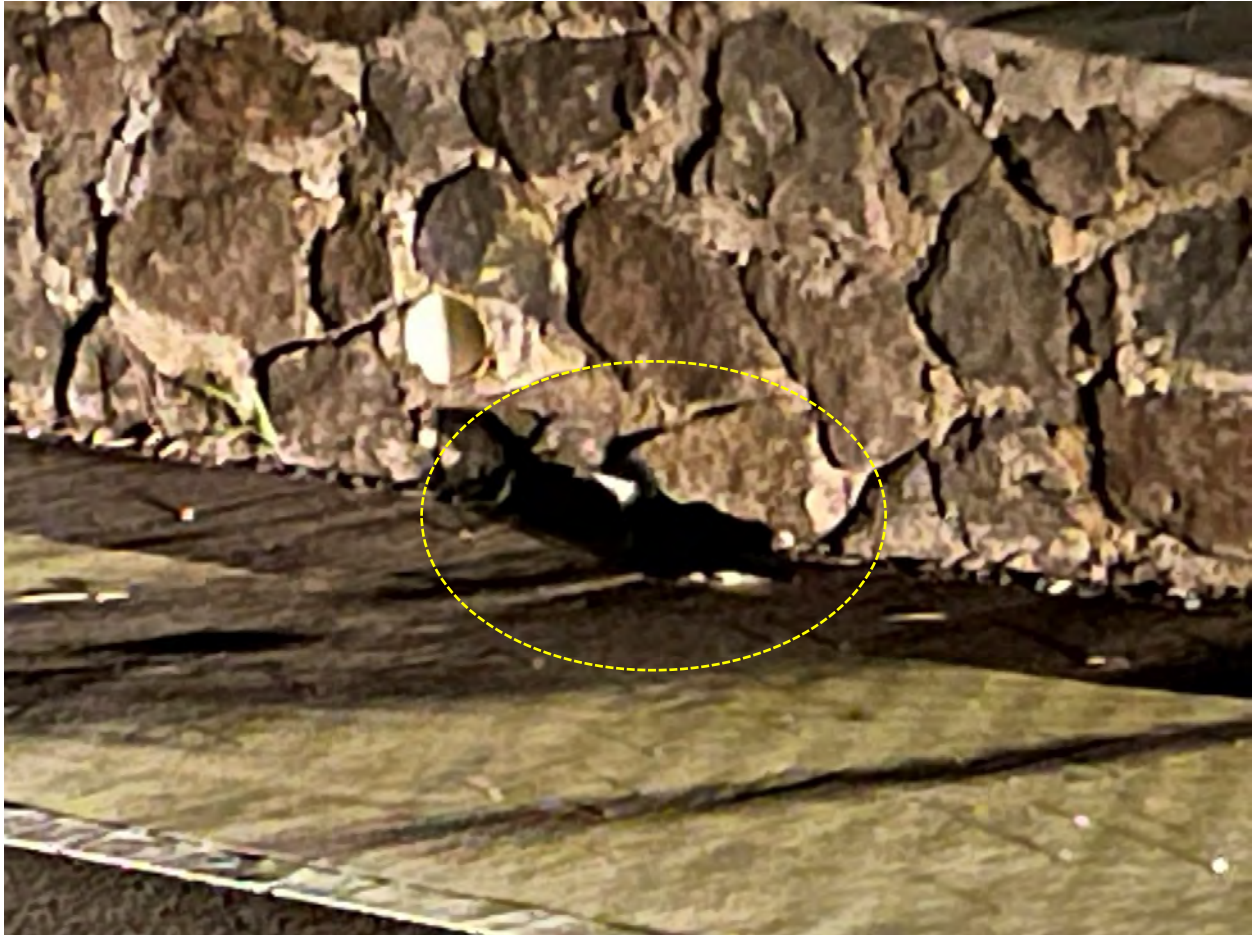
Newell's shearwater discovered by search personnel conducting seabird light attraction fallout monitoring at Nawiliwili Harbor, October 14, 2023.

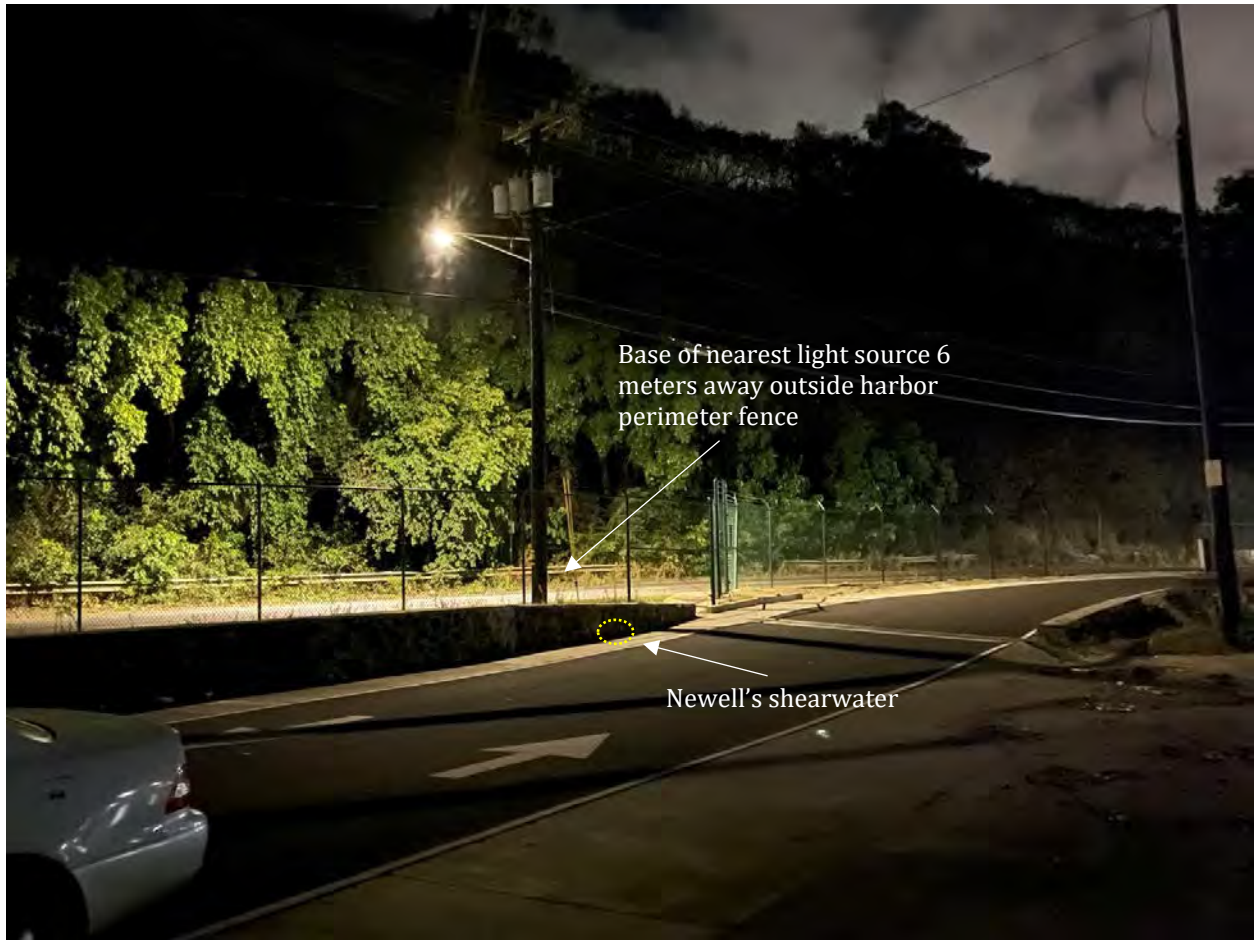
Base of nearest light source 6 meters away outside harbor perimeter fence

Location where a Newell's shearwater was discovered along the access road between Pier 2 and Pier 3 along a low rock wall adjacent to Waapa Road.

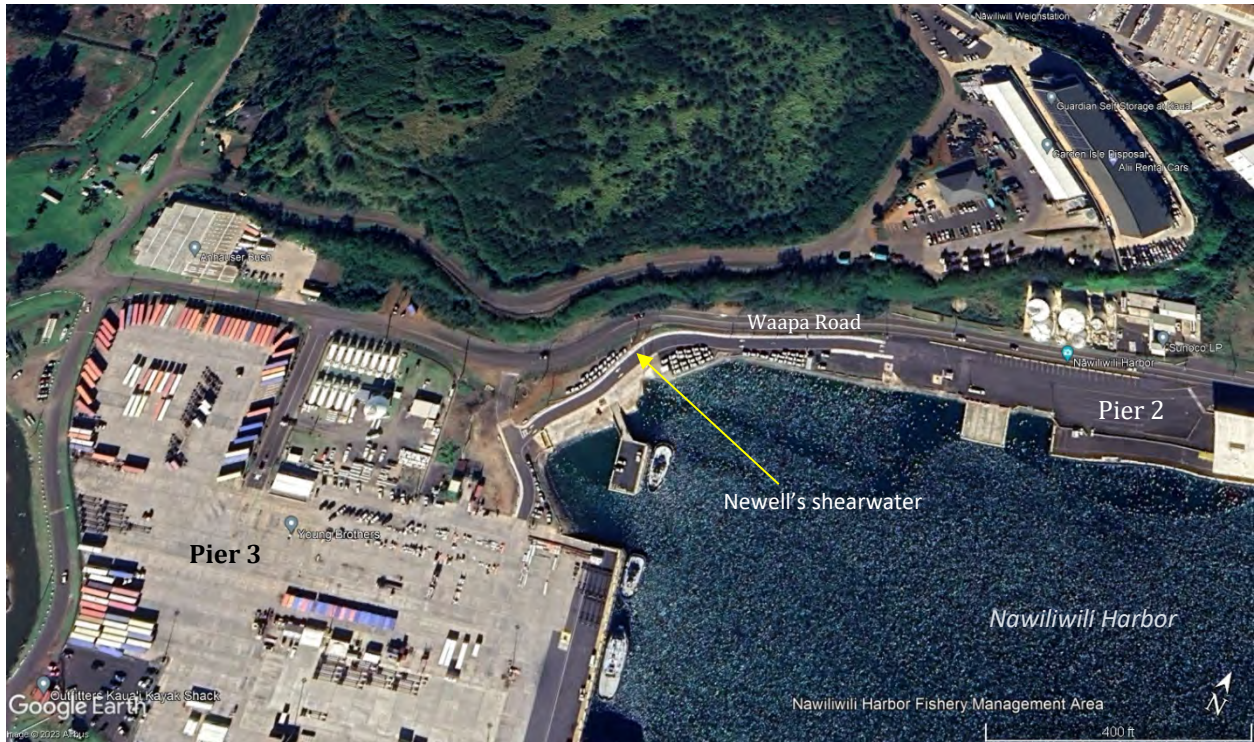
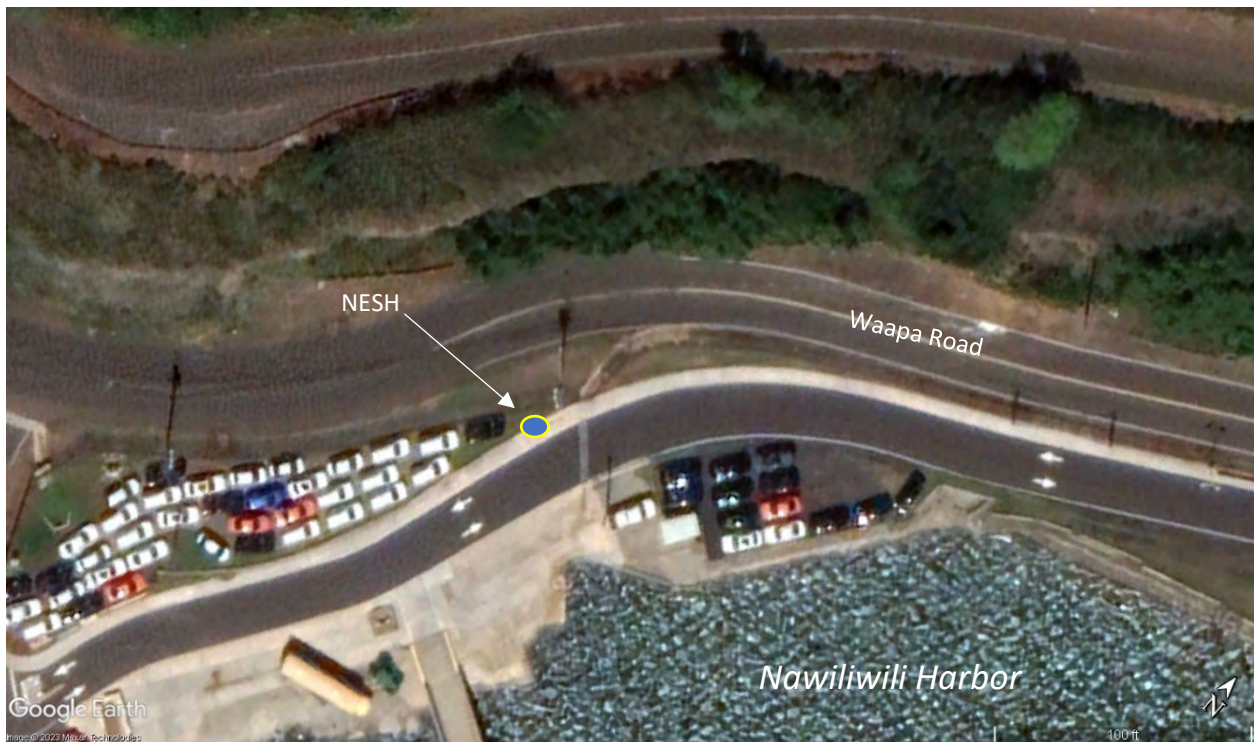
Overview of Nawiliwili Harbor facility infrastructure and location of Newell's shearwater grounding (above) and zoomed in to show specific point where the shearwater was discovered (below).

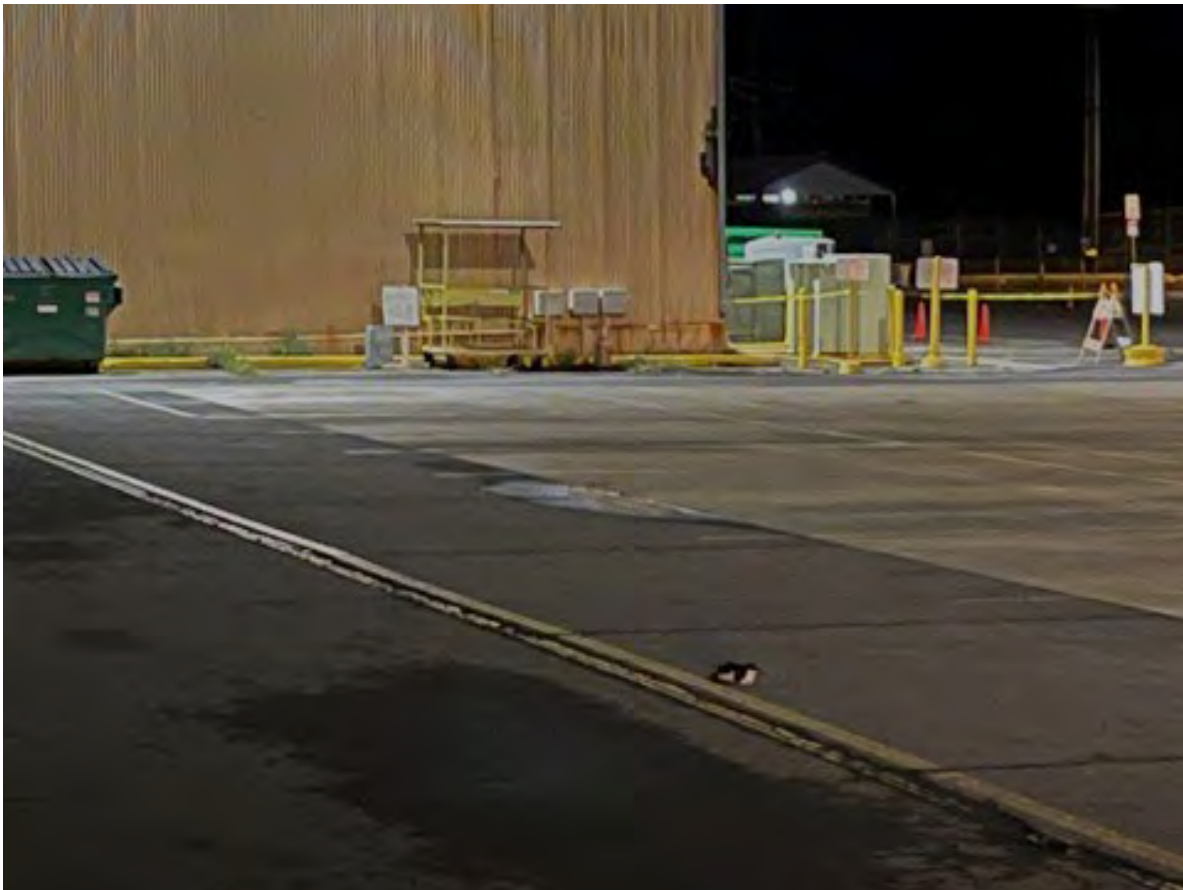
A grounded Newell's shearwater was discovered during routine seabird monitoring activities at Nawiliwili Harbor, island of Kauai, on October 15, 2023. The discovery is consistent with the well-documented island-wide peak of fledging for Newell's shearwaters, amplified in some years by the timing of the new moon.

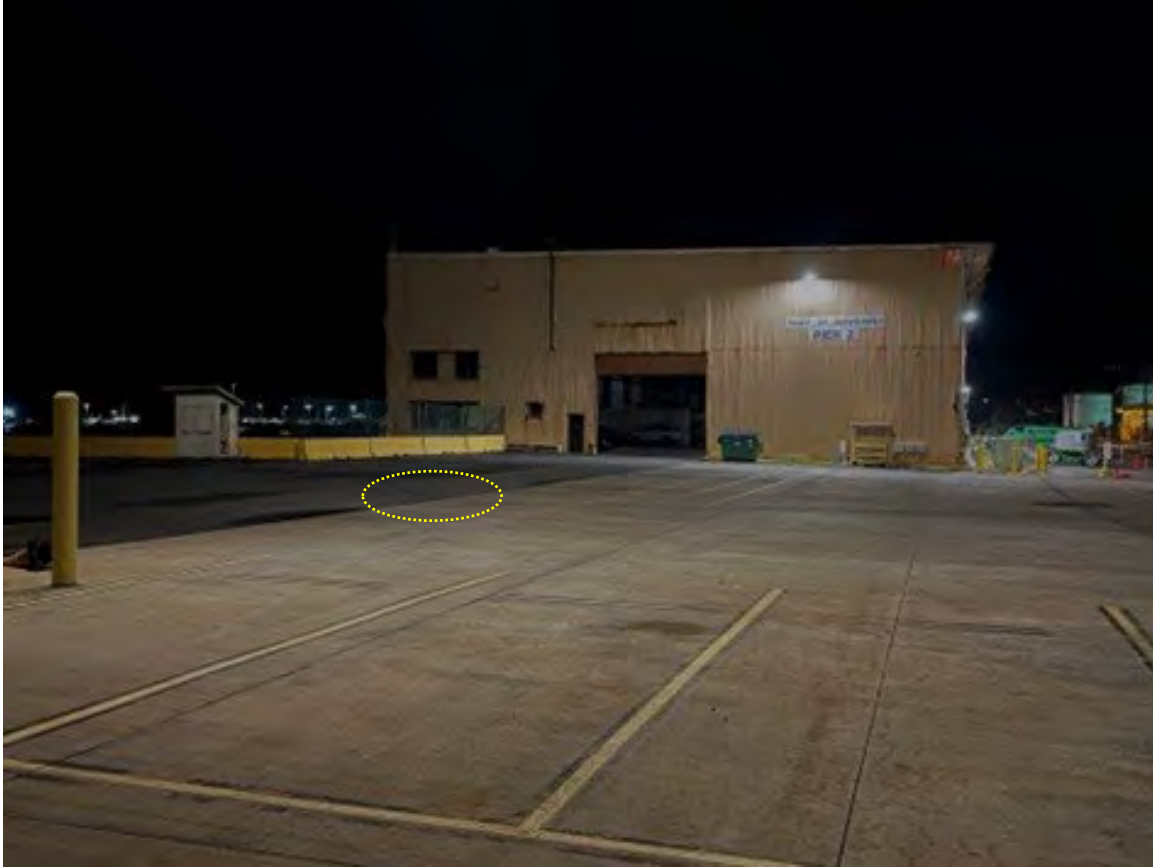
Vicinity of the grounding location for the Newell's shearwater discovered on October 15, 2023, at Nawiliwili Harbor; facing the east end of the warehouse. Though no longer present in the image, the dashed oval approximates the location of the discovery.

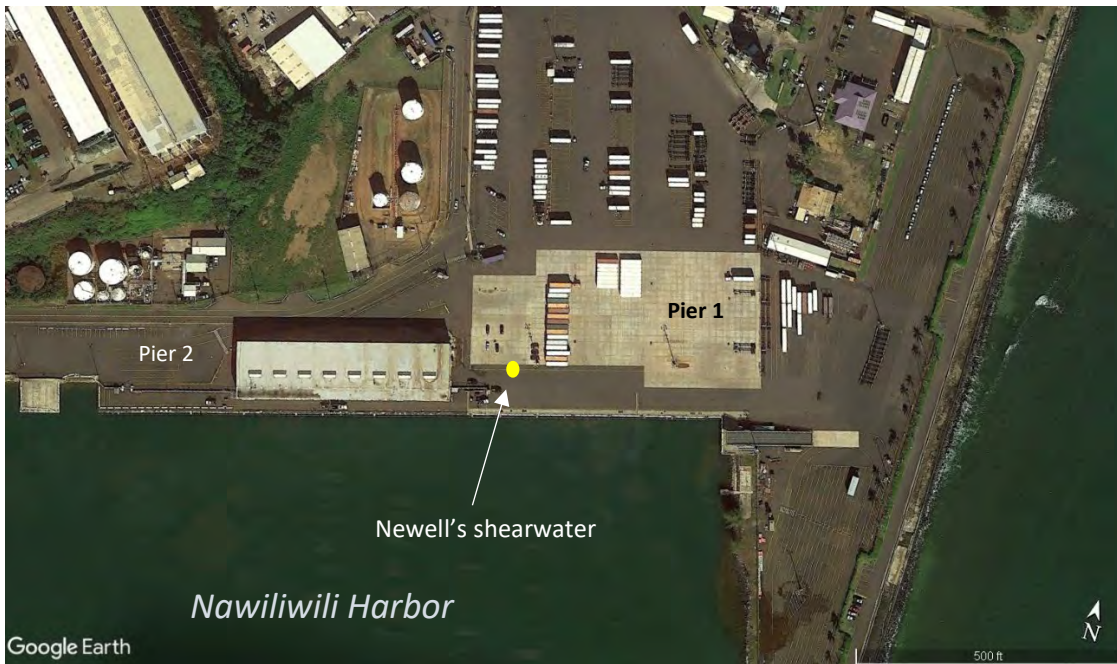
Nawiliwili Harbor facilities and location of Newell's shearwater.

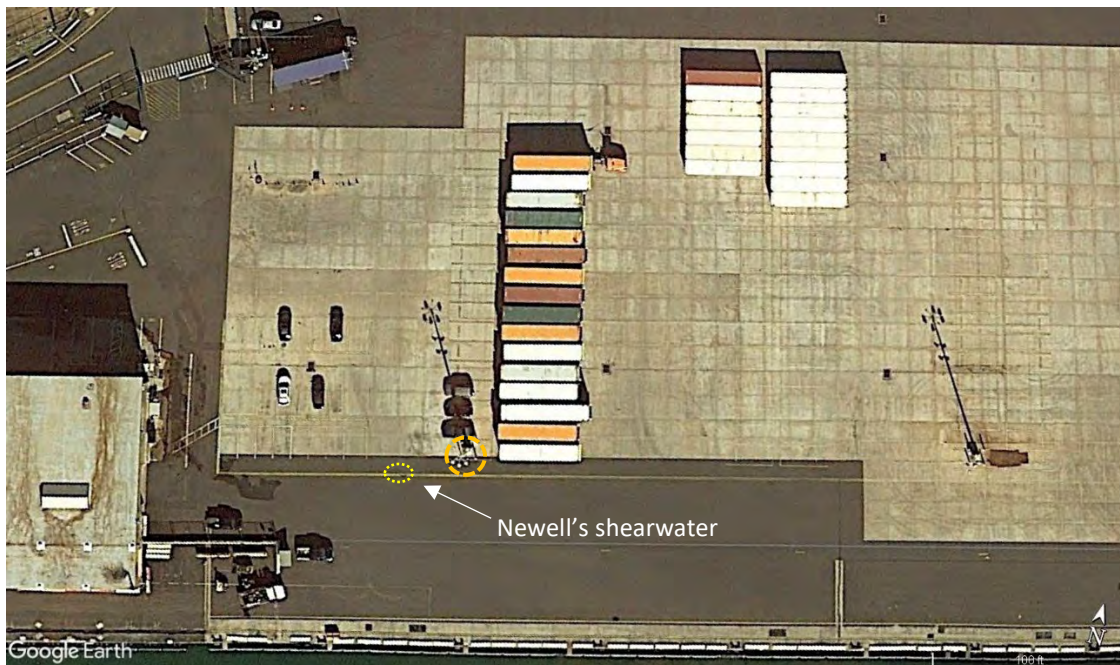
Location of Newell's shearwater discovery and nearest high mast light (12 meters bearing 56°) a distance of 37 meters bearing 265° to the warehouse wall-mounted light.

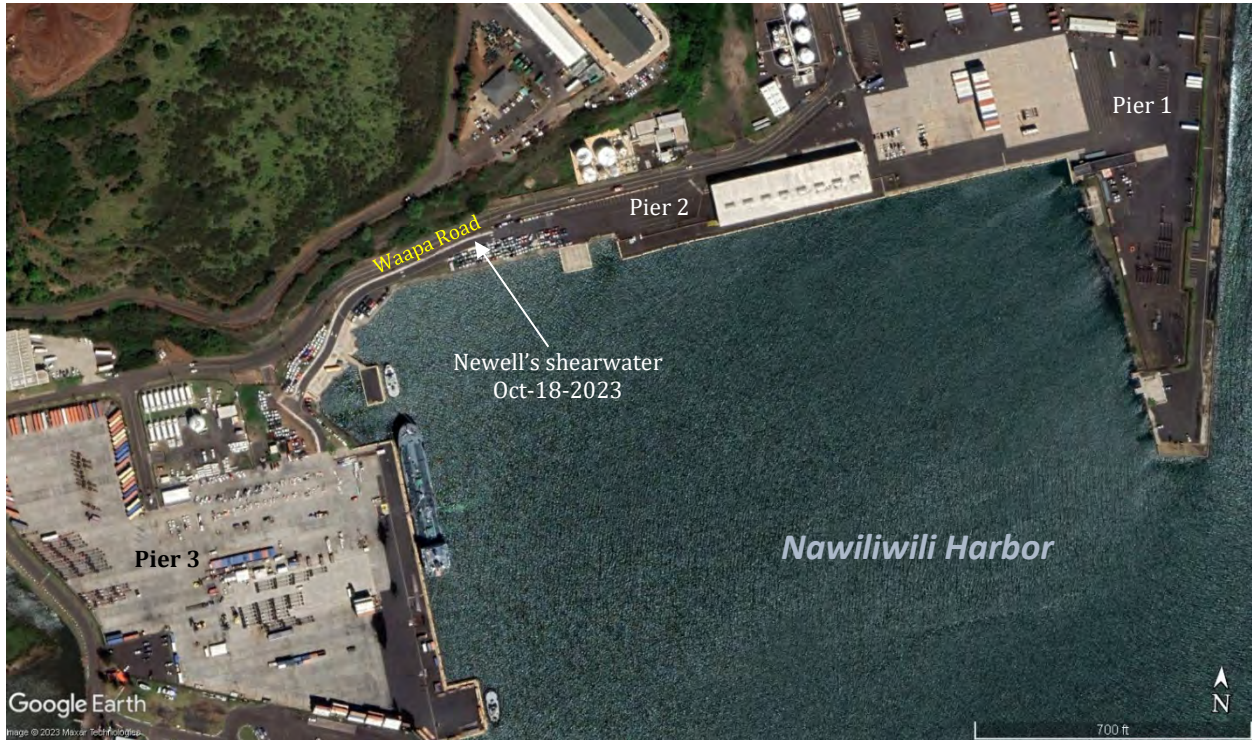
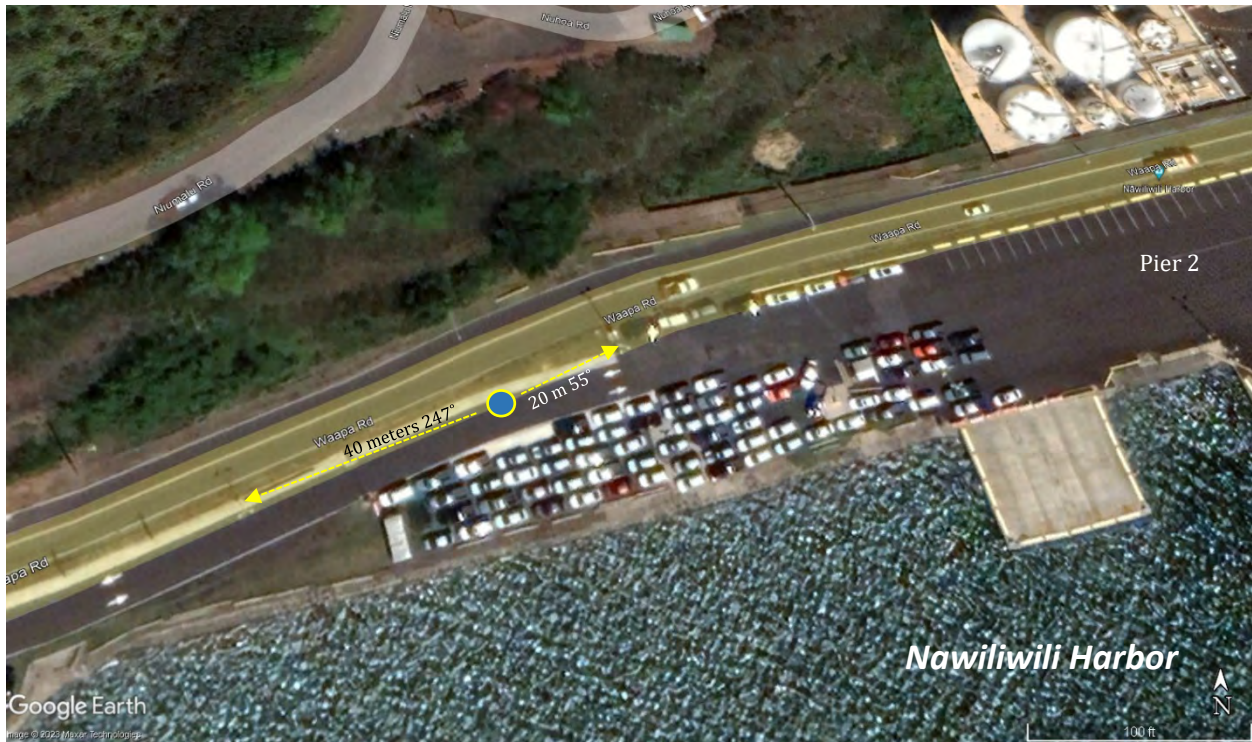
Location of a Newell's shearwater discovered at Nawiliwili Harbor on October 18, 2023 (above) and relative distance and bearings of two nearby high mast lights (below).

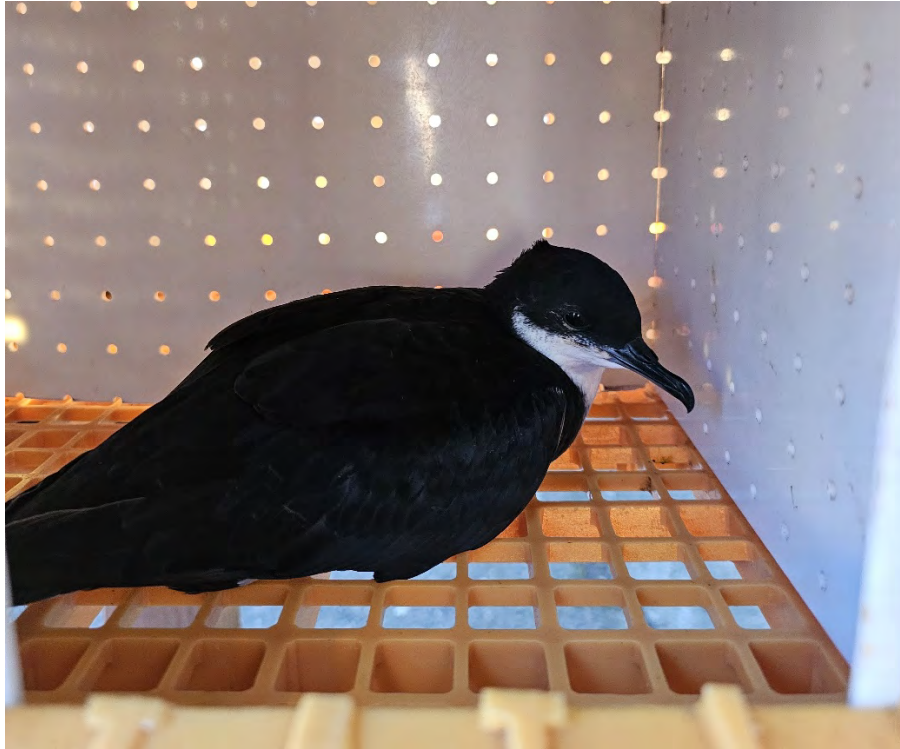
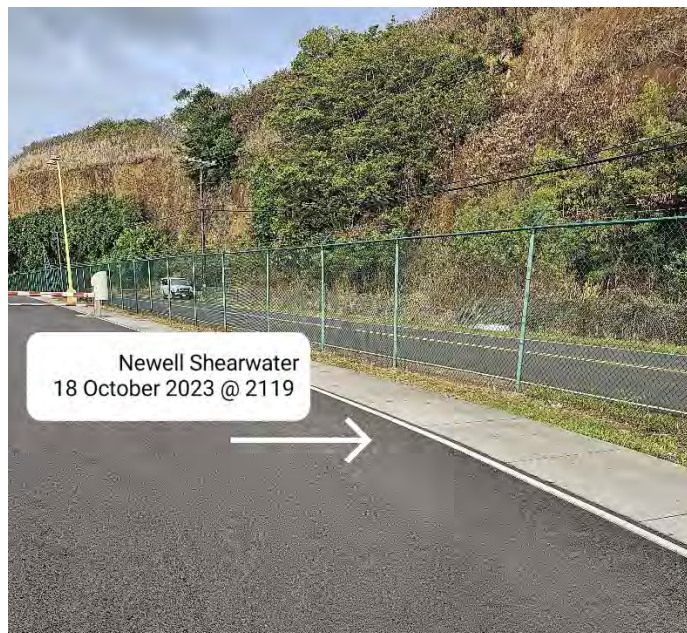
Newell's shearwater, presumably a fledgling, resting securely inside the SOS Aid Station at Nawiliwili Harbor (above) and vicinity features where the shearwater was discovered (below).

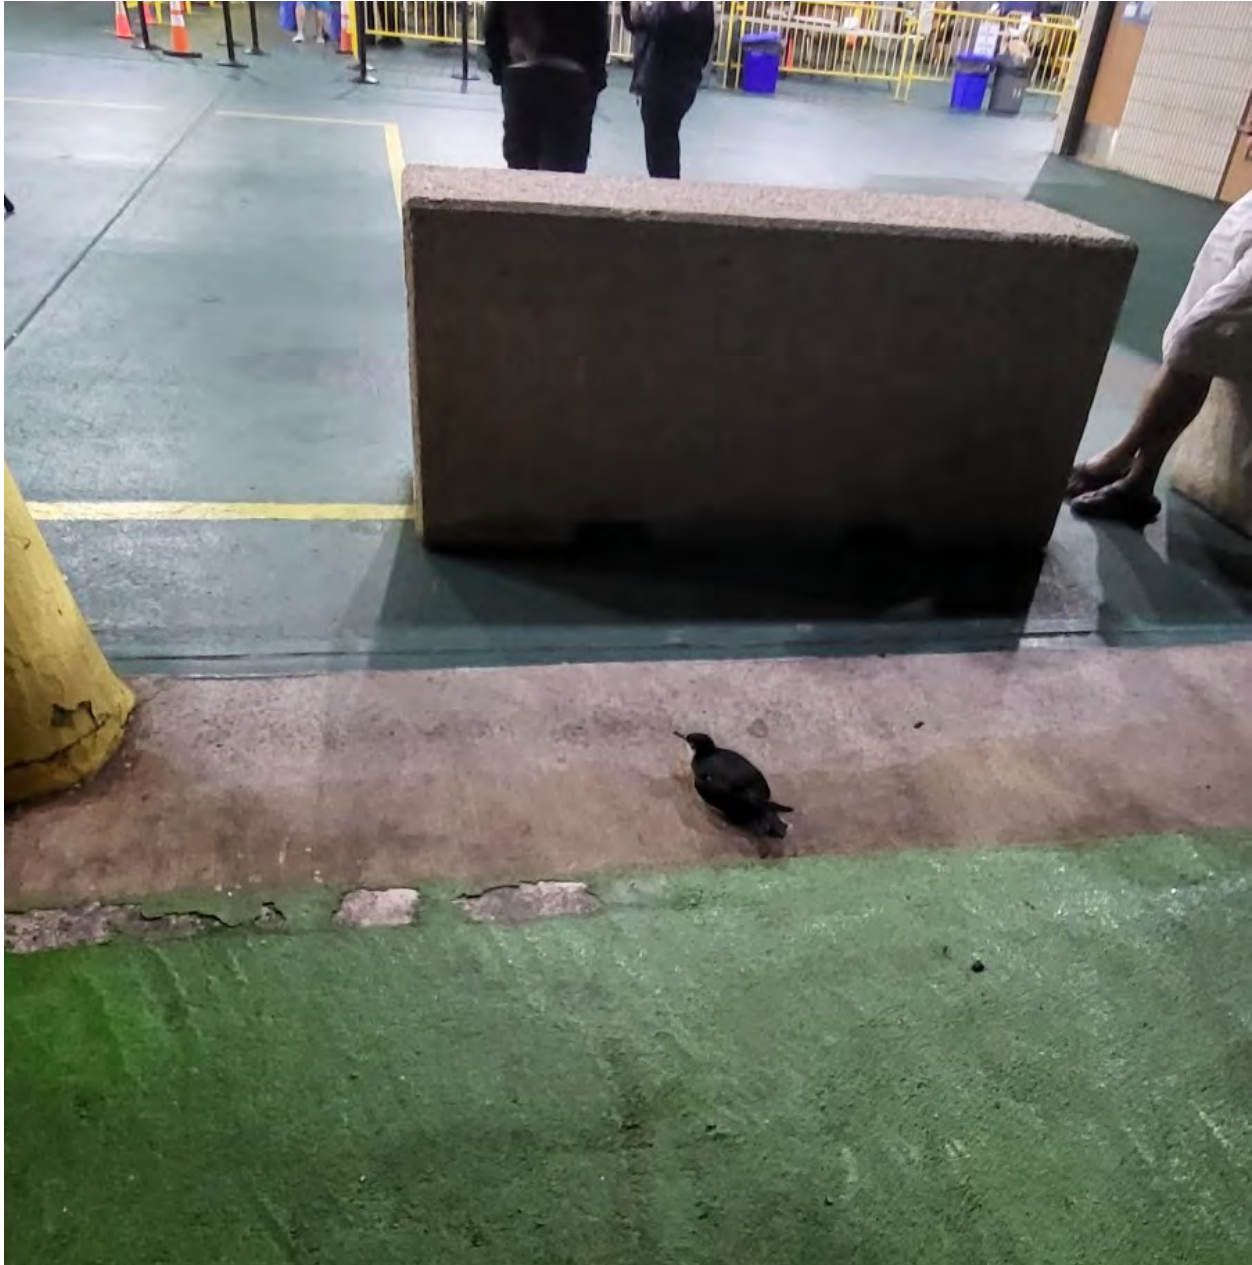
This Newell's shearwater was discovered and reported on October 19, 2023, outside the active cruise ship terminal at Nawiliwili Harbor, an area frequented by passengers and support personnel during vessel overnights. Harbor security responded quickly by securing the seabird and carefully placing it in the SOS Aid Station, located a short distance away next to the main gate.

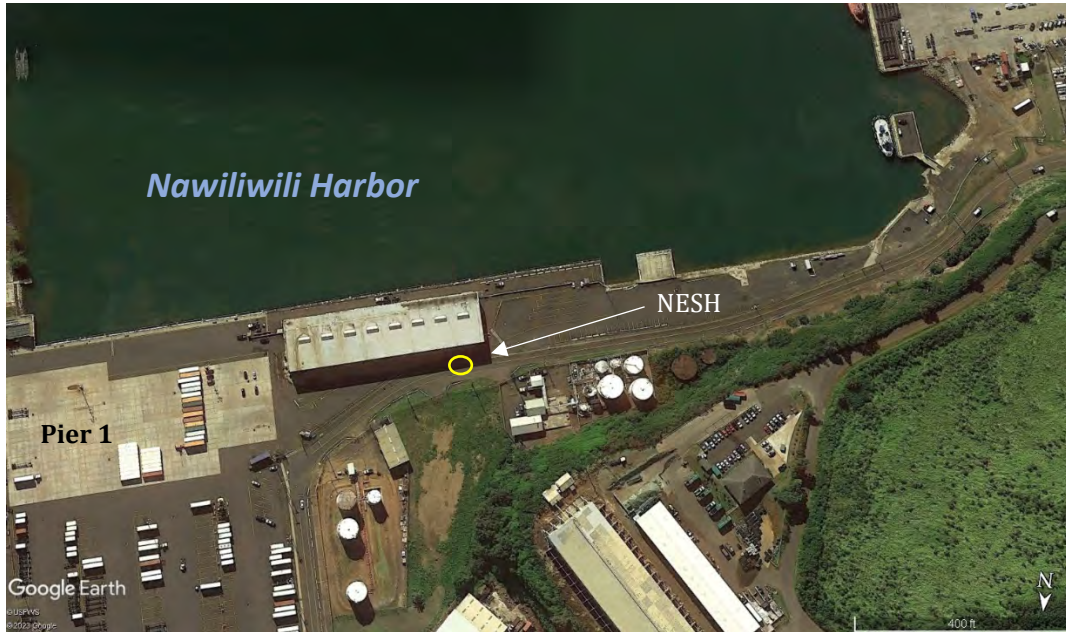
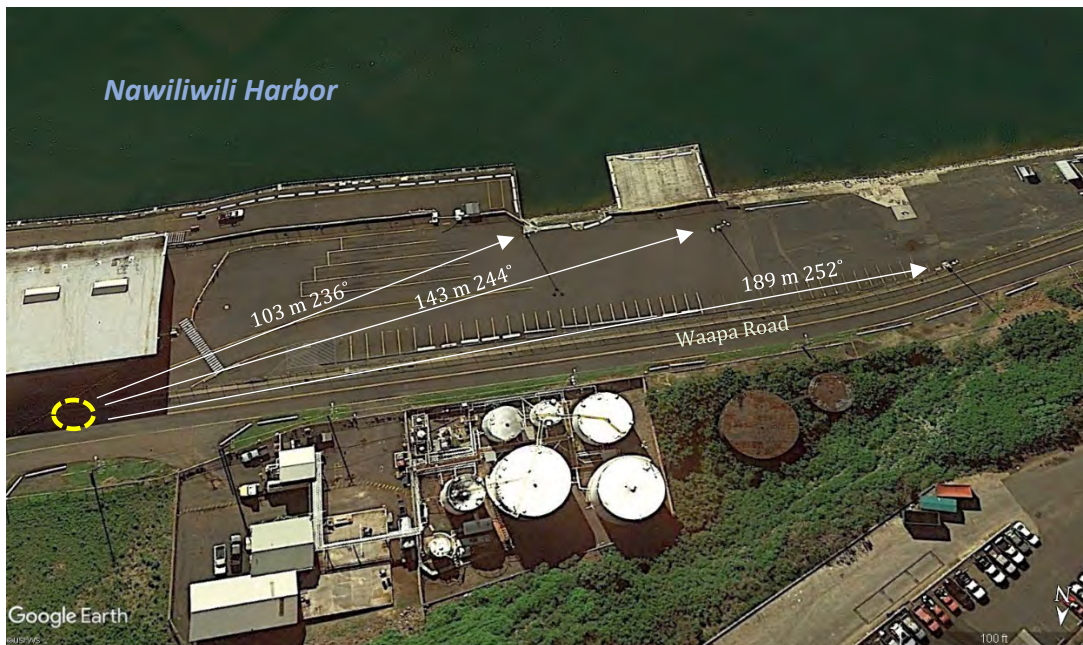
The top image provides a view of Pier 2 and sections of Piers 1 and 3, and the general location of the Newell's shearwater (NESH) is noted by the yellow oval. The lower image provides a closer view of the position of the shearwater (dashed oval) when it was discovered relative to the distance and direction to the nearest high mast lights.

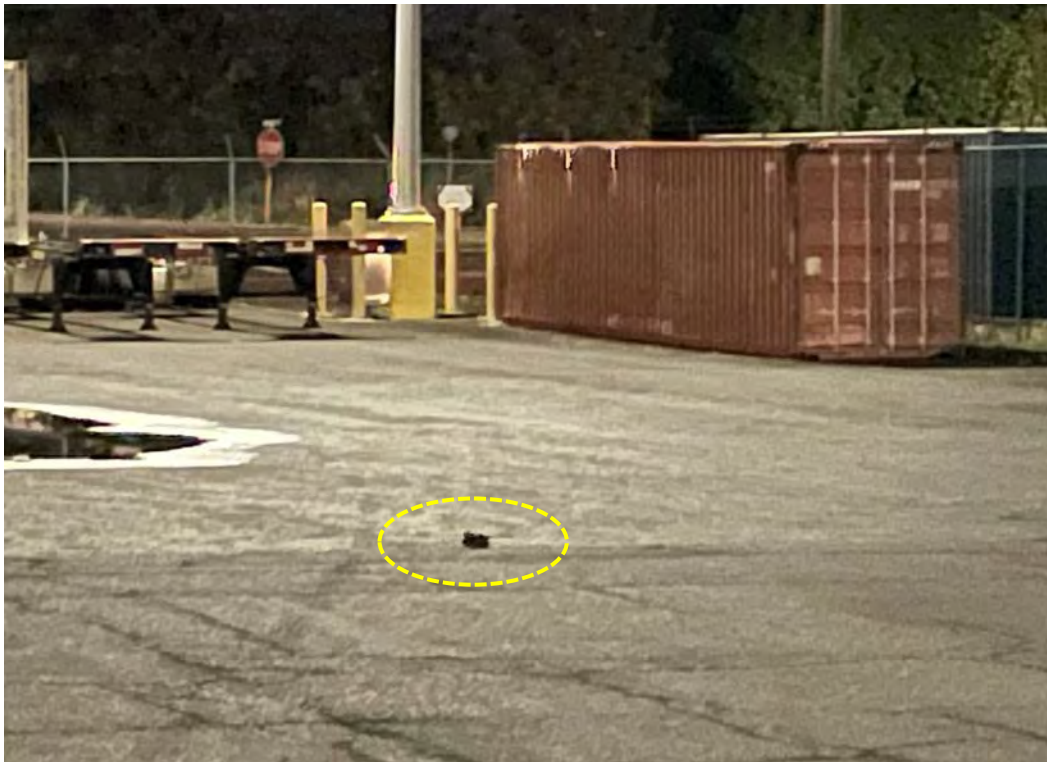
Visible in the open Pier 1 yard, this Newell's shearwater, discovered grounded at Nawiliwili Harbor on October 20, 2023, was alive and did not exhibit signs of injury.
