KSHCP Participant Annual Report - Base Form

| Reporting Year | 2023 | Participant Name | Hawaii Department of Transportation | | |

KSHCP 2023 -- Summary of Take of Covered Seabirds Documented at Nawiliwili Harbor, Kauai

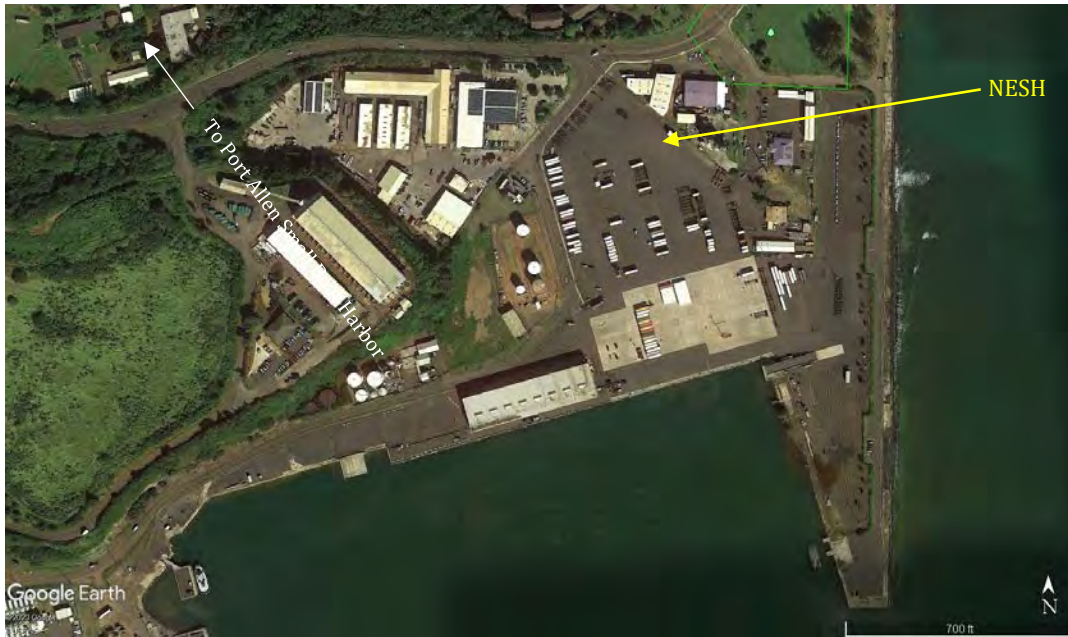
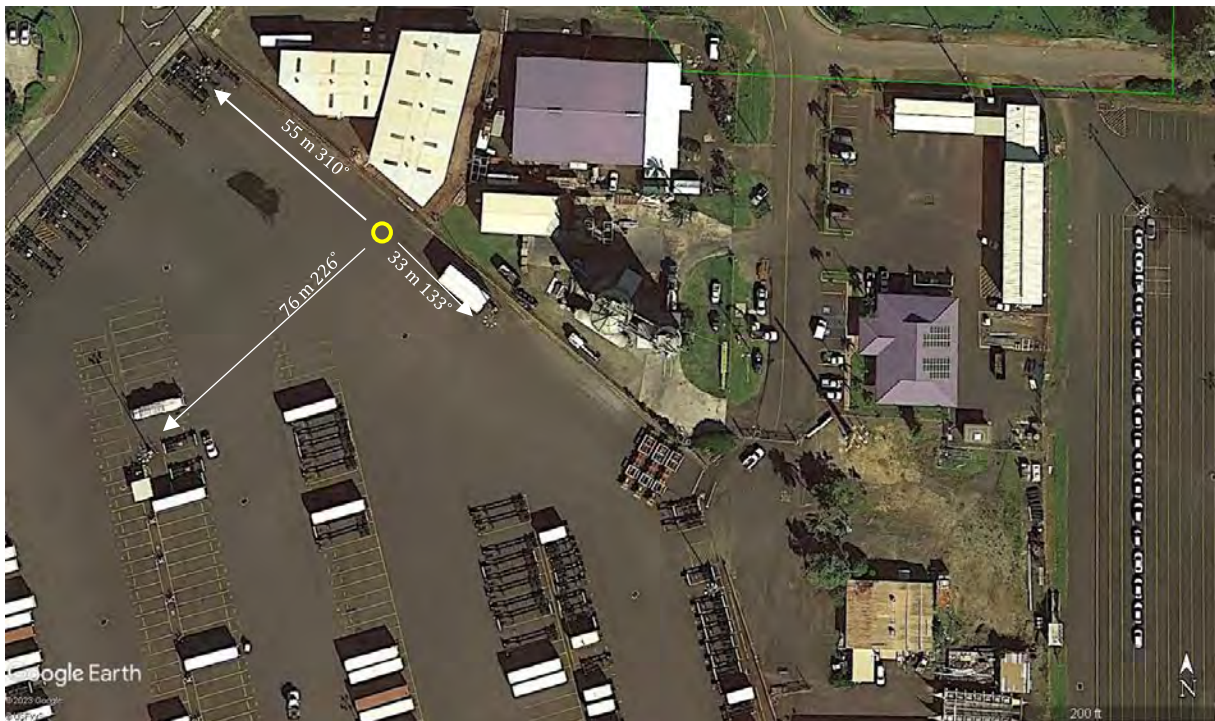
Wide-scale overview shown in the top image provides reference to the location where a Newell's shearwater was discovered on October 20, 2023. The image below provides distances and directions to the nearest high mast lights relative to where the shearwater was discovered.

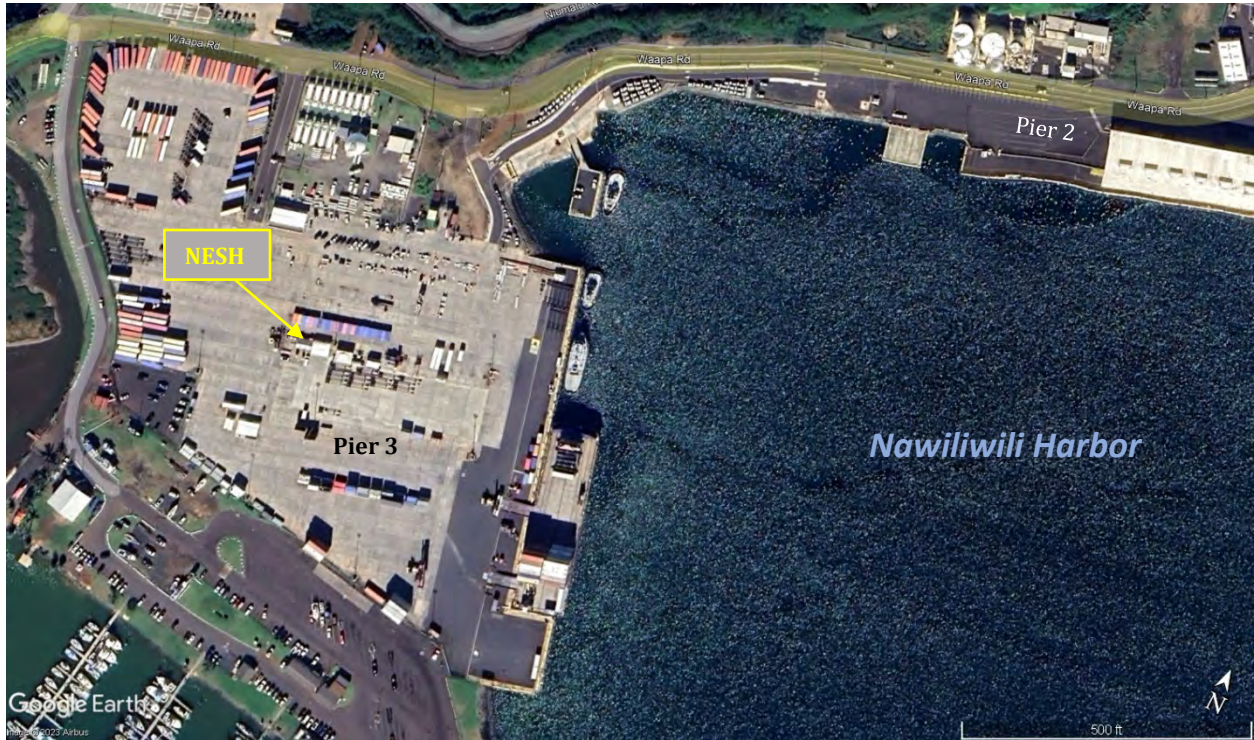
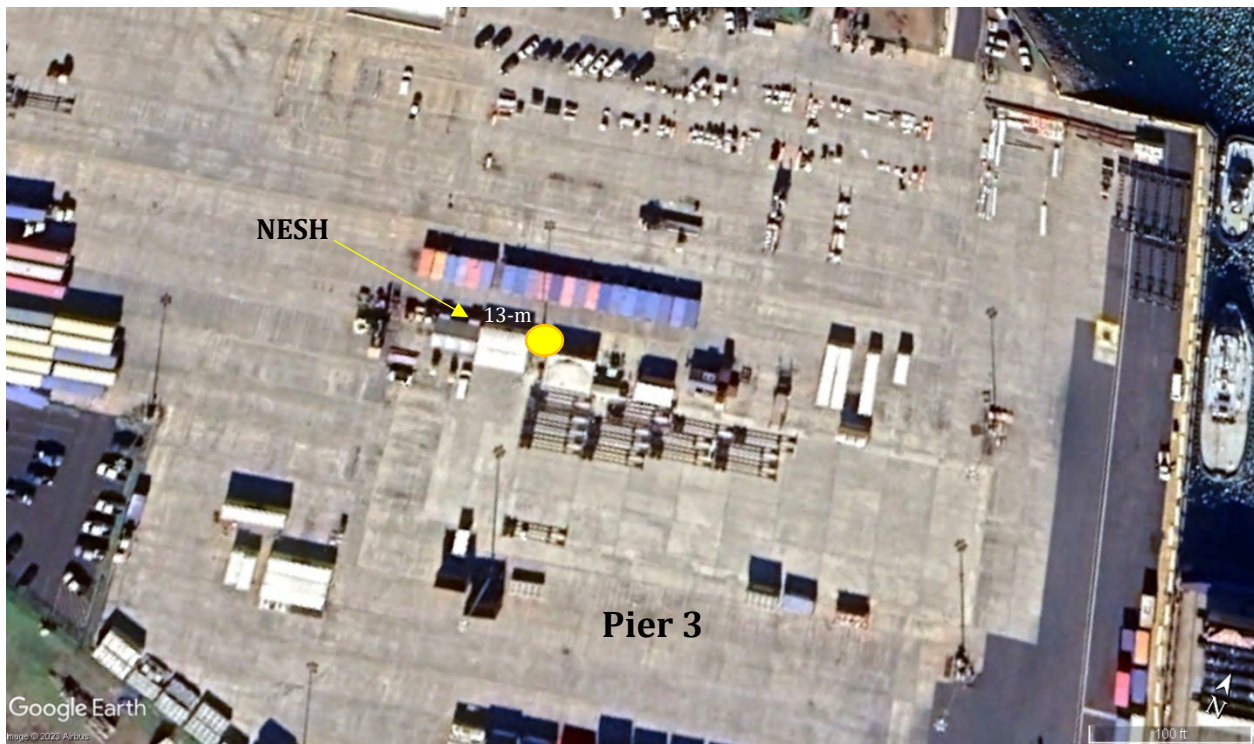
Location where a Newell's shearwater (NESH) was discovered in the Pier 3 yard at Nawiliwili Harbor on November 1, 2023 (top) and relative to the nearest high mast light located 13 meters to the east (indicated by the yellow oval below).

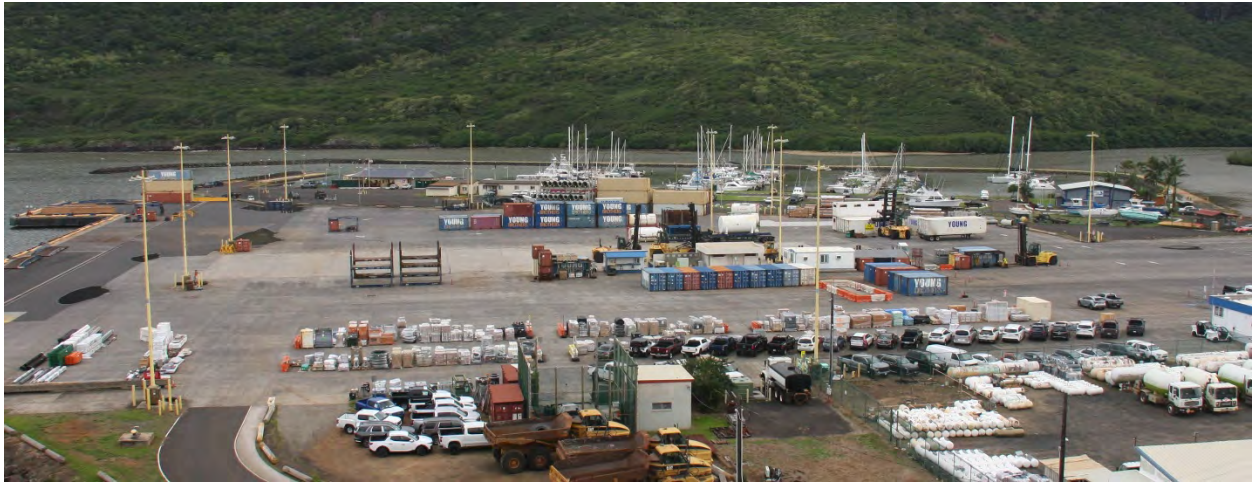
Photo 1. Broad view of Nawiliwili Harbor (Pier 3) showing the distribution of high mast light installations (10 visible in this image).

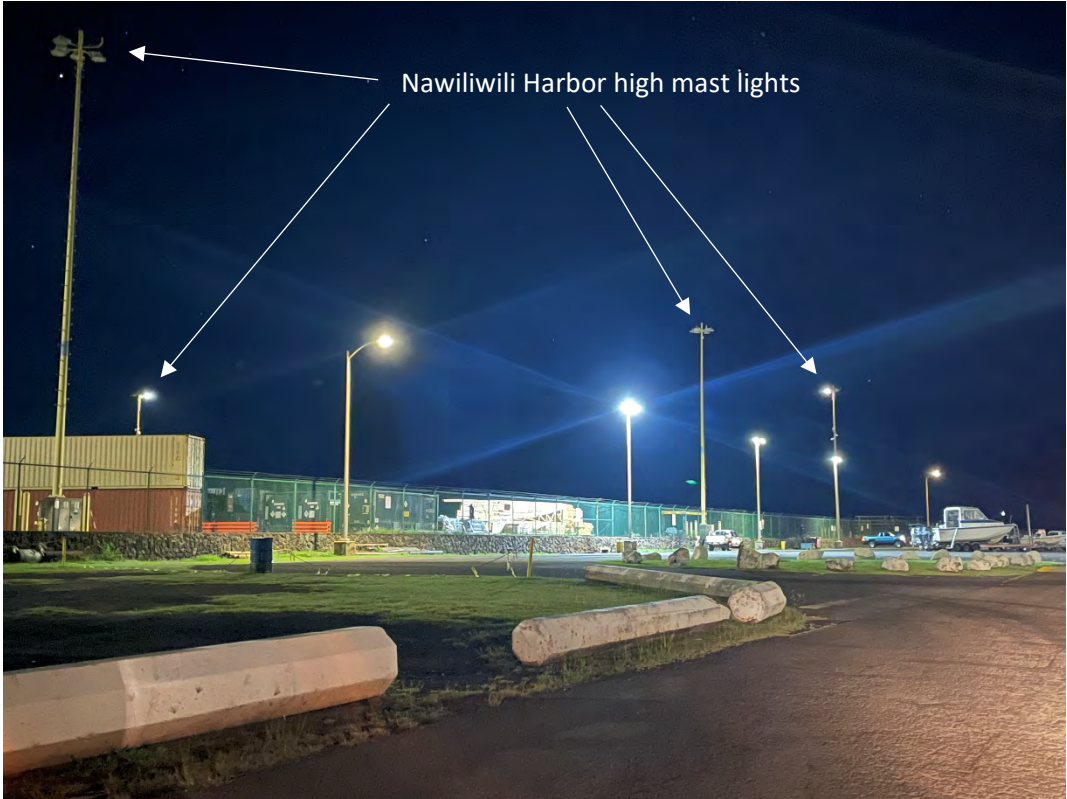
Photo 2. High mast lights along the boundary of Pier 3 and the small boat harbor showing high masts at a lowered security level setting.

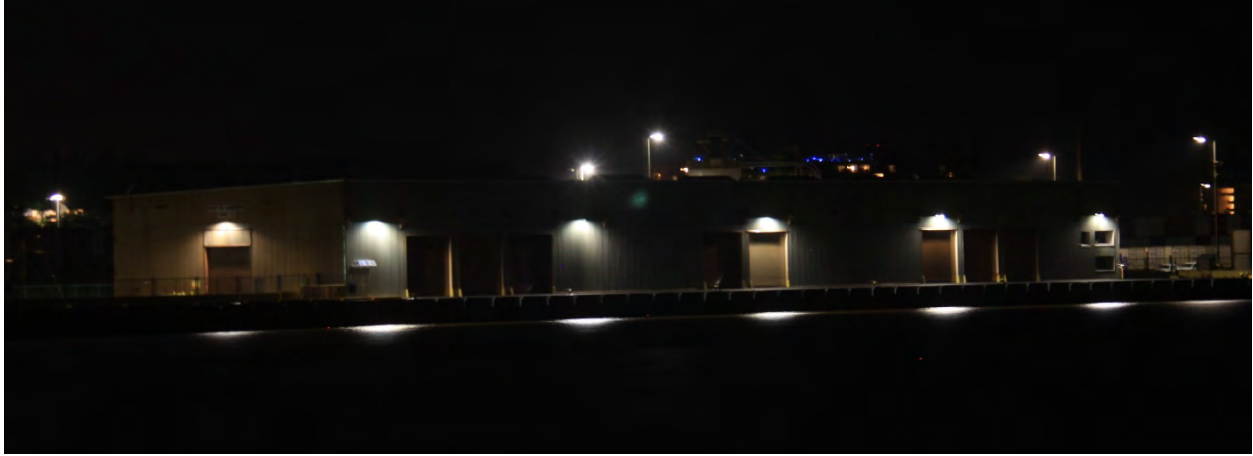
Photo 3. Wall-mounted lights illuminating bay doors and bulkhead along Pier 2.

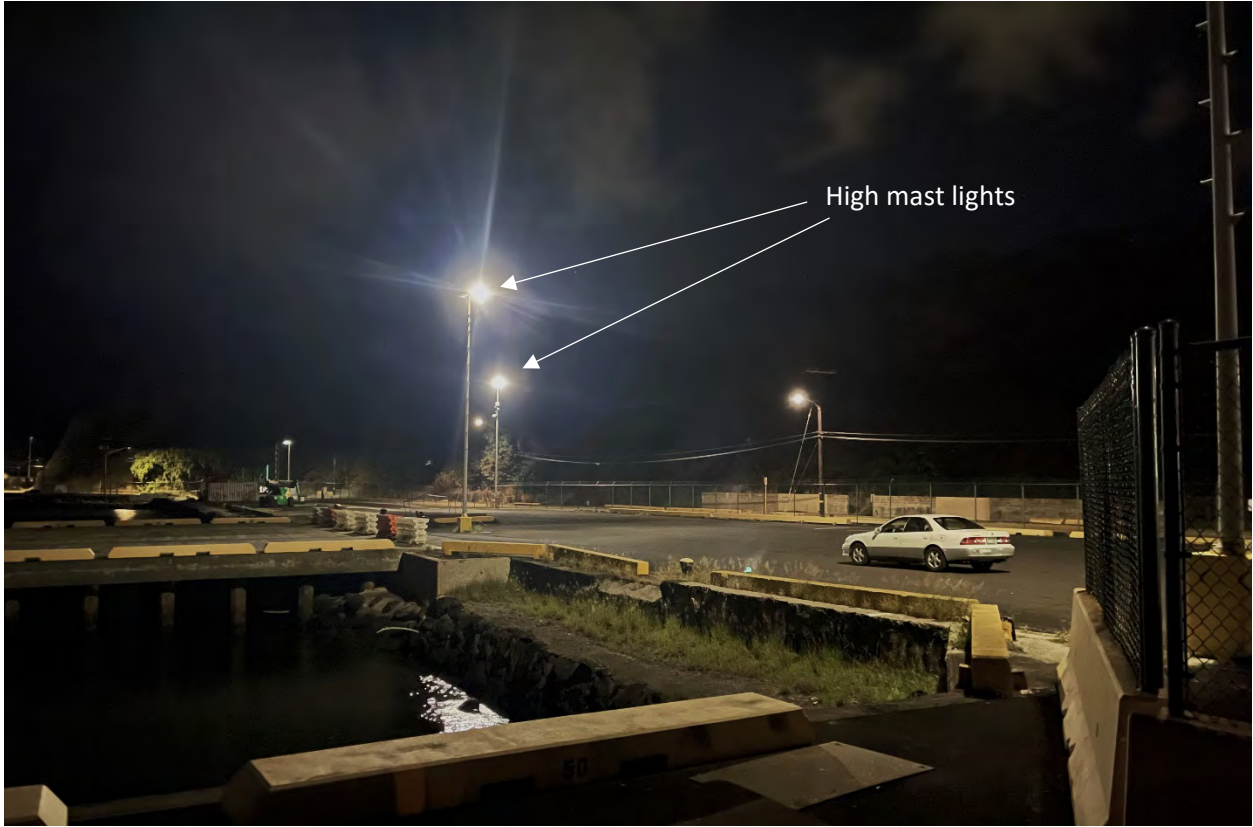
Photo 4. Two high mast lights between Piers 2 and 3 just to the southwest of the Pier 2 warehouse and cruise ship terminal.

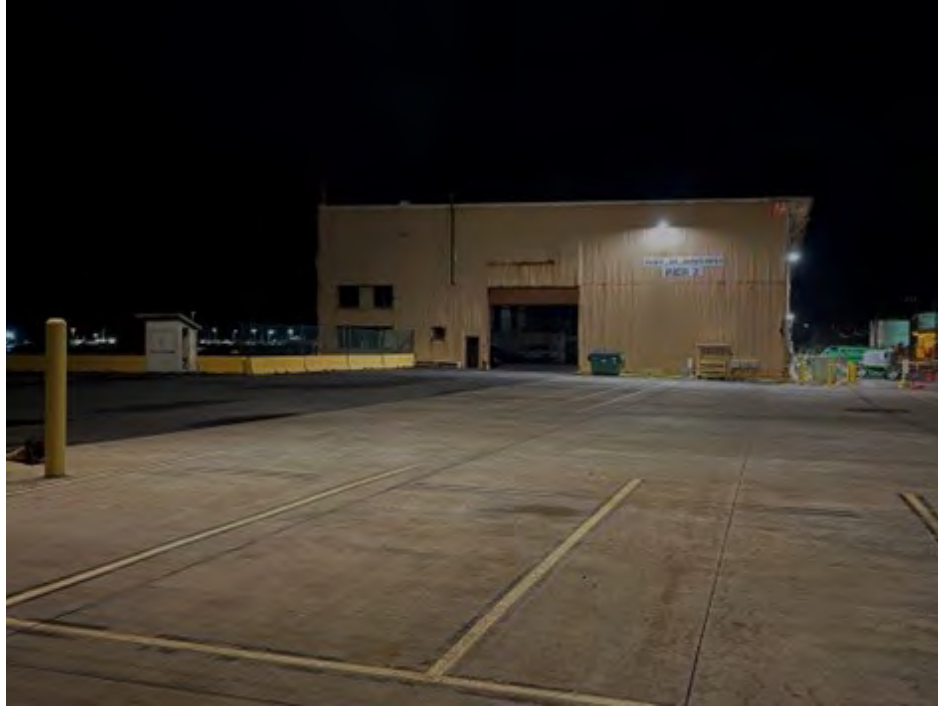
Photo 5. Wall mounted light on the side of the Pier 2 warehouse (east side facing Pier 1). This light typically remains on during both operational and security light level settings.

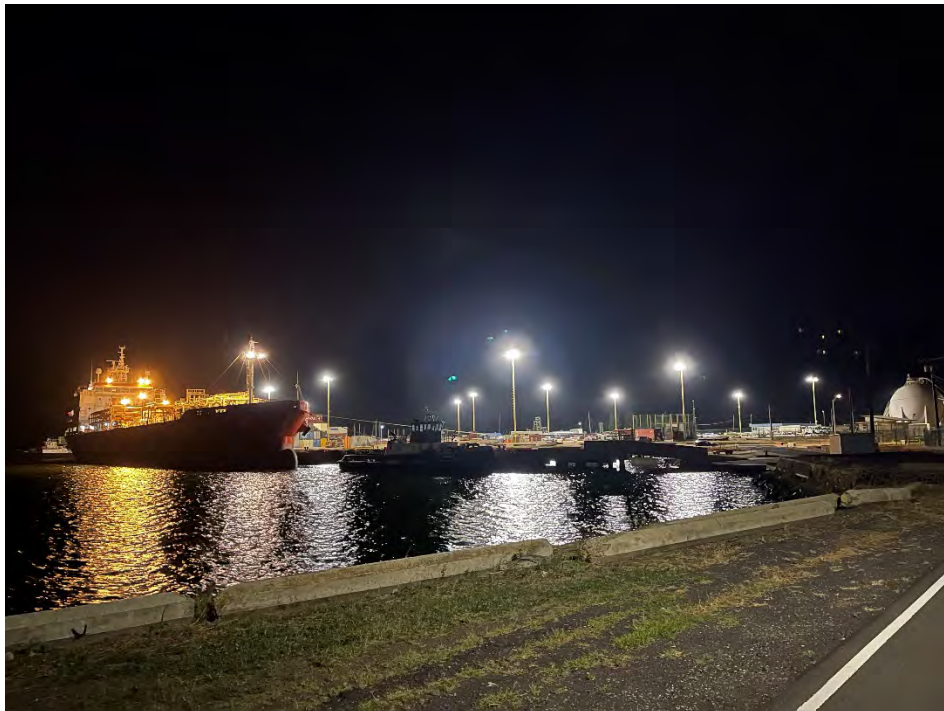
Photo 6. Lighting conditions at Pier 3 during bulk fuel operations.

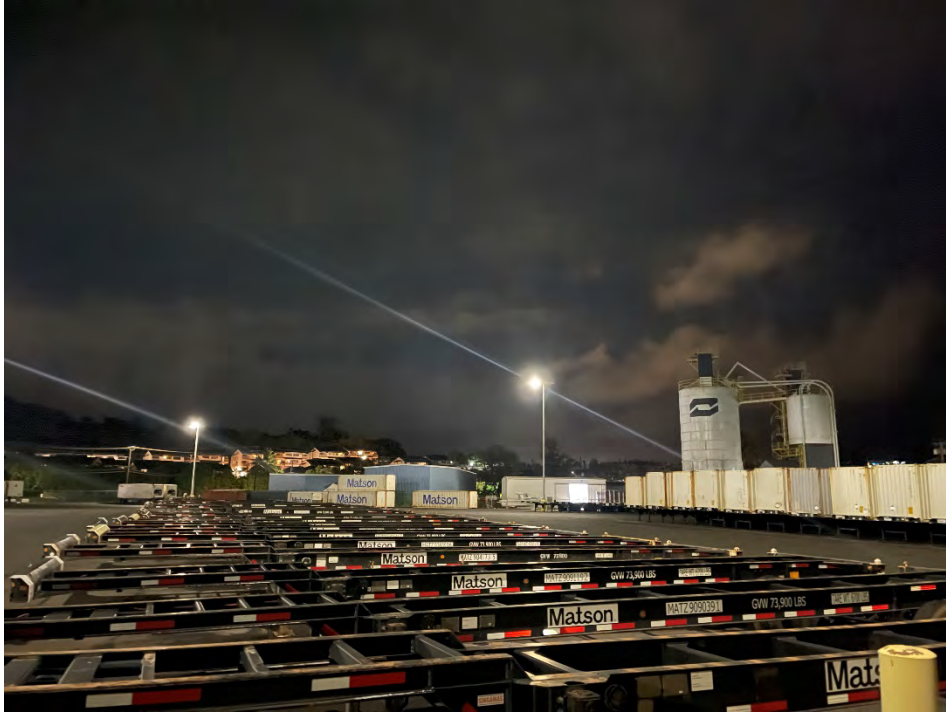
Photo 7. High mast lights in security setting at Pier 1.

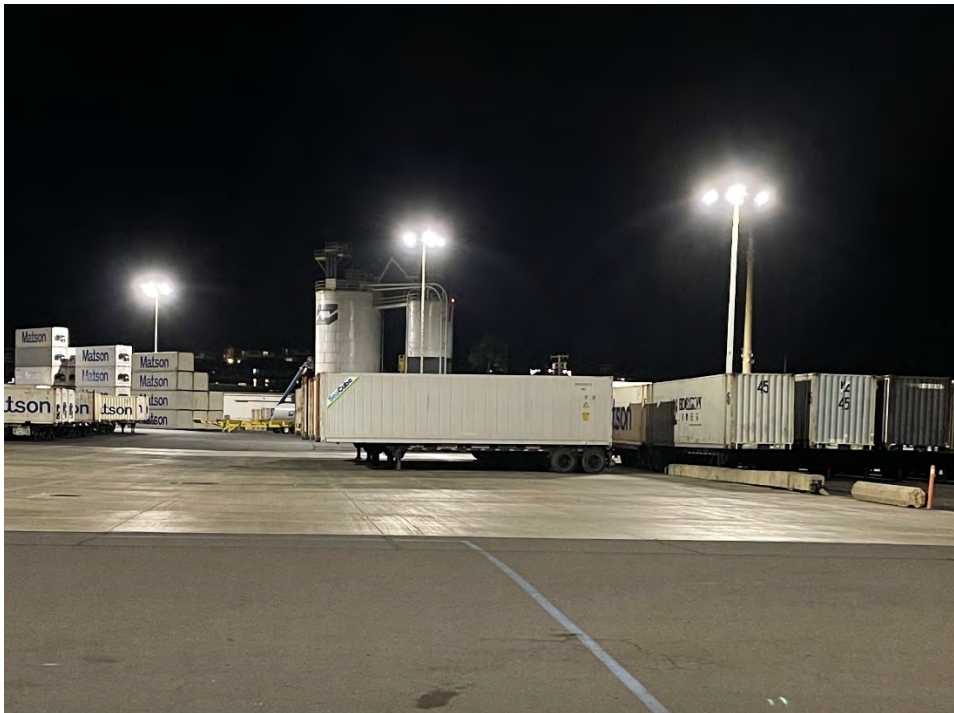
Photo 8. High mast lights in operational setting at Pier 1, Nawiliwili Harbor.
