STATE OF HAWAII
DEPARTMENT OF LAND AND NATURAL RESOURCES
Land Division
Honolulu, Hawaii 96813

Approve a 3-Year Term Extension of General Lease No. S-3698, Bank of Hawaii, Lessee, Pursuant to Act 207, Session Laws of Hawaii 2011; Lot 7, Waiakea House Lots Extension, Waiakea, South Hilo, Hawaii, Tax Map Key: (3) 2-2-049:022.

INSPECTION REPORT
Commercial/Industrial/Resort/Other Business**General Information**Document Number: GLS 3698 or RPS _____Character of Use Commercial/IndustrialInspection Date: 09/21/2016 Inspection Time: 9:00 amLand Agent: Candace Martin**TENANT INFORMATION**Name: Bank of HawaiiHome Phone: N/AAddress: 417 E. Kawili StreetBusiness Phone: (808) 961-0681Hilo, HI 96720Fax: N/AContact Person: Roxann IkedaContact Phone: (808) 854-2082**SITE INFORMATION**TMK: (3) 2-2-049:022Area: 29,912 square feetSite Address: 417 E. Kawili Street, Hilo, Hawaii 96720**FISCAL INFORMATION**

09/21/2016 Photos of GL S-3698 Bank of Hawaii

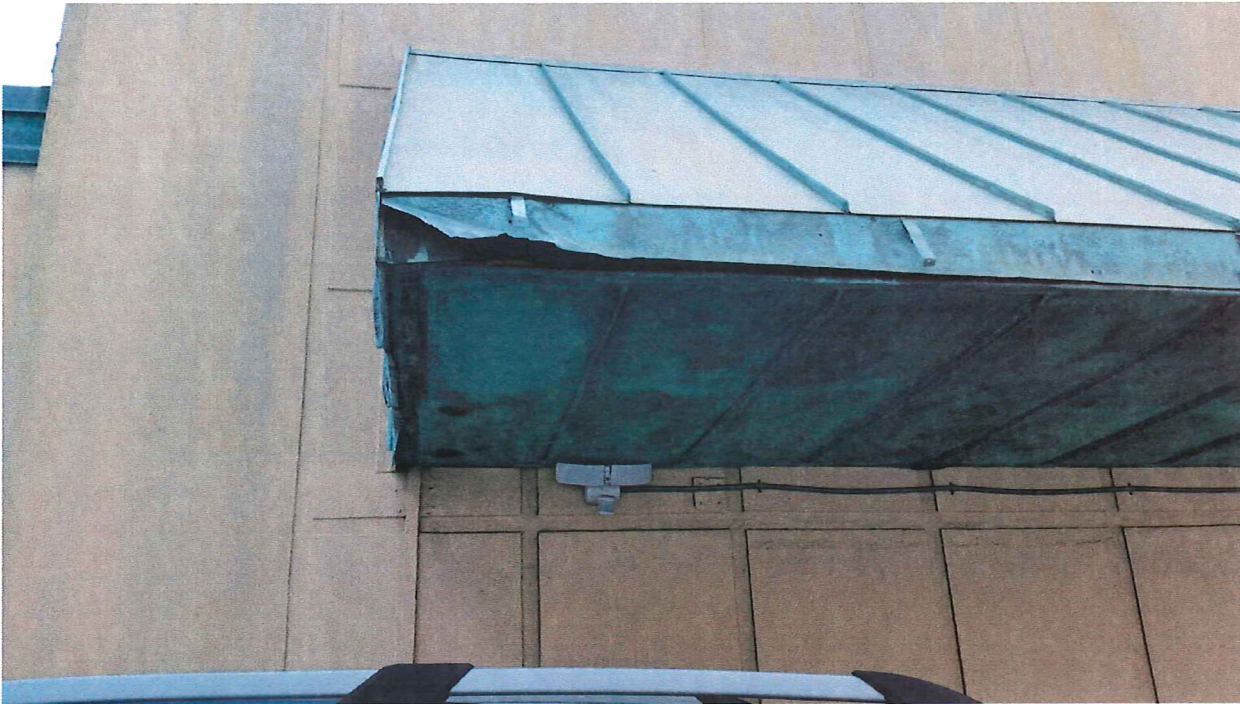
Peeling edge of mansard roofs located over drive-thru teller lane.

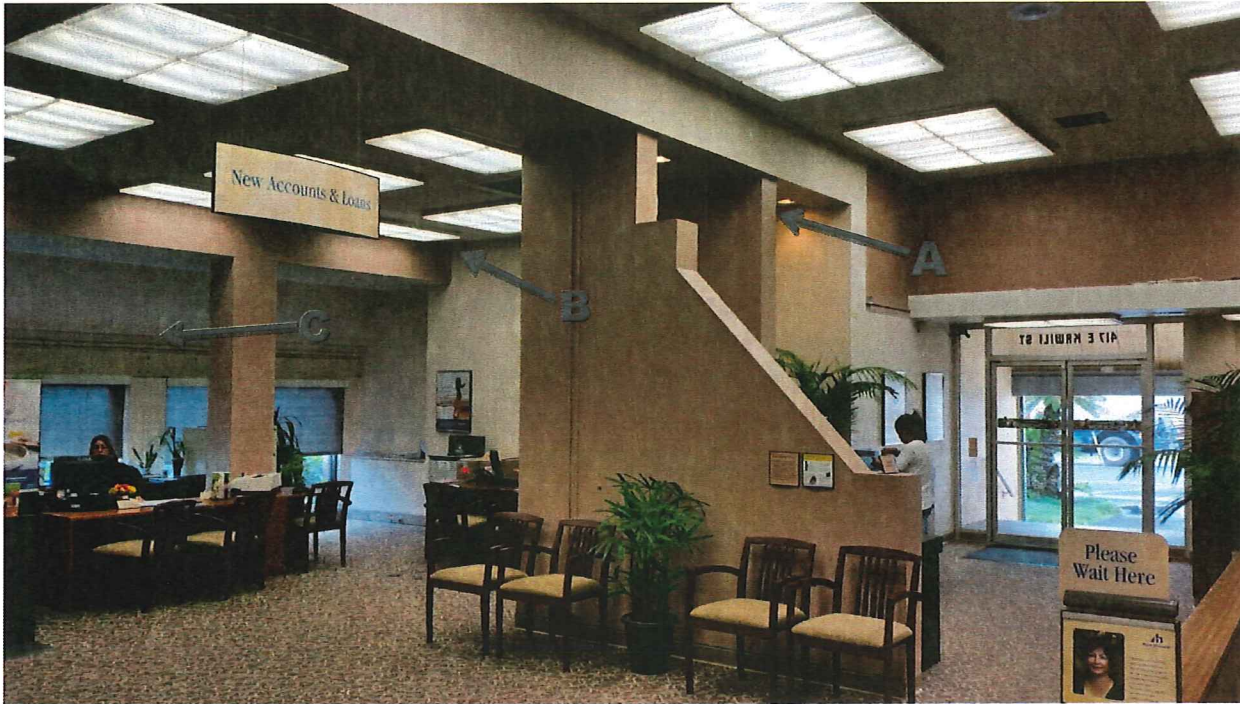
East wing on left (arrows indicate areas of following pictures).

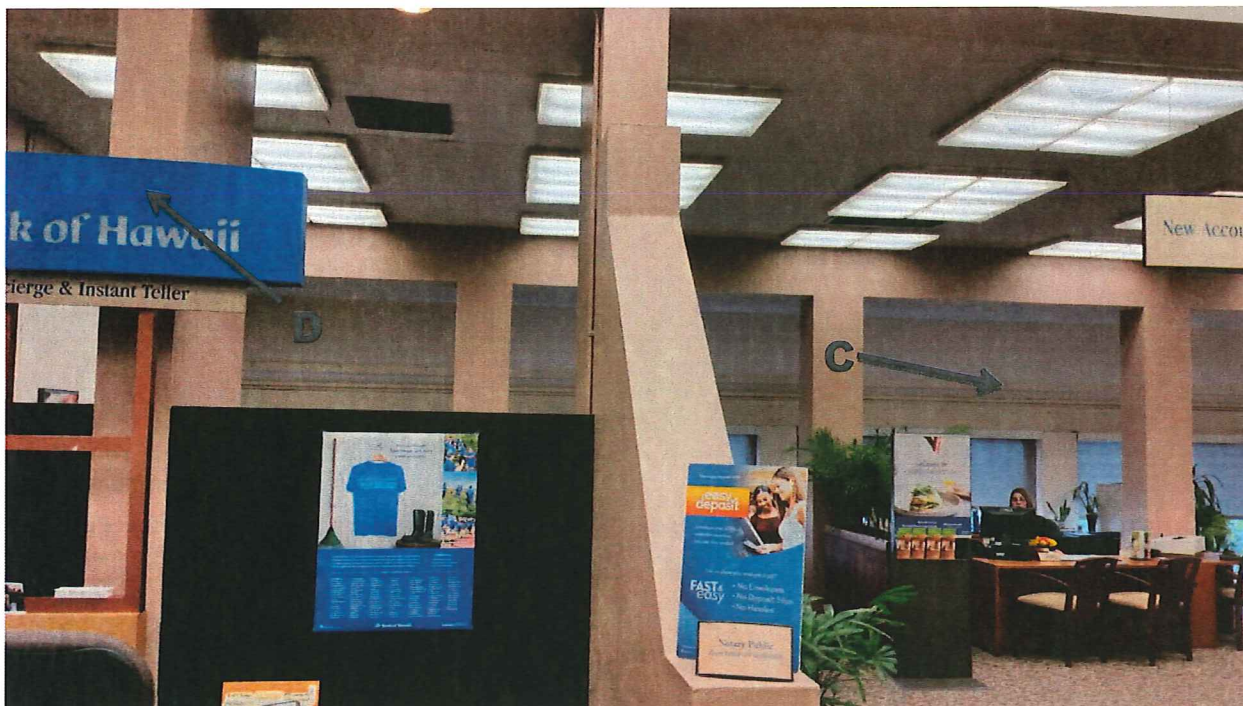
East wing (arrows indicate areas of following pictures).

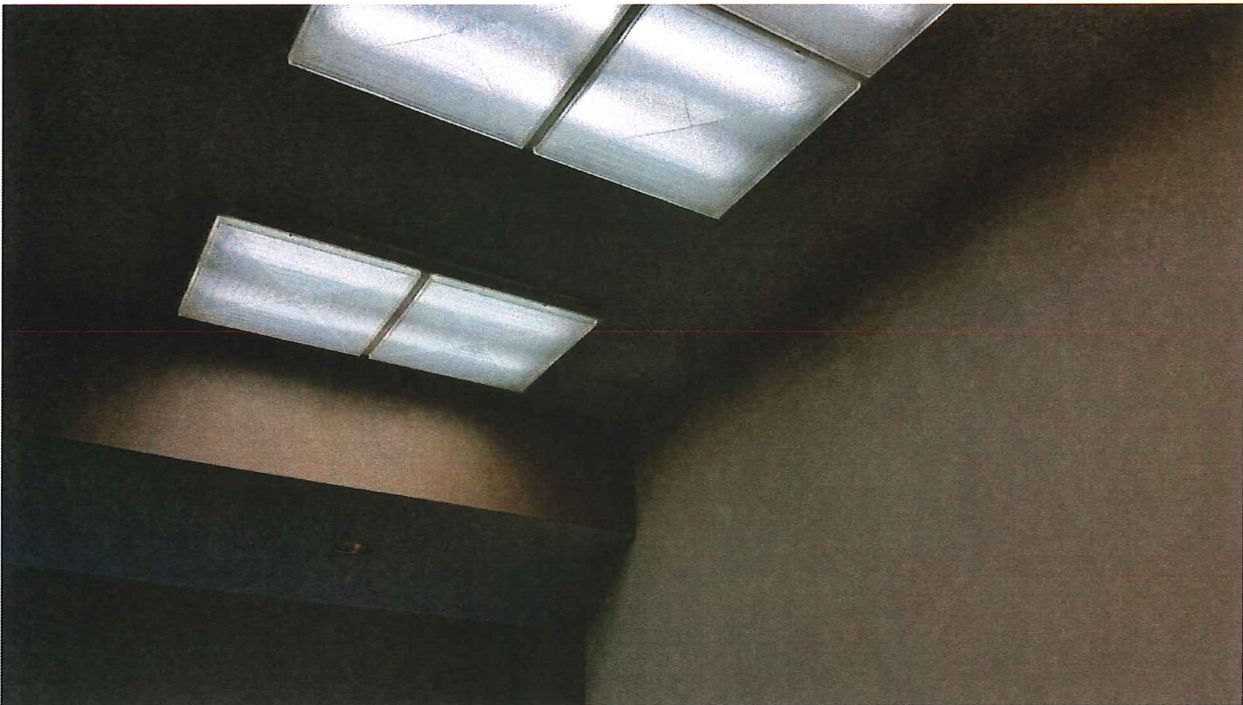
Photo of area B. Leak damage to southeast end of east wing.

9/21/2016 – Inspection walk-thru was led by Joe Francher of the Corporate Facilities Division, Bank of Hawaii. He indicated that the roof of the east wing would be repaired/replaced as necessary, the gutter and windows would of that same section would be repaired, and the air-conditioning unit would have the necessary parts replaced.

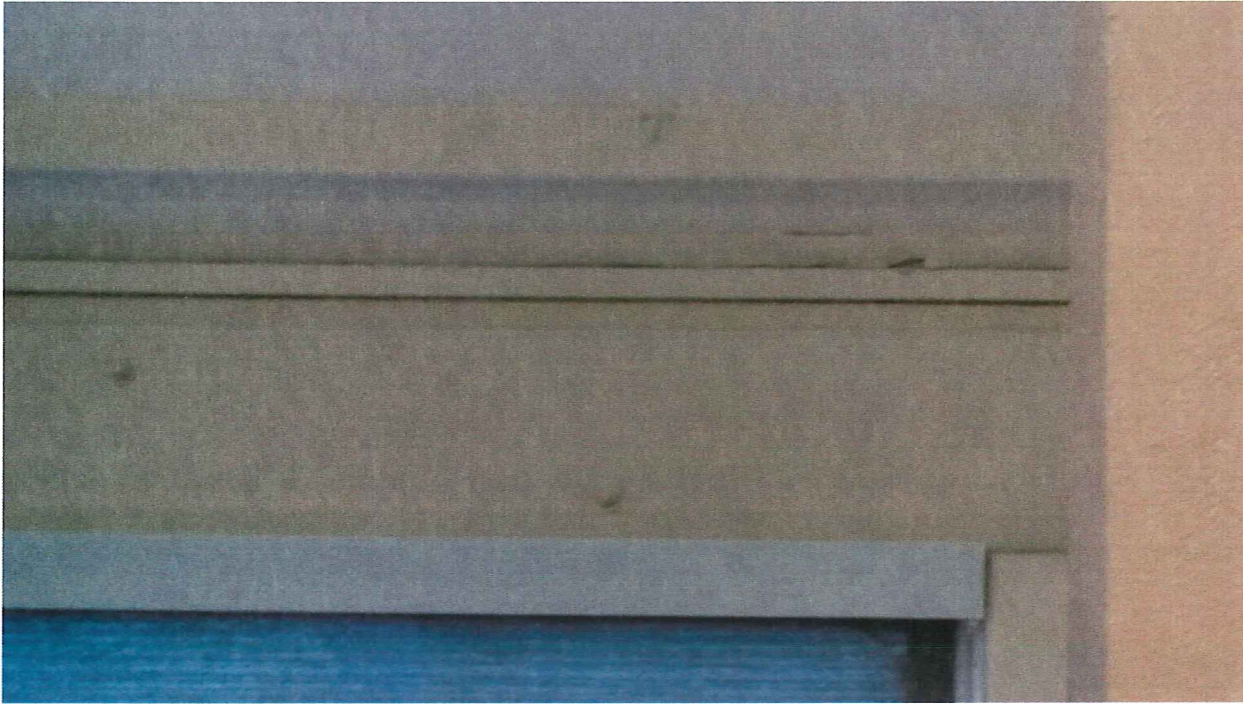
Photo of area C. Leak damage from water behind wall on eastside wall of east wing. Suspect gutter problem.

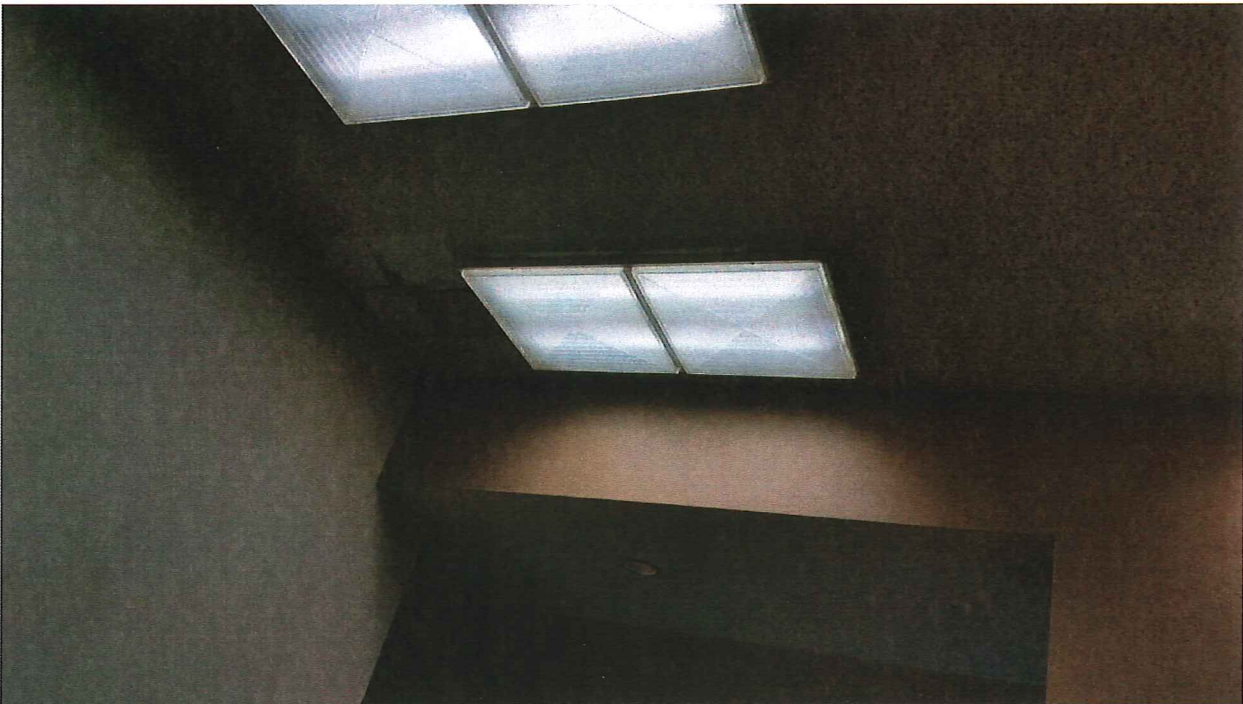
Photo of area D. Leak damage located at Northeast end

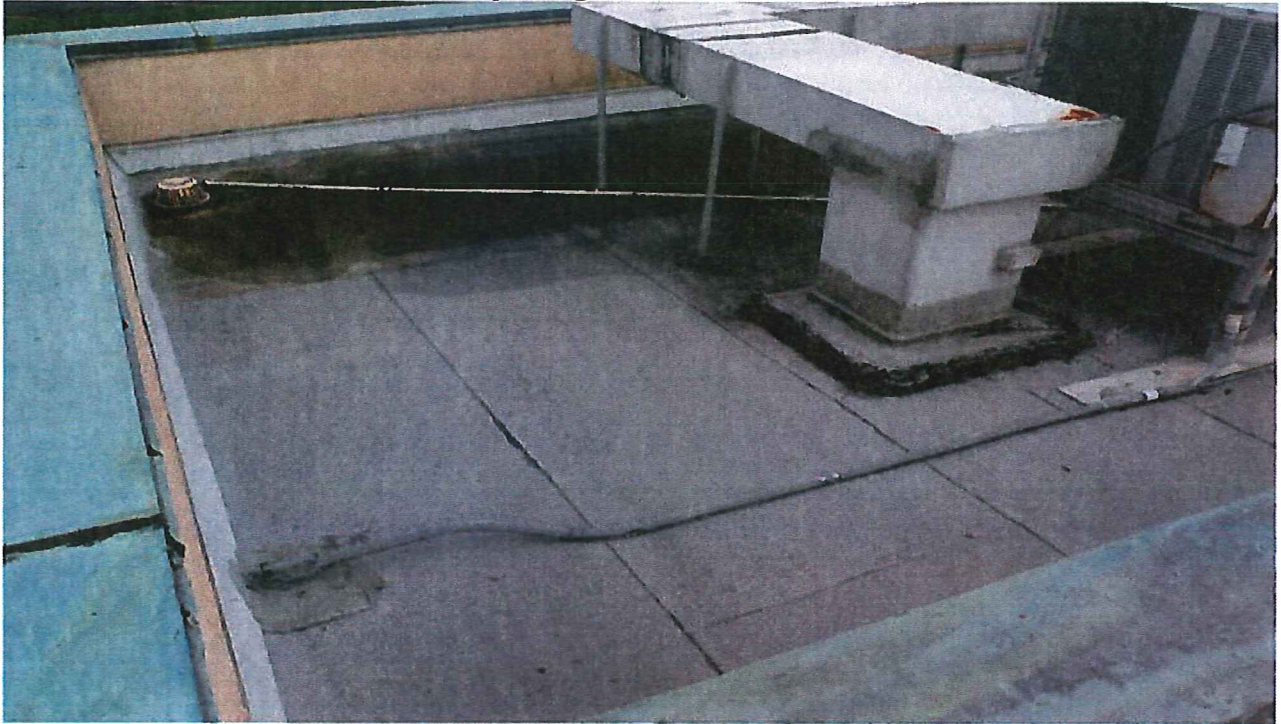
Photo below shows current conditions of ponding water:

The proposed work will remediate defects to the property and extend the useful life of the building by approximately five years. Importantly, the roof is not failing universally. Rather, the ponding areas near the drains on the HVAC portion are the primary isolated source of the leaks. A prudent buyer would likely opt to extend the useful life by five years (with support of the annual inspections over the five-year period) by addressing the problem areas at this point rather than opting for a premature roofing coating replacement on the entire building.

- Repair leaks at two drain areas
- Perimeter counterflashing caulking replacement
- Seal three duct penetrations with fabric and Silicone coating
- Annual inspection for 5 years

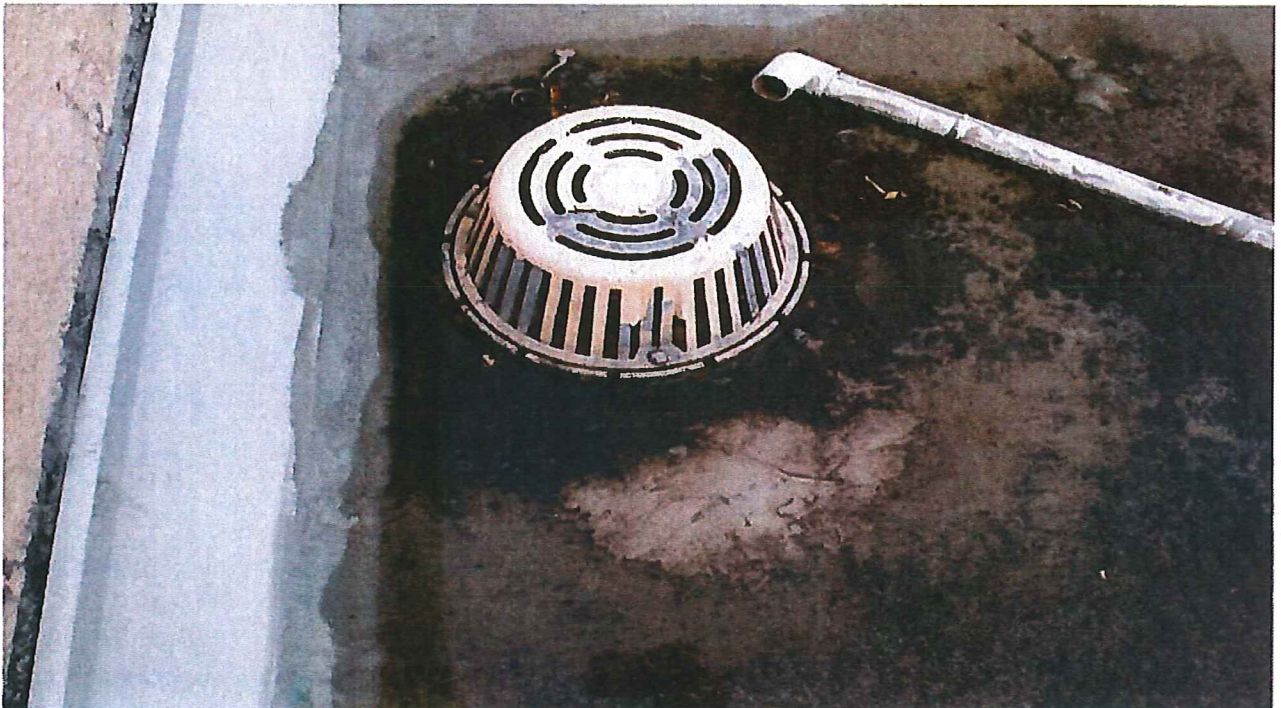
Photo below shows current conditions of roof drain:

The roofing contractor identified that the existing roofing is in poor condition, is in excess of 15 years old and has active leaks. The active leaks serve to disrupt occupancy and represent a material form of deferred maintenance that any prospective buyer would identify and correct in a similar or more extensive manner as proposed.

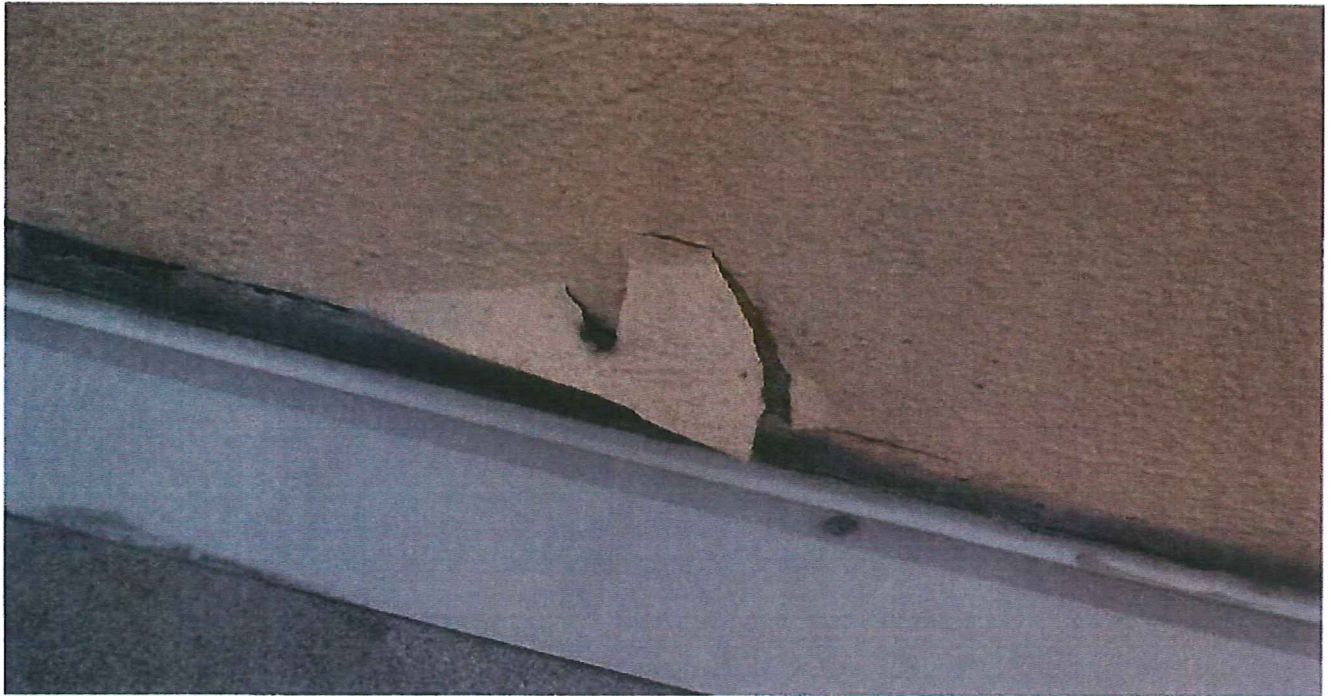
Photo below shows current conditions:
