BLNR Hearing K-1 Punaluu/ Johnson

Written testimony Aug 13, 2021

PUNALU'U EMERGENCY SHORELINE PROTECTION

SPA: OA-13-55 EP: OA-20-8

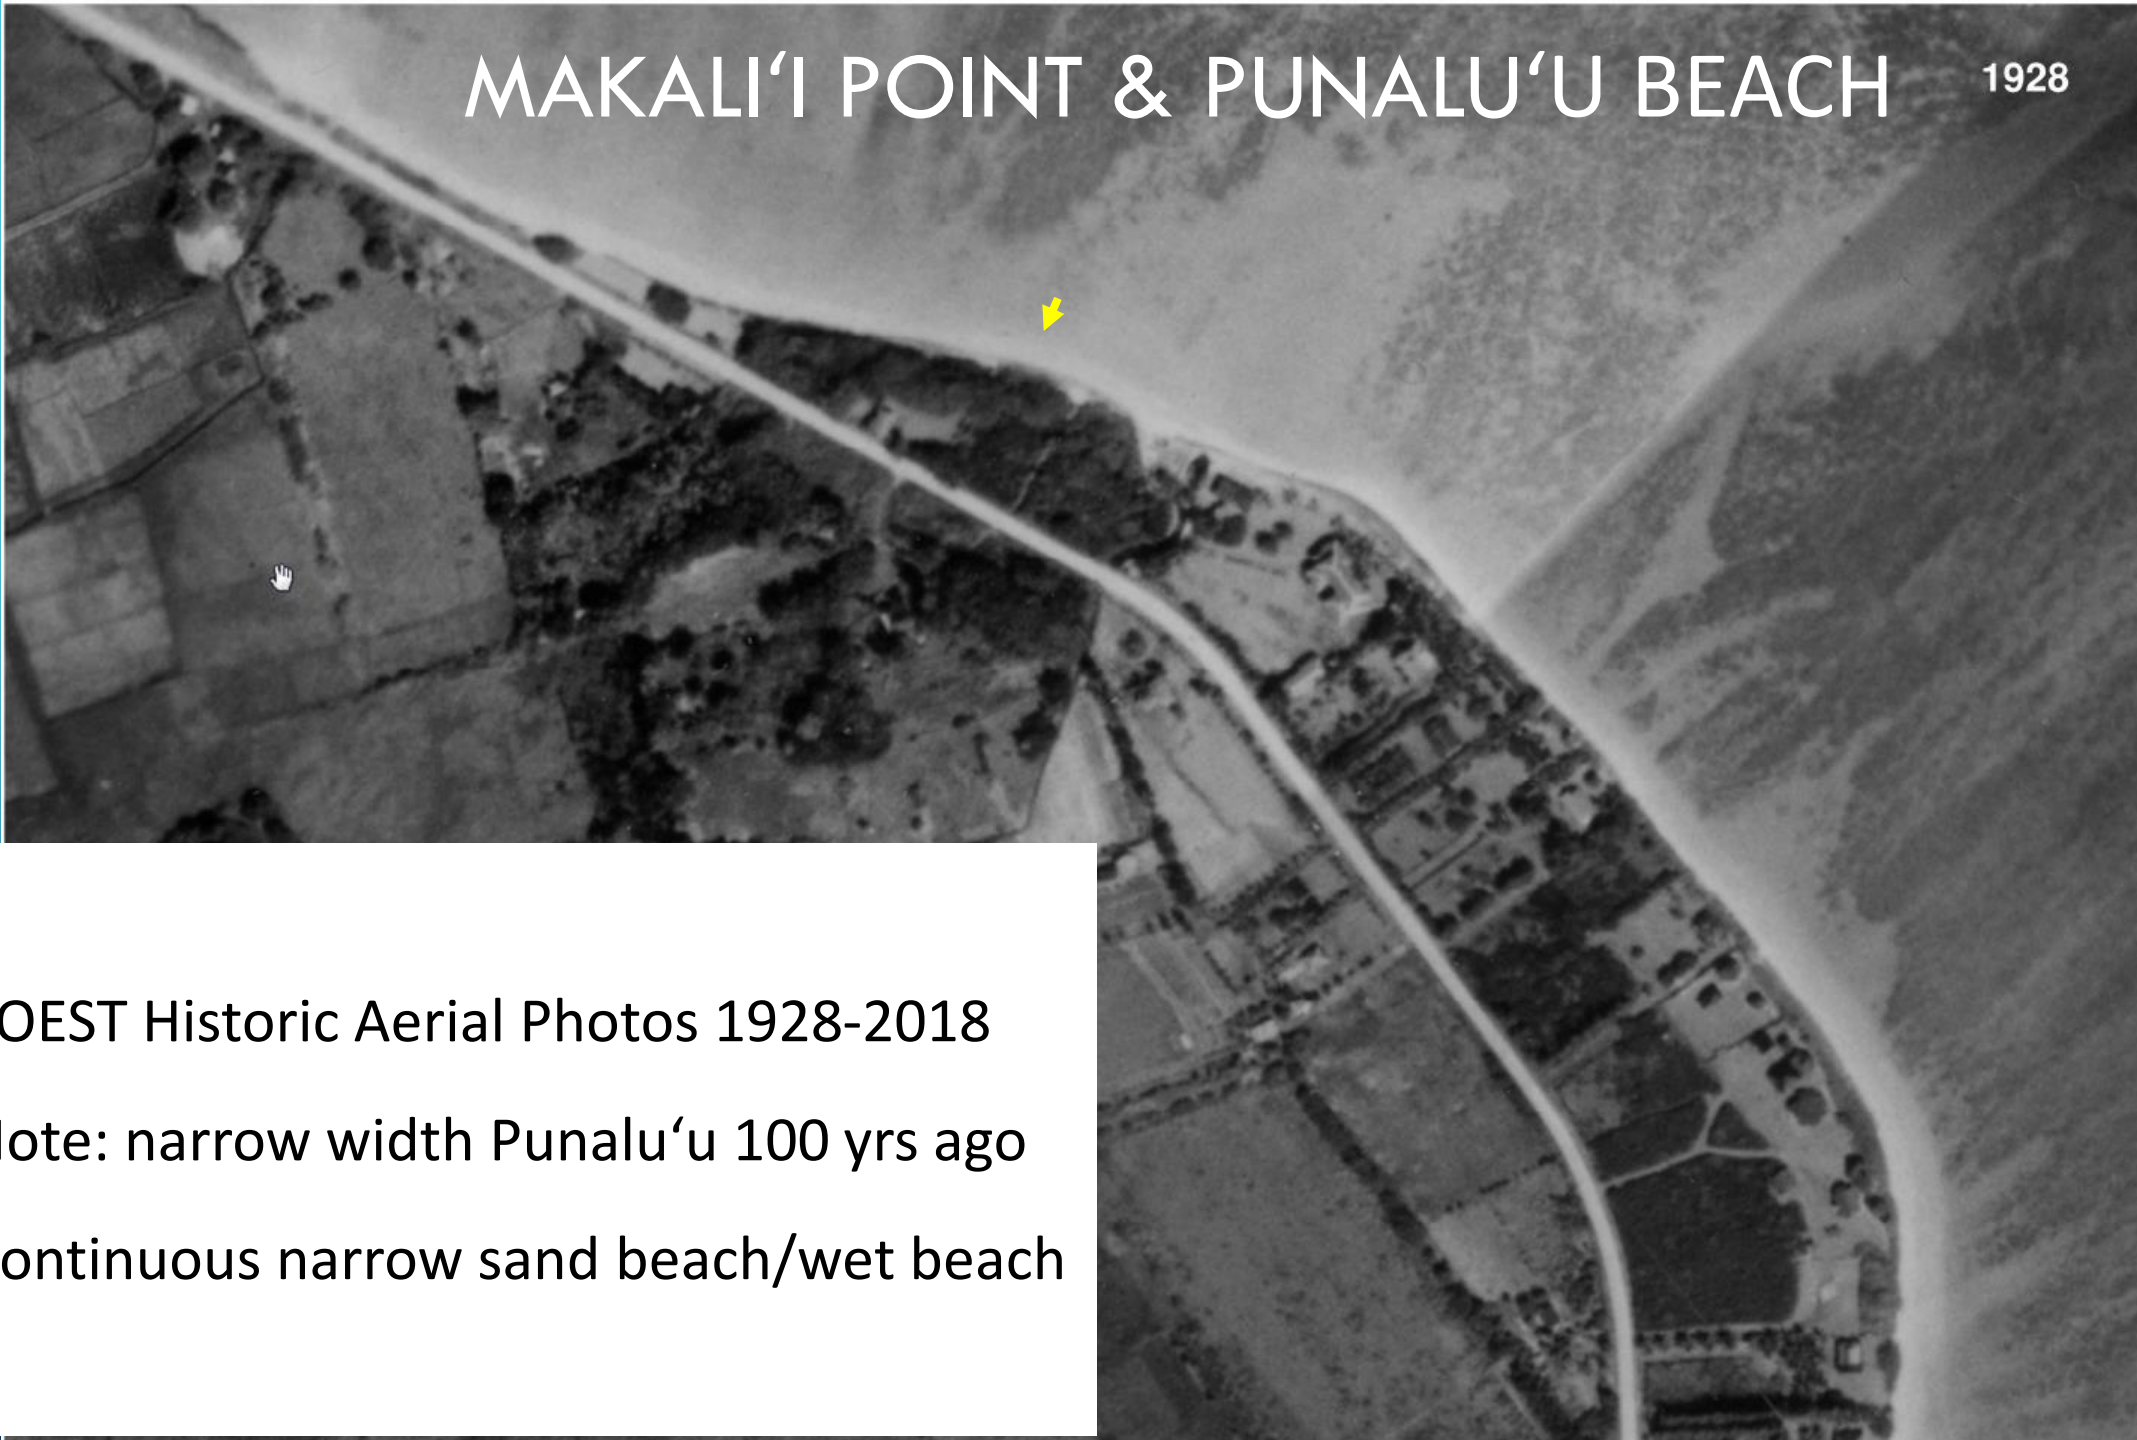
1928

- SOEST Historic Aerial Photos 1928-2018
- Note: narrow width Punalu'u 100 yrs ago
- Continuous narrow sand beach/wet beach

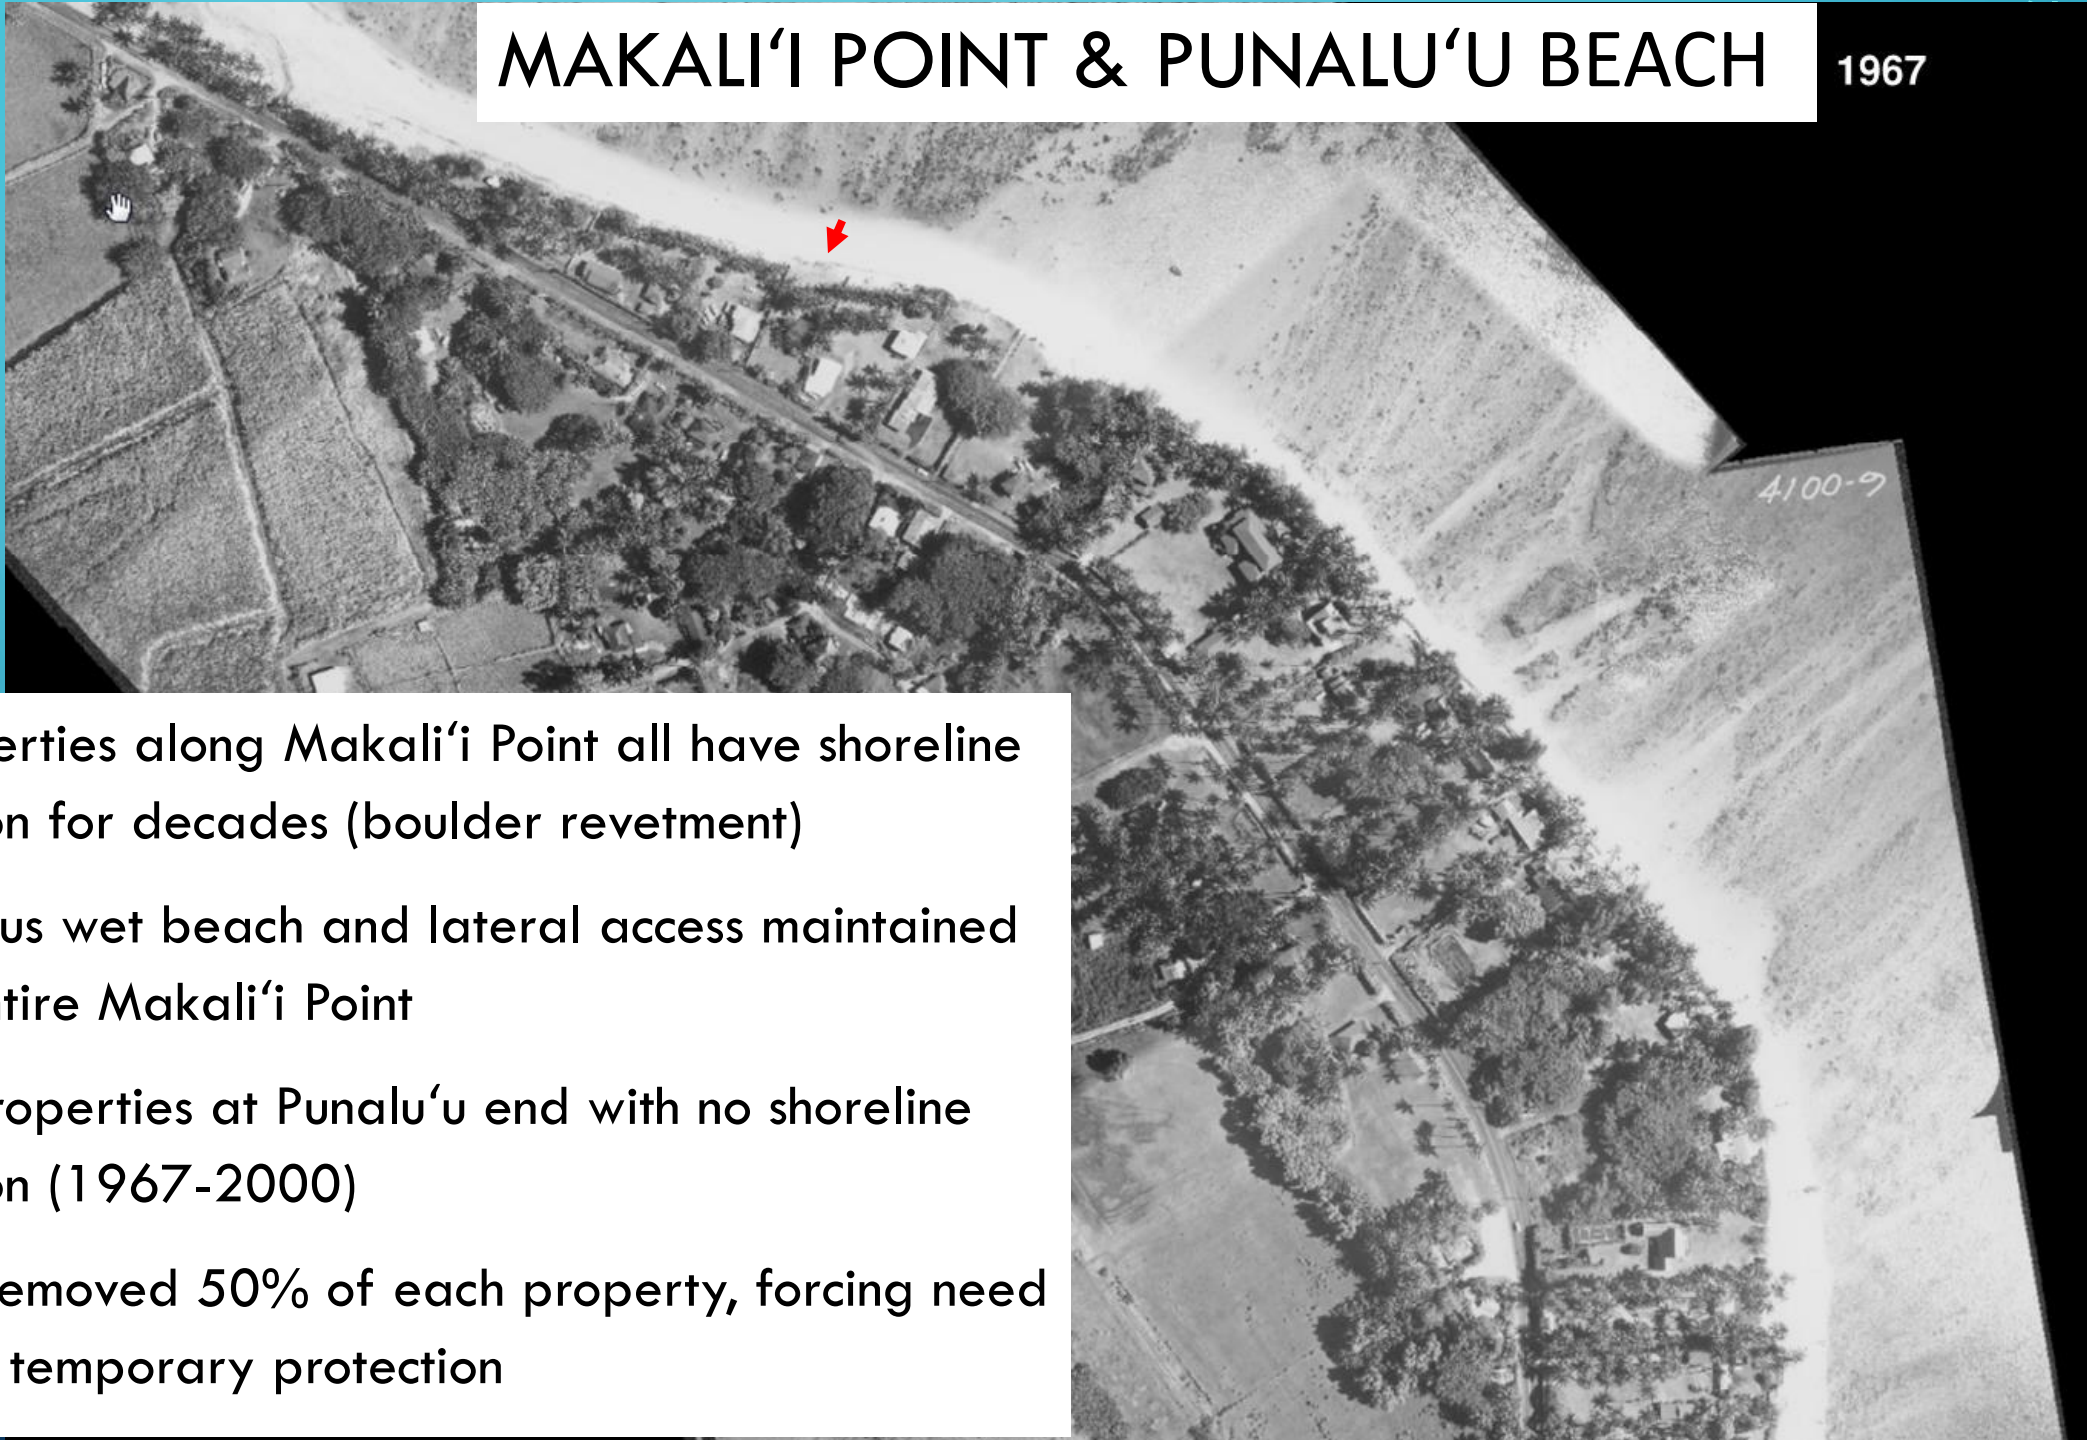
1967

- 38 Properties along Makali'i Point all have shoreline protection for decades (boulder revetment)
- Continuous wet beach and lateral access maintained along entire Makali'i Point
- Seven properties at Punalu'u end with no shoreline protection (1967-2000)
- Erosion removed 50% of each property, forcing need to install temporary protection

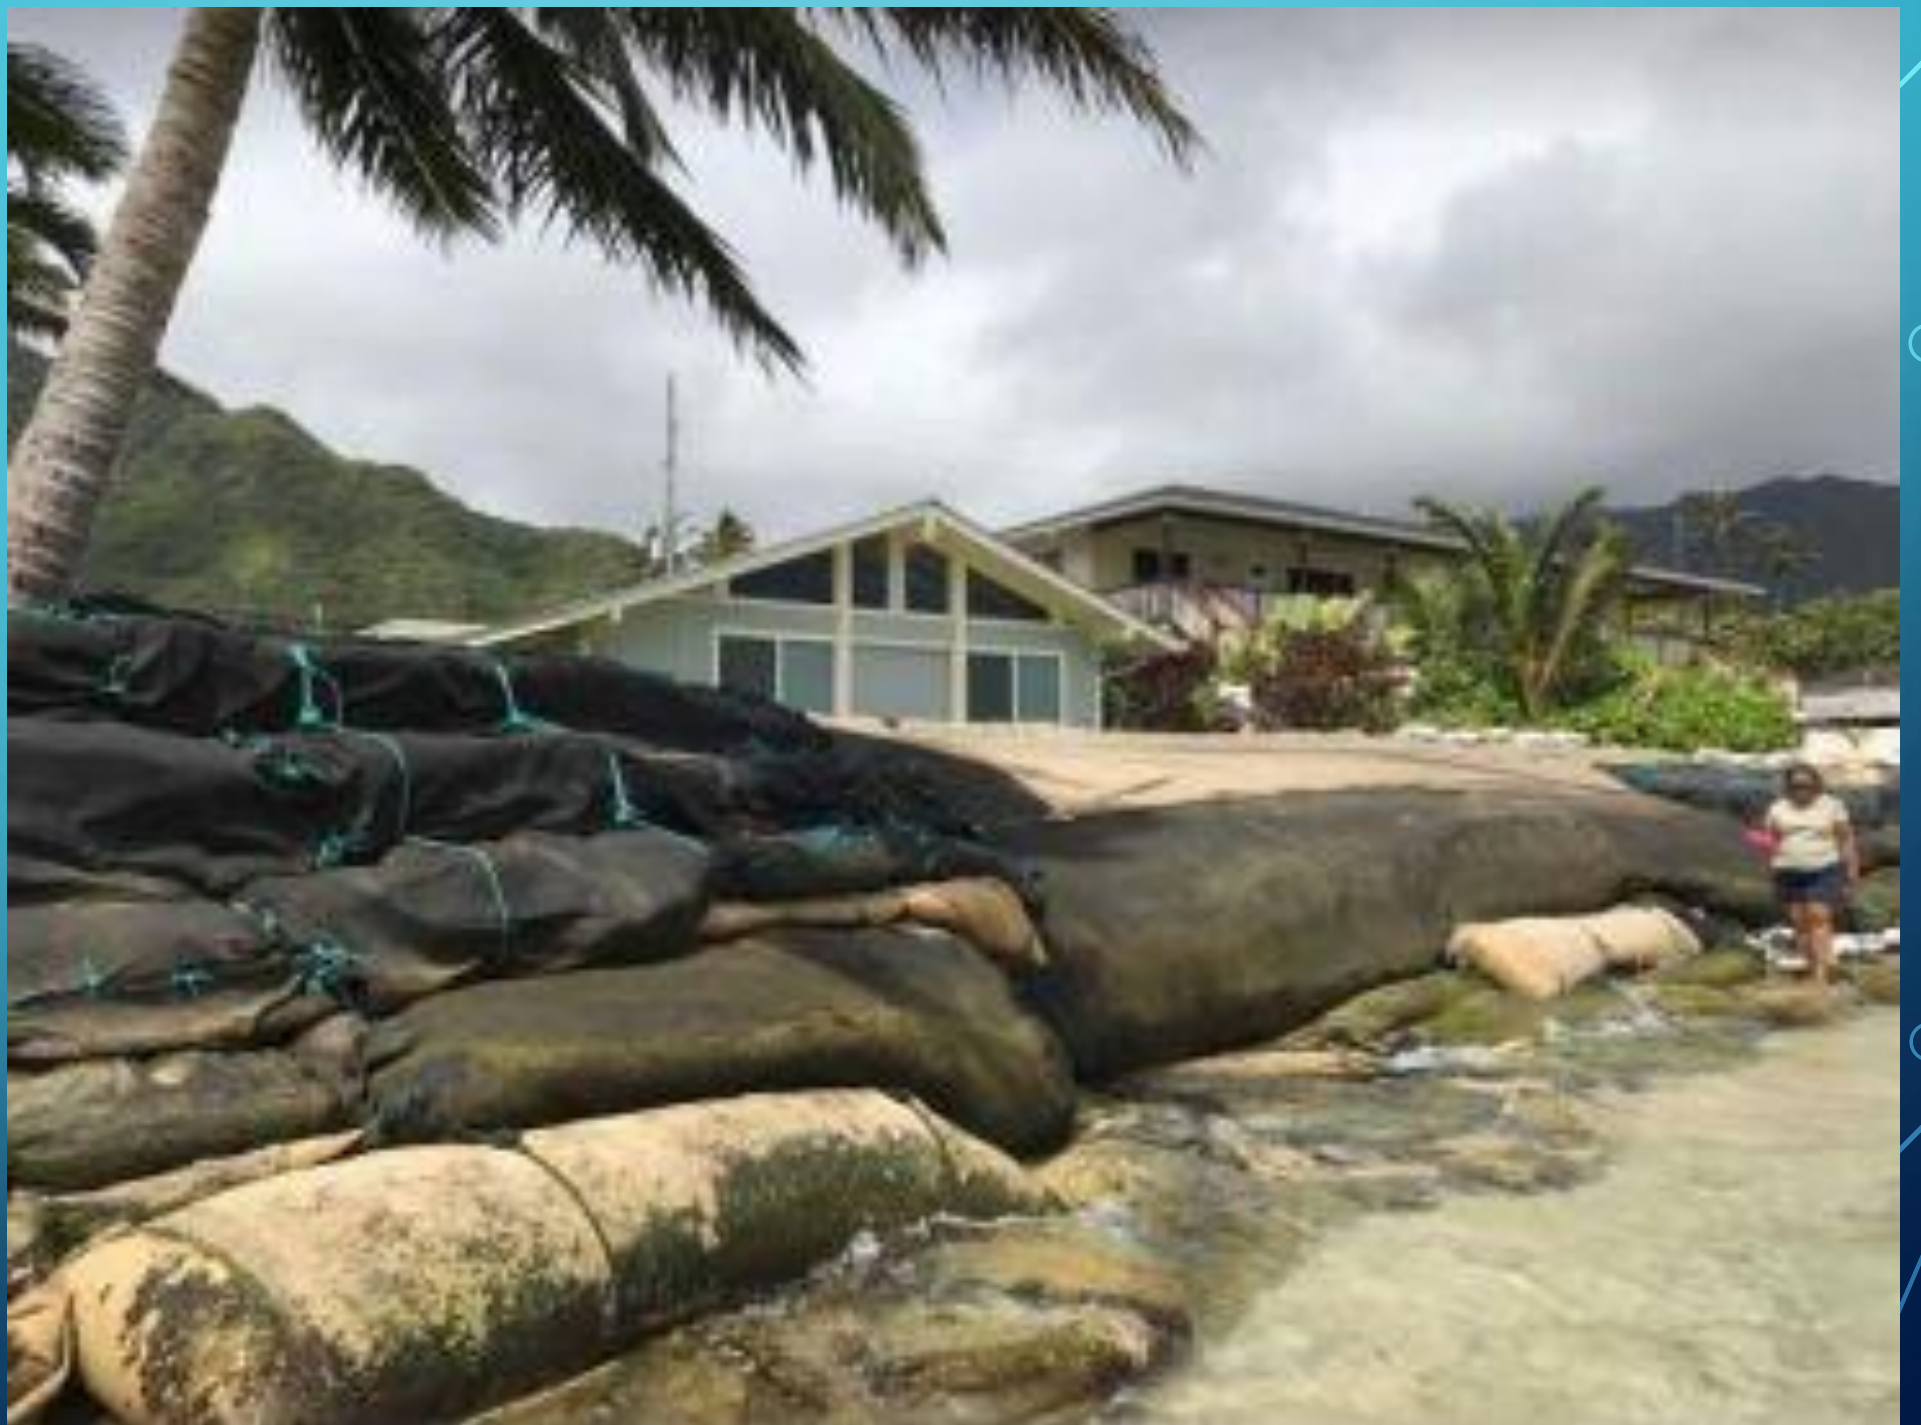
**OCT
2018**

**PRE-
REPAIR**

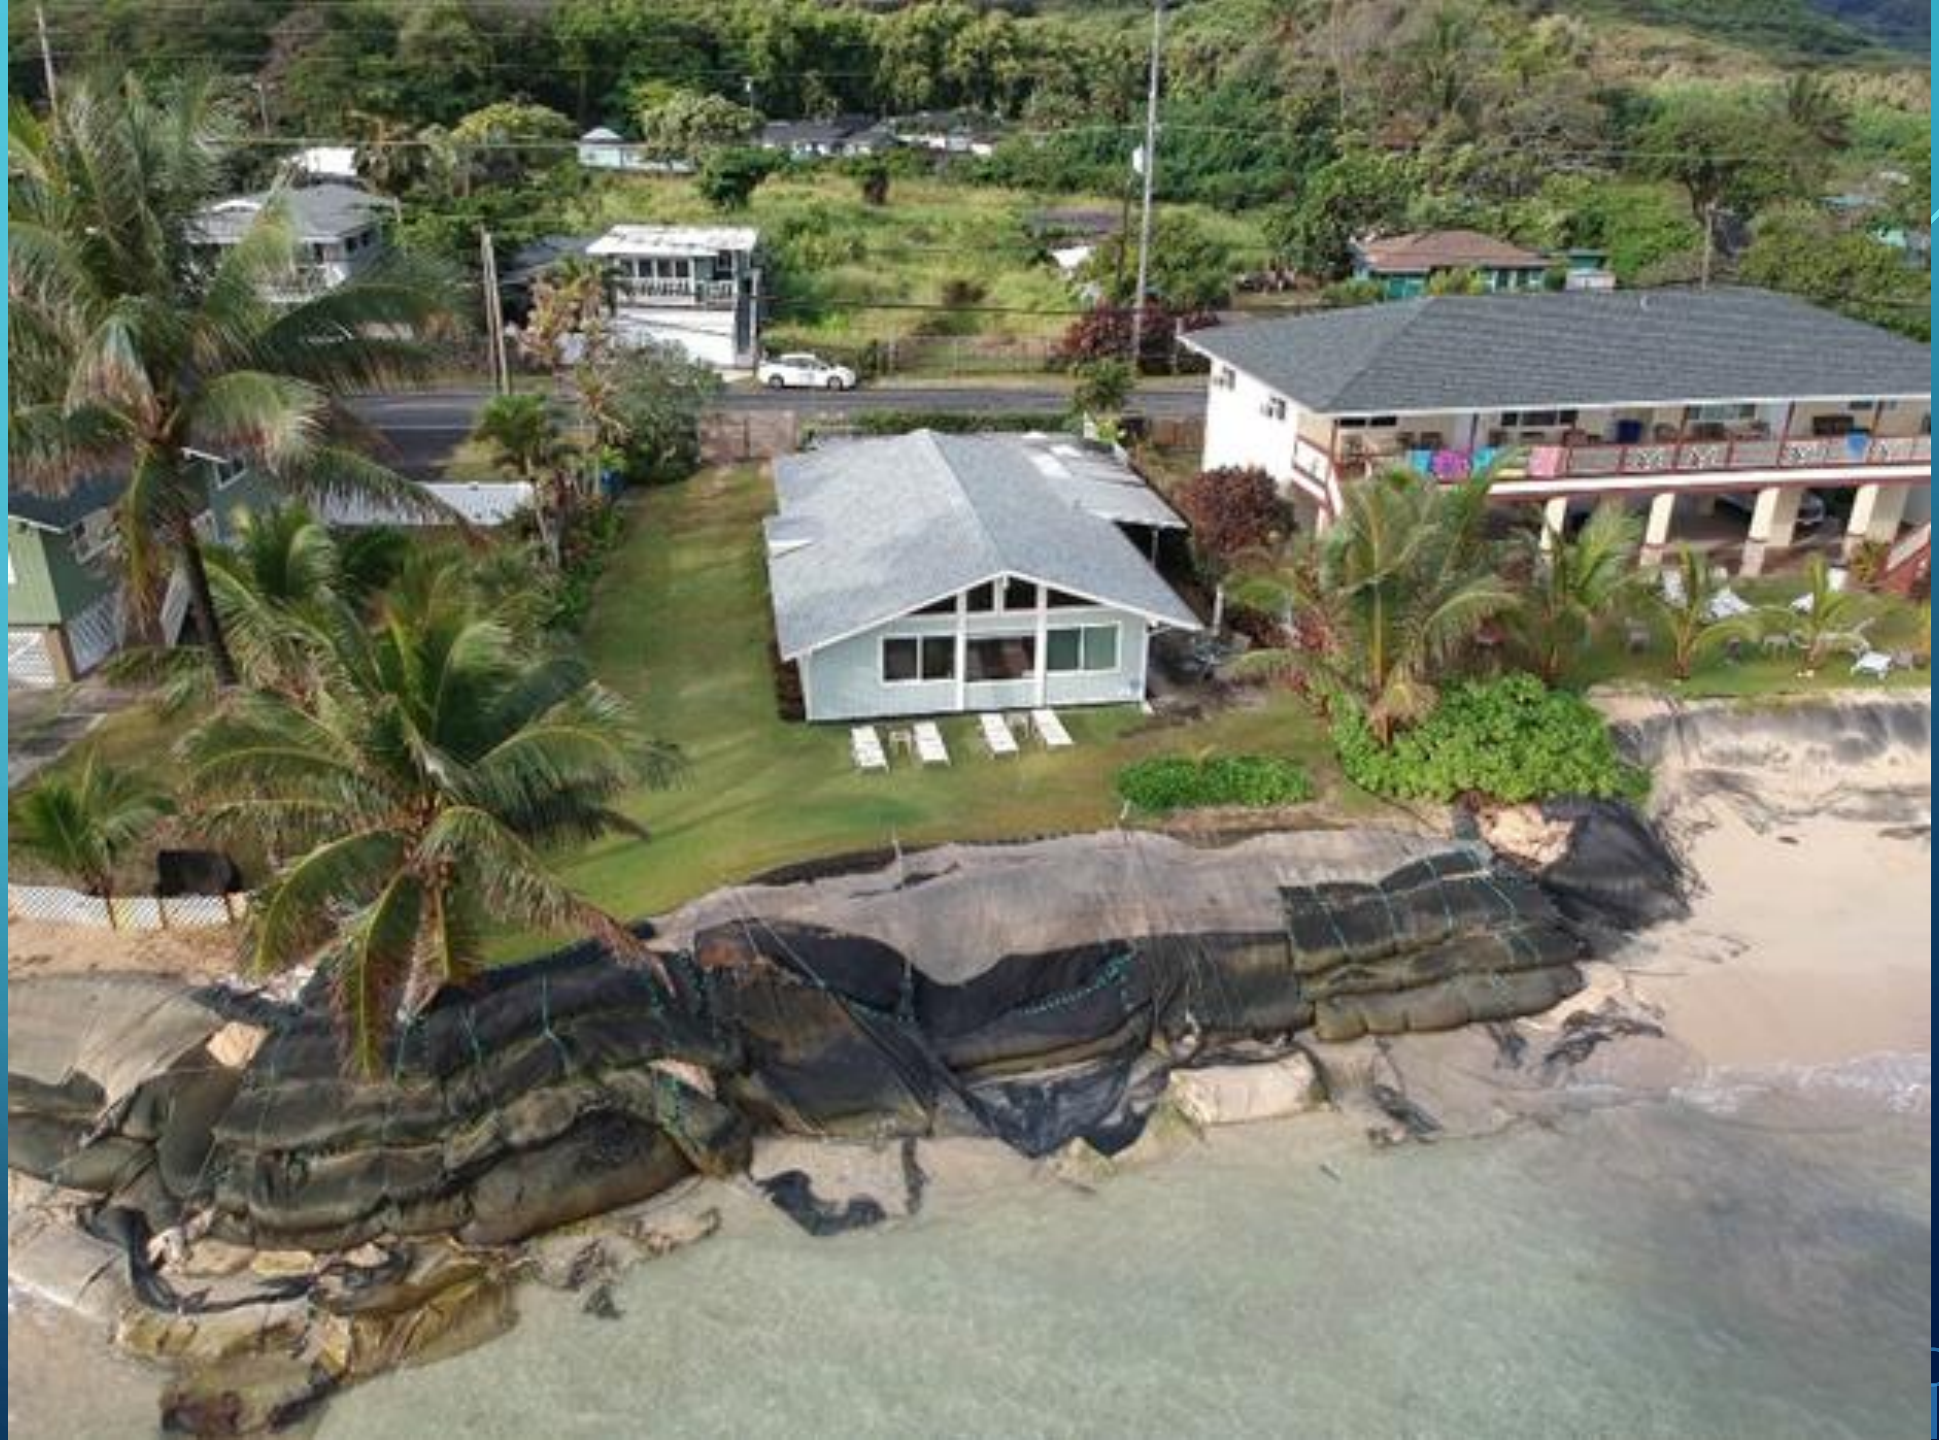
**APRIL
2018**

**PRE-
REPAIR**

- FAILING STRUCTURE**
- DEFLATED SANDBAGS**
- DEBRIS IN NEARSHORE AREA**
- POOR LATERAL ACCESS**

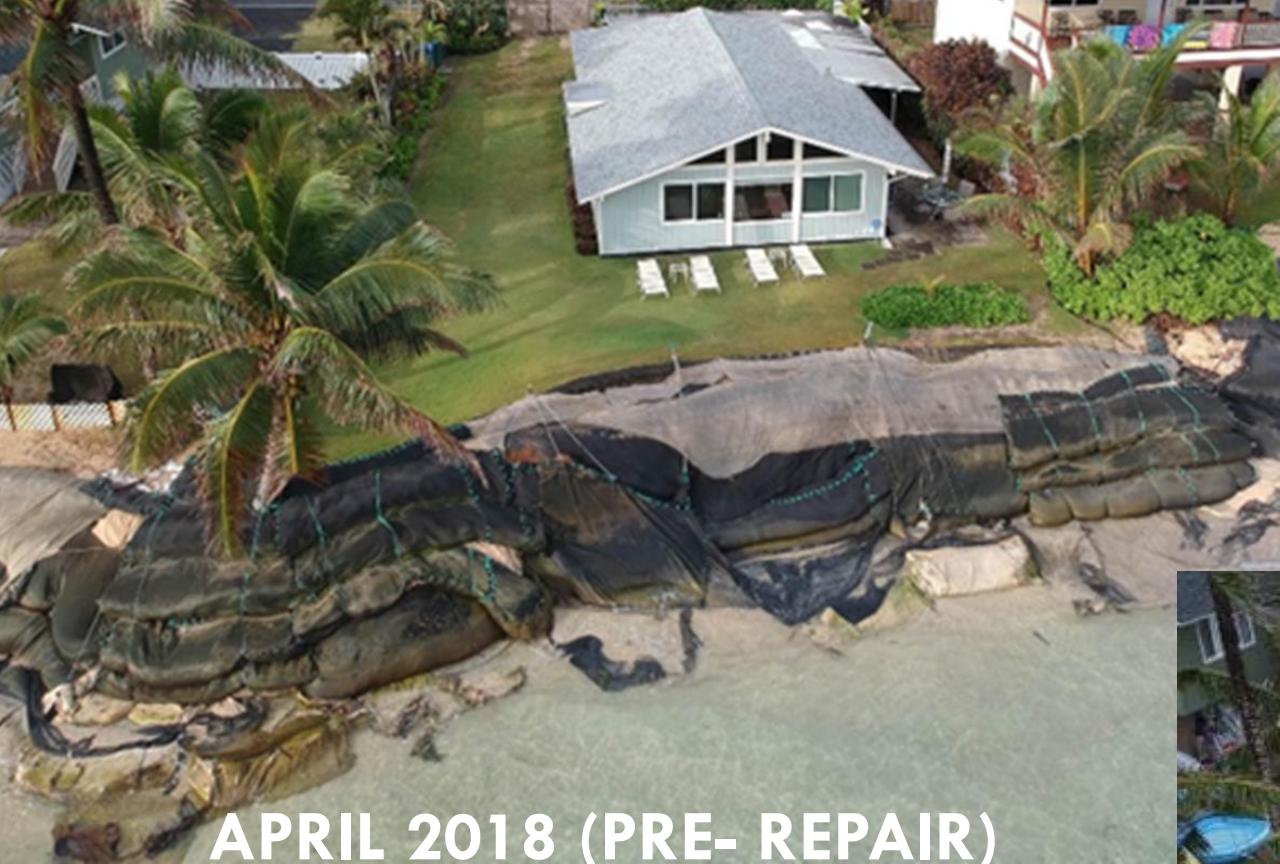
**MAY 2021
POST-REPAIR**

- + SAME STRUCTURE FOOTPRINT**
- + REMOVED NEARSHORE REMNANTS**
- + IMPROVED LATERAL ACCESS ACROSS
2ND ROW OF SANDBAGS**

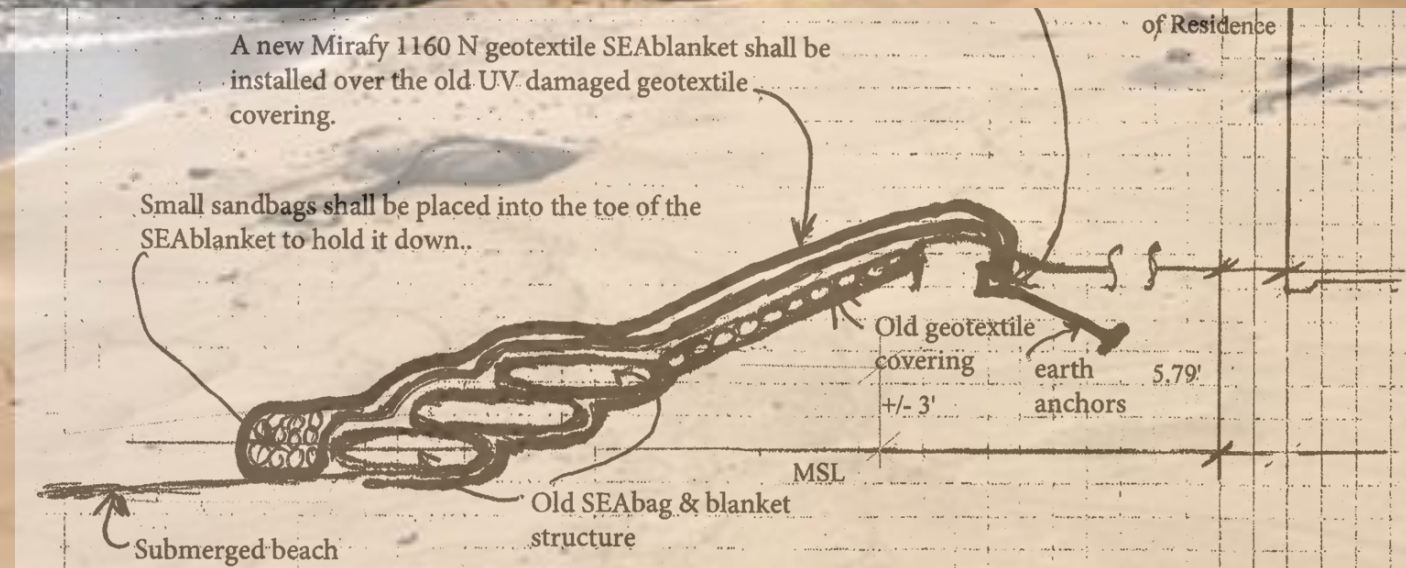
MAY 2021

**FOLLOWS
APPROVED
PLAN**
