2012 Waikīkī Beach Maintenance

Waikīkī, Oahu, Hawai'i

Prepared by:

July 2013

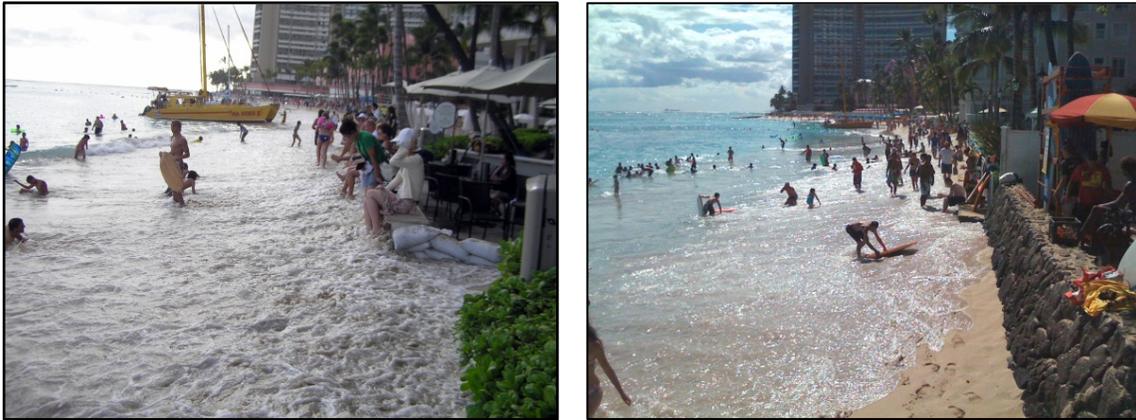
FIGURE 2: Chronic erosion leads to beach loss

Waikīkī Beach has experienced chronic erosion and beach loss for many decades due to a combination of natural processes and anthropogenic activities. At high tide, the beach in many areas is submerged, and sections of the beach have been badly eroded or, in some cases, completely lost. Historical sand hauling from the beach and dredging/mining of the reef in Waikīkī during the early 20th century significantly reduced beach volume and changed the nearshore morphology (Conger, et.al. 2012).

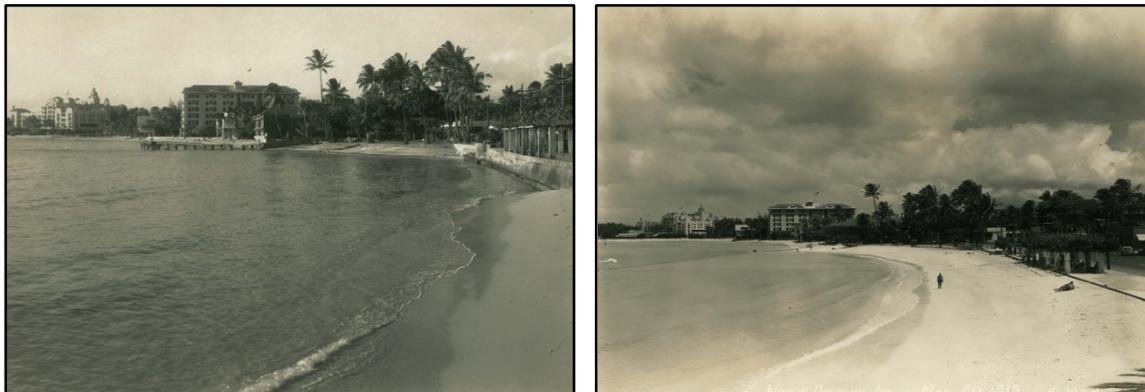
FIGURE 3: Kuhio Beach 1939; pre-beach fill (left) and post-beach fill (right)

Significant portions of the Waikīkī shoreline were armored with seawalls in the early part of the 20th century in an effort to protect hotels, infrastructure, and parkland from erosion and wave inundation. In 1928, the “Waikīkī Beach Reclamation Agreement” set the stage for large-scale beach nourishment in Waikīkī (Office of the Commissioner of Public Lands, 1928). Approximately 307,400 yards³ of sand were imported to Waikīkī, much of which was mined from other Hawaiian beaches (Wiegel, 2002).

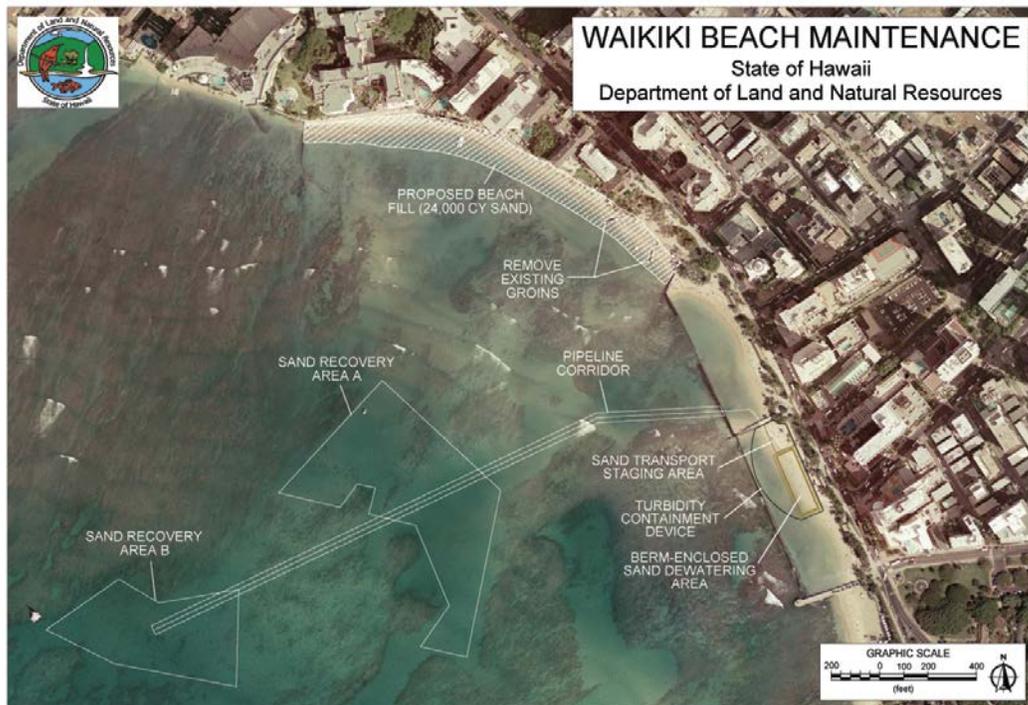
FIGURE 4: Waikīkī Beach Maintenance Project overview map

The project site is located on Waikīkī Beach, along the shoreline of Mamala Bay on the south shore of the Island of O‘ahu. The project area extends approximately 1,700 linear feet from the west end of the Kuhio Beach crib walls, near the Duke Kahanamoku statue, to the existing Royal Hawaiian groin between the Royal Hawaiian and Sheraton Waikīkī hotels. The backshore area at the east end of the project area is open and landscaped with grass and palm trees, and provides space for three beach concession operations. The remainder of the project backshore is occupied by resort hotels. From east to west, the hotels on the backshore are the Moana Surfrider, Outrigger Waikīkī, and Royal Hawaiian.

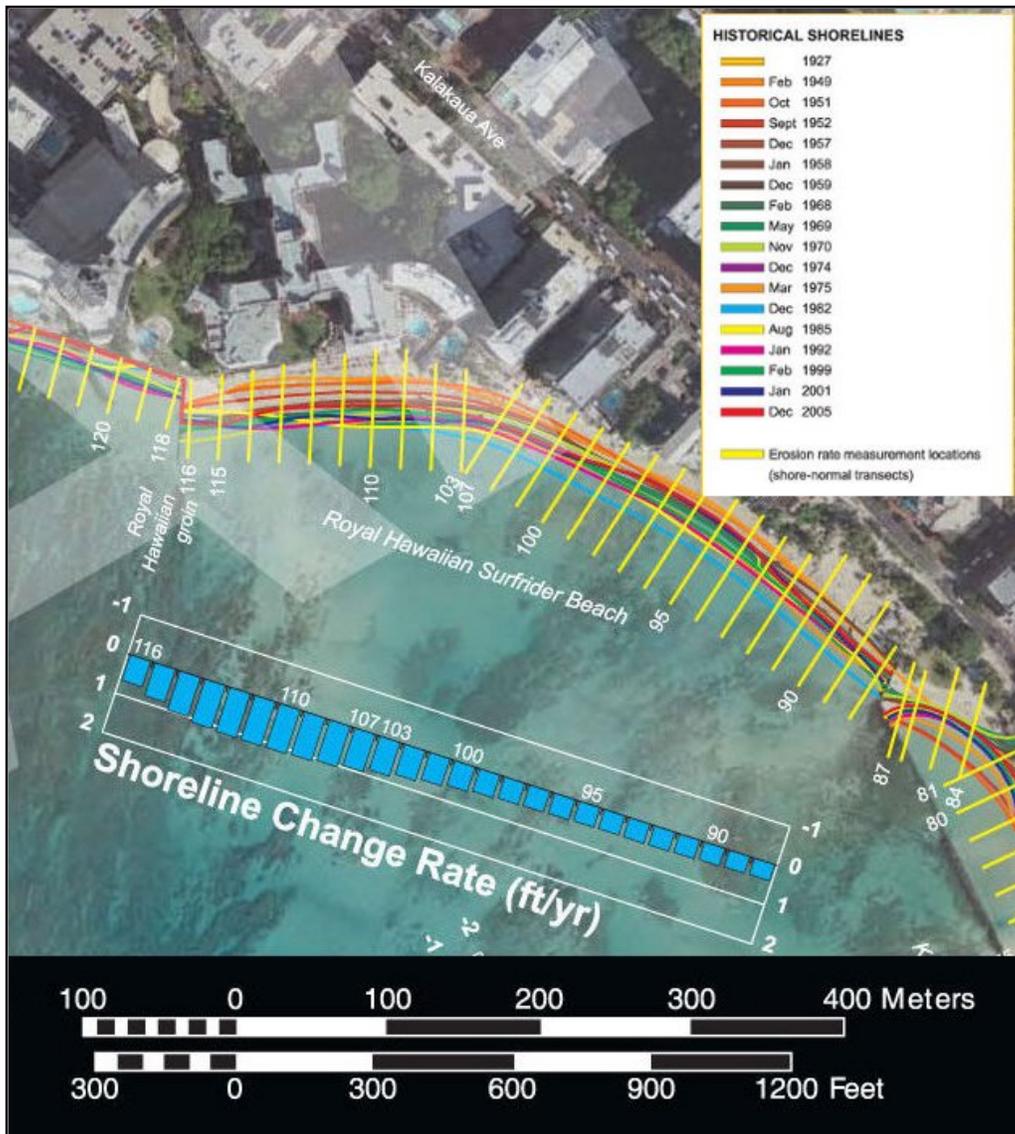
FIGURE 5: Historical shoreline positions and erosion trends for Waikki Beach

Waikīkī Beach consists of primarily medium-coarse grain calcareous beach sand interspersed with larger-diameter coral cobble (Sea Engineering Inc., 2009). The beach experiences seasonal fluctuations in beach width due to seasonal variations in wave energy. During the winter months, when wave energy is relatively low, beach sand migrates from the west end of the beach toward the middle. During large wave events a strong offshore rip current pulls sand out of the ‘Āpuakehau Stream Channel. If sand is transported far enough offshore and into deeper water it becomes unavailable to the beach system, as waves and currents will no longer be able to return the sand to the beach. From 1985 to 2009, the primary trend has been shoreline recession, with the shoreline retreating at rates up to 2.4 feet per year, and an average annual rate of 1.5 feet (Sea Engineering, Inc., 2009).

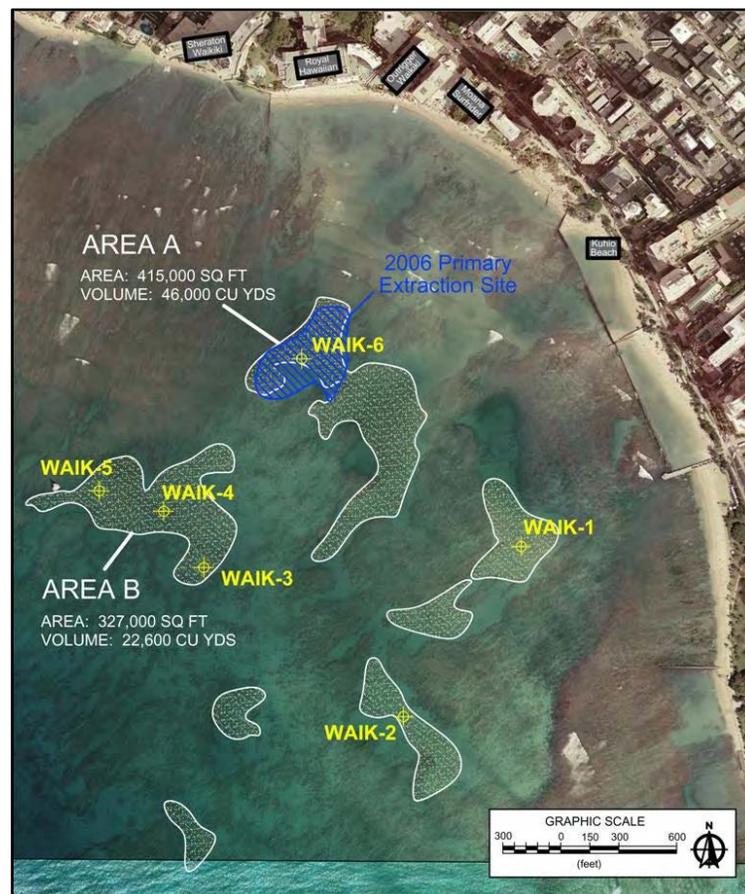
FIGURE 6: Marine surveys identify offshore ephemeral and non-ephemeral sand bodies

The sand recovery area is located in a sand-filled channel in the reef 2000 feet offshore at a depth of approximately 10-20 feet. Multiple studies assessed the quality and suitability of the offshore sand deposits for beach nourishment (Noda & Associates (2000), University of Hawai'i Coastal Geology Group (2005), and Sea Engineering, Inc. (2009) and found suitable sand sources. In 2005, the University of Hawai'i Coastal Geology Group used jet probes to measure sand thickness and estimate sand volume for three sand deposits with a total estimated volume of 86,000 yards³ of sand within the proposed sand recovery area (Final Environmental Assessment, Waikīkī Beach Nourishment, 2010).

In 2009, Sea Engineering, Inc. used a sub-bottom profiler and jet probes to investigate the sand quantity and quality. The sub-bottom profiler created four track lines across the previously-identified sand fields to measure sand thickness. The track lines indicated some variability in the thickness of the sand deposits. Thickness was variable, ranging from 2-7 feet. The jet probing showed a strong correlation with the results of the sub-bottom profiling (Sea Engineering Inc., 2009). Sand samples were collected from the most viable sand recovery areas with a mechanical push-core device. An analysis of sand grain distribution found that the offshore sand had the same characteristics as the existing Waikīkī beach sand, with minor color discrepancy.

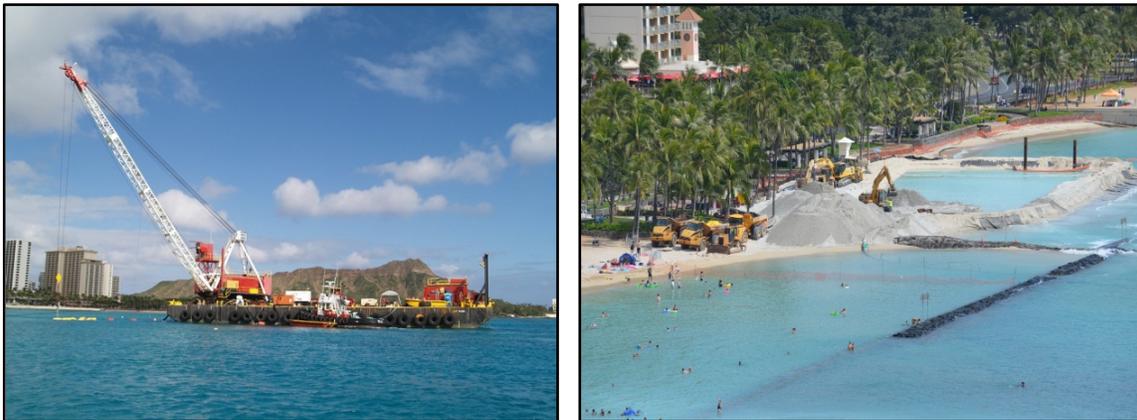
FIGURE 7: Sand recovery barge and dewatering basin

The potential dredging of coral rubble was addressed in the construction specifications. The contractor installed a rebar screen with a 1.5-inch grid over the suction head to screen for coral fragments greater than 1.5 inches in diameter. The grate worked well except that longer pieces of coral could get through, and there was much more coral rubble in the sand than was anticipated. As a result, the amount of coral rubble encountered during sand placement exceeded the project specifications. In response, the contractor performed rock picking with a sand rake along the dry portions of the beach. In addition, the Waikīkī Improvement Association organized volunteer efforts to remove coral rubble from the toe of the beach by hand. While the potential long-term impacts of coral rubble on Waikīkī Beach remain unclear, ongoing beach profile monitoring may inform decisions regarding the extent of the issue, if any.

Sand extraction was accomplished with the use of a Toyo DB 75B 8-inch pump with ring jet attachment suspended from an 80-ton capacity crawler crane. The pumping regime was staged on a barge that was towed to the site and stationed with a 4-point anchor mooring system. This system allowed the crane operator to continuously reposition the pump to adapt to changing water levels and variations in the thickness of the sand deposits. The average rate of sand recovery was approximately 500 cubic yards per day, which was consistent with the minimum estimates in the project specifications.

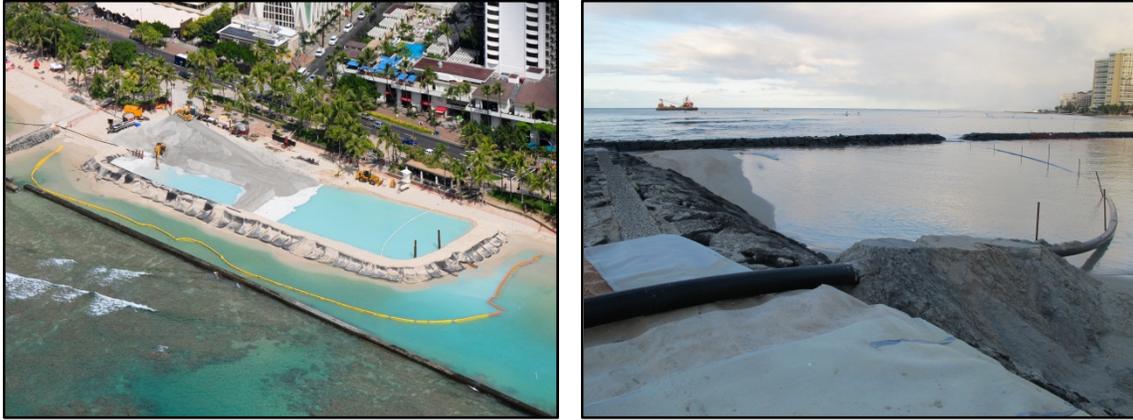
FIGURE 8: Dewatering basin (left) and sand recovery pipeline (right)

The sand discharge pipeline was an 8-inch high-density polyethylene (HDPE) pipe, with a total length of 3,200 feet. Pipe lengths of 50 feet were fused together and flanged at 400 foot intervals. The pipeline was assembled in the Ala Wai Canal and towed to the project site using an 800hp tugboat and two 500hp workboats. The pipeline was routed over a breakwater into a dewatering basin constructed in the east Kuhio Beach swim basin. The terminal end of the pipeline was positioned as close to shore as possible using a small workboat. A winch was then used to drag the pipeline over the breakwater to the dewatering basin. From the nearshore area to the barge, the pipeline was anchored using a system of metal plates and chains.

The dewatering basin measured approximately 100 feet in width and 400 feet in length and was constructed using sand from within the Kuhio Beach swim basin. The outer walls were fortified with filter cloth and a discharge weir was installed at the end of the basin opposite the sand discharge pipeline to allow water to drain from the basin. The area immediately outside the dewatering basin was surrounded by floating silt fences to provide additional water quality protection. A sand/water slurry was pumped into the basin. Sand was then pushed up into large piles with an excavator and bulldozer and then transported to the sand placement area on Waikīkī Beach.

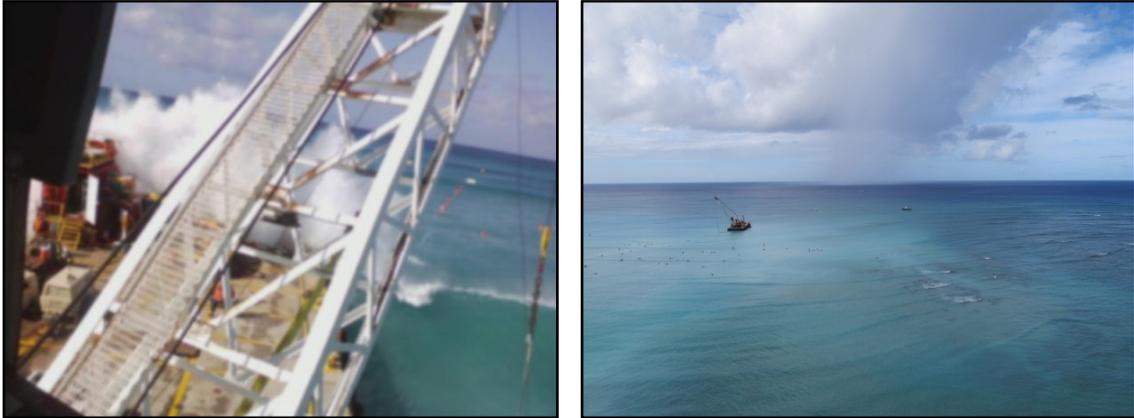
FIGURE 9: Weather and high surf affected sand recovery operations

Sand recovery operations were constrained by wave action. A rocking motion, created by small swells, limited the productivity of the Toyo pump, adding additional time to the project. In some cases, production had to be stopped due to safety and risk of equipment damage. In several cases, sand recovery operations were suspended due to inclement weather and high surf conditions. However, even with substantial delays due to ocean conditions, sand recovery was successfully accomplished within the three month project window.

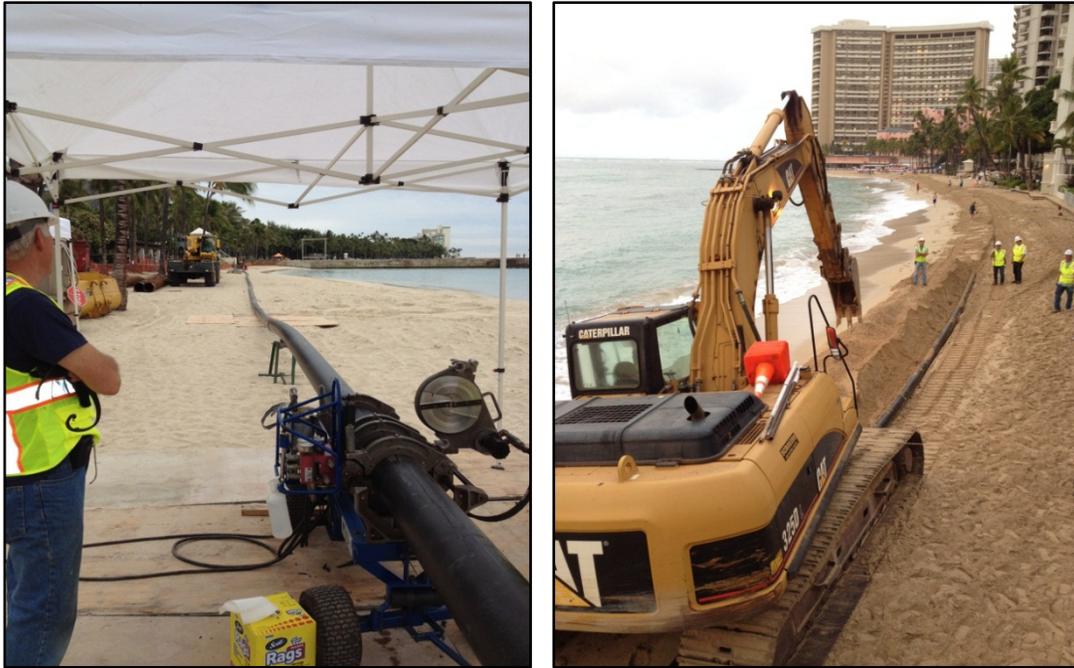
FIGURE 10: Constructing the pneumatic sand conveyance system

The original proposal called for the sand to be transferred from the dewatering basin to the sand placement sites through a pneumatic sand conveyance system utilizing a Vortex Low Pressure Pumping System. An 8-inch HDPE pipe was buried in the sand 2,500 feet along the beach from a sand hopper stationed at the sand stockpile area. The process involved loading the dewatered sand into the hopper where it would enter the pneumatic pipeline. Once the sand fill profile was achieved for a given segment of beach, the pipeline was to be cut with a saw and the next beach segment would be filled. Unfortunately, the pneumatic sand conveyance system was unable to achieve the minimum volume requirements for sand placement – e.g., 100 cubic yards/hour. After several failed attempts to increase sand conveyance rates, the pneumatic sand conveyance system was replaced with a conventional truck hauling approach.

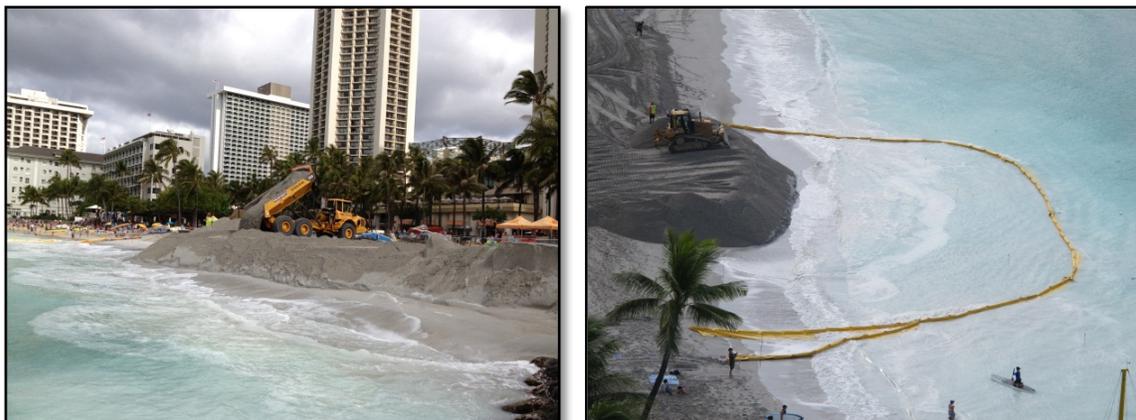
FIGURE 11: Sand placement using dump trucks and bulldozers

Three CAT 725 articulated dump trucks were used to transport the sand from the dewatering basin to the sand placement site, starting from the southeast Kuhio Beach breakwater and finishing at the Royal Hawaiian Groin. A truck haul route was cordoned off with steel safety barriers to accommodate the articulated dump trucks and a bulldozer. Crossing guards were stationed at regular intervals to escort beach users across the truck haul route to the water. The beach was built from the southeast (Kuhio Beach) to the northwest (Royal Hawaiian). Sand was graded using a CAT DK6 Dozer. Truck hauling ended promptly at 12:00pm each day, after which the entire beach was available for public use.

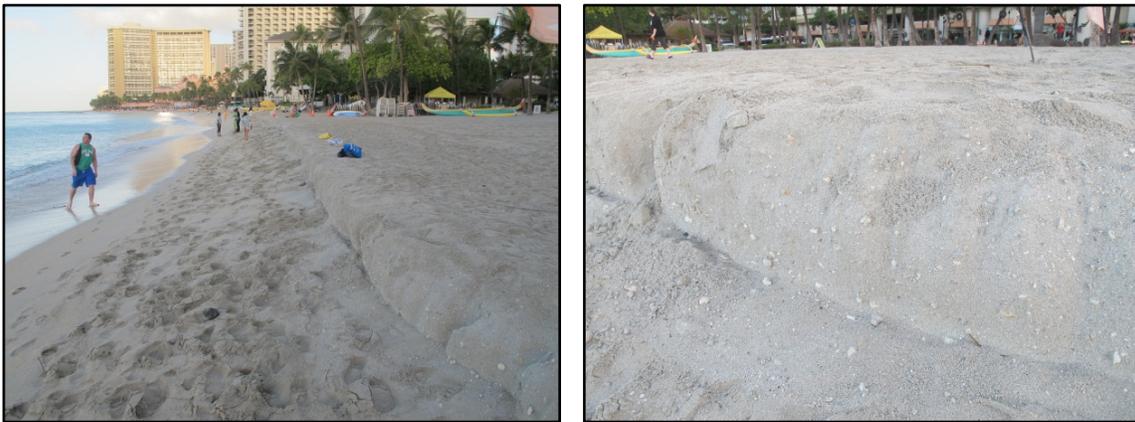
FIGURE 12: Sand compaction led to formation of a berm along the truck haul route

One unexpected issue involved sand compaction, with a hardened berm forming along parts of the beach, particularly near the Kuhio Beach swim basins and the Royal Hawaiian Hotel and groin. While the origin of the berm is not certain, there is a general consensus that it likely resulted from compaction of the sand under the weight of the trucks as they made repeated passes along the truck haul route. This hypothesis seems reasonable in that the berm formed along the seaward edge of the truck haul route. Similarly, the sand landward of the berm crest appears significantly harder and more consolidated than the sand seaward of the berm. While this may be due to a lack of wave action in this area, it is plausible that the observed compaction occurred as a result of truck hauling. While further research is necessary to determine the cause of the berm, ongoing beach profile monitoring may provide insights into the long-term stability of the berm and the potential impacts to beach processes along Waikīkī Beach.

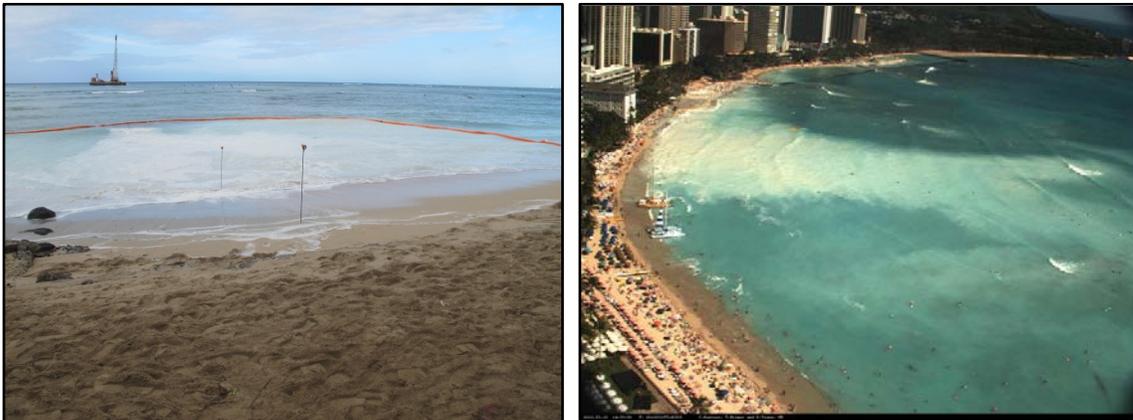
FIGURE 13: Sediment plume formed despite the use of containment booms

Of the monitoring constituents, turbidity showed by far the most response to construction operations of the beach nourishment work. Levels of exceedance of the decision criteria (DQOs) for turbidity were far higher at the nearshore stations at the site of sand placement than at the offshore control station. Turbidity remained elevated in the post-construction period relative to the pre-construction period. This elevation could be a result of either (or both) increased wave action during south swells that occurred during the post-construction period, and/or as a residual effect of re-suspension of the fine-grained fraction of the material placed on the beach (Marine Research Consultants, Inc., 2010).

The potential for increased turbidity was addressed in the Environmental Assessment (EA). Comparative analysis of grain size distribution for native sand samples (taken from Waikīkī Beach) and borrow sand (taken from the proposed dredging area) found that the borrow sand had the same grain size distribution, the same texture, and a similar color as the existing beach sand. Furthermore, the analysis found that the native and borrow sand was not finer in size than the native beach sand, thus no significant loss of finer material was expected to rapidly occur after sand placement.

Despite the use of Best Management Practices (BMP), the sand placement process did result in increased turbidity in the nearshore waters adjacent to the project area. However, project work was never halted due to turbidity. Upon commencement of sand placement a sediment plume consisting of a milky white color extended alongshore and several hundred meters offshore of Waikīkī Beach. In response, a sand berm was constructed and a second silt curtain was installed, neither of which resulted in a measurable decrease in turbidity.

There was a general consensus that the sediment plume likely formed due to the release of micritic calcium carbonate (CaCO₃). Micritic calcium carbonate is a product of bioerosion, a microbiological process by which organisms, such as boring clams and worms, bore through the reef producing a silt-like material that can become concentrated in topographic depressions in the reef. Despite the formation of the sediment plume, there were no human health risks or negative impacts to benthic habitat.

The Department of Health, Clean Water Branch (CWB) rules require silt containment and may require a work stoppage if any “objectionable color” is observed in waters in or adjacent to the project area. Best Management Practices (BMP) were designed to minimize the potential for increased turbidity and to ensure permit compliance, including dewatering and deployment of floating silt containment devices in areas of active sand placement.

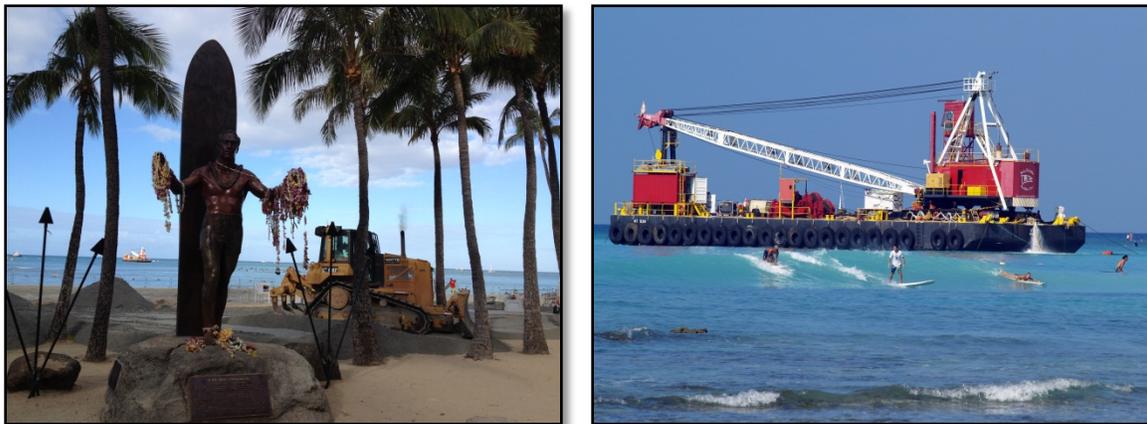
FIGURE 14: Beach nourishment did not negatively impact surfing resources at Waikīkī Beach.

George Downing, a legendary surfer, Waikīkī local, and President of Save Our Surf (SOS), has written and spoken extensively about the effects of sand nourishment on Waikīkī surf breaks. Downing has stated that, “Queens surf site, which once had a single take-off peak, has developed three take-off peaks due to the excess sand. All of these changes are due to the sand filling in, changing the contours and depth of the reef bottom.”
