GEOMORPHOLOGICAL STUDY OF PĀPŌHAKU DUNE
with recommendations for dune preservation

Prepared for the State of Hawai'i
Office of Hawaiian Affairs

by
Zoe Norcross-Nu'u
University of Hawai'i Sea Grant Extension Service
April 2005

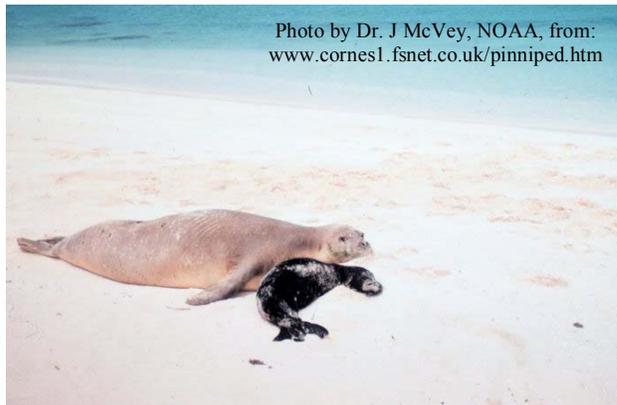
Figure 1. Beaches and dunes provide critical habitat for endangered species in Hawai‘i.

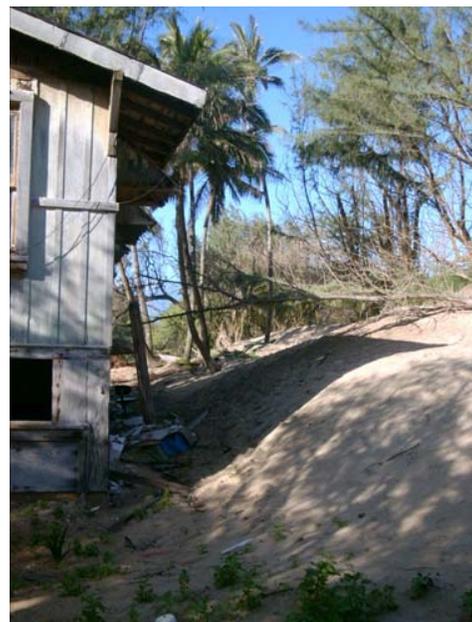
Figure 2. (right) A migrating dune moves into a coastal home on Maui.

As beaches and dunes are subject to seasonal as well as long-term influences, they are constantly in a state of dynamic flux, responding to the shaping forces of the wind and waves. As such, it is important that their mobility not be restricted. Attempts to fix the shoreline or dune in place with structures or aggressive vegetation are often, in addition to being unsuccessful, harmful to the system. Dunes need room to move; thus, buffer zones between coastal dunes and development are important, and the greater the buffer space the longer the dune is likely to be able to maintain its form and function (Figure 2).

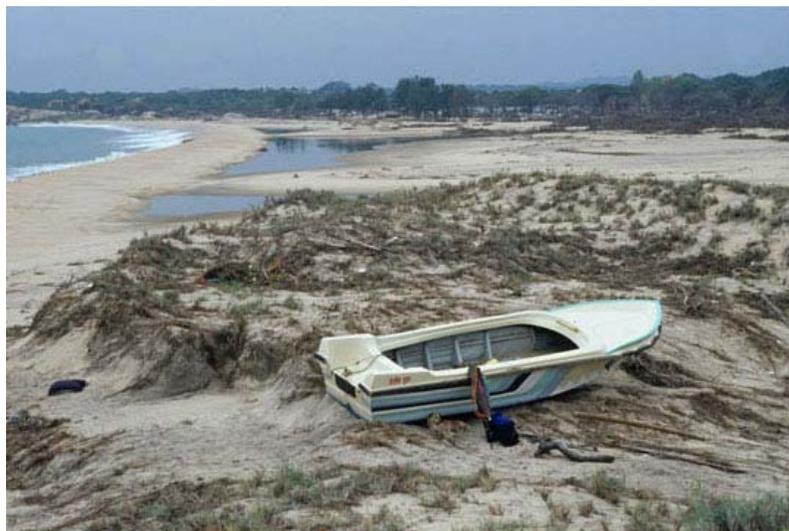
Figure 4. Foreground shows intact dune that was barely overtopped by the tsunami and sustained little damage. In the background, the area where the dune had been removed prior to the tsunami to improve the ocean view from Yala Lodge, is visible.

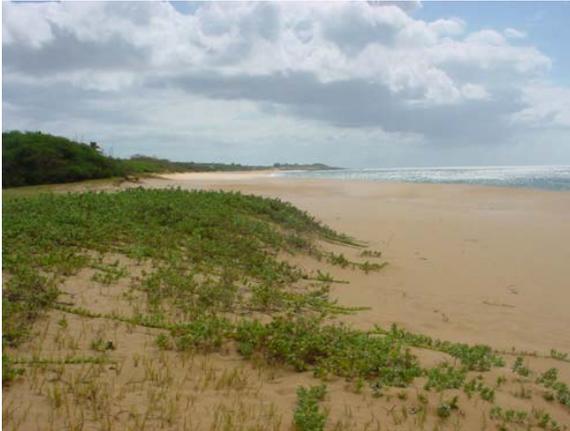
Figure 5. Plants trap wind-blown sand, causing it to accumulate and eventually form dunes.

Natural dune building is initiated when wind picks up sand grains off the beach and carries them up the beach. Salt-tolerant coastal vegetation, that often grows seaward up to the mauka extent of the reach of the waves, traps the wind-blown sand, causing it to accumulate around the plants. As the sand volume builds up, the plants grow taller to avoid being buried; in this manner sand dunes are built up (Figure 5).

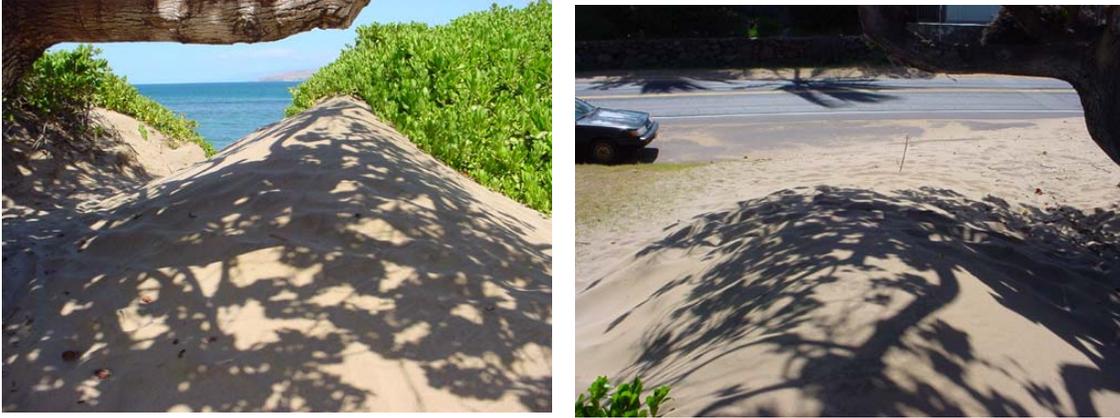
Figure 6. These images are taken looking makai and mauka from the same location. This beach access path on Maui became a blowout due to the prevailing onshore winds. The funneling effect of the wind through the break in vegetation led to a low, weak area in the dune and considerable loss of sand from the beach.

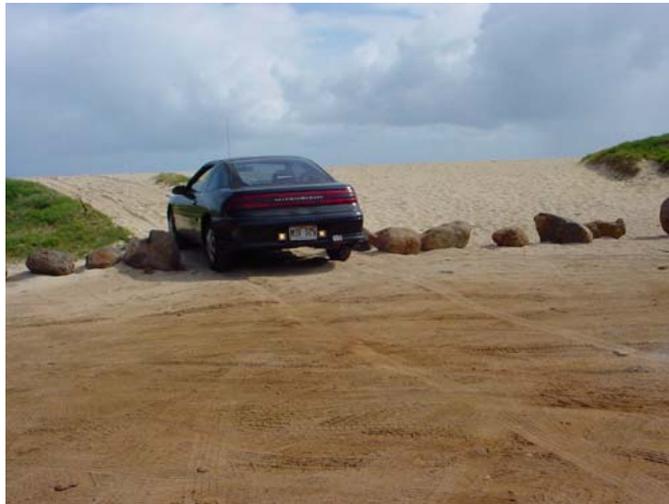
Figure 7. Vehicular traffic over dunes destroys vegetation and causes erosion of the dune.

Virtually any activity directly on a dune, except for dune restoration activity, is potentially harmful to the dune. Due to the sensitive nature of coastal vegetation, foot traffic alone is enough to destroy dune plants. As such, beach access paths often turn into blowouts. However, even when they are not causing blowouts, footpaths through the dune inevitably lead to erosion of the path, which eventually creates a low point in the dune that is absent of vegetation, which increases the vulnerability of the dune and inland areas to breaching and storm damage during high surf events. Vehicular traffic is also extremely damaging to dunes, as are such activities as boat storage, camping and camp fires (Figure 7).

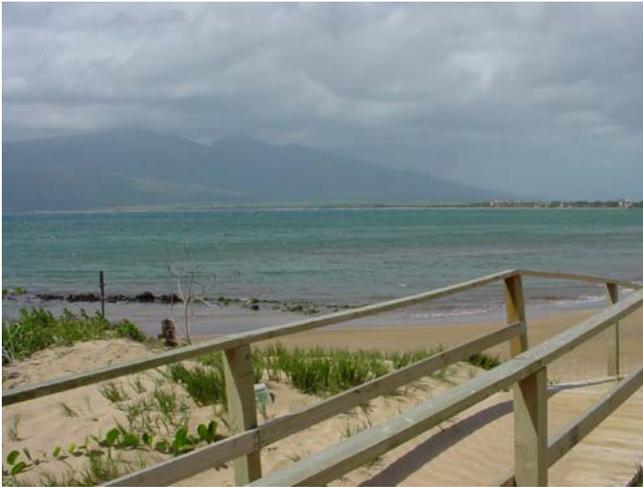
Figure 8. Dune walkovers allow access over the dunes while minimizing erosion and damage to plants.

An alternate way to access the beach is to have elevated dune walkovers that allow access to the beach while minimizing impacts to the dune. Elevated walkovers often consist of ramps or stairways supported by pilings driven deep into the sand and are usually constructed of wood or recycled plastic (Figure 8). They eliminate the erosive action of foot traffic and allow plants to grow underneath, preserving the structural integrity of the dune. For guidelines on dune walkover construction, see Appendix B.

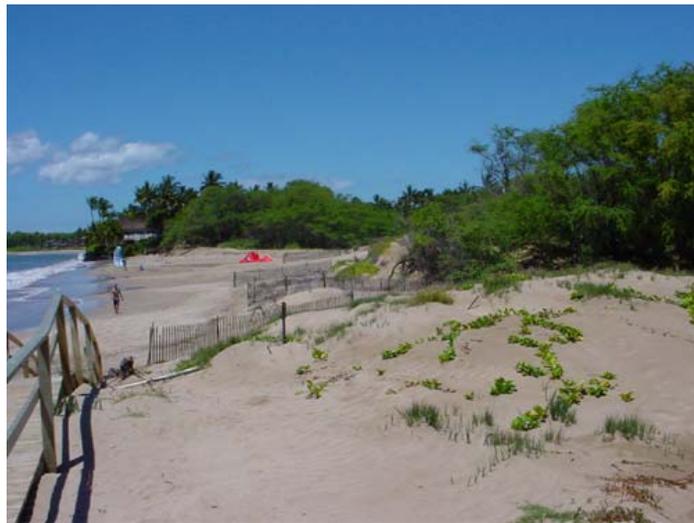
Figure 9. Dune restoration often involves a combination of dune walkovers, sand fencing, planting and irrigation.

Sometimes, sand fencing is used in conjunction with planting to assist with trapping the sand while the new vegetation becomes established (Figure 9). Sand fencing comes in a variety of material from wood to plastic to fabric, is usually about 3 to 4 feet high, and consists of approximately 50% air space and 50% solid material (Figure 10). This allows the wind-borne sand to pass through, but due to the interruption of the wind flow it loses speed and the sand drops out and accumulates behind the fence. The fencing is oriented perpendicular to the prevailing wind direction, and is usually installed in staggered sections of approximately 5-10 feet in length. Once the new plants are healthy and strong, the fencing can be removed.

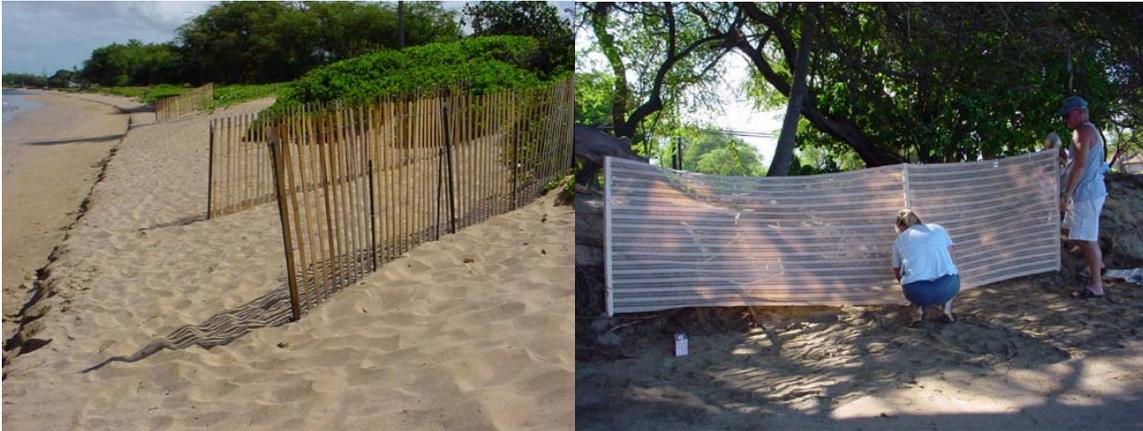
Figure 10. Sand fencing made of wood (left), fabric (right), or other materials can be used to trap wind-blown sand while new vegetation growth is established

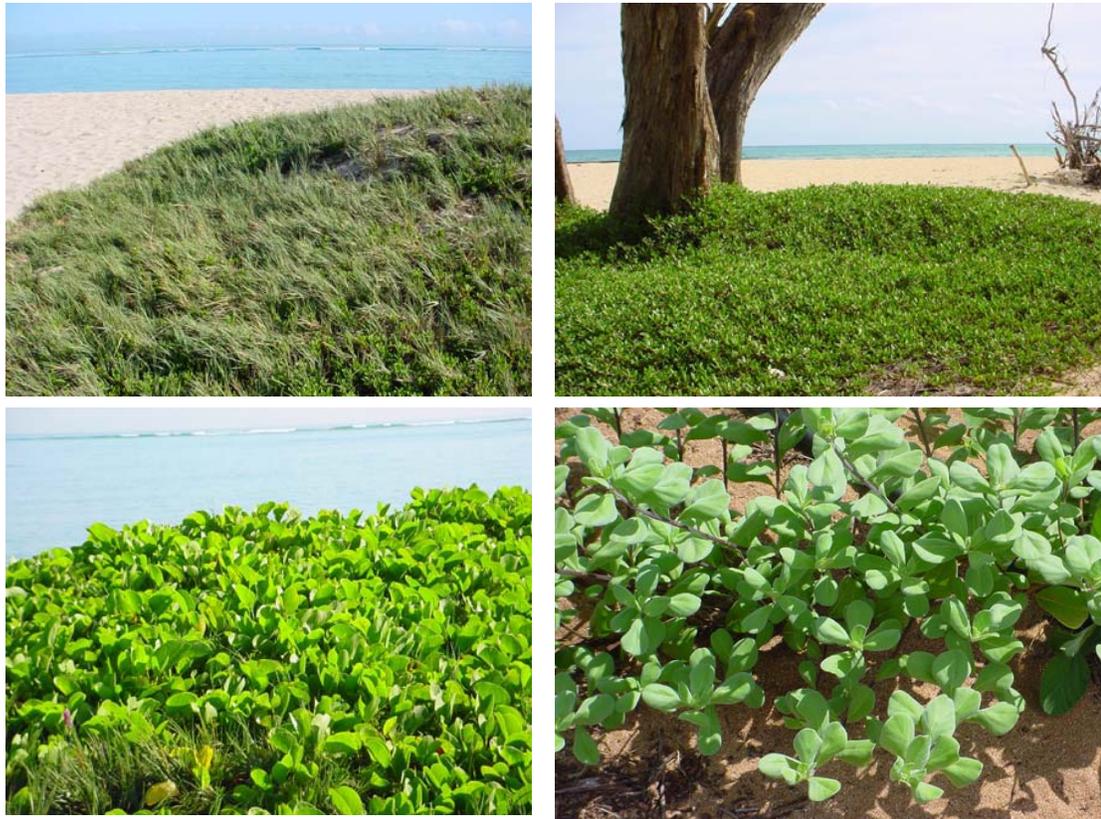
Figure 11. ‘Aki ‘aki grass (top left), pohuehue (top right), ‘ākulikuli (bottom left), and pōhinahina (bottom right) provide excellent groundcover while allowing dunes to maintain mobility. A botanist or local expert would be able to recommend the best plants for a given location at Pāpōhaku.

When planting vegetation in the coastal area, there are several important things to keep in mind. While it may seem ideal to plant the thickest, toughest plants with the most dense root systems available for maximum stability, such as naupaka kahakai for example, these plants often lock in the sand underneath them, preventing its natural release under storm conditions as described earlier in this section. It was also pointed out that dunes need to be able to move in response to changing wind and wave conditions, as well as to retreat in response to chronic erosion. This can be best accomplished with native coastal groundcover species such as ‘aki ‘aki grass, pohuehue, ‘ākulikuli, and pōhinahina (Figure 11). These types of salt-tolerant plants have an excellent ability to spread quickly and provide effective groundcover to trap the sand and build up the dune, yet release the sand well under erosional conditions to allow the dune to respond naturally. A botanist or local expert would be able to recommend the best type of plants for dune restoration at Pāpōhaku.

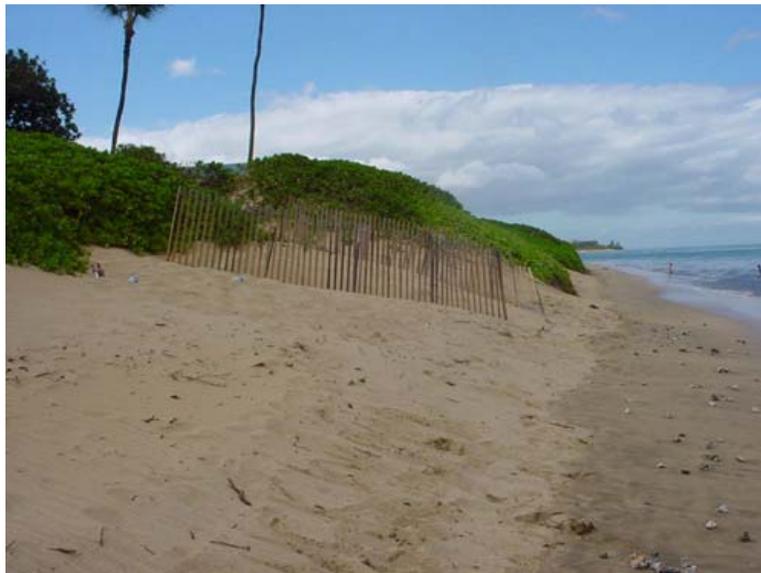
Figure 12. In the foreground, a dry beach exists. In the background, vegetation has been forced seaward such that no dry beach exists at high tide.

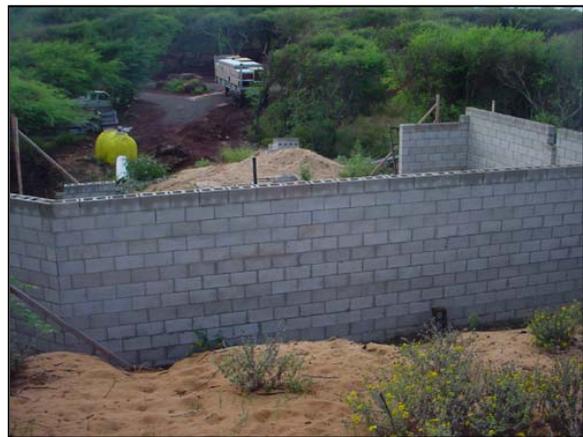
Figure 1. Example of a misunderstanding: Partially-constructed dwelling in the primary dune. Outcome to be determined.

2) Every proposed new structure in the Pāpōhaku coastal area should be checked to ensure that it does not fall within the primary dune. As the dune is actively migrating, the dune line delineated by this study will change. Thus, site visits and/or photographed submittals of the proposed structure locations are recommended to visually ensure that no structures are built within the primary dune.

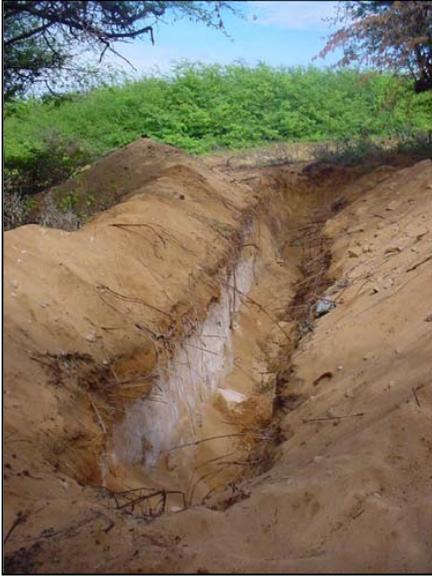
Figure 2. Archaeological trench dug using heavy machinery left exposed in primary dune for several months

3) Archaeologists should perform any digging in the primary dune by hand with shovels rather than with backhoes or other mechanical trenching equipment. Following the digs, the trenches or holes should be filled back in and restored as best as possible to the pre-dug condition.

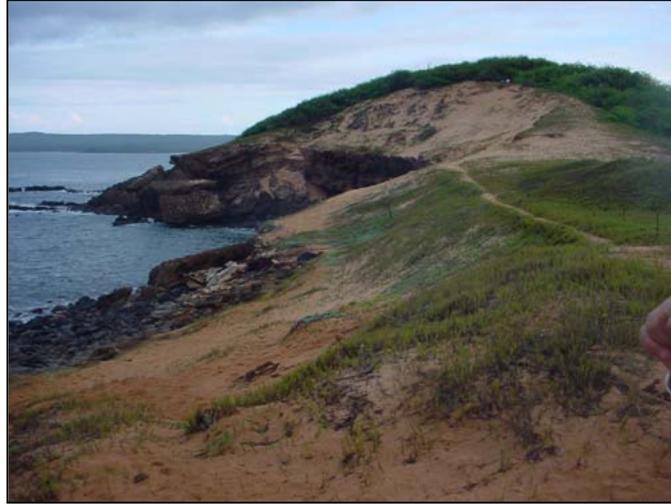
Figure 3. Pu‘u Koa‘i, at the southwestern (downwind) end of Pāpōhaku, consists of an active, perched sand dune overlying eolianite (solidified dunes) and basalt.

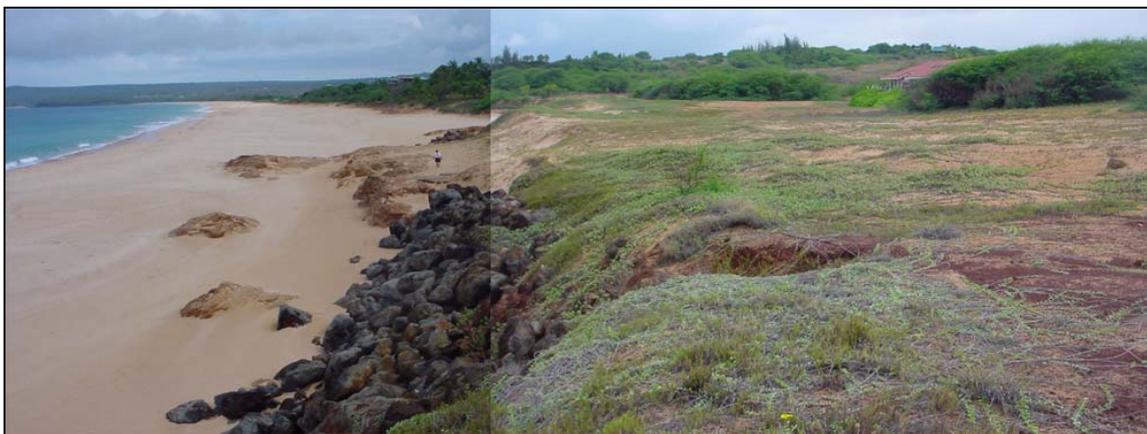
Two areas of large revetments, consisting mainly of large boulders and to a lesser extent concrete, exist at the south end of Pāpōhaku beach (Figure 4). The revetments may have been built as part of the sand mining operations in the 1960s and 1970s, but this has not been confirmed. At the location of the larger of the two revetments, the dune ends and the land drops steeply down approximately 25-30 feet to the beach at the face of the revetment. This morphology suggests that the revetment is protecting the land behind it from erosion, and is thus contributing to erosion of the beach by impounding the sand source that, in the absence of the revetment, would have been supplied by the dune. Adjacent to the revetments, outcrops reveal layers of coral rubble and dirt fill that represent former road beds on which the trucks and machinery for the sand mining operation were driven (Figure 5). Landward of the revetments, the dune has a broad, flattened surface, probably as a result of the sand mining. Numerous exposures of eolianite and beach rock in Section 3 are indicative of an erosional trend.

Figure 4. This image shows the main boulder revetment at the southwestern end of Pāpōhaku Beach, and the flattened area above where a sand dune likely formerly existed. This area was heavily used in the sand mining operations in the 1960's and 1970's. Eolianite exposures are visible on the beach (appearing as brown exposed rock in the photo).

solid structure, they may fail under prolonged exposure to heavy wave action. Removal of the revetments would be beneficial to the health of the beach and dune.

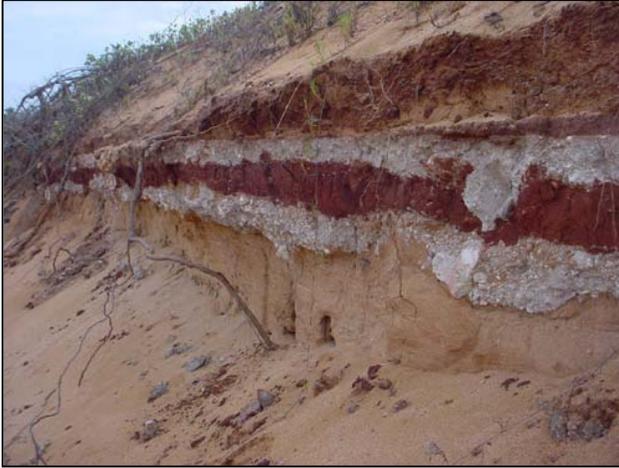
Figure 5. Crushed coral and clay layers are evidence of former road bed.

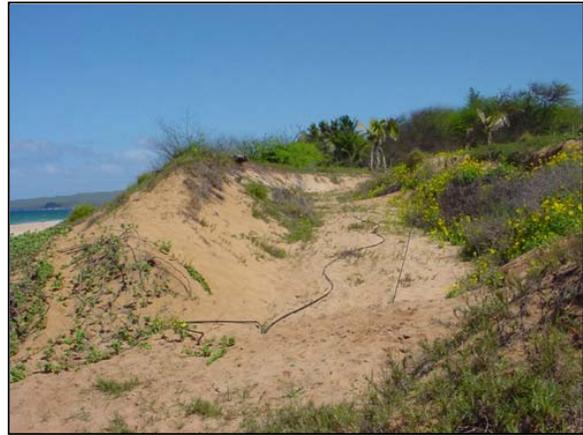
Seaward of TMK 2-5-1-007:048, a diagonal slash of approximately 15 feet wide has been cut through the primary dune, leading from the crest of the dune to the base (Figure 6). It appears to have been created to facilitate access to the beach. While it is not known how long ago this swath was created, it has undoubtedly damaged the dune at this location and weakened its capacity as a natural protective structure against storm and high surf damage, as well as a source of sand to the retreating beach.

Figure 6. Slash cut through the primary dune, possibly to facilitate beach access.

- 1) Repair of the blow-outs by replanting with native dune groundcover vegetation such as ‘aki ‘aki grass or pōhinahina would help in trapping wind-blown sand, building up the dune, and keeping the sand in the active beach and dune system. This will assist in slowing down rates of dune migration and sand loss from the beach and dune.

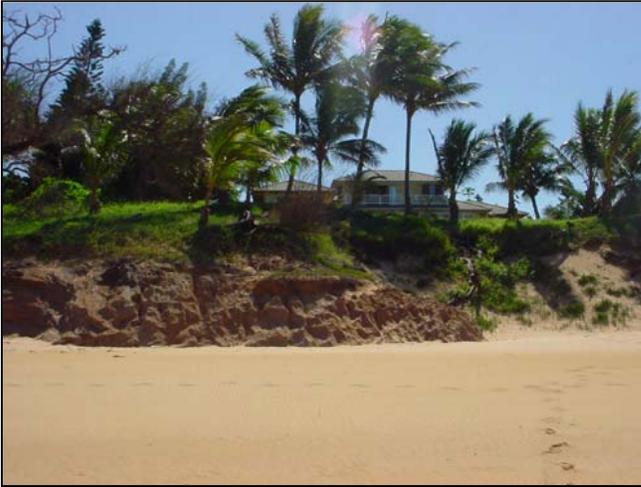
Figure 7. Houses are elevated above the beach area. The right side of the eolianite exposure in foreground (rock seen at center and left) was reportedly recently removed.

According to the locals, a section of the eolianite rock in front of TMK 2-5-1-007:053 was removed around the time the house was built. This house can be seen in Figure 7, with the section where the rock has been removed on the right-hand side of the photo. While the reasons for the removal of the rock are uncertain, this has effectively exposed the property to a higher risk of erosion from which the rock offered natural protection. Removal of naturally occurring rock is not recommended.

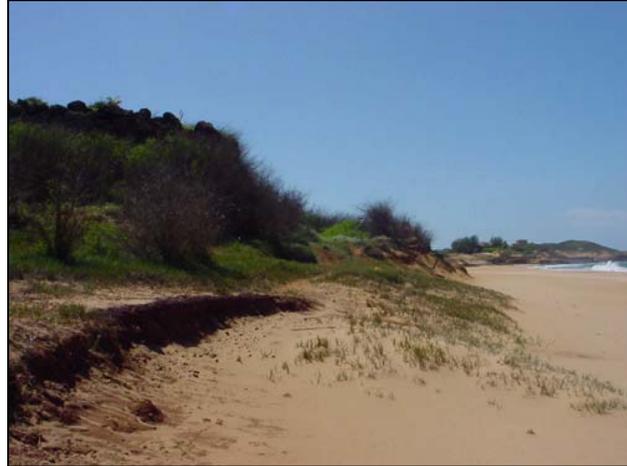
Figure 8. Basalt outcrop can be seen in upper left. In lower left, clay layer may represent a former road bed.

- 1) Repair the small blow-out at the southwestern end of section 4 with native coastal groundcover plants.
- 2) Access paths should consist of elevated dune walkover structures or stairways built of wood or recycled plastic, so that foot traffic does not cause continuous erosion of the dune face, and so that plant growth is not disturbed.

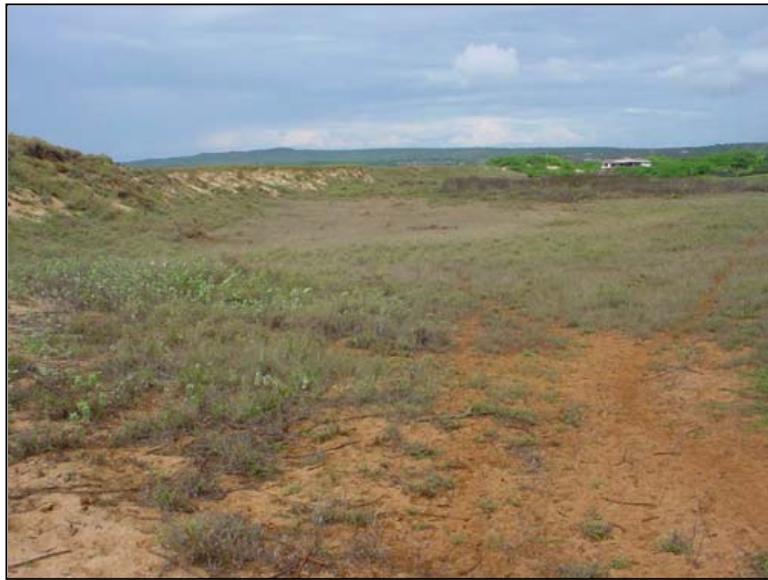
Figure 9. Trench remaining from former sand mining operations.

- 1) Elevated dune walkovers are especially important in Section 5 where the former sand mine pit has left the remaining dune weak and vulnerable. Elevated ramps or stairs on both sides of the dune should be required for any beach access locations in order to eliminate the damaging effects of foot traffic which include erosion of sand, destruction of vegetation, and creation of low points and blowouts which increase the susceptibility of the dune to breaching. Concrete and/or stone landings or foundations should not be permitted.

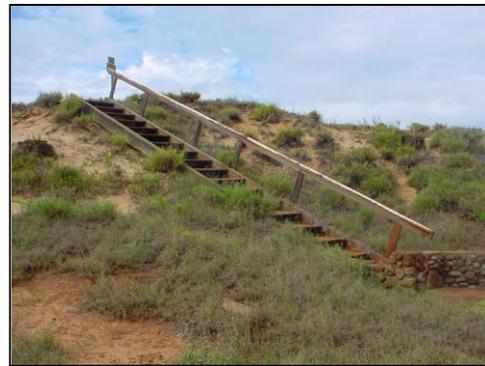
It was good to see that a wooden staircase had been built from the mauka side of the dune up to the dune crest (Figure 10), which will minimize erosion due to foot traffic; however, the cement landing and rock wall at the base of the stairs does not allow for dune migration. Unfortunately, there is not much that can be done to restore the original strength of the dune fronting the sand mine, as the volume of sand necessary to replenish the dune would be prohibitive. Thus, the focus should be on minimizing further impacts.

Figure 10. Stairway on mauka side of dune

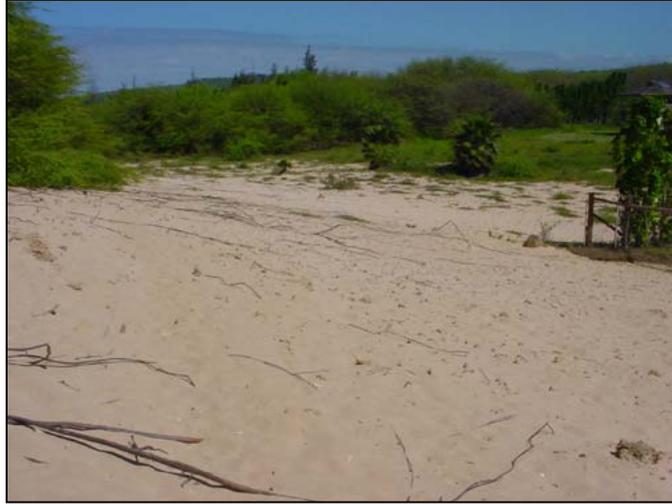
Figure 11. Cleared back dune area with numerous root casts

- 1) The bare, exposed sand patch on the mauka side of the dune in the southwestern part of Section 6 should be replanted with native coastal vegetation.
- 2) Elevated dune walkovers at access points would be beneficial.
- 3) Boulders on the dune interfere with natural dune movement, and should be removed.

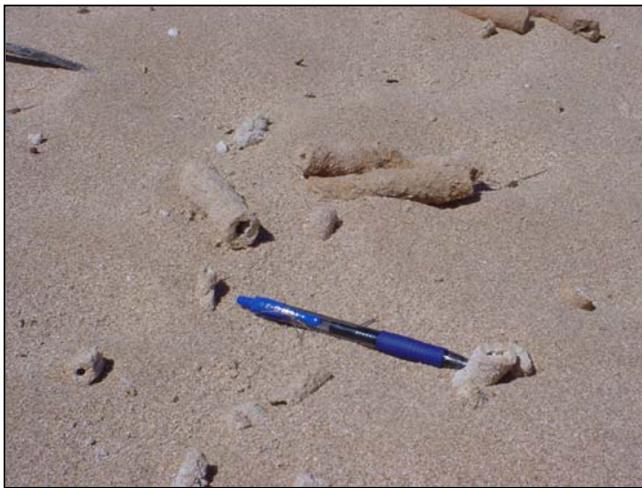
Figure 12. Root casts with pen for scale

An interesting feature of the cleared area is the great number of root casts lying on the sand (Figure 12). Root casts are hardened tubes of cemented sand with a hollow core that represents the former existence of a root which has since biodegraded. The casts are formed in a series of chemical reactions between carbon dioxide emitted from living plant roots, water from rain or the atmosphere, and the calcium carbonate of which the sand is composed. Some of the casts are up to one foot long and as large as 2 inches in diameter. As the formation

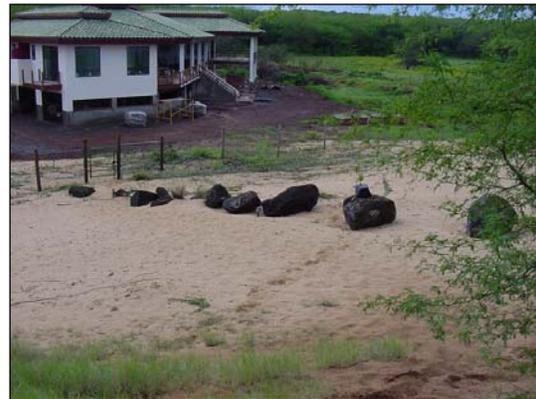
A line of boulders extends from the fence line up the back of the dune at a new house under construction (Figure 13). The purpose for the boulders is unclear, however they appear to delineate access to the beach as they extend seaward from the gate in the fence.

Figure 13. Boulders on back of dune.

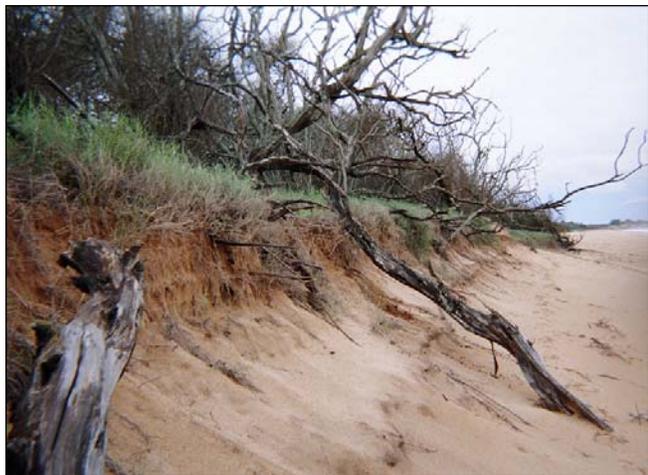
Figure 14. Erosional scarp and exposed tree roots indicate recent erosion.

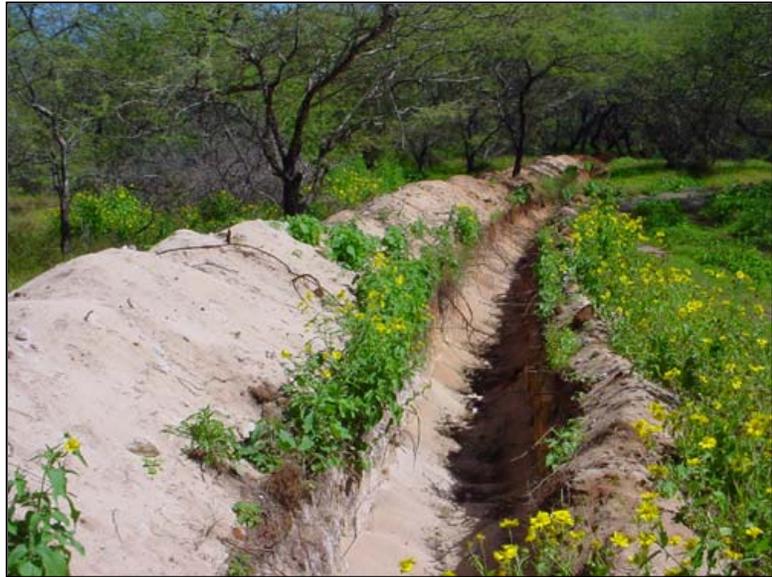
A trench mauka of the dune and perpendicular to the shoreline that has likely been dug for construction purposes near the middle of Section 7 reveals that below the uppermost soil/organic layer lies a significant amount of sand (Figure 16). As the trench gets further from the dune and closer to the road, the soil content visible in the walls of the trench increases, visible as a

Figure 16. A trench mauka of the dune reveals an abundance of beach-quality sand in the floodplain area.

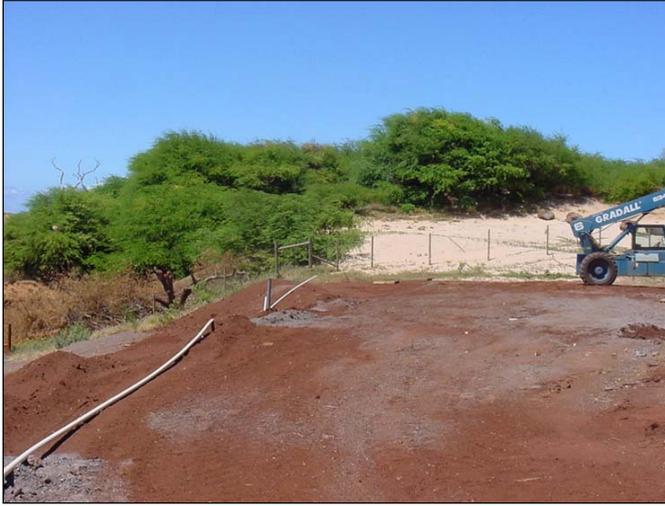
Figure 17. Dirt fill has been placed immediately mauka of the dune on three properties in this section, for construction purposes.

1) Beach access paths will likely be created by property owners in the near future in Section 7 as there are a number of new construction projects underway for which access paths do not currently exist. Access paths are not necessary for each individual property as they have been created in Section 6; instead, it might be advisable to have every pair of adjacent property owners share a single access path. These access paths should be elevated wooden or recycled plastic structures to minimize damage to the dune and plants from pedestrian traffic.

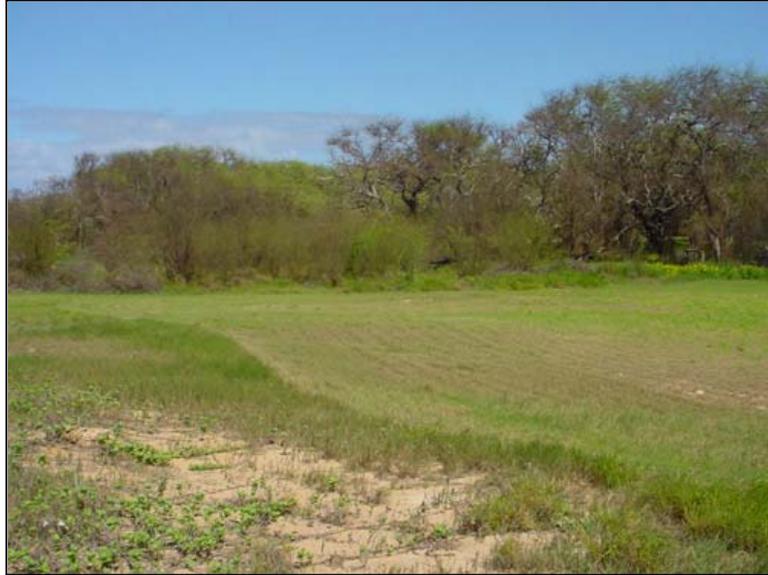
Figure 18. ‘Aki ‘aki grass in the State conservation land, which has been mowed.

- 1) The small blowout should be repaired by replanting with native coastal groundcover vegetation.
- 2) Property owners should be advised not to mow any native coastal plants in State Conservation Land, in particular ‘aki ‘aki grass.
- 3) Elevated dune walkover structures would reduce damage to dunes from foot traffic.
