Royal Hawaiian Beach: Replenishment, Monitoring, and History of Engineering

Interim Report, Year 1

June, 2013

Coastal Geology Group
Department of Geology and Geophysics
School of Ocean and Earth Science and Technology
University of Hawaii at Manoa

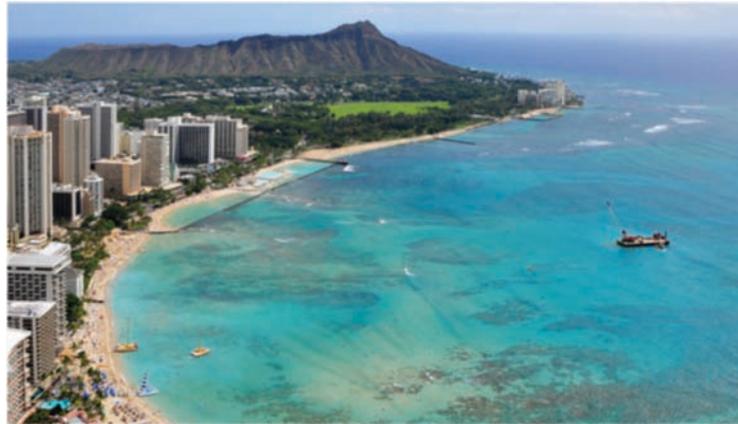
FIGURE 3 The dredging barge illustrates the location of sand recovery approximately 2,000 ft offshore of Royal Hawaiian Beach.

As part of this project, Sea Engineering was contracted to recover approximately 24,000 cubic yards of sand from offshore sand deposits. The sand was relocated by pumping a sand water slurry through a submerged 3,200 ft pipe to the shoreline for dewatering. Dewatering took place within a basin formed by temporary sand dikes located inside of the Kuhio Beach Crib walls. The project also included the removal of two cement sand bag groin structures at the east end of the area. Sand recovery took place 2000 m offshore at a depth of 10-20 ft, shown in **FIGURE 3**. Sand extraction was accomplished using a submersible slurry pump that relocated an average of 500 yds³ of sand per day (Lemmo et al., 2013).

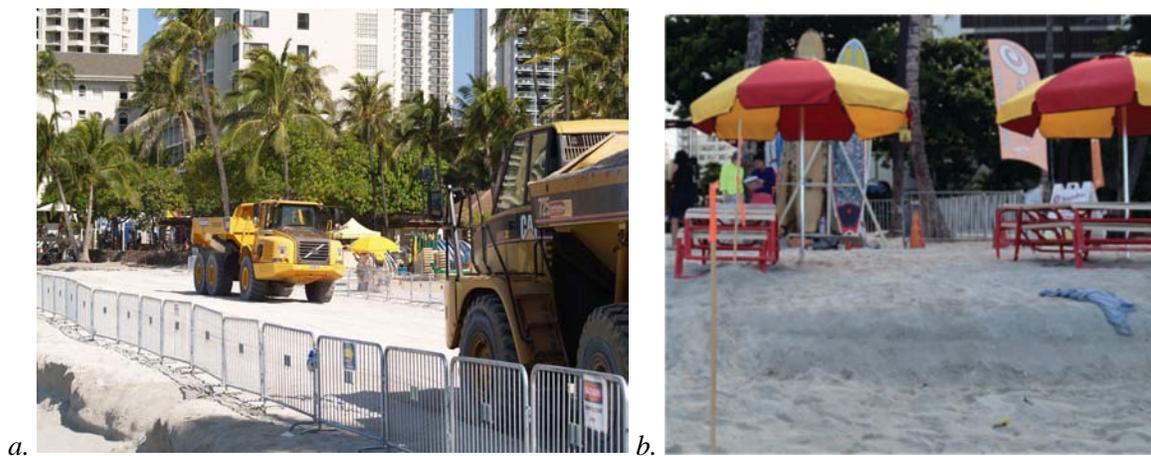
FIGURE 4 (a.) Sand hauling on Royal Hawaiian Beach undertaken as the alternate sand distribution method. (b.) Hardened beach berm located at the eastern most end of the project area, taken on 12/14/12, about 8 months following completion of the replenishment project. The berm may be a result of compaction due to truck traffic.

Truck hauling may have resulted in a 1-3 ft hardened berm (**FIGURE 4b**) that subsequently developed along the beach as a result of erosive wave action. The weight of the trucks likely caused compaction of the sand along the haul route.

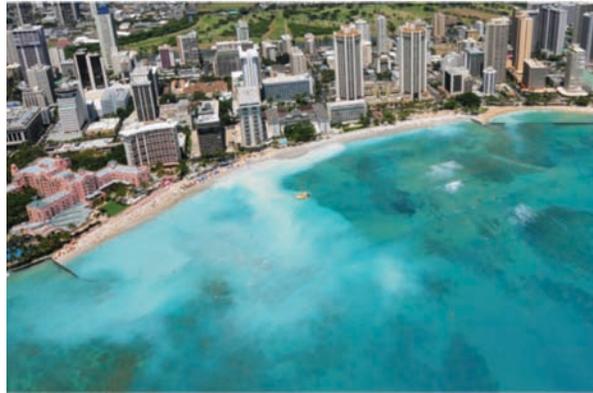
FIGURE 5 Discharge of sediment plume from the project site. In this photo, sand is being placed in the middle of the project area. A NW flowing current is carrying a plume of micritic silt from the site.

Prior to the project, there was concern that the turbidity of water offshore would increase. Silt curtains were used to mitigate increases in turbidity, but despite these efforts, near-shore areas experienced increased turbidity. **FIGURE 5** shows the sediment plume that was observed extending several hundred meters offshore of the project site. In an attempt to reduce turbidity, a second silt curtain was installed; however, turbidity remained significantly elevated. The sediment plume is thought to have resulted from the release of micritic calcium carbonate produced by organisms such as boring clams and worms, and potentially by abrasion of friable carbonate material during pumping and handling (Lemmo et al., 2013). No risks or impacts to humans or the benthic habitat were observed (Forsman, et al., 2012). Turbidity increases in conjunction with increased wave energy (**FIGURE 6**).

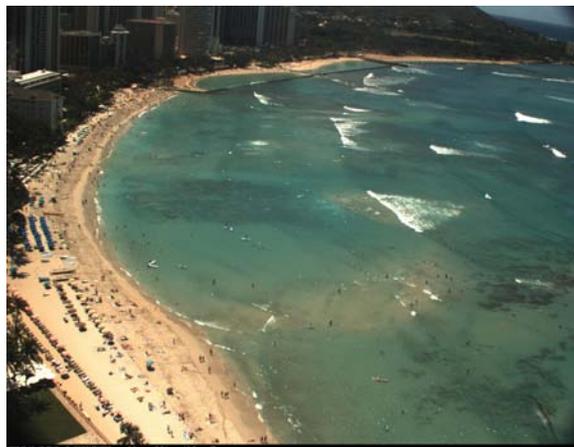
FIGURE 6 Micrite (carbonate) silt originating from the beach fill increases in conjunction with increased wave energy. 5/24/13 <http://oos.soest.hawaii.edu/pacioos/focus/conditions/livephotos.php>

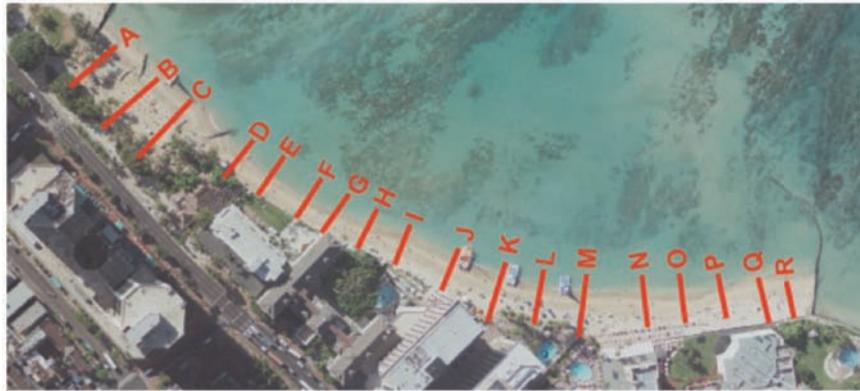
FIGURE 7 Eighteen cross-shore transect lines denoted by letter progressing sequentially from east to west. Surveys have been conducted on the following dates: 12/8/11, 5/4/12, 8/8/12, 12/14/12, and 4/17/13.

Eighteen cross-shore beach profiles were established at roughly 100 ft intervals along the 1,728 ft project study area, illustrated in **FIGURE 7**. Transects were defined along the beach by establishing predefined bearings that extend seaward from backshore reference points. Transects are denoted by letter from A to R alphabetically from east to west.

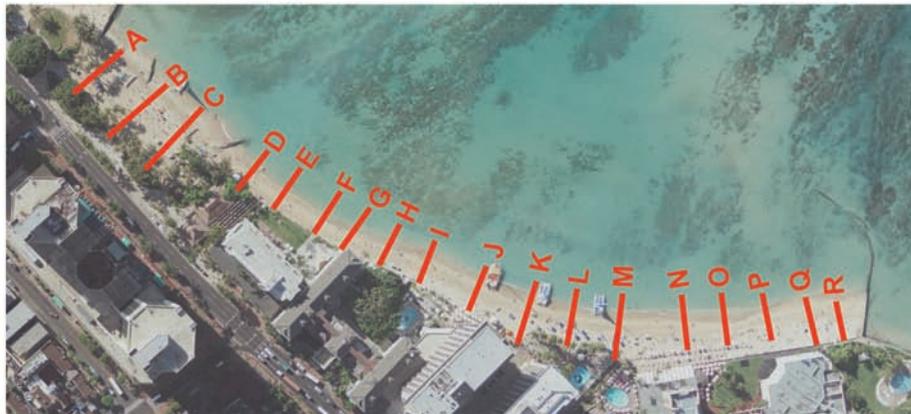
Plotted data signifies width change for each post-fill survey with respect to the pre-fill survey. This plotting method was chosen in order to illustrate total width addition resulting from the replenishment project. Alternately, rate change data was calculated using width change between surveys in order to form a time series representation of erosional and accretional trends. Bins are estimates of self similar behavior among groups of transects (open to interpretation)

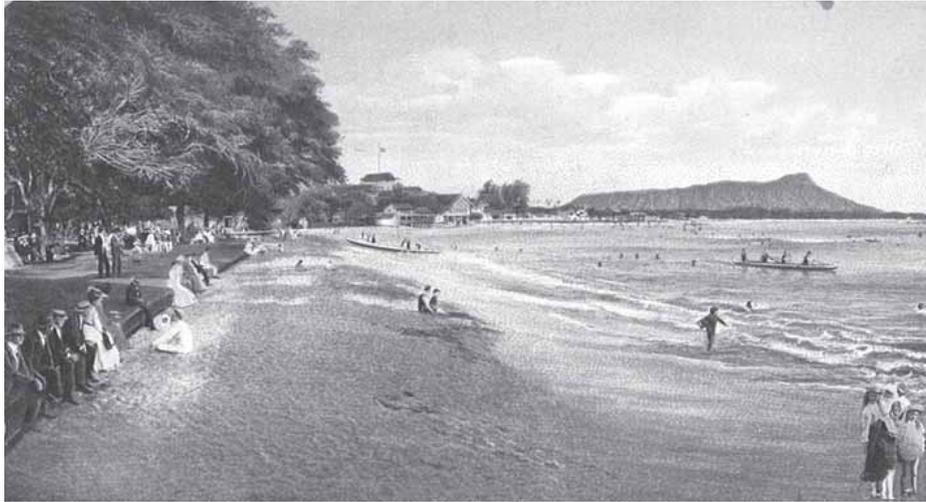
FIGURE 22 Postcard photo of beach fronting Seaside Hotel; present location of the Royal Hawaiian hotel circa 1910 (Anon. 1910, within Weigel, 2008).

In 1905, Hawai'i's Supreme Court responded to the degradation of Waikiki Beaches by establishing the public trust doctrine. This piece of legislation aimed to prohibit the construction of seawalls seaward of the high water mark on Waikiki Beaches (Weigel, 2002). One year following application of the public trust doctrine, a low seawall was constructed fronting the Seaside Hotel, indicating a lack of implementation of regulations established by the doctrine (**FIGURE 22**).

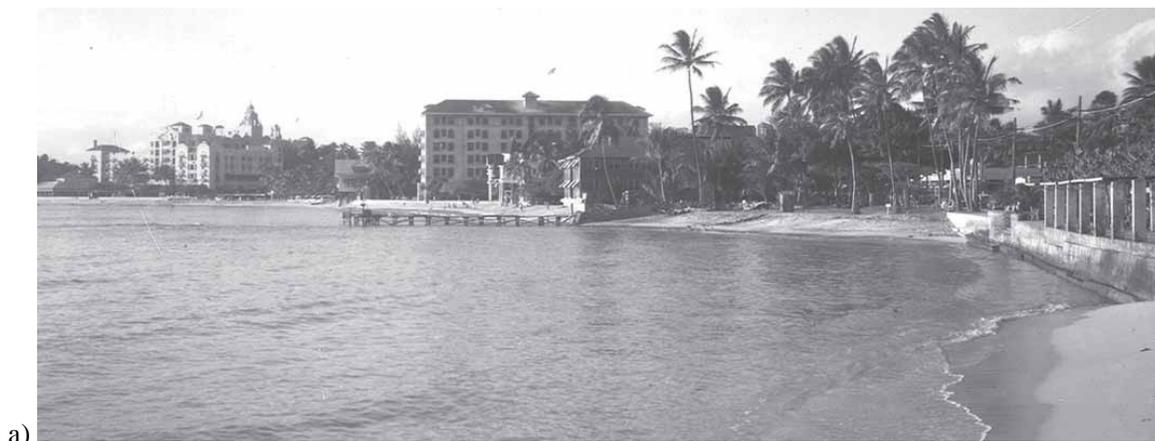
FIGURE 23 (a.) Photo taken May 20, 1939 prior to construction of the Kuhio Beach cribwall breakwater and replenishment. (b.) Photo taken in 1939 following construction of the crib wall breakwater and sand fill (USACE Beach Erosion Board within Weigel, 2008).

In response to coastal damages, a 700 foot long shore-parallel breakwater was constructed 200 ft offshore of Kuhio beach in 1938, known as the crib wall (Gerritsen, 1978; within Miller and Fletcher 2003). This initial portion of the crib wall forms what is now known as the Ewa Basin. As part of the construction, the nearshore area was cleared of approximately 4000 yds³ of coral and replaced by 7,000 yds³ of sand, forming a 75 ft wide beach (Crane, 1972; Gerritsen, 1978; within Miller and Fletcher, 2003). Images of Kuhio beach prior to and following construction of the Crib wall are shown in **FIGURE 23**.

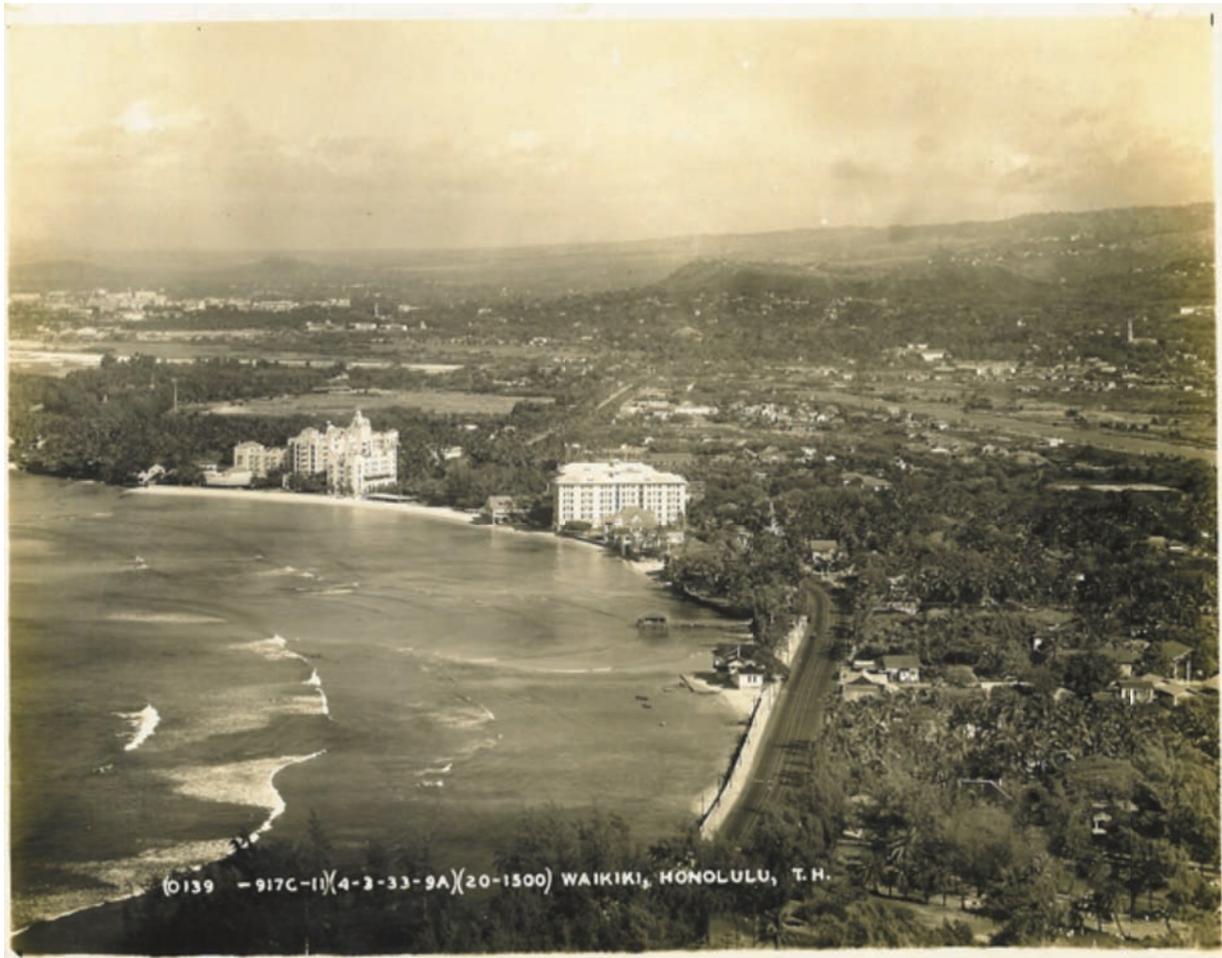
FIGURE 24 *Oblique image of the Royal Hawaiian Beach and adjacent beaches on April 3, 1933. Very little sand fronts beaches on either side of Royal Hawaiian Beach, likely as a result of near-shore seawall construction during the 1920's.*

By the 1940's the state of Waikiki beach was severely degraded; the only remaining usable section of beach was that fronting the Moana Surfrider and the Royal Hawaiian Hotel. An oblique photo of the Royal Hawaiian Beach and adjacent beaches illustrates the degraded state of Waikiki beaches at that time (**FIGURE 24**). The Royal

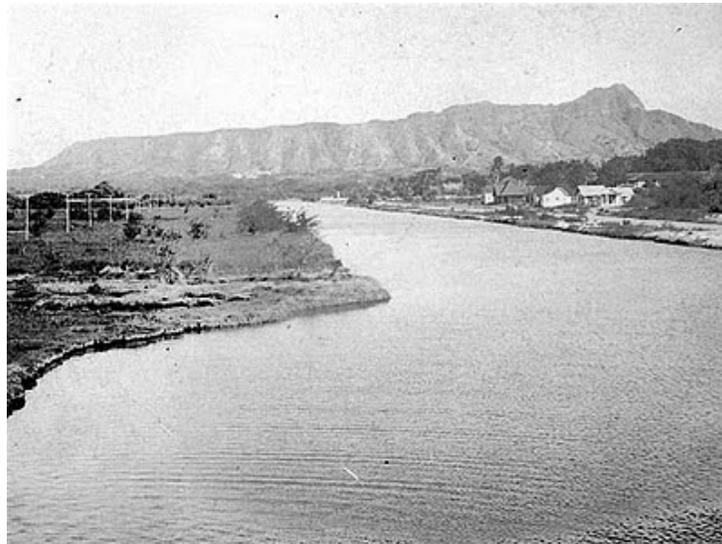
FIGURE 26 Ala Wai Canal looking from the west towards Diamond Head, circa 1925 (Waikiki Time Machine: View of Hawaii From Another Time http://waikikitimemachine.blogspot.com/2010_06_01_archive.html)

In 1924, the Apuakehau and Ku'ekaunahi streams no longer flowed into the ocean at Waikiki (Weigel, 2008). As a product of diversion, sediments normally carried to the ocean were trapped and deposited in the Ala Wai Canal (**FIGURE 26**). It has been estimated that 8,000 – 10,000 yards³ per year are trapped in the canal as a result of the diversion, which requires ongoing maintenance. Maintenance dredging projects were completed in 1966, 1978 and in 2002. Effects of the project have included the alteration in reef ecology and sediment deposition along parts of Waikiki beach (Grigg, 1995; 1996; Mamala Bay Study Commission April 1996; within Weigel 2008).
