**Category II General Application
Small-Scale Beach Nourishment Projects
(SSBN)**

PROJECT NAME: SBRF, Inc. Proposed Volume 3,500yds³ over 5 years

Nearshore Marine Site Assessment:**Conditions****Date:** February 21, 2006**Time:** 12:00 to 2:00pm**Personnel:** Dolan Eversole, Chris Conger (OCCL)**Marine Conditions:** North Swell 2-4 ft faces, Northeast winds 10-15 mph,

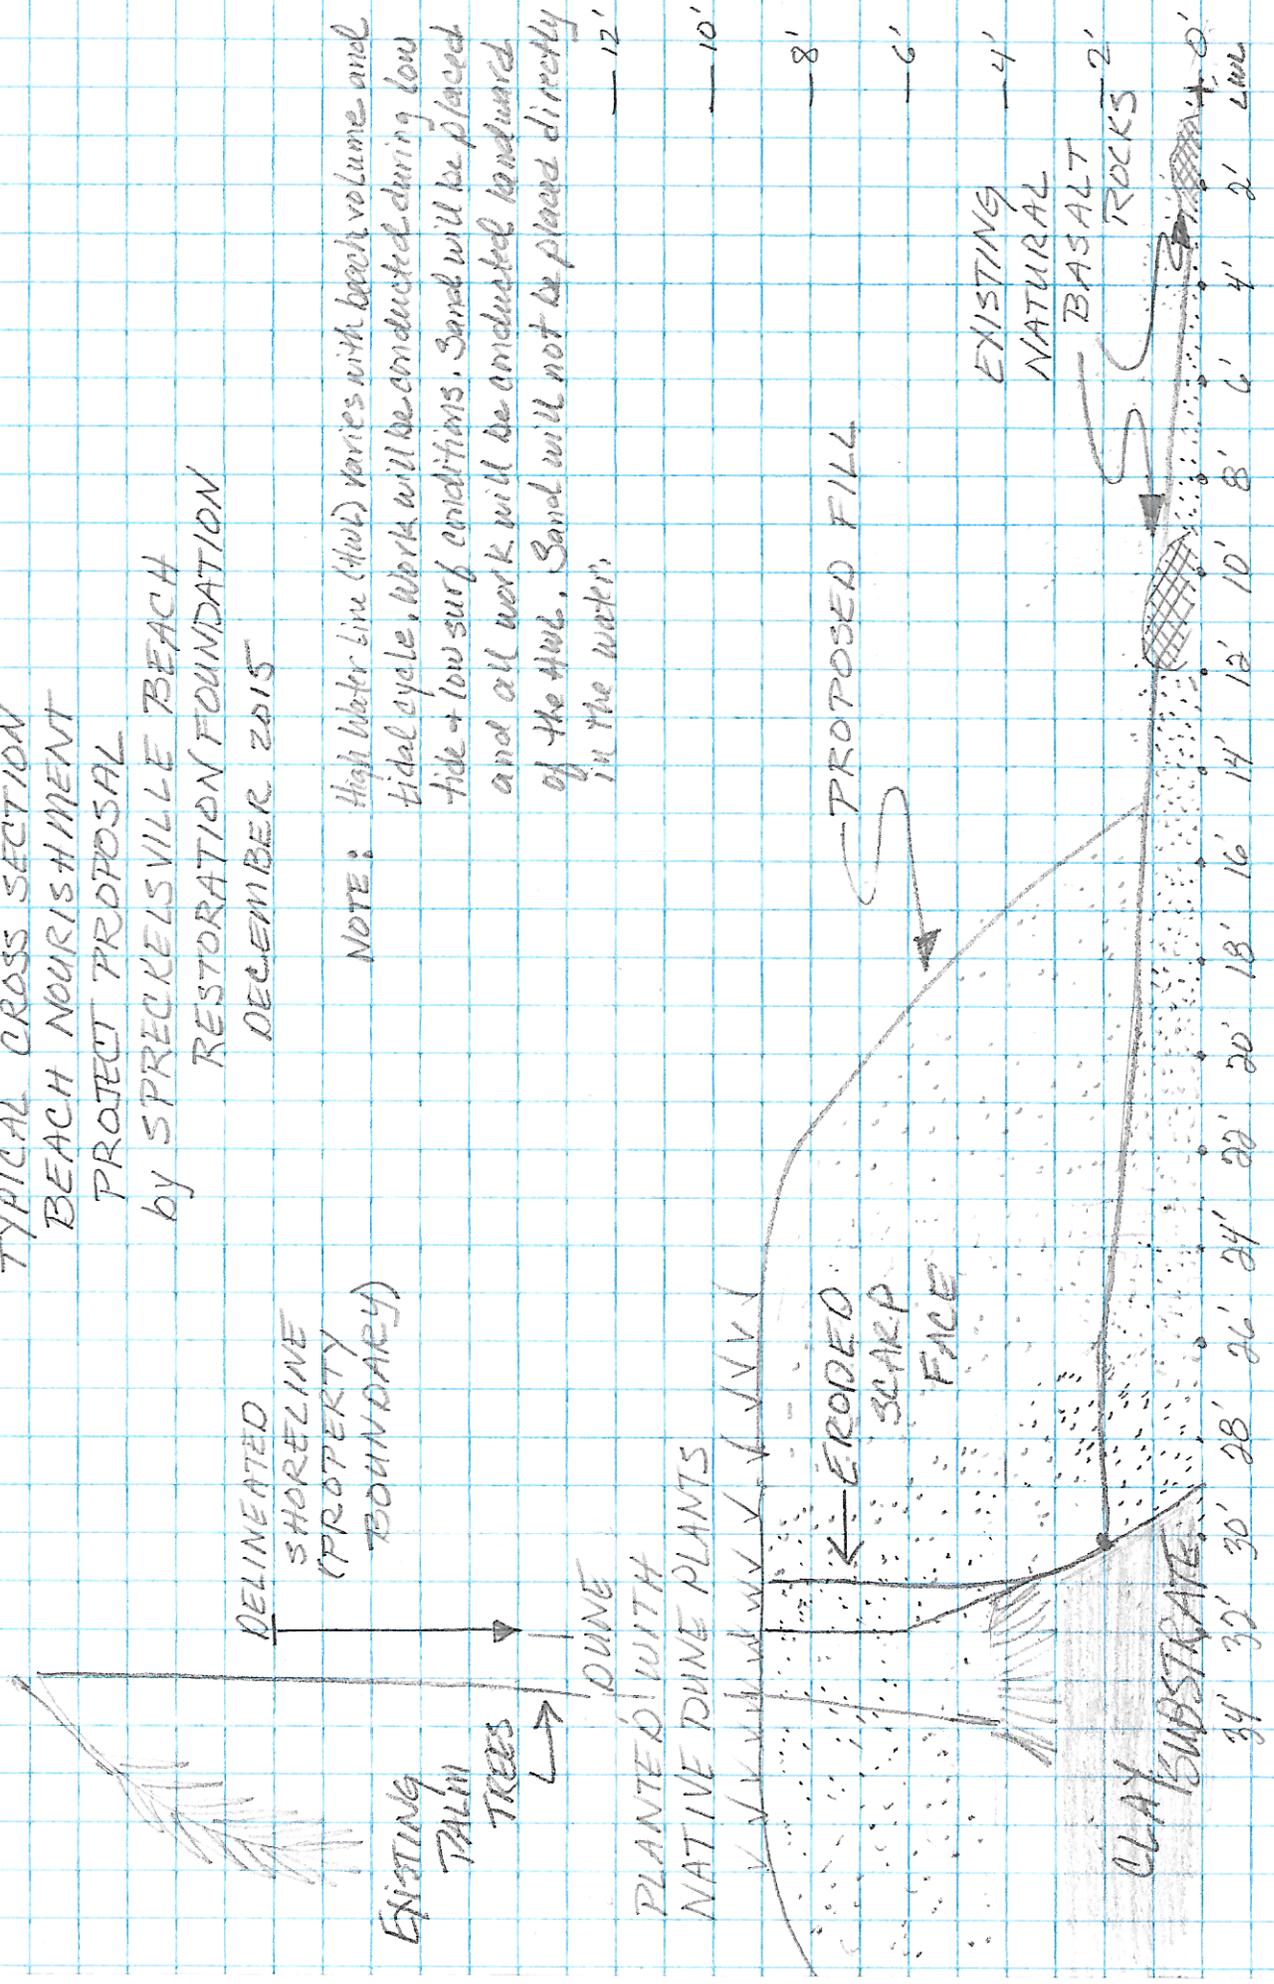
461 LAULEA PLACE
 TYPICAL CROSS SECTION
 BEACH NOURISHMENT
 PROJECT PROPOSAL
 by SPRECKELSVILLE BEACH
 RESTORATION FOUNDATION
 DECEMBER 2015

NOTE: High water line (HWL) varies with beach volume and tidal cycle. Work will be conducted during low tide + low surf conditions. Sand will be placed and all work will be conducted landward of the HWL. Sand will not be placed directly in the water.

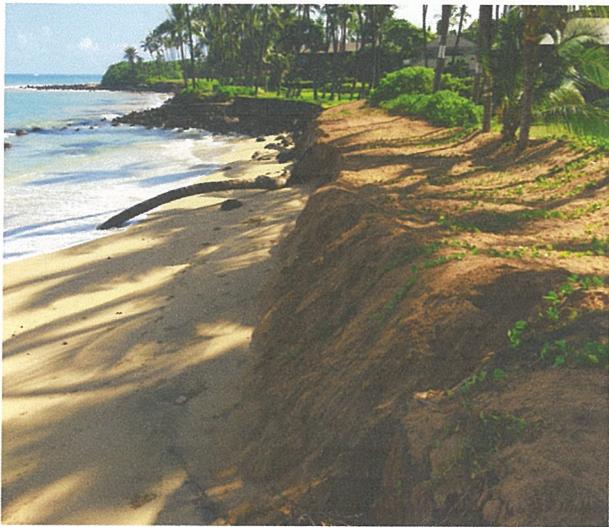
10/7/14

Eastward view before and after erosion event on 10/27/15

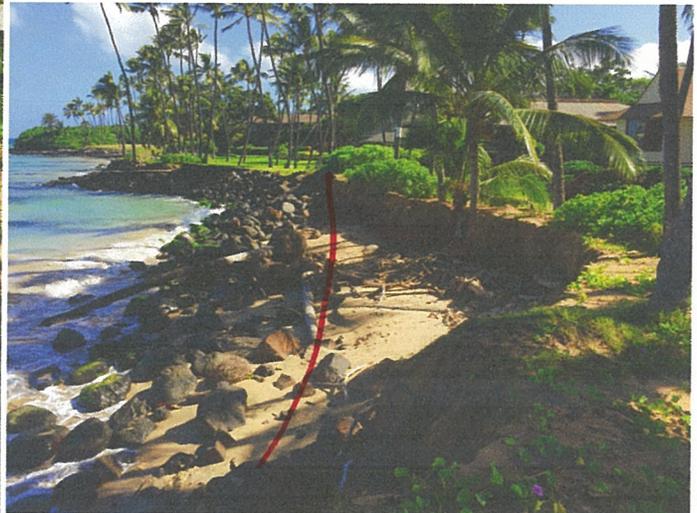
11/18/15

Westward view before and after erosion event on 10/27/15

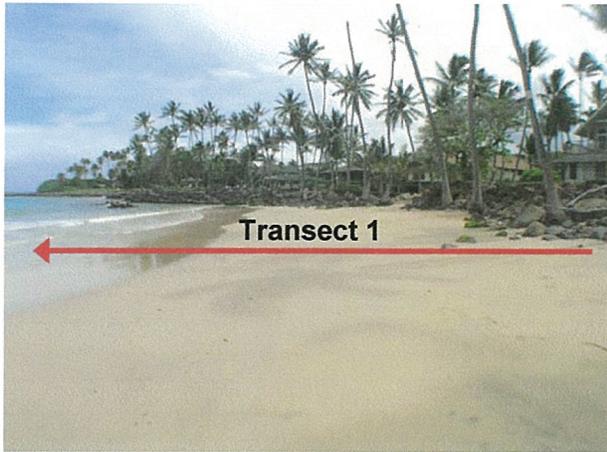
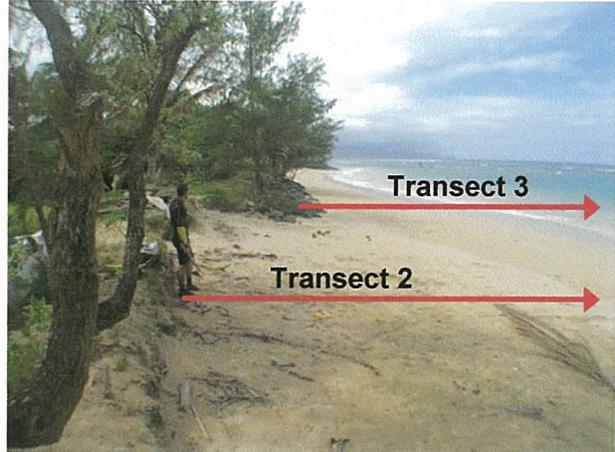
Typical beach profile

Project area is characterized by fine to medium. Moderately well sorted, dominantly tan to white carbonate beach sands and some basalt sand, minor terrestrial brown clays, silts to east. Hard bottom (uncolonized) observed sporatically where thin sand bed wasn't present. Shoreline armoring present on either side of subject property. This is the only property without shoreline armoring.

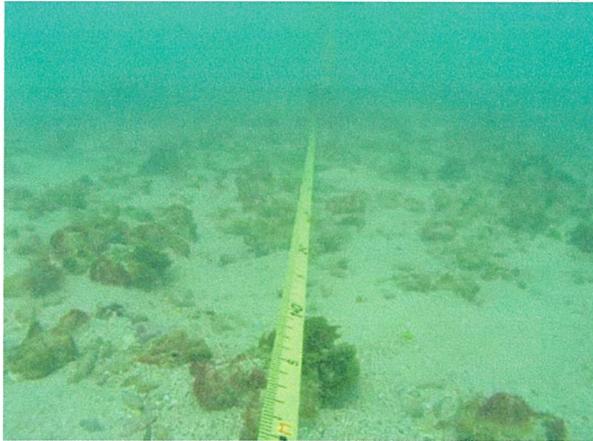
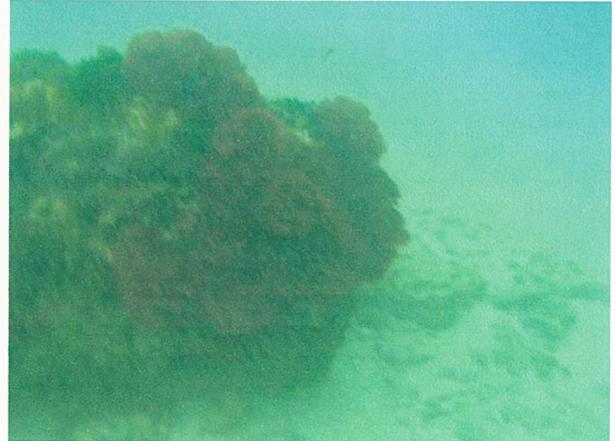
Typical offshore Sand and rubble bottom types

Fair to good water visibility. Colonized coral rubble and basalt boulders (mostly fleshy algae). Fossil reef hard bottom with coralline algae colonization. 100% sand 20m from waterline, then progressively more hard bottom cover. Estimated coral cover less than 1%. Variety of fleshy brown and green algae. A few scattered sea urchin observed on basalt boulders. No other benthic communities observed. Some ghost crab holes observed on beach face.

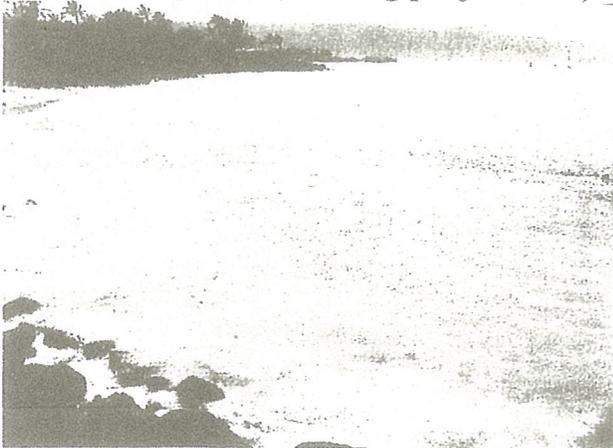
Nearshore water visibility is poor to fair (~5 ft). A small tan plume was observed in the immediate nearshore (wave breaker zone) extending ~15 ft offshore. A different tan plume was observed in the am fronting the Williams property 2 properties to the east extending offshore parallel to the rocky headland. Not clear if the plume is related to any sand placement activities. The plume appears to be sandy in origin and dissipated with the incoming tide. High tide conditions (~+2 ft tide at 4pm) were just approaching newly placed fill. Nearshore visibility improved over morning conditions at lower tide. Thin layer of white carbonate (Micrite?) silt was observed covering bottom nearshore. This was also observed in pre-construction site visit and doesn't appear to have changed in concentration or extent.

Near shore plume (fronting project area)

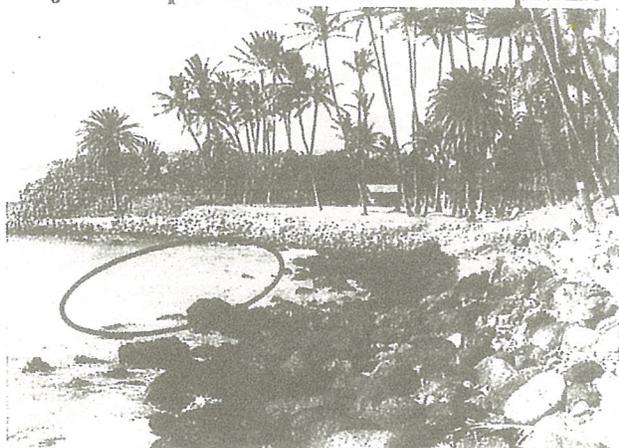
Adjacent updrift area with similar plume

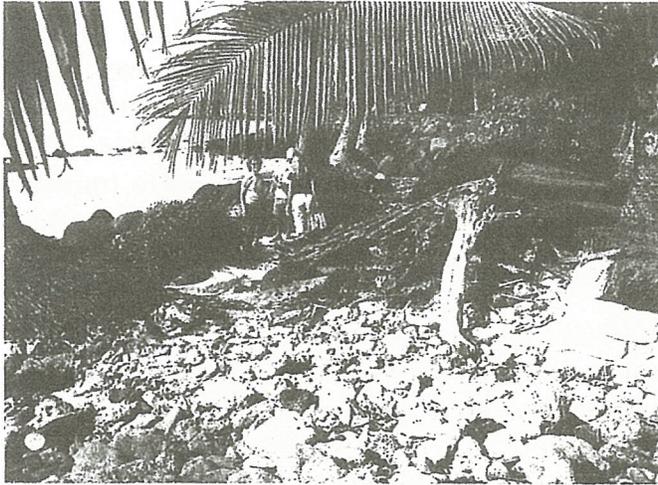
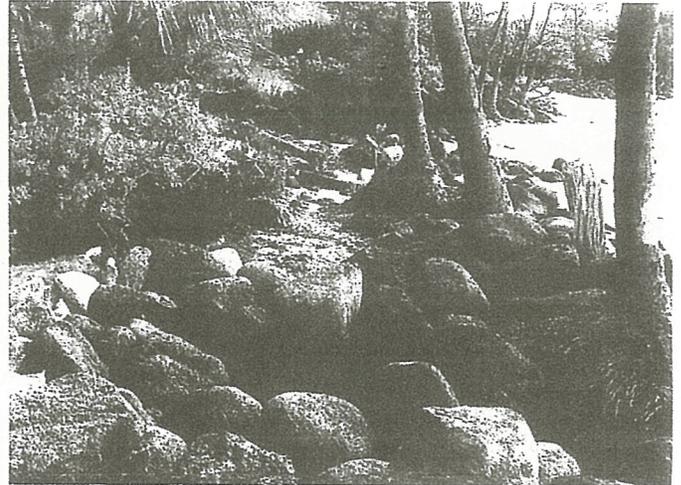
Pre Construction Photos:

Beach fill placed approximately 20 ft seaward and landward of the pre-existing bank. Vertical scarping of the placed fill occurring with a near-vertical seaward face approximately 10 ft above the existing beach grade. No obvious signs of placed sand migrating across the active beach or change in beach width. Minimal fill sand has entered the littoral system to date due to lack of significant erosion of place sand. **No observed change in marine conditions or marine substrate from previous site assessment in February, 2007.**

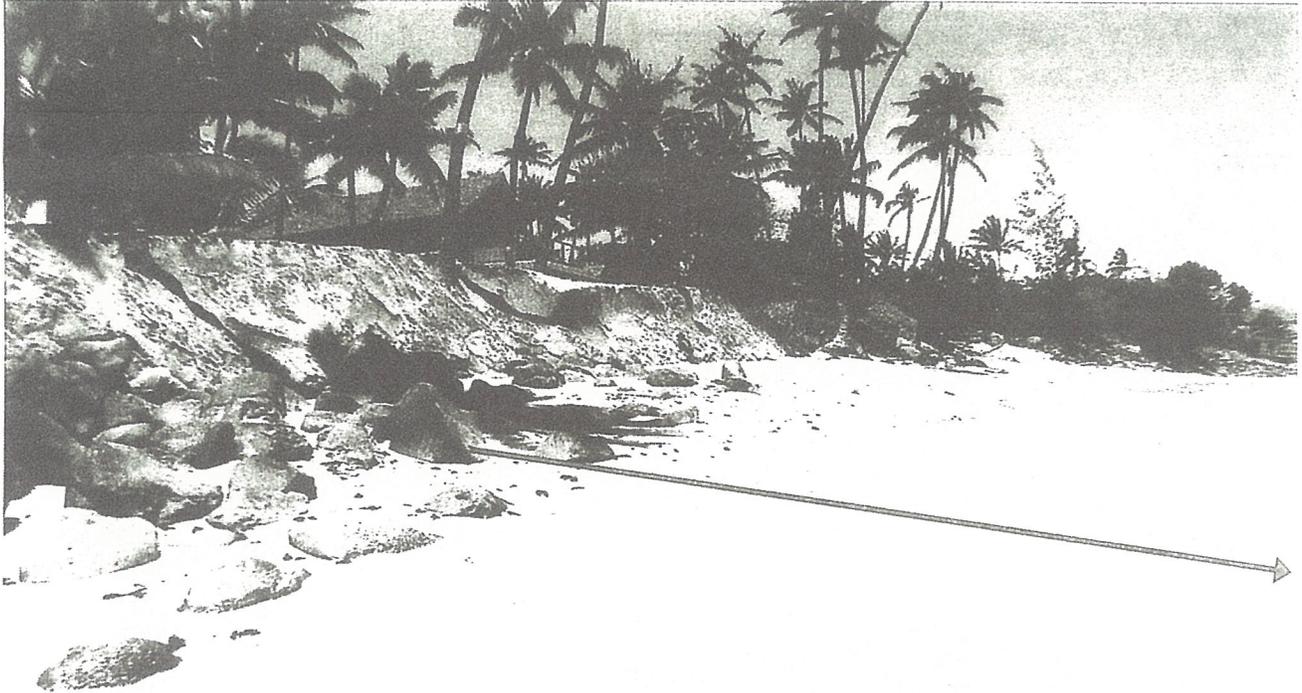
Transect 1

Fair to poor water visibility. Colonized coral rubble and basalt boulders (mostly fleshy algae). Fossil reef and coralline rubble hard bottom with coralline algae colonization. 100% sand 20 – 40 m from waterline, then progressively more hard bottom cover. Estimated coral cover less than 1%. Variety of fleshy brown and green algae. A few scattered sea urchin observed on basalt boulders. No other benthic communities observed. Some ghost crab holes observed on beach face.

Typical offshore sand and rubble bottom types

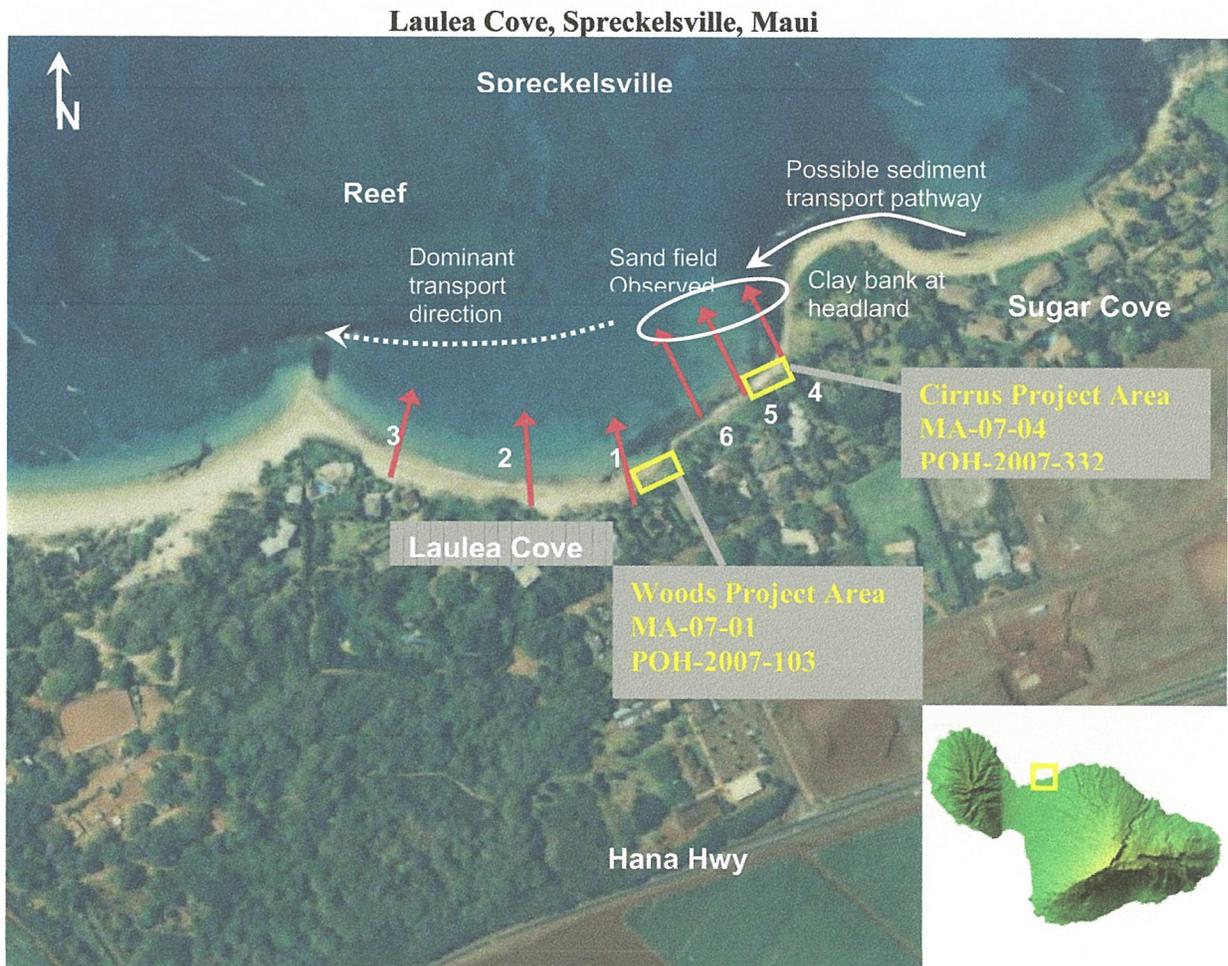
6, 50 meter (160 ft) shore-perpendicular transects established for project area (Figure 1).

Location: Laulea Cove, Spreckelsville, Maui N 20.90776° W 156.41237°

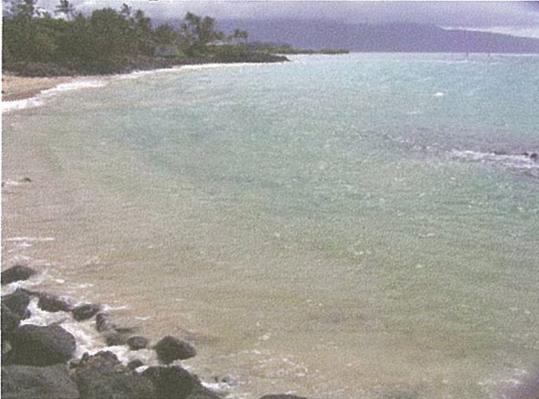
**Woods Property Post-construction
Near shore plume June 19, 2007**

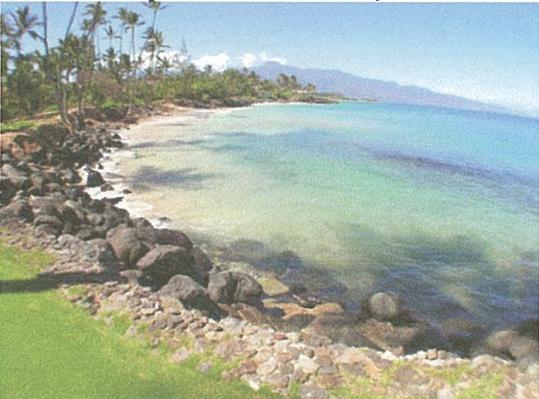
**Woods Property Post-construction
Near shore plume October 22, 2007**

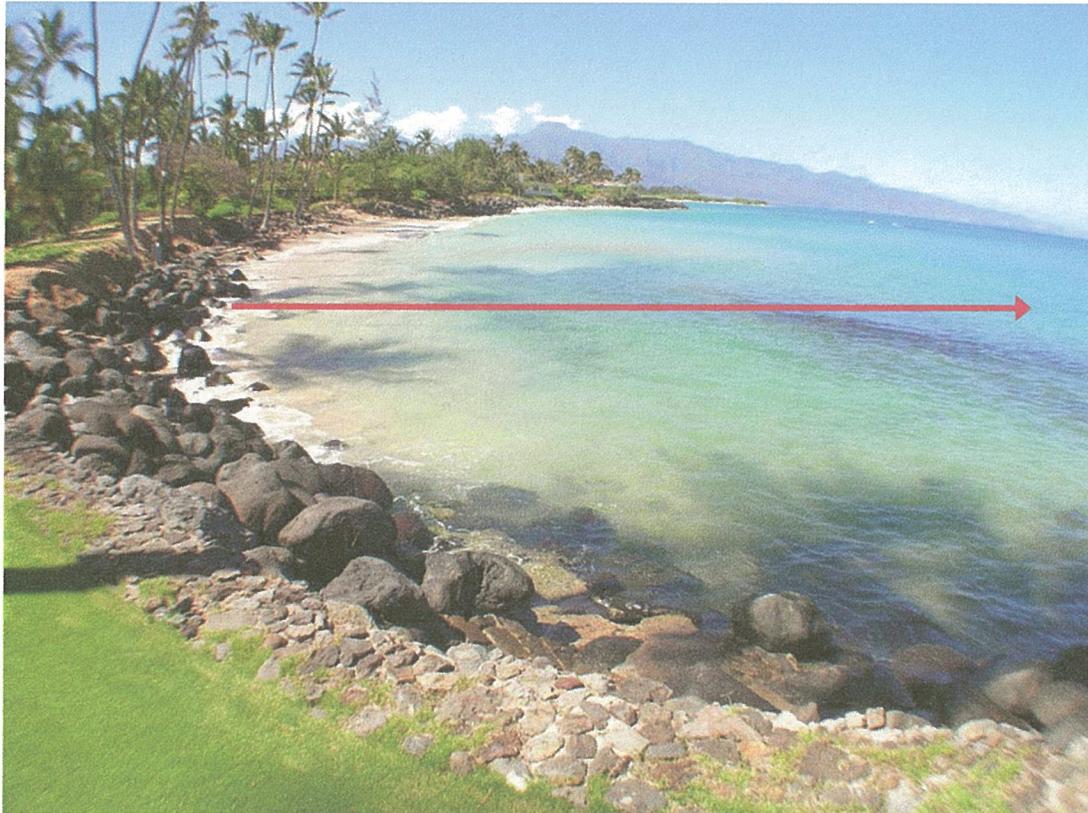
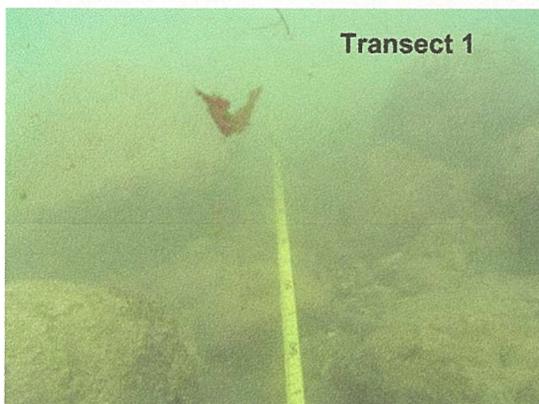
Fair to poor water visibility. Fair visibility nearshore at Transect 1 progressively decreasing offshore. Very low visibility near shore to 10 to 25 m offshore at Transect 2 with coarse coral gravel material on beach. Colonized coral rubble and basalt boulders (mostly fleshy algae). Fossil reef and coralline rubble hard bottom with coralline algae colonization. Sand lenses 20–40 m from waterline, then progressively more hard bottom cover. Estimated coral cover less than 1%. Variety of fleshy brown and green algae. A few scattered anemone beds observed on flat hard grounds. Large step crest and wave action on rocks at transect 2. Transect 3 shows better water quality than all other transects.

Typical offshore sand and rubble bottom types (October 22, 2007)

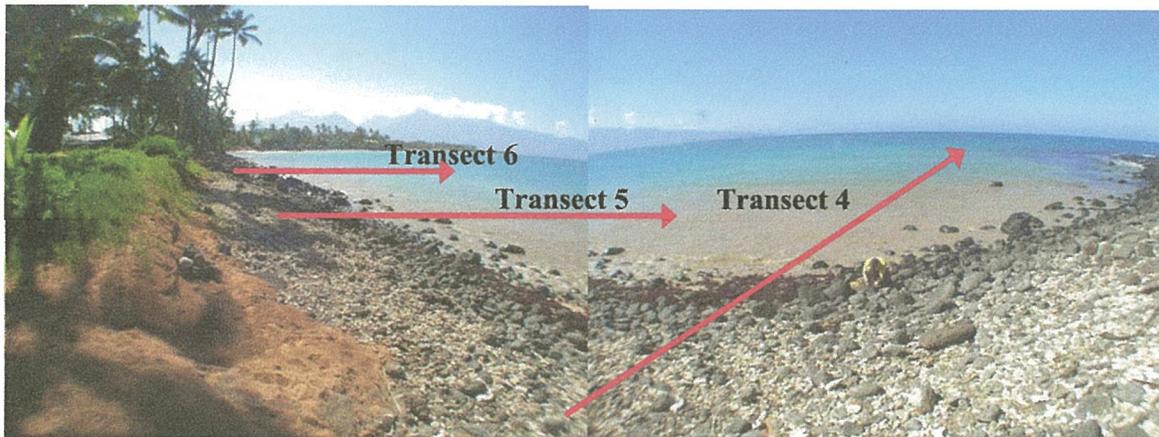
Fair to poor water visibility. No visibility nearshore at Transect 4 progressively improving offshore to 2-3 ft. Silty mud (1-3 inches thick) observed in shallow nearshore (2-3 ft water depth) in pockets around rock scour holes. Silt and clay in suspension nearshore possibly attributed to erosion of clay bank on rocky headland to the east. Historical aerial photographs and local resident's statements suggest this area exhibited turbid water before any fill activities occurred in the region. Possible contributors to silty plume are natural erosion of the clay bank, fine sediment transport from up current collecting in the cove or resuspension of fine sediment eroded from previous or associated fill efforts.

Typical nearshore conditions at Transect 4

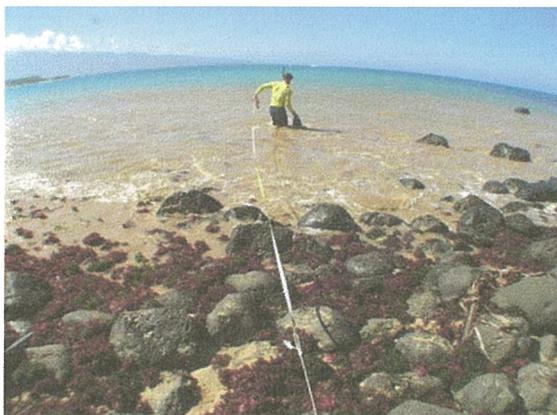
Very low visibility near shore to 20 m offshore at Transect 5 with coarsening sediment size seaward. Uncolonized coral rubble and basalt boulders with thin sand veneer. Tan, well-sorted medium-grain size, carbonate sand field observed approximately 150 ft offshore and roughly in-line with aeolian sand transport around the headland. Fossil reef and coralline rubble hard bottom with coralline algae colonization. Estimated coral cover less than 1%. Transect 6 shows better water visibility than all other transects with >6 ft visibility.

Typical nearshore conditions at Transect 6 and offshore sand field

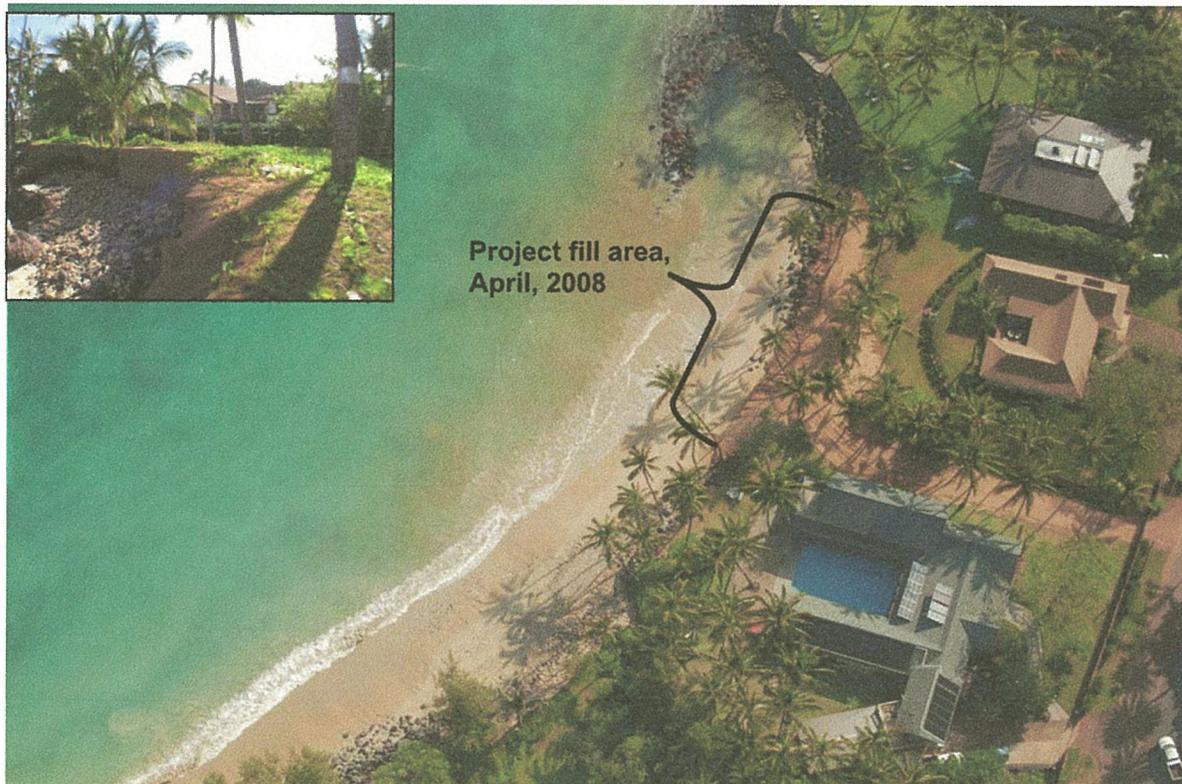
Project area is characterized by fine to medium moderately well sorted dominantly tan to white carbonate beach sands, some basalt sand, suspended terrestrial brown clays and silts to the east. Coral rubble, shingle and gravel are more pronounced in eroded beach sections (Transects 2 and 3). Hard bottom (uncolonized coral rubble) is observed offshore sporadically where a thin sand bed wasn't present. Bottom type is characterized by a mix of thin carbonate sediment with coralline and beach rock rubble. Platy beach rock and coralline rubble observed at 40-50 m (128-150 ft) offshore where it appears to transition from thin marine sands to hard bottom at Transects 1-3. Transects 4-5 are mostly rocky shoreline (2-4 ft diameter basalt rocks) with very small amount of fine sand within swash zone transitioning to thick bed of fine sand that thickens and coarsens seaward. Well-sorted med to fine tan sand field observed approximately 30-60 meters offshore. Sand field appears thicker and more stable than surficial deposits nearshore. Shoreline armoring present along entire project area. Low beach slope ~1V: 15H, wet sand beach present. Little to no branching corals observed in this marine survey. **Generally there was little recognizable change in the marine substrate or biological assemblages from the past surveys (June, 2007 and October, 2007).**

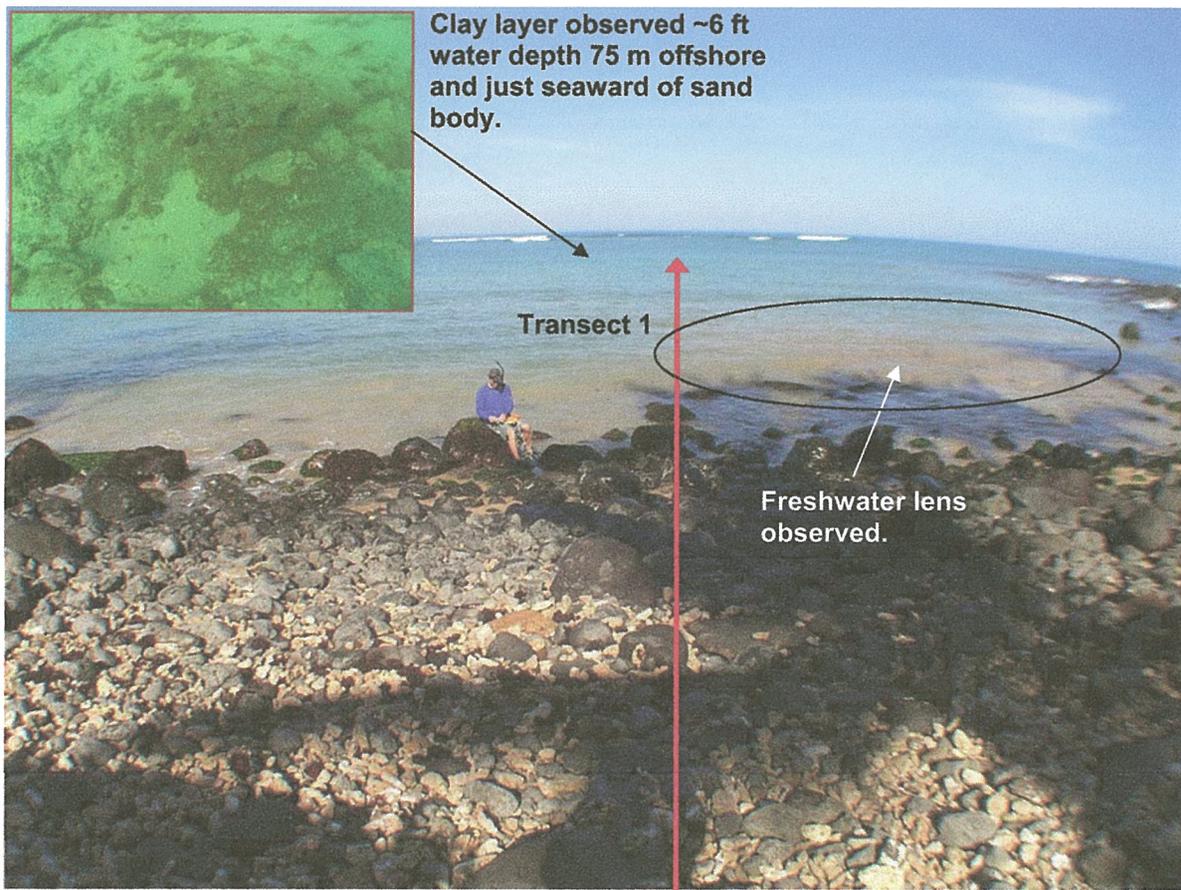
Fair to poor water visibility. Poor visibility nearshore at Transect 1 progressively improving offshore. Very low visibility (0-1ft) near shore to 10 to 25 m offshore at Transect 1 with coarse coral gravel material on beach. Freshwater lens observed in immediate shoreline area. Colonized coral rubble and basalt boulders (mostly fleshy algae). Fossil reef and coralline rubble hard bottom with coralline algae colonization. Sand body ~40 m from waterline, then progressively more hard bottom cover. Estimated coral cover less than 1%. Variety of fleshy brown and green algae observed on hard grounds. Hard, dense, clay layer with thin layer of coralline sand covering observed just seaward of sand body approximately 75 m offshore. Silt and clay in suspension nearshore. Historical aerial photographs and local resident's statements suggest this area exhibited turbid water well before any fill activities occurred in the region. Possible contributors to silty plume are erosion of the natural clay bank, fine sediment transport from up current collecting in the cove or re-suspension of fine sediment eroded from previous or associated fill efforts.

Typical offshore sand and rubble bottom types (Dec 14, 2009)

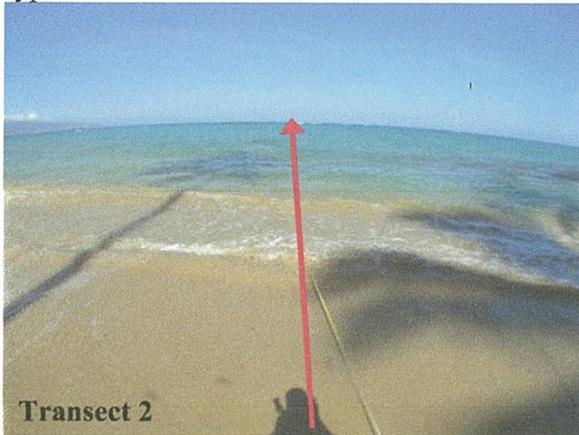
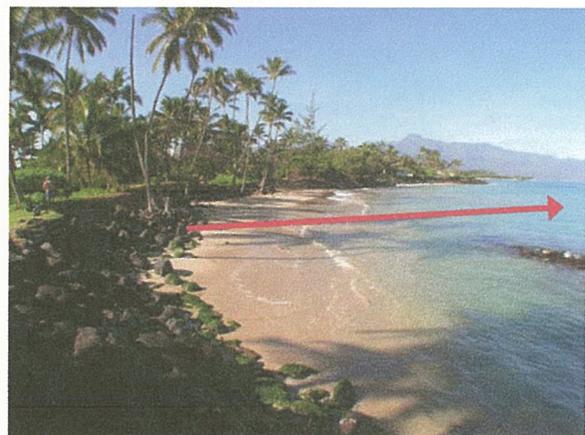
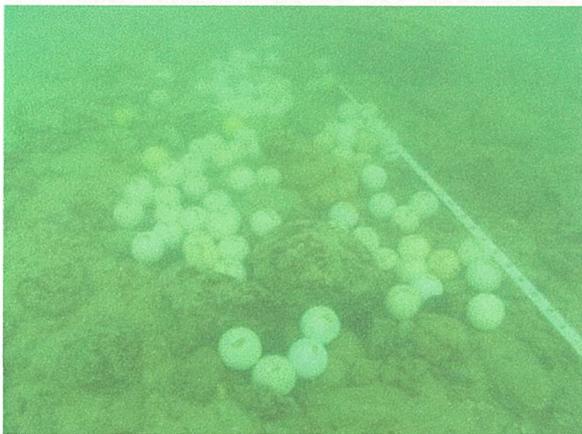
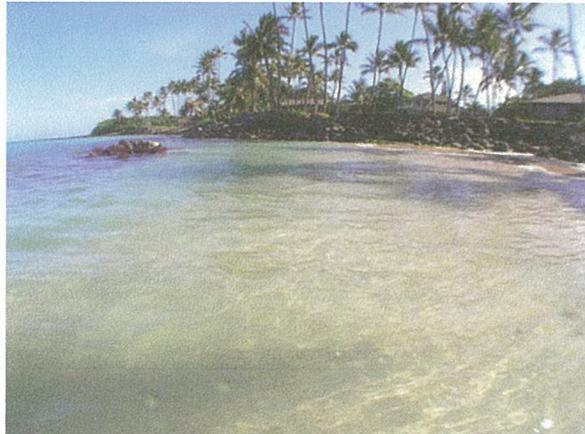
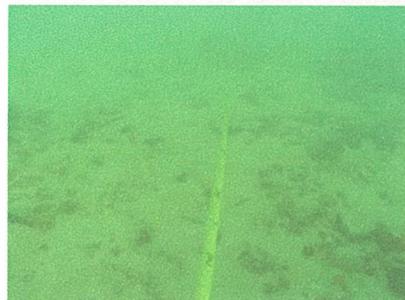
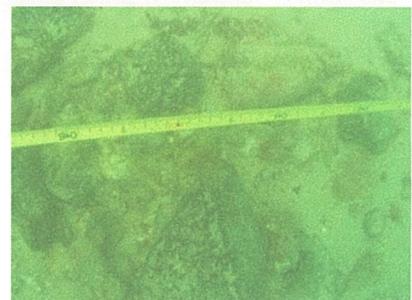
Primary area of sand fill activities. Low beach slope ~1V:15H, wet sand beach with coarsening sediment size seaward present fronting a rock revetment. Coral rubble observed at beach toe. Laulea Cove Fair water visibility. Very low visibility near shore at shore break to 20 m offshore at all 3 transects. Primarily uncolonized coral rubble and basalt boulders with thin sand veneer. Tan, well-sorted medium to fine-grain size, carbonate sand field observed approximately 50m offshore. Fossil reef and coralline rubble hard bottom with little to no coralline algae colonization. Estimated coral cover less than 1%. Little to no branching corals observed in this marine survey. Transect 5 & 6 show better water visibility than all other transects with >4 ft visibility and improving visibility with distance from shore. No coral or coralline algae observed along transect. Human debris (golf balls, masts, etc..) observed at 40-50 m offshore.

Typical nearshore conditions at Transect 2

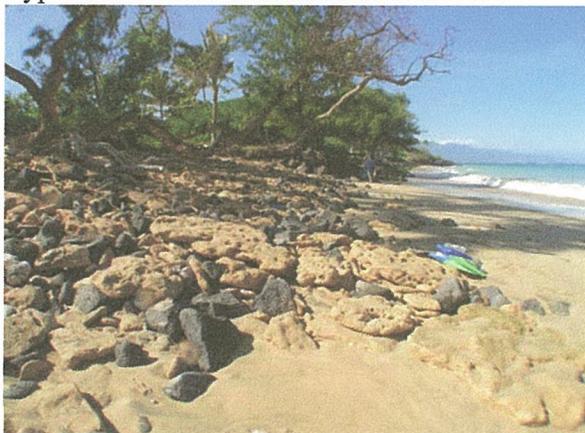
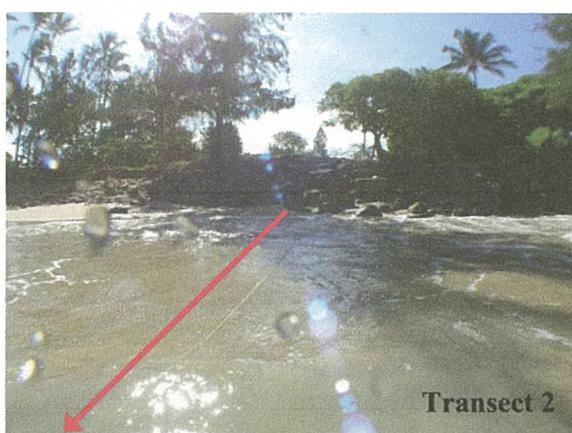
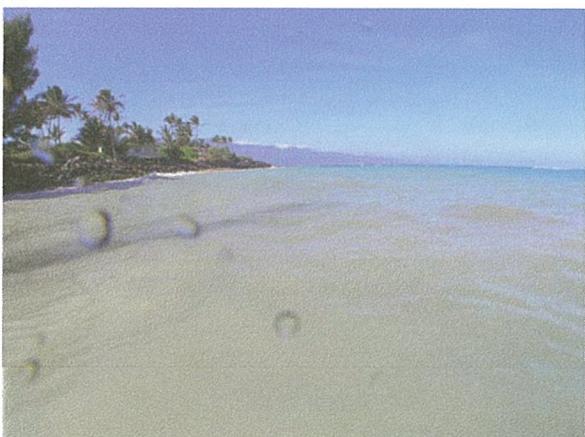
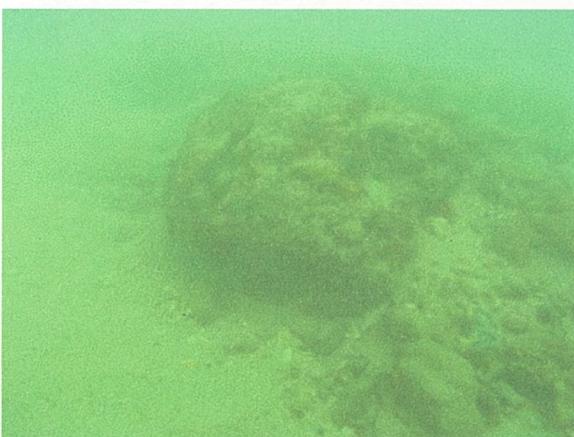
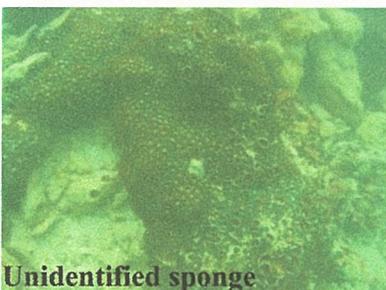
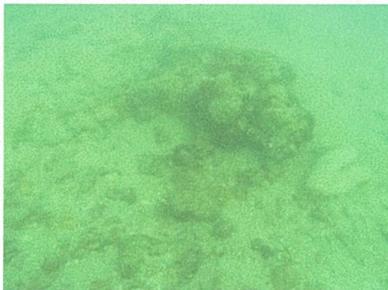
Shoreline armoring present along entire project area. Coral rubble and shingle back beach, exposed during erosion events. Low beach slope ~1V:15H, wet sand beach with coarsening sediment size seaward present fronting a rock revetment. Coral rubble observed at beach toe. Very low visibility near shore at shore break to 20 m offshore at all 3 transects. Primarily uncolonized coral rubble and basalt boulders with thin sand veneer beyond 60 m offshore. Tan, well-sorted medium to fine-grain size, carbonate sand observed approximately 0-50m offshore. Fossil reef and coralline rubble hard bottom offshore with little coralline algae colonization. Estimated coral cover less than 1%. No branching corals observed in this marine survey. Unidentified sponge present (<1% cover) at 50 m offshore. Transect 3 visibility improving with distance from shore. No coral or coralline algae observed along transect. Green-red algae observed on subaerial exposed rocks.

Typical nearshore conditions at Transect 3

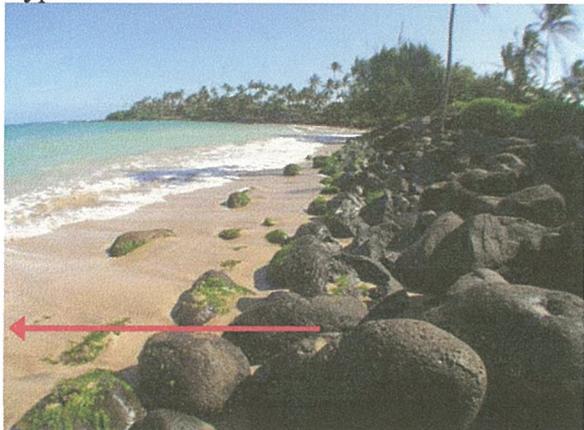
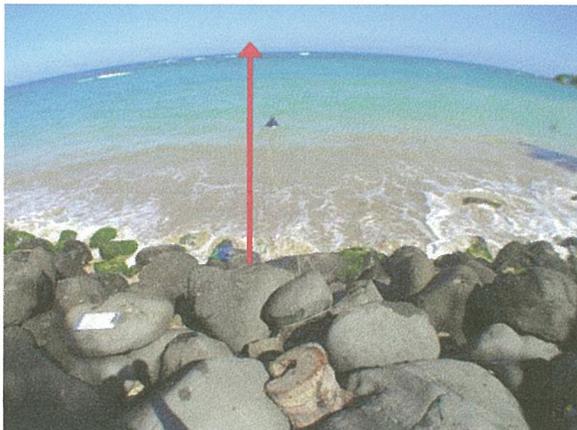
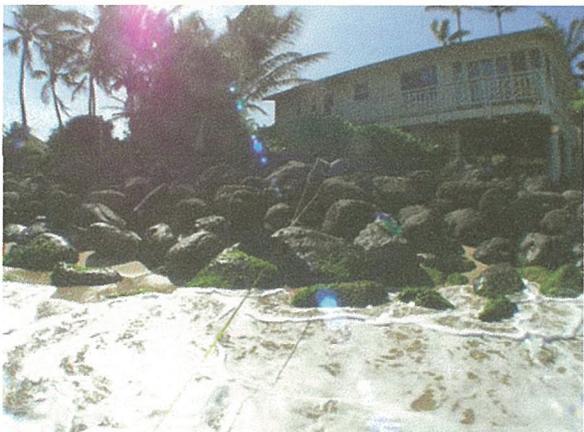
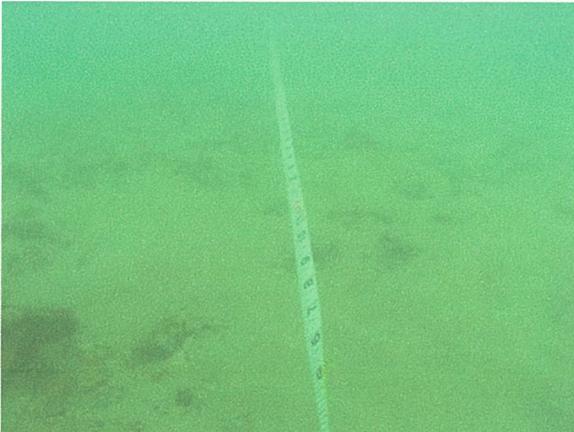
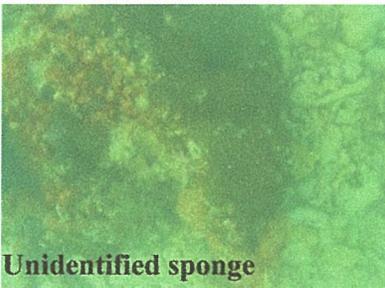
Shoreline armoring present along entire project area. Narrow wet sand beach with coarsening sediment size seaward present fronting a rock revetment. Coral rubble observed at beach toe. moderate visibility near shore at shore break to 20 m offshore. Primarily uncolonized coral rubble and basalt boulders with thin sand veneer beyond 60 m offshore. Tan, well-sorted medium to fine-grain size, carbonate sand observed approximately 0-50m offshore. Fossil reef and coralline rubble hard bottom offshore with coralline algae colonization. Estimated coral cover less than 1%. No branching corals observed in this marine survey. Unidentified sponge present (<1% cover) at 50 m offshore. Transect 4 visibility improving with distance from shore. Green-red algae observed on subaerial exposed rocks. Hard bottom cover present beyond 50 m offshore.

Typical nearshore conditions at Transect 4

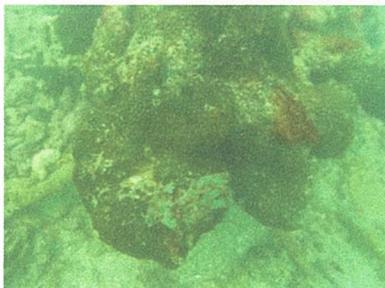
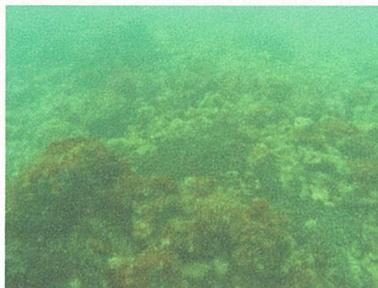
Unidentified sponge

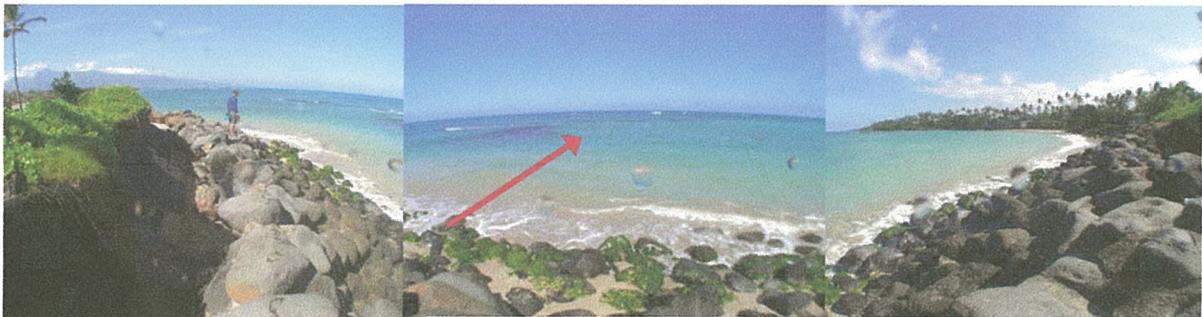
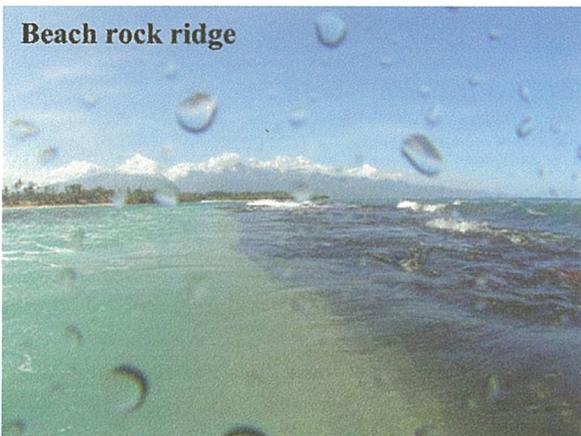
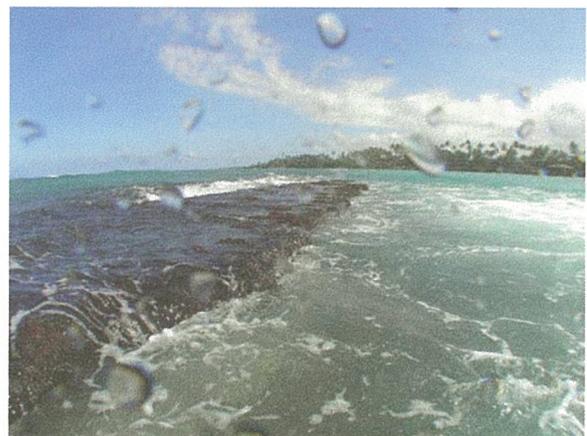
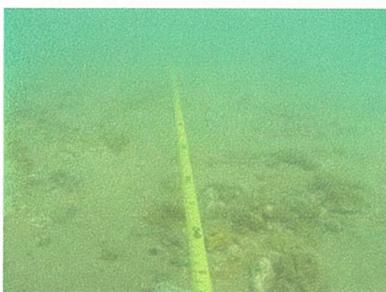
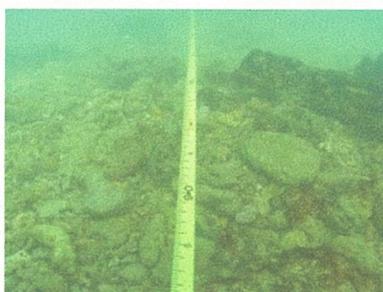
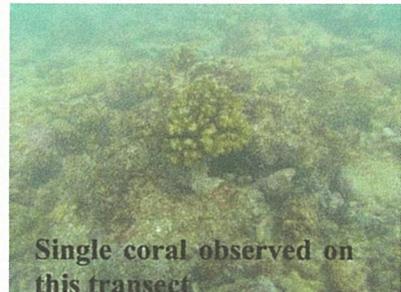
Shoreline armoring present along entire project area. Coral rubble observed at beach toe. Moderate to fair visibility near shore at shore break to 20 m offshore. Primarily uncolonized coral rubble and basalt boulders with thin sand veneer beyond 60 m offshore. Shore-parallel intertidal beach rock ridge at 60-70 m offshore. Basalt boulder (natural?) groin-like feature extending perpendicular to shoreline connecting to beach rock ridge. Fossil reef and coralline rubble hard bottom >50m offshore with some coralline algae colonization. Estimated coral cover less than 1%. One branching coral observed in this marine survey. Unidentified sponge present (<1% cover) at 50 m offshore. Transect 5 visibility improving with distance from shore. Green-red algae observed on subaerial exposed rocks. Hard bottom cover present beyond 50 m offshore.

Typical nearshore conditions at Transect 5

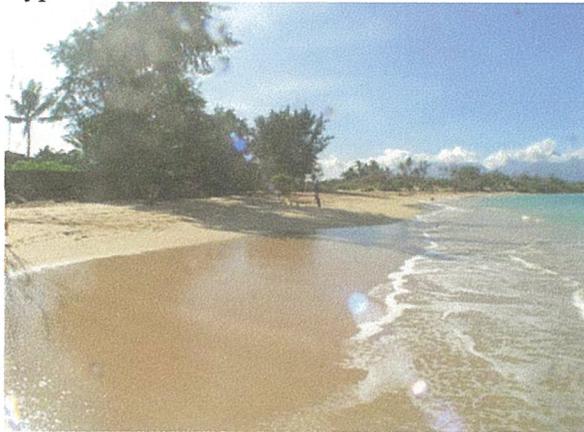
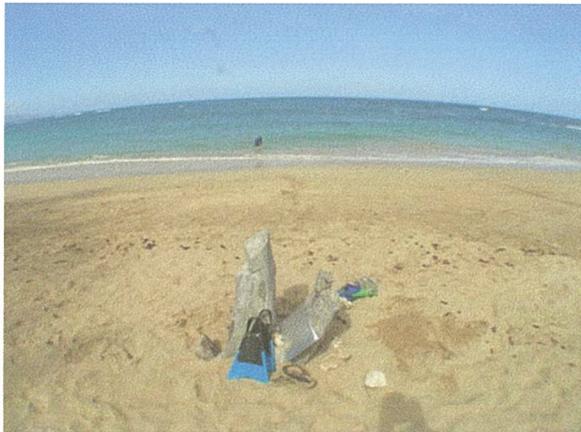
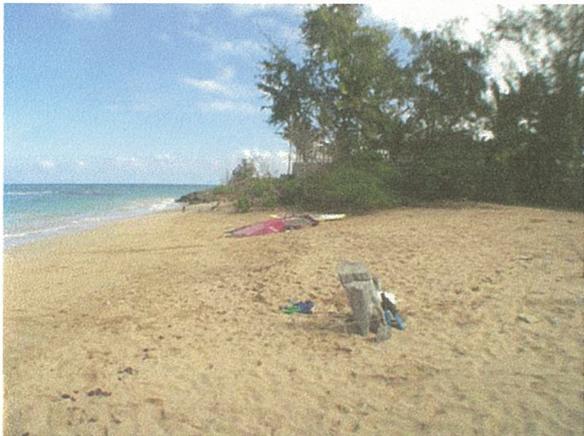
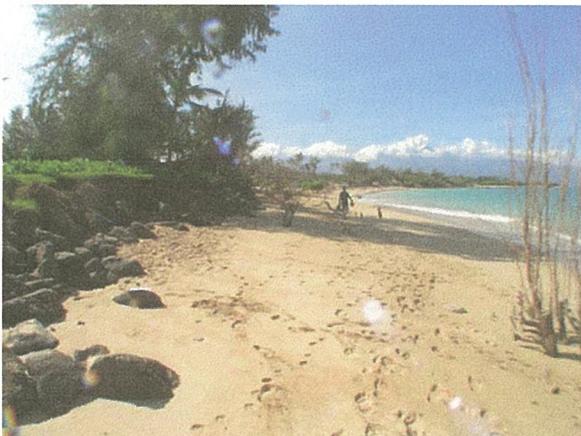
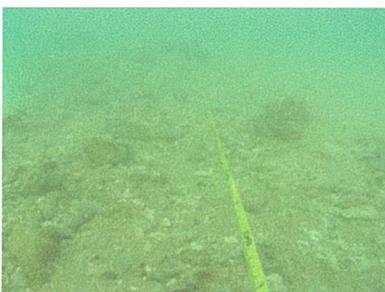
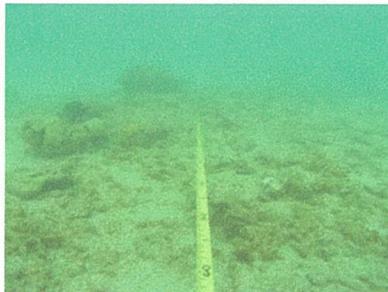
Moderate to good visibility (5-10') near shore and improving with distance from shore. Sandy shoreline at public beach park. Primarily sand and uncolonized coral rubble nearshore (<50 m) and basalt boulders with thin sand veneer beyond 60 m offshore. Shore-parallel inter-tidal beach rock ridge at 60-70 m offshore. Basalt boulder (natural?) groin-like feature extending perpendicular to shoreline connecting to beach rock ridge. Fossil reef and coralline rubble hard bottom >50m offshore with some coralline algae colonization. Estimated coral cover less than 1%. Unidentified sponge present (<1% cover) at hard bottom near beach rock ridge. Wider assemblage of marine life near beach rock (spiny lobster, wrasse, green algae, sponges). Hard bottom cover present beyond 50 m offshore.

Typical nearshore conditions at Transect 6
