**Category II General Application
Small-Scale Beach Nourishment Projects
(SSBN)**

PROJECT NAME: SBRF, Inc. Proposed Volume 3,500yds³ over 5 years

Nearshore Marine Site Assessment:**Conditions****Date:** February 21, 2006**Time:** 12:00 to 2:00pm**Personnel:** Dolan Eversole, Chris Conger (OCCL)**Marine Conditions:** North Swell 2-4 ft faces, Northeast winds 10-15 mph,

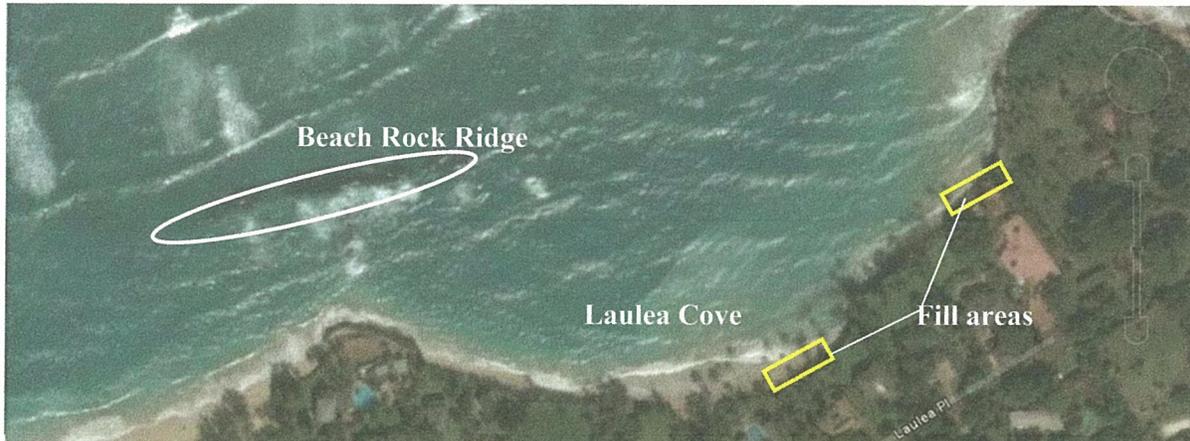
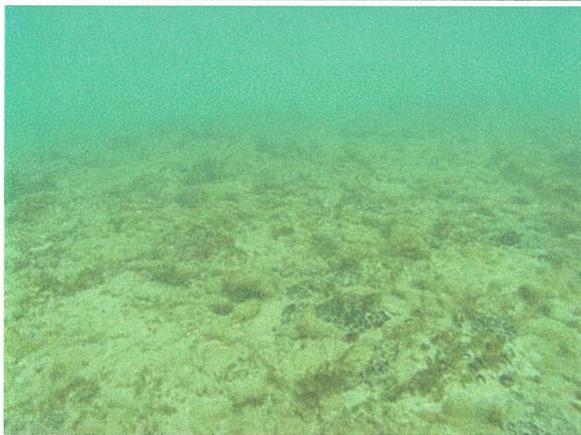
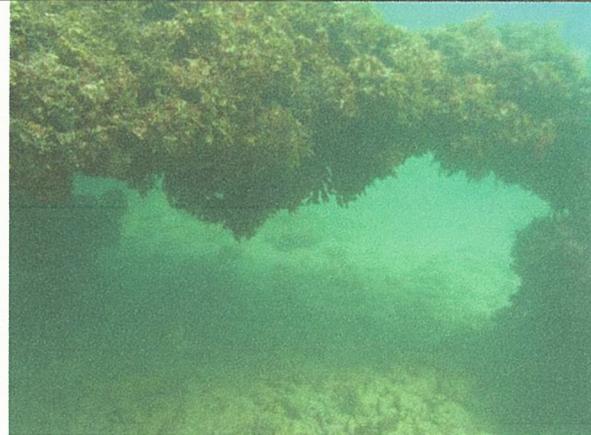
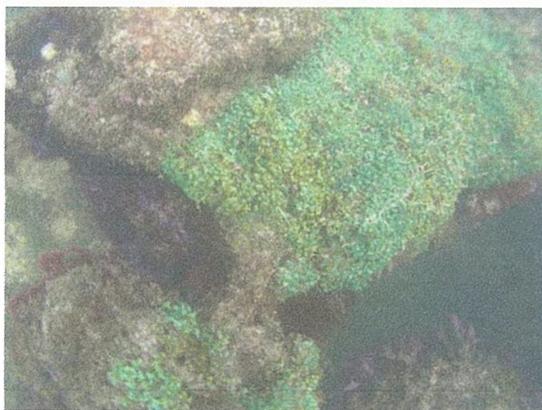
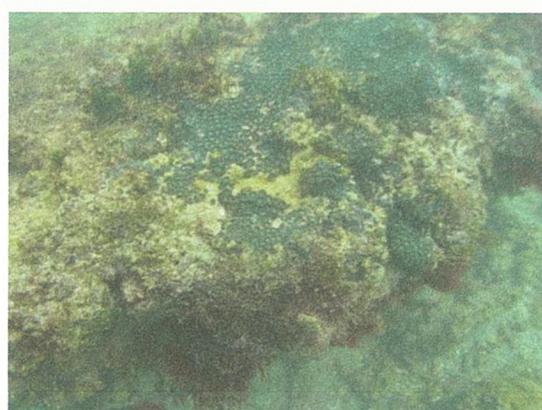
Moderate to good visibility (5-10') near shore and improving with distance from shore. Shore-parallel inter-tidal beach rock ridge at 60-70 m offshore. Basalt boulder (natural?) groin-like feature extending perpendicular to shoreline connecting to beach rock ridge. Fossil reef and coralline rubble hard bottom >50m offshore with some coralline algae colonization. Estimated coral cover less than 1%. Unidentified sponge present (<1% cover) at hard bottom near beach rock ridge. Wider assemblage of marine life near beach rock (spiny lobster, wrasse, green algae, sponges). Hard bottom cover present beyond 50 m offshore.

Typical nearshore conditions at Beach Rock ridge.
