Cape Flattery Settlement Restoration Project: Restoring Reefs in Kāneʻohe Bay

PROGRESS REPORT

Division of Aquatic Resources
Aquatic Invasive Species Team

June-December 2017

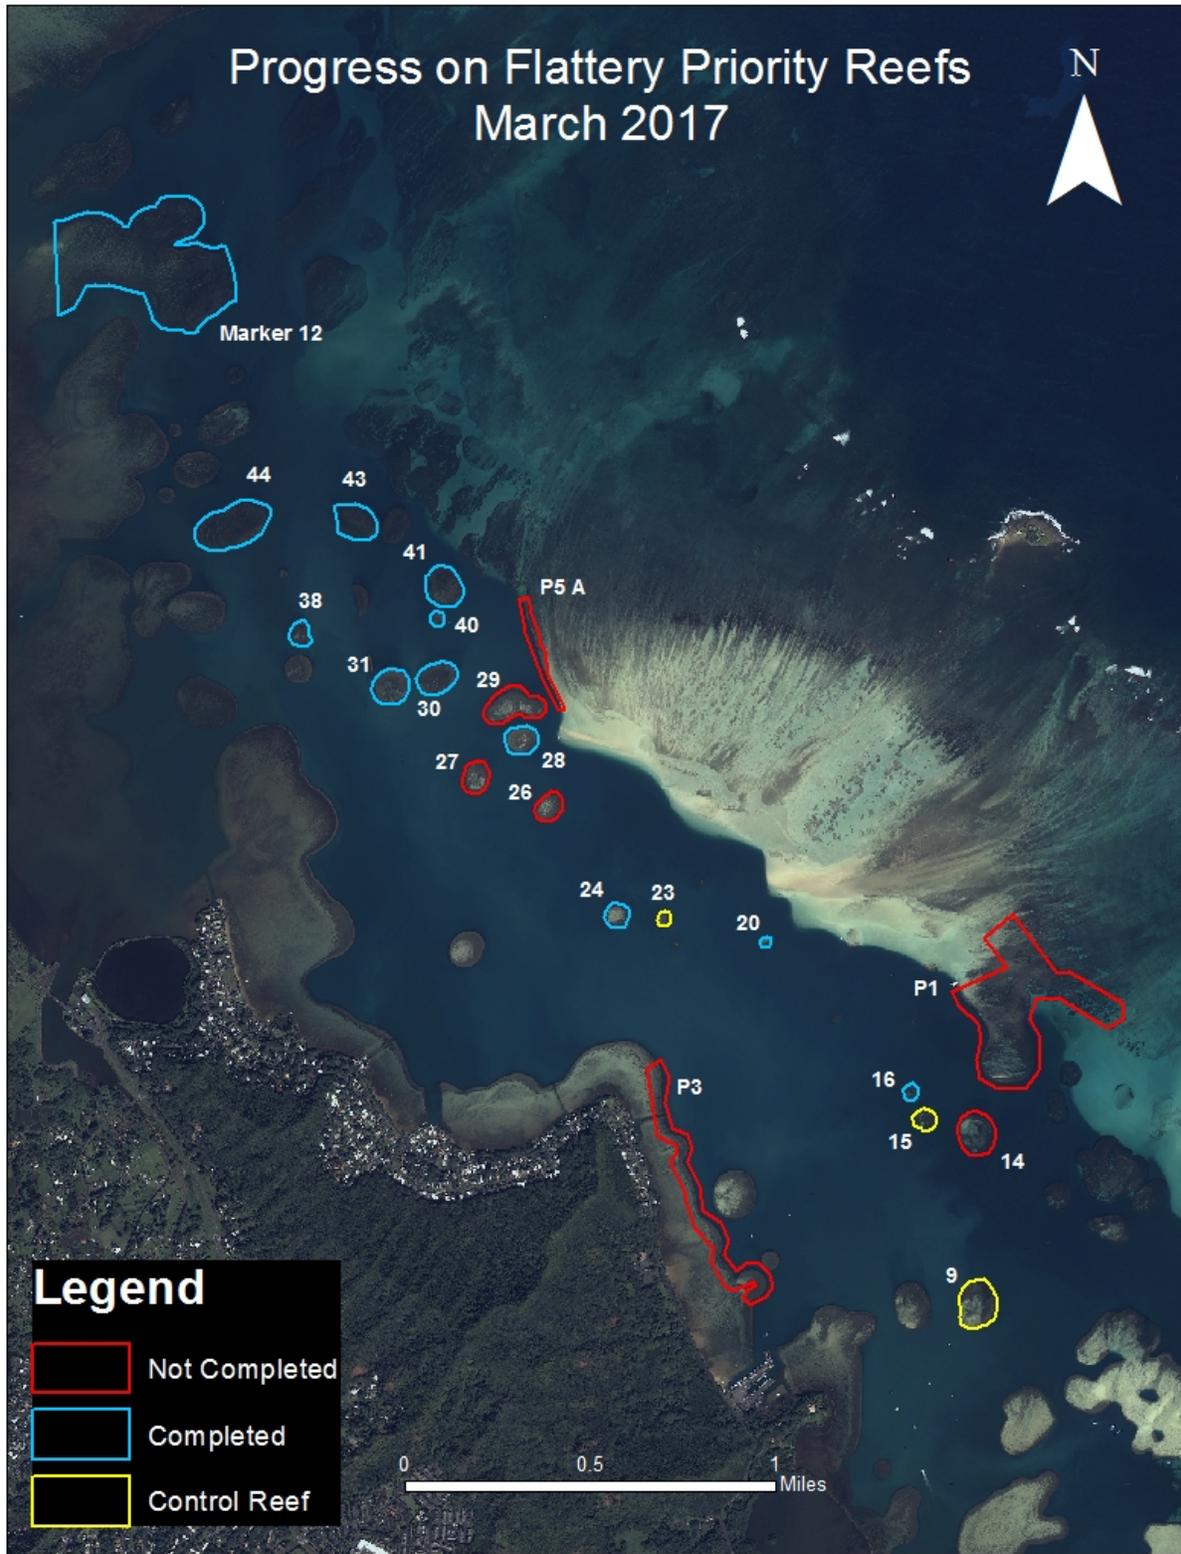
Figure 1: Invasive algae control progress on priority reefs in Kāneʻohe Bay.

As of February 15, 2017, all remaining priority reefs (Reefs 20, 24, 28, 30, 31, 38 and 41) have been stocked with target numbers of urchins. Outplanting will continue on newly identified priority reefs. Additionally, monitoring and photo documentation of the coral reattachment pilot project will continue as well as the planning phase of the Heʻeia Watershed Reef Restoration. Table 1 shows the project progress to date, and planned timeframes for future activities. Figure 1 shows the location and progress of priority reefs.

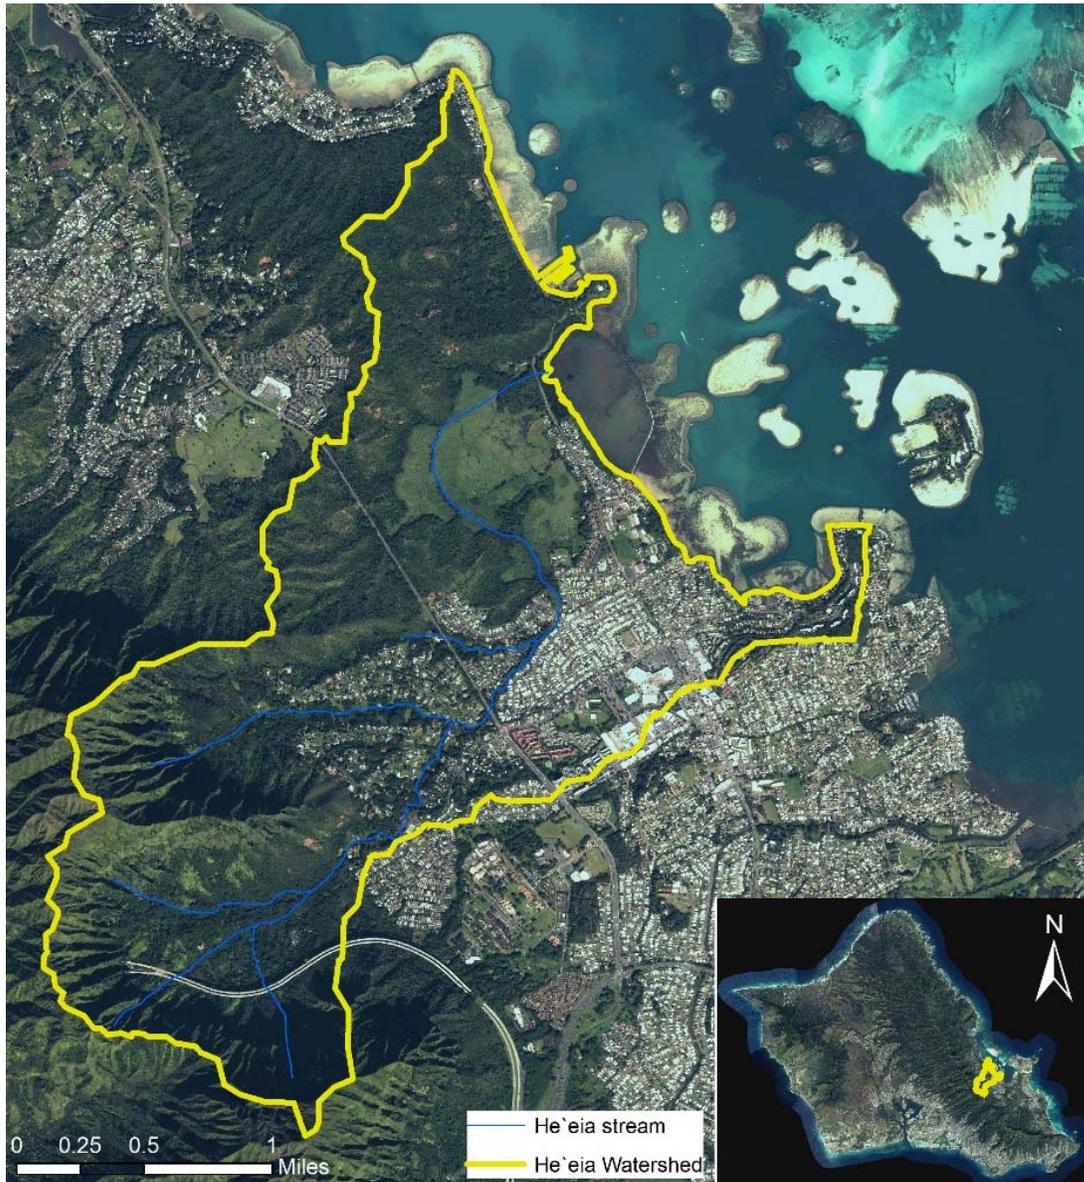
Fig.1. He'eia watershed, Kāne'ohe Hawai'i.

He'eia watershed is located on the windward (north-east) side of O'ahu and spans approximately 2,800 acres, extending from the Ko'olau range to the 75 acre He'eia fishpond where it meets Kāne'ohe Bay (Fig.1). Prior to western settlement, the watershed

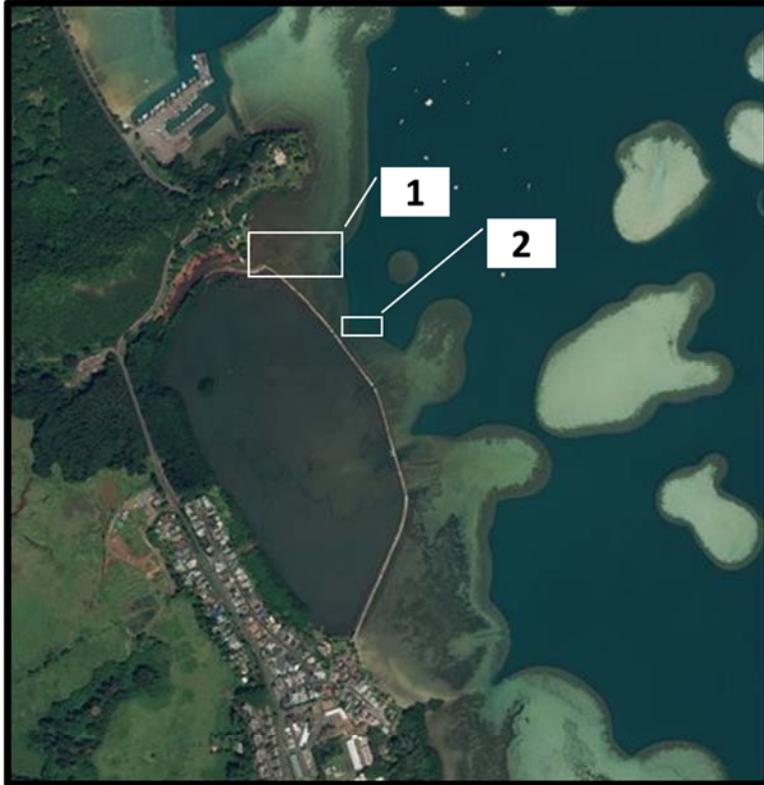
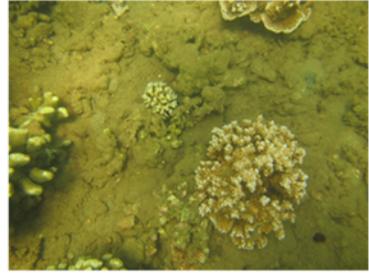
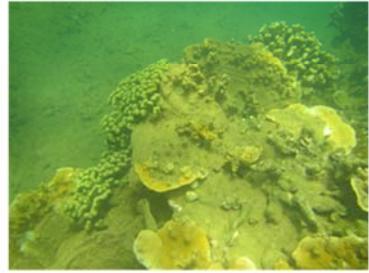
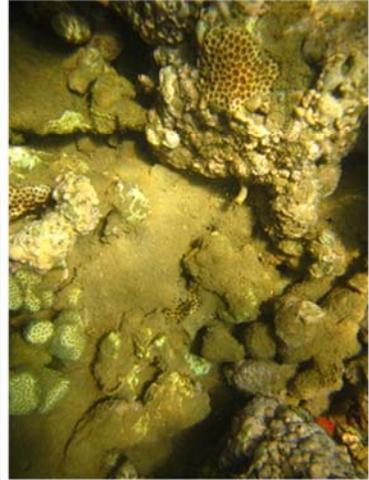
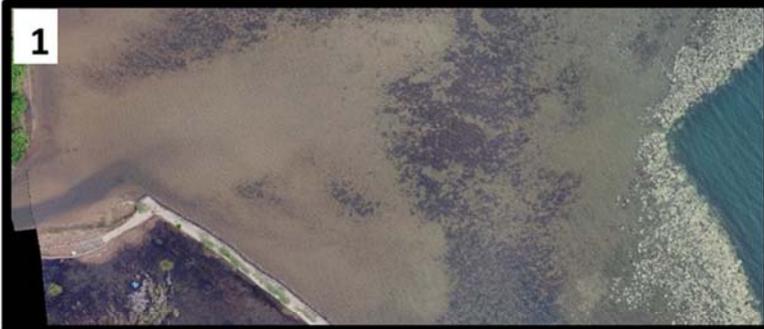
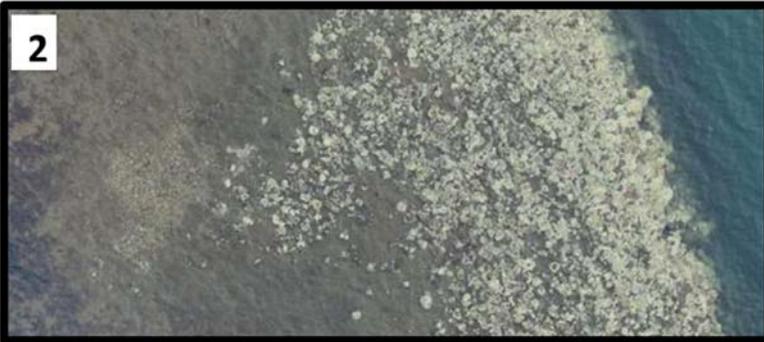
Fig.2. He‘ei reef and He‘eia stream outlet (inset 1). Bleached coral colonies are evident in aerial photos taken in 2015 (inset 1 and 2). Sediment settling on and around the coral colonies at He‘eia reef (right panel).

The benthic cover of the fringing reef extending out from the He‘eia fishpond follows a general gradient ranging from terrestrial derived fine silt with patches of invasive and native algae and rubble, to sparse coral cover and sand, to high coral cover at the reef edge and slope (Fig.2). The distance between the stream mouth and the fishpond wall to the reef edge ranges from approximately 25 m to 200 m. Corals along the reef edge appear to be in similar condition to those on offshore patch reef sites. Coral cover, especially that of *Montipora capitata*, *Porites compressa*, and *Pocillopra damicornis*, extends inward on the reef flat for a variable distance but abruptly ends in a line parallel to the reef edge. The highly tolerant coral species *Leptastrea purpurea* is the only exception in coral distribution, growing directly on the fishpond wall and nearby on scattered rubble. Sediment plumes extending from the stream mouth and mākāhā (sluice gate) can be seen in aerial photographs of the area and may influence coral distribution. A distinct band of dead coral lies between the reef slope and the reef flat. Regions of recent dead coral skeletons may have occurred following the 2014 and 2015 widespread bleaching events that caused approximately 20% mortality of corals in Kāne‘ohe Bay.
