Cape Flattery Settlement Restoration Project: Restoring Reefs in Kāneʻohe Bay

PROGRESS REPORT

Division of Aquatic Resources
Aquatic Invasive Species Team

July – December 2019

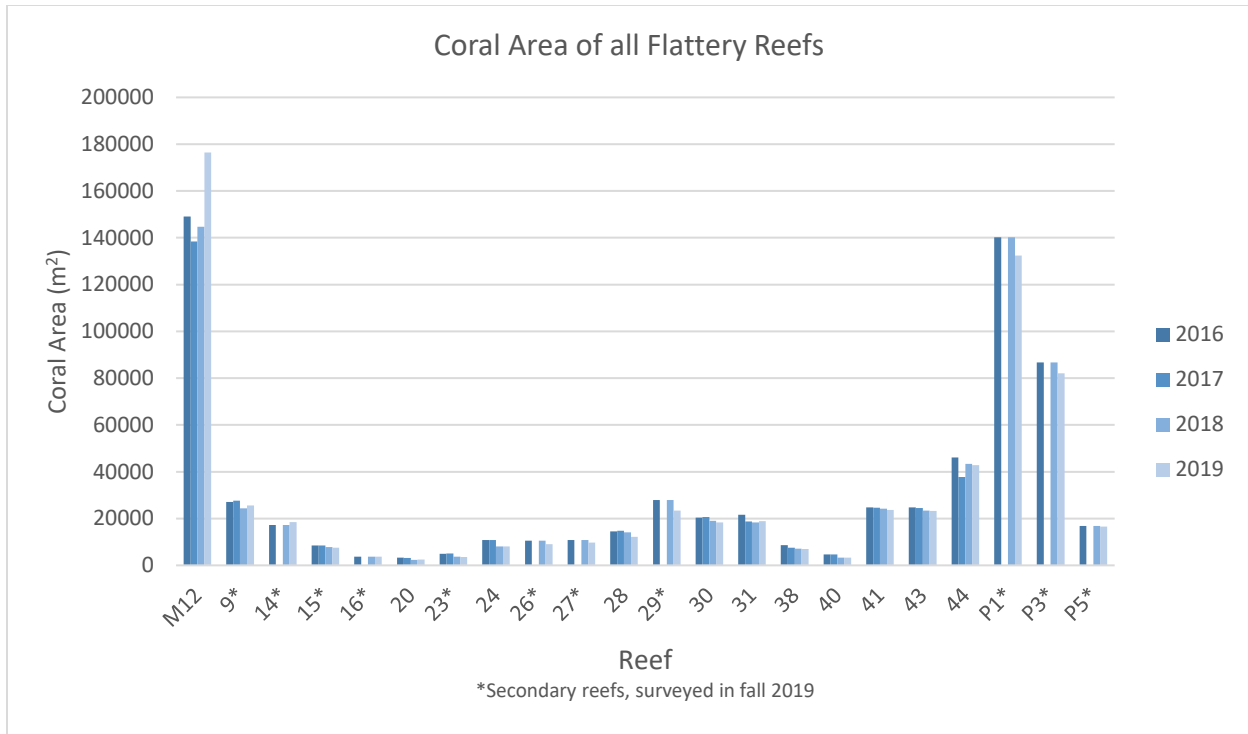
Figure 2: Coral cover (m²) by reef.

Coral distributions were variable throughout the survey area. Coral cover ranged from 3,731 m² to 132,446 m² (Figure 2). This is because the areal extent of each reef surveyed is highly varied. The total area of the secondary restoration area covered by coral was estimated at 295,433 m² while the total area of the combined primary and secondary restoration area covered by coral was approximately 668,742 m².

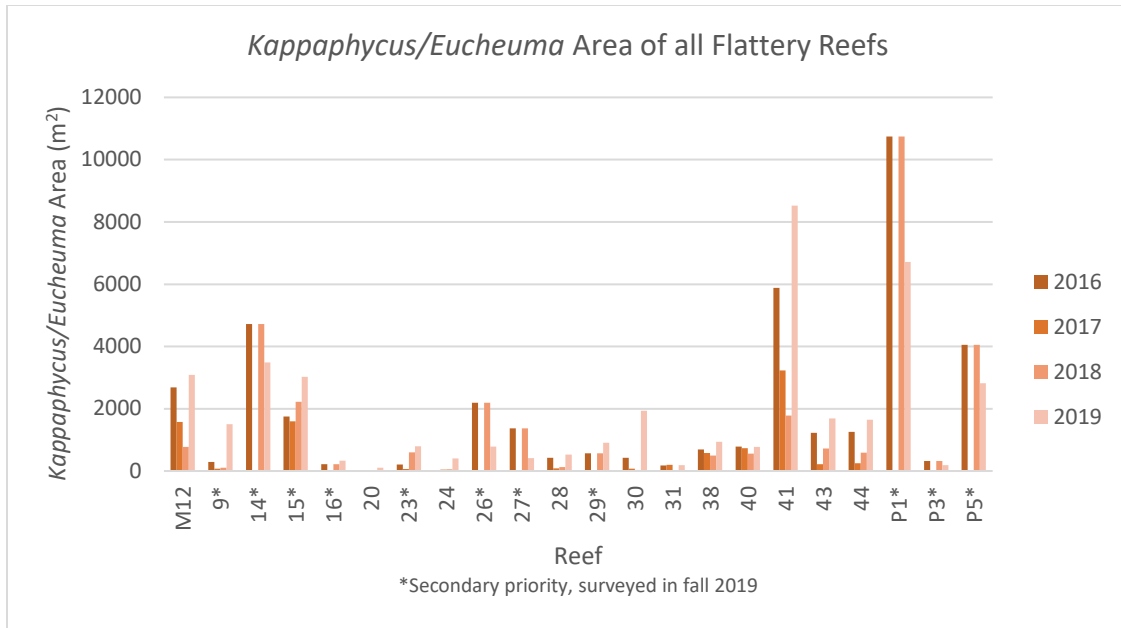
Figure 3: *Kappaphycus/Eucheuma* cover (m²) by reef.

The total area of *Kappaphycus/Eucheuma* decreased between 2018 and 2019 on nine of the eleven reefs surveyed in the fall (Figure 3). None of the reefs surveyed in this reporting period showed interpolated algae densities above the target of 5% cover. Reef 14 and reef 15 showed the highest interpolated percent cover of algae of the reefs surveyed at 2.16% and 3.49% respectively.

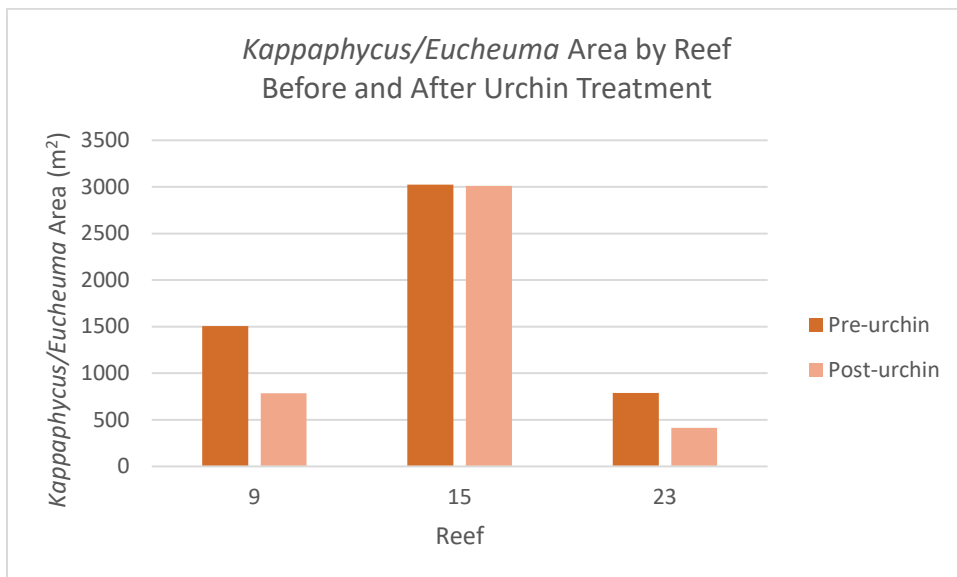
Figure 4: *Kappaphycus/Eucheuma* density on converted control reefs.

Reefs 9, 15, and 23 were the only reefs monitored in both spring and fall SNAP surveys (Figure 4). Initial urchin outplantings on these reefs occurred in spring 2019 and algae densities were not yet affected by the biocontrol at the time of the spring surveys. While the fall SNAP surveys showed a general decline in *Kappaphycus/Eucheuma* areal coverage on these reefs, future years' surveys may indicate if this decline can be attributed to ongoing treatment.

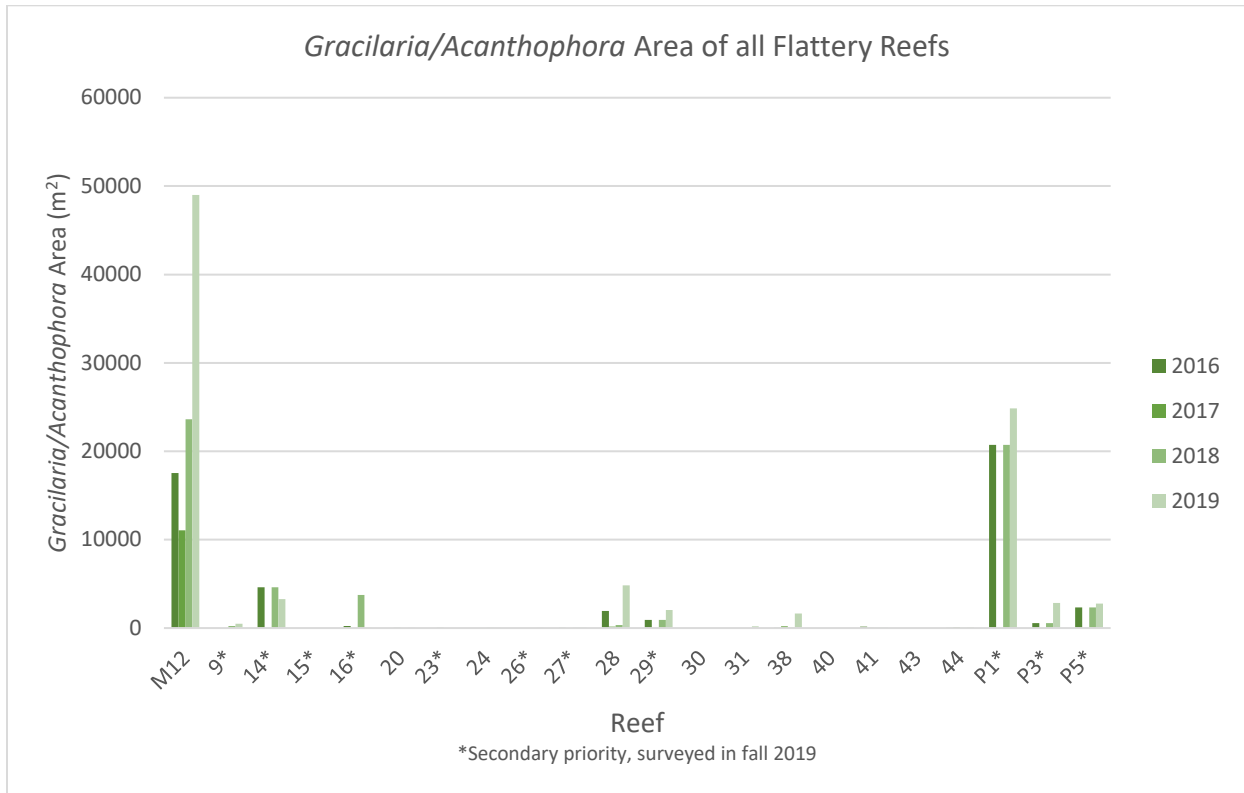
Figure 5: *Gracilaria/Acanthophora* cover (m²) by reef.

An increase in *Gracilaria/Acanthophora* was noted on seven of the eleven reefs surveyed in the fall (Figure 6) though areal coverage remained relatively low. *Gracilaria/Acanthophora* is typically seen in higher densities in the fringing reef areas (P1, P3, P5) and is generally found in more rubbly, sandy areas with lower coral cover. For this reason, *Gracilaria/Acanthophora* areas are currently not directly targeted for urchin outplanting. We will continue monitoring these invasive algae to determine if the areas should be targeted for biocontrol in the future.

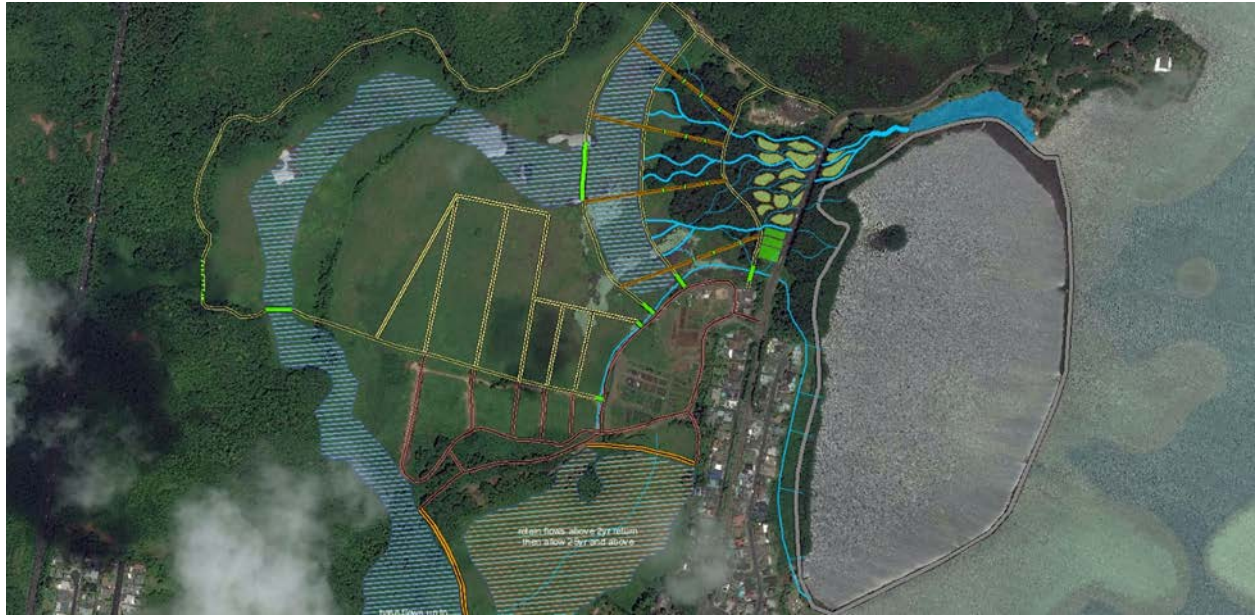
Figure 7: Draft designs for He'eia wetland.

The current road design plan for Kāko'o 'Ōiwi was digitized into AutoCad and ArcGIS and is in the process of being input into additional iterations of the hydro flood model. The results will be used as a planning tool to assess critical areas potentially impacted by floods, develop retention areas to capture sediment, identifying and minimizing detrimental effects to aquatic biota from planned infrastructure (Figure 7).

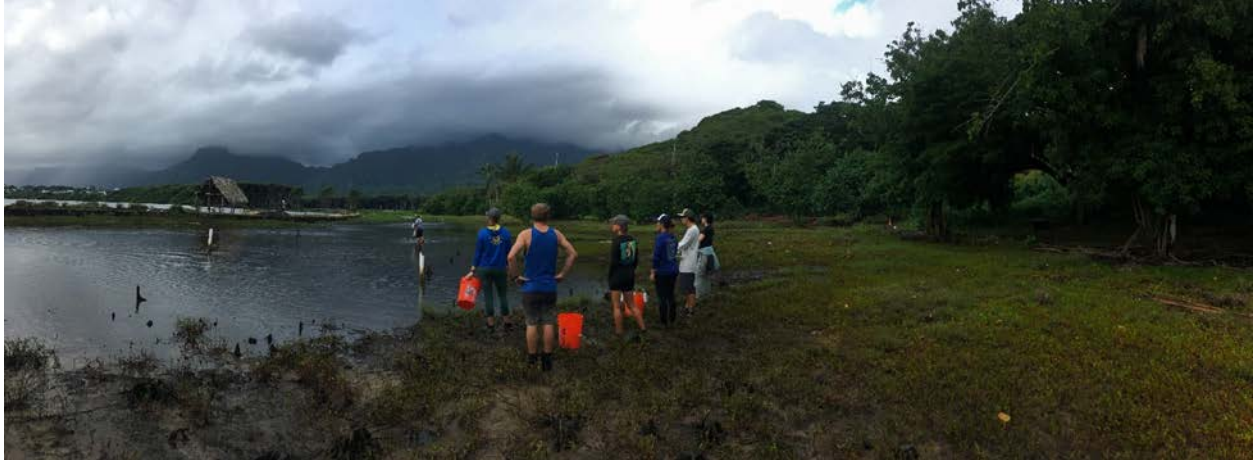
Figure 8: Estuary fish sampling.

A lack of past and current baseline aquatic biota data in He'eia watershed was identified during an initial review in early 2019. Planning for the collection of aquatic biota data began in 2019 and the first full watershed aquatic survey was conducted in June 2019. The second full aquatic sampling was conducted in December 2019. The sampling took place from the estuary up to just below the headwaters of He'eia stream. Participants in the planning and data collection included NERR, Kāko'o 'Ōiwi, TNC, and DAR staff.
