Preliminary Demolition Assessment for the Former Pagoda Hilo Bay Hotel, Country Club Condominium/Hotel, and Reeds Bay Hotel

Island of Hawai'i, State of Hawai'i

VOLUME 2 OF 2 - APPENDICES

February 2018

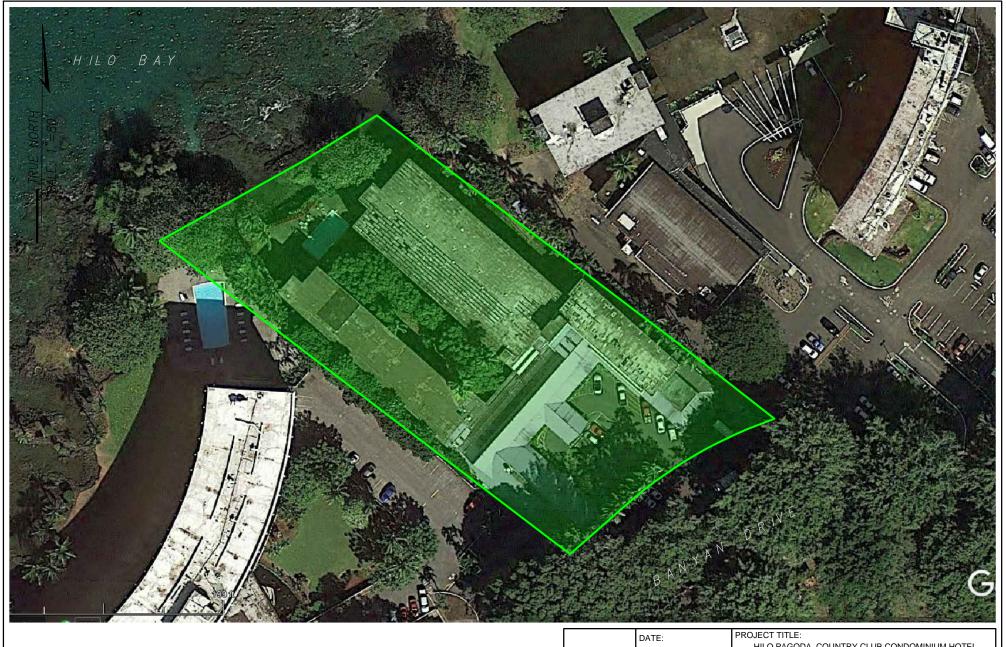
FIGURE NO.: 2-3

HILO PAGODA LAYOUT

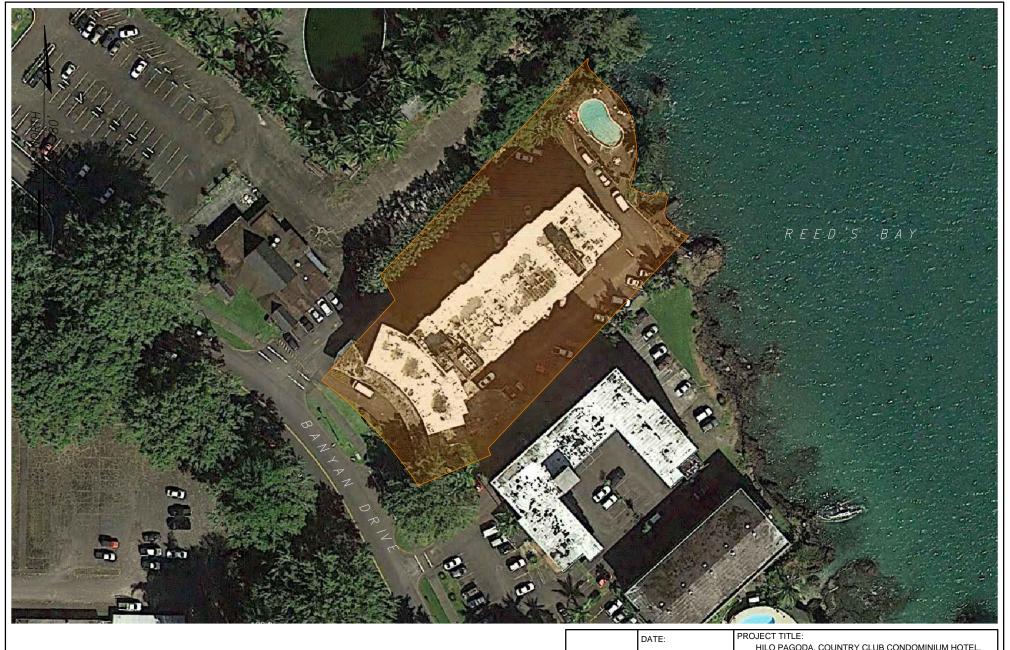
FIGURE NO.: 2-4

COUNTRY CLUB CONDOMINIUM HOTEL LAYOUT

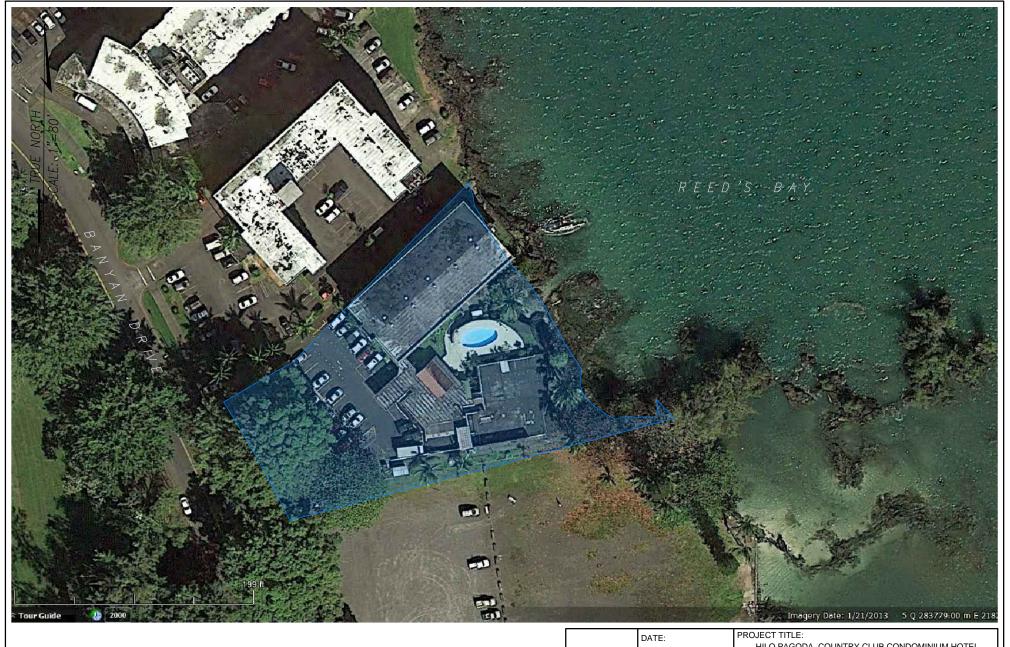
2-5

REED'S BAY RESORT LAYOUT

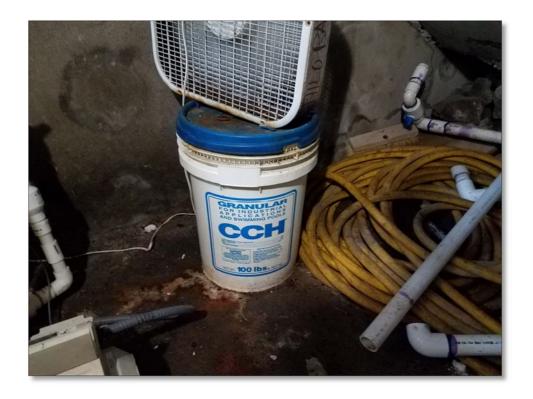
E2 Project No.:	Description	A 100 lb. bucket of Chlorine granules was observed seeping into soil within the pool pump and filter room.	Photo I
170004	Site Name	Hilo Pagoda	Photo Date
170004	Client	R.M. Towill Corporation	3/1/2017

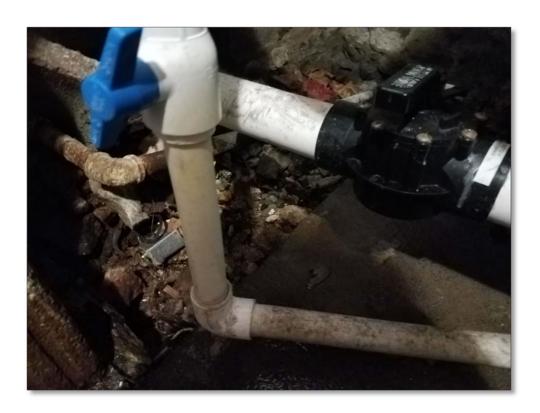
E2 Project No.:	Description	Chlorine contaminated water is emptying to soil within the pool pump and filter room.	Photo 2
170004	Site Name	Hilo Pagoda	Photo Date
170004	Client	R.M. Towill Corporation	3/1/2017

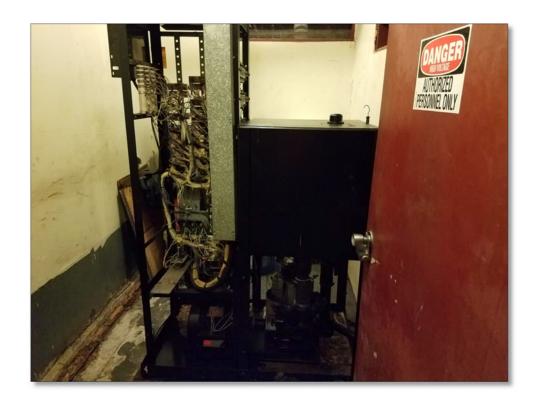
E2 Project No.:	Description	A hydraulic aboveground storage tank and pump are located in the Elevator Hydraulic Room.	Photo 3
170004	Site Name	Hilo Pagoda	Photo Date
170004	Client	R.M. Towill Corporation	3/1/2017

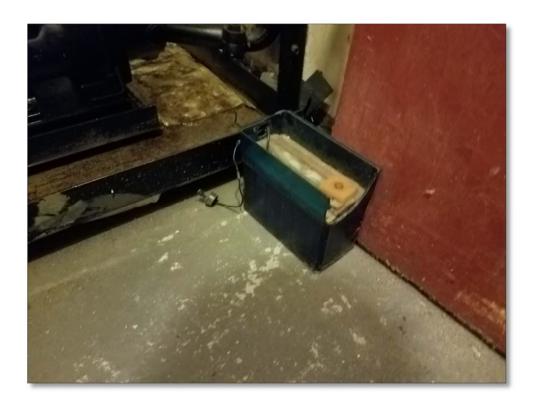
E2 Project No.:	Description	A damaged lead-acid battery was observed within the Elevator Hydraulic Room.	Photo 4
170004	Site Name	Hilo Pagoda	Photo Date
170004	Client	R.M. Towill Corporation	3/1/2017

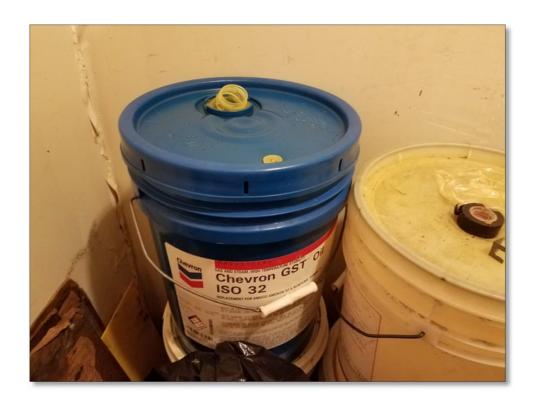
E2 Project No.:	Description	Improperly stored (open) 5 gallon drums of hydraulic oil were observed within the Elevator Hydraulic Room.	Photo 5
ı	170004	Site Name	Hilo Pagoda	Photo Date
ı	170004	Client	R.M. Towill Corporation	3/1/2017

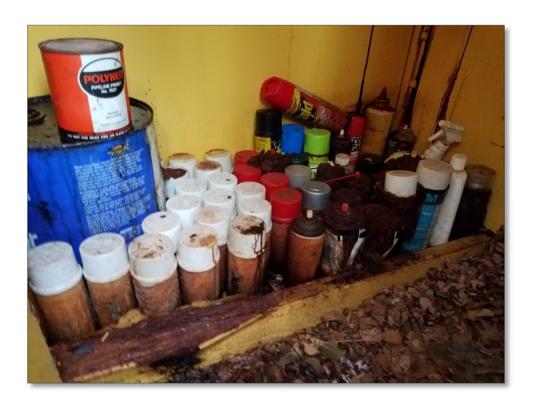
E2 Project No.:	Description	Flammable storage locker outside the General Store; used to store hazardous materials. Both the locker and the stored materials are in poor condition.	Photo 6
170004	Site Name	Hilo Pagoda	Photo Date
170004	Client	R.M. Towill Corporation	3/1/2017

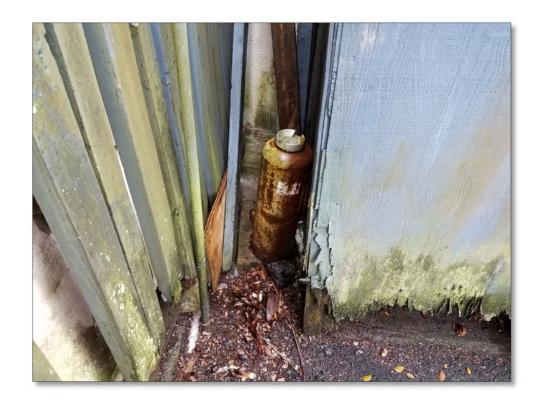
E2 Project No.:	Description	A compressed gas cylinder (~20lbs.) of unknown content was observed along the east wall of the hotel/general store.	Photo 7
170004	Site Name	Hilo Pagoda	Photo Date
170004	Client	R.M. Towill Corporation	3/1/2017

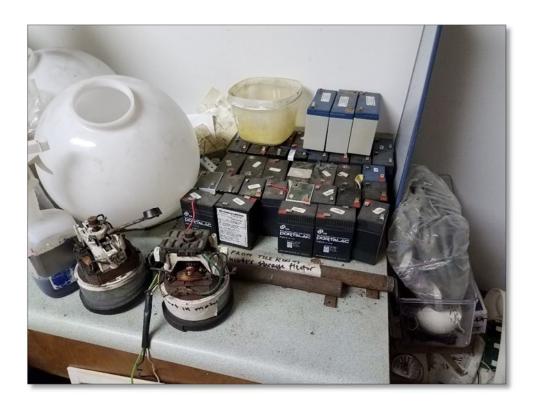
E2 Project No.:	Description	Several types of small lead-acid batteries and light fixtures were observed in the basement maintenance shop storage area.	Photo 8
170004	Site Name	Hilo Pagoda	Photo Date
170004	Client	R.M. Towill Corporation	3/1/2017

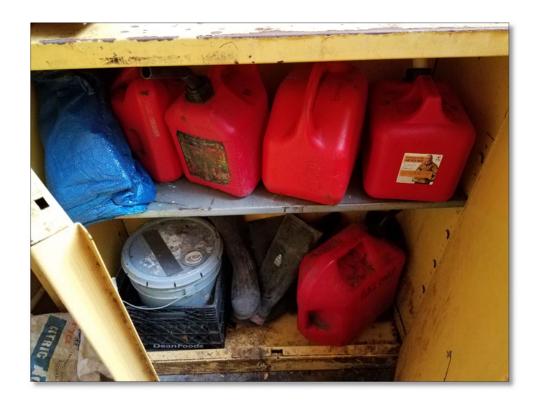
E2 Project No.:	Description	Gasoline cans and other unidentified materials were observed stored in a flammable locker in the basement maintenance shop storage area.	Photo 9
170004	Site Name	Hilo Pagoda	Photo Date
170004	Client	R.M. Towill Corporation	3/1/2017

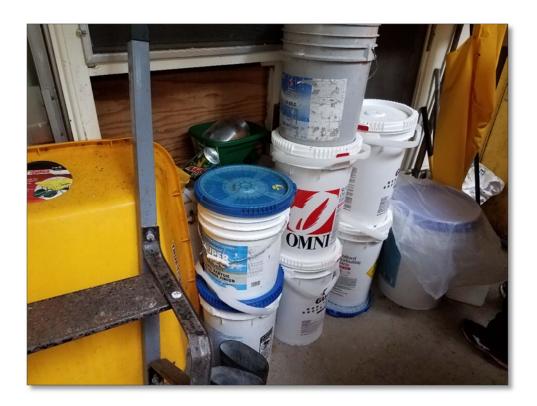
E2 Project No.: Description 5-gallon containers of chlorine tablets and paint in the basement maintenance shop storage area.		Photo 10	
170004	Site Name	Hilo Pagoda	Photo Date
170004	Client	R.M. Towill Corporation	3/1/2017

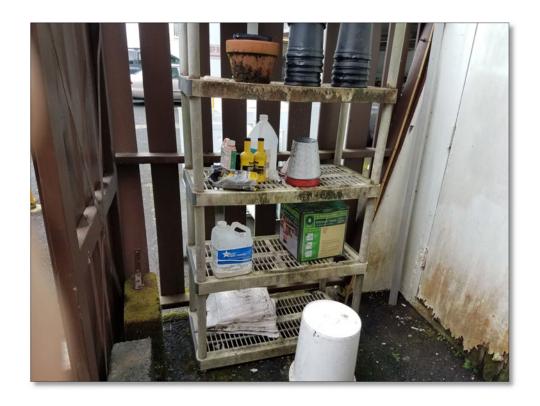
E2 Project No.: Description		Outside chemical storage area adjacent to the ground floor main electrical room.	Photo II
170004		Site Name	Country Club Condominium Hotel	Photo Date
		Client	R.M. Towill Corporation	2/28/2017

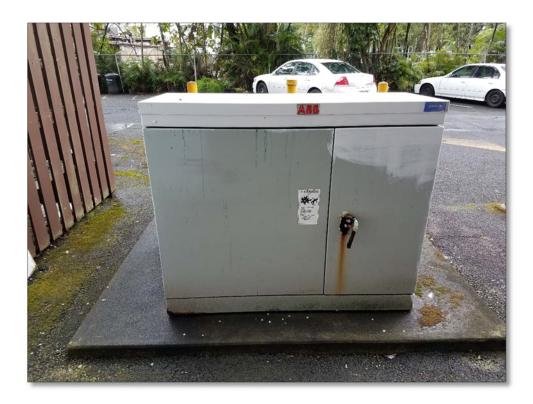
E2 Project No.: Description		Transformer ABB on a concrete pad within the parking lot. The transformer identification numbers have been painted over and the unit may contain PCBs.	Photo 12
170004	Site Name	Country Club Condominium Hotel	Photo Date
170004	Client	R.M. Towill Corporation	2/28/2017

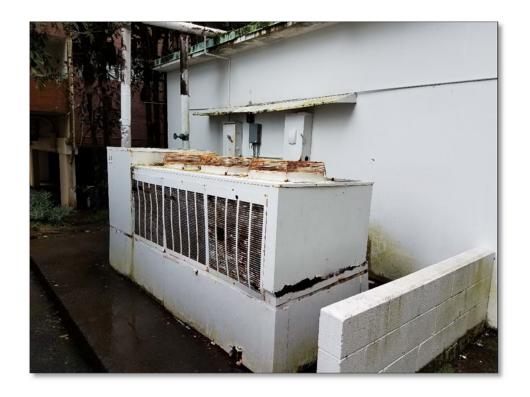
2 Project No.:	2 Project No.: Description Non-functioning air conditioning unit with rust and metal damage located behind the restaurant. View looking south.		Photo 13
170004	Site Name	Country Club Condominium Hotel	Photo Date
170004	Client	R.M. Towill Corporation	2/28/2017

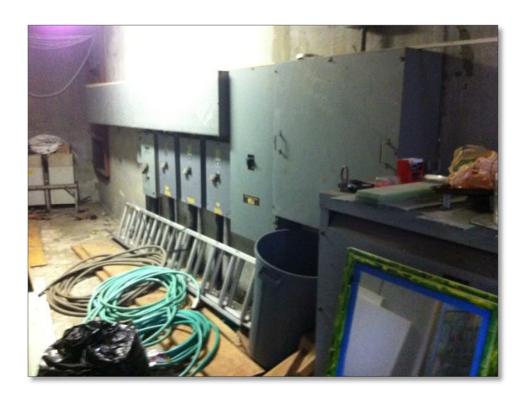
E2 Project No.: Description		The ground floor main electrical room contains two large capacitors (pictured in the left of the photo).	Photo 14
170004	Site Name	Country Club Condominium Hotel	Photo Date
170004	Client	R.M. Towill Corporation	2/28/2017

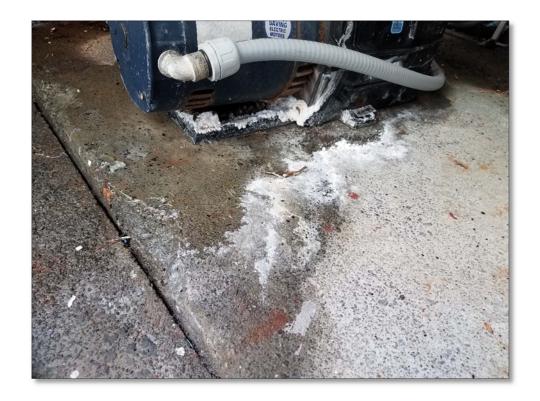
2 Project No.:	Description	The pool filter system pump is leaking water. The chlorine contaminated water drains to soil outside of the pump shed.	
170004	Site Name	Reed's Bay Resort Hotel	Photo Date
170004	Client	R.M. Towill Corporation	3/1/2017

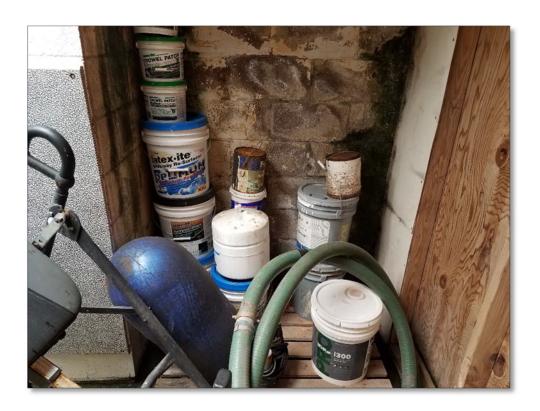
E2 Project No.:	No.: Description Multiple maintenance related chemicals are stored in the former restaurant basement adjacent to the maintenance shop.		Photo 16
170004	Site Name	Reed's Bay Resort Hotel	Photo Date
170004	Client	R.M. Towill Corporation	3/1/2017

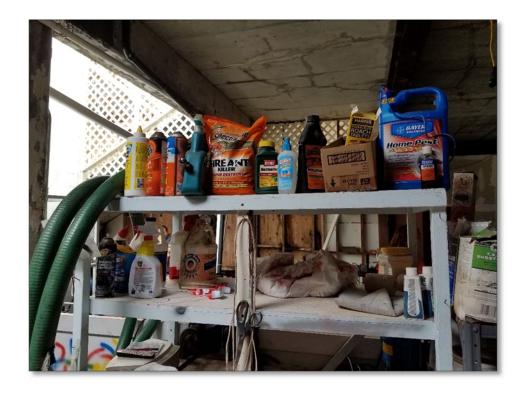
E2 Project No.:	E2 Project No.: Description Pest control chemicals and miscellaneous grounds maintenance supplies are stored in the former restaurant basement.		Photo 17
170004	Site Name	Reed's Bay Resort Hotel	Photo Date
170004	Client	R.M. Towill Corporation	3/1/2017

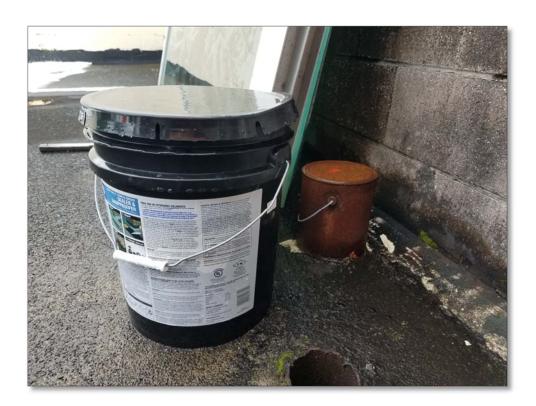
A 5-gallon bucket of roofing chemical is stored next to a heavily rusted I-gallon can of unknown contents in the vicinity of the former restaurant.	Photo 18
170004	Site Name	Reed's Bay Resort Hotel	Photo Date
170004	Client	R.M. Towill Corporation	3/1/2017

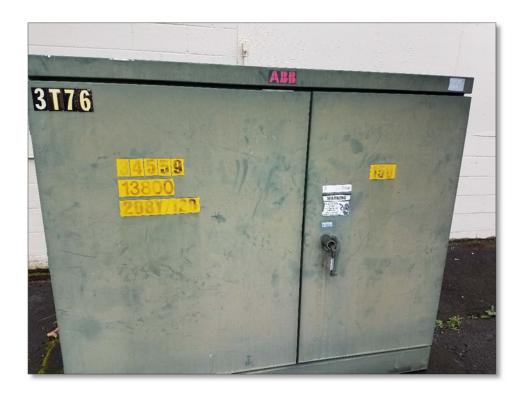
E2 Project No.:	Description	Transformer number 34559. This unit has a sticker indicating "No PCBs". View looking east.	Photo 19
170004	Site Name	Reed's Bay Resort Hotel	Photo Date
170004	Client	R.M. Towill Corporation	3/1/2017

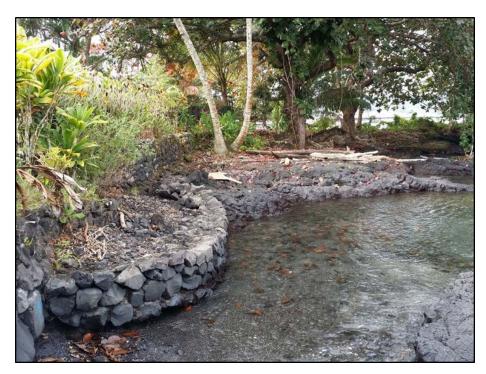
Figure 28. Photo of the seawall along the *makai* boundary of the Pagoda Hilo Bay Hotel; view to southwest

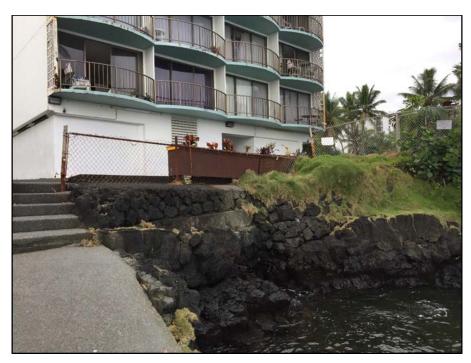
Figure 33. Photo of the seawall, concrete stairs and walkway along the *makai* side of the Country Club Condominium Hotel; view to west

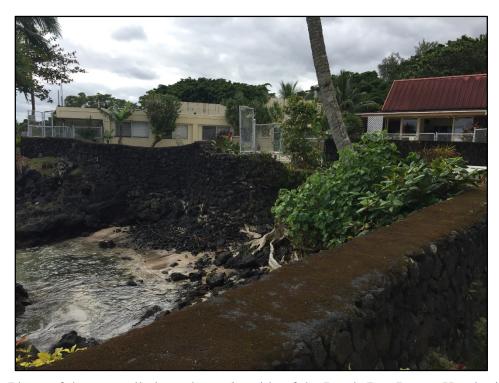
Figure 40. Photo of the sea wall along the *makai* side of the Reeds Bay Resort Hotel; view to southeast

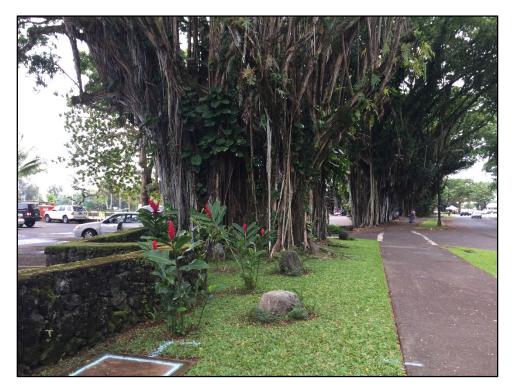
Figure 41. Photo of the banyan tree near the entrance to the Reeds Bay Resort Hotel; view to southeast

The Reeds Bay Resort Hotel is in active operation. The hotel is bounded to the northwest by the Bay View Banyan apartments, Kūhiō Bay to the northeast, Reeds Bay Beach Park to the southeast, and Banyan Drive to the southwest (see Figure 3). The hotel parking lot fronts the property and is accessed from Banyan Drive (Figure 35). The majority of hotel grounds are covered by asphalt and concrete, with the exception of a few landscaped areas along the hotel boundaries and surrounding the swimming pool area (Figure 36 through Figure 39). A seawall bounds the *makai* side of the property; a concrete walkway provides access to the shoreline (Figure 40). A banyan tree planted in 1936 is present near the hotel entrance on Banyan Drive (Figure 41). No historic properties were identified during the field inspection of the Reeds Bay Resort Hotel.

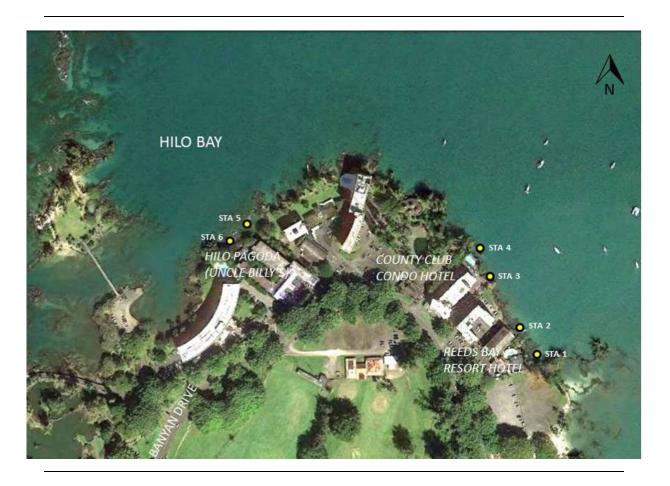
Figure 4. Water quality and sediment stations sampled February 15, 2017.

Water quality samples were collected February 15, 2017 at six stations in the nearshore waters off Banyan Drive (Figure 3). Temperature, salinity, pH, and dissolved oxygen (DO) were measured *in situ*. The remaining samples were collected, chilled, and returned to the *AECOS* laboratory for analysis (*AECOS* Log No. 33695). The following parameters were measured in the laboratory: salinity, turbidity, total suspended solids (TSS), ammonia nitrogen, nitrate+nitrite nitrogen, total nitrogen (total N), total phosphorus (total P), and chlorophyll a. Table 1 lists the instruments and analytical methods used for field and laboratory analyses.

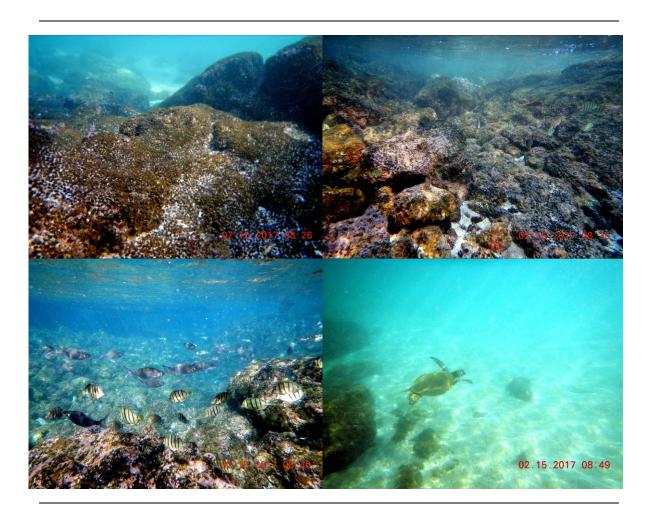
Figure 5. A basalt shelf, coated with mussels occurs at the south end of Reeds Bay Resort (top left). Basalt boulders host coralline algae (top right), and schools of fish (*K. xenura*, *A. triostegus*, and *Parupeneus* spp.; bottom left). One green sea turtle was observed (bottom right).

Reeds Bay Resort — Figure 5 presents representative photos of the nearshore structure and biota fronting Reeds Bay Resort. Fronting the shoreline are basalt boulders with sand patches that extend gradually into deeper water. At the south end of the property, a basalt bench is present in shallow water. Here, freshwater input was noticeable by cooler water temperature and schlieren effect created by the fresh water. A moderate amount of coralline algae and algal turf grow on the basalt bench and boulders, including *Boodlea composita*, Chaetomorpha atennina, Cladophoropsis sundanensis, Ahnfeltiopsis flabelliformis, Amansia glomerata, Gracilaria salicornia, Martensia fragilis, Pterocladiella and *Hydrolithon* spp. Hawaiian mussel (*Brachiodontes* crebristriatus) occur in large numbers, forming mats on the basalt bench and on some boulders. A conspicuous purple sponge (Leucetta sp.) was abundant in this area. Barnacles (Chthamalus proteus and Nesochthamalus intertextus) and nerite snail (Nerita picea) are common in the intertidal zone. Other macroinvertebrates observed include limpet (Siphonaria normalis), worm snails (Serpulorbis variabilis and Petaloconchus keenea), brown purse shell (Isognomon perna), and Hawaiian oyster (Dendostrea sandvicensis). Sea urchins (*Echinometra mathaei* and *E. oblonga*) are rare. Corals are uncommon throughout this survey area, and no coral occurs within 5 m (15 ft) of the shore. Further offshore (approximately 50 m), biologists encountered one small (5- to 10 cm) *Pocillopora damicornis* colony.

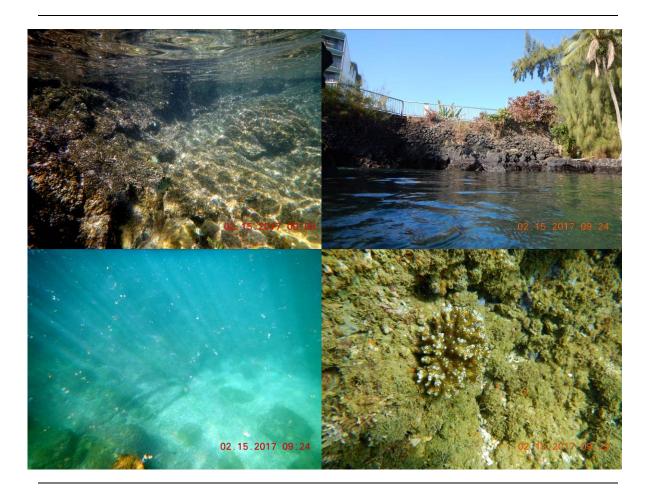
Figure 6. The shore fronting Country Club Condominium Hotel is basalt, encrusted with mussels (top left). About the middle of the property is a cove, with a steep basalt shore (top right). Sand and boulders make up the bottom in this cove (bottom left). A few small *Poc. damicornis* occur approximately 15 m (50 ft) from the shore (bottom right).

<u>Country Club Condominium Hotel</u> — Figure 6 (above) presents representative photos of the nearshore bottom and biota fronting Country Club Condominium Hotel. The shoreline here is similar to that fronting Reeds Bay Resort. A steep basalt shore fronts segments of the property and a small cove with sand bottom and cobbles occurs approximately midway along the property shore. Algae composition is similar to that described for Reeds Bay Resort. The basalt boulders host mussels (*B. crebristriatus*) and barnacles (*C. proteus* and *N. intertextus*). Small, unidentified, non-stinging jellyfish were abundant ast the time off the Country Club Condominium Hotel. Urchins (*E. mathaei* and *Tripneustes gratilla*) are uncommon in the area. Corals (*Montipora capitata* and *Poc. damicornis*) are rare in this area, with a few small colonies observed approximately 50 ft (15 m) off the shore.

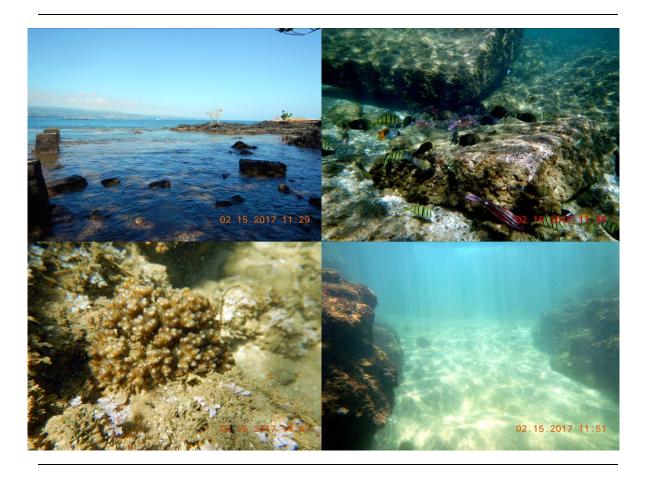
Figure 7. A basalt bench extends seaward approximately 50 m from the shore off the west side of the Hilo Pagoda property. Here, several above-water concrete structures dot the nearshore area, and a few subsurface concrete slabs occur (top left). Fishes aggregate around the submerged concrete slabs (top right). Small corals (*Poc. damicornis*) are uncommon (bottom left). A reef platform with sand channels is present off the east side of the Hilo Pagoda property (bottom right).

Hilo Pagoda (formerly Uncle Billy's) — Figure 7 presents representative photos of the nearshore bottom and biota off Hilo Pagoda. The shore is a narrow sand and basalt cobble beach. Offshore of the beach on the east side of the property, the seafloor is sand with scattered basalt rocks that host algal growth (*Hydrolithion* spp., *Amansia glomerata*, *G. salicornia*). Tide pools, of depths up to 1 m (3 ft) deep occur along the shore. Children were seen swimming and playing in the tide pools during our survey. Common biota of the littoral zone on basalt boulders are crustose coralline algae (*Hydrolithion* spp.), nerite or *pipipi* (*N. picea*), barnacles (*C. proteus* and *N. intertextus*), and urchins (*E. mathaei* and *E. oblonga*). Beyond the tide pools, a submerged basalt platform, interspersed with channels, occurs. Common fishes here include convict tang or *manini* (*A. triostegus*), Hawaiian sergeant (*A. abdominalis*), butterflyfishes (*C. lunula* and *C. auriga*) and goatfishes (*Mulloidichthys* spp.). Flagtails (*Kuhlia xenura*) and moorish idols (*Zanclus cornutus*) were also frequently observed in this area.

On the west side of the property, the seafloor off the narrow sand beach is a basalt bench extending seaward some 50 m (164 ft). Here, several above-water remnant concrete structures dot the nearshore area, and a few submerged concrete slabs occur (See Fig. 7). The bench and concrete structures host algal growth including *C. atennina, Amansia glomerata*, coralline algae (*Hydrolithion* spp.), and *Martensia fragilis*. Fishes (*A. triostegus, A. abdominalis, C. lunula, C. auriga*, and *Mulloidichthys* spp.) aggregate around these subsurface concrete slabs. Urchins (*E. mathaei, E. oblonga* and *Echinothrix calamaris*) and scattered corals (*M. capitata, Poc. damicornis, P. compressa*, and *Leptastrea bewickensis*) occur on the basalt bench. A single pearl oyster (*Pinctada margaritifera*) was observed.
