Archaeological Monitoring Report: Geotechnical Boring for the Proposed Thirty Meter Telescope (TMT) in the Astronomy Precinct of Mauna Kea

(TMK: 3-4-4-15:009)

Ka'ohē Ahupua'a
Hāmākua District
Island of Hawai'i

October 2013

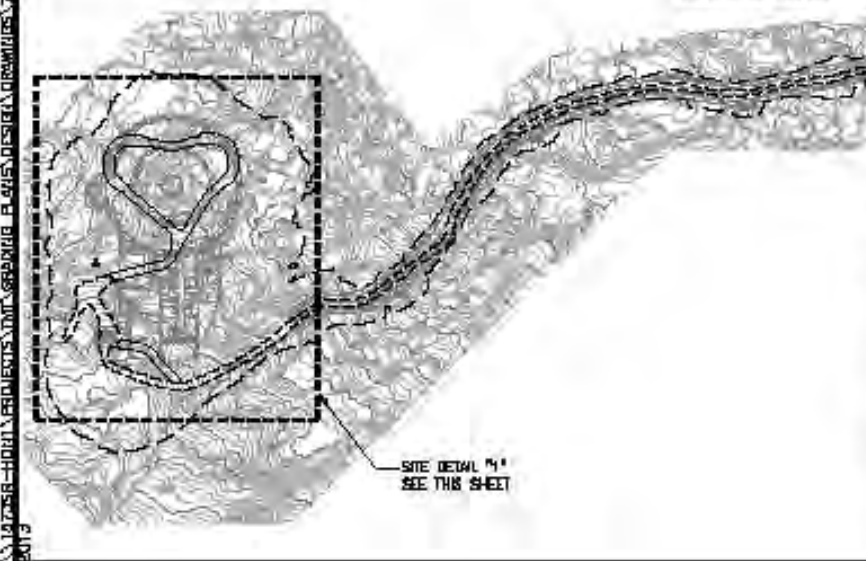
Figure 6. Map of Boring Locations and Road Work.

The project area is located within the Mauna Kea Science Reserve, in Area E of the Astronomy Precinct (see Figure 2). The Geotechnical Boring for this phase of construction for the TMT consisted of grading and improving an existing access road, as well as creating a new road extension, and drilling/auguring for the extraction of core samples and percolation testing. Sixteen holes were drilled/augured along the access road and within the footprint of the proposed TMT development area (Figure 6). Twelve of these holes (B-1, B-2, B-2b, B-3, B-3b, B-4, B-5, B-6, B-7, B-8, B-9, and B-10) were drilled in order to retrieve core samples, and four (P-1, P-2, P-3, and P-4) were augured for percolation testing. Additional testing that took place during this process included thermal resistivity and conductivity, and seismic refraction. The proposed TMT observatory location is at the northern end of an existing 4WD road. This road runs roughly north/south and provides access from the summit loop road to the proposed development area. The southern section of this access road runs along a portion of the northwestern edge of the defined Kukuahu‘ula TCP site (SIHP Site 21438). A Komatsu WA500 Loader and a Komatsu 275AX bulldozer were used to cut, grade, fill and generally improve the existing road in some areas (Figure 7 and 8). This was done to provide safe and easier access for the drill rig, water trucks, and other vehicular traffic to the site area. An extension to the road was also created in order to secure access to the boring locations within the proposed TMT observatory development area. This new road was cut roughly six meters wide with the Komatsu 275AX bulldozer, and formed a loop through the proposed TMT observatory area. No surface or subsurface cultural material was observed during this activity.

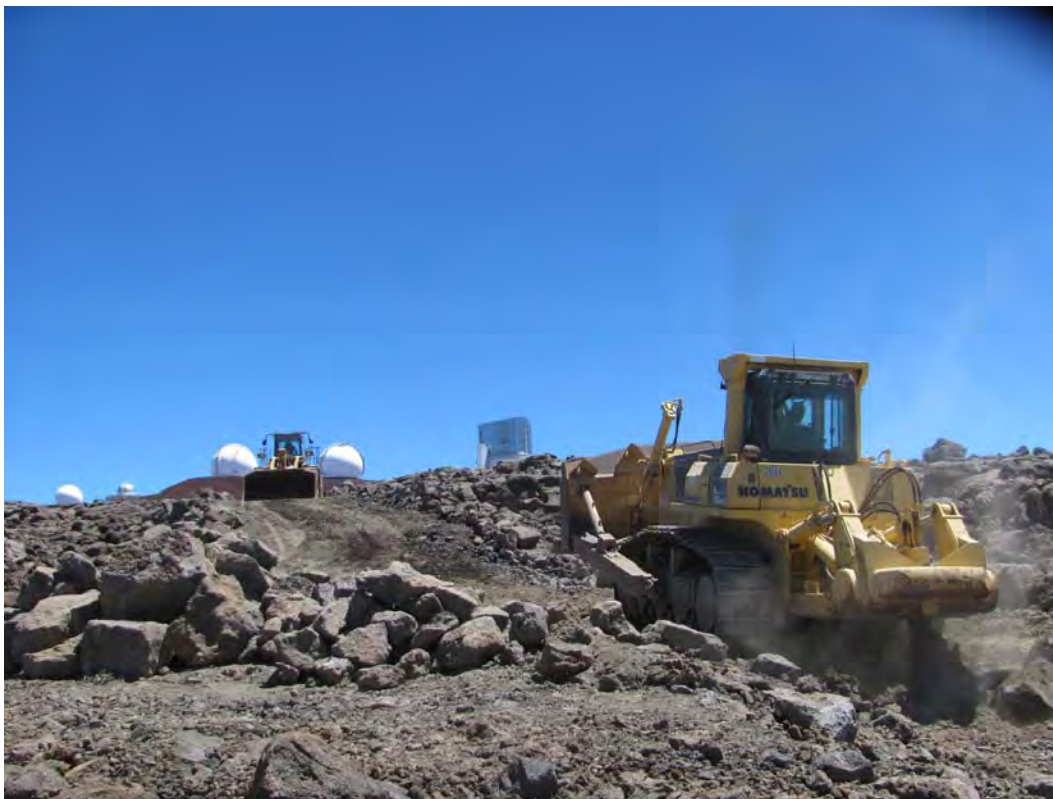
Figure 7. Komatsu 275AX bulldozer and Komatsu WA500 loader grading the existing 4WD road, note observatories in background.

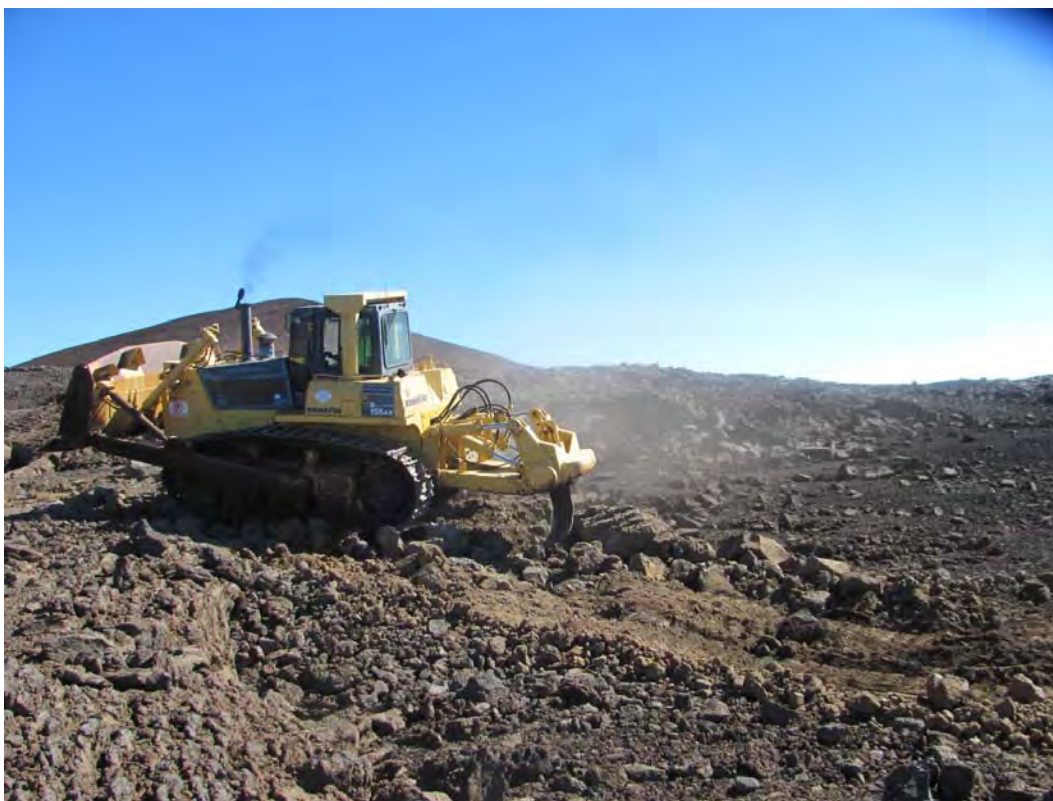
Figure 8. Komatsu 275AX bulldozer ripping existing 4WD road, Pu'u Pohaku in background.

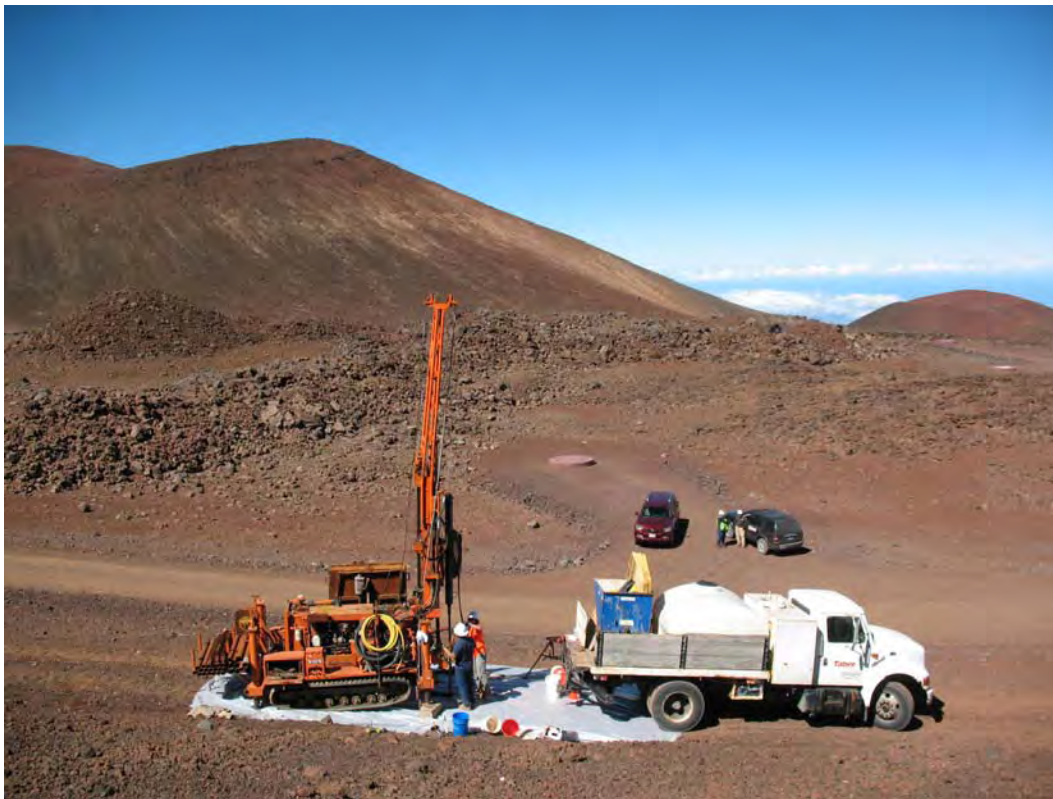
Boring activities began on September 4, 2013 and continued intermittently until October 18, 2013. Taber Drilling (working as a subcontractor under URS) used a limited access CME 55 HD crawler drill rig mounted on rubber tracks (Figure 9) to drill and auger the holes. The drilling depths for the core sampling ranged from 10 feet to 80 feet. Two samples (B-8, and B-9) were taken along the access road, while the remaining samples (B-1 to B-7 and B-10) were located within the footprint of the proposed TMT observatory development area (see Figure 6). The individual depths of B-1 to B-10 are listed in Table 1. During the drilling process an auger (Figure 10) was used in areas of looser material (mainly consisting of clinkers and cinder); and in areas of more compact rock, a standard diamond bit core barrel was utilized. The core samples were extracted and packaged in roughly 5 foot sections (Figure 11). Five of the bore holes (B-6, B-2, B-2b, B-3, and B-3b) had grouted PVC casings inserted for the seismic refraction testing. The four percolation test holes were each augured to a depth of 2.5 feet (Figure 12). No cultural material was observed during the drilling/auguring activities.

Figure 9. CME 55 HD crawler drill rig.

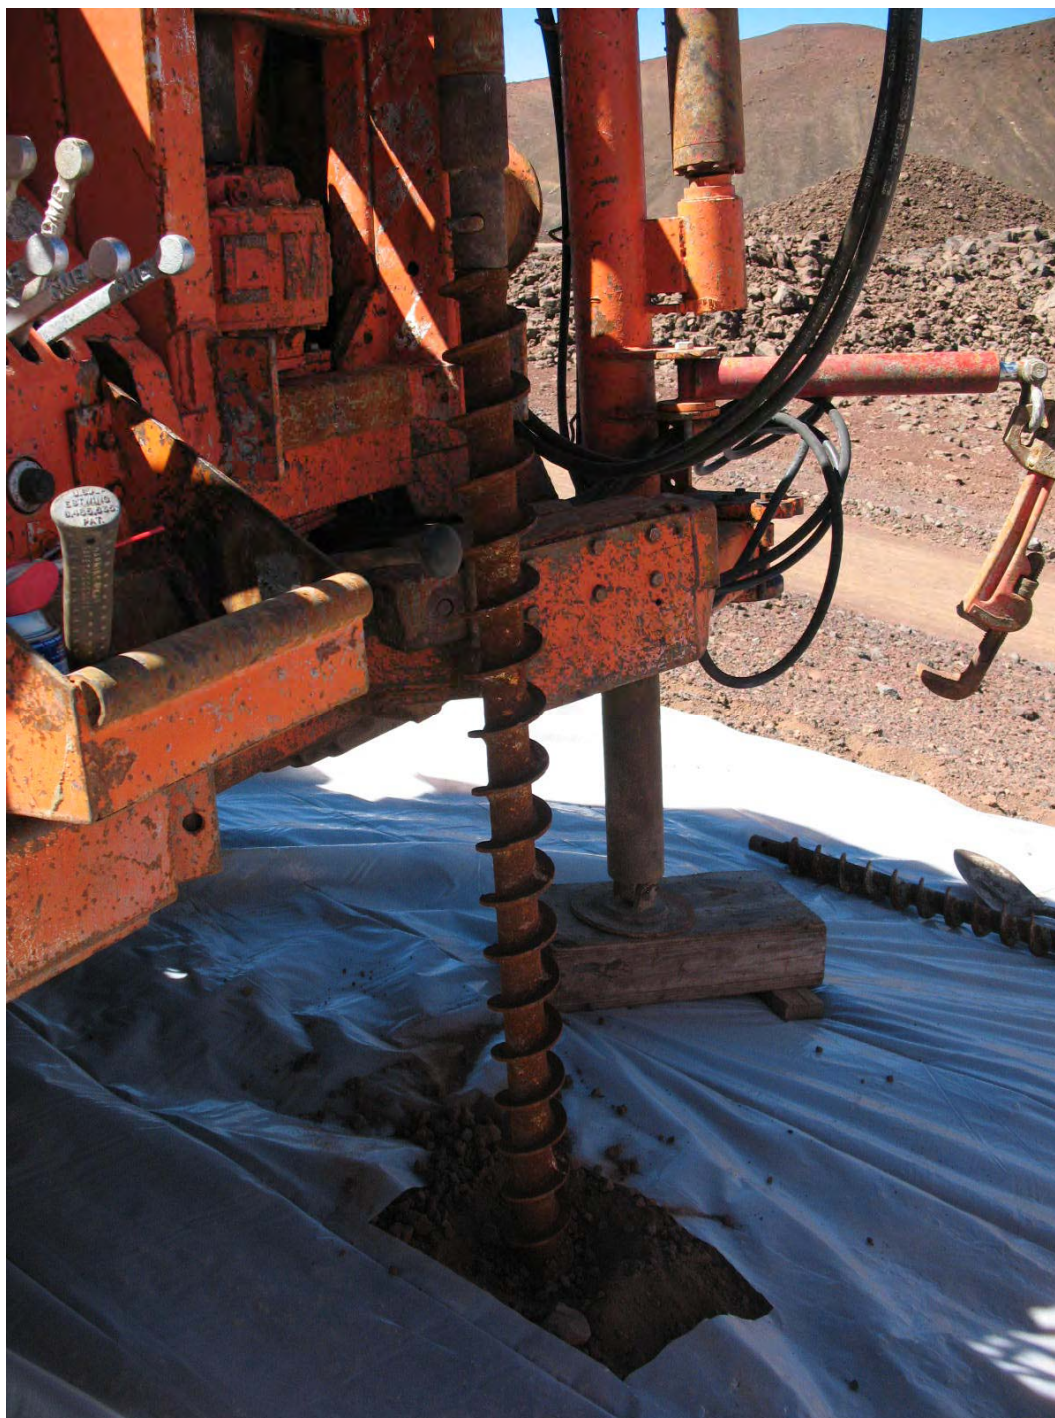
Figure 10. Auger being used at B-9.

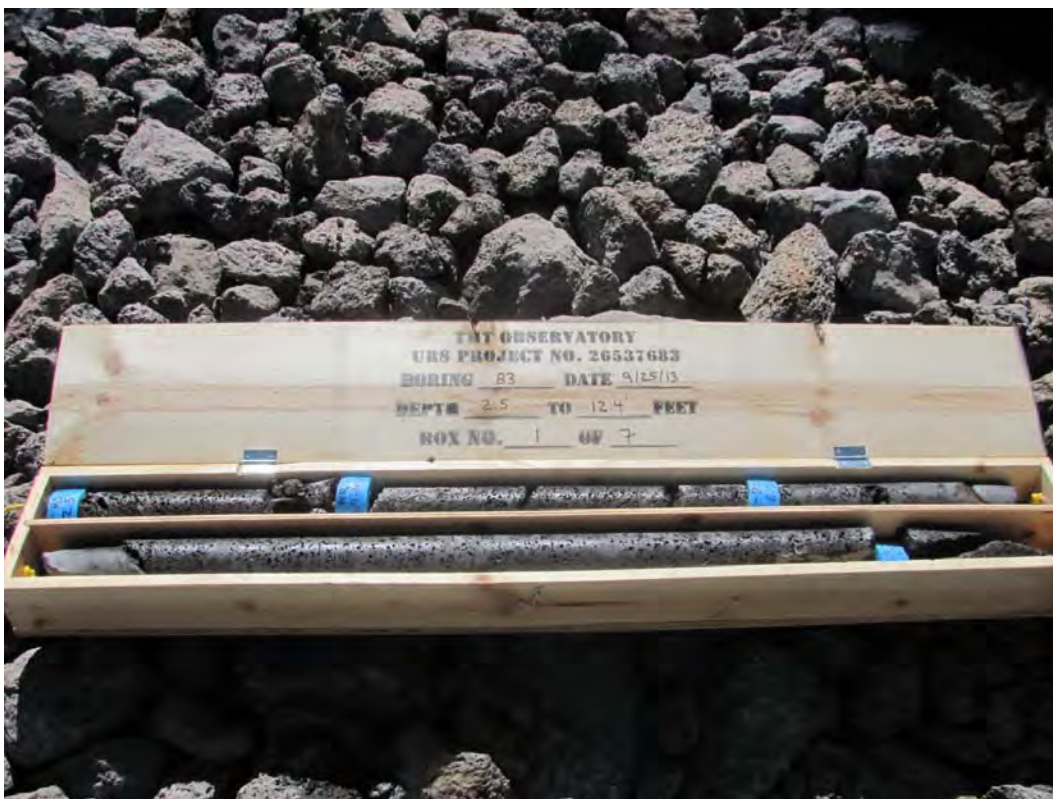
Figure 11. Core sample box from B-3.

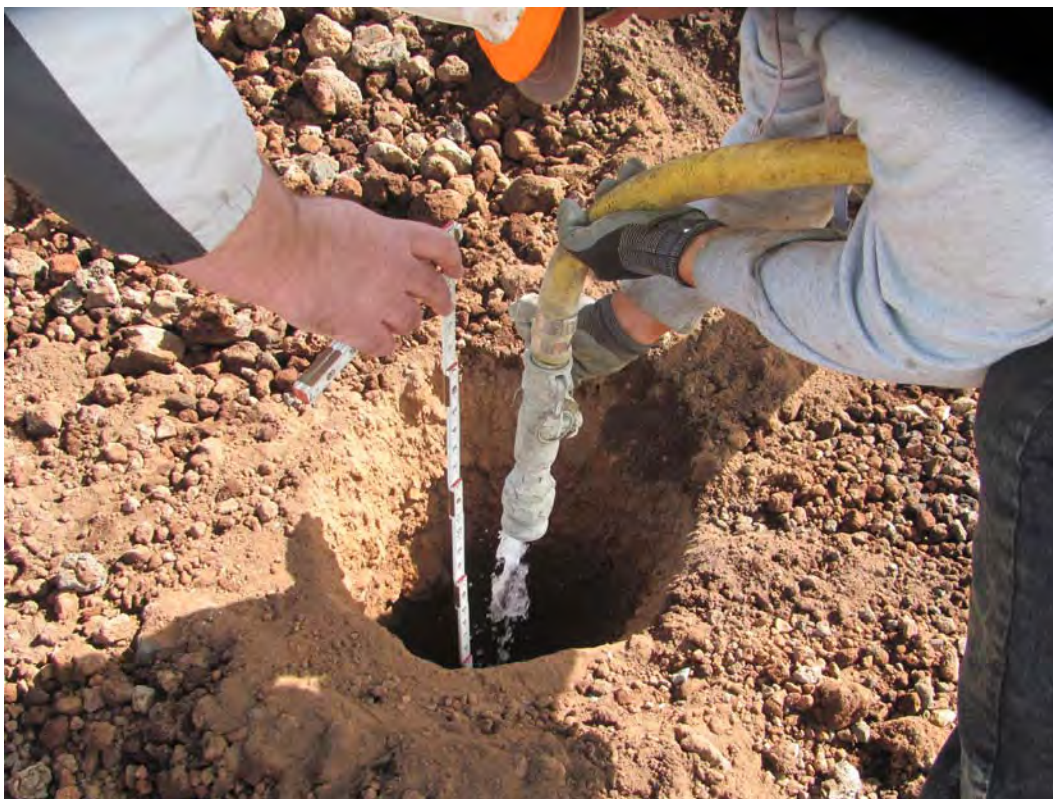
Figure 12. Percolation testing.

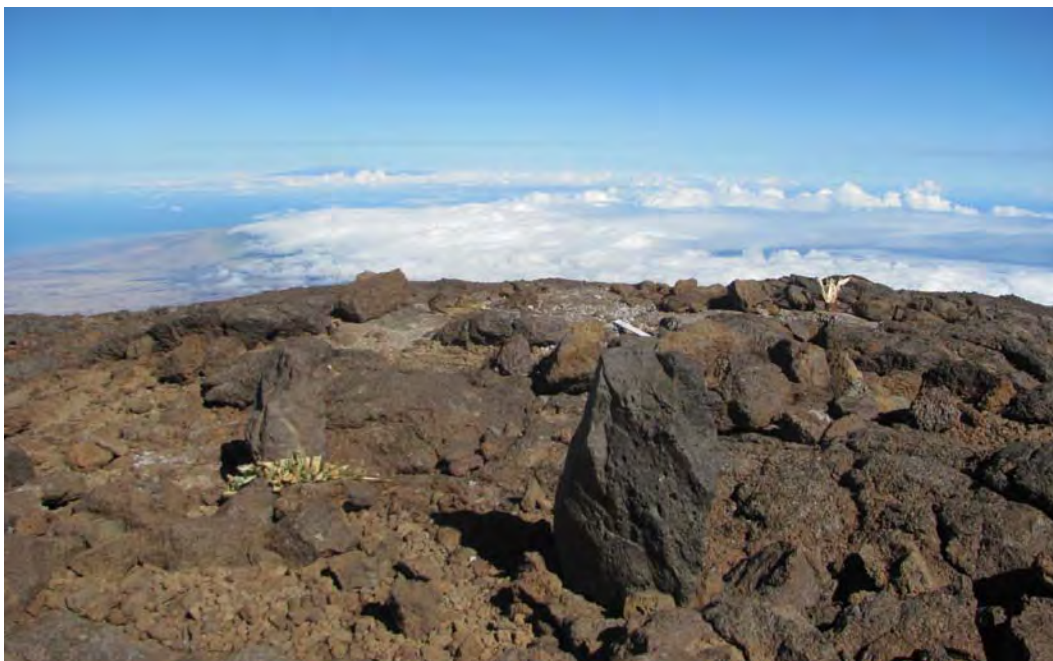
Although no historic properties were observed during the monitoring of the geotechnical test activities described in this report, there were a few instances of “new” construction (Find Spots) and modern cultural items placed in the work area. These included the erection of two small upright boulders and placement of a ti leaf bracelet at the northern outlying boundary of the TMT observatory development area (Figure 13), the placement of a second braided ti leaf bracelet by the drill rig while located at B-3b (Figure 14), and a the placement of a bouquet of *‘ohelo* at the northern end of the access roadway. The two uprights were later dislodged by OMKM staff.

Figure 13. Newly placed upright boulders and ti leaf bracelet at the northern boundary of the TMT area.

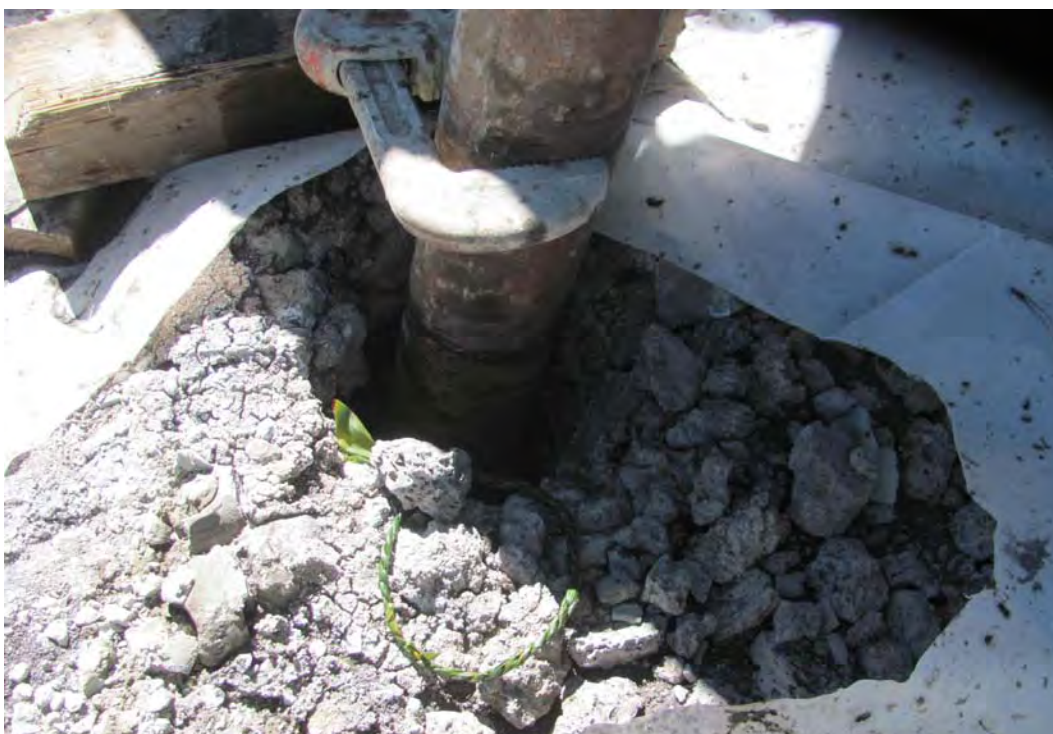
Figure 14. Ti leaf bracelet placed at B-3b.

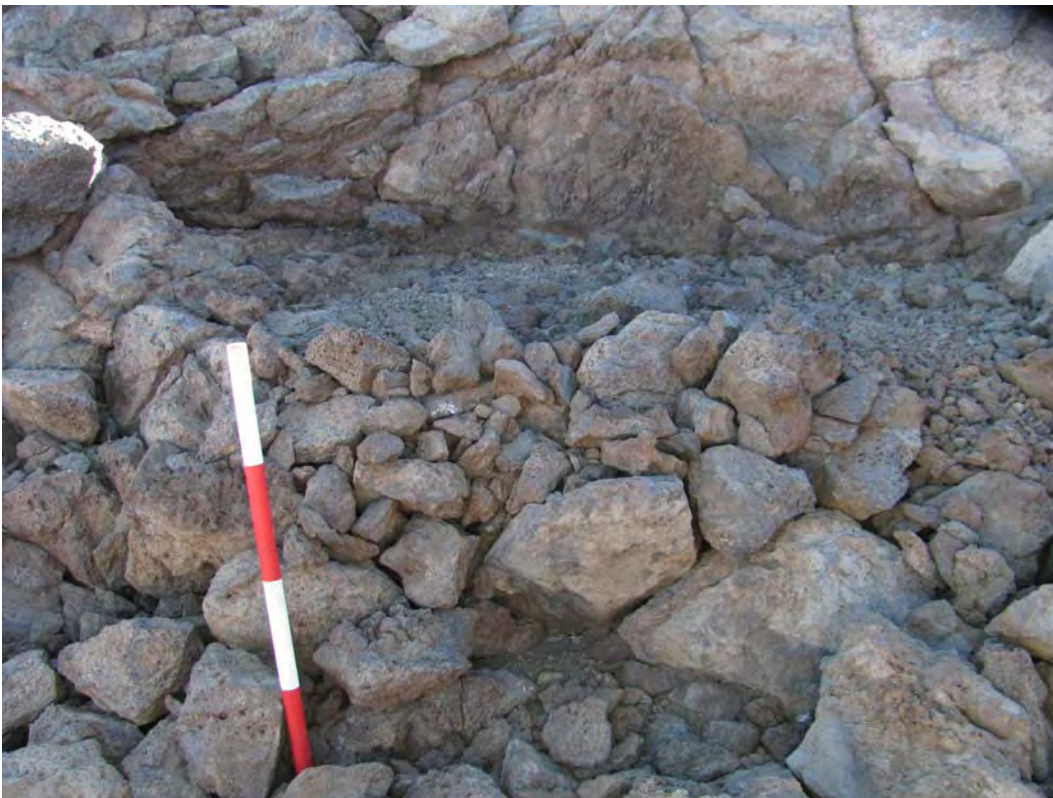
Worthy of note and a brief discussion are a series of natural geological features that number in the hundreds if not thousands within the general TMT development area. These features have variously been called “gelifluction terraces,” “solifluction terraces,” “stone-banked gelifluction lobes,” and “stone nets or polygonbodens” (Davies 1972; Embleton and King 1975; Washburn 1956, 1979, Gregory and Wentworth 1937). One such natural feature was recorded in 2005 as a possible archaeological site and designated SIHP Site 21449, but was later subject to subsurface testing that indicated the feature was completely natural (McCoy et al. 2010). As McCoy et al. reported, “[e]xcavation of Site 21449 (a terrace) in 2008 did not recover any cultural remains and the terrace is now thought to be a natural gelifluction terrace” (2010:6-1). These terraces have the appearance of constructed features (Figure 15) in various shapes and sizes, and can be observed widely throughout the area. Gregory and Wentworth (1937) described a process whereby terraced features (“stone nets”) form in a periglacial environment through the slow downslope movement of water-saturated sediment as part of a recurrent freezing and thawing cycle (a phenomenon that still occurs daily on the summit terrain of Mauna Kea). This process (gelifluction) involves the transport and sorting of localized ground material, creating a pattern of banks/retaining walls of larger rock material with associated leveled interiors consisting of trickled down sediment and smaller rock and gravel material (Huddart and Stott 2010).

Figure 15. Example of natural stone-banked gelifluction terrace.
