# Waikiki Beach, Oahu, Hawaii: History of its transformation from a natural to an urban shore

Robert L. Wiegel

## ABSTRACT

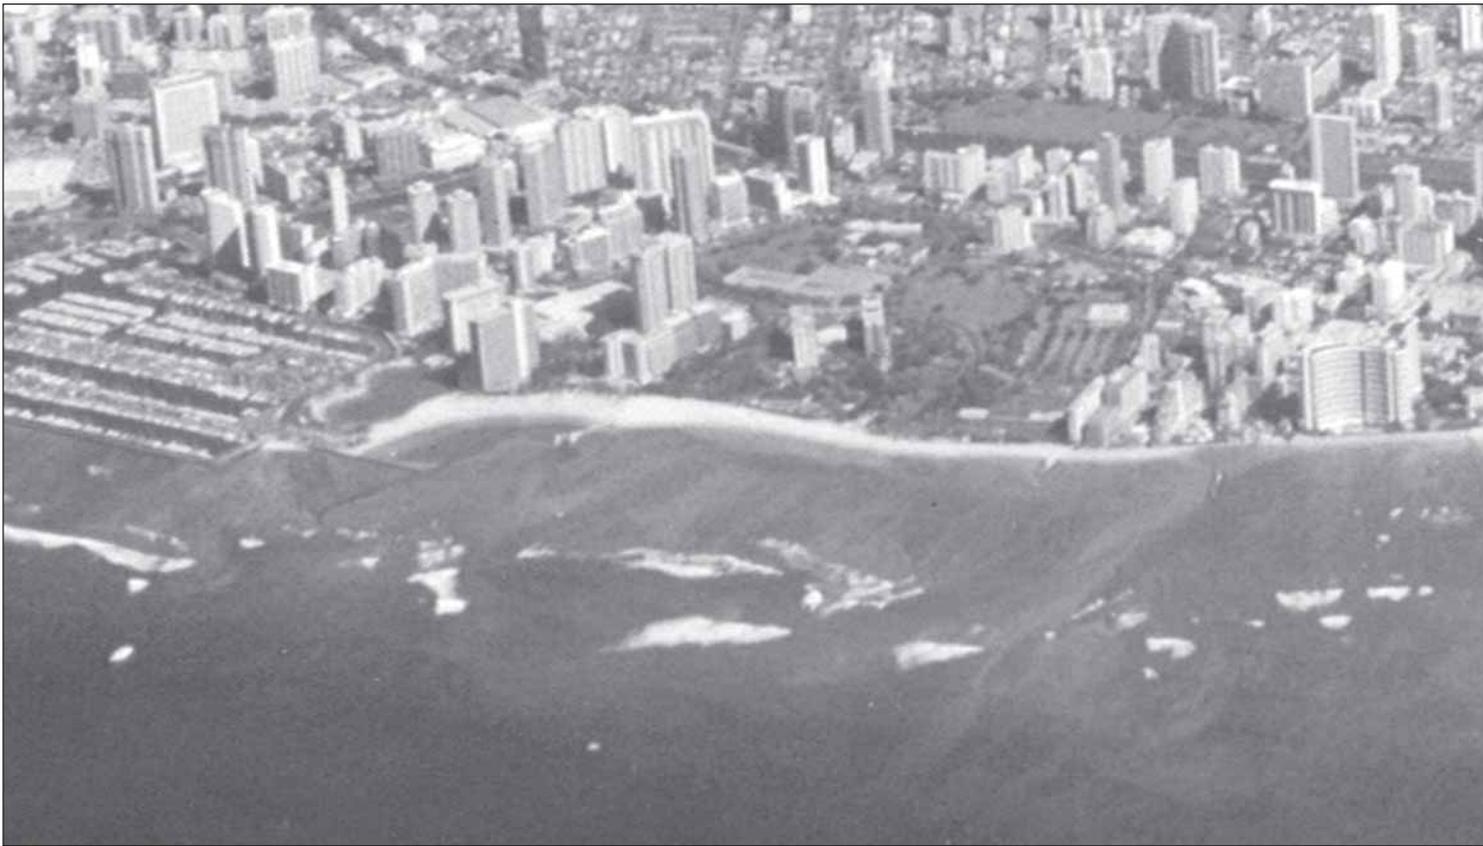
**Figure 1. Waikiki Beach,, Oahu, Hawaii. Aerial photo, 24 January 1998; between Ala Wai Yacht Harbor (left) and Sans Souci (Kaimana) Beach (right). (By R.L. Wiegel, #8878.)**

Figure 1 is a 1998 aerial photo of most of the extended Waikiki Beach. The section between Ala Wai Yacht Harbor is on the left, and Sans Souci (Kaimana) Beach is on the right. Figure 5 is a photo look-

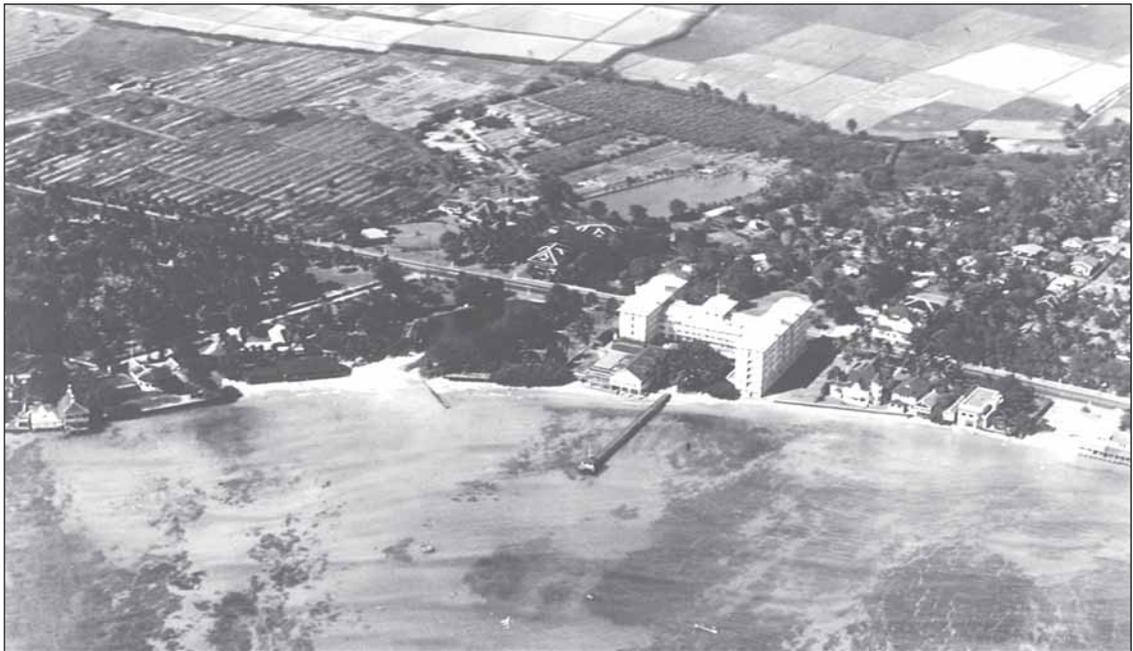
**Figure 2.**  
**Waikiki, Oahu,**  
**Hawaii. Aerial**  
**photo, 9**  
**September 1920,**  
**looking**  
**landward over**  
**shore; taro**  
**patches, rice**  
**paddies.**  
**Apuakehau**  
**Stream mouth**  
**(almost closed**  
**by beach sand),**  
**Moana Hotel**  
**and pier in**  
**center. (U.S.**  
**Army Museum**  
**of Hawaii,**  
**USAMH No.**  
**1716.)**

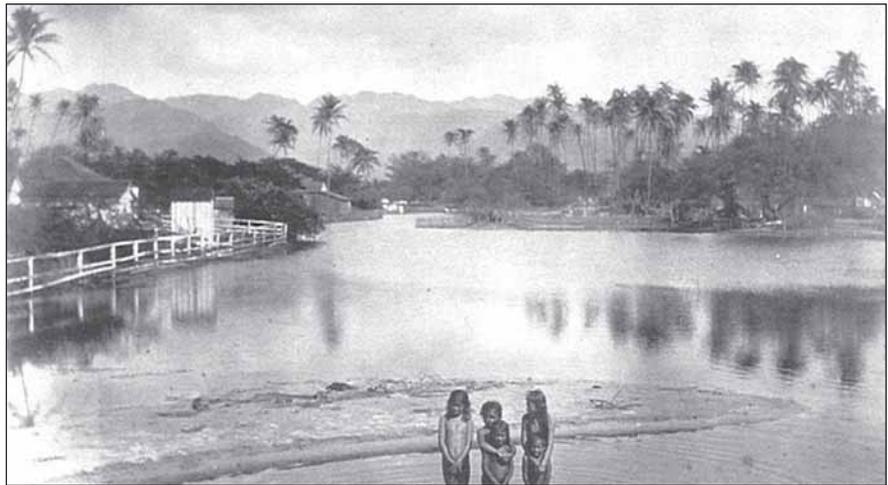
**Figure 3a (above).** Ku'eikaunahi Stream, looking inland from mouth, 1886. (A. Mitchell, Bishop Museum, Neg. No. CP 56428.)

**Figure 3b (below).** Historic postcard, circa 1912, Apuakehau Stream to left of Moana Hotel and pier; note stream mouth closed. (Island Curio Co., Jas. Steiner, Honolulu.)

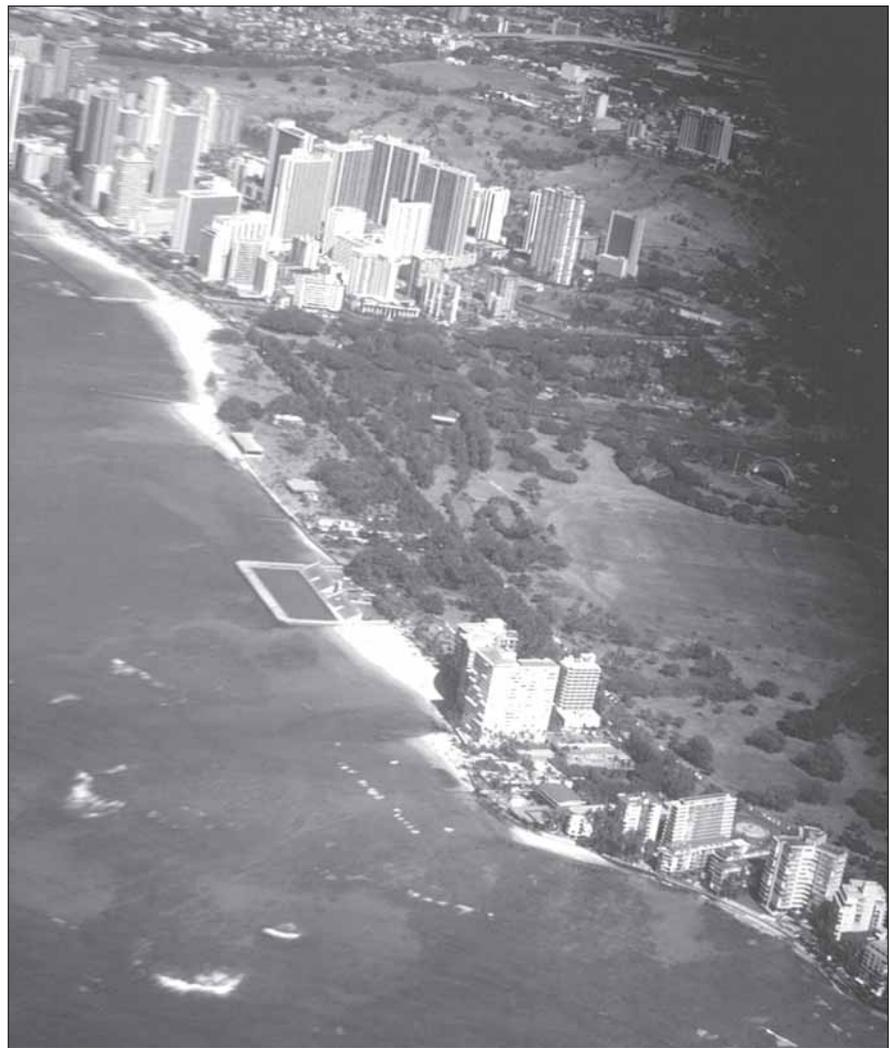
**Figure 6. Waikiki Beach; aerial photo from offshore Diamond Head, 16 January 1986: Elks Club and Outrigger Canoe Club (at bottom of photo), Sans Souci (Kaimana) Beach, Natatorium, Kapiolani Park, Queen’s Surf Beach, and Kuhio Beach (top). (By R.L. Wiegel, #5581.)**

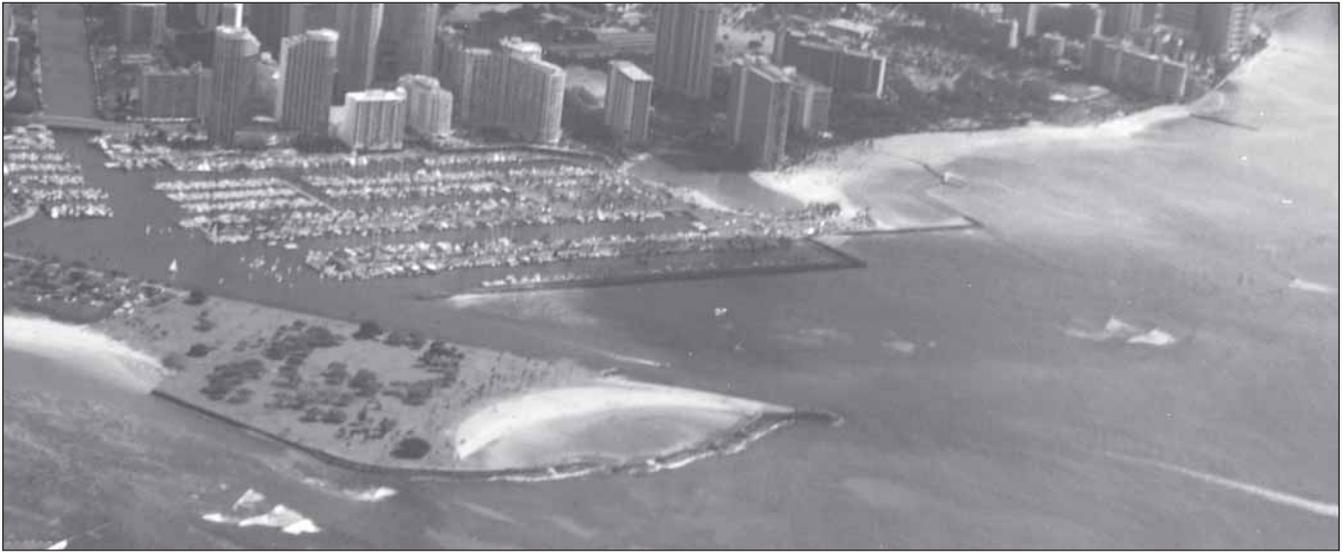
**Figure 7. Magic Island (Aina Moana), Ala Wai Canal entrance channel, Ala Wai Yacht Harbor, Duke Kahanamoku Beach and Lagoon, Fort DeRussy Beach. Aerial photo, 30 January 1999. (By R.L. Wiegel, #9523.)**

Figure 7 is an aerial photo from 1999 of Magic Island (Aina Moana) at the left, Ala Wai Canal entrance channel and Ala Wai Yacht Harbor at left center, Duke Kahanamoku Beach and Lagoon and Fort DeRussy Beach at top right and center right. Figure 8 is an aerial photo from 1998 of Kewalo Basin at the left side, Ala Moana Beach Park and dredged channel in front of the beach at the center, and the west side of Magic Island (Aina Moana) at the top right.

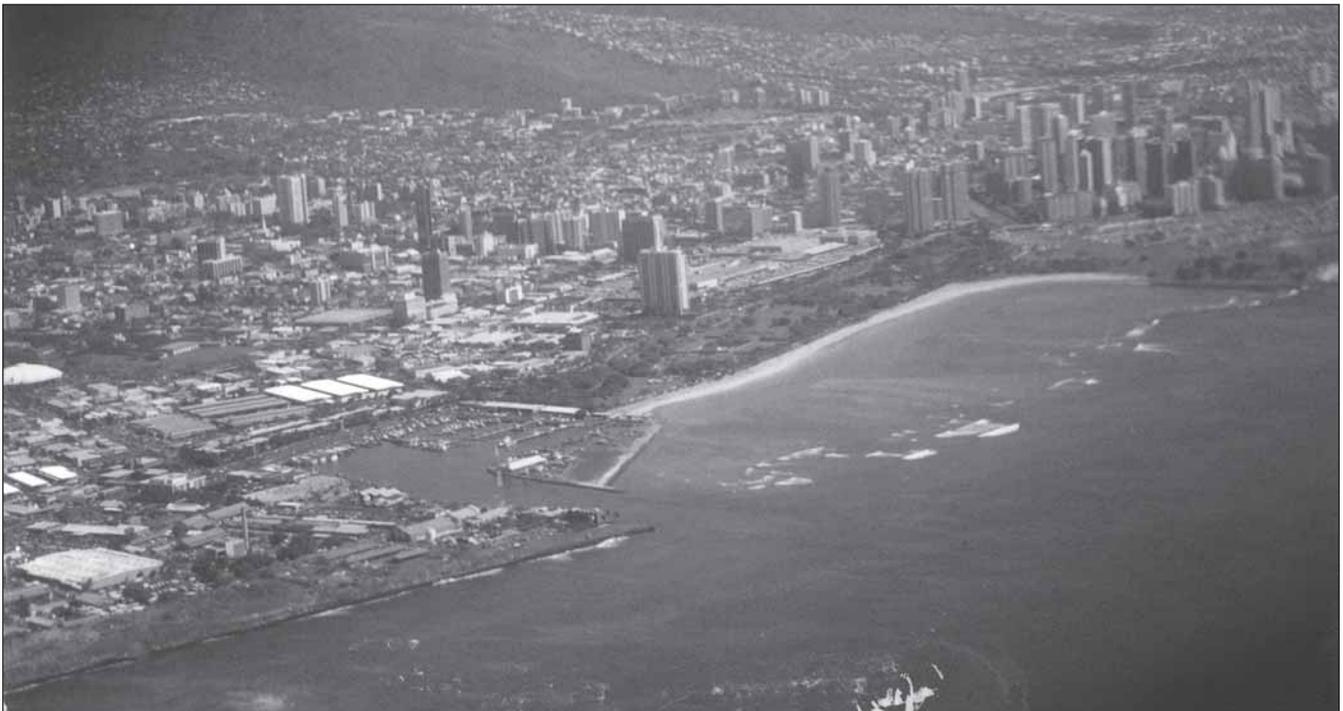
**Figure 8. Kewalo Basin, Ala Moana Beach Park, Magic Island (Aina Moana); aerial photo, 19 January 1988. Note dredged channel in front of the man-made beach. (By R.L. Wiegel, #6354.)**

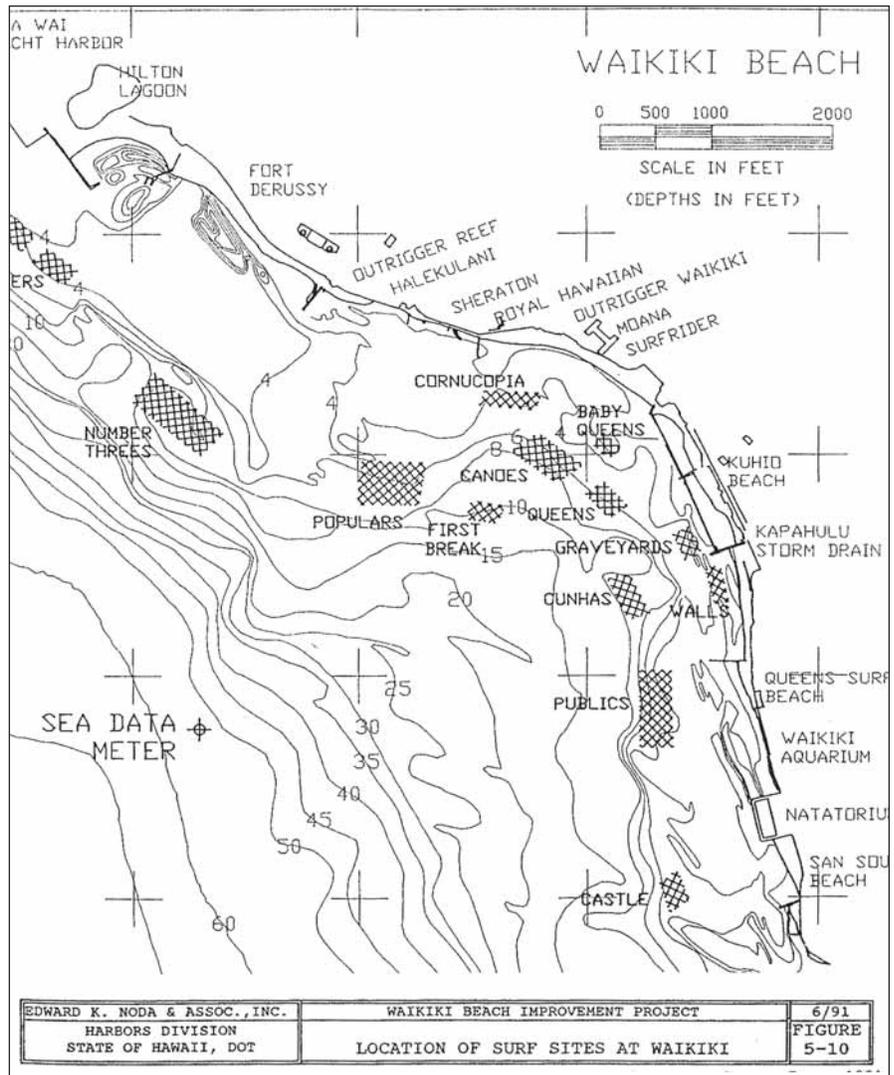
Figure 9. Locations of surf sites at Waikiki. (From Edward K. Noda & Associates Inc., July 1991.)

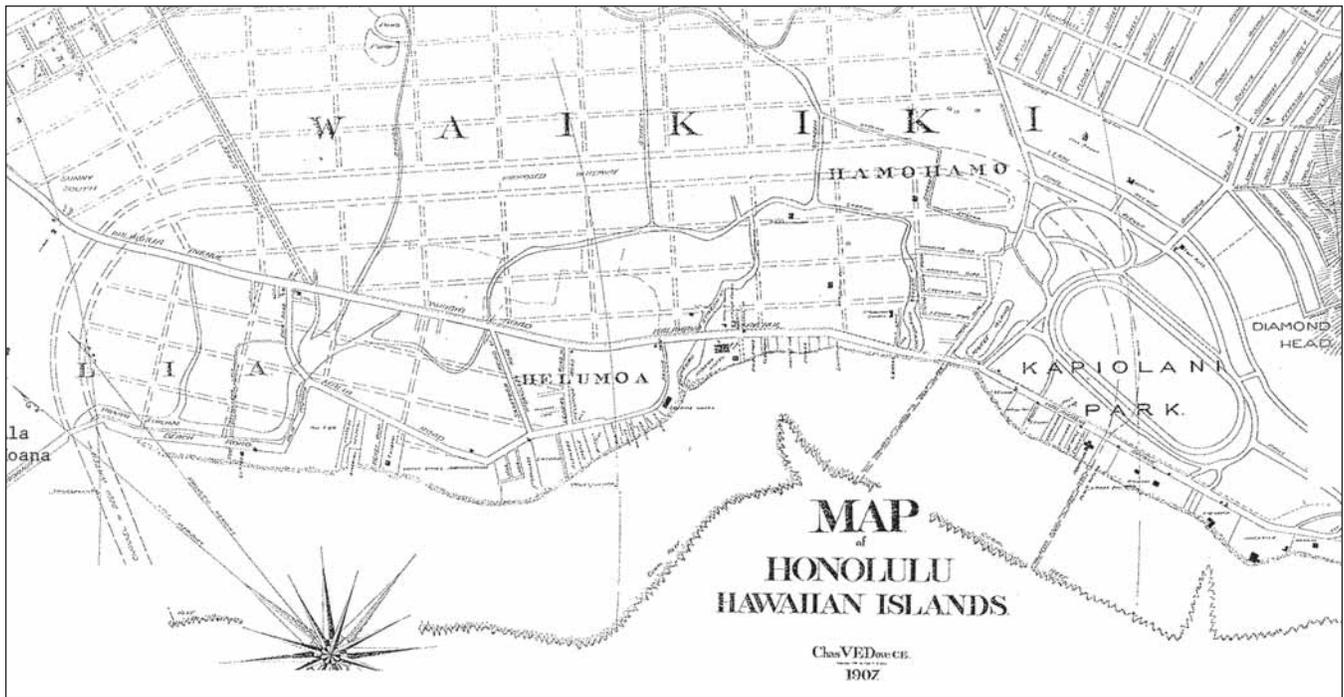
Figure 10. 1907 Map of Waikiki (Chas. V.E. Dove).

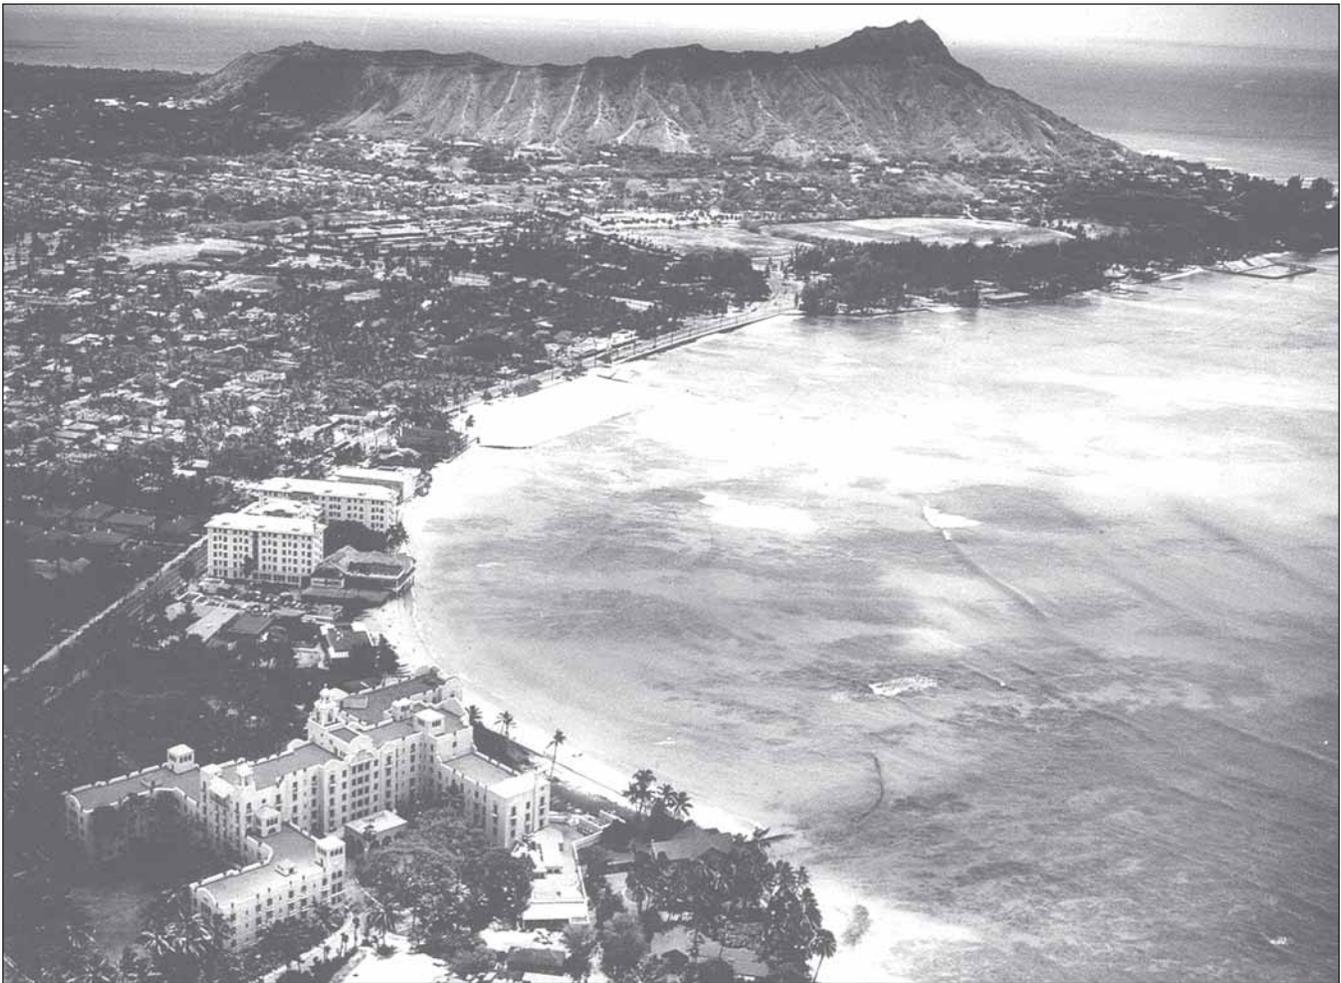
**Figure 11. Aerial photo, circa 1940, looking toward Diamond Head; Royal Hawaiian-Moana Hotels Beach (curved groin near bottom); Kuhio Beach; “crib wall” breakwater; seawall along section of Kalakaua Ave.; Natatorium in distance at top right. (By Anon.)**

Vegetation grows rapidly in this climate, and the bare sand beach was naturally narrow. The beach was encroached upon by people building homes, other structures, and landscaping, Figure 11. The postcard photo (circa 1910) shown

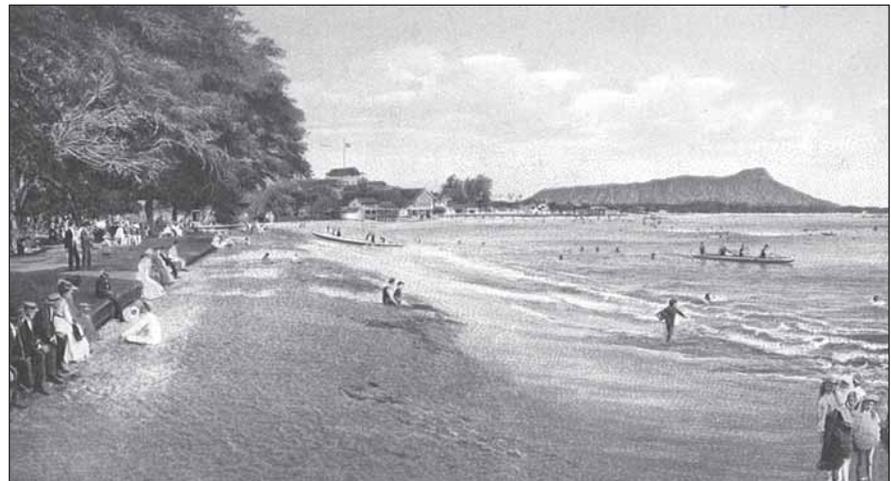
**Figure 12. Seaside Hotel, seawall, beach, circa 1910; postcard (Anon., 1910).**

in Figure 12, is of the Seaside Hotel (opened in 1906), its lawn and seawall, and a narrow beach. This was at the site of the present Royal Hawaiian Hotel. Historic photos of buildings and seawalls are in the Bishop Museum Photo Collection, and in the books by Hibbard and Franzen (1986), Brown (1985), and Grant (1996).

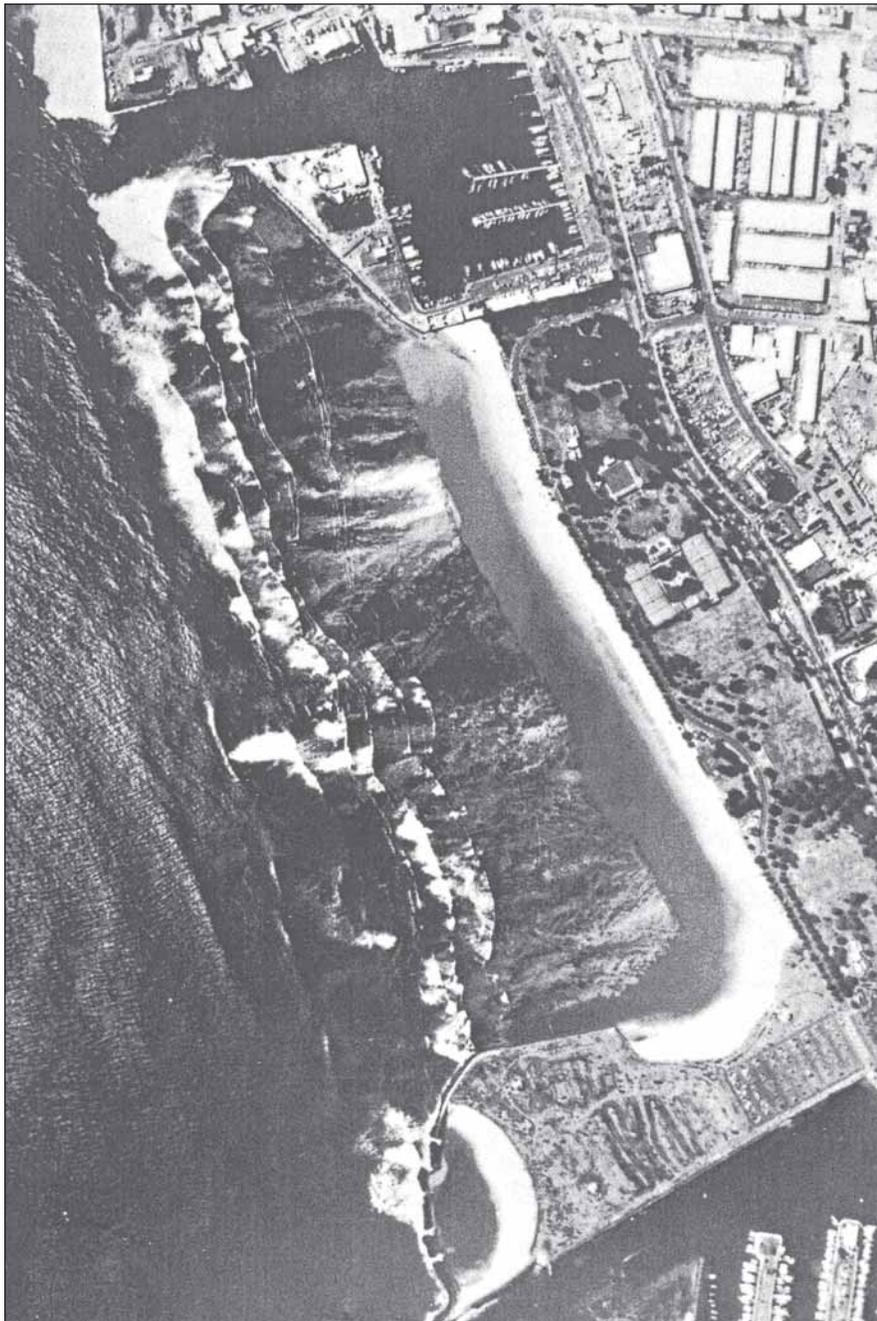
**Figure 13. Ala Moana Reef, Kewalo Basin, Ala Moana Beach Park, Magic Island (Aina Moana), Ala Wai Yacht Harbor/Canal entrance; dredged channels, aerial photo. (From Gerritsen, March 1981, p. 215.)**

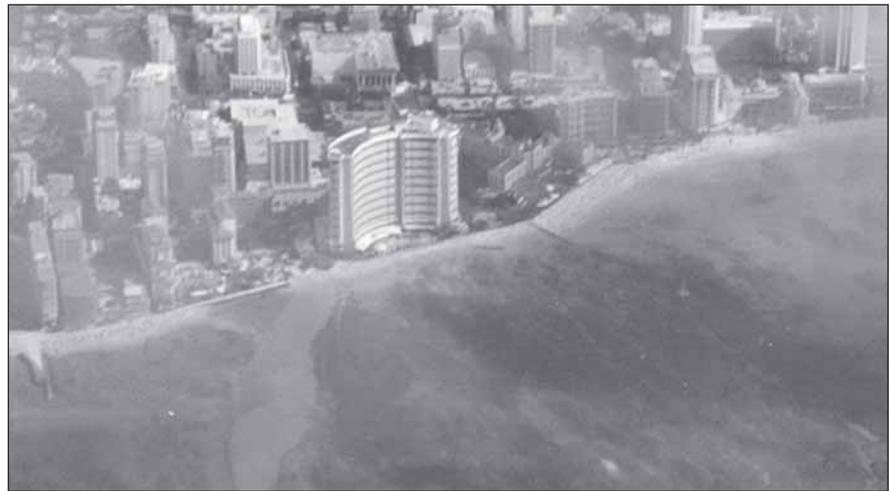
**Figure 14.** Halekulani, Sheraton Waikiki, Royal Hawaiian (and long curved groin), Moana Surfrider, Moana Hotels; Halekulani "sand channel" at left; aerial photo, cloudy, 30 January 1999. (By R.L. Wiegel, #9524.)

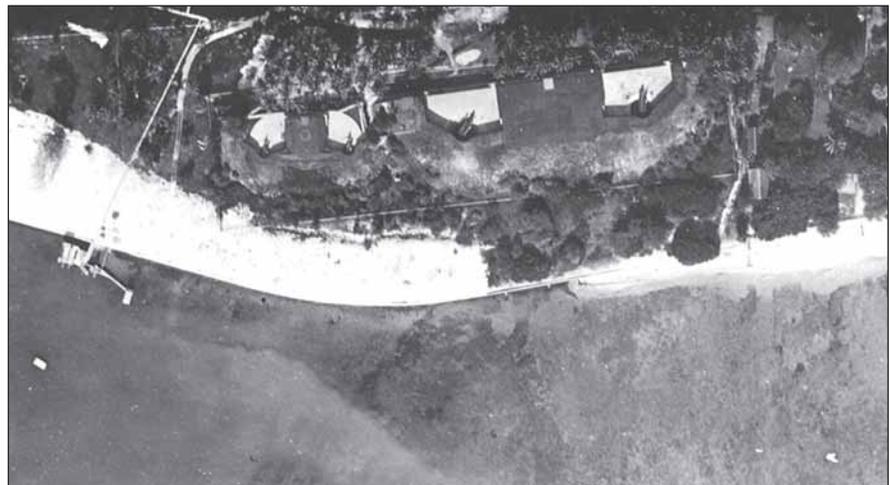
**Figure 15.** Vertical aerial photo of Fort DeRussy, 21 November 1919; narrow channel dredged in reef connecting to dredged channel in front of new beach. Note diving tower at left. (U.S. Army Museum of Hawaii, USAMH No. 2078.)

aerial photos of Figures 15 (1919) and 19 (1932). The channel had become a swimming basin.

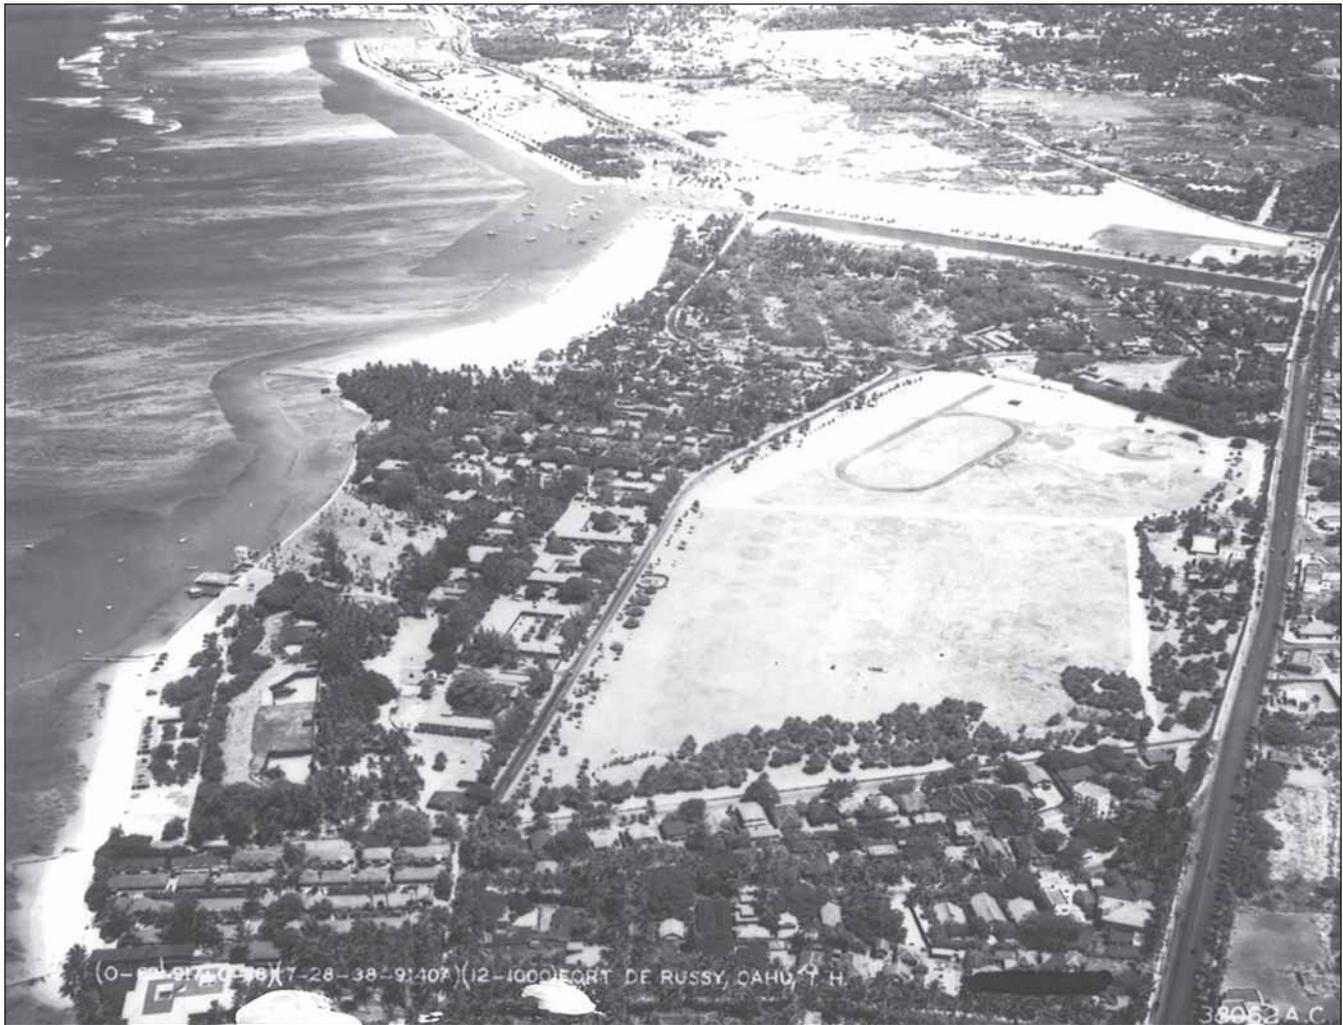
**Figure 16. Oblique aerial photo of Fort DeRussy, Ala Wai Yacht Harbor, Ala Moana Beach Park, 28 July 1938, Dredged channels parallel to shore are evident. (U.S. Army Museum of Hawaii, USAMH No. 2789.)**

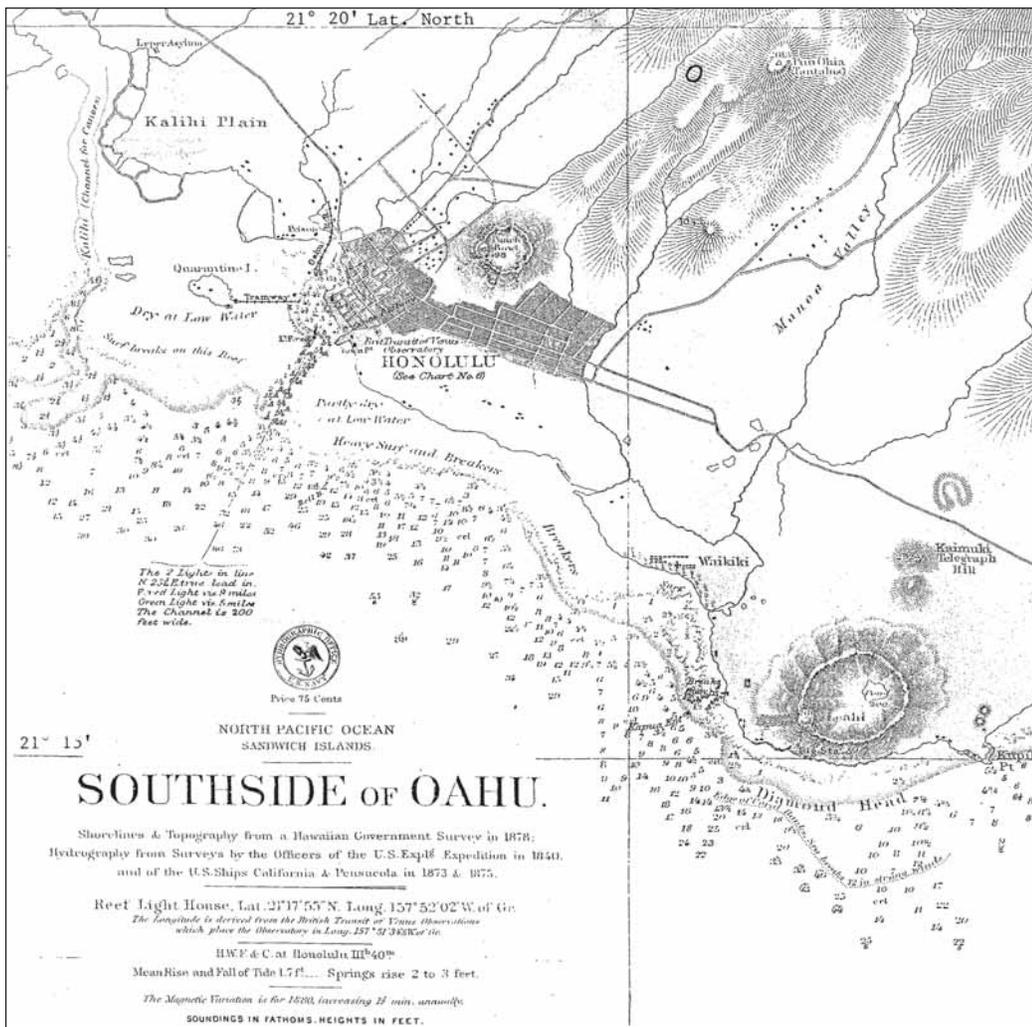
**Figure 17. Southside of Oahu, Sandwich Islands, North Pacific Ocean, 1880. (U.S. Navy Hydrographic Office, No. 867; hydrography from survey in 1840, 1873 and 1875; courtesy Survey Division, State of Hawaii.)**

Kapua Entrance is a natural channel through the reef that extends nearly to shore here. It is shown on the 1880 chart of the U.S. Navy Hydrographic Office, Figure 17. [Historic note. The first submarine communication cable between San Francisco and Honolulu was brought ashore through the Kapua Entrance (Channel) on 28 December 1902; Clark (1977) says remnants of the old submarine cable can still be found in this channel.] On 23 June 2002, Orville T. Magoon observed the bottom in this channel, using a face mask. He took underwater photos, and one of them showed two cables (2" to 3" in diameter) on the "dead" coral rubble or hard bottom, but the cables were buried at some places. Copies of several of his photos are in

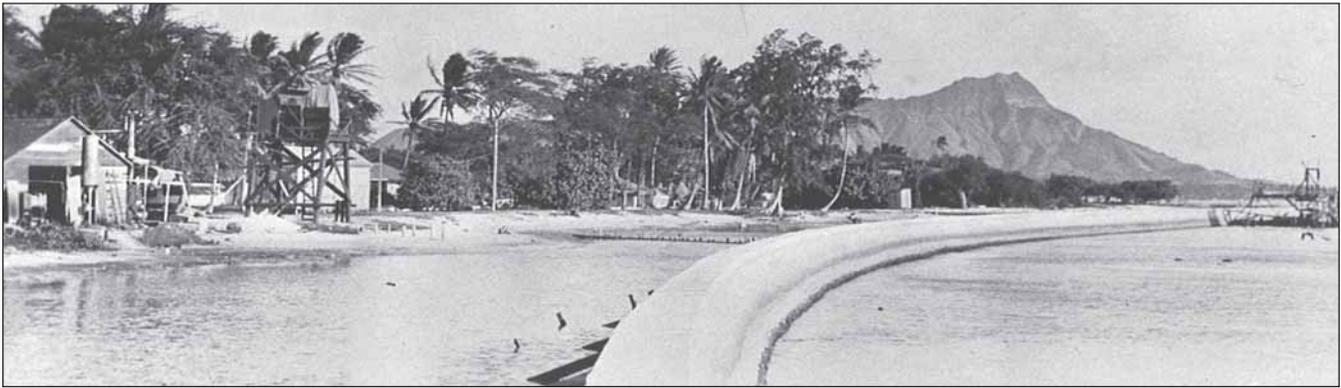
**Figure 18. Looking along “new” seawall at Fort DeRussy, toward Diamond Head, circa 1916. Note seawater inland of seawall. (U.S. Army Museum of Hawaii, USAMH No. 4582.)**

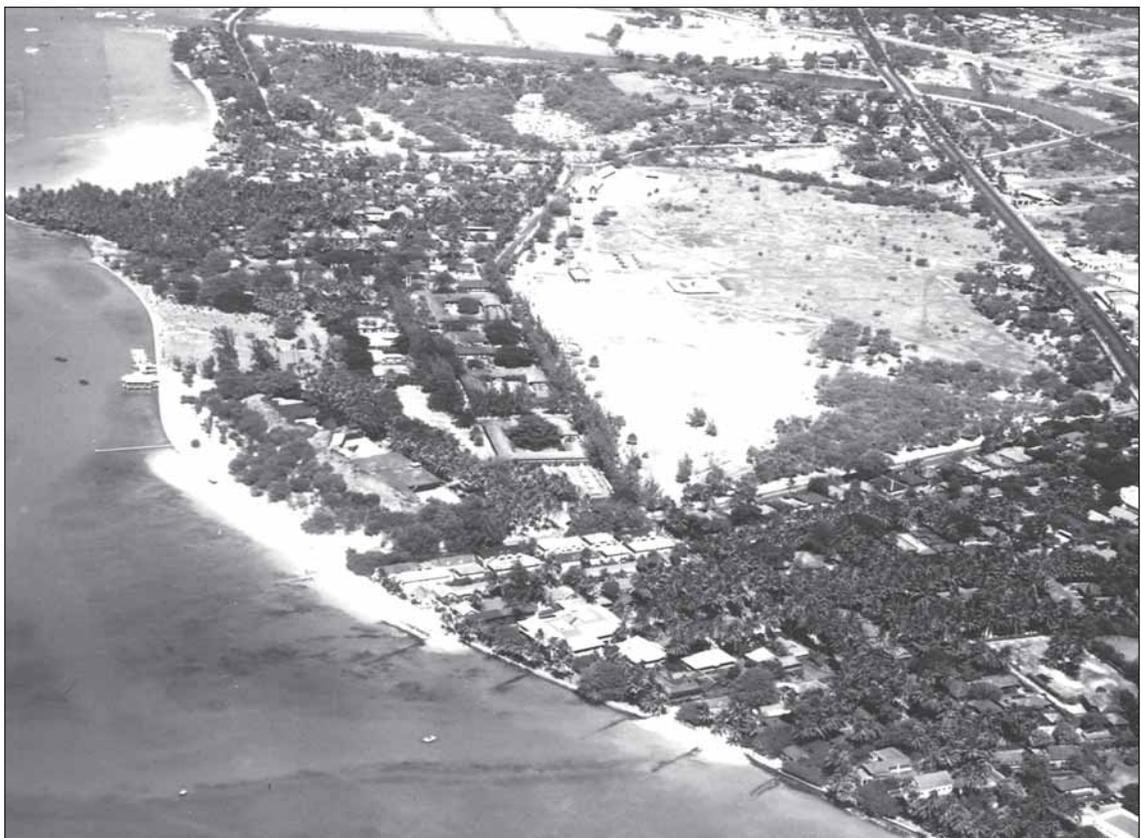
**Figure 19. Oblique aerial photo, looking from west boundary of Royal Hawaiian Hotel to Fort DeRussy, Cassidy’s Point, and Ala Wai Canal entrance (at upper left), 2 November 1932. (U.S. Army Museum of Hawaii, USAMH No. 2788.)**

Groins were built in this reach, which can be seen in the 1932 aerial photo, Figure 19. When Crane inspected them in 1972, all but one had completely deteriorated or were buried, or nothing remained. The short “YWCA groin” was in reasonable condition, owing to repairs; it is a short distance east of the Fort DeRussy storm drain/groin. A long box culvert/groin at the easterly end of Fort

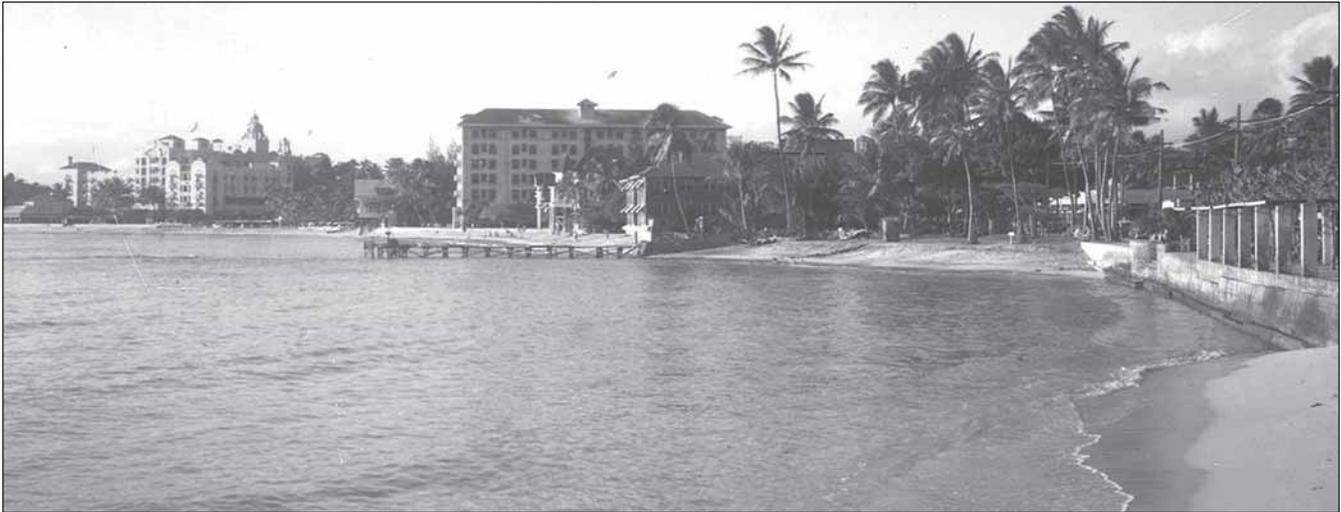
**Figure 20a. Kuhio Beach, 20 May 1939, prior to construction of crib wall breakwater and placement of sand fill. (Courtesy USACE Beach Erosion Board.)**

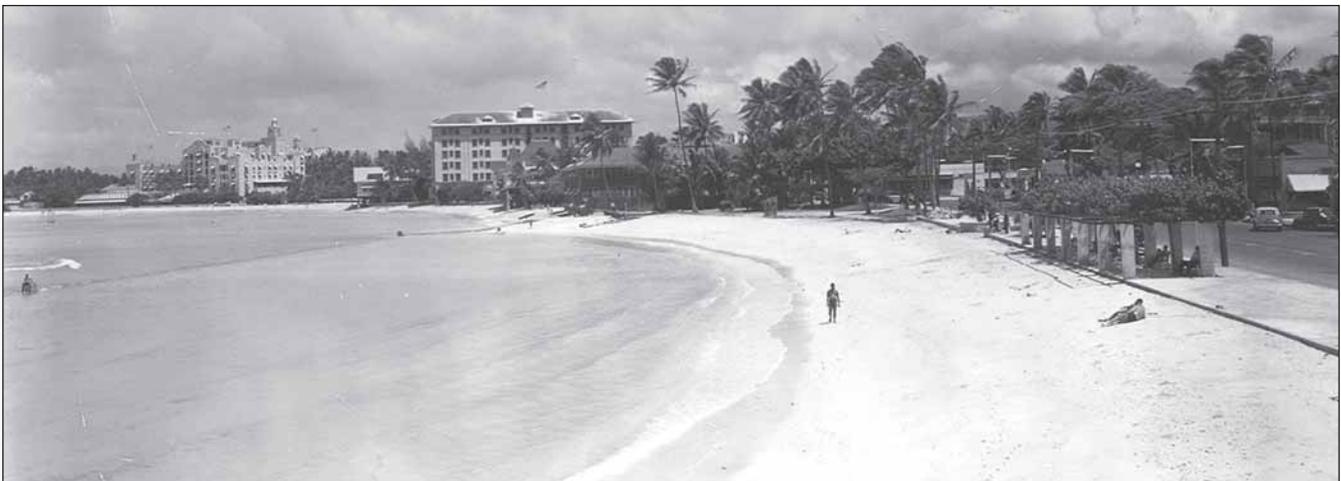
**Figure 20b. Kuhio Beach, 1939, after construction of crib wall breakwater and placement of sand fill. (Courtesy USACE Beach Erosion Board.)**

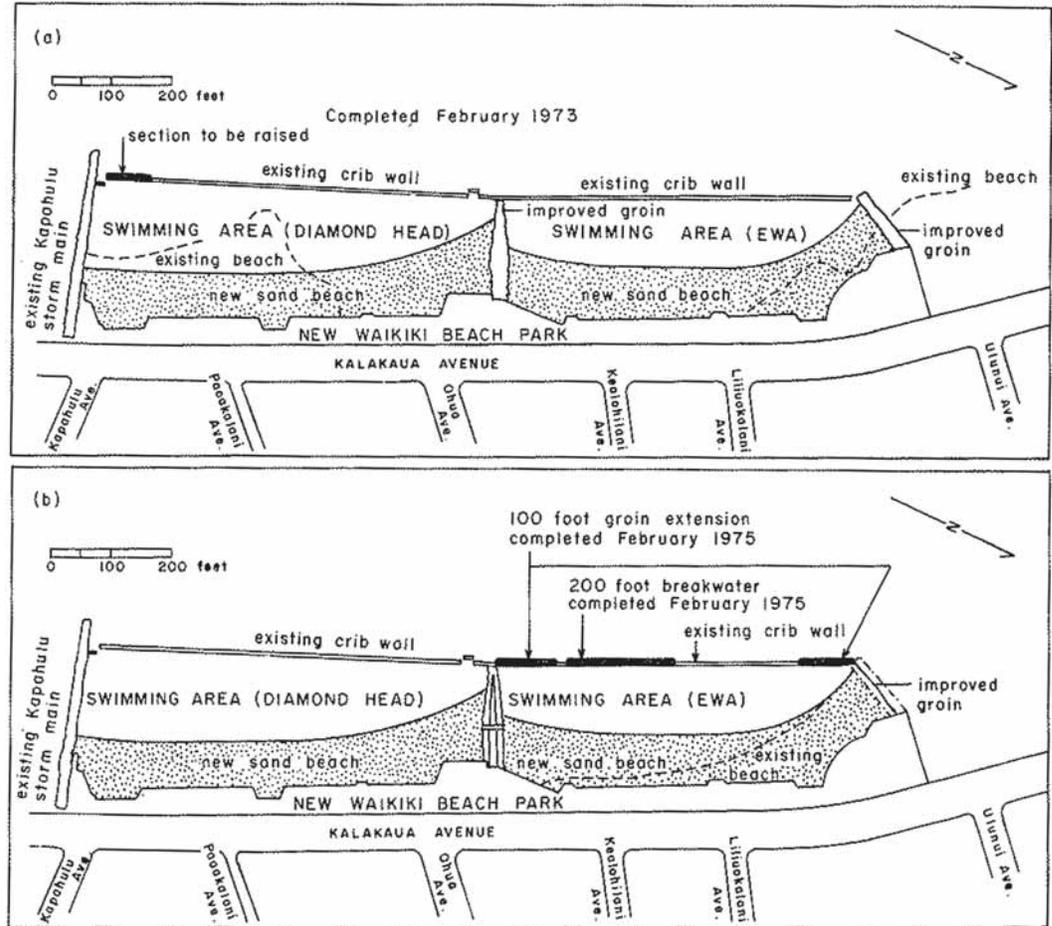
Figure 21 a,b. Kuhio Beach improvement plans: (a) 1973 and (b) 1975. (From Gerritsen, 1978, p. 29.)

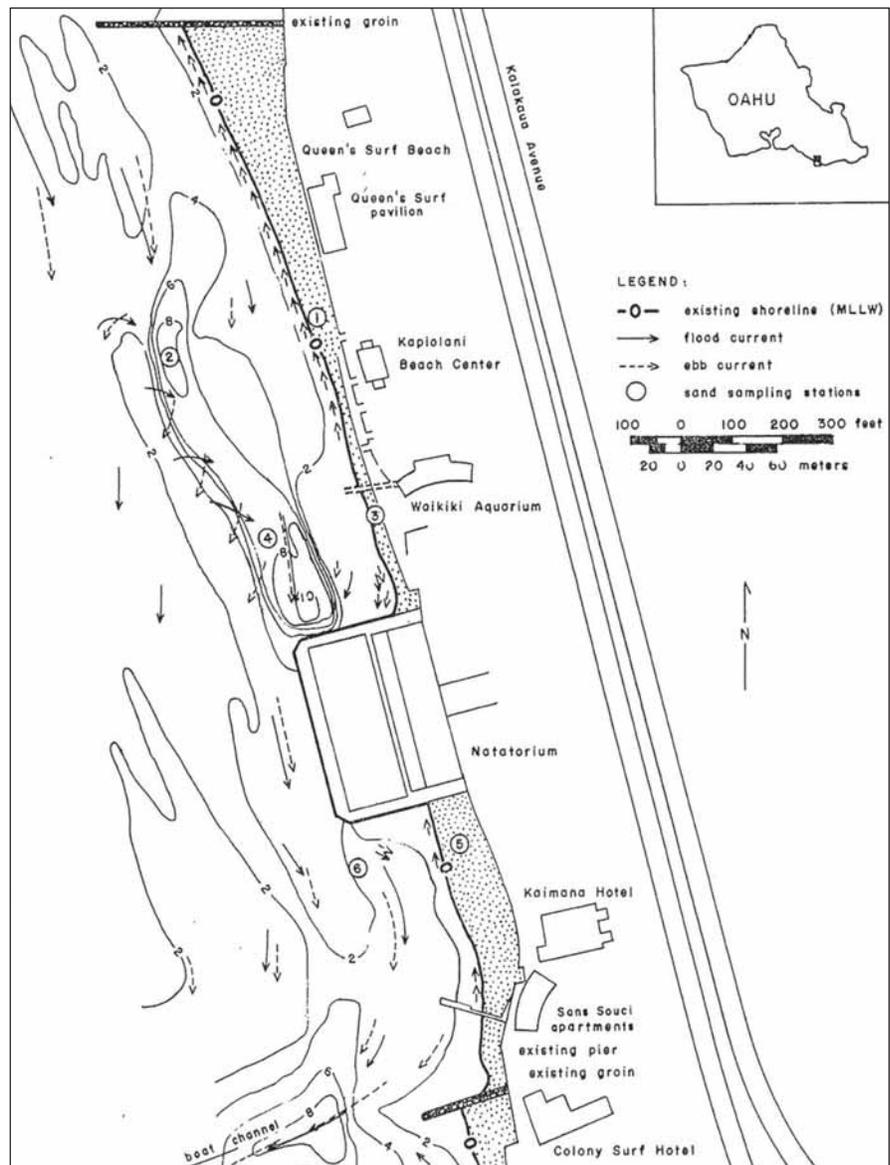
**Figure 22. Ebb and flood current patterns around the Natatorium, and bathymetry; Queen’s Surf Beach/Kapiolani Park Beach, and Sans Souci (Kaimana) Beach. (From Gerritsen, 1978, p. 45.)**

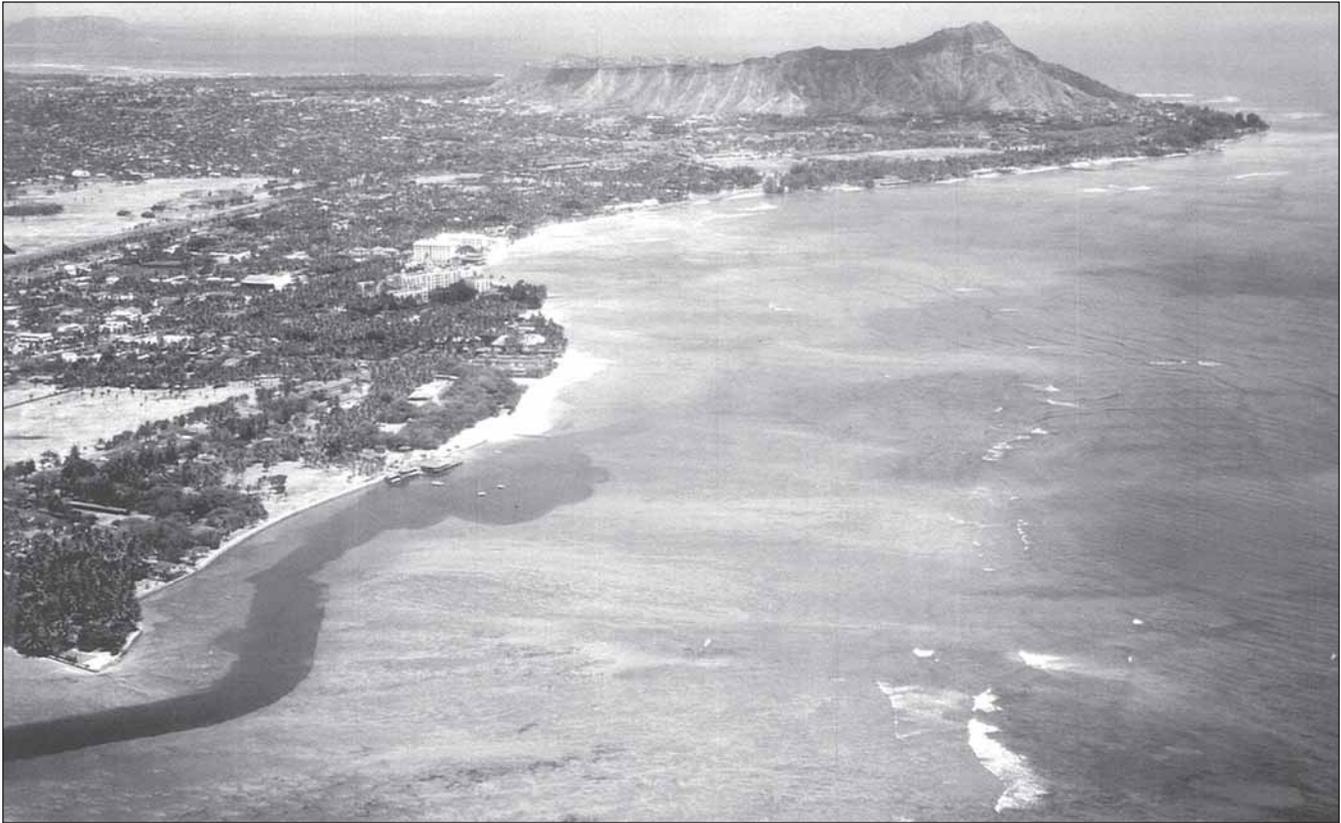
**Figure 23. Aerial photo looking toward Diamond Head, 1946; Cassidy's Point, lower left and Fort DeRussy, 1946. Note dredged channel in front of Fort DeRussy. (From Isaacs, 1946.)**

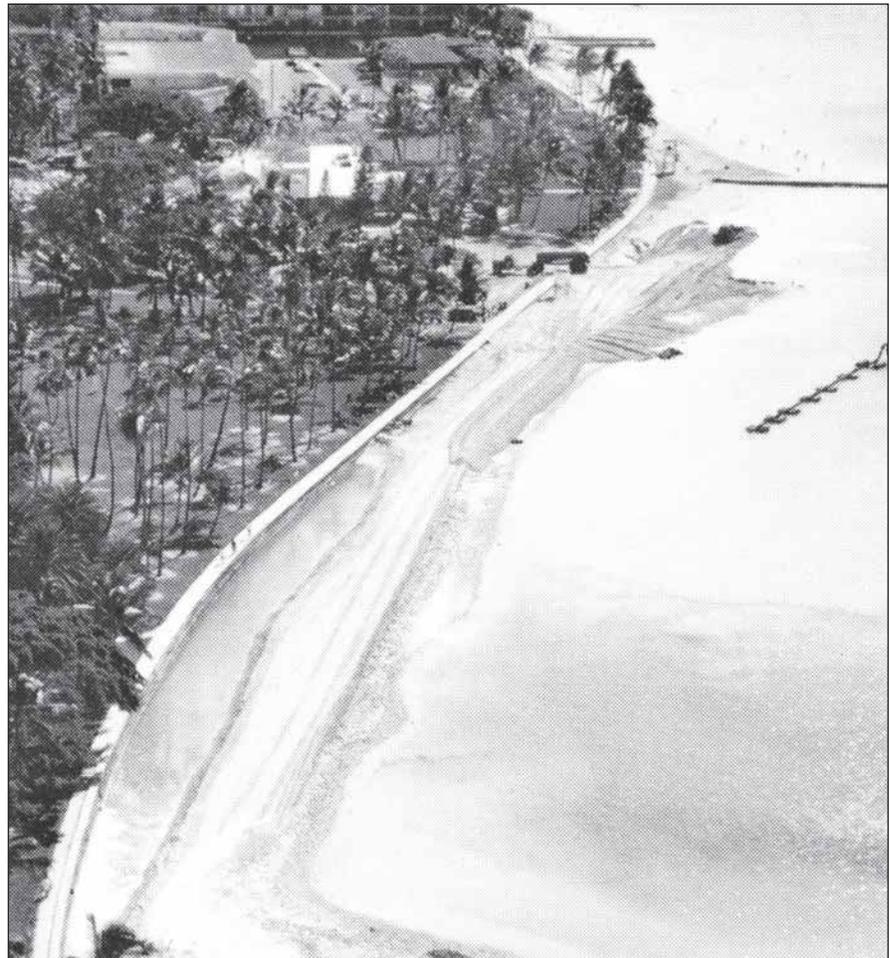
**Figure 24. Fort DeRussy Beach; restoring sand beach, 1970 aerial photo; box culvert/groin near top (From Thompson, 1985, p. 259.)**

The early work at Fort DeRussy has been described in a previous section. In 1957 "one severe storm caused the beach to virtually disappear" (USACE, Honolulu District 5 May 1975). A postcard of an aerial photo of Fort DeRussy, circa 1967 (Dexter Press), shows four groins with evidence of alongshore transport of sand towards "Diamond Head." According to Crane (1972) the groins were removed in 1970. In 1969 a beach construction project was authorized, which was done in 1970. This beach was built in front of the seawall. An aerial photo of the work underway is in Figure 24. The box culvert and groin, which was

built in 1917 at the easterly boundary, can be seen at the top center. The beach, about 1,800 feet long, was made with about 82,000 cubic yards of dredged coral material and concrete debris. Unwashed crushed coral sand was used to cover the fill (Thompson 1985). During construction Waikiki was subject to high winds and waves by a storm on 13-14 January 1970; but there was no damage to the beach or to construction equipment (Yoshimoto 1970).
