Category II General Application Small-Scale Beach Nourishment Projects (SSBN)

STATE OF HAWAII
DEPARTMENT OF LAND AND NATURAL RESOURCES

PROJECT NAME: Kauai Kailani Beach Restoration

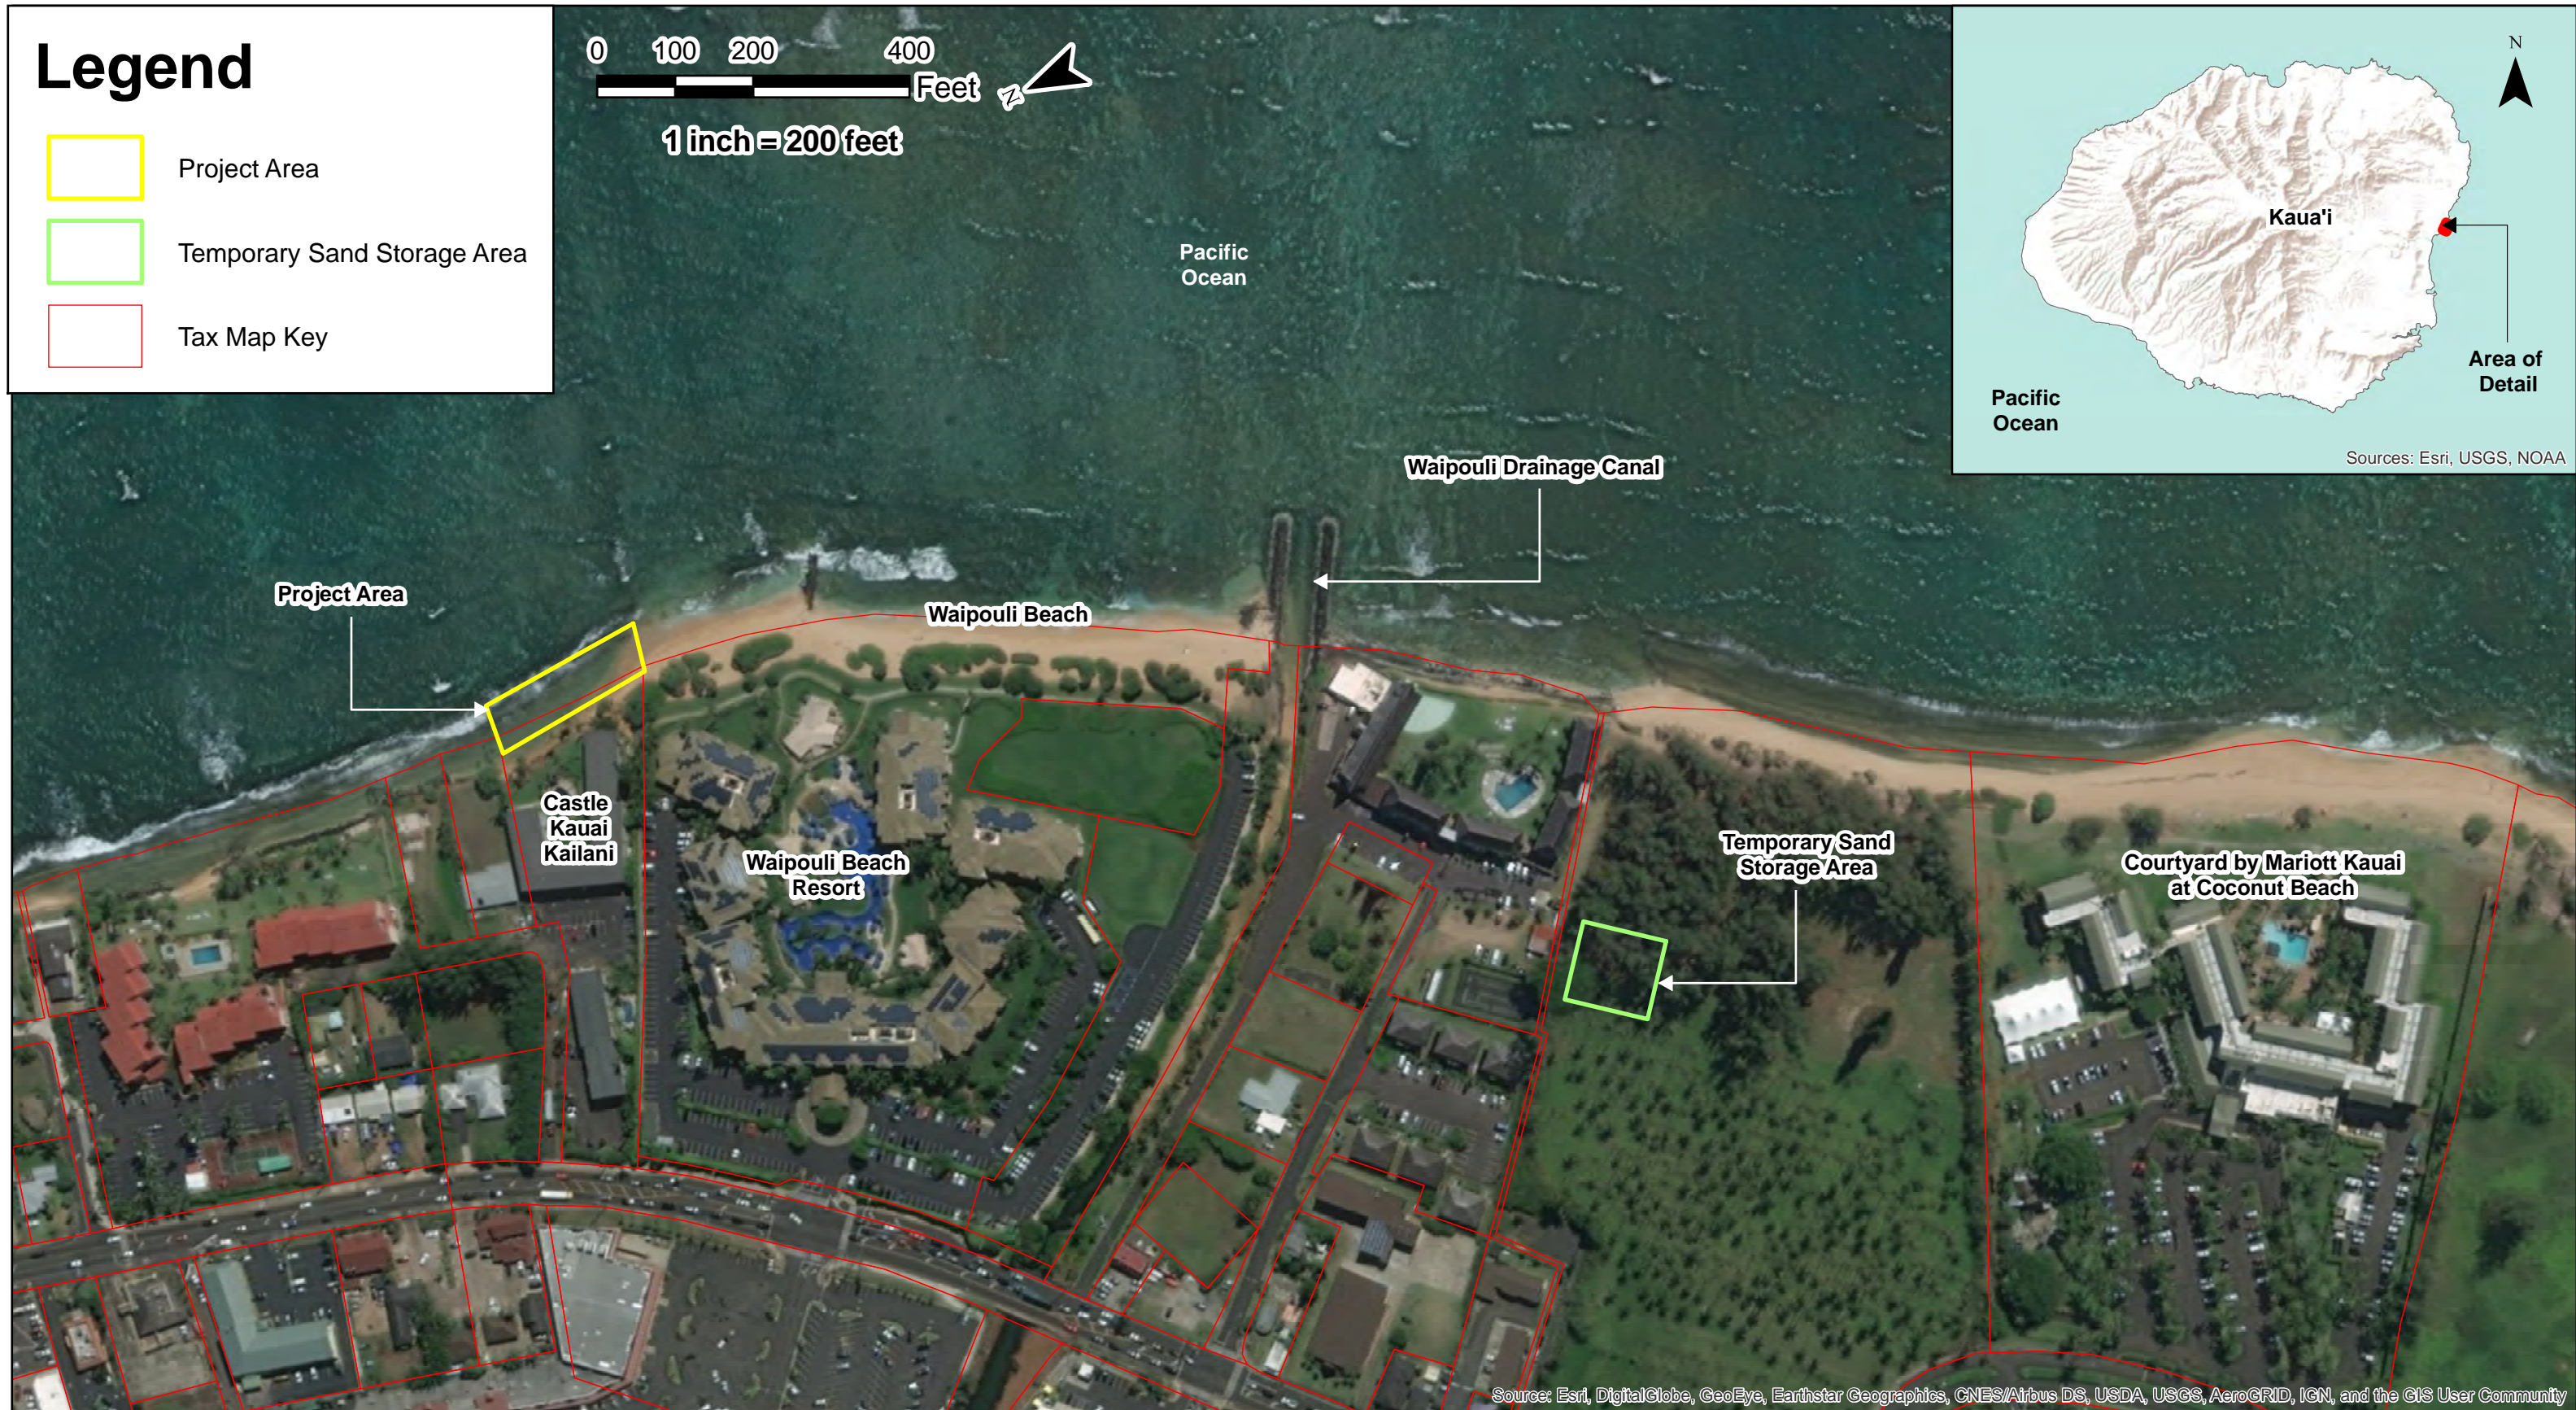
Figure 1

Project Site Map

Kaua'i Kailani Association Premises, Kapa'a, Kaua'i

The erosion at the Kauai Kailani Association premises is located at 4-856 Kuhio Highway in Kapa'a, on the east side of the island of Kaua'i (herein referred to as the site) (Figure 1). Formerly, a 70-foot (ft) long concrete groin was located at the northern boundary of the site but was removed in 2012. The groin removal caused severe erosion to the shoreline (Appendix E). An emergency erosion protection repair structure was installed in 2017 with the approval of the DLNR after erosion was deemed a threat to public health, safety, and welfare. Since its installment, the emergency structure has required maintenance repairs. The emergency structure is permitted to remain in place for three (3) years while a long-term solution is developed. The long-term solution proposed is a beach nourishment event stabilized by a temporary sand bag groin.

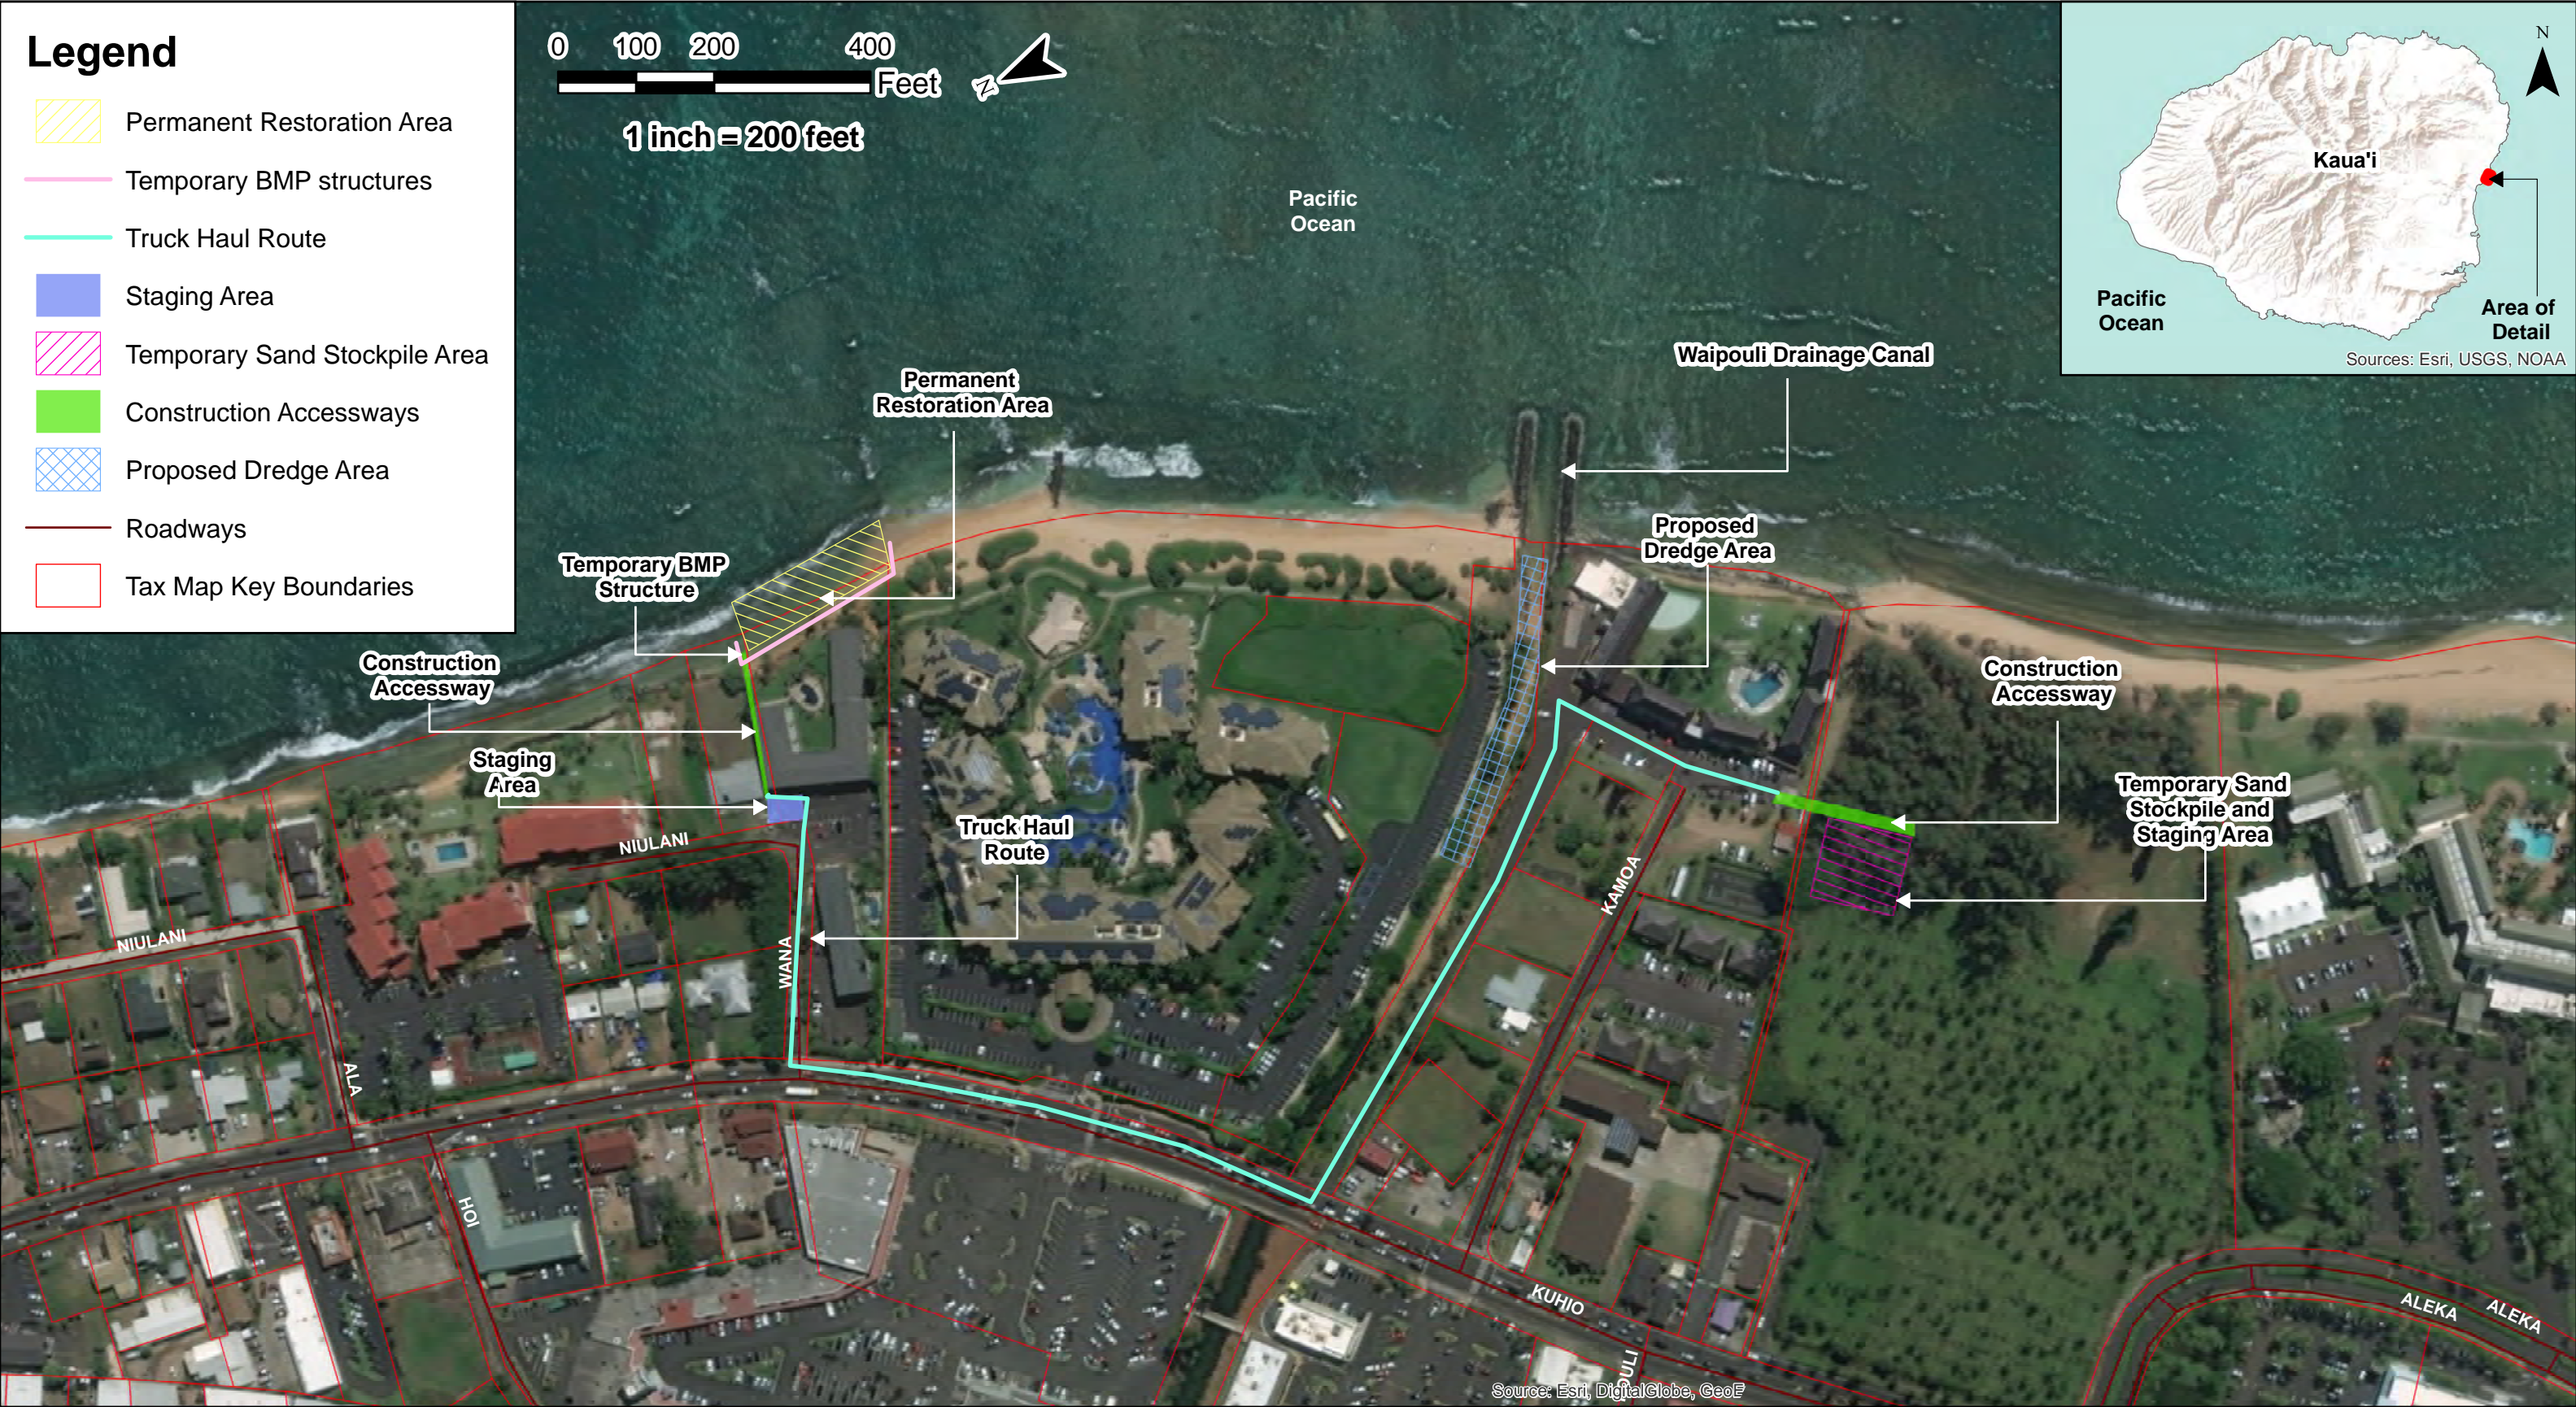
Figure 2

Proposed Action

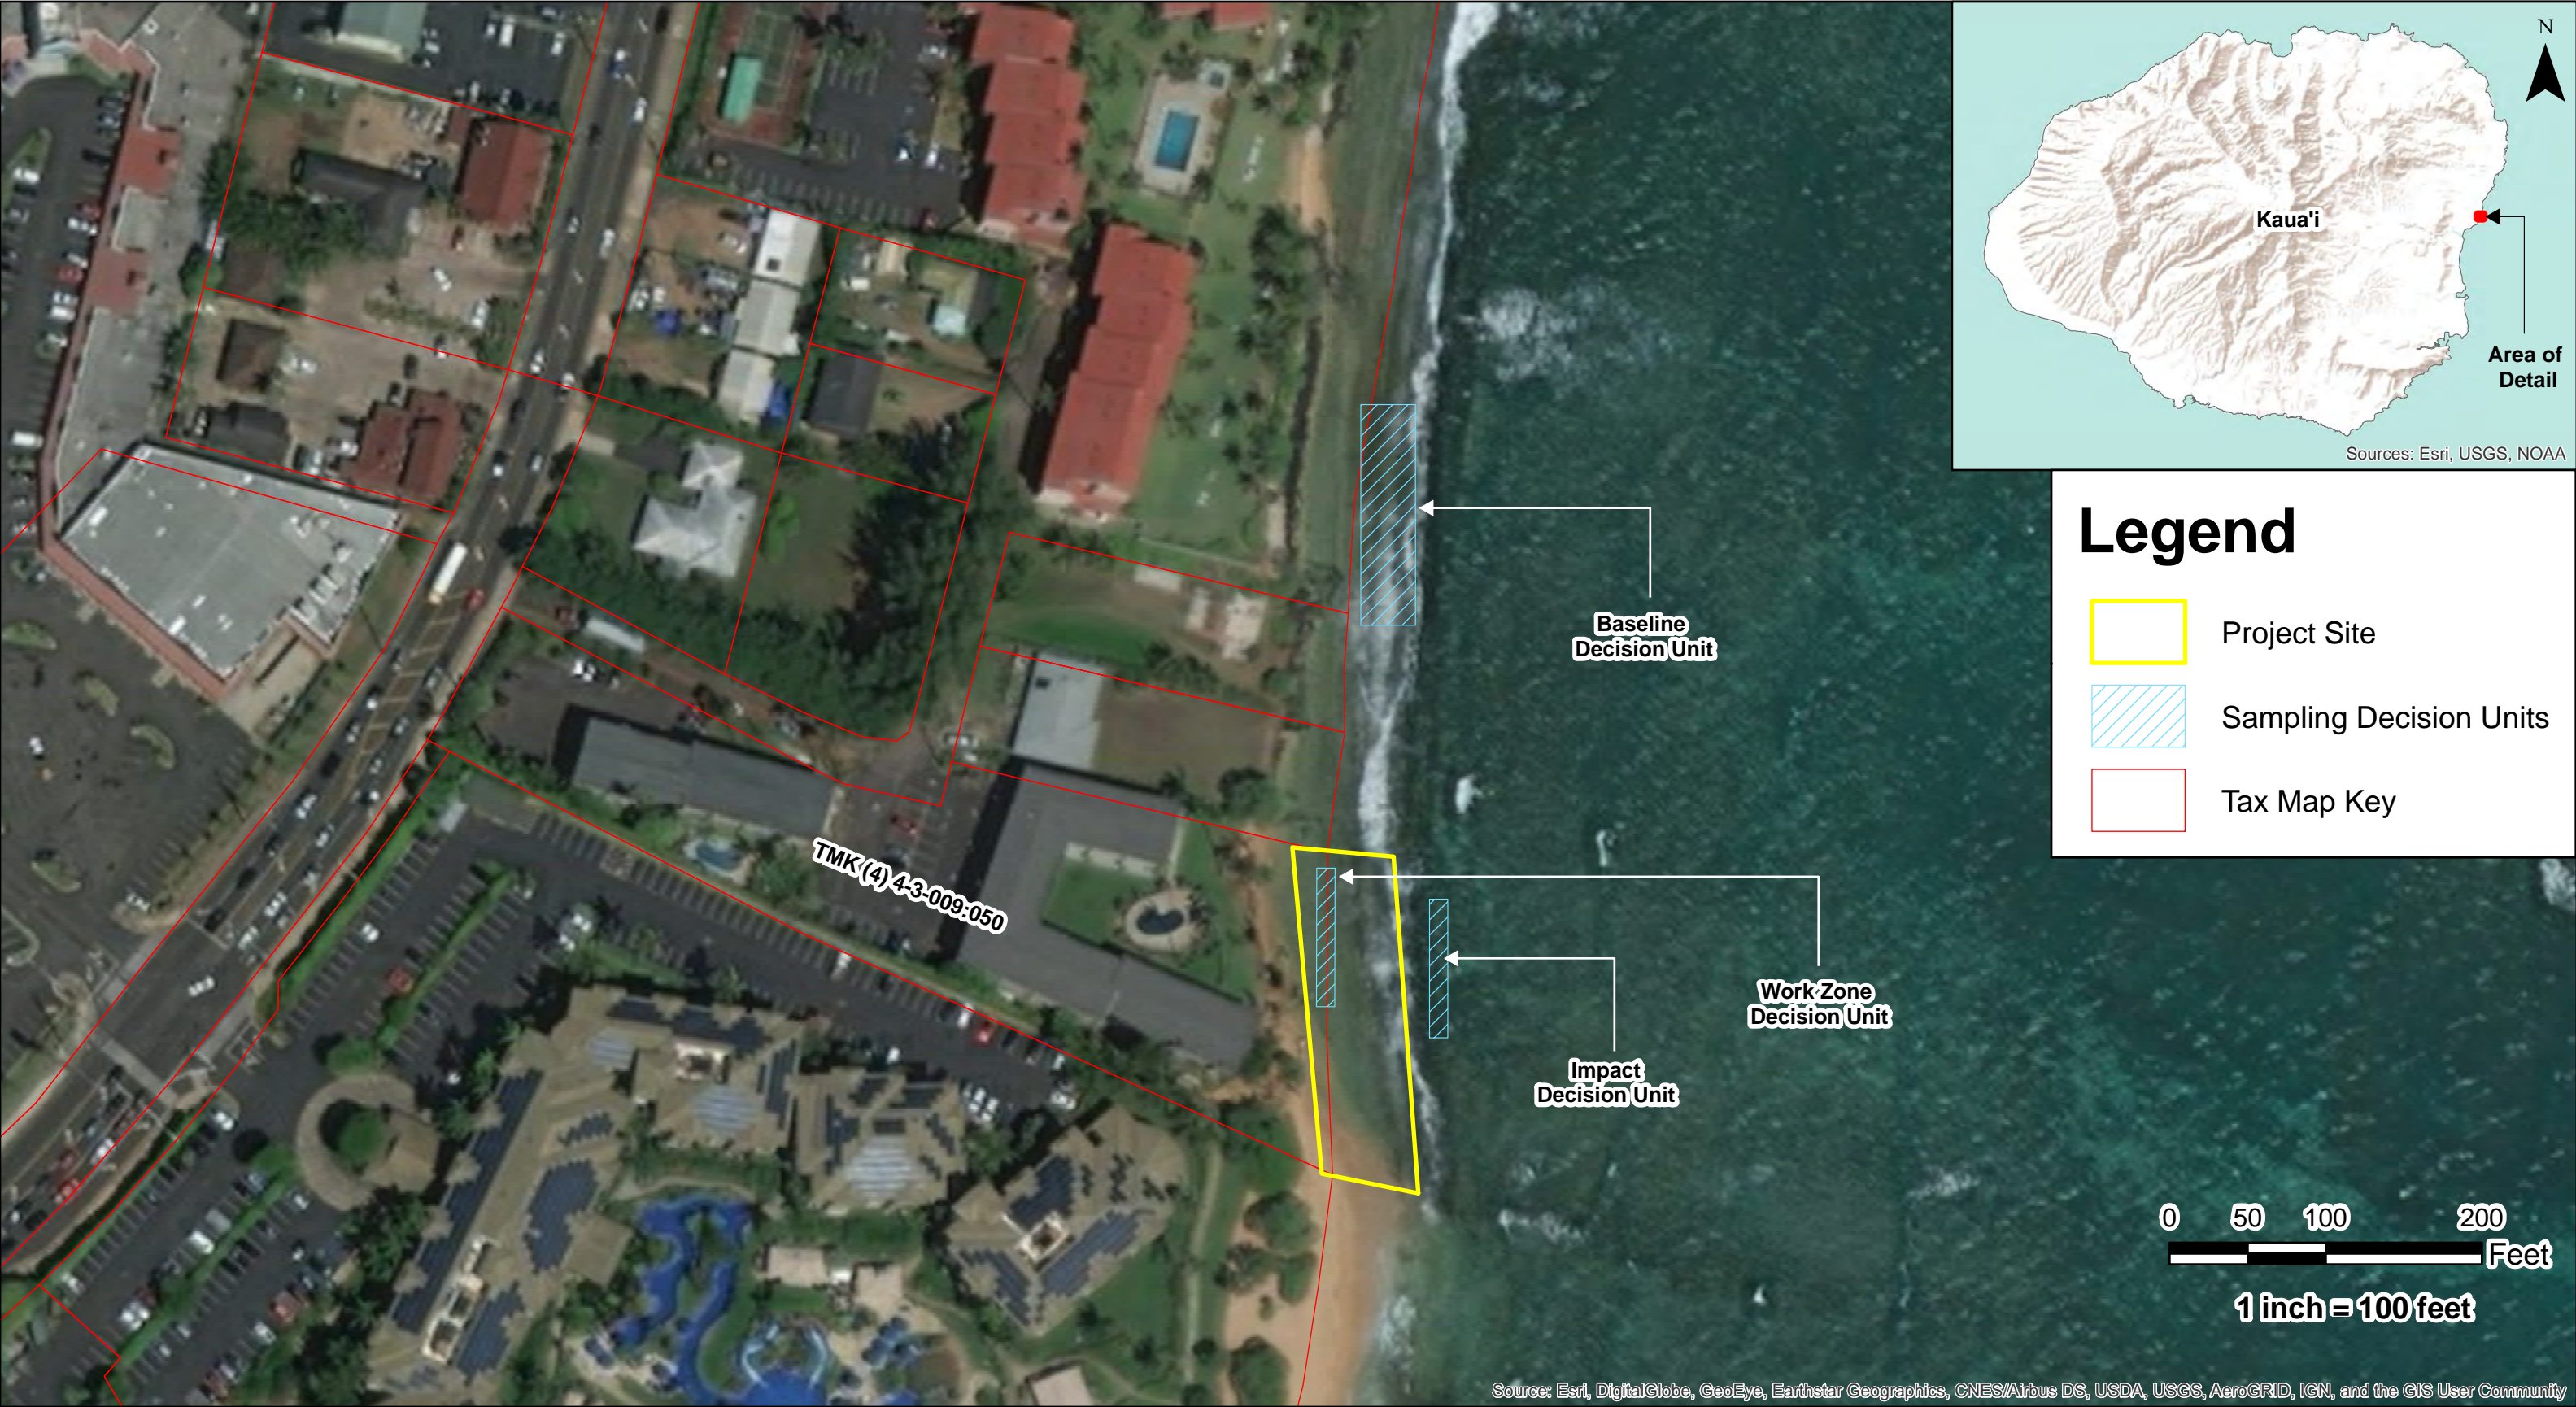
Small Scale Beach Nourishment Application	Figure 4
	Sampling Decision Unit Map Kaua'i Kailani Association Premises, Kapa'a, Kaua'i

Water Quality Monitoring will take place pre-, during, and post- construction activities. There will be three DUs where water quality monitoring will be conducted. These are selected to represent baseline water quality in the vicinity of the project site (i.e., Baseline DU), water quality condition at the worksite within the area protected by the BMPs (i.e., Work DU), and the area immediately outside the BMPs where the most severe impacts are expected (i.e., Impact DU). Each of the locations for the suggested DUs are shown in Figure 4.

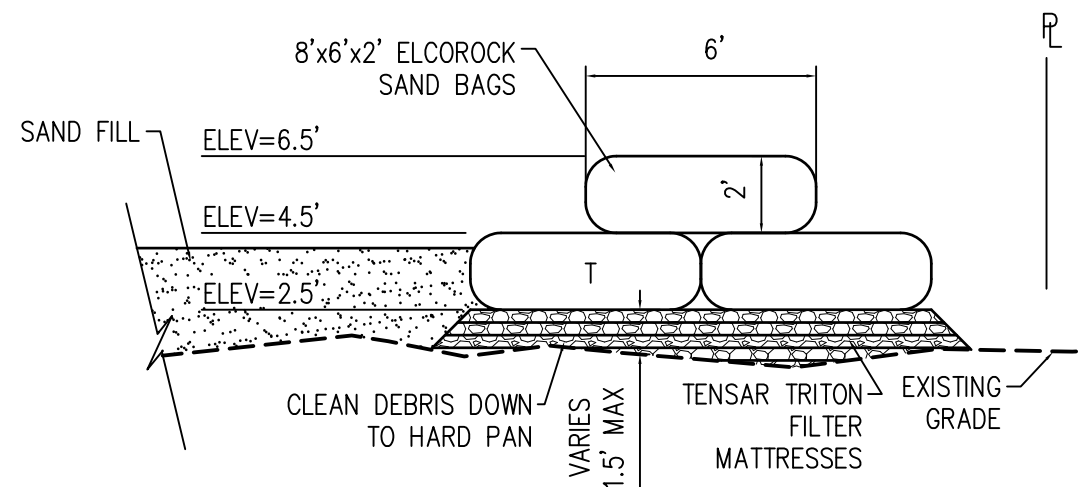
SECTION 1 - SAND BAG GROIN
SCALE: 1"=5'

The location of the groin structure is at the location of the original groin, at the north boundary of the property line. A foundation layer of Tensar Triton Filter Mattresses will be placed beneath approximately 29 Elcorock sand bags stacked to create a groin. The groin will be perpendicular to the shoreline berm and extend 80 ft seaward over the beachrock. The footprint of the groin is 12 ft wide at the bottom and tapered to 6 ft wide at the top. The top elevation will be +6.5 ft MLLW.

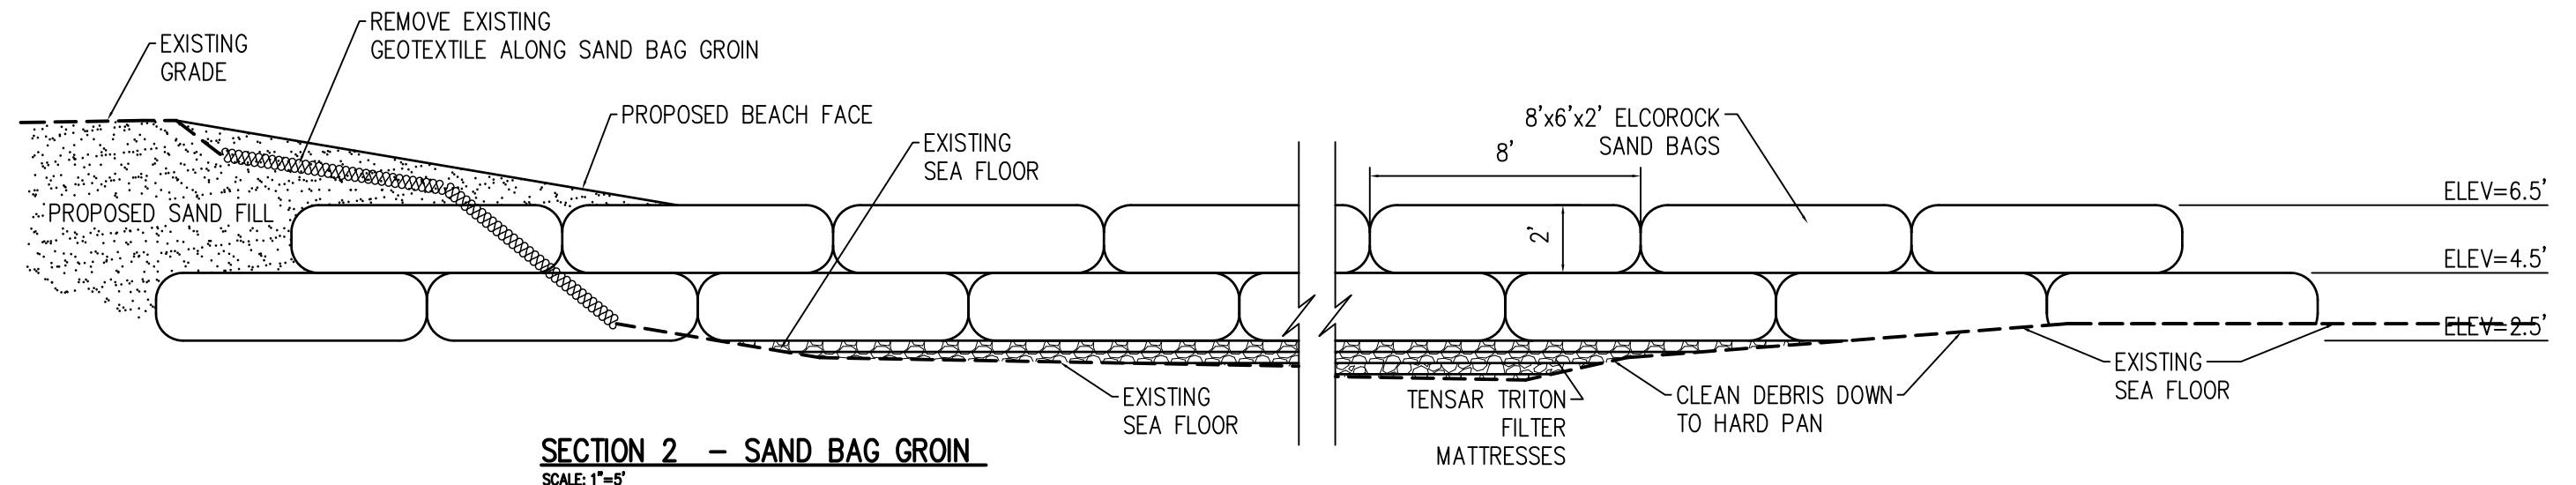
SECTION 2 - SAND BAG GROIN
SCALE: 1"=5'

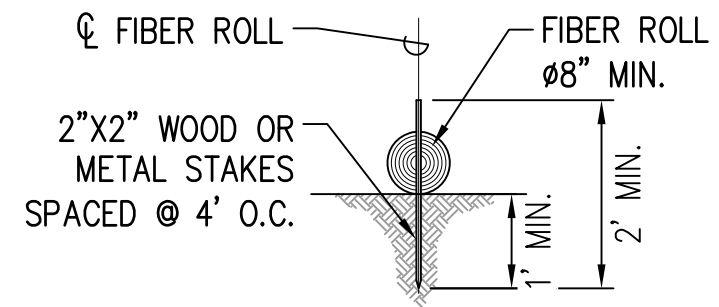
FIBER ROLL DETAIL
NOT TO SCALE

A temporary fiber roll will be installed as a pollution control measure (Figure 3). In water pollution control measures are not anticipated to be needed the installation of the Tensar Triton Filter Mattresses and Elcorock sand bags are not expected to produce any sediment or plumes. Placement of sand fill will be initiated above the MHHW on the Kauai Kailani property and grading will be performed so that no heavy equipment enters the water in the nearshore area. See the site-specific BMP Plan for further details.

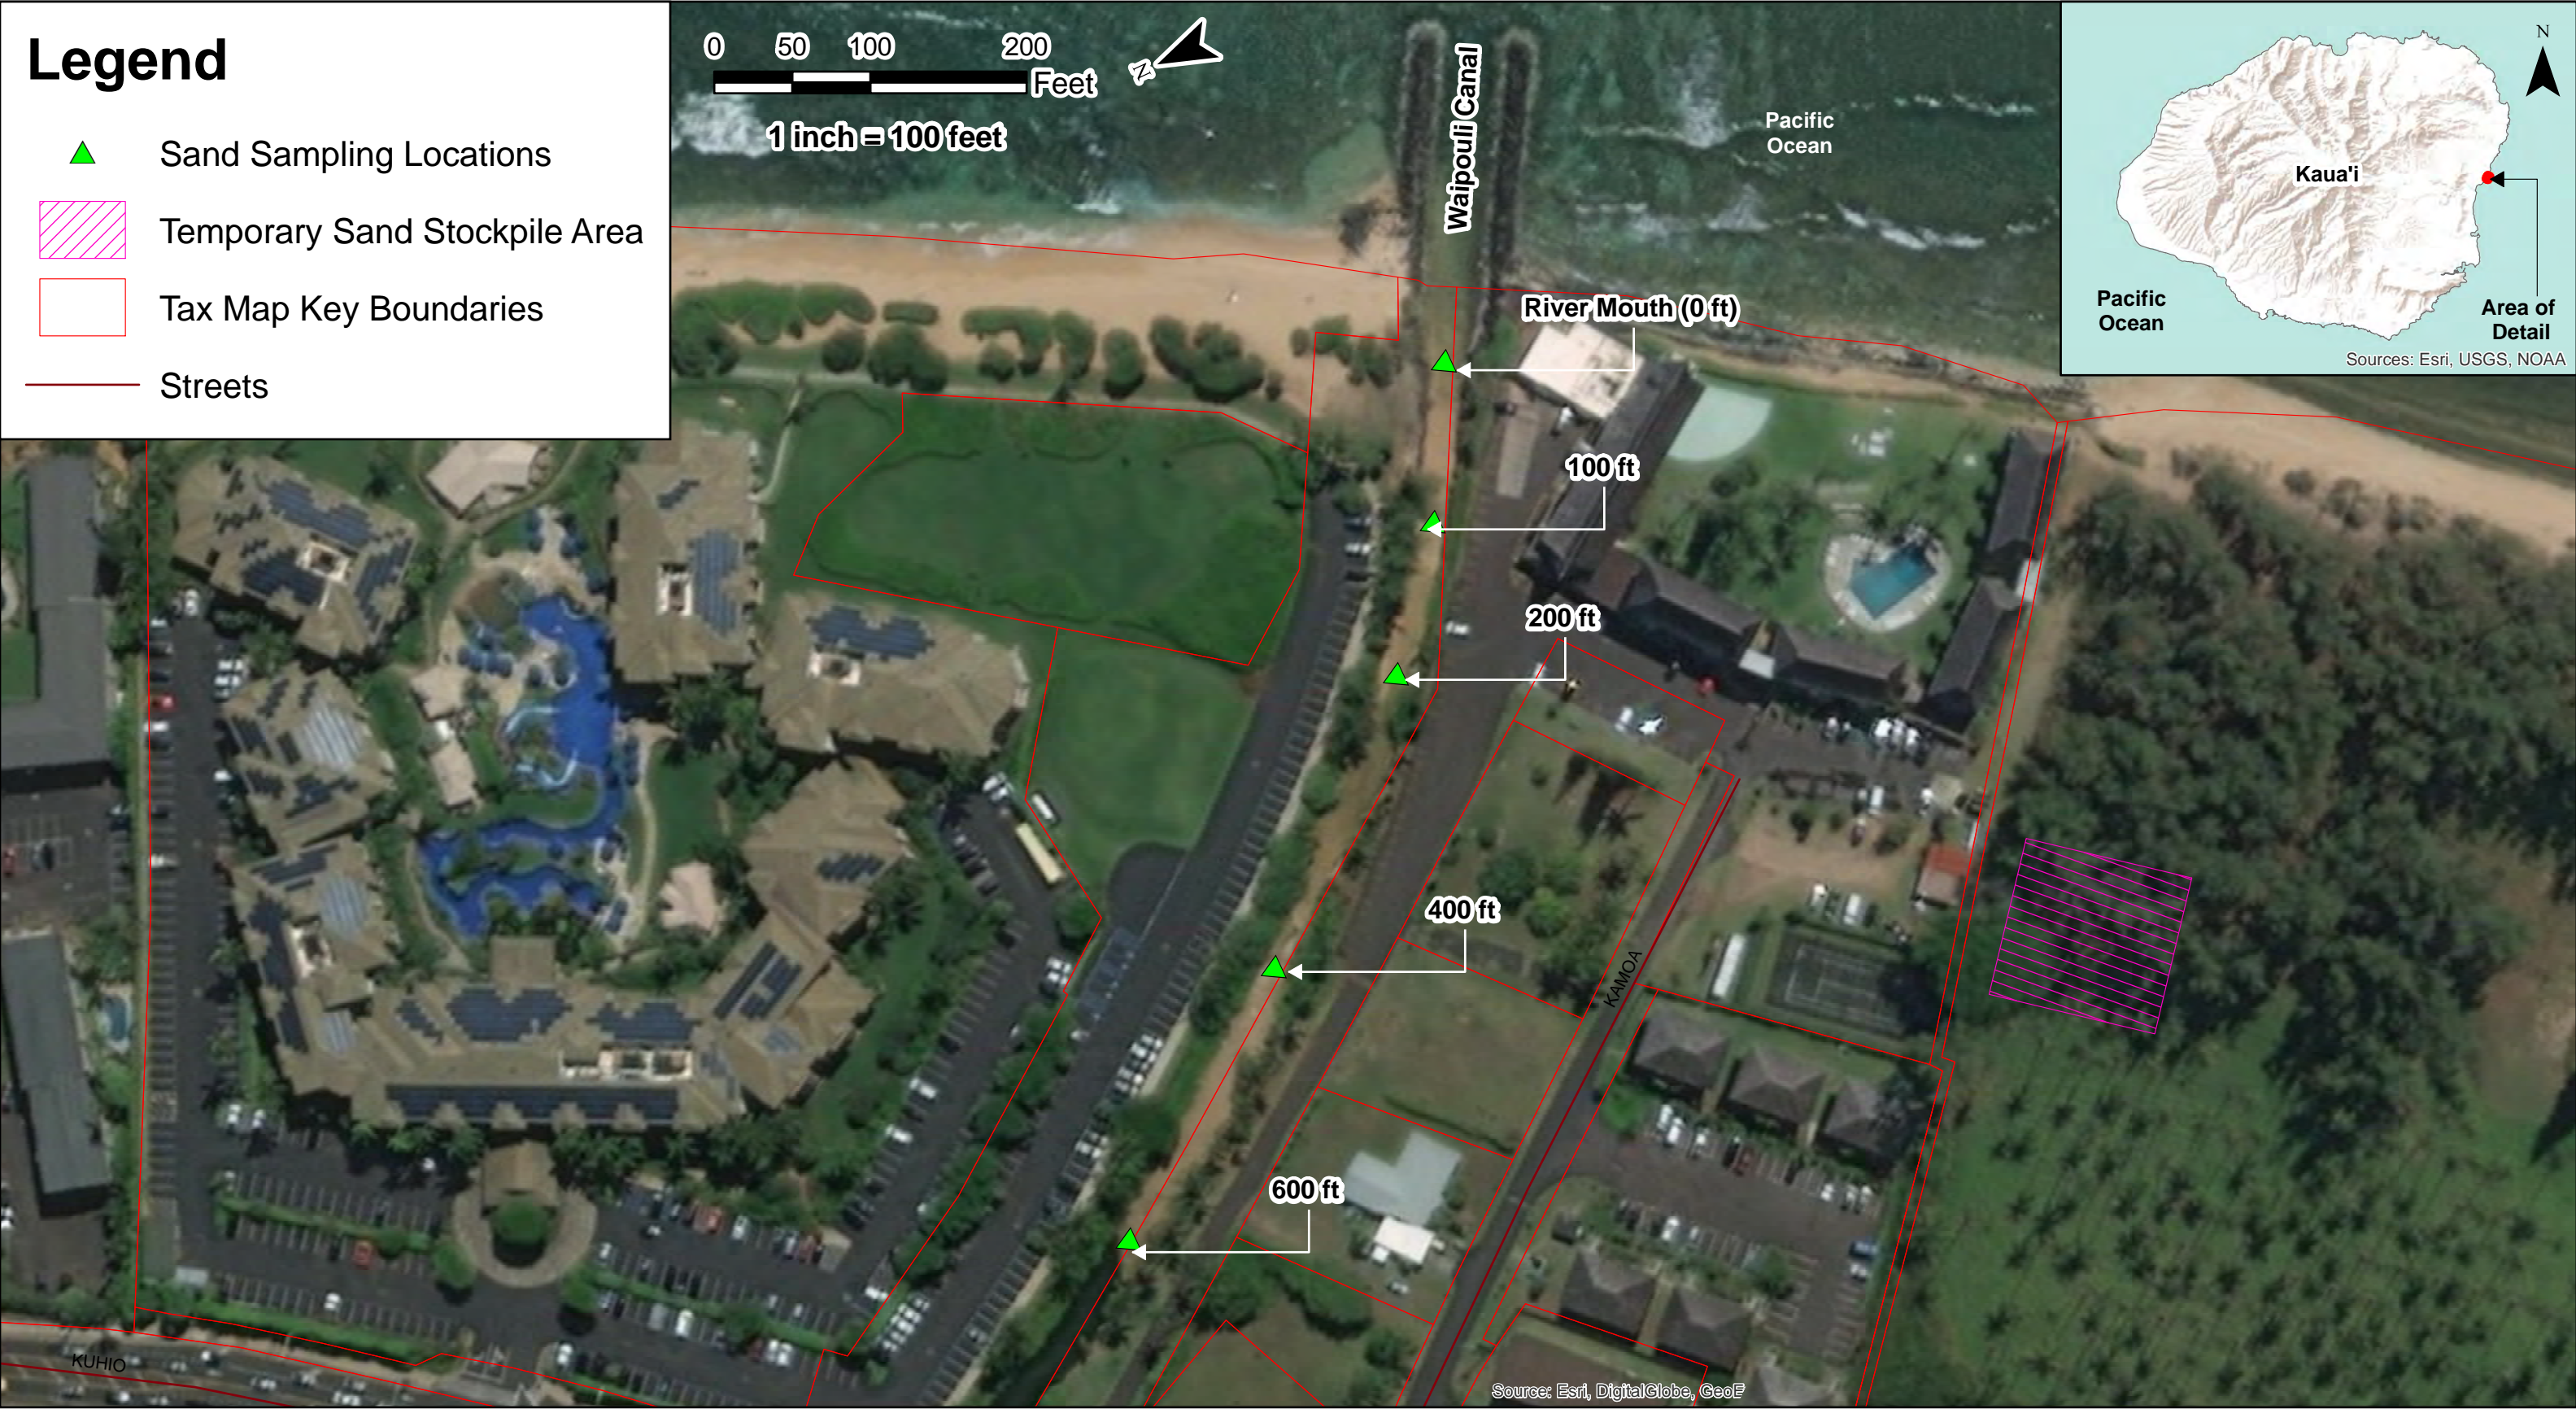
Figure
11

Additional Waipouli Canal Sand Sampling Locations

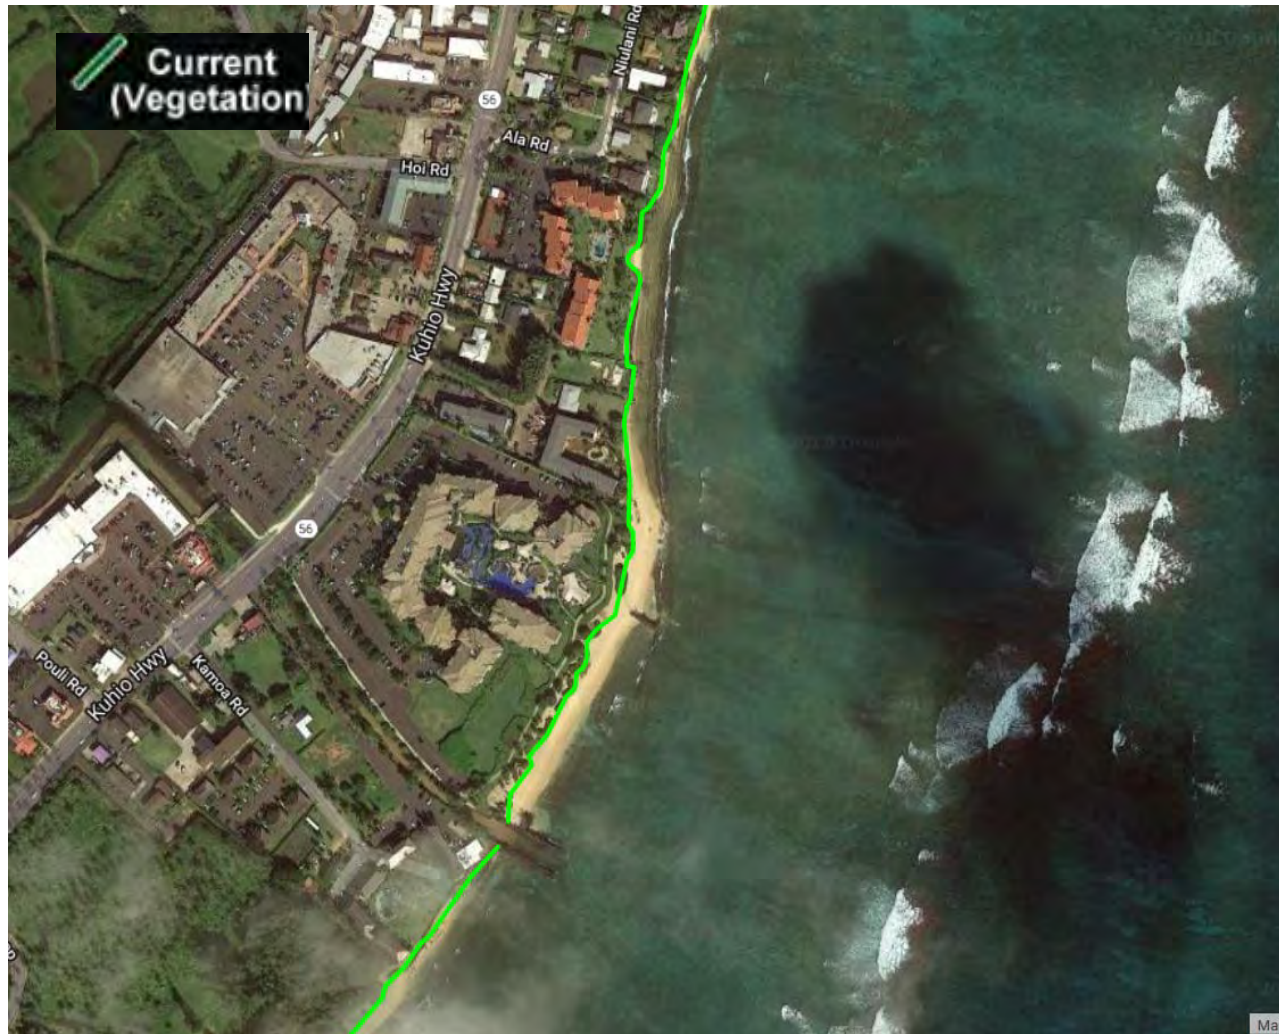
Figure 12: Modern shoreline delineation around project area

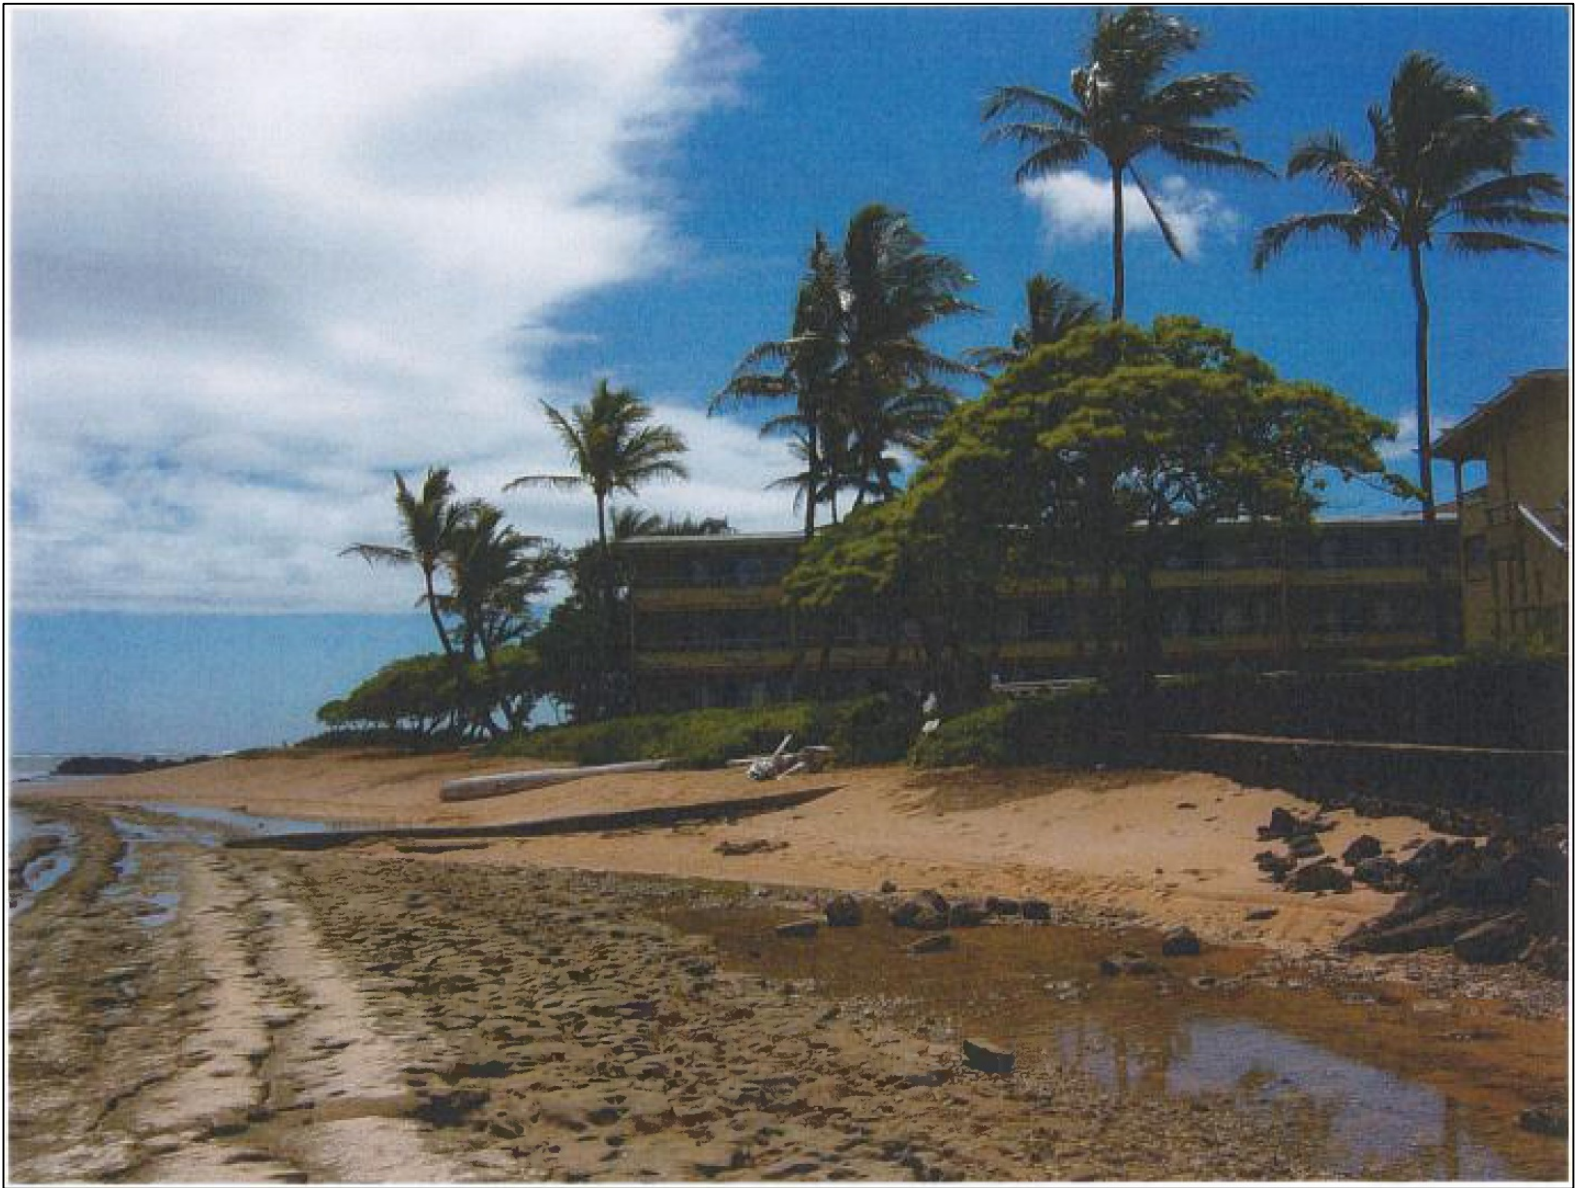
Shoreline prior to groin removal and goal
of the proposed beach nourishment
Photo taken prior to 2012

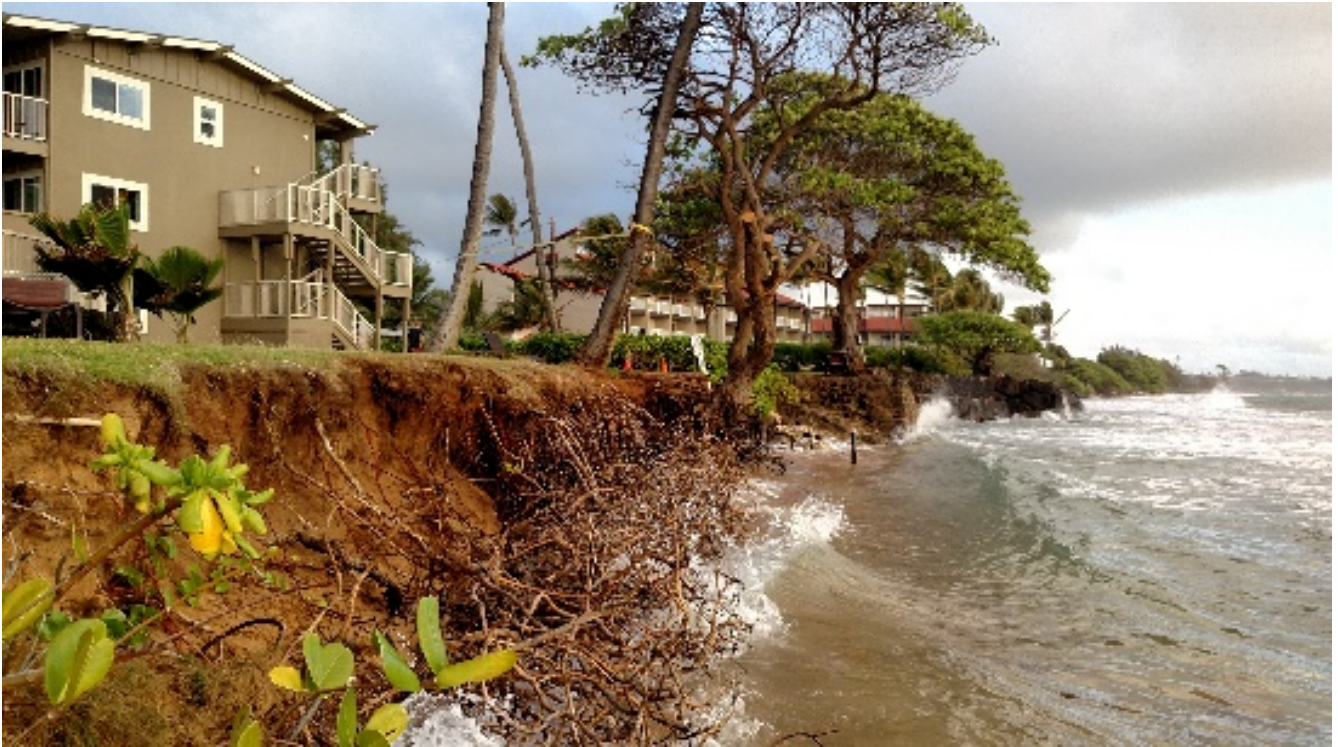
Erosion exposing root vegetation and threatening property prior to the 2017 temporary erosion control revetment

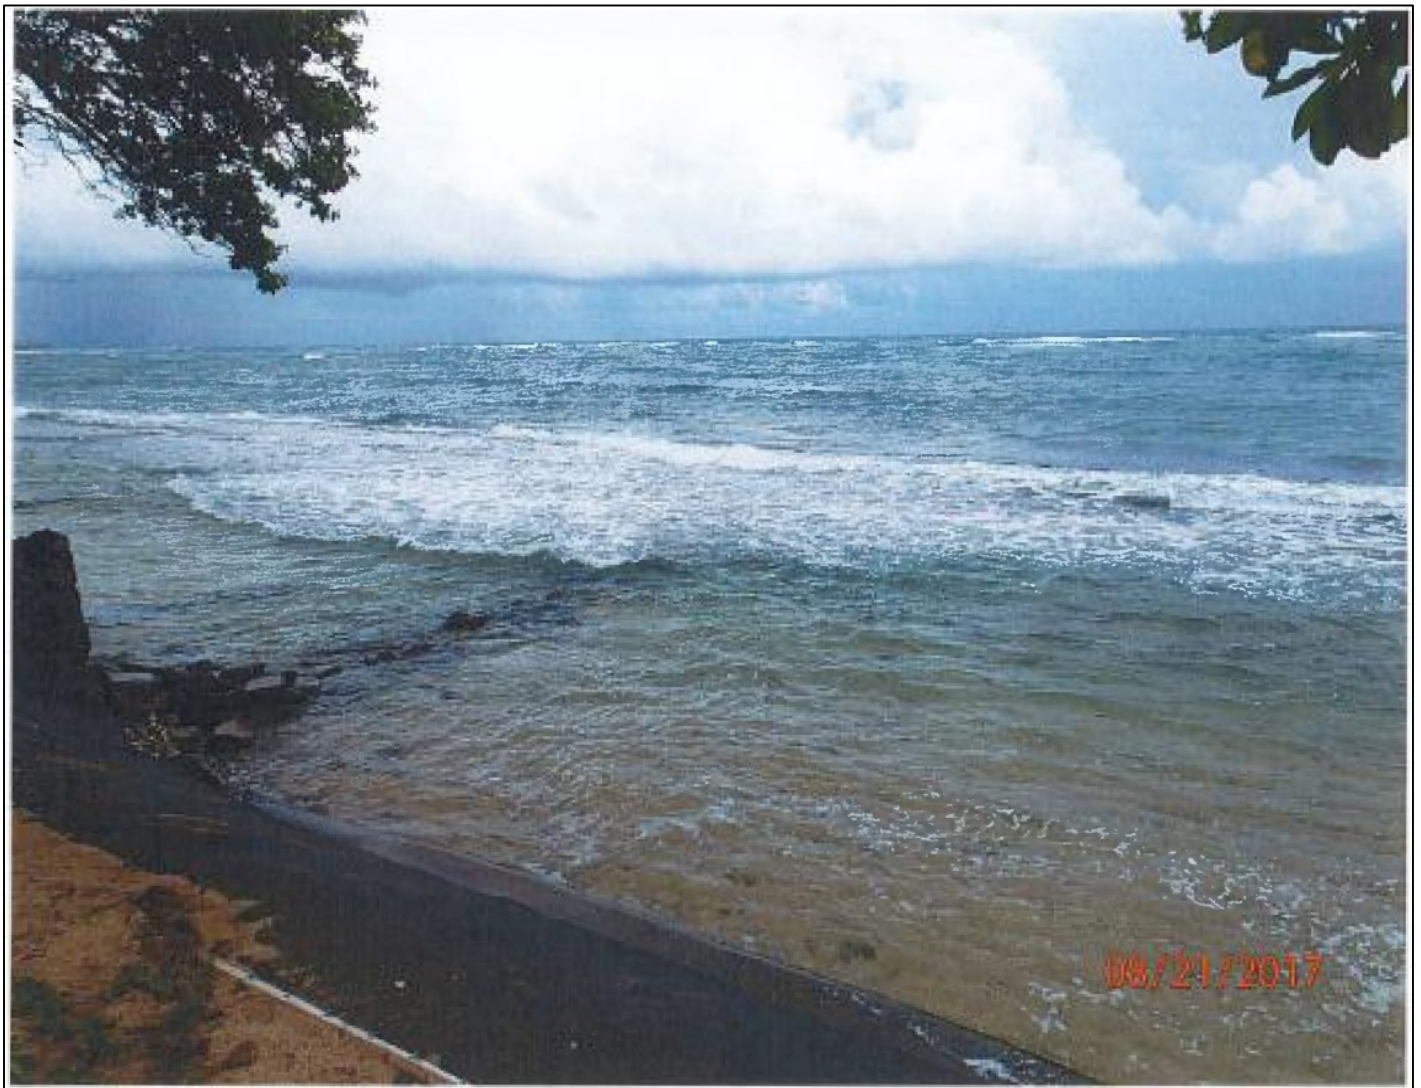
Site of pre-existing groin and location of proposed
groin
Photo taken Aug 2017
