Category II General Application Small-Scale Beach Nourishment Projects (SSBN)

STATE OF HAWAII
DEPARTMENT OF LAND AND NATURAL RESOURCES

PROJECT NAME: Kauai Kailani Beach Restoration

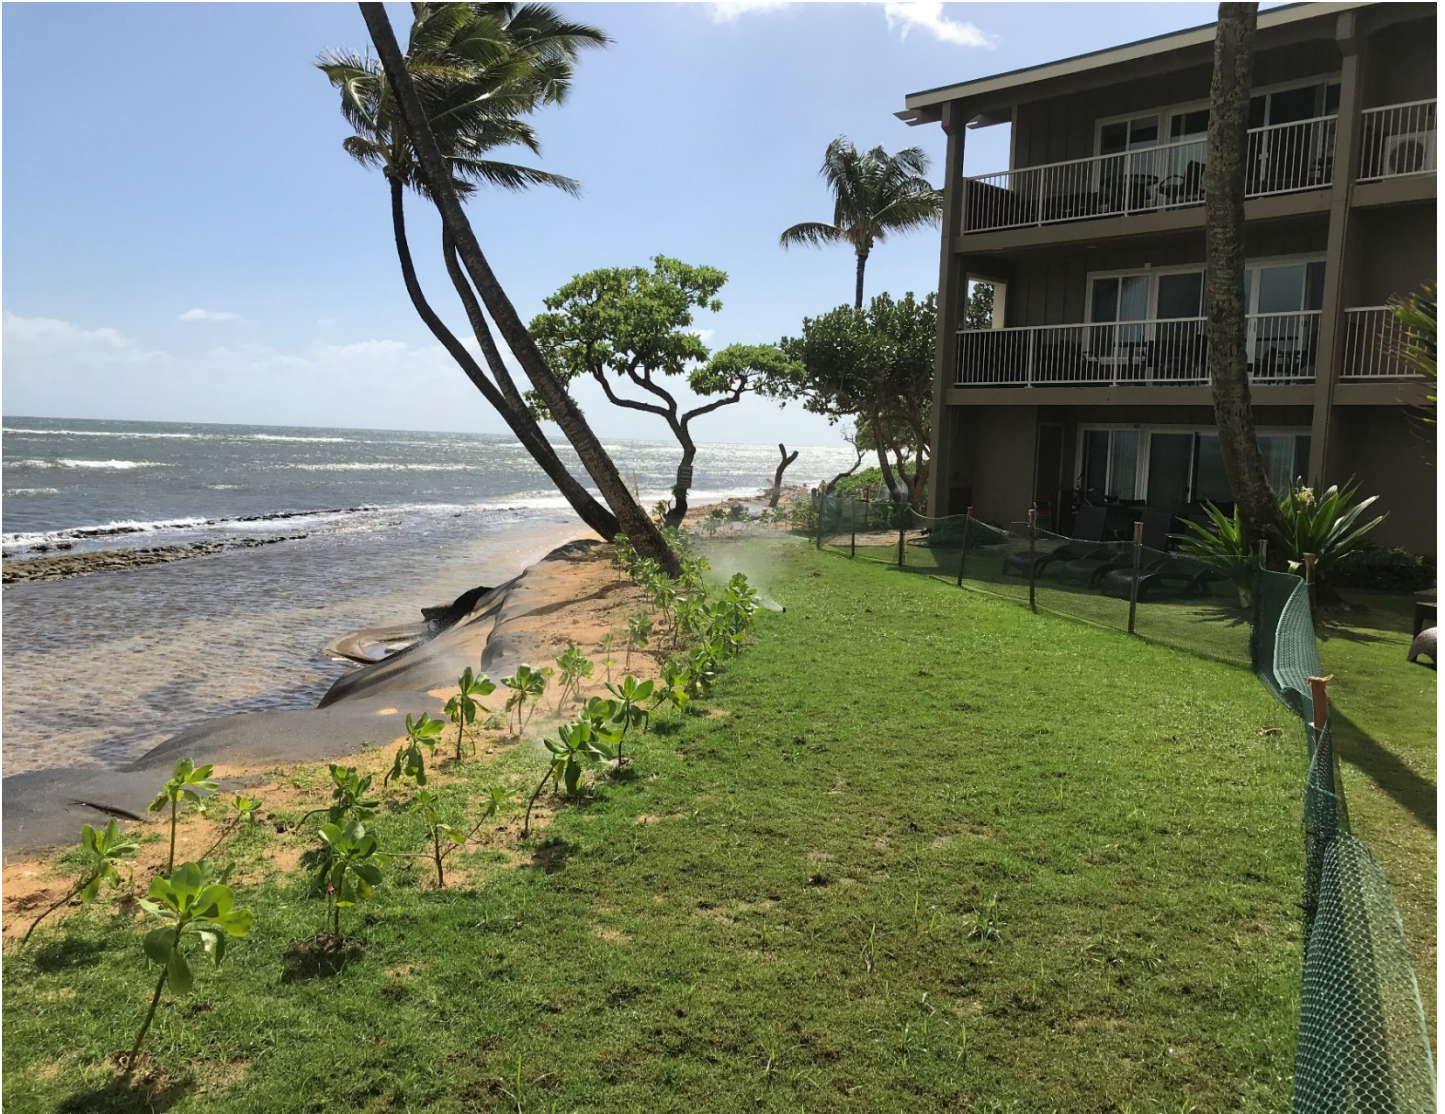
Current view of the property with temporary erosion control measures in place

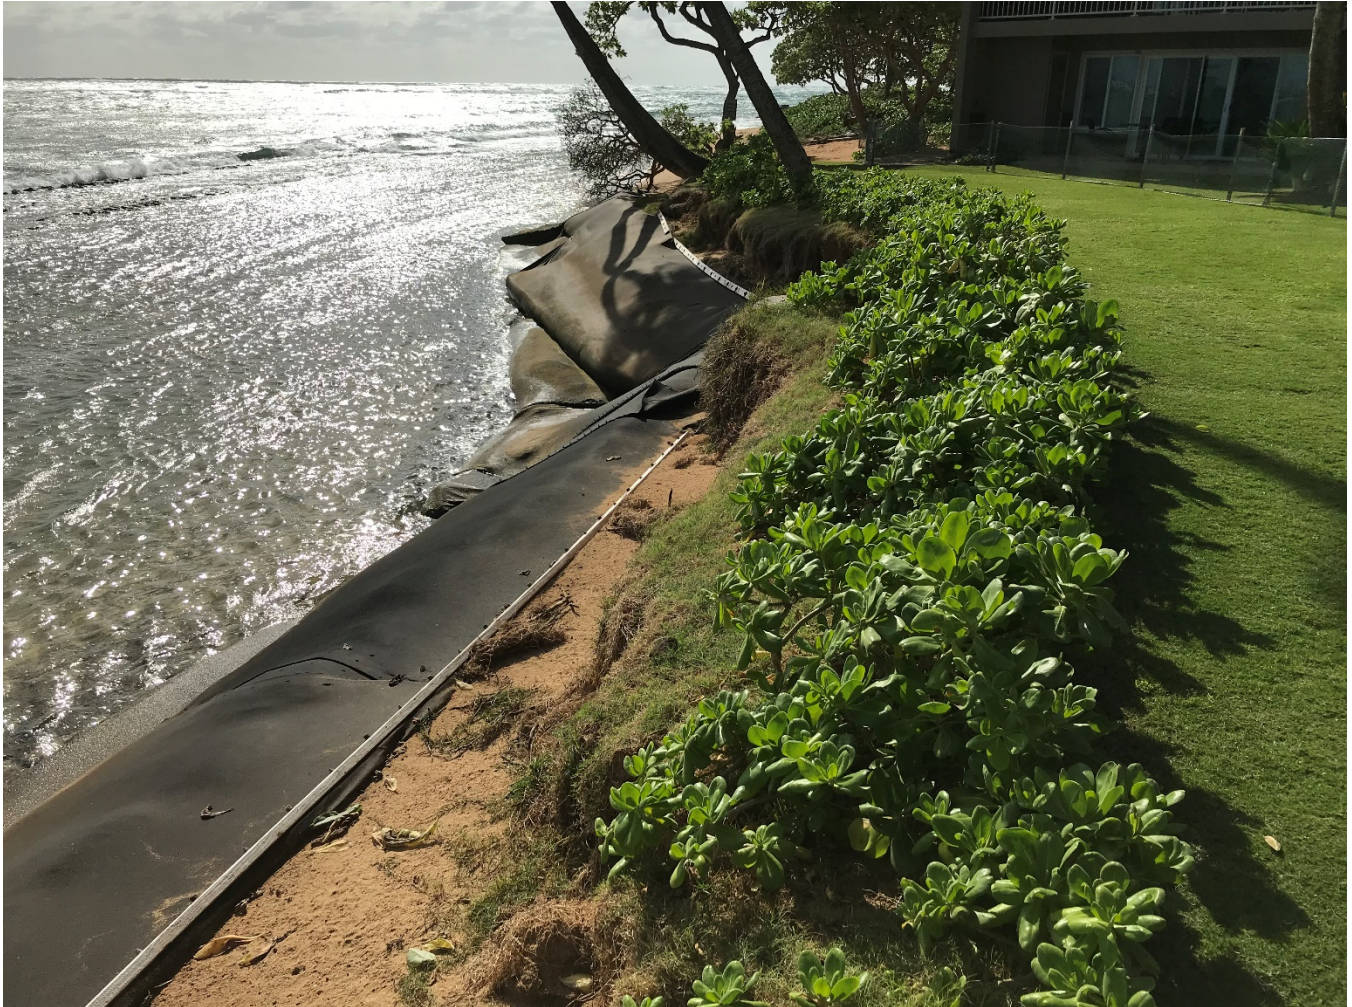
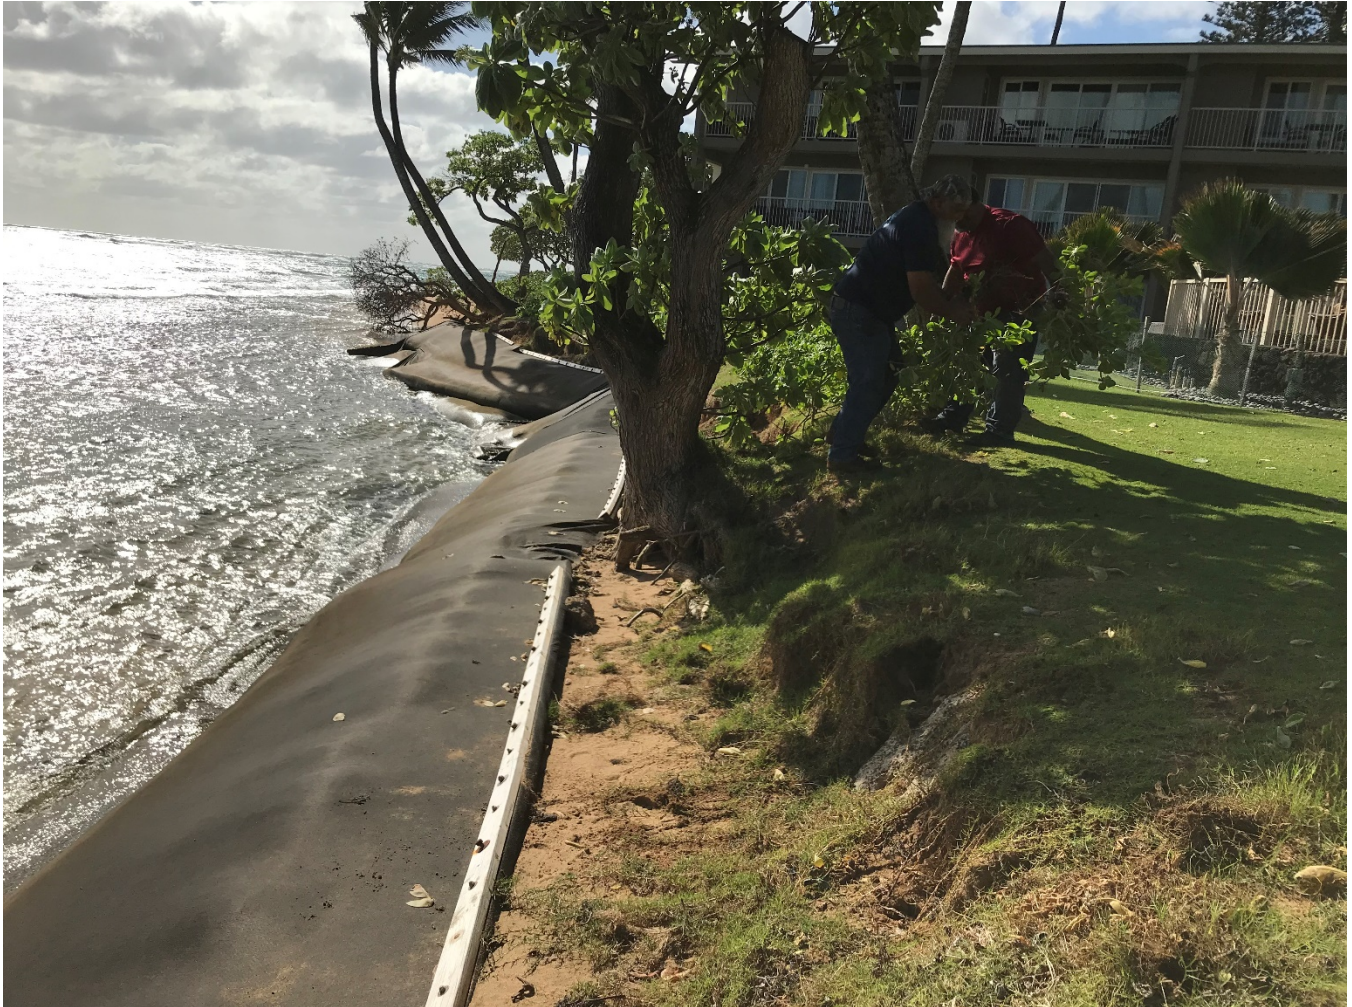
Temporary Sand Bag Revetment Installed in 2017
Photo Taken Dec 2017

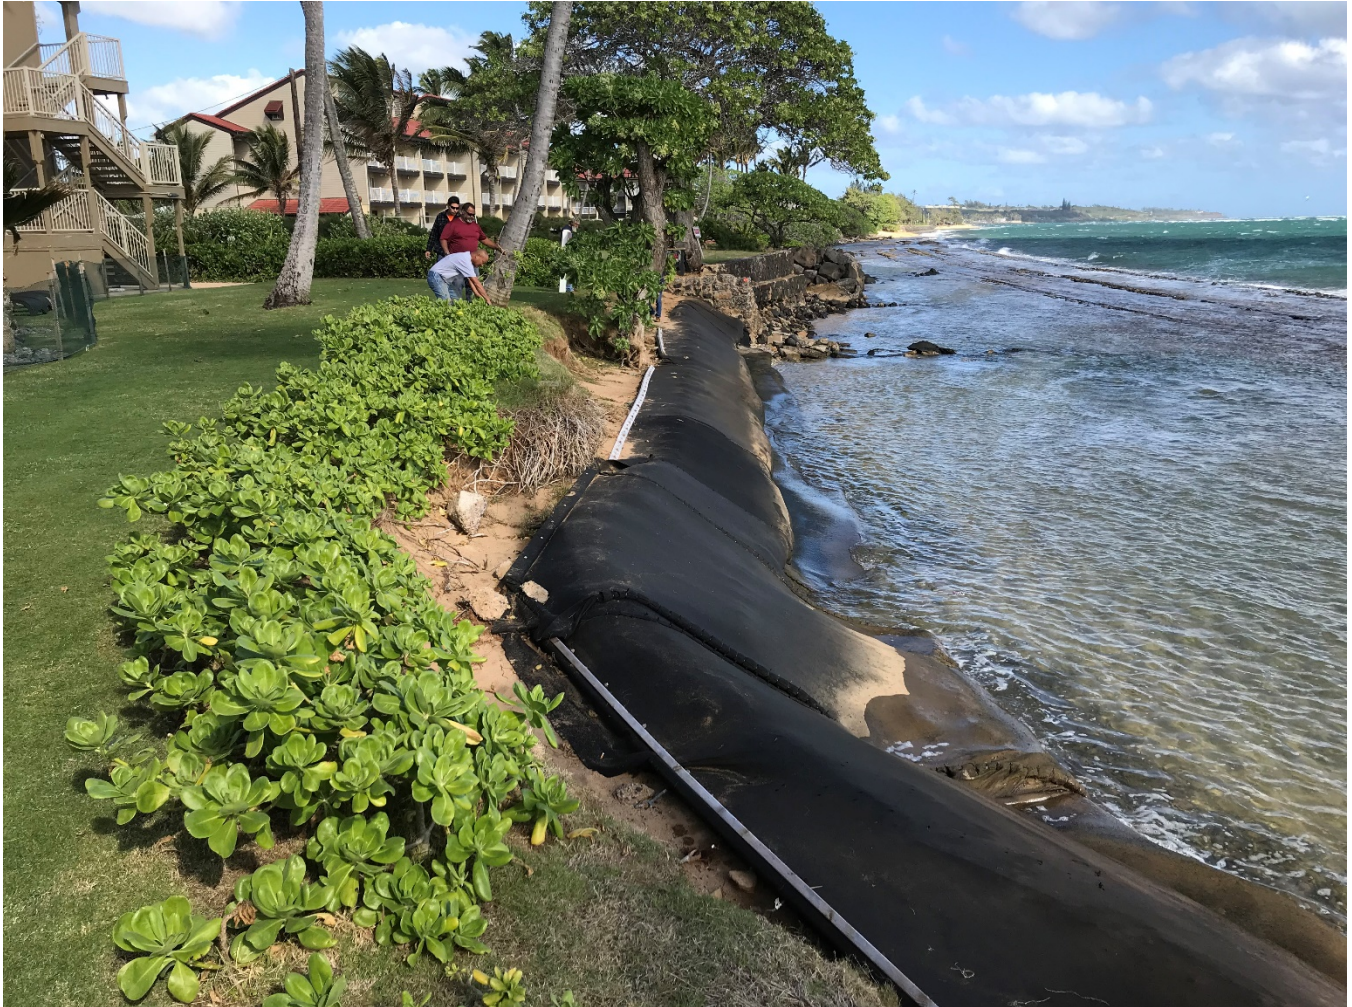
Project Site Conditions and Temporary Sand Bag Revetment
Photo Taken Dec 2017

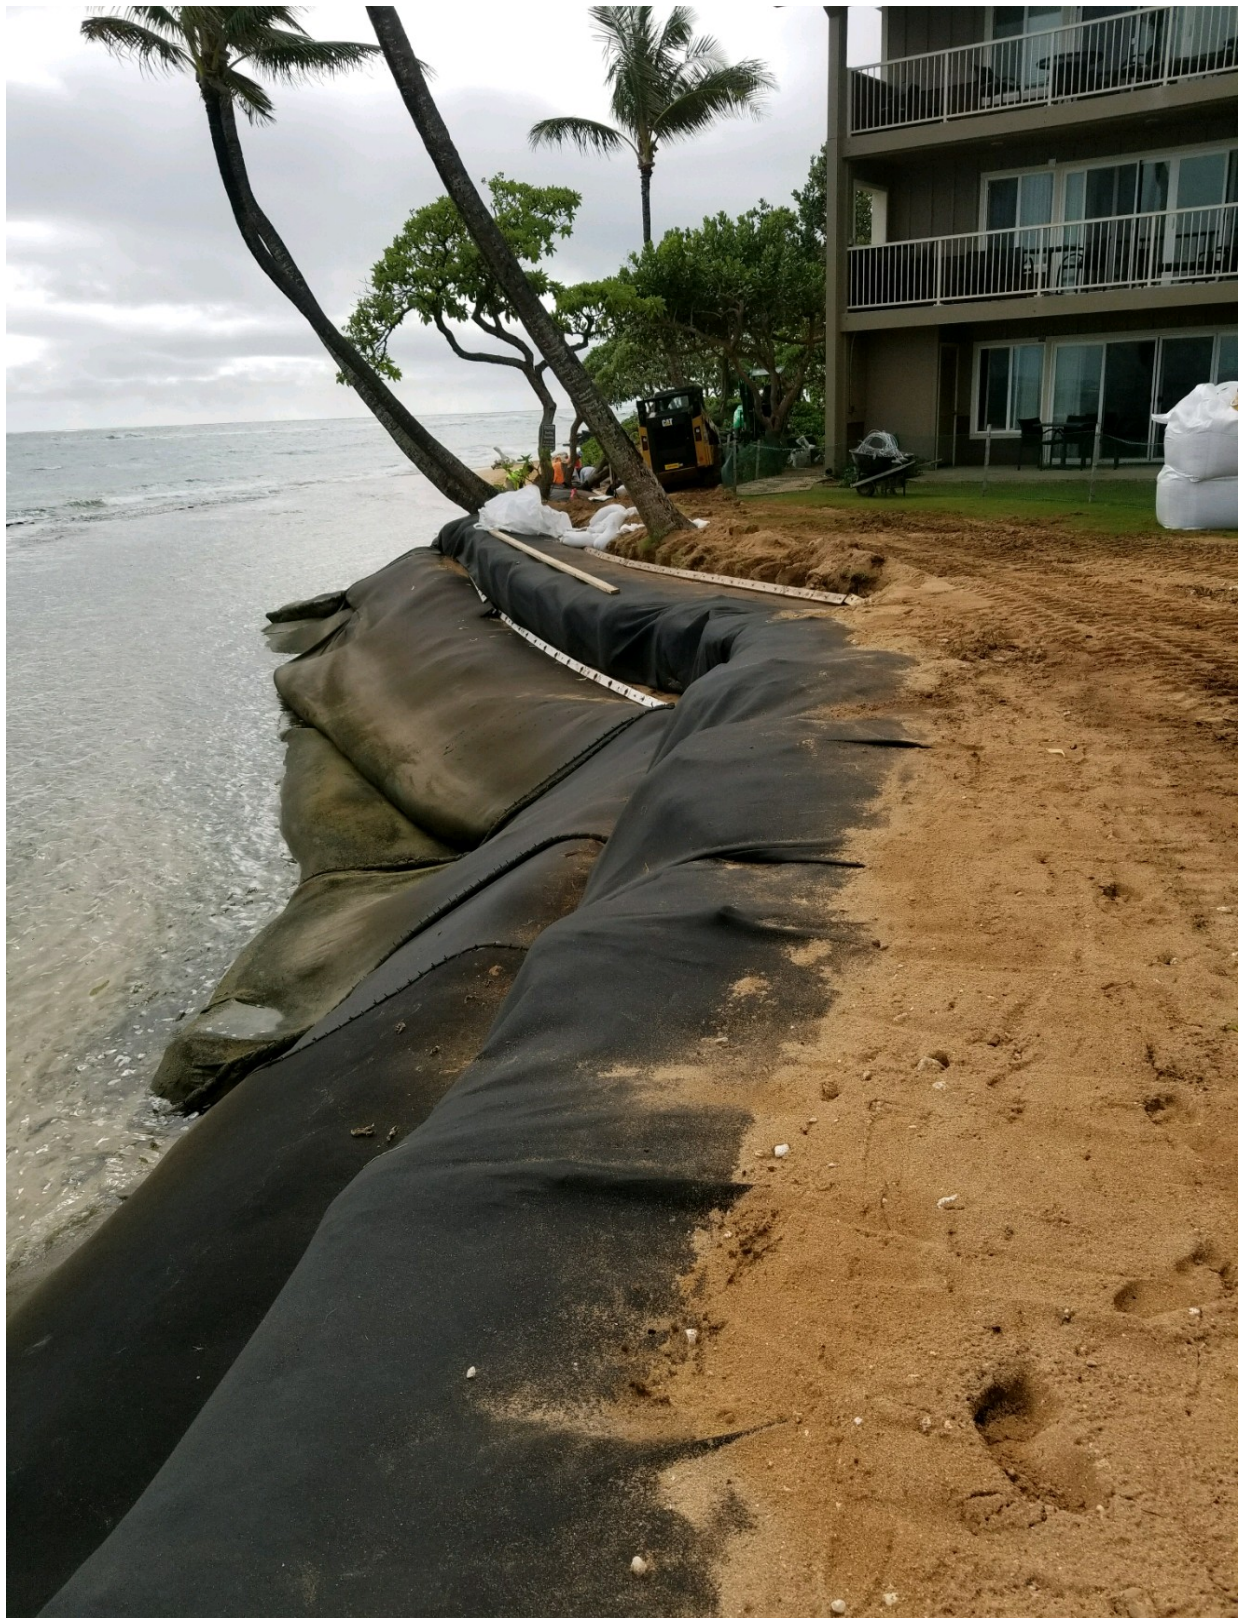
Temporary Sand Bag Revetment
Photo Taken Jan 2018

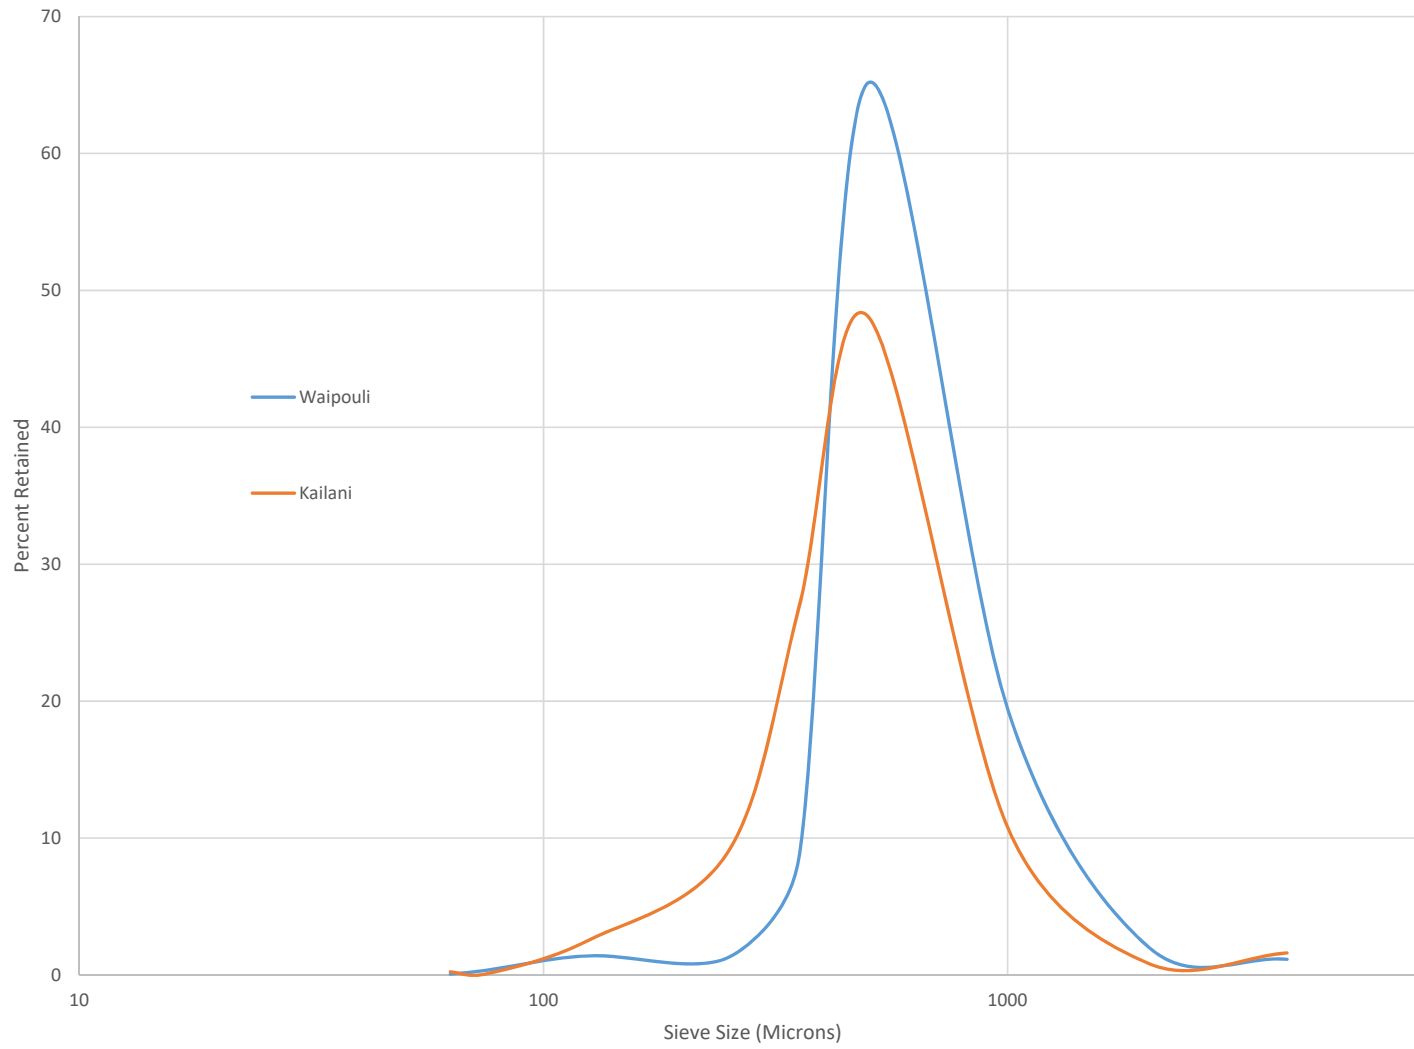
Sand Grain Size Comparison

Cumulative Percentage Greater Than

Description	Sample ID	Percent Finer by Weight (%)								
		size (mm)								
		4.00	2.00	1.00	0.500	0.355	0.250	0.125	0.075	0.063
Kauai Kailani Beach #1	C	97.73	96.81	82.18	37.74	10.65	1.80	0.33	0.29	0.29
Kauai Kailani Beach #2	D	99.06	98.22	91.28	39.50	13.02	3.88	0.29	0.19	0.17
Waipouli Canal STA 0+00	E	99.76	97.40	75.66	11.59	4.10	2.95	0.87	0.44	0.36
Waipouli Canal STA 4+29	F	99.10	98.64	85.24	11.10	1.44	0.78	0.30	0.17	0.17
Waipouli Canal STA 2+71	G	98.76	96.38	77.13	12.35	2.87	1.74	0.87	0.66	0.60
Waipouli Canal STA 1+59	H	97.81	94.59	71.22	13.60	6.24	4.44	2.26	1.62	1.50

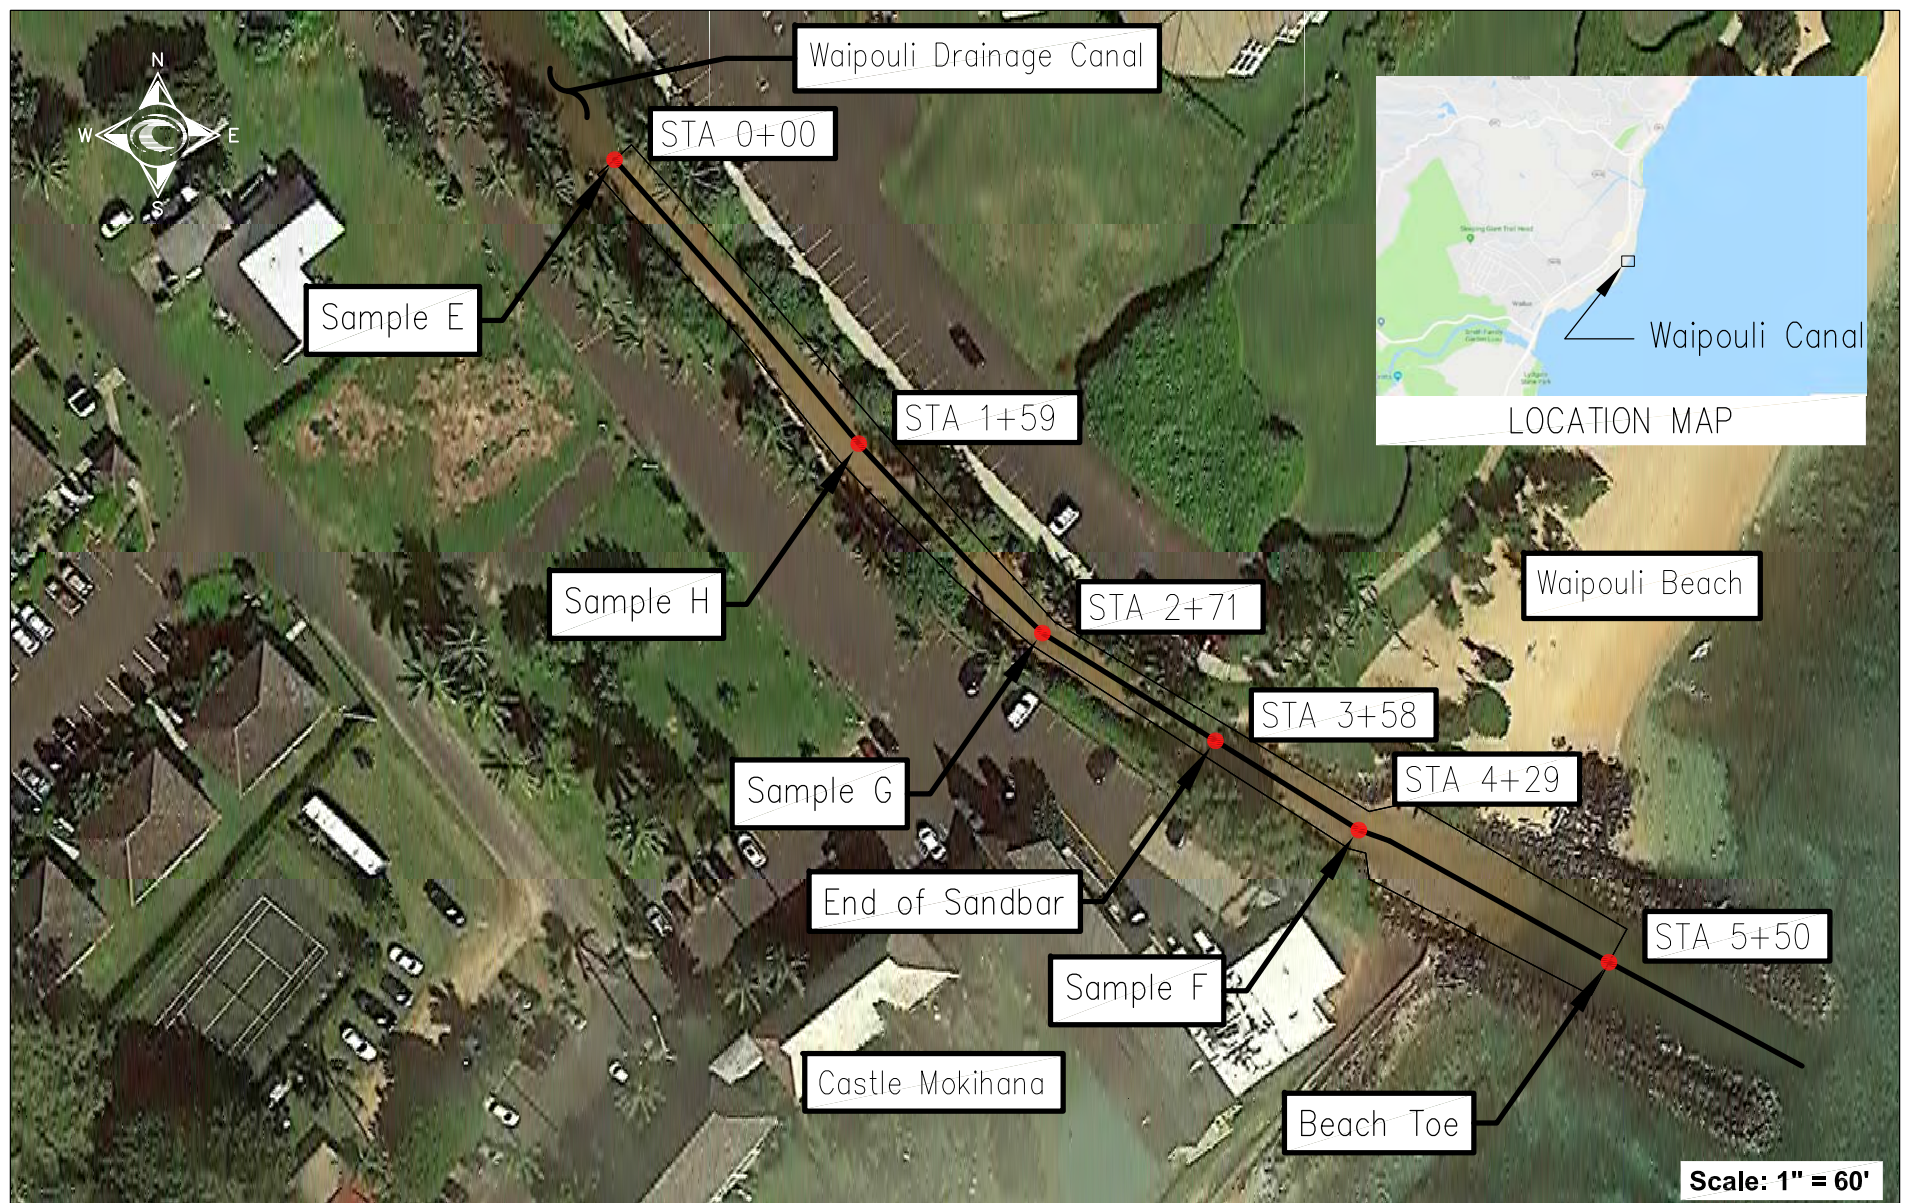
Figure 1: Waipouli Drainage Canal Sediment Sampling
Plan View

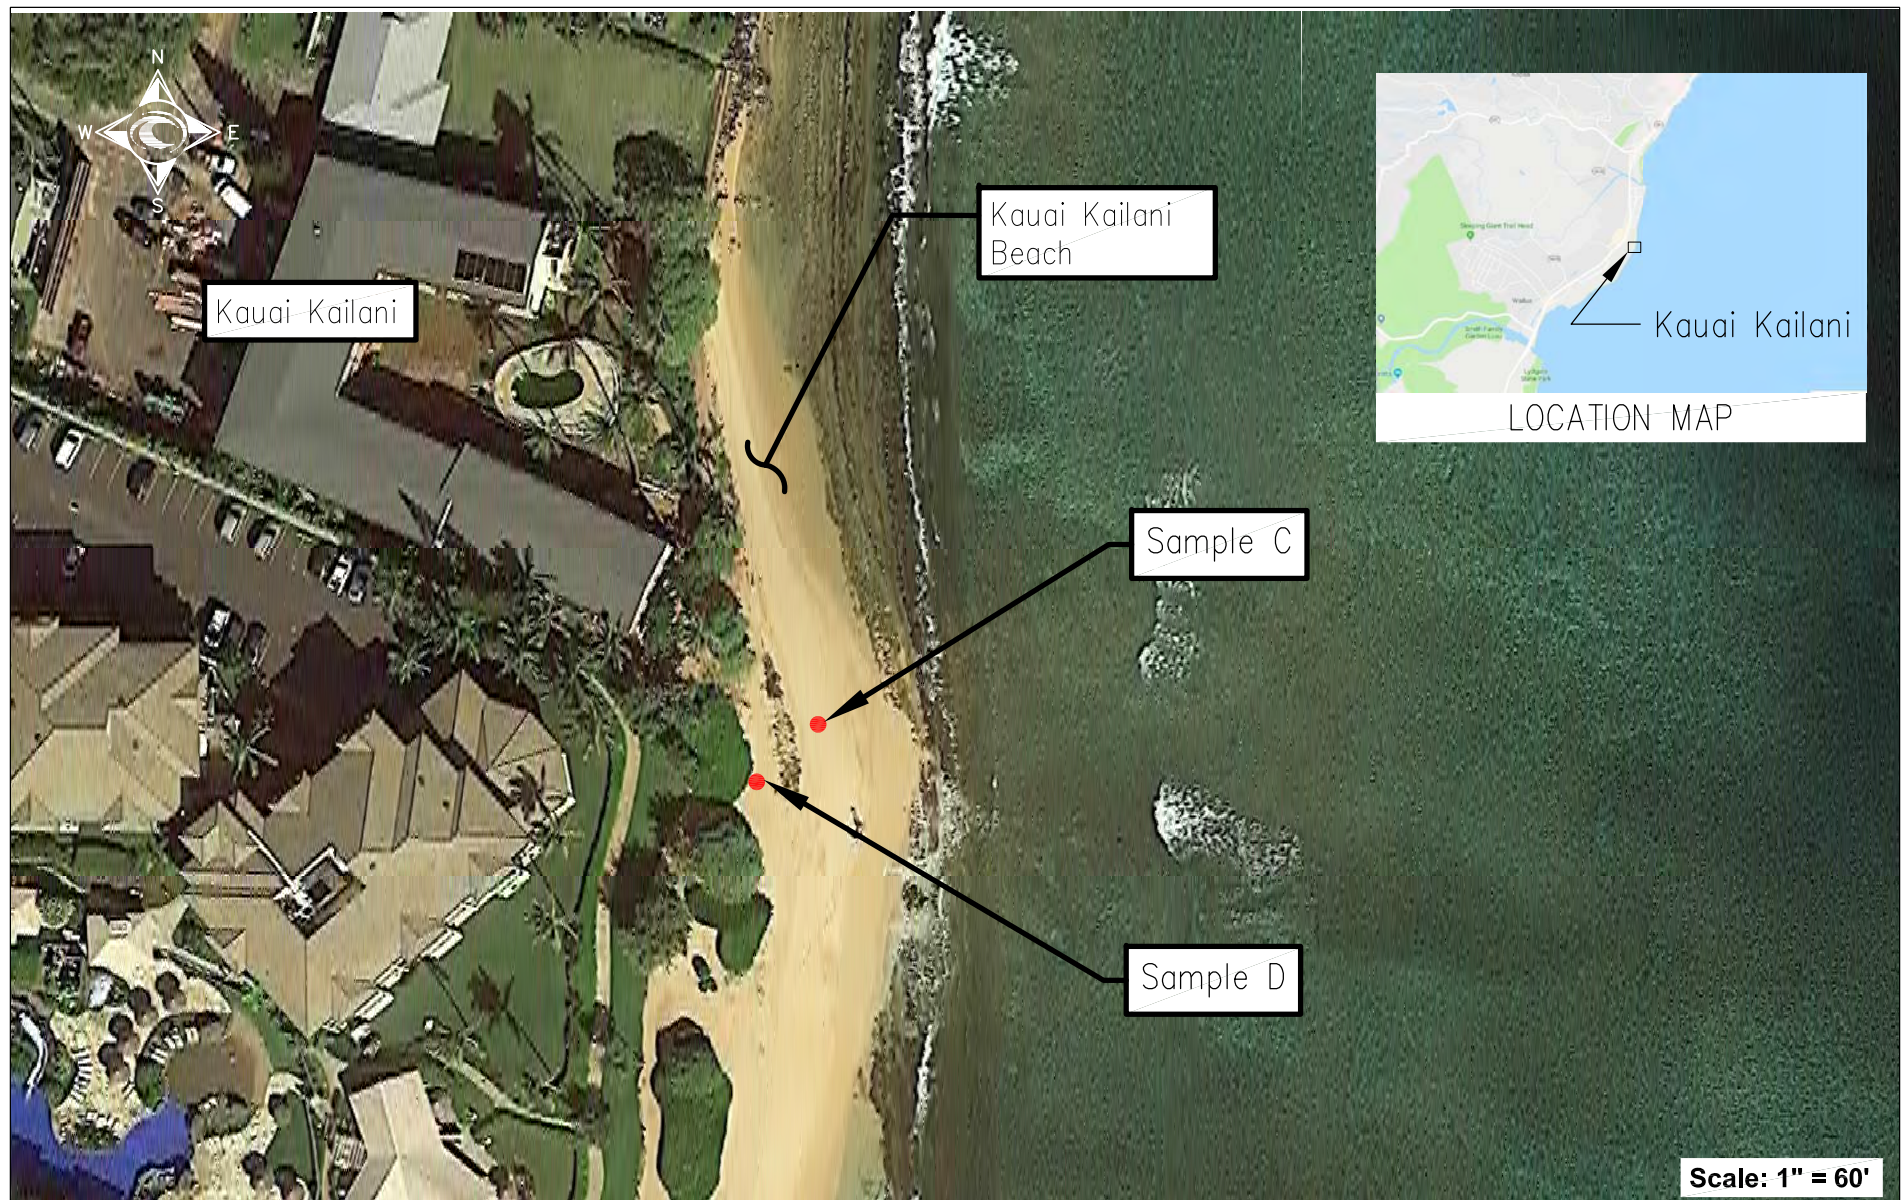
Figure 3: Kauai Kailani Beach Sediment Sampling
Plan View

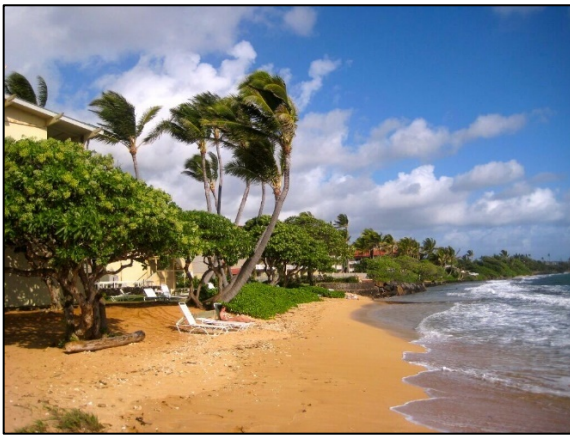
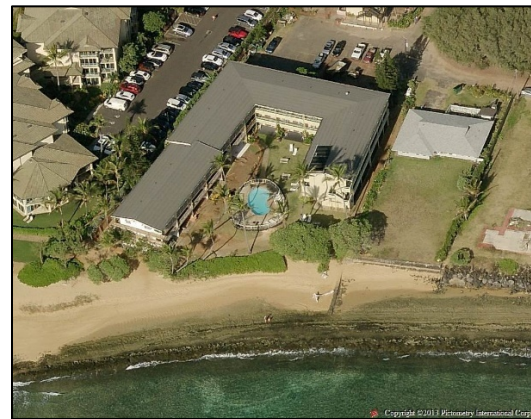
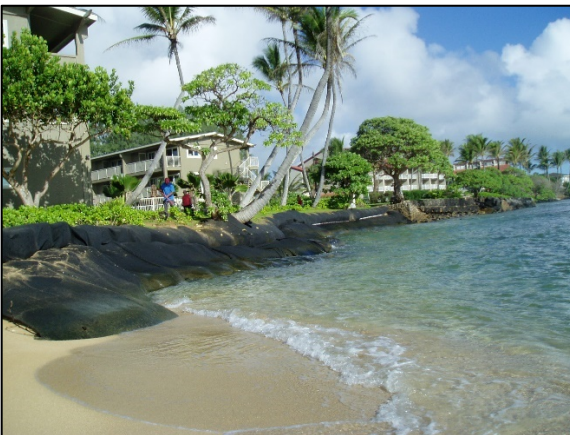
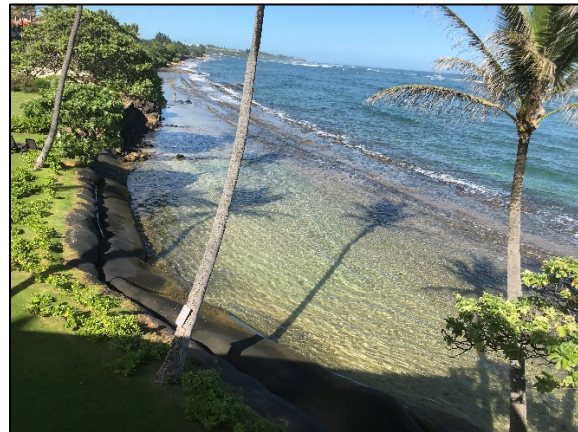
Figure 1-1: Photographs Taken Before (a,b) and After (c,d) Groin Removal

a) Photograph of Kauai Kailani beach taken prior to groin removal.

b) Aerial photograph of Kauai Kailani beach taken prior to groin removal.

c) Photograph of Kauai Kailani beach following groin removal with emergency erosion protection taken on October 31, 2018

d) Photograph of Kauai Kailani beach following groin removal looking down from the Kauai Kailani Apartment buildings taken on October 31, 2018.

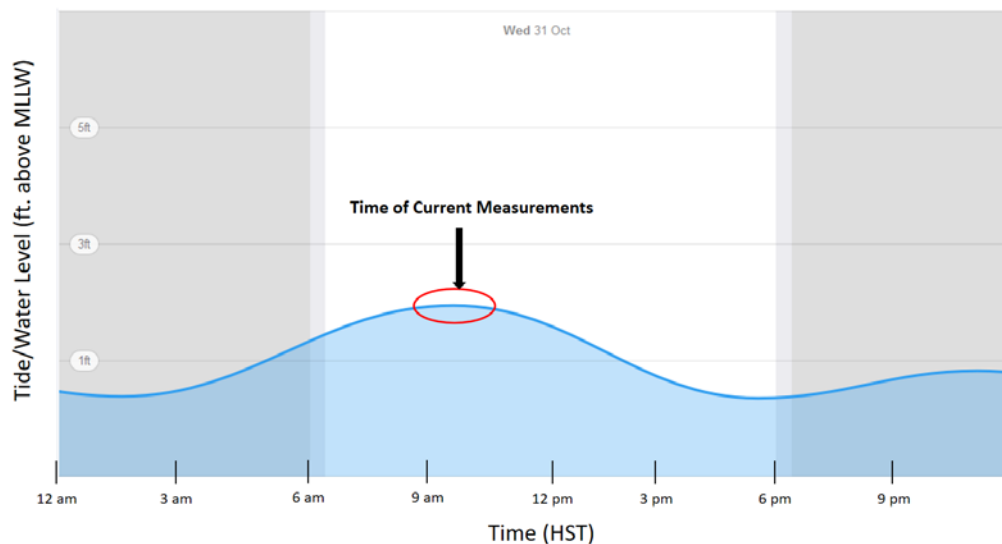
Figure 3-1: Tide Cycle on October 31, 2018 Recorded by NOAA Gage at Nawiliwili

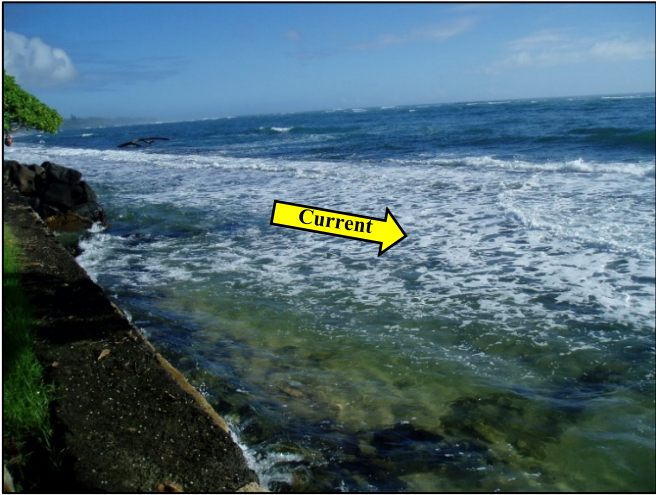
Photograph of the reef flat area inundated during high tide. Photograph taken from the shoreline at about the former groin location, facing northeast.
2

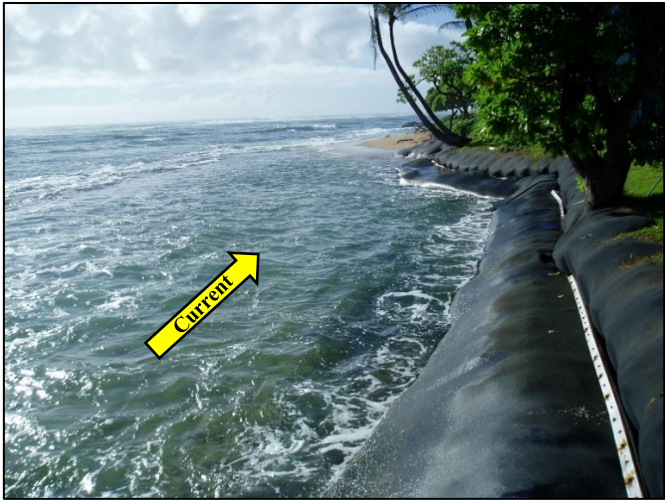
Photograph taken facing southeast along the structure temporarily providing emergency shoreline erosion protection.
3

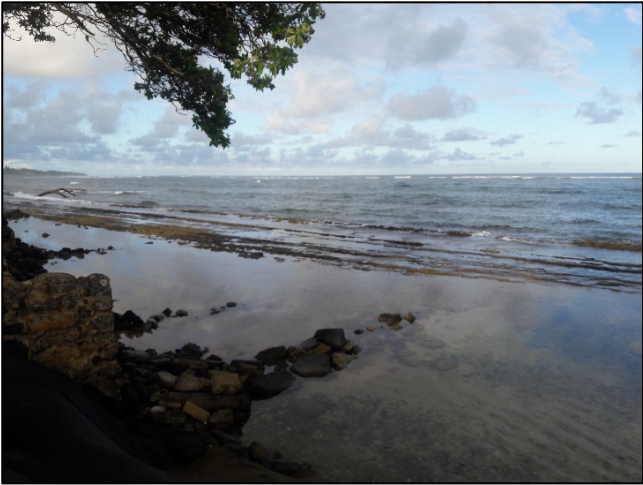
Photograph looking along the former groin location facing northeast.
2

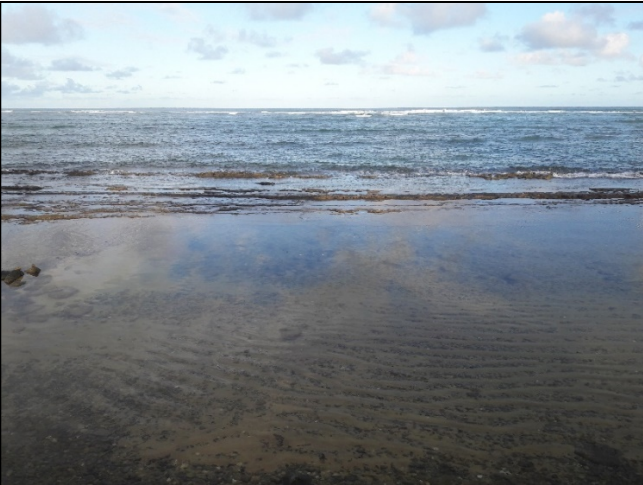
The bottom in the channel area is sandy with scattered rock and coral rubble. Photograph taken facing east.
3

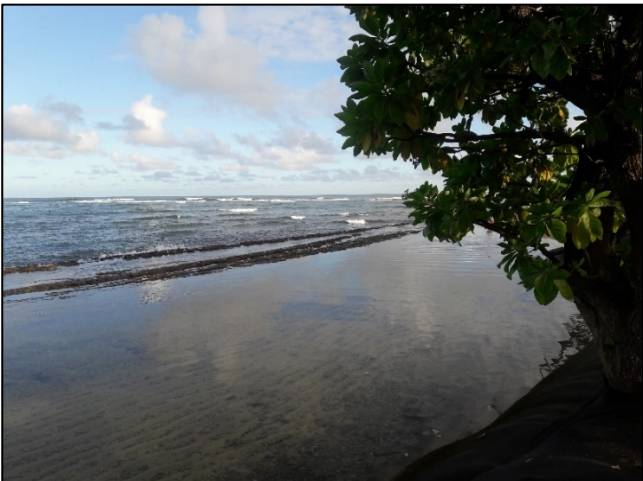
The beach rock reef is exposed during low tide and waves generally do not top the reef crest, resulting in a placid channel area. Photograph taken facing southeast.

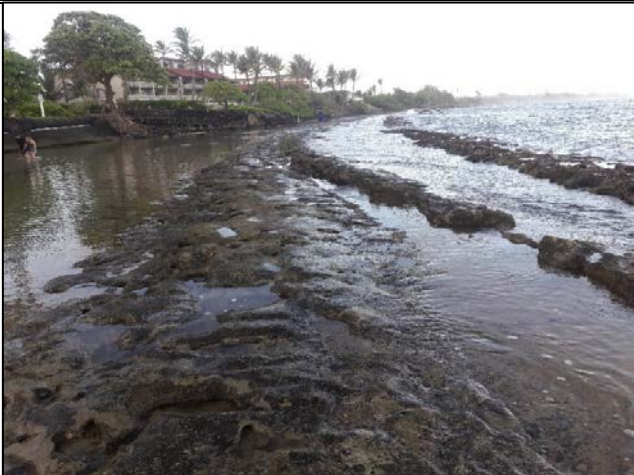
Photograph taken while standing on the beach rock reef looking north along a secondary channel cutting along the reef crest parallel to the shoreline.

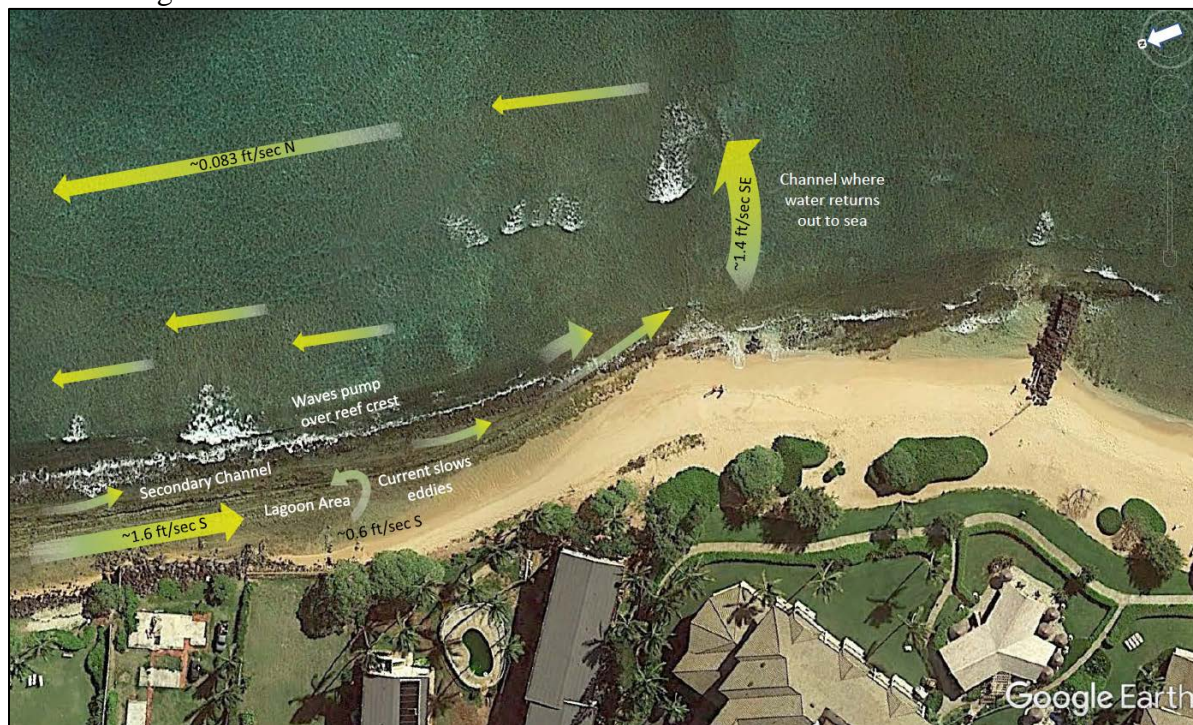
Figure 3-3: Approximate Surface Current Flow Direction and Velocities (Length of Arrows)

Based off the nearshore current measurement data, a map depicting surface current patterns is shown in Figure 3-3.

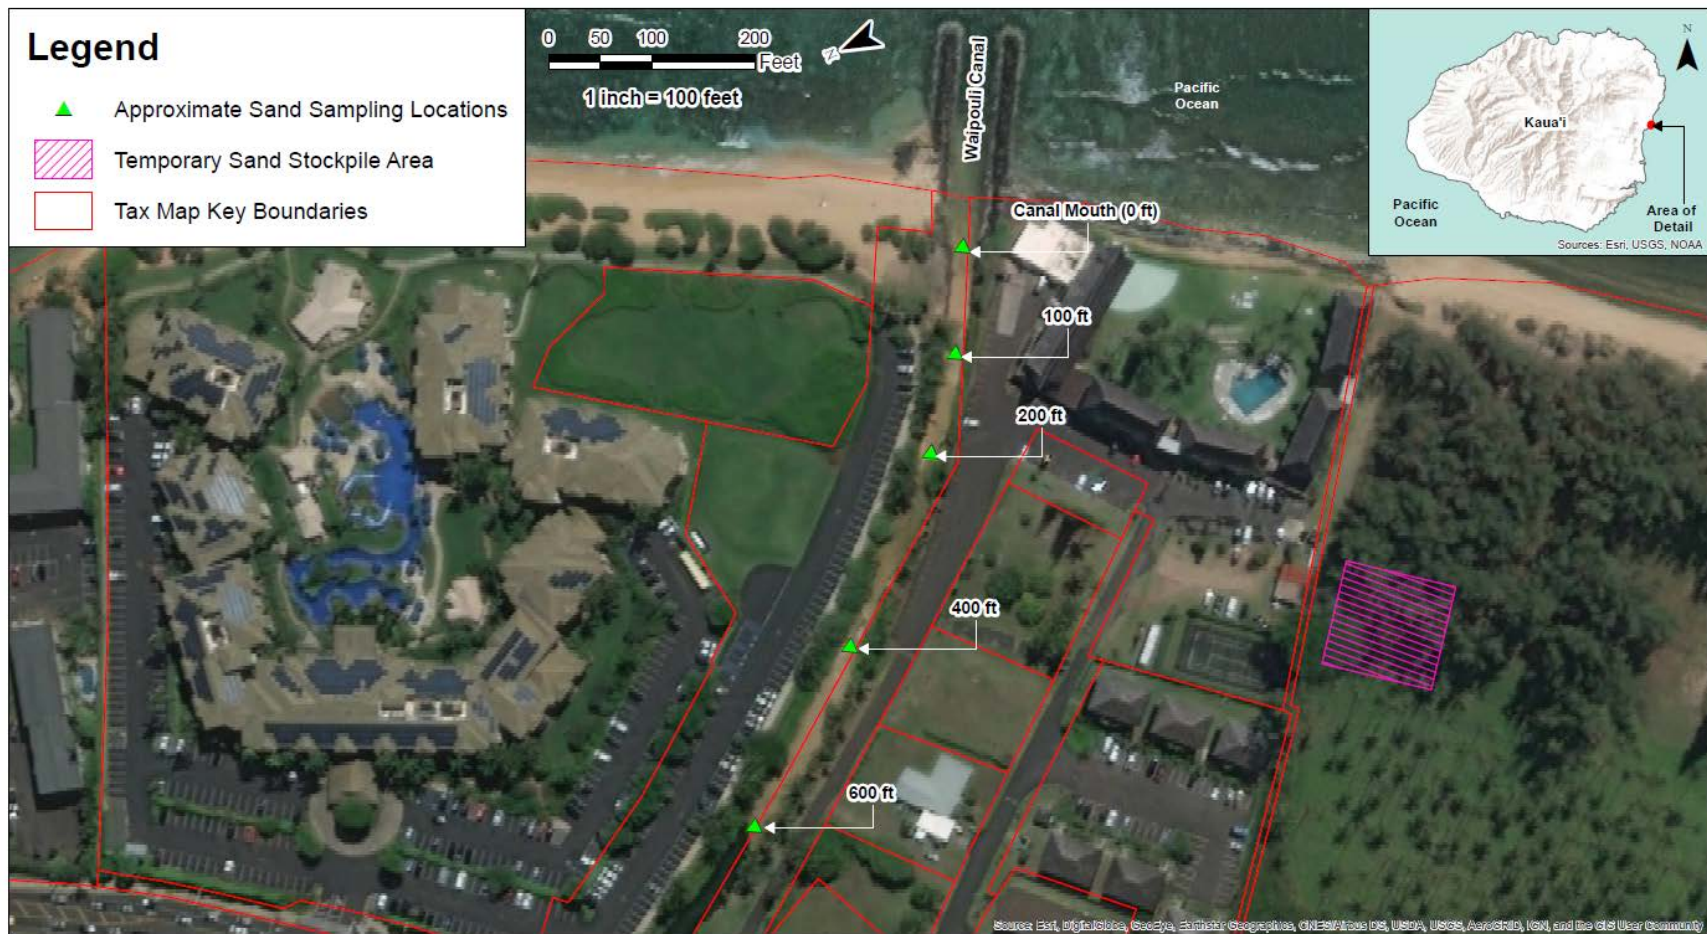
Figure 3-4: Waipouli Canal Approximate Sand Sampling Locations

A polyvinyl chloride (PVC) pipe was driven to three (3) ft bgs or until refusal. At depth, the pipe was cupped and carefully removed from the ground. The sand core was removed from the pipe and photographed. Core samples were collected for further study from surface to six (6) inches bgs and the depth samples were collected from about 2.5 to three (3) ft bgs.

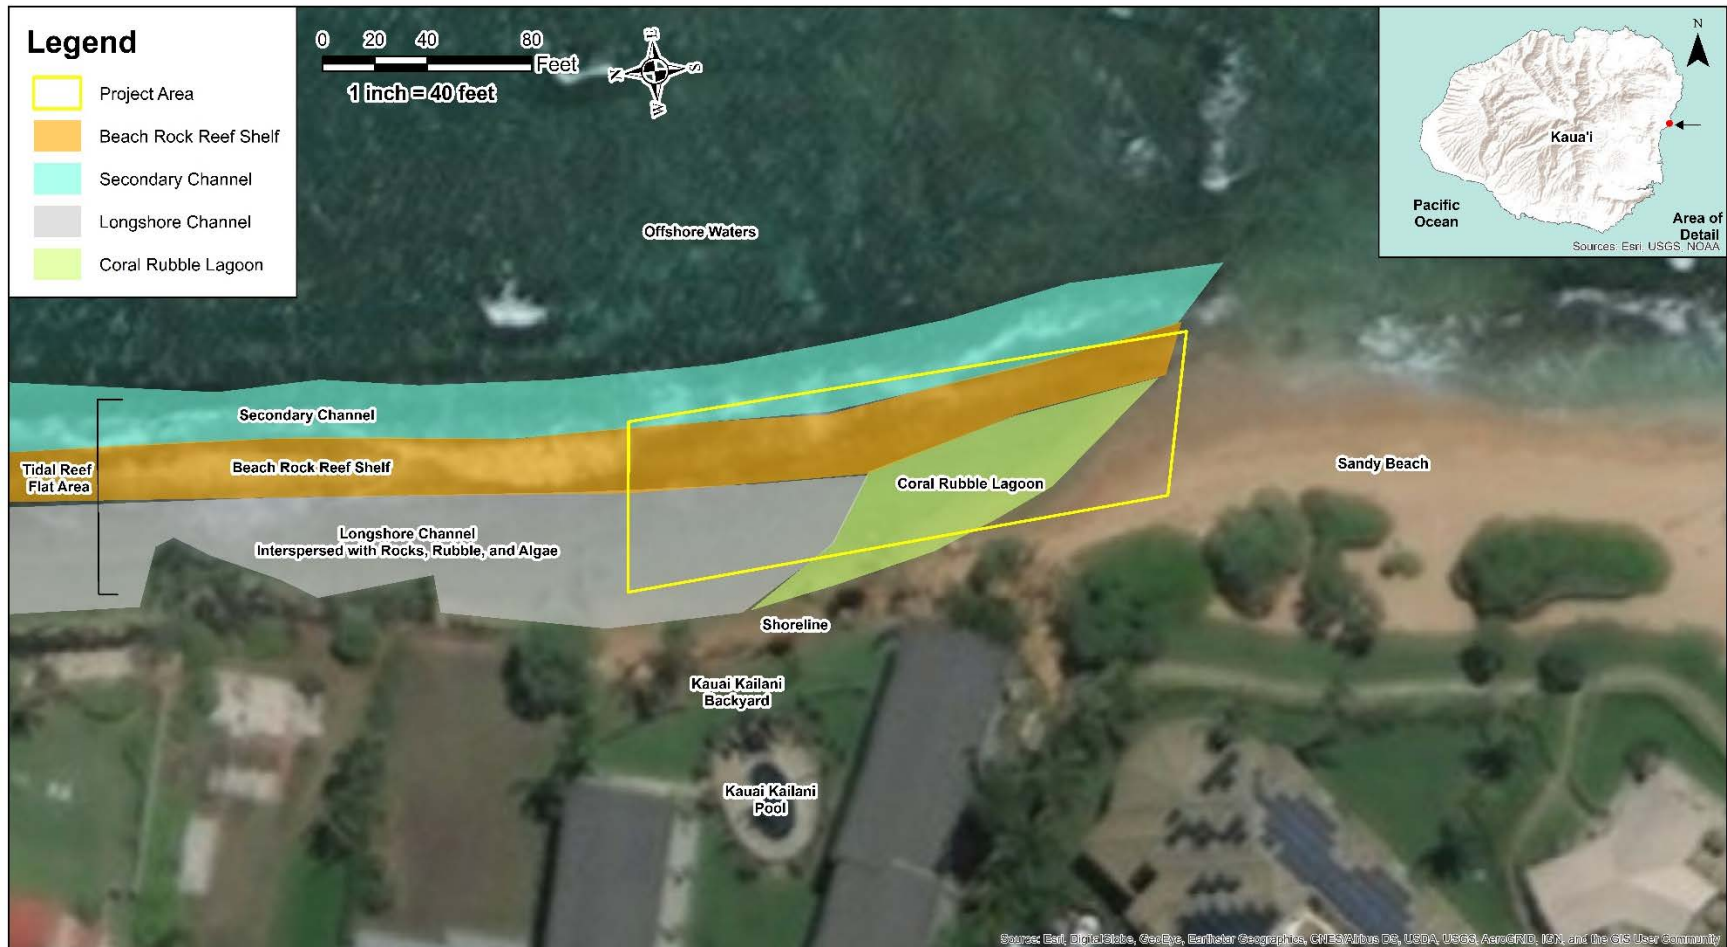
Figure 3-6: Marine Bottom Type Map

No live corals were observed in the reef flat area. Corals were observed in the offshore area outside of the project site and consisted mainly of cauliflower corals (*Pocillopora meandrina*), *Porites lobata*, and few *Montipora spp.* and *Acropora spp.* individuals. This area is in shallow water exposed to high wave action, therefore live corals are rare in the area.
