Waikīkī Beach Improvement and Maintenance Program

Environmental Impact Statement Preparation Notice (EISPN)
Public Scoping Meeting
January 7, 2021 | 2:00pm – 5:00pm

ENVIRONMENTAL IMPACT STATEMENT PREPARATION NOTICE

Waikiki Beach Improvement and Maintenance Program

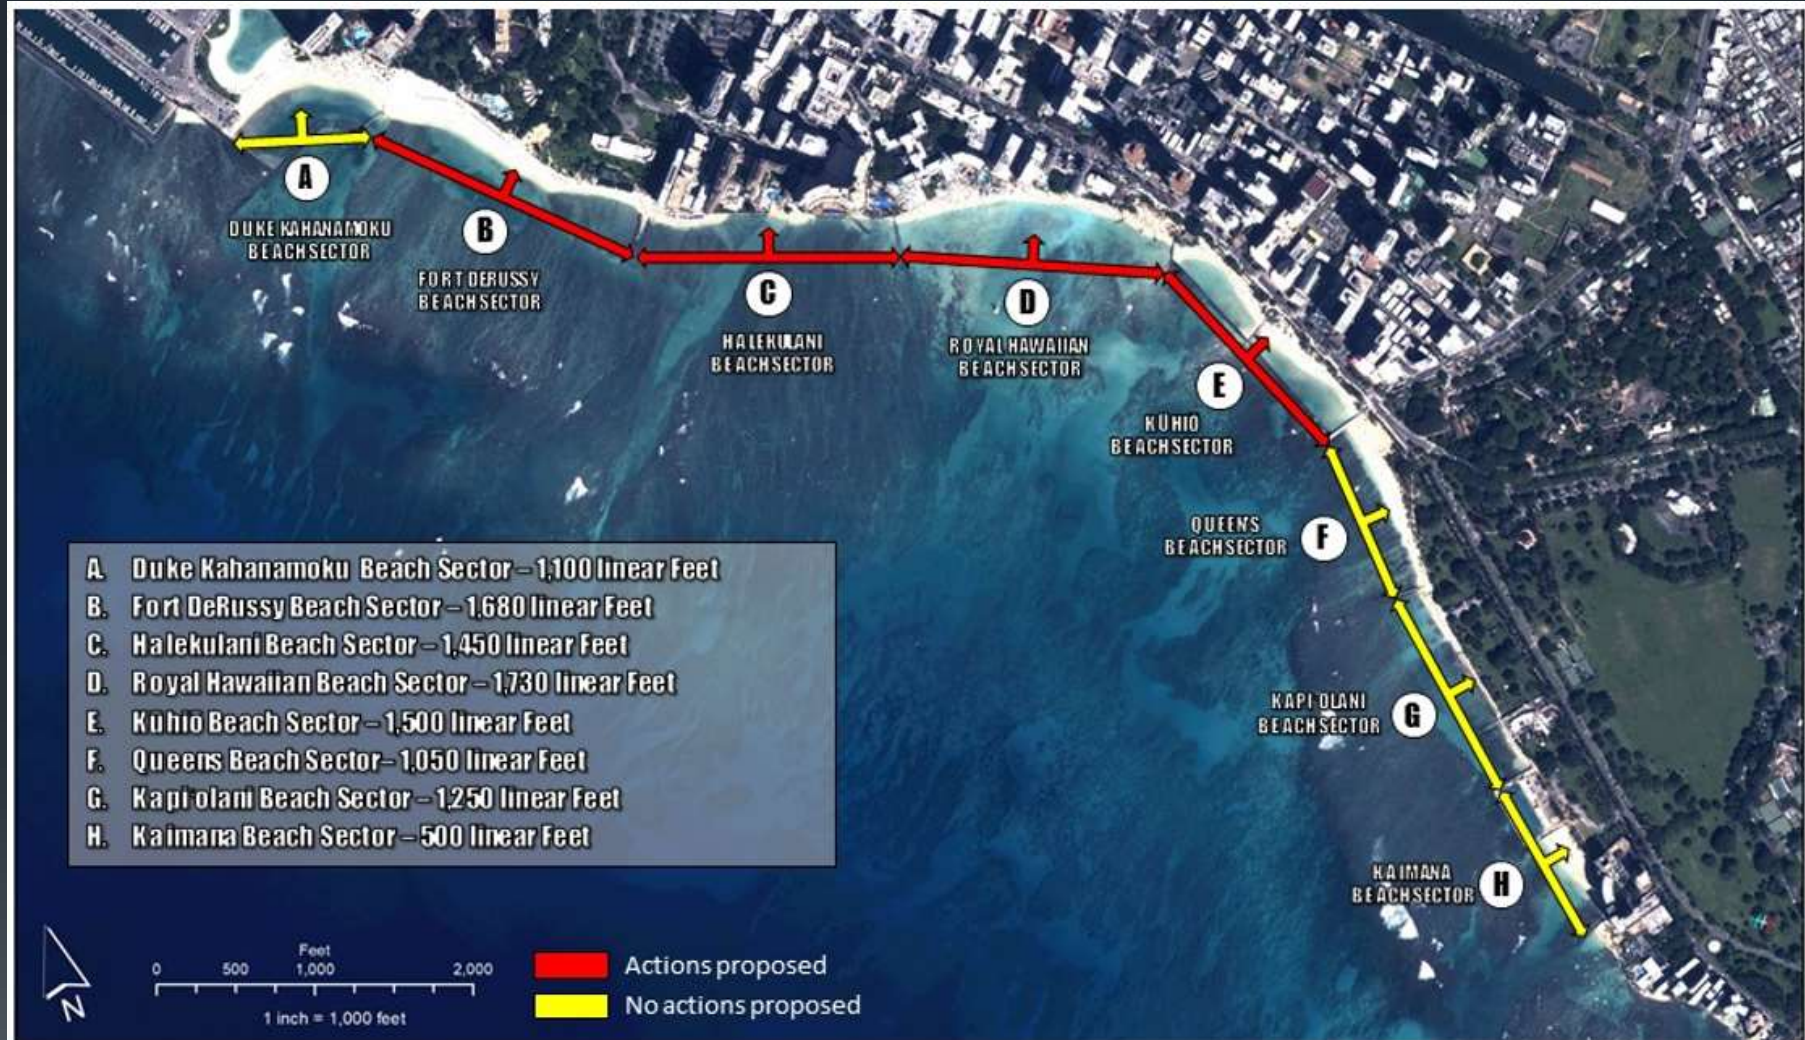
WAIKĪKĪ BEACH SECTORS

- Waikiki spans over 10,000 linear feet (2 miles) of shoreline.
- Groins compartmentalize the shoreline into 8 littoral cells (beach sectors).
- ***Duke Kahanamoku Beach Sector*** consists of approximately 1,100 feet of shoreline from a rubblemound breakwater to the Hilton Hawaiian Village pier.

- ***Fort DeRussy Beach Sector*** consists of approximately 1,680 feet of shoreline from the Hilton Hawaiian Village pier to the Fort DeRussy outfall groin.

- ***Halekūlani Beach Sector*** consists of approximately 1,450 feet of shoreline from the Fort DeRussy outfall groin to the Royal Hawaiian groin.
- ***Royal Hawaiian Beach Sector*** consists of approximately 1,730 feet of shoreline from the Royal Hawaiian groin to the 'Ewa (west) groin at Kūhiō Beach Park.

- ***Kūhiō Beach Sector*** consists of approximately 1,500 feet of shoreline from the 'Ewa (west) groin at Kūhiō Beach Park to the Kapahulu storm drain.

- ***Queen's Beach Sector*** consists of approximately 1,050 feet of shoreline from the Kapahulu storm drain to the Queen's Surf groin.
- ***Kapi'olani Beach Sector*** consists of approximately 1,250 feet of shoreline from the Queen's Surf groin to the north wall of the Waikīkī Natatorium War Memorial.

- ***Kaimana (Sans Souci) Beach Sector*** consists of approximately 500 feet of shoreline from the north wall of the Waikīkī Natatorium War Memorial to the rubblemound groin fronting the New Otani (Kaimana) Hotel.

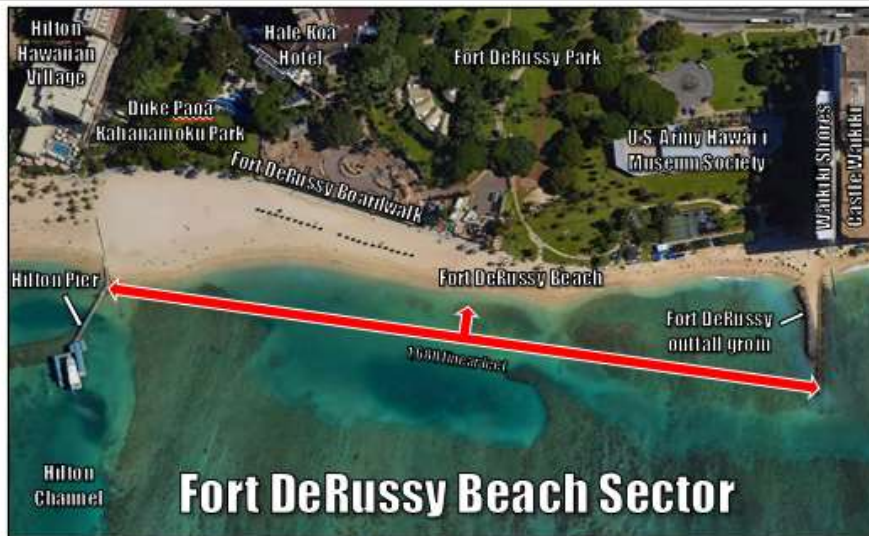
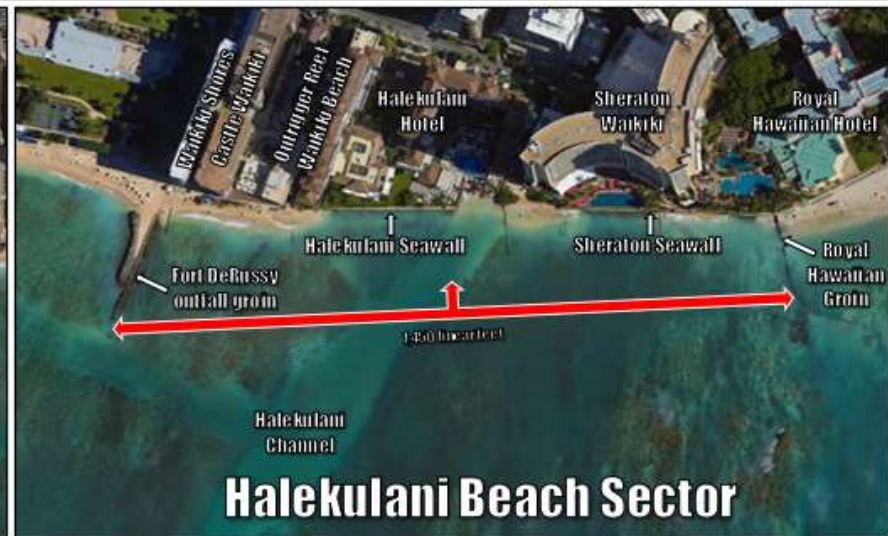
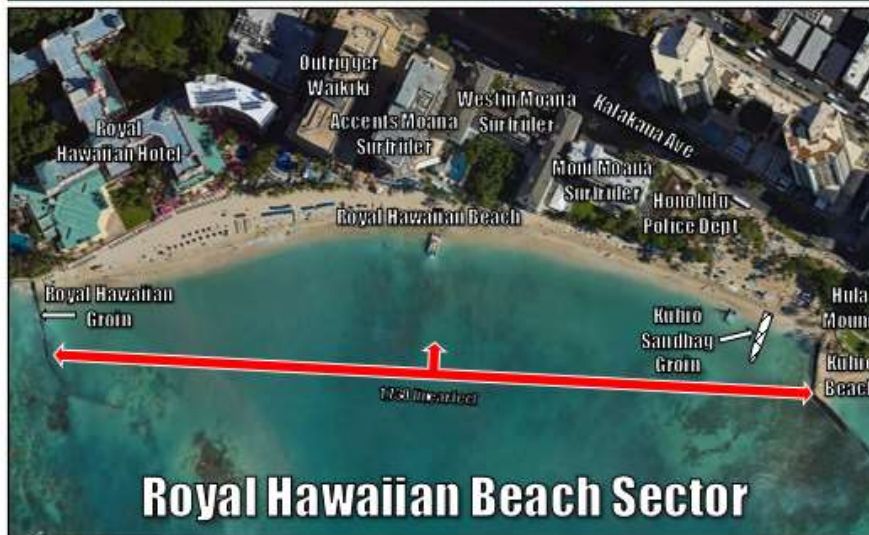
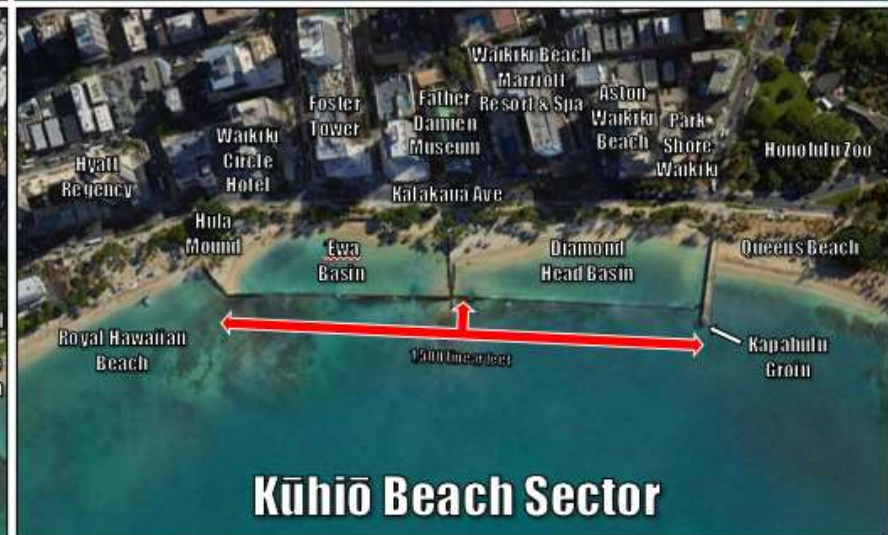
WAIKĪKĪ BEACH SECTORS SELECTED FOR IMPROVEMENT AND MAINTENANCE ACTIONS

1. Royal Hawaiian Beach sector (50%).
2. Kūhiō Beach sector (25%).
3. Halekūlani Beach sector (19%).
4. Fort DeRussy Beach sector (6%).

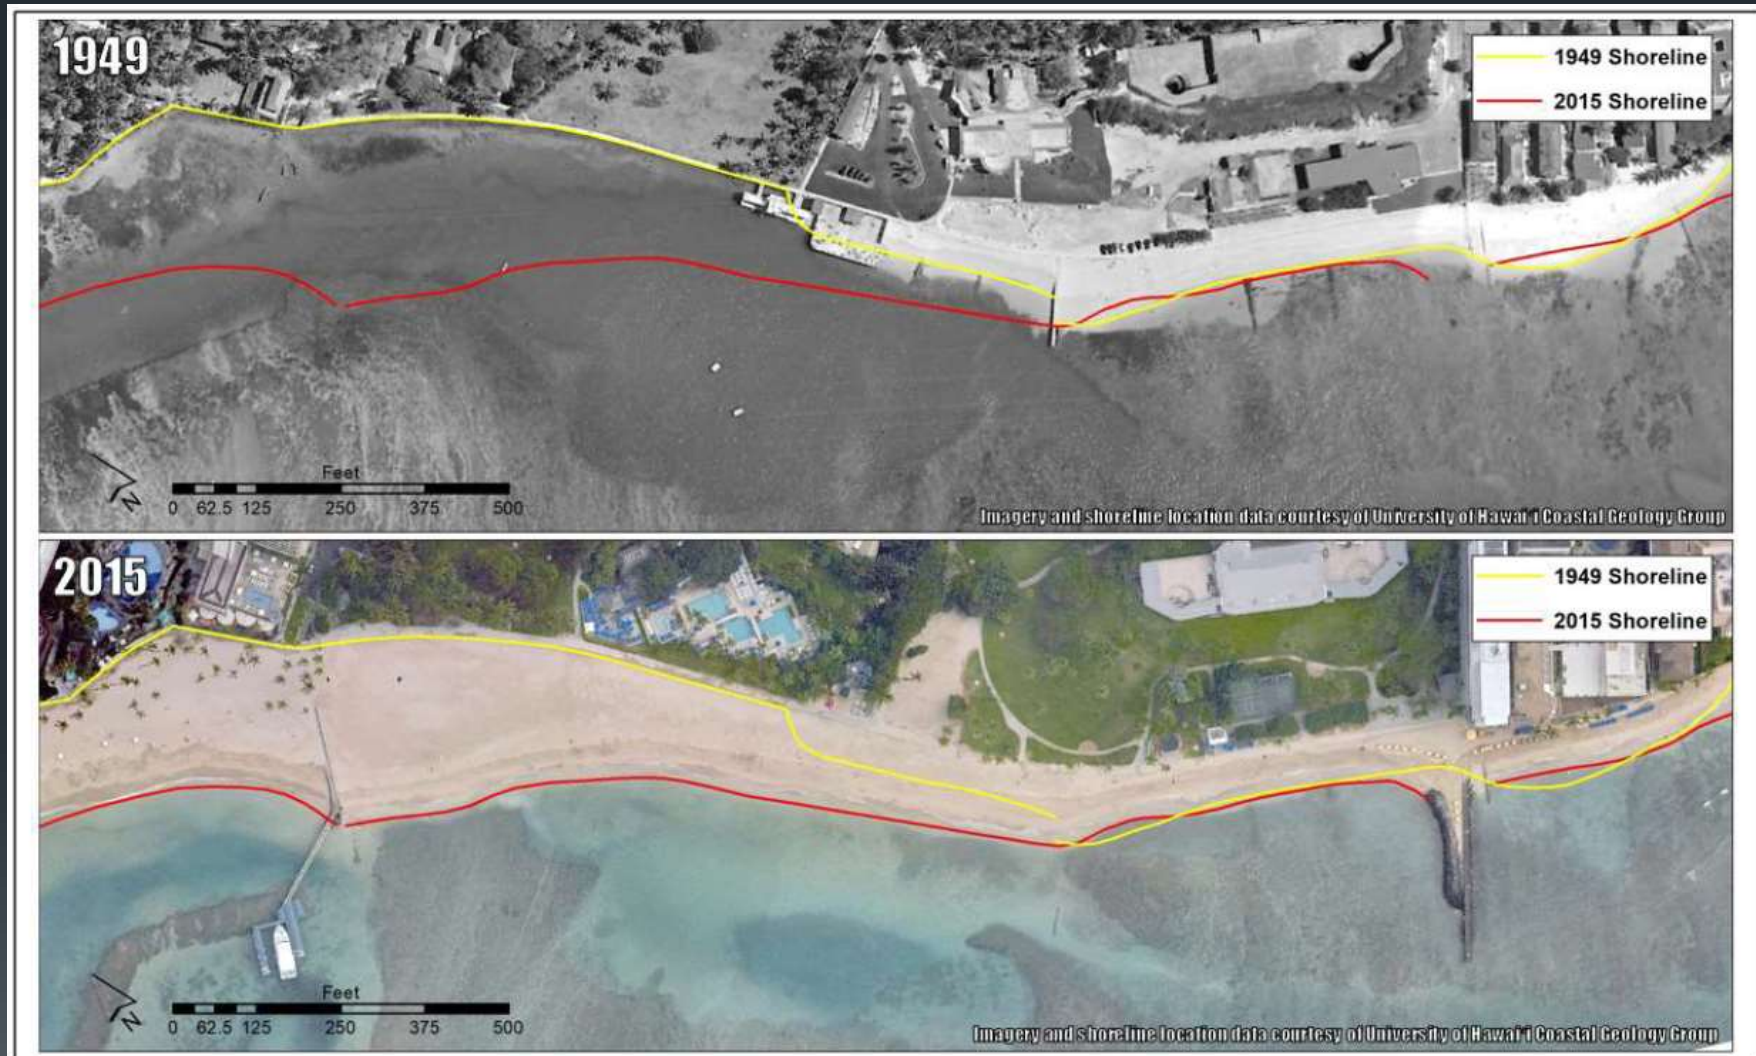
HISTORICAL SHORELINE POSITIONS – FORT DERUSSY BEACH SECTOR

- Fort DeRussy Beach Sector is an entirely engineered shoreline.
- Entire shoreline is armored by a seawall that was constructed in 1916.
- Beach was constructed in the early 1970's.
- East end of the beach has been eroding at a rate of -1.2 feet/year.
- West end of the beach has been accreting at a rate of +0.4 feet/year.
- Erosion is more pronounced at the east end of the beach because the predominant direction of sediment transport is from east to west.
- No beach improvements or maintenance since the mid-1990's.

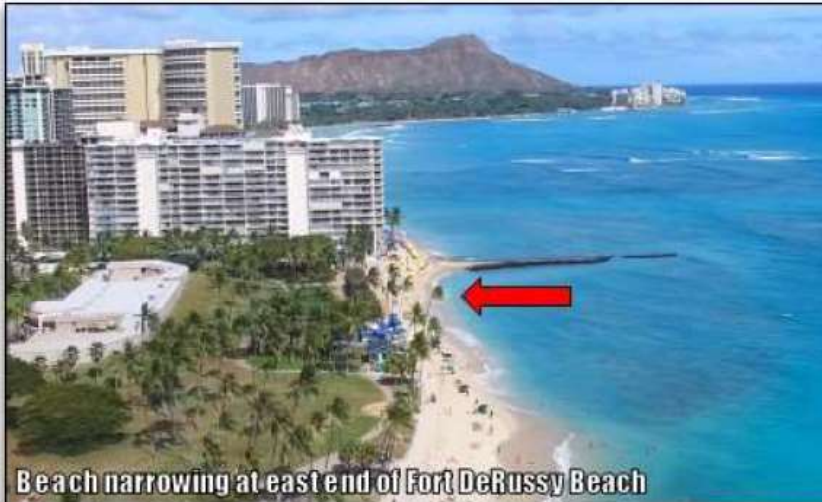
Beach narrowing at east end of Fort DeRussy Beach

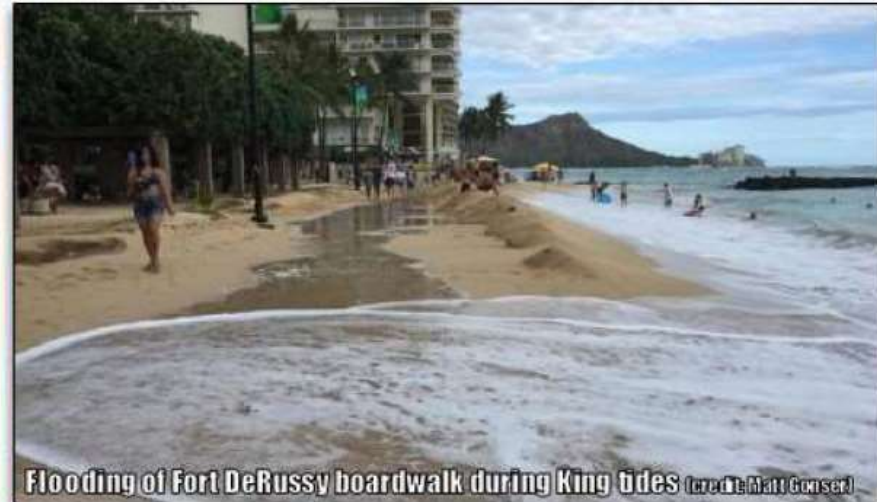
Flooding of Fort DeRussy boardwalk during King tides (credit: Matt Gonsen)

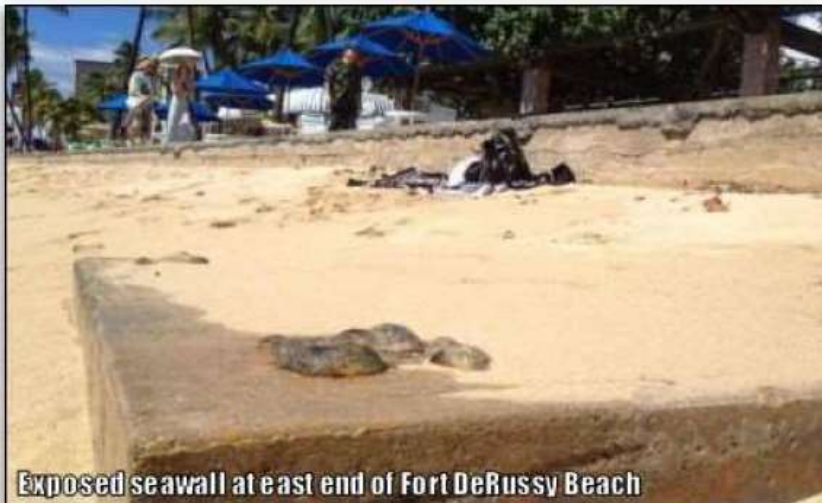
Exposed seawall at east end of Fort DeRussy Beach

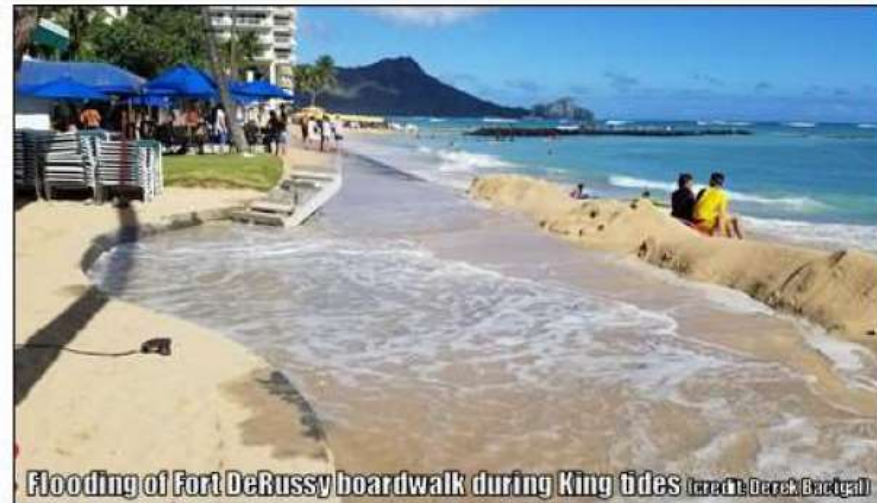
Flooding of Fort DeRussy boardwalk during King tides (credit: Derek Bartol)

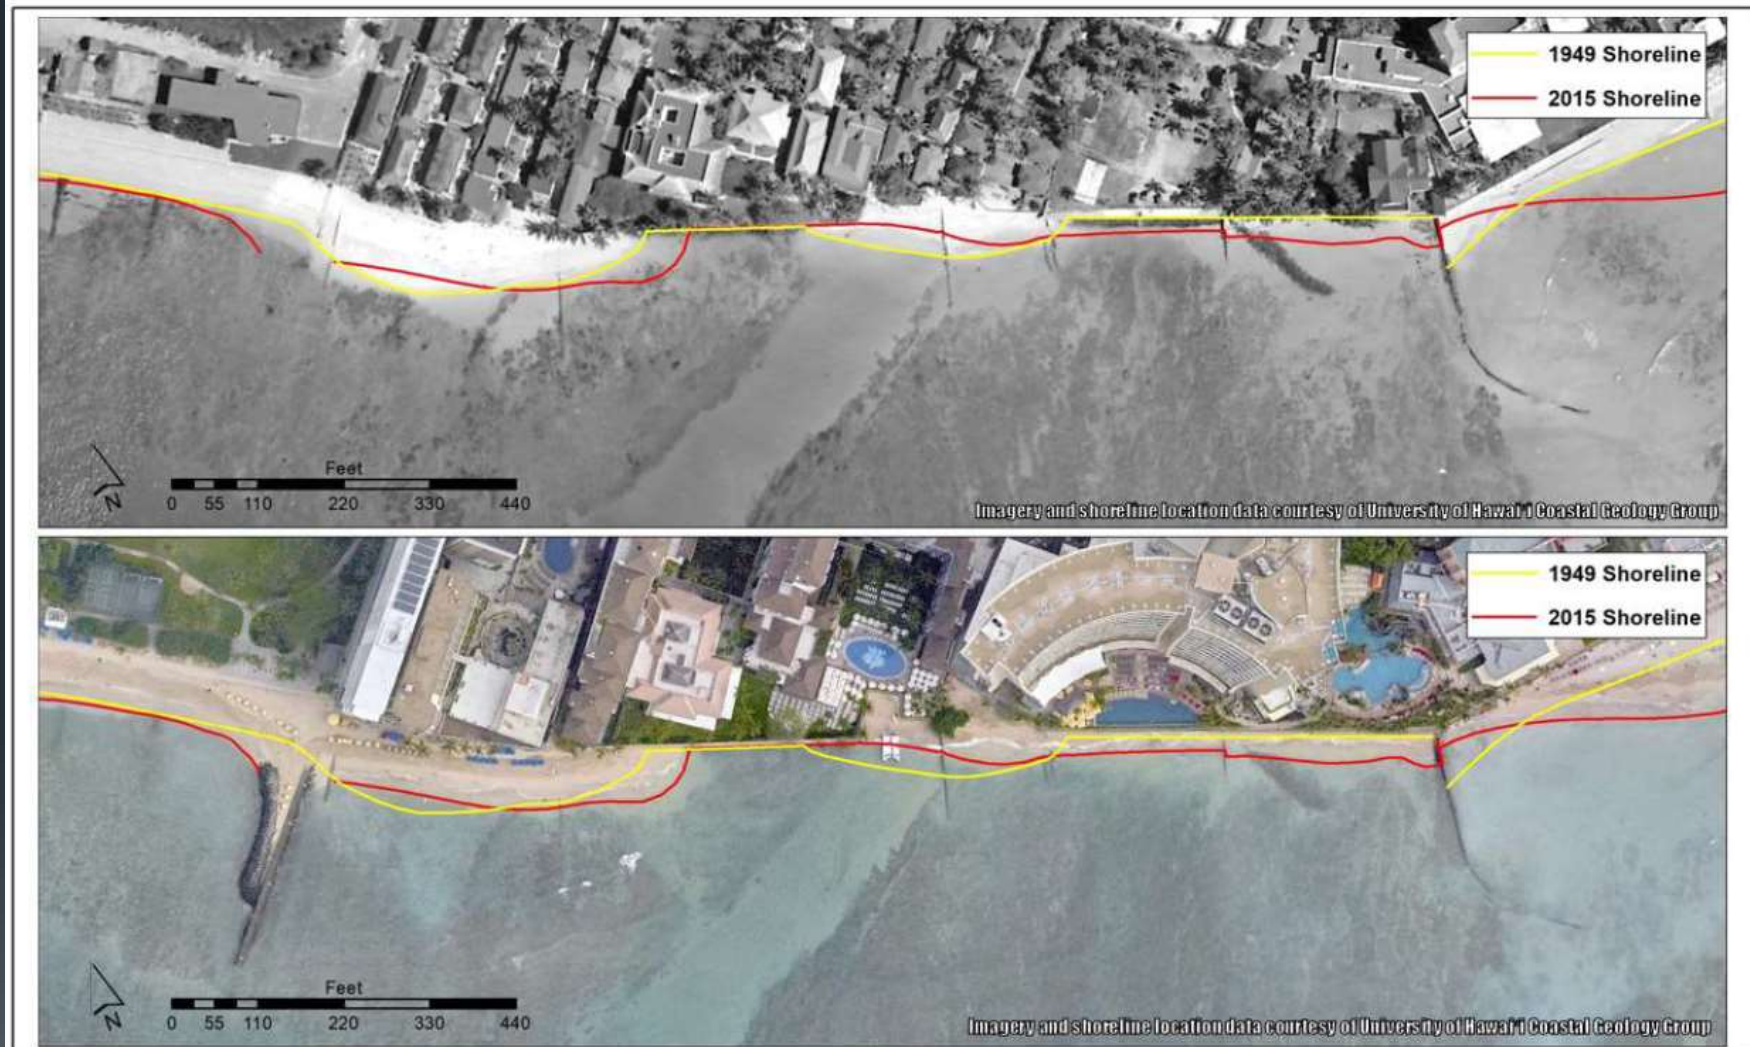
HISTORICAL SHORELINE POSITIONS – HALEKULANI BEACH SECTOR

- Halekūlani Beach Sector is an entirely engineered shoreline.
- Entire shoreline is armored by seawalls constructed in the early 1900's.
- Beach has changed very little over the past century.
- With the exception of the replacement of the Royal Hawaiian Groin in 2020, no beach improvements or maintenance since the 1930's.

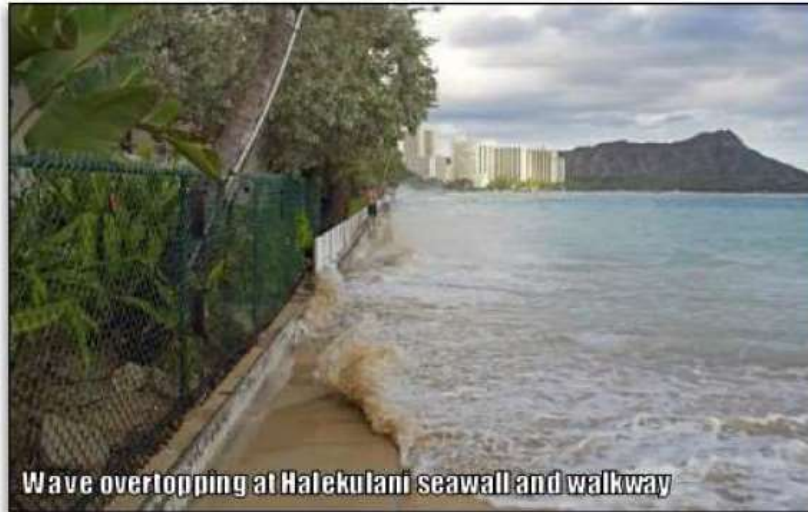
Wave overtopping at Halekulani seawall and walkway

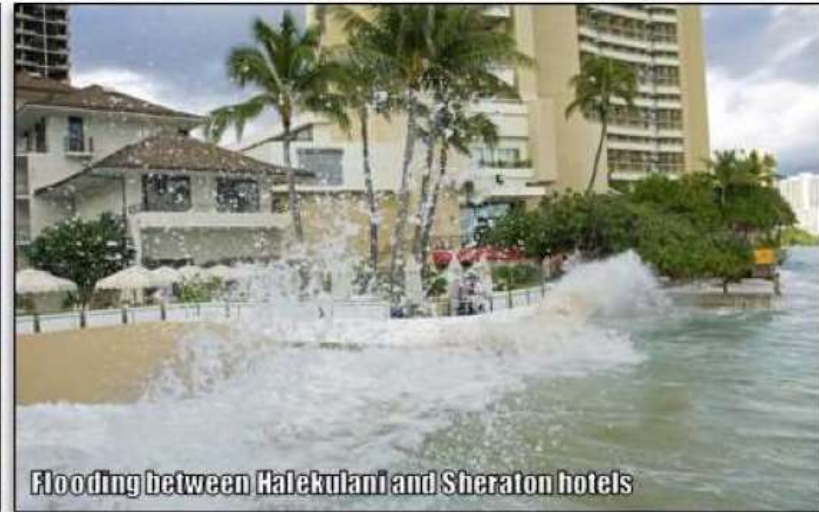
Flooding between Halekulani and Sheraton hotels

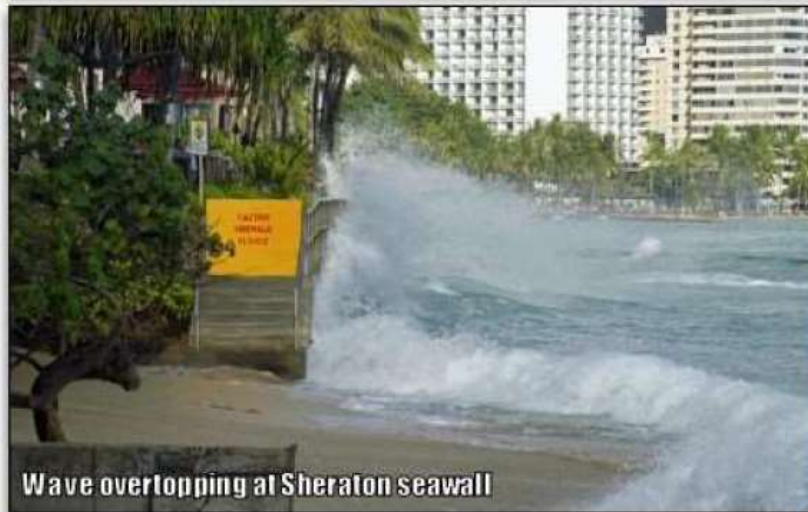
Wave overtopping at Sheraton seawall

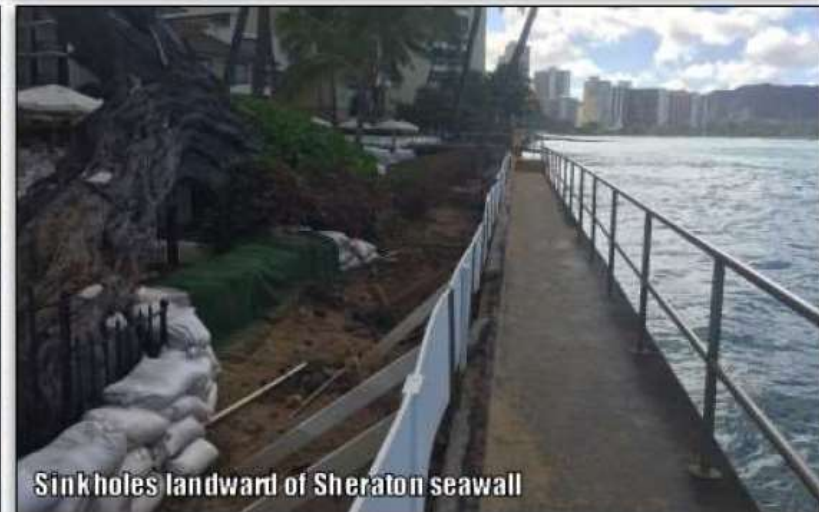
Sink holes landward of Sheraton seawall

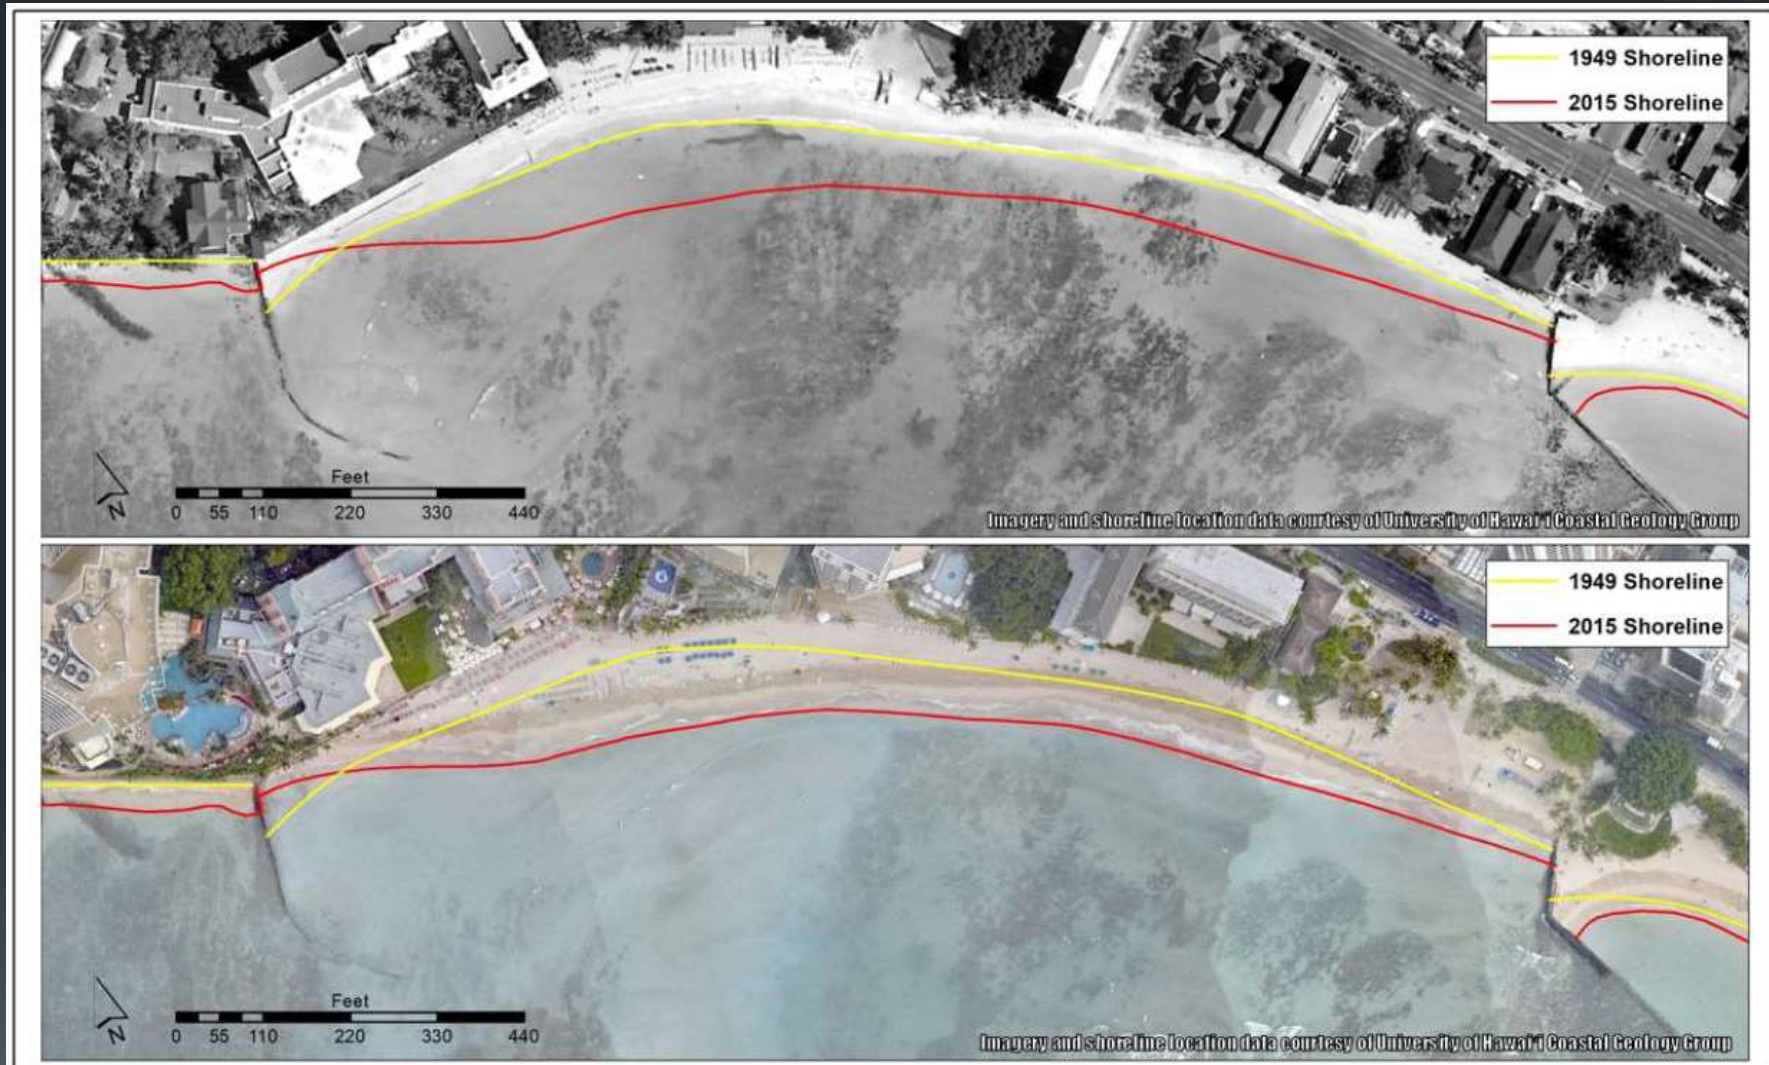
HISTORICAL SHORELINE POSITIONS – ROYAL HAWAIIAN BEACH SECTOR

- Royal Hawaiian Beach Sector is an entirely engineered shoreline.
- Mostly armored by seawalls constructed in the early 1900's.
- Beach has been chronically eroding since the mid-1980's.
- Recent beach improvements: Waikīkī Beach Maintenance I (May 2012), Kūhiō Sandbag Groin (Nov 2019), Royal Hawaiian Groin Replacement (Aug 2020), Waikīkī Beach Maintenance II (planned for 2021).

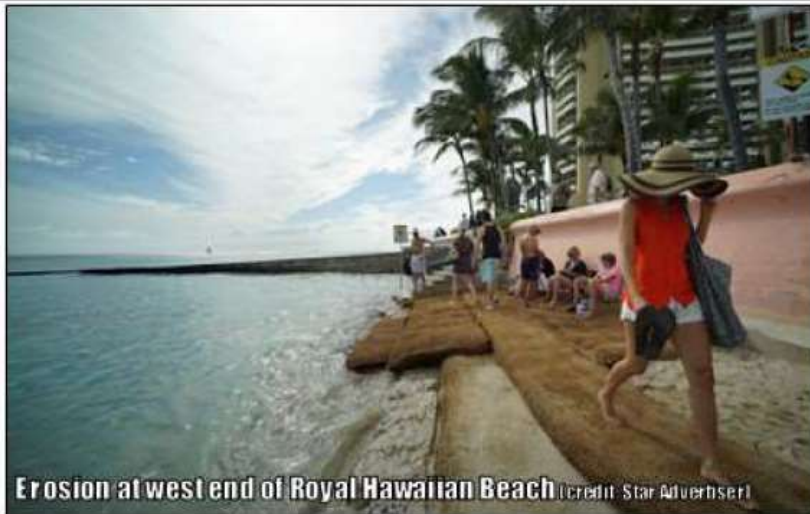
Erosion at west end of Royal Hawaiian Beach (credit: Star Advertiser)

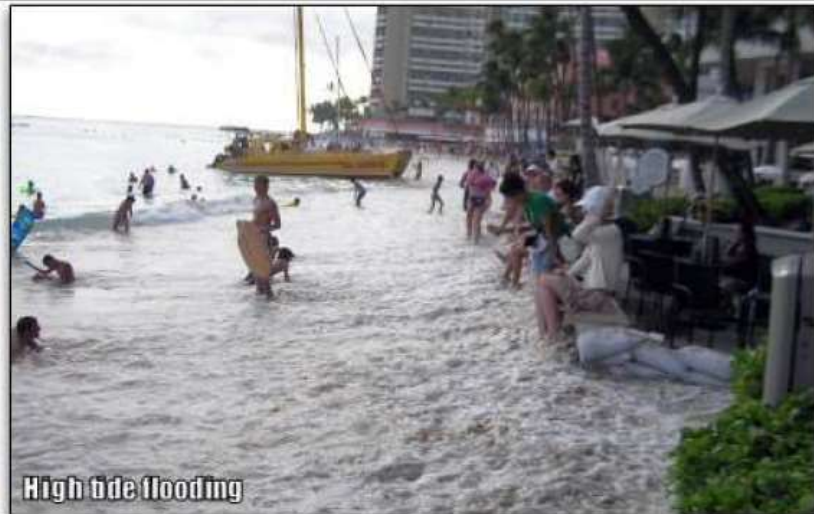
High tide flooding

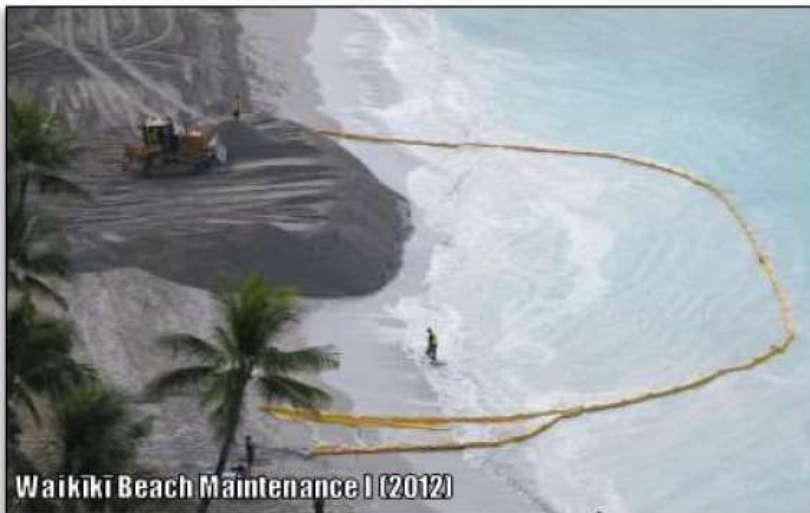
Waikiki Beach Maintenance I (2012)

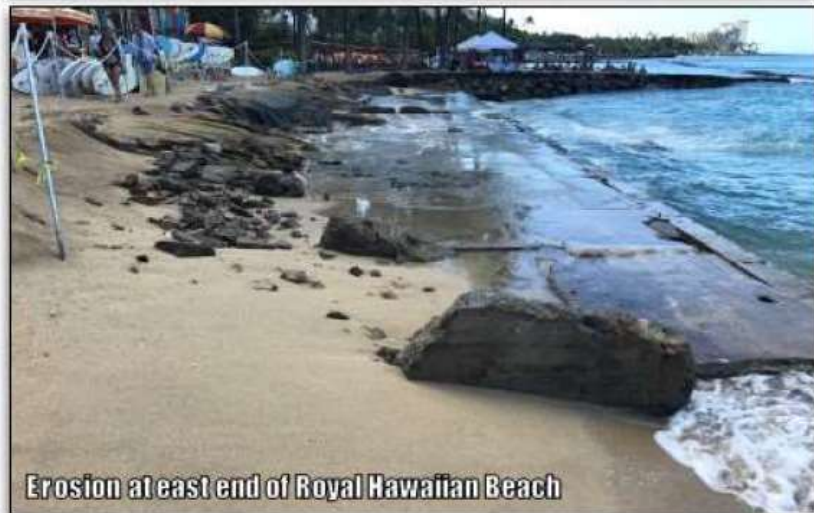
Erosion at east end of Royal Hawaiian Beach

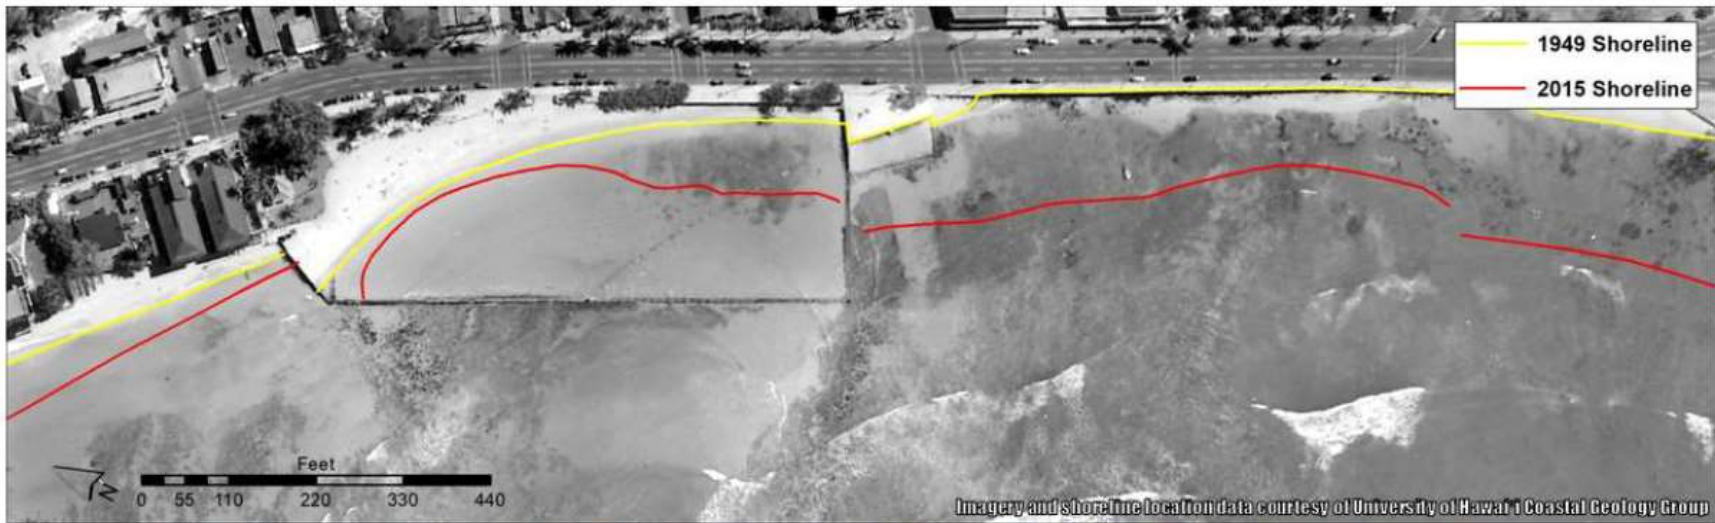
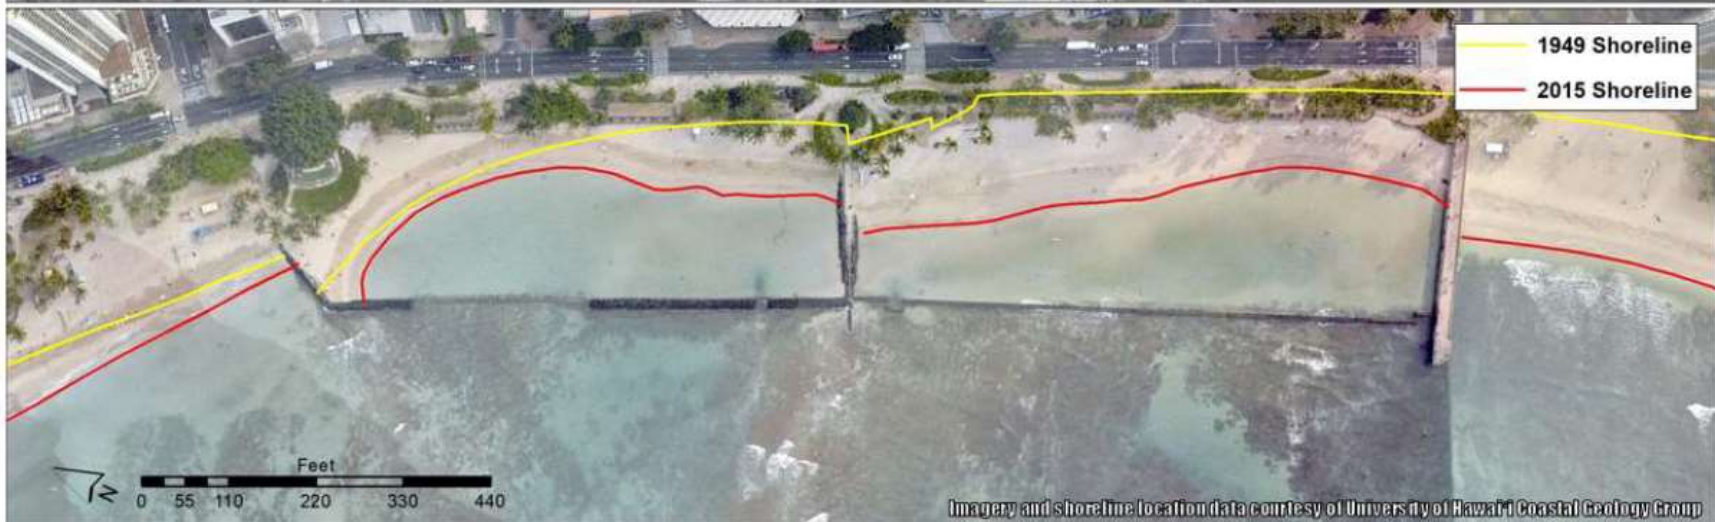
HISTORICAL SHORELINE POSITIONS – KŪHIŌ BEACH SECTOR

- Kūhiō Beach Sector is an entirely engineered shoreline.
- Shoreline is entirely armored by seawalls constructed in the early 1900's.
- Breakwater and beach constructed to form 'Ewa Basin in 1939.
- Breakwater and beach constructed to form Diamond Head Basin in 1953.
- Various beach maintenance efforts from 1950-2000.
- Recent beach improvements: Kūhiō Beach Nourishment (2006).

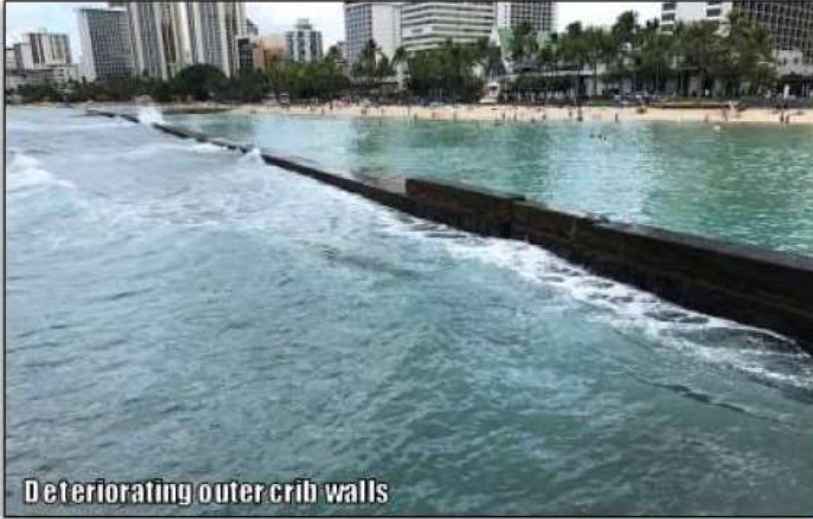
Deteriorating outer crib walls

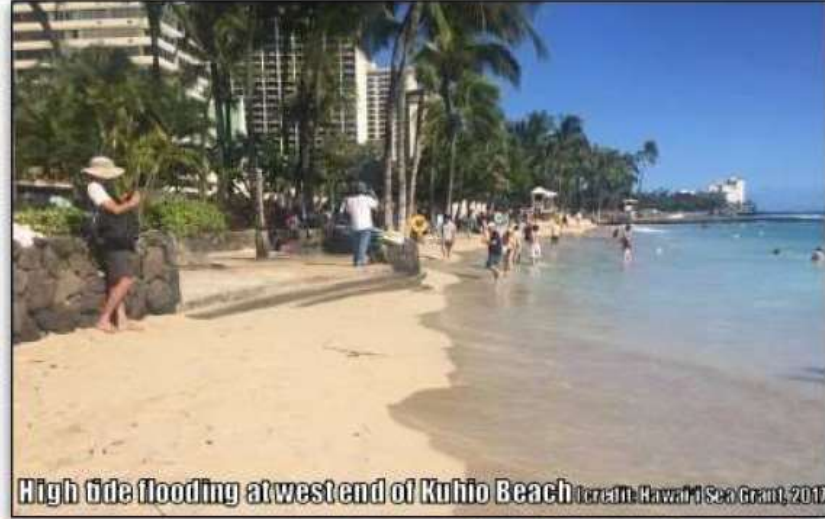
High tide flooding at west end of Kūhiō Beach (credit: Hawaii Sea Grant, 2017)

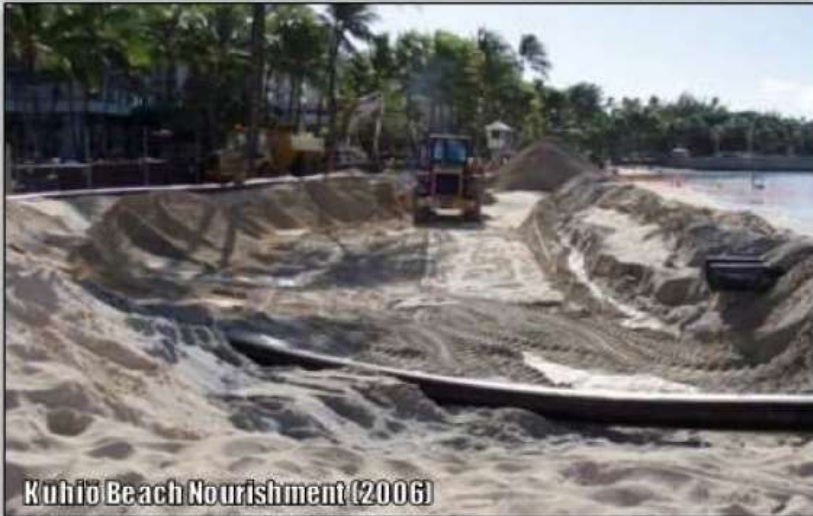
Kūhiō Beach Nourishment (2006)

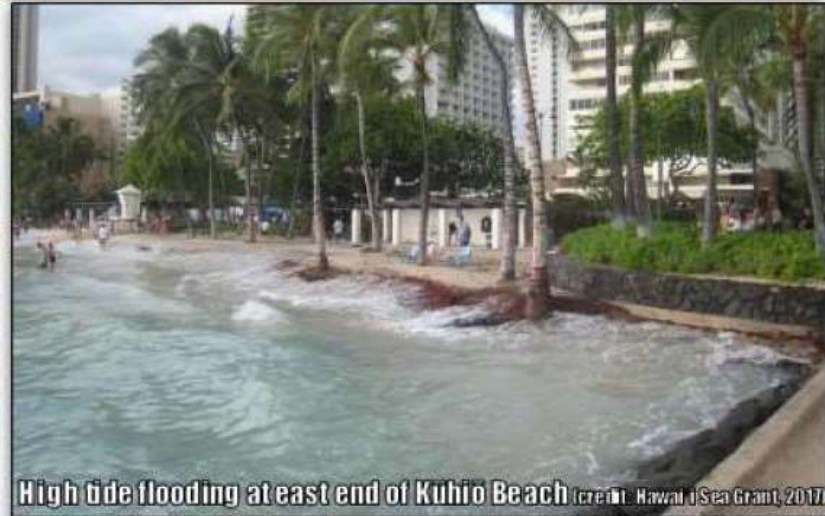
High tide flooding at east end of Kūhiō Beach (credit: Hawaii Sea Grant, 2017)

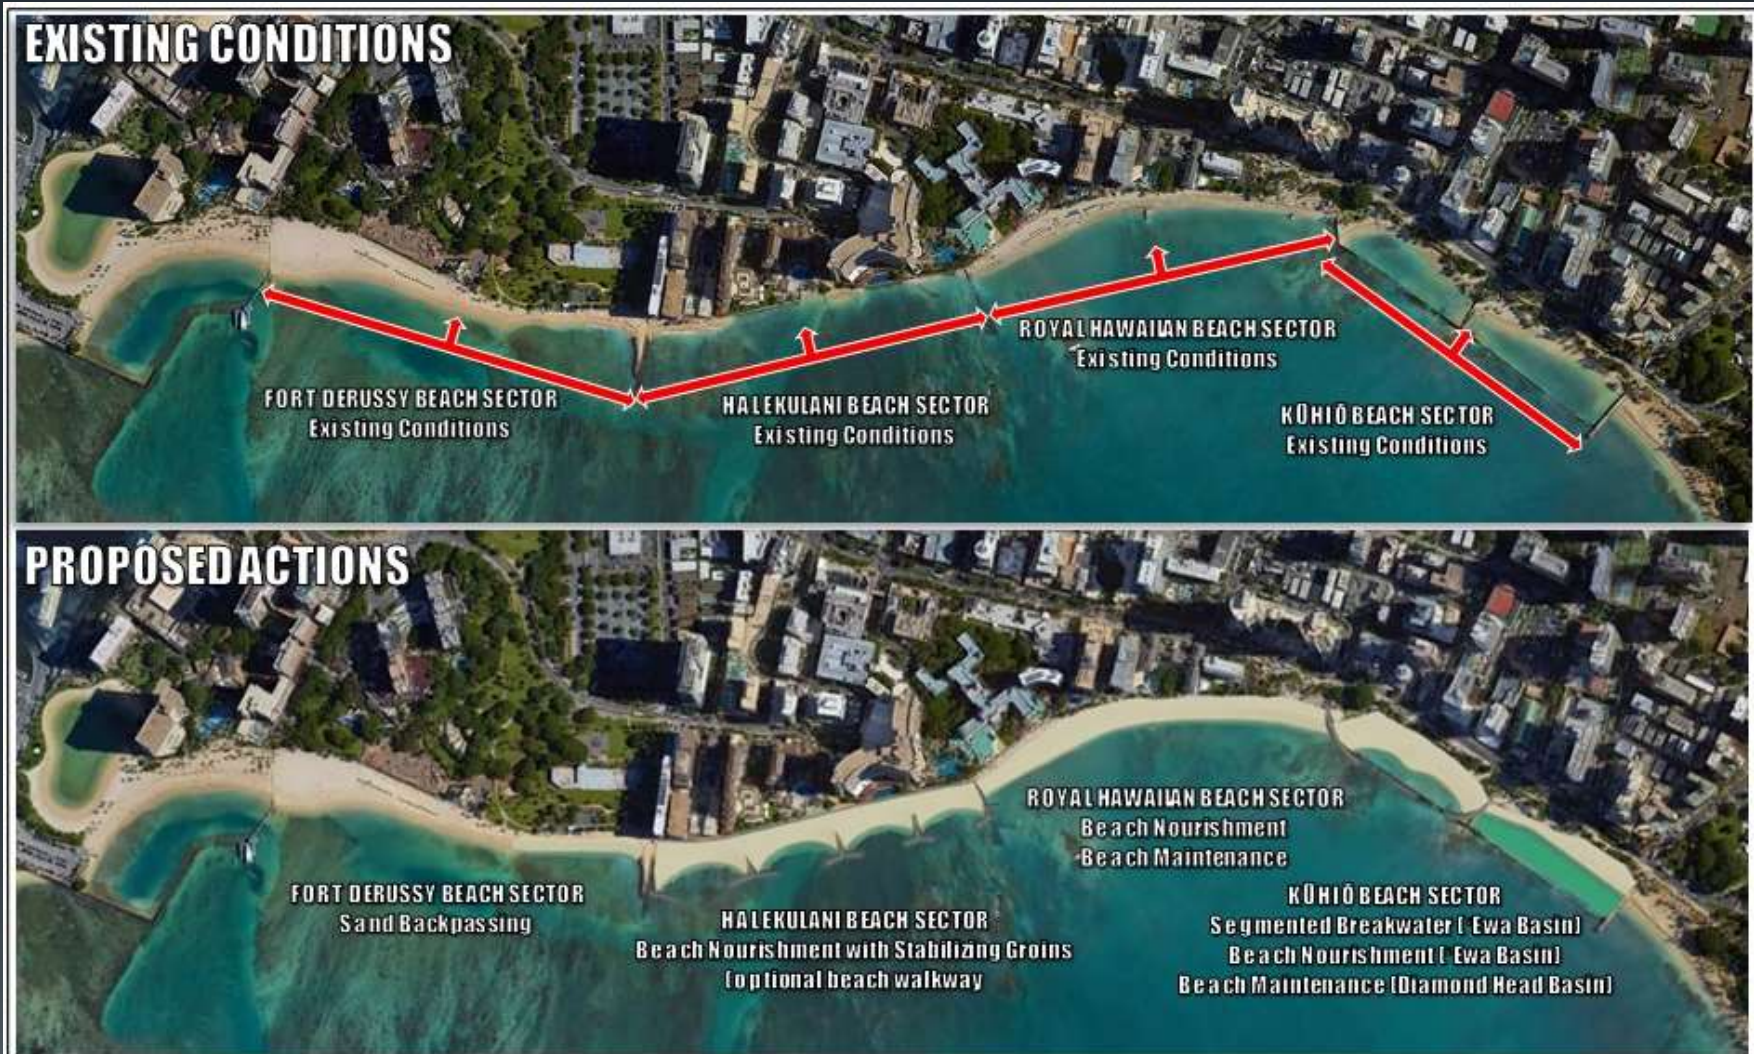
CONCEPTUAL RENDERING OF PROPOSED BEACH IMPROVEMENT AND MAINTENANCE ACTIONS

- Proposed Action: Beach Maintenance (Sand Backpassing)
- Requires 1,200 cubic yards of sand

- Proposed Action: Beach Construction with Stabilizing Groins
- Requires 60,000 cubic yards of sand

- Proposed Action: Beach Nourishment
- Requires 25,000 cubic yards of sand

- Proposed Action: Beach Nourishment, Segmented Breakwater (‘Ewa Basin)
- Proposed Action: Beach Maintenance (Diamond Head Basin)
- Requires 28,500 cubic yards of sand

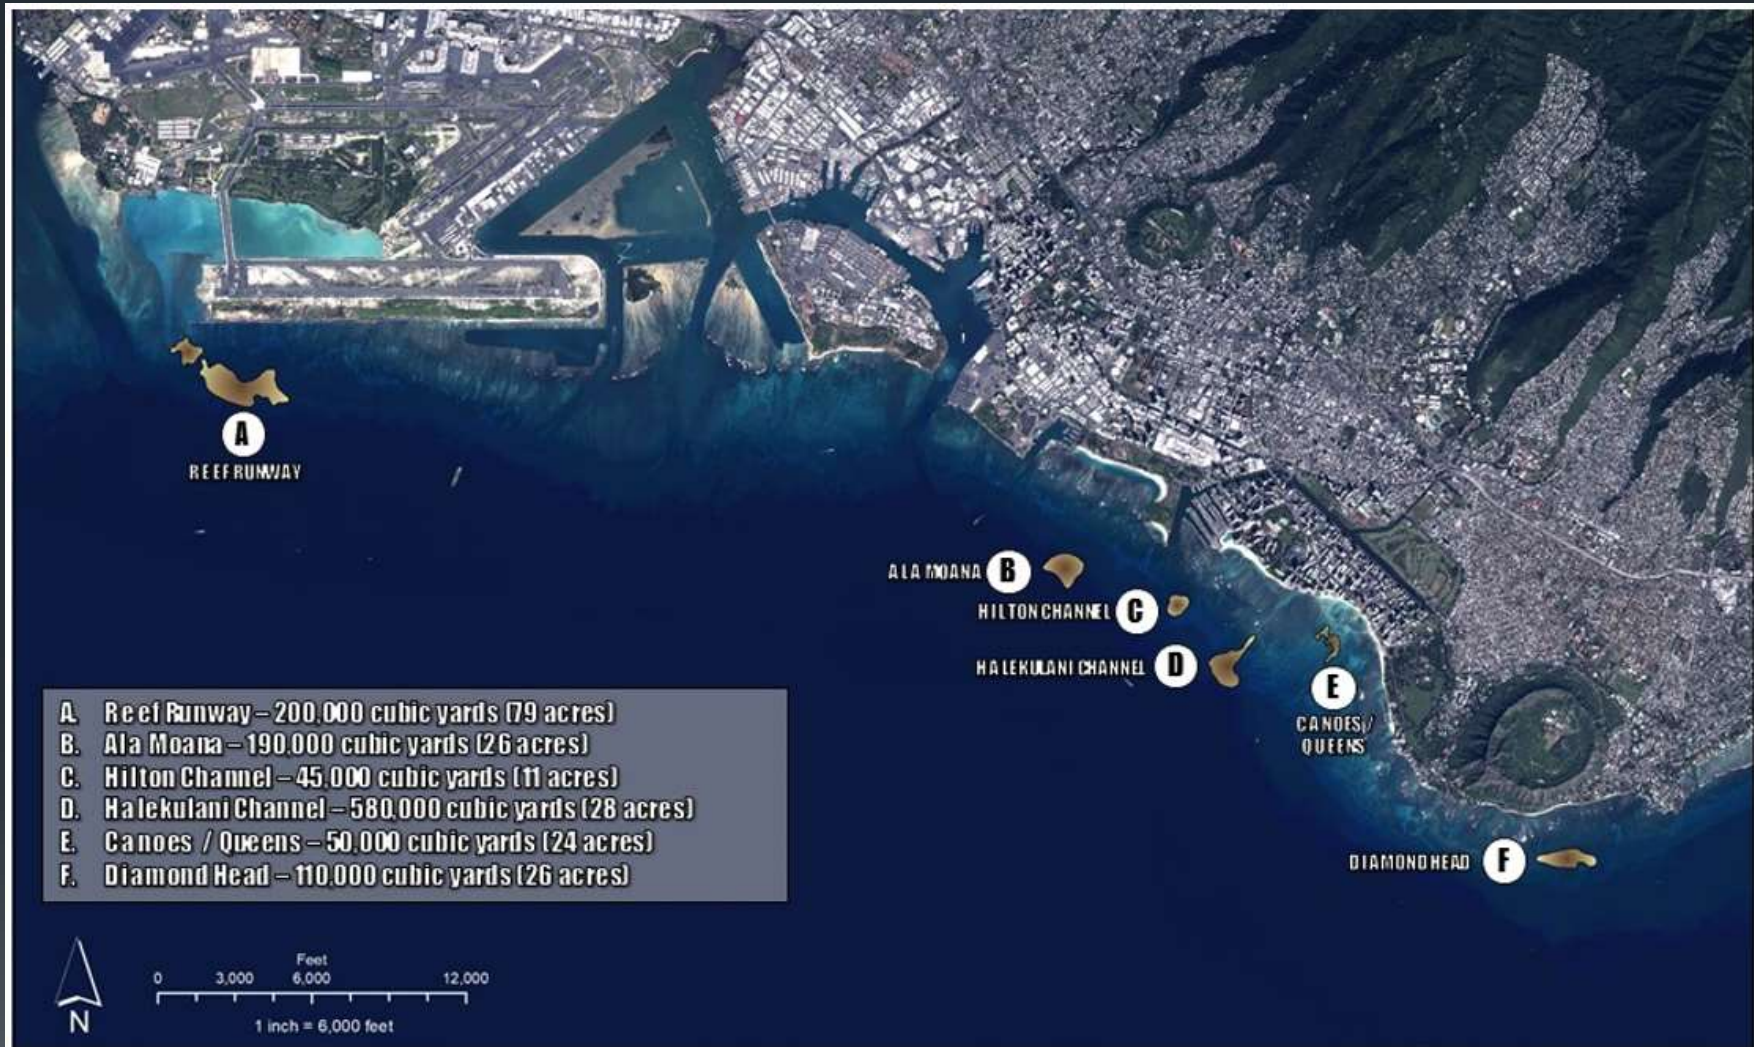
WAIKĪKĪ REPRESENTATIVE OFFSHORE SAND DEPOSITS

- ~ 200,000 cubic yards of sand (79 acres)

- ~ 190,000 cubic yards of sand (26 acres)

- ~ 45,000 cubic yards of sand (11 acres)

- ~ 580,000 cubic yards of sand (28 acres)

- ~ 50,000 cubic yards of sand (10 acres)

- ~ 110,000 cubic yards of sand (26 acres)
