Waikīkī Beach Improvement and Maintenance Program

Environmental Impact Statement Preparation Notice (EISPN)
Public Scoping Meeting
January 7, 2021 | 2:00pm – 5:00pm

ENVIRONMENTAL IMPACT STATEMENT PREPARATION NOTICE

Waikiki Beach Improvement and Maintenance Program

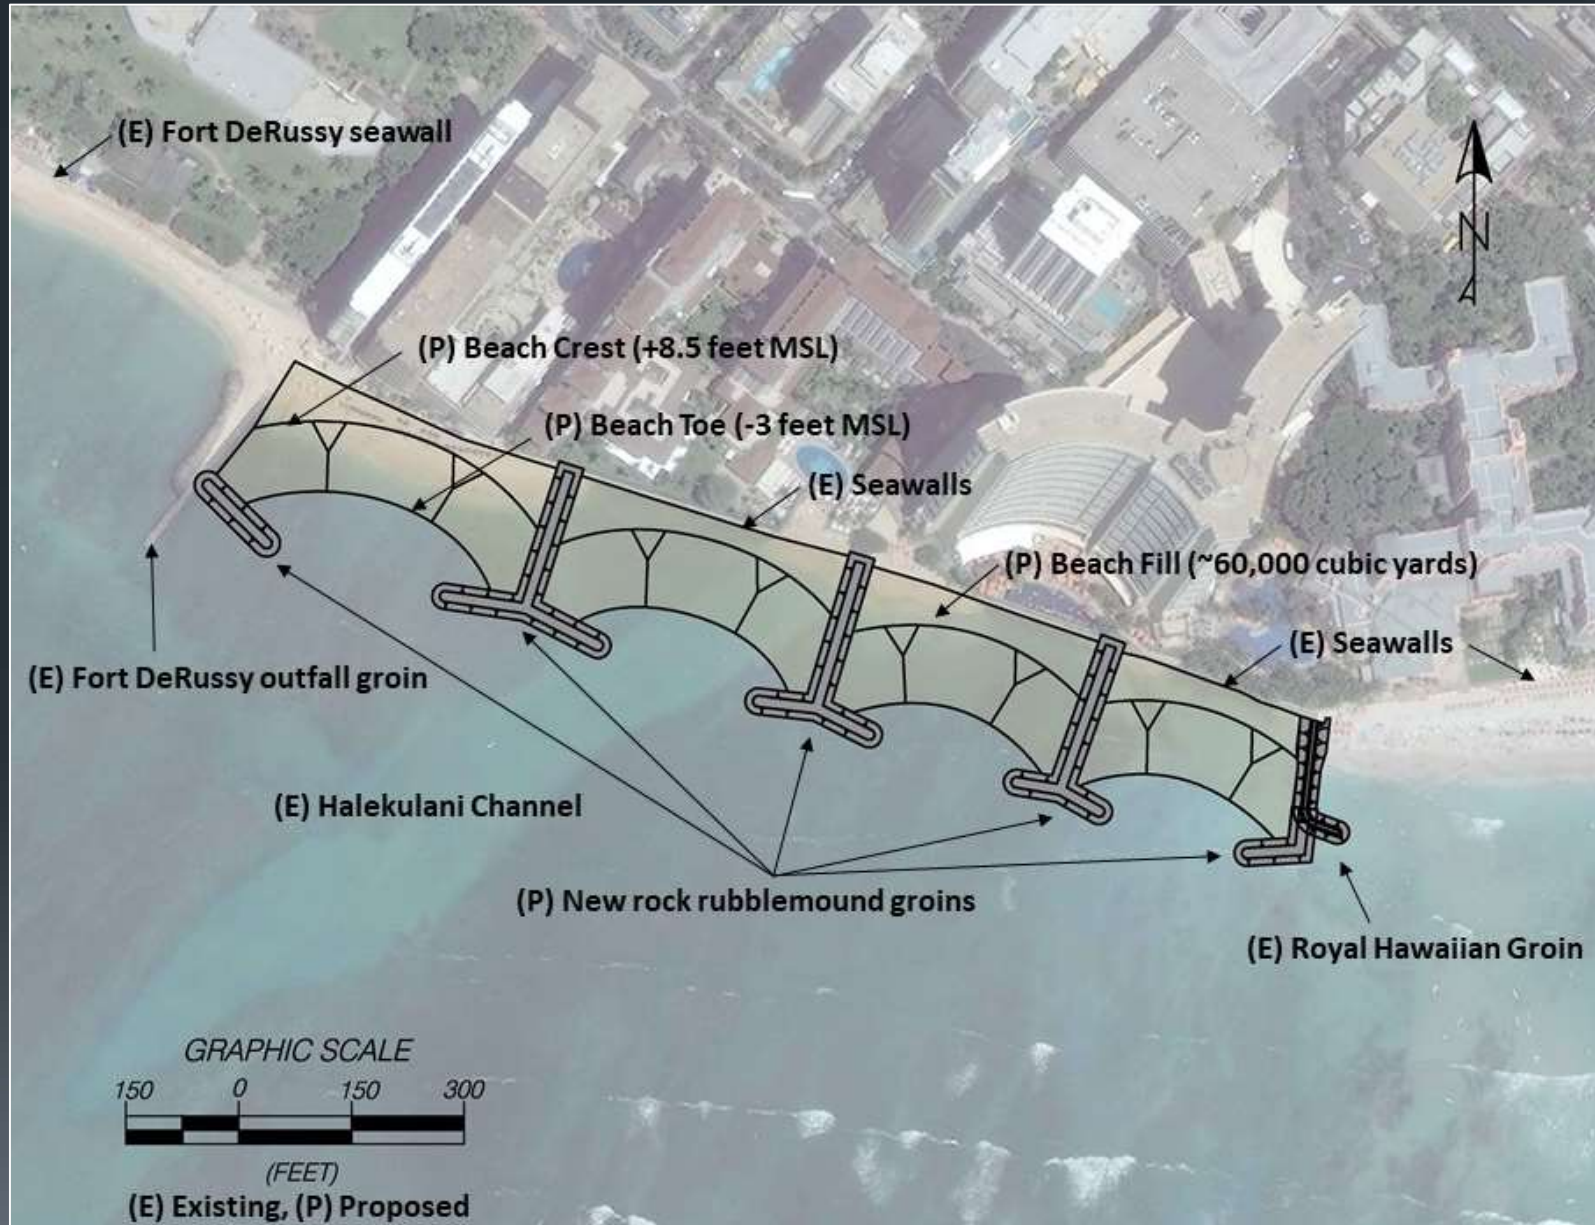
Halekūlani Beach Sector

PROPOSED ACTION : Beach Construction with Stabilizing Groins

- Description: Construct a new beach with groins to stabilize the sand. Optional beach walkway to improve lateral shoreline access. Beach cells between the groins would be stable with minimal maintenance.
- Beach Crest Elevation: +8.5 feet MSL
- Beach Toe Elevation: -3 feet MSL
- Beach Face Slope: TBD
- Beach Fill Volume: 60,000 cy
- Sand Source: Multiple options (TBD)

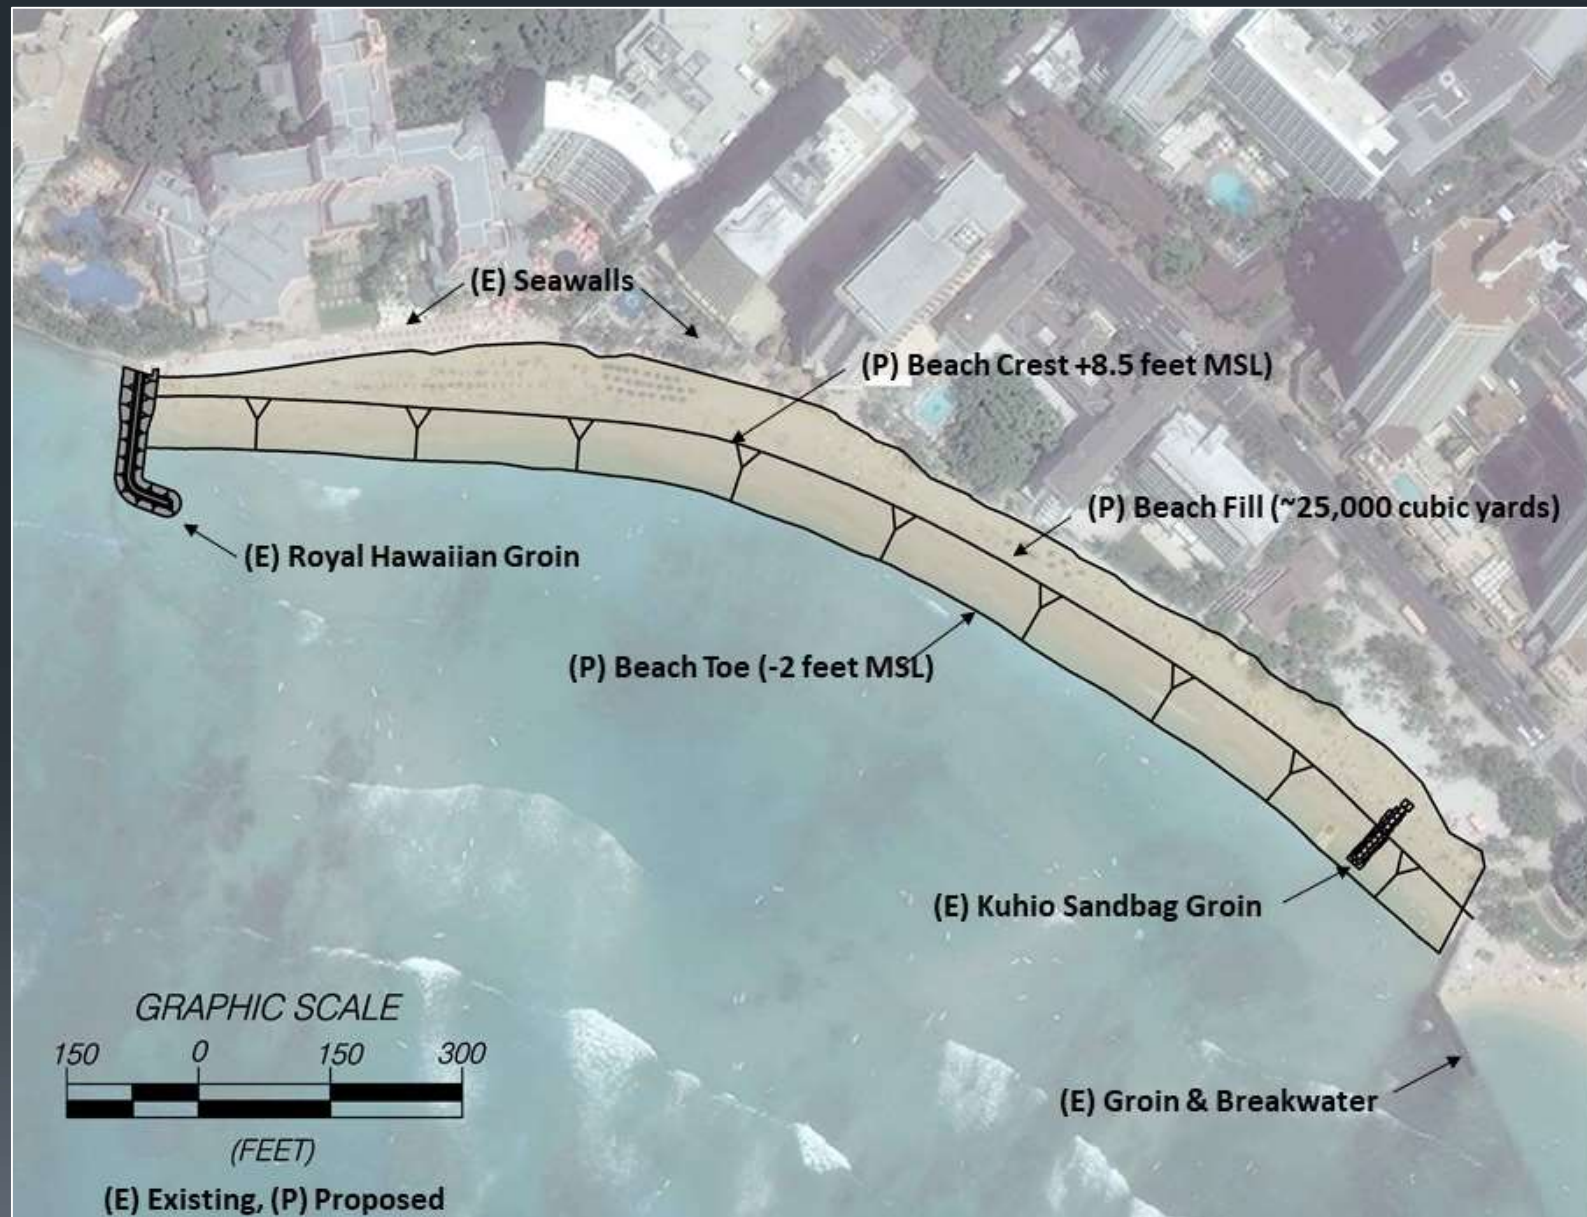
Royal Hawaiian Beach Sector

PROPOSED ACTION : Beach Nourishment

- Description: Conduct beach nourishment to maintain a stable beach. Periodic renourishment would be required. Would be similar in scope to Waikiki Beach Maintenance I (2012) and Waikiki Beach Maintenance II (2021).
- Beach Crest Elevation: +8.5 feet MSL (1.5-foot increase)
- Beach Crest Elevation: -2.0 feet MSL
- Beach Face Slope: 1V:8H
- Beach Fill Volume: 20,000 to 30,000 cubic yards
- Sand Source: Canoes/Queens offshore sand deposit

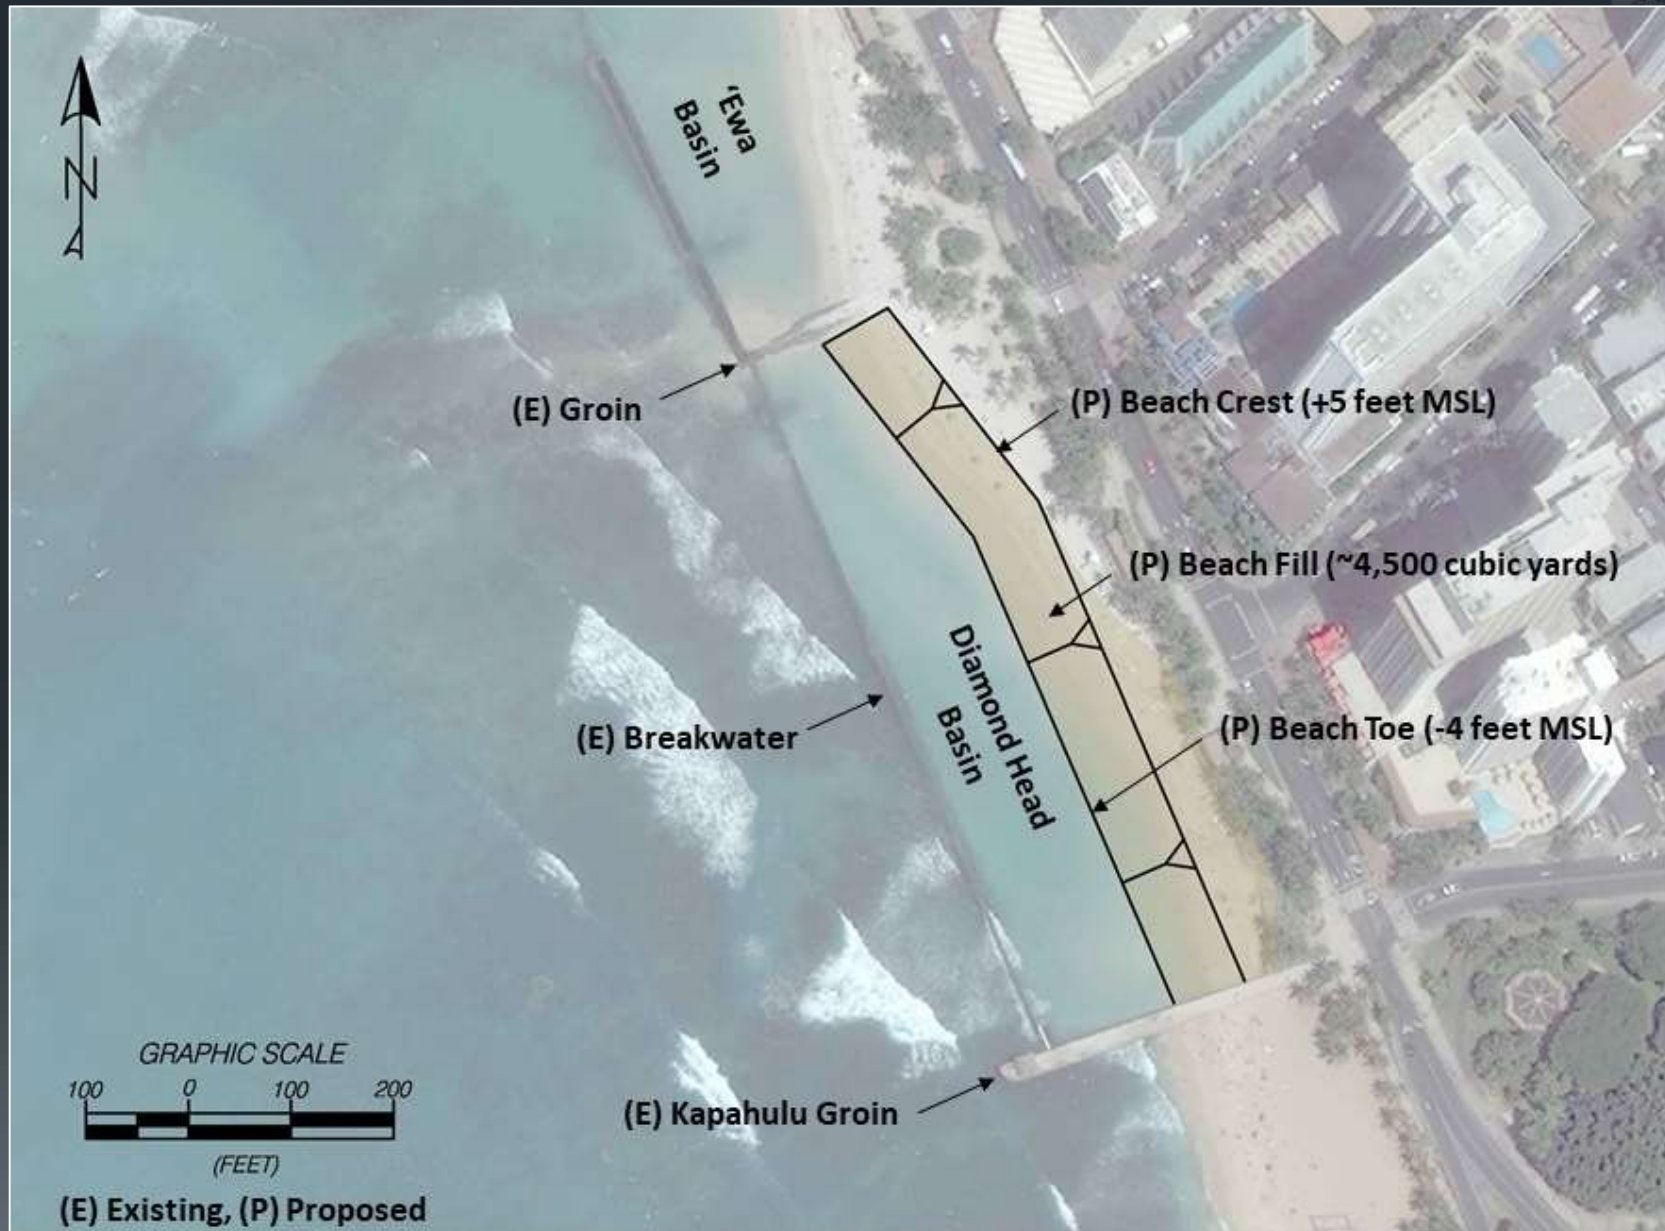
Kūhiō Beach Sector

PROPOSED ACTION : Beach Maintenance

- Description: Conduct beach maintenance to increase recreational dry beach area. Periodic maintenance would be required to maintain a stable beach profile.
- Beach Crest Elevation: +5.0 feet MSL
- Beach Toe Elevation: -4.0 feet MSL
- Beach Face Slope: 1V:8H
- Beach Fill Volume: 4,500 cubic yards
- Sand Source: Diamond Head Basin
