STATE OF HAWAII DEPARTMENT OF LAND AND NATURAL RESOURCES OFFICE OF CONSERVATION AND COASTAL LANDS Honolulu, Hawai'i March 20, 2018

FILE NO.: SSBN OA-19-04

REGARDING: Conservation District Use Application for Category II Small Scale Beach

Nourishment (SSBN) OA-19-4 for the Kuhio Beach Stub Groin and Back Passing Small Scale Beach Nourishment Project, Located at Waikiki Beach,

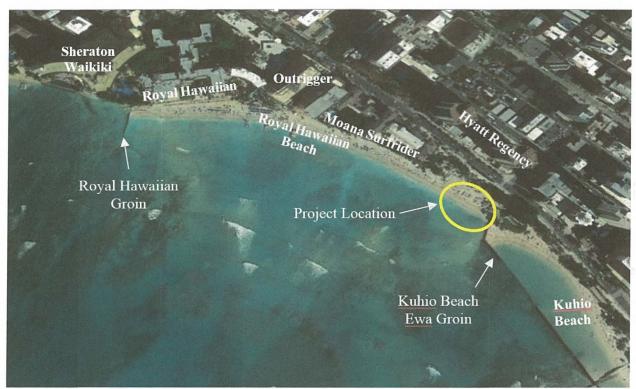
EXHIBIT 2: Overview of Project Site

The proposed project site is located on Waikiki Beach, along the shoreline of Malama Bay on the south shore of Oahu, fronting TMK: (1) 2-6-001:003 and 008. The project site is at the boundary of two discrete Waikiki beach sectors – Kuhio Beach Park and Royal Hawaiian Beach, and fronts an open area used by beach concessionaires and was the site of the old Waikiki Tavern (ca. 1930s). It is in the Resource Subzone of the State Land Use Conservation District.

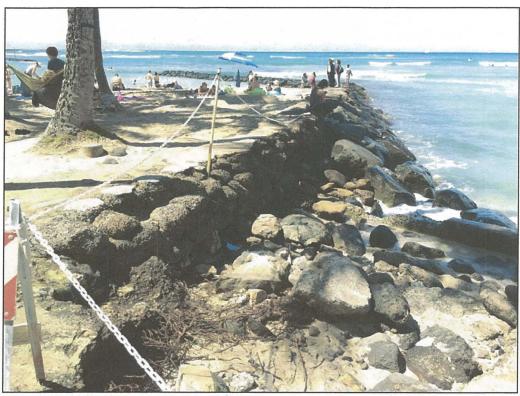
EXHIBIT 7: Flanking of Kuhio Beach Ewa groin (May 2017 photo)

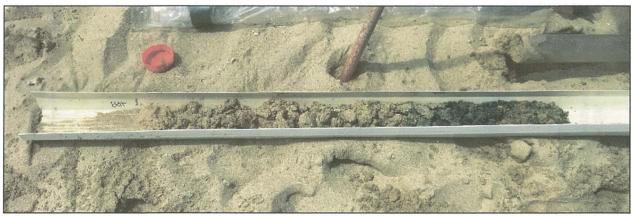
EXHIBIT 12: Sand core samples

(which often indicates hard bottom) was at elevations of -5 to -9 msl. Sand layer thickness ranged from about 5 to 8 feet (Exhibit 9). Note that at the northern end of the Ewa basin, seaward of which there is a gap in the crib wall and thus limited wave protection, there is virtually no sand overlaying the hard bottom and a steeper beach face of about 1V:8H. Hammer push core sand samples were taken in each basin at the locations shown in Exhibit 9, and illustrations of the core depths and in situ sand color are also shown. Significant variation in sand color was noted in the cores, ranging from light brown/tan to dark gray almost black. The sand color variation is shown in Exhibit 12.

The dark gray/black sample rapidly changed to light gray with exposure to air and sunlight. Grain size analysis of the core samples shows an average median grain size of 0.42, and percent fine material (<0.074mm) ranging from 1.2 to 3.2. The sand is moderately sorted.
