**Kona Village Resort
Small Scale Beach Nourishment Category II**

Completion Report

June 30, 2023

Sea Engineering, Inc.
Makai Research Pier
Waimanalo, HI 96795

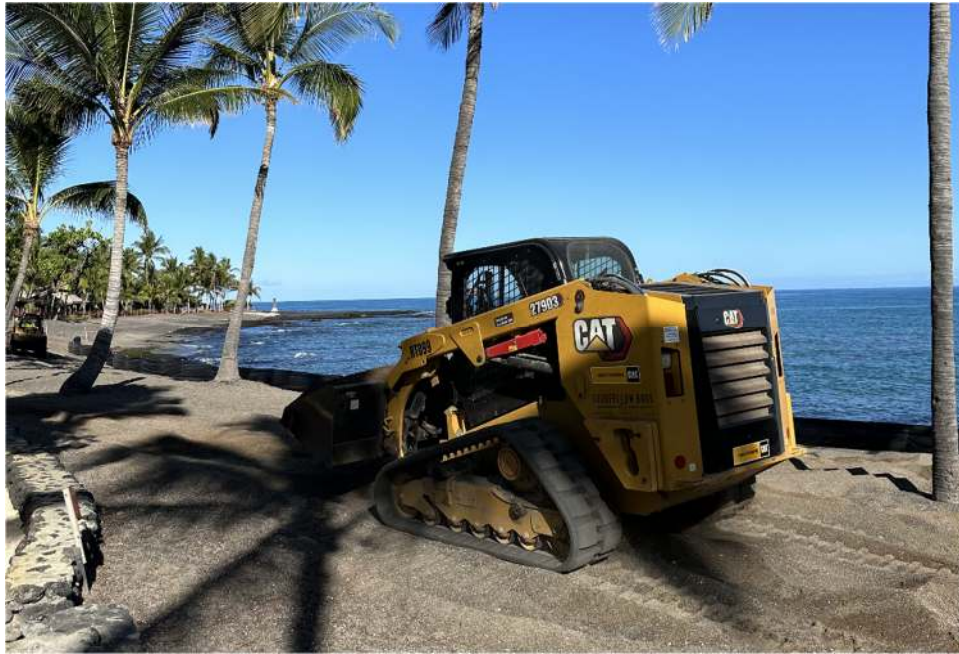
Figure 2-1 Skid steer used to transport sand to placement area

The sand was moved from the stockpile location to the vicinity of the placement area using skid-steer loaders. Then skid-steer loaders placed sand directly onto the placement area. Figure 2-1 to Figure 2-3 shows skid steer loaders transporting sand to the placement area on the beach.

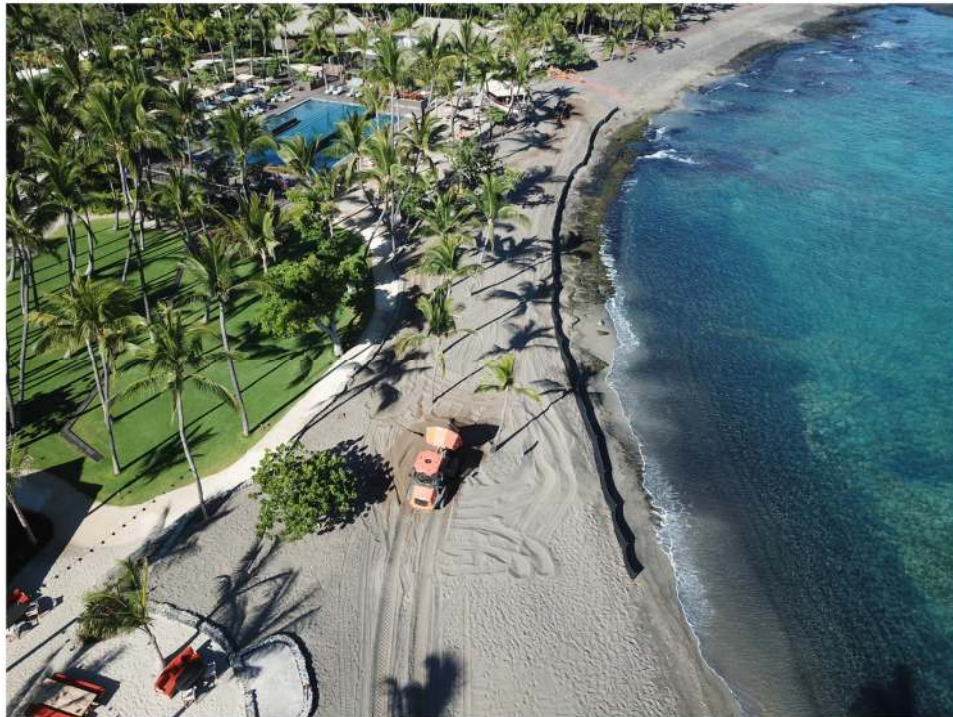
Figure 2-2 Beach Nourishment operations, Aerial photo facing south

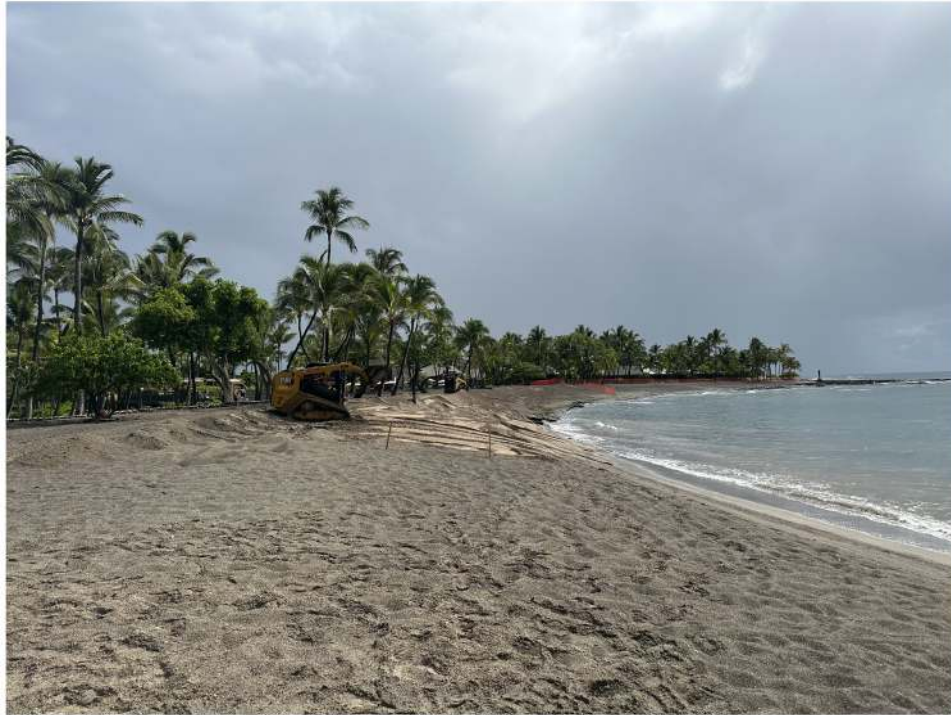
Figure 2-3 Beach Nourishment operations, ground photo facing south

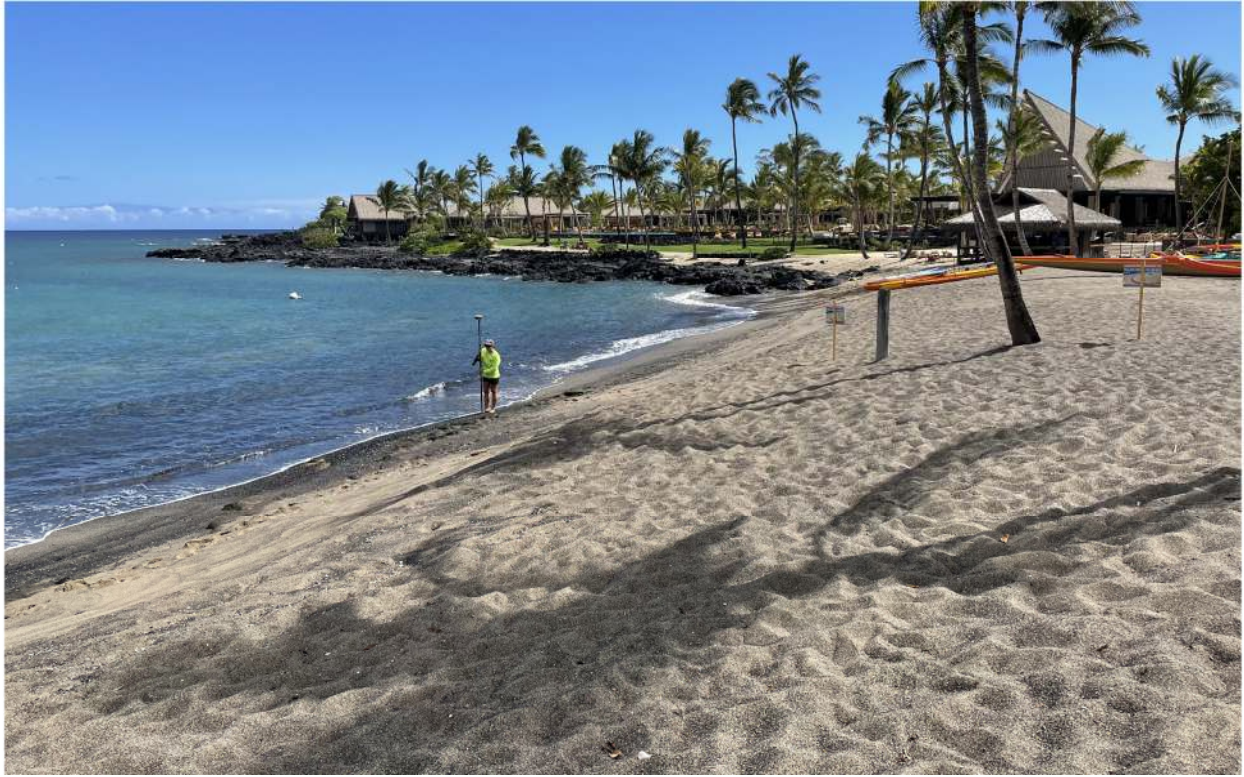
Figure 2-6 Pre-nourishment beach conditions, north facing photo (May 25, 2023)

Photographs of the beach taken prior to and following beach nourishment are presented in Figure 2-6 to Figure 2-9, respectively.

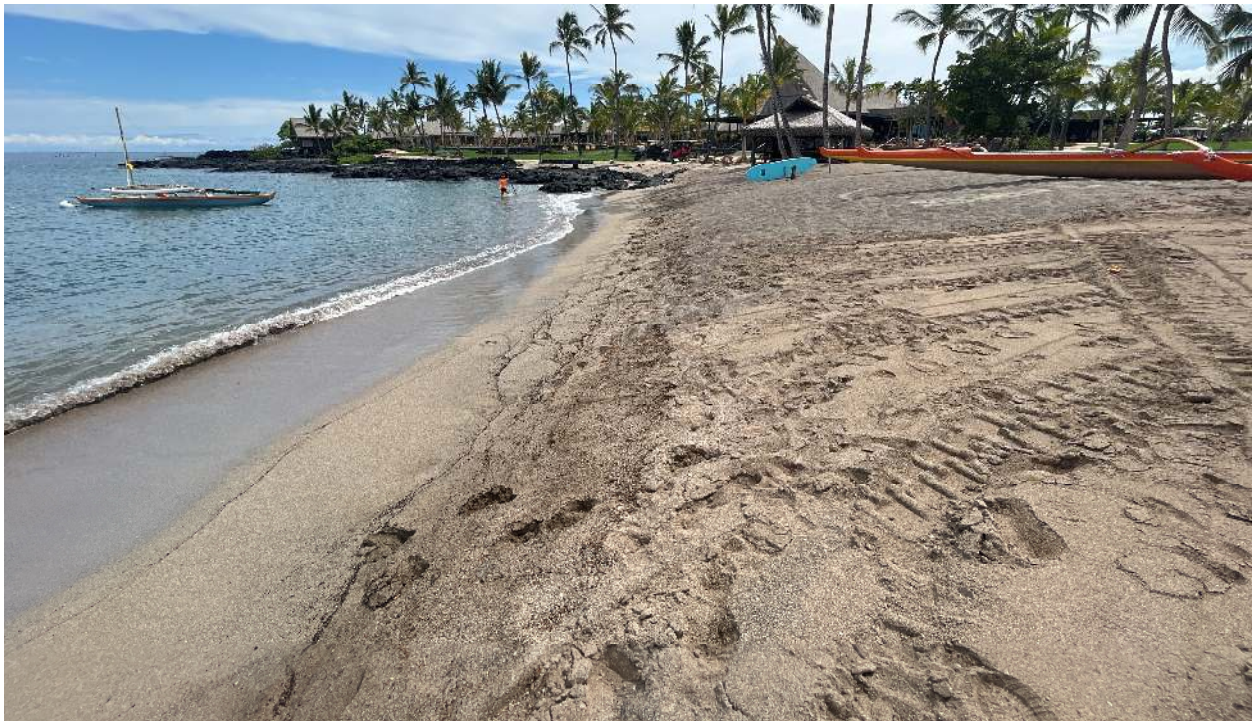
Figure 2-7 Post-nourishment beach conditions, north facing photo (May 30, 2023)

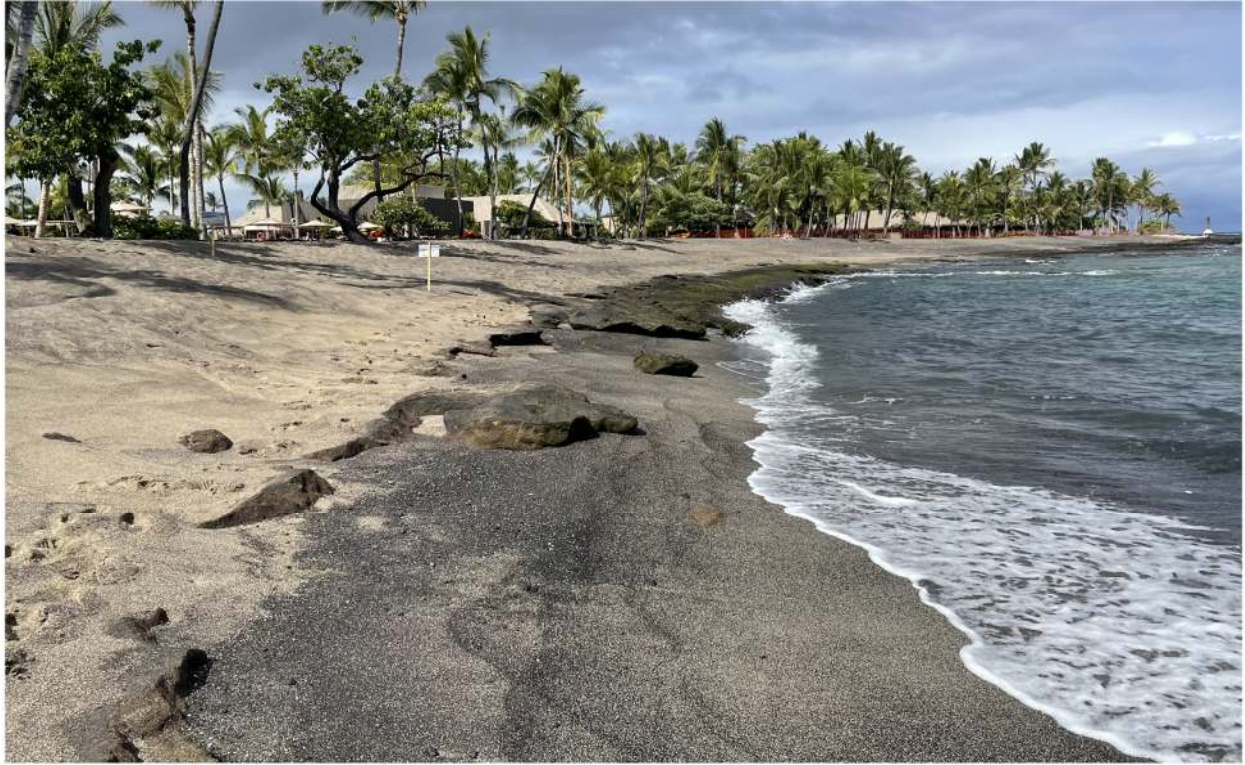
Figure 2-8 Pre-nourishment beach conditions, south facing photo (May 25,2023)

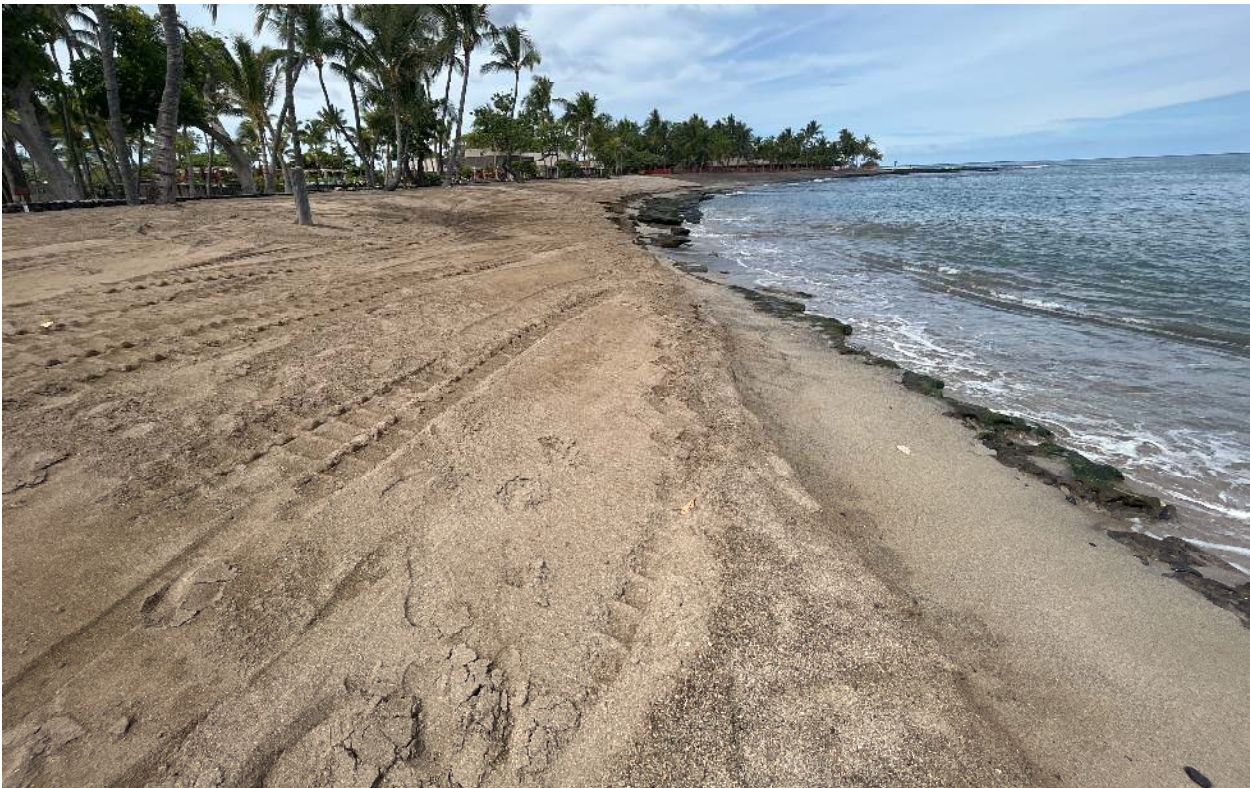
Figure 2-9 Post-nourishment beach conditions, south facing photo (May 30,2023)

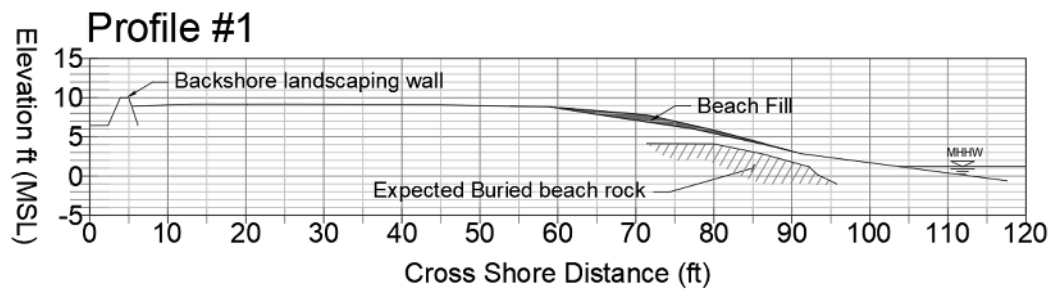
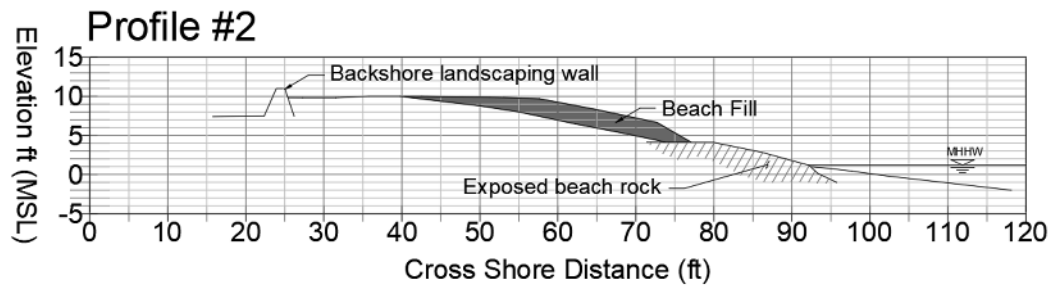
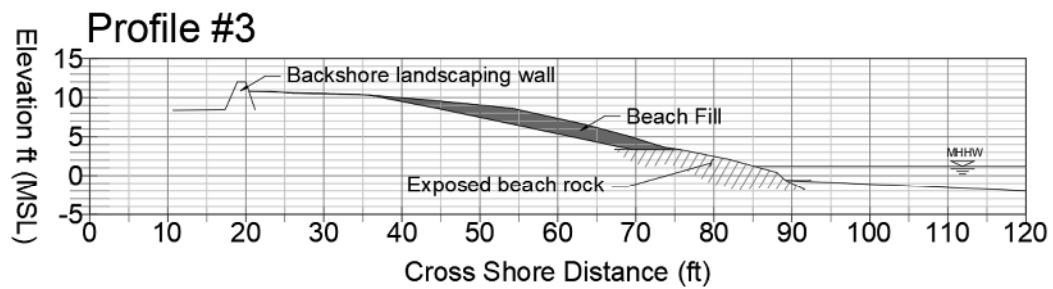
Vertical Datum:	Mean Sea Level (MSL)
Pre-nourishment Survey:	05.25.2022
Post-nourishment Survey:	05.30.2022

Figure 3-2 Beach Profiles, pre- and post-nourishment

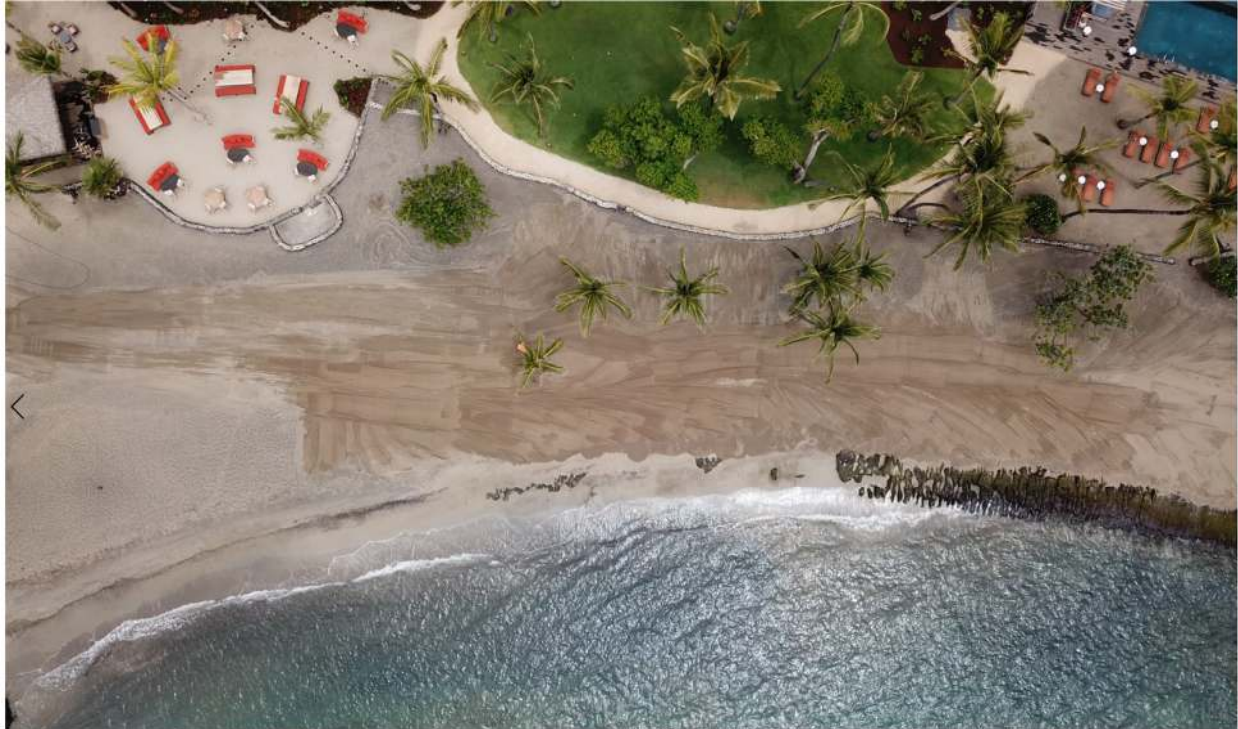
Figure 3-3 Completed Beach Nourishment operations, top view aerial photo

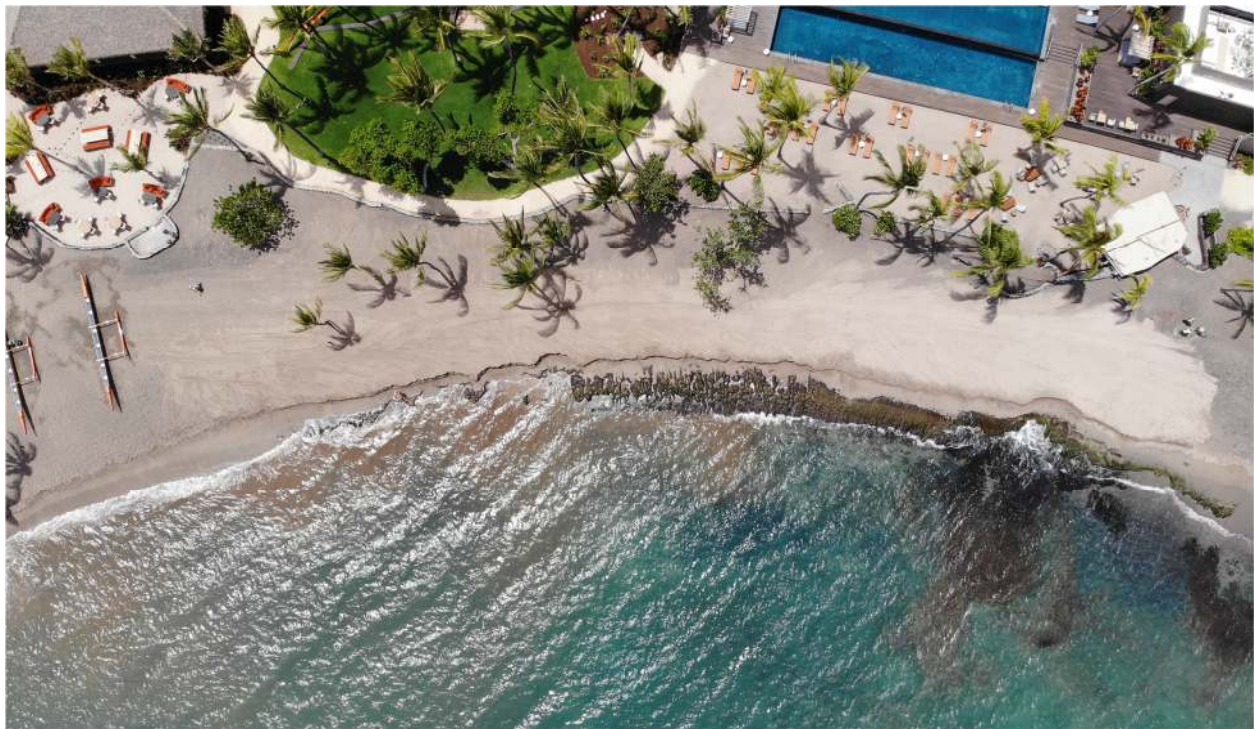
Figure 3-4 Post-nourishment beach conditions, top view aerial photo (May 30, 2023)
