Sugar Cove Berm Maintenance Effort #1 Summary Report

Sugar Cove, Sprecklesville, Maui, Hawaii

November 2015

Sea Engineering, Inc.
Makai Research Pier
Waimanalo, HI 96795

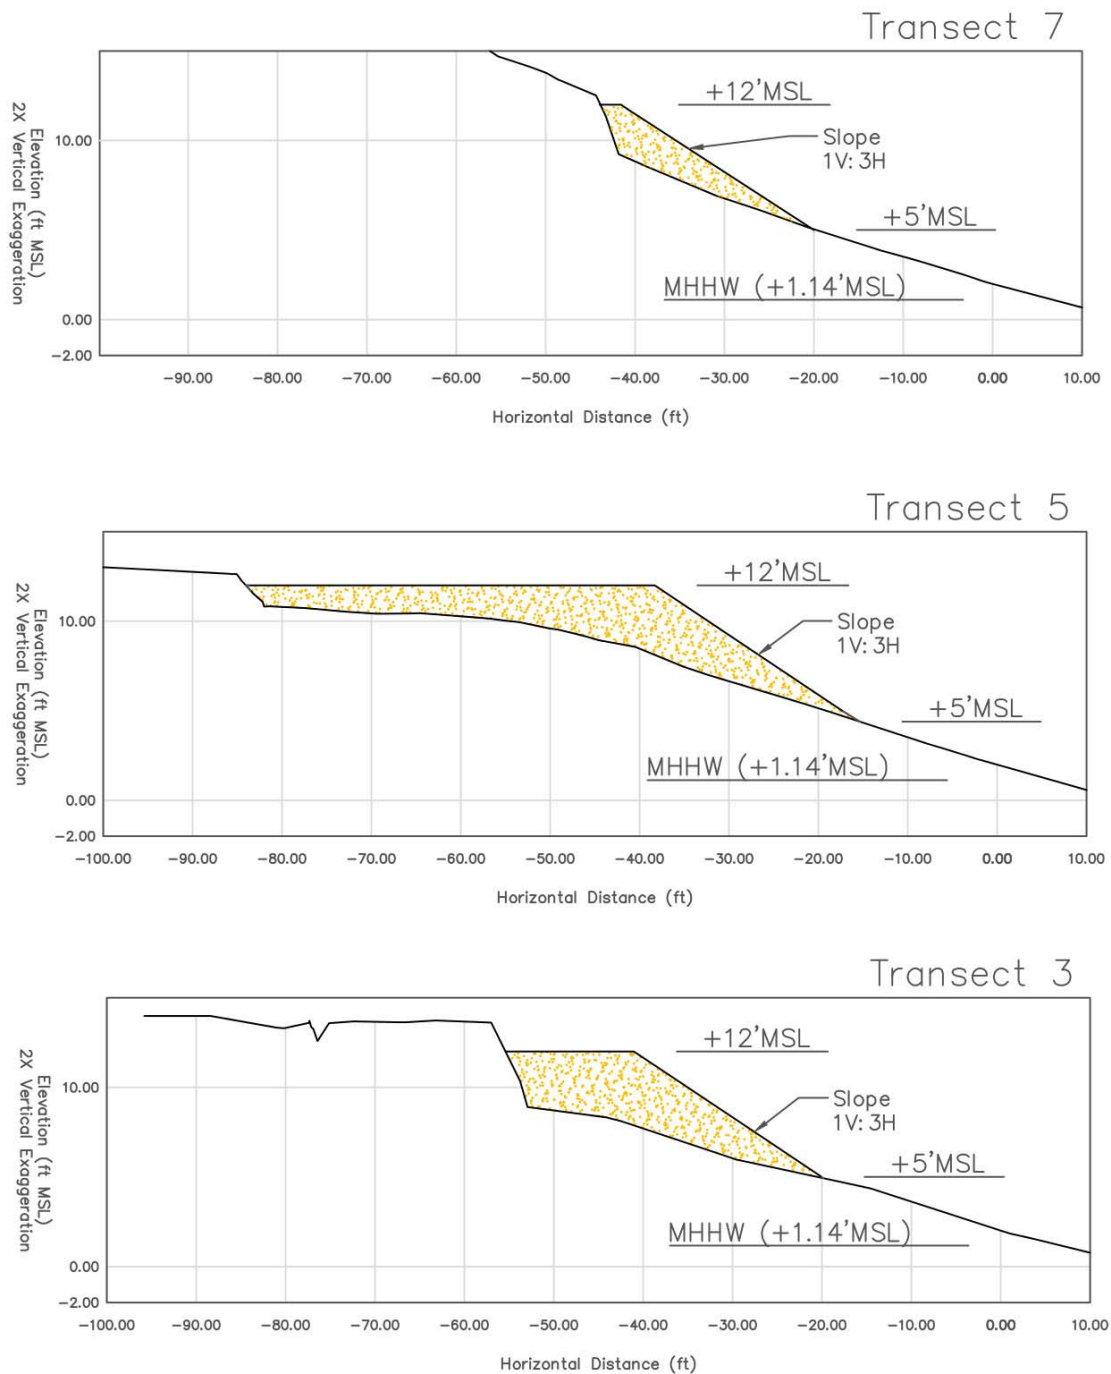
Figure 2-2 Proposed berm maintenance profiles (LMSL Datum)

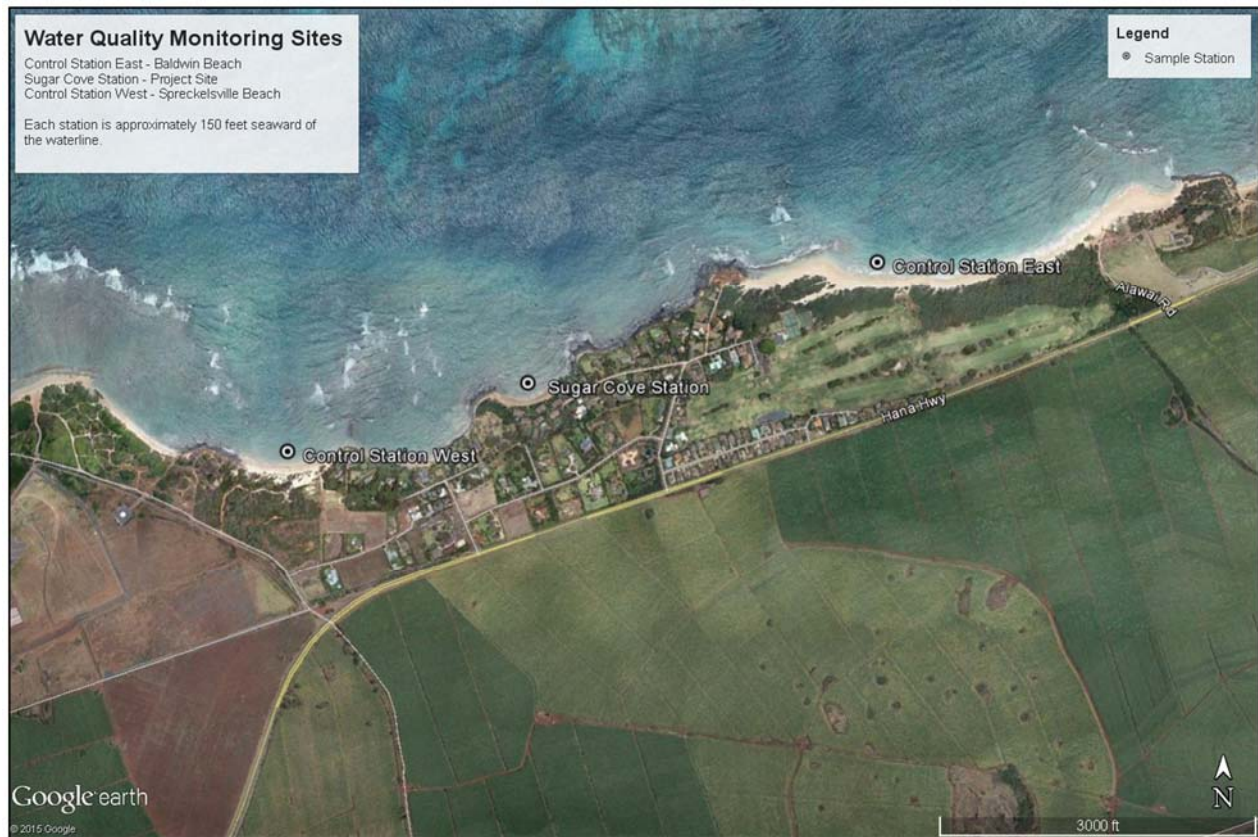
Figure 3-1 identifies the locations of each sample station. Each sample station is located approximately 150 feet from the waterline. Control Station East is located at Baldwin beach, approximately 0.65 miles east of the project site station. Sugar Cove Station is located in the middle of the project beach. Control Station West is located at Spreckelsville Beach, approximately 0.45 miles west of the project site station.

Figure 3-1 Water quality monitoring stations for turbidity sample collection.

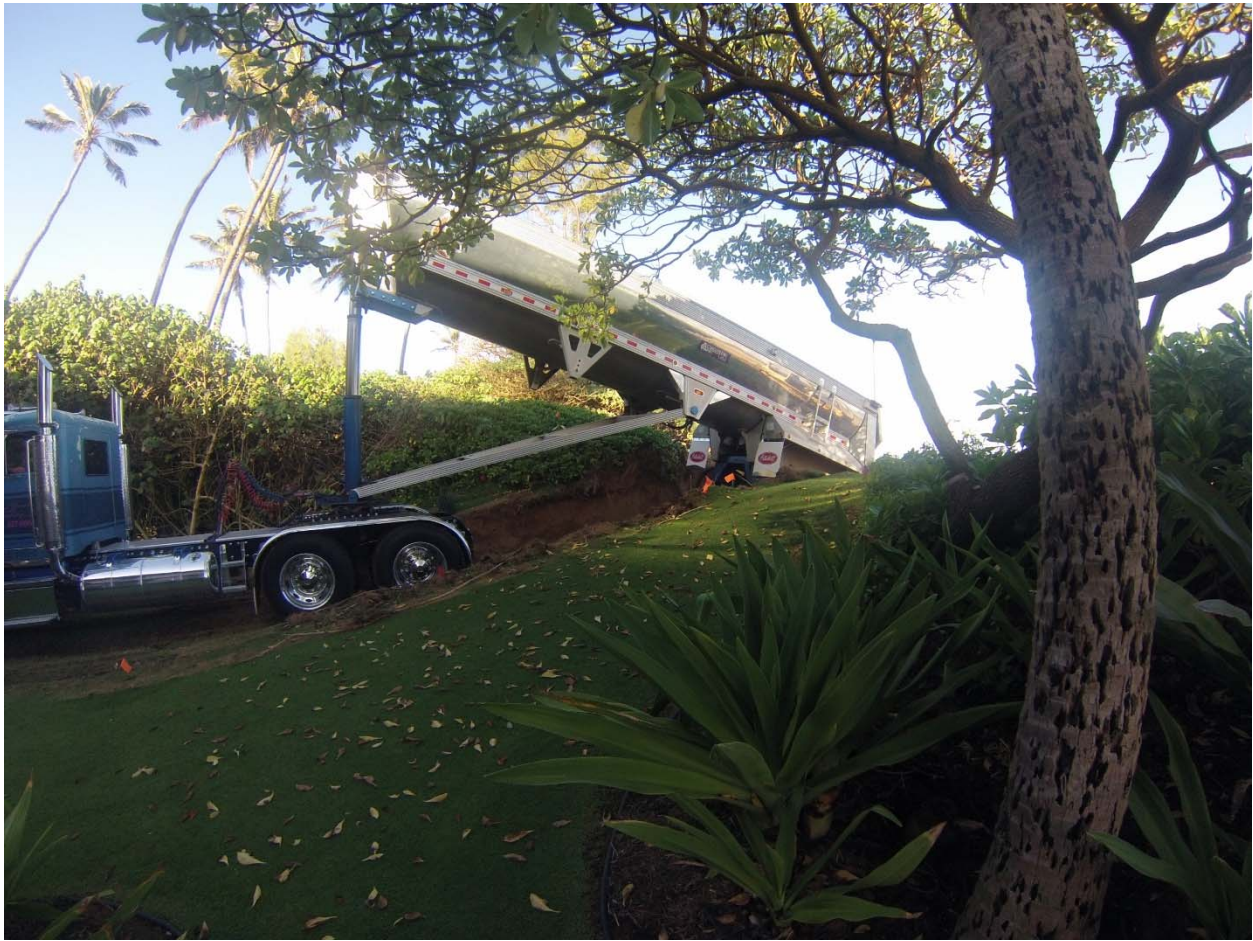
Figure 4-1 Dump truck delivering sand to the west end of the cove for placement on the berm

Delivery Method: Tavares Trucking utilized four vehicles to maintain consistent delivery pace. Morning and afternoon delivery speeds were negatively impacted by local traffic issues. Truck delivery of sand to the berm was at the west end of the embayment, through the Sugar Cove property to the public beach. A small gap was cut into the sand bank (Figure 4-1) allowing the trucks to deliver sand directly to the berm. Truck delivery of sand to the County of Maui beach access utilized a smaller truck and delivered sand directly to the beach access from the street (Figure 4-2).

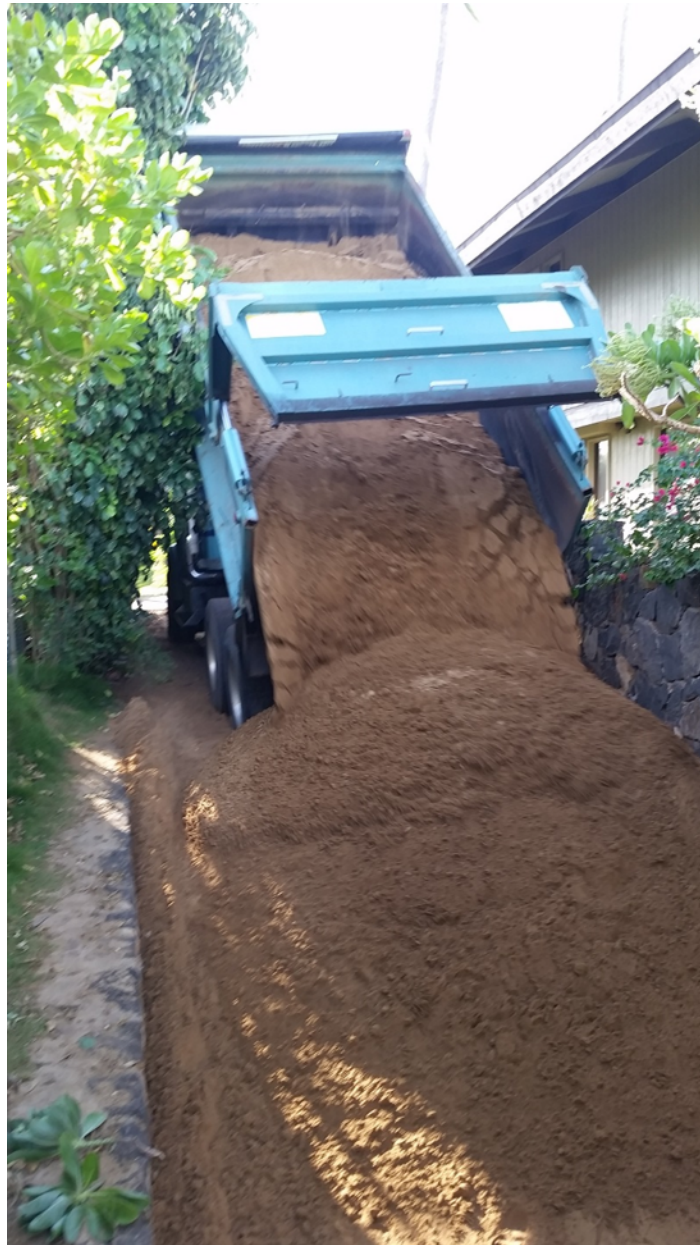
Figure 4-2 Smaller dump truck delivering sand to the County of Maui beach access path

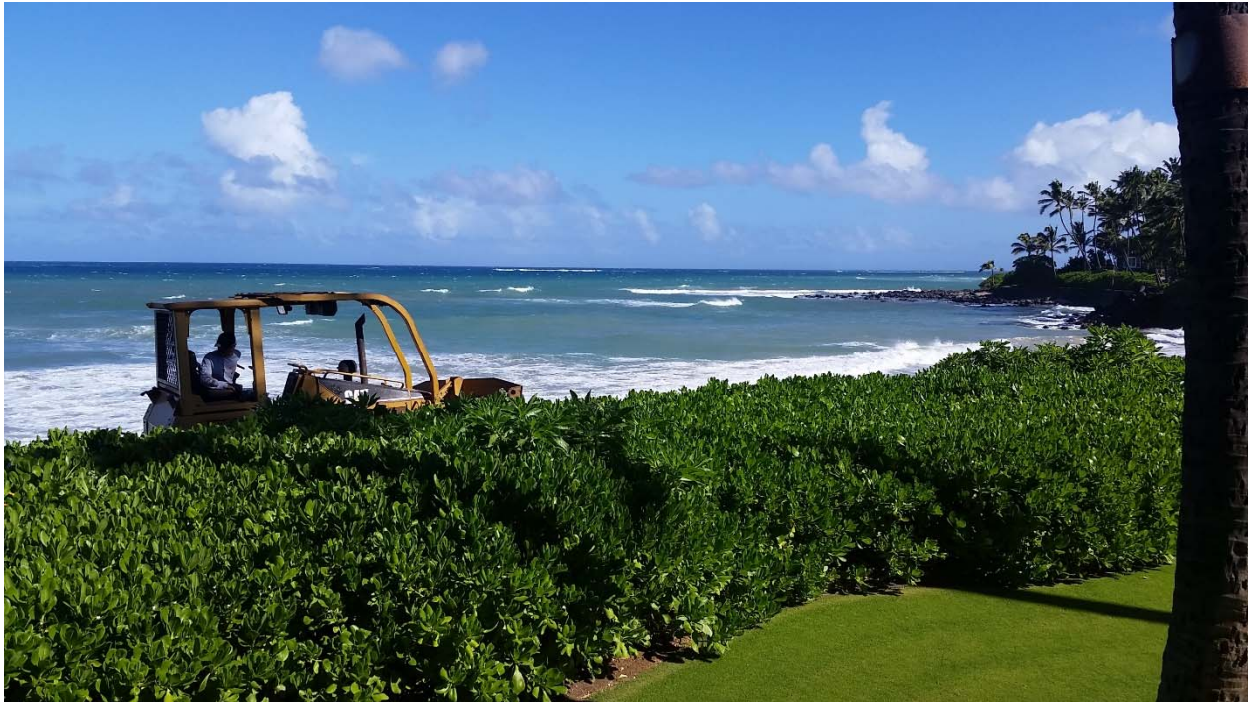
Figure 4-3 Bulldozer spreading sand along the berm

Placement: A single operator, contracted by Tavares Trucking, used a Caterpillar D4G bulldozer (Figure 4-3) to move sand along the berm and shape the new sand bank (Figure 4-4). Sand pushing and grading was completed from west to east along the berm. All sand moving and grading was conducted on the berm, makai of the shoreline vegetation and well inland from mean higher high water. The maintenance sand berm abutted the boulders and sand bank on the mauka side, and extended from the west end of the property to Transect 3. Low elevation of the existing berm prevented placement of the maintenance sand between Transect 3 and the County of Maui beach access path (Figure 4-5). Sand placed within the County of Maui beach access was brought in from the street and pushed down the beach access by the Caterpillar operator.

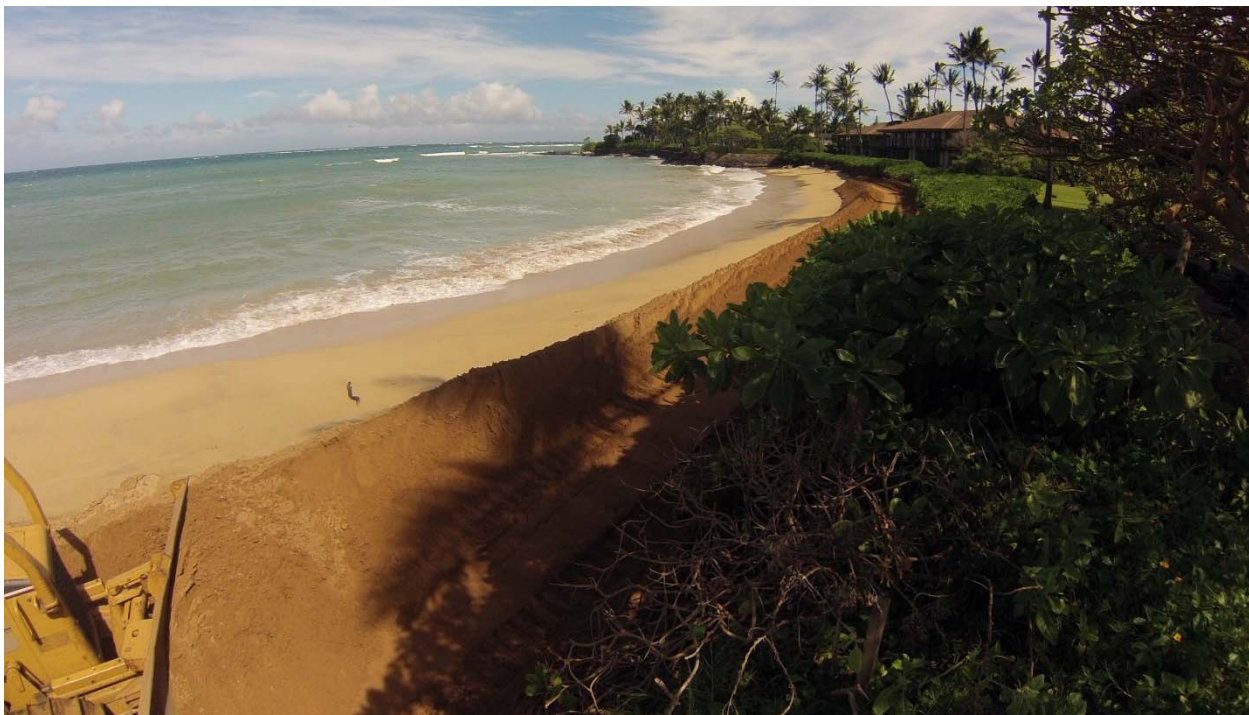
Figure 4-4 Sand grading on the berm

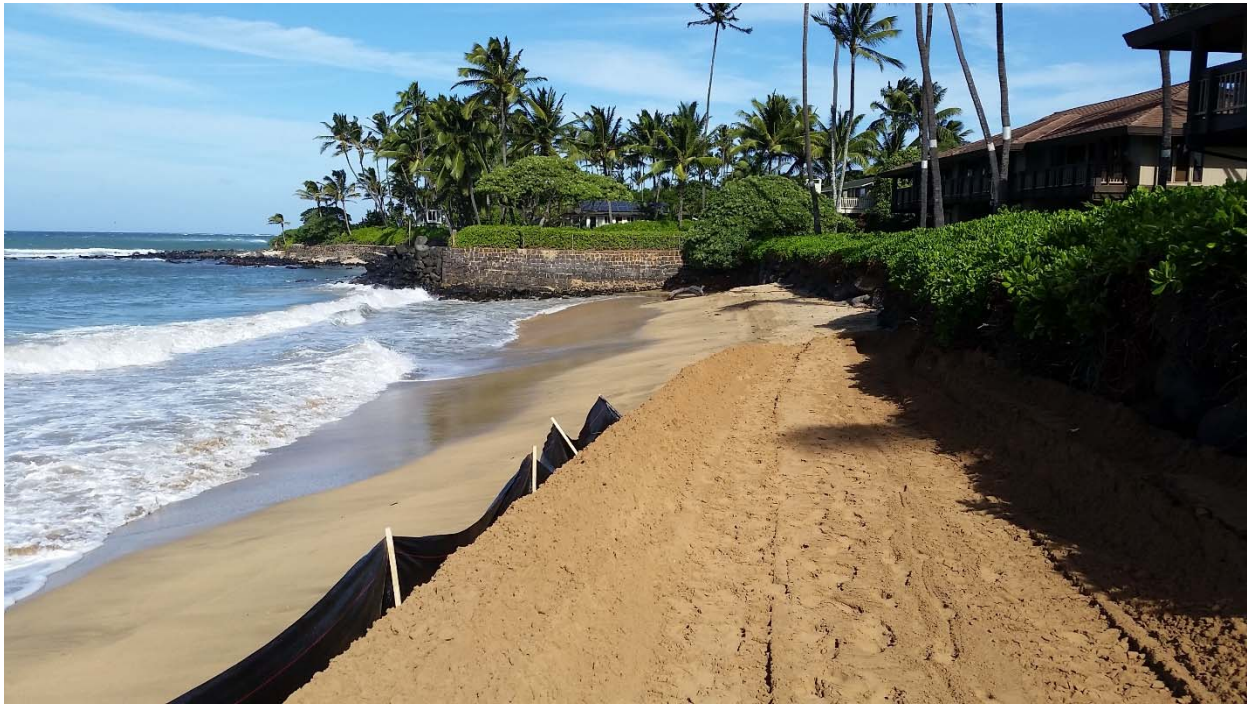
Figure 4-5 Graded sand with finished makai slope and silt fencing ending near Transect 3

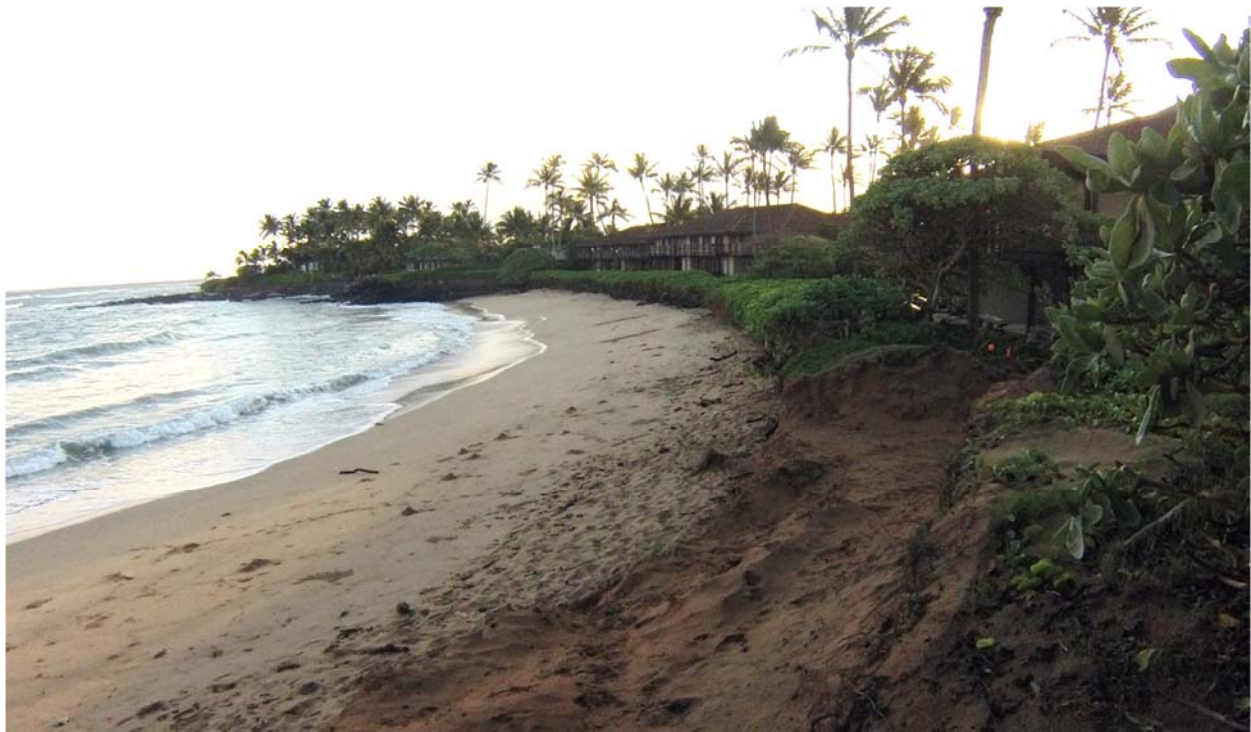
Figure 4-6 Beach condition prior to placement on November 9, 2015

Final Grade: The upper portion of the berm maintenance sand was placed atop the low elevation berm (Figure 4-6) on the beach profile, and was graded to a nearly horizontal plane (Figure 4-7). The makai face of the material was graded to as gentle a slope as was possible, given the already deflated and narrow beach profile. 60 ton of sand was placed in the County of Maui beach access to cover the pre-existing irregular grade (Figure 4-8), including a 3 foot tall ledge (Figure 4-9). The final grade in the access was a smooth slope from the top of the access path to the beach berm (Figure 4-10).

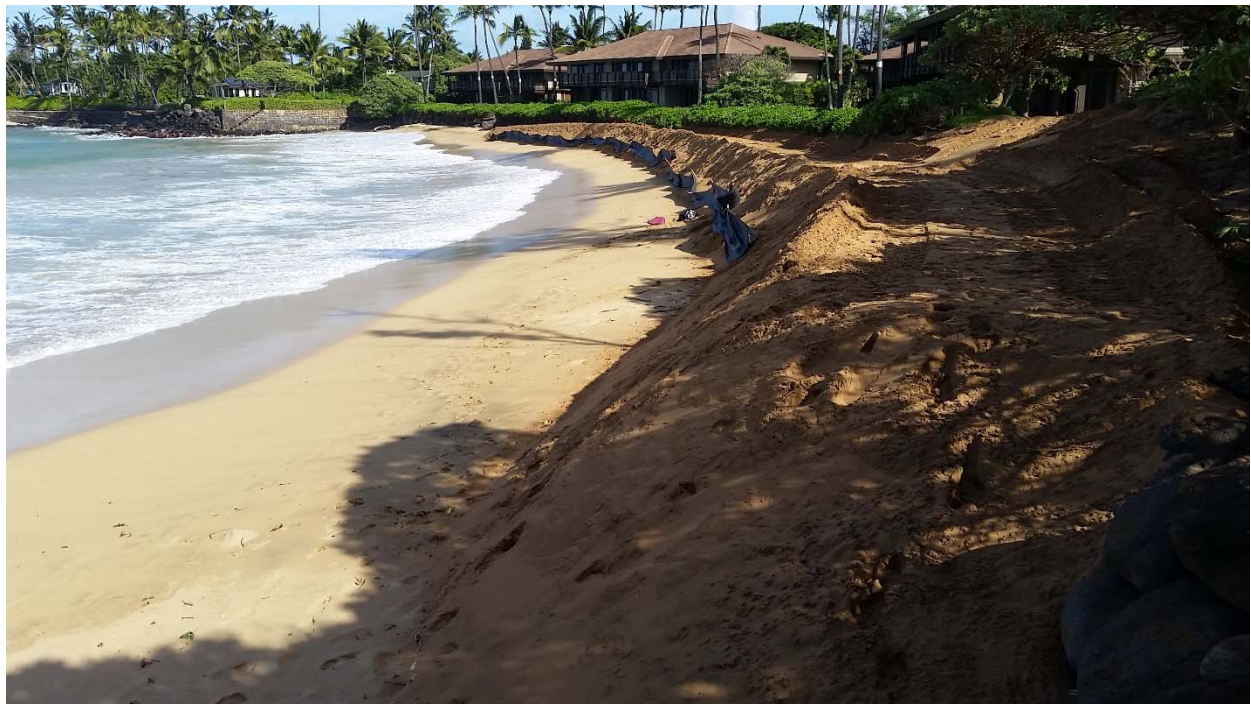
Figure 4-7 Beach and berm condition after placement on November 10, 2015

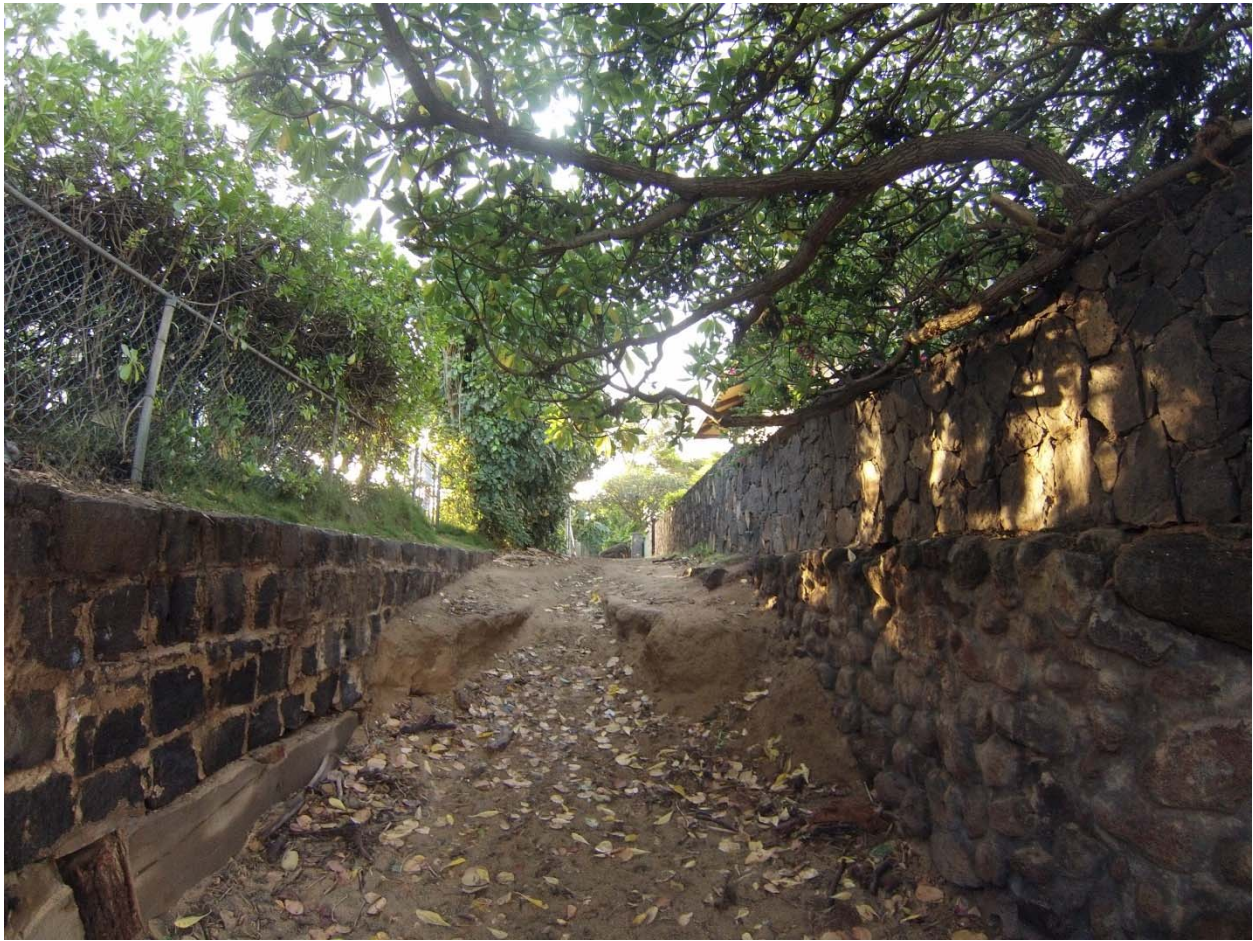
Figure 4-9 Three foot scarp in County of Maui beach access path

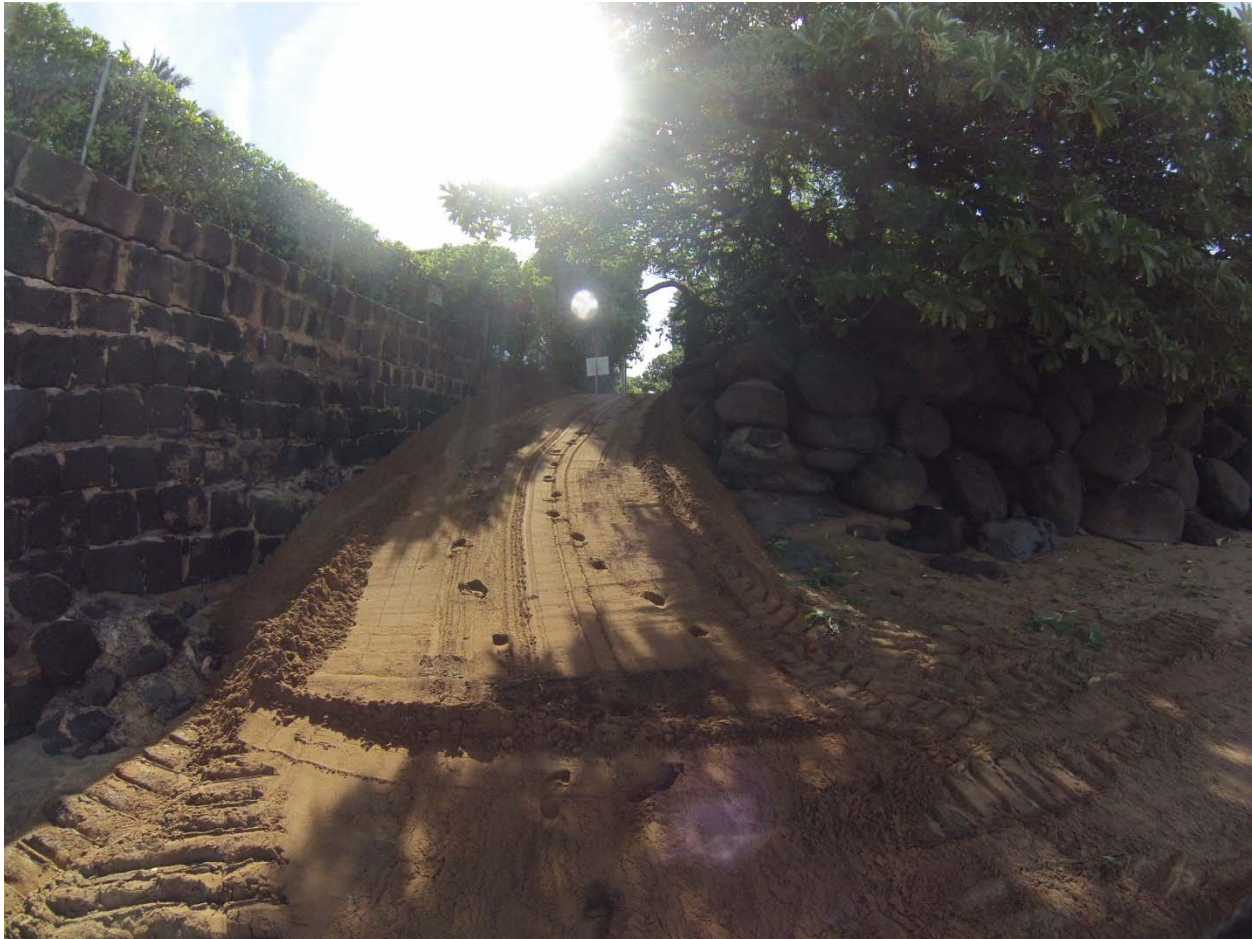
Figure 4-10 County of Maui beach access path with graded maintenance sand

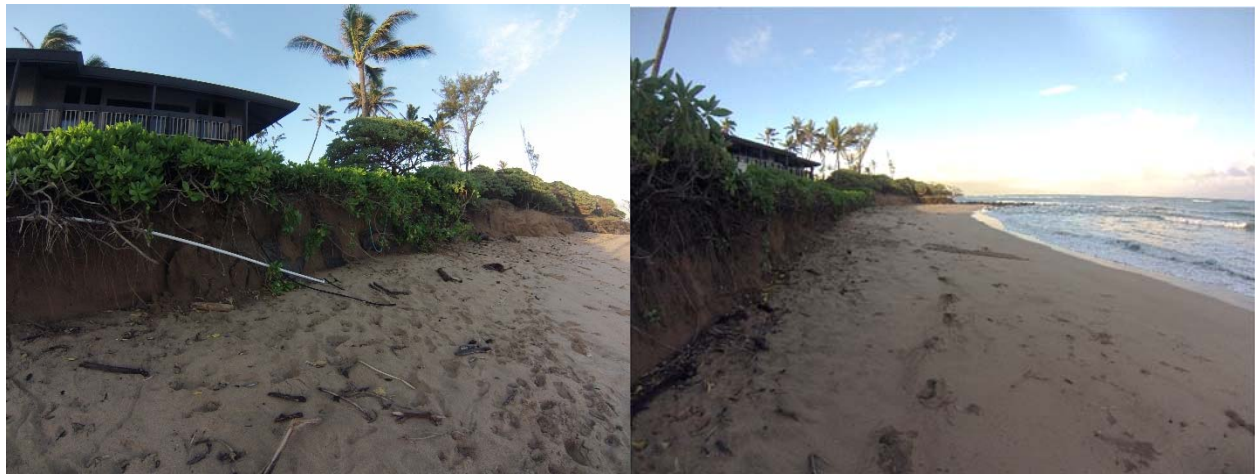
Shoreline conditions, along the mauka side of the beach berm, showed signs of heavy erosion. The erosion scarp was three to four feet tall along the western half of the Hayashi seawall. The eastern half of the seawall's upper boulders was entirely exposed due to beach deflation.

Figure 5-15 Pre-maintenance conditions near Transect 7 (right picture) and Transect 5 (left picture)

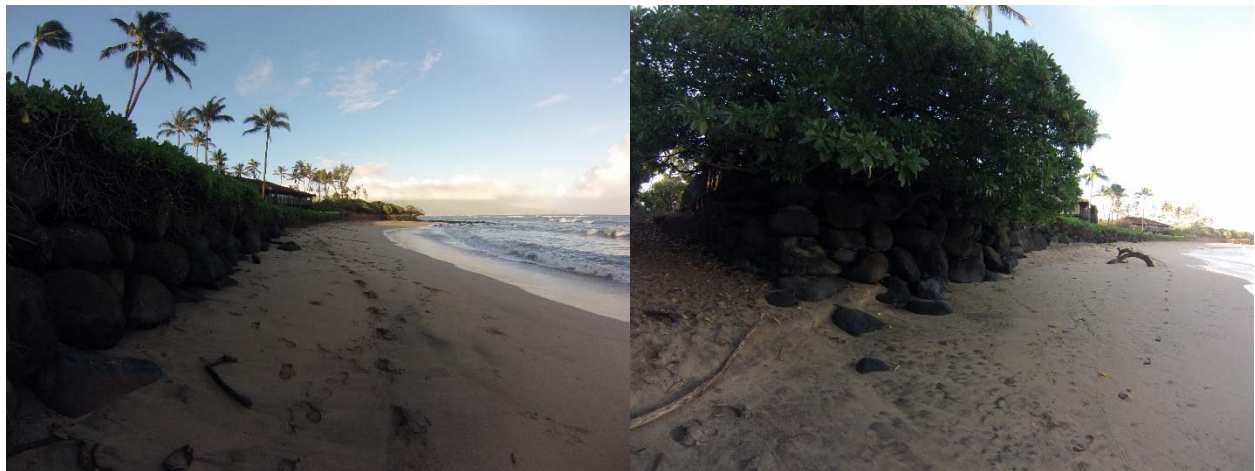
Figure 5-16 Pre-maintenance conditions near Transect 3 (right picture) and the County of Maui beach access (left picture)

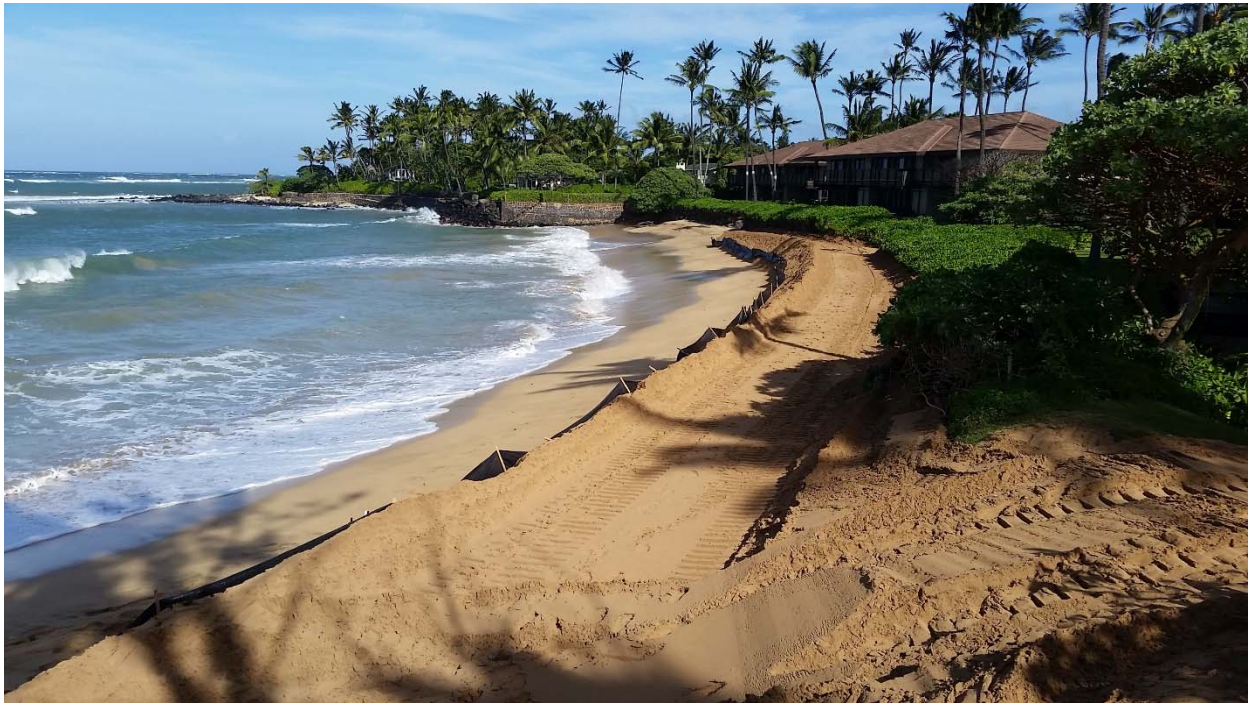
Post-maintenance the shoreline on the western two-thirds of the beach was stabilized by the berm-maintenance materials (Figure 5-17 and Figure 5-18). The maintenance sand elevated the berm along the western portion of the cove.

Figure 5-17 Post-maintenance conditions on the berm at Transect 5

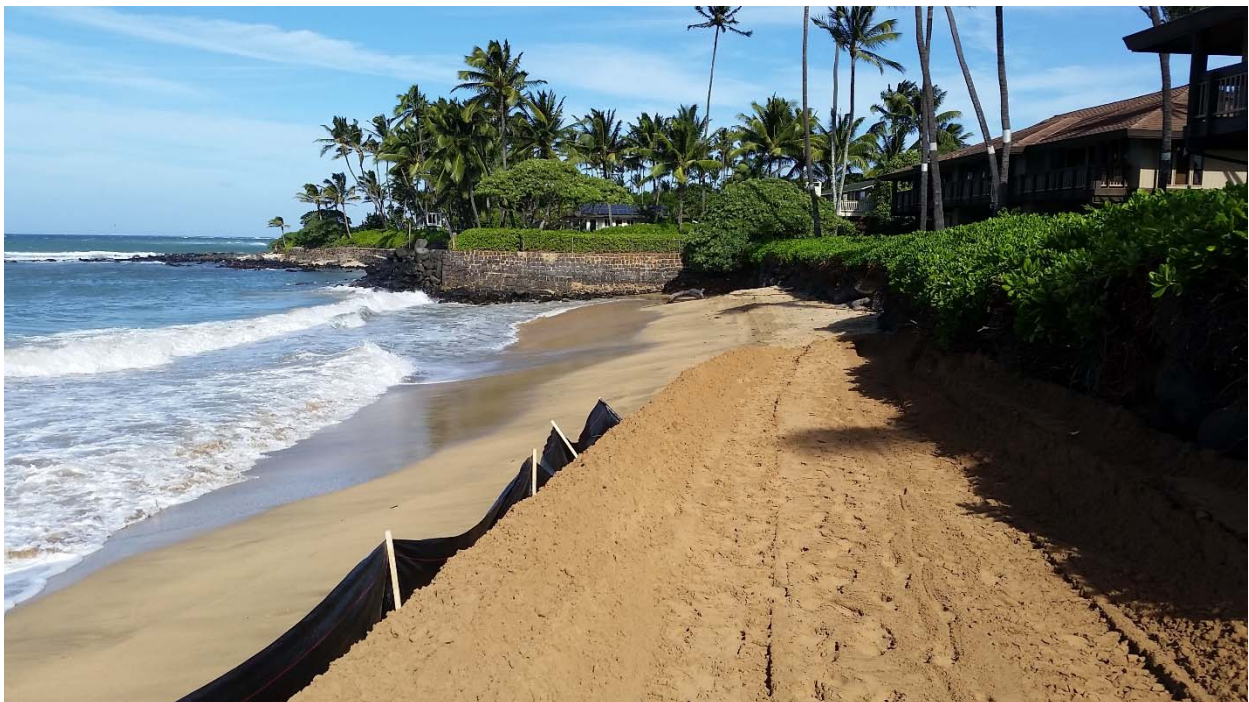
Figure 5-18 Post-maintenance conditions on the berm looking toward Transect 3 from the west

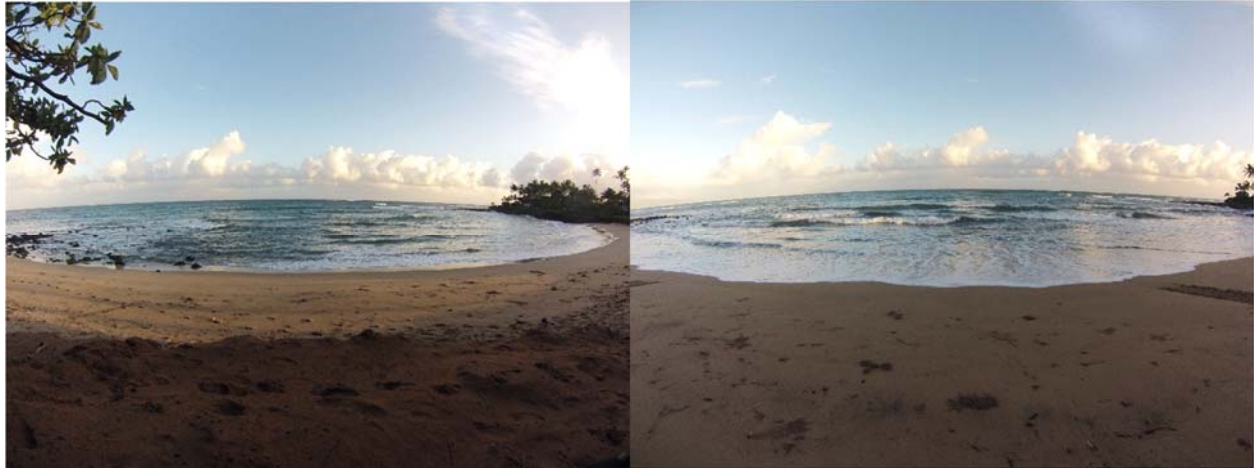
Pre-maintenance the beach showed signs of deflation (Figure 5-19 and Figure 5-20), which has occurred during the four years since the previous berm maintenance efforts. The low profile beach face was awash during higher tides. There was a recent debris line mid-face on the beach prior to initiating berm maintenance.

Figure 5-19 Looking makai along Transect 7 (left picture) and Transect 5 (right picture), pre-maintenance

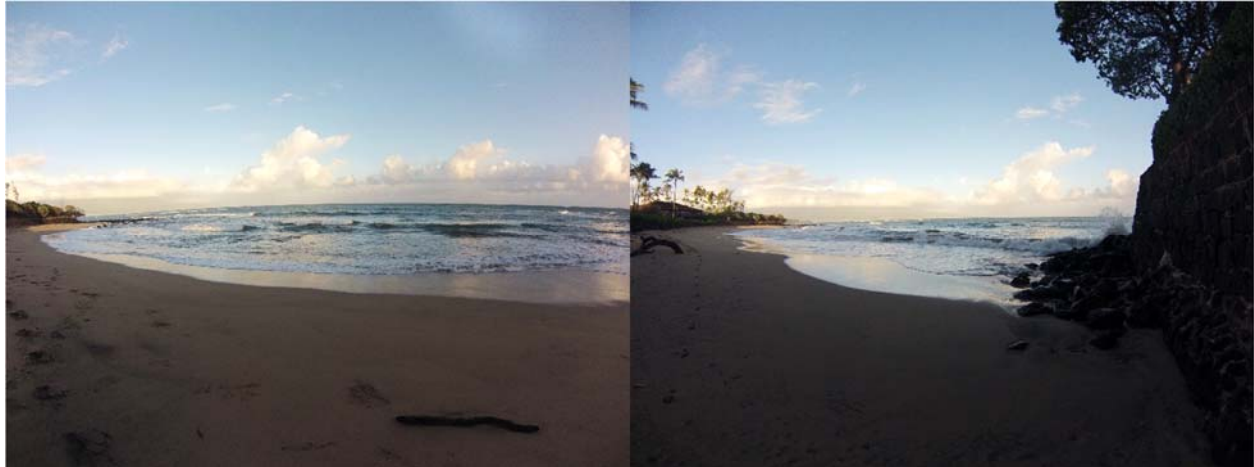
Figure 5-20 T Looking makai along Transect 3 (left picture) and the County of Maui beach access (right picture), pre-maintenance

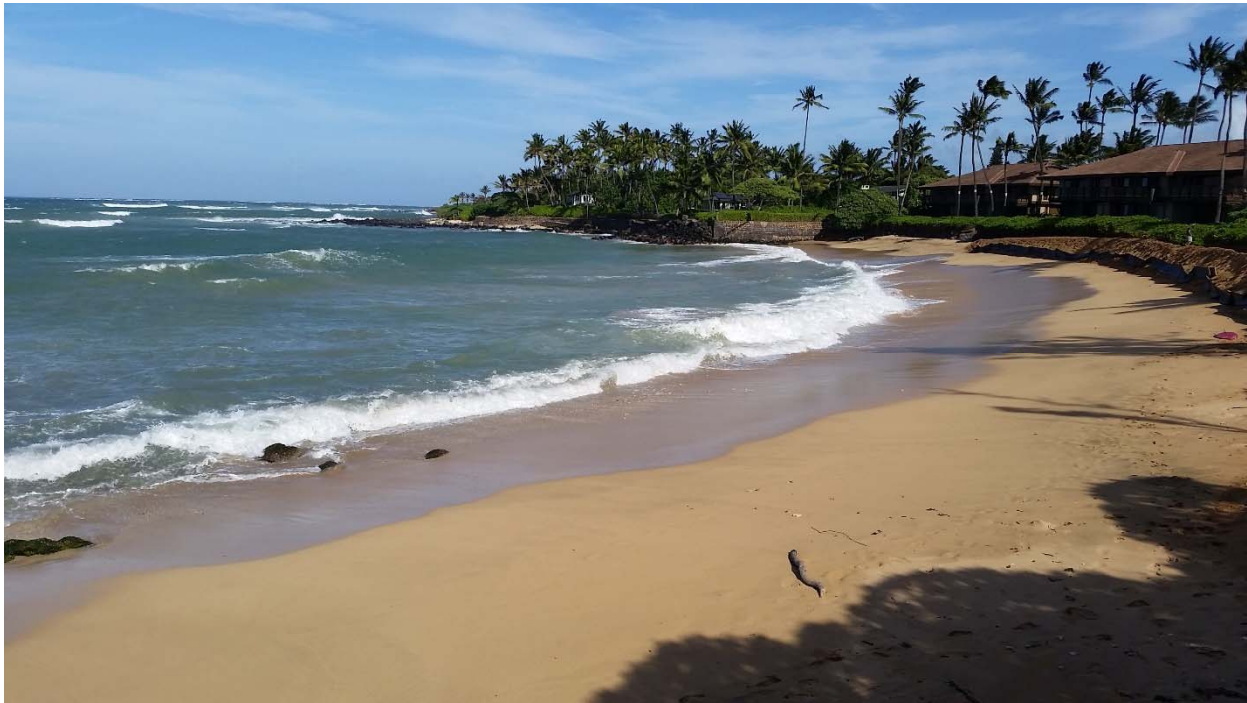
Post-maintenance the beach face was still deflated; however, the western two-thirds of the berm was re-inflated with maintenance sand, which abutted the upper portion of the Hayashi seawall (Figure 5-21).

Figure 5-21 Looking east along the beach face, from Transect 7 toward the County of Maui beach access

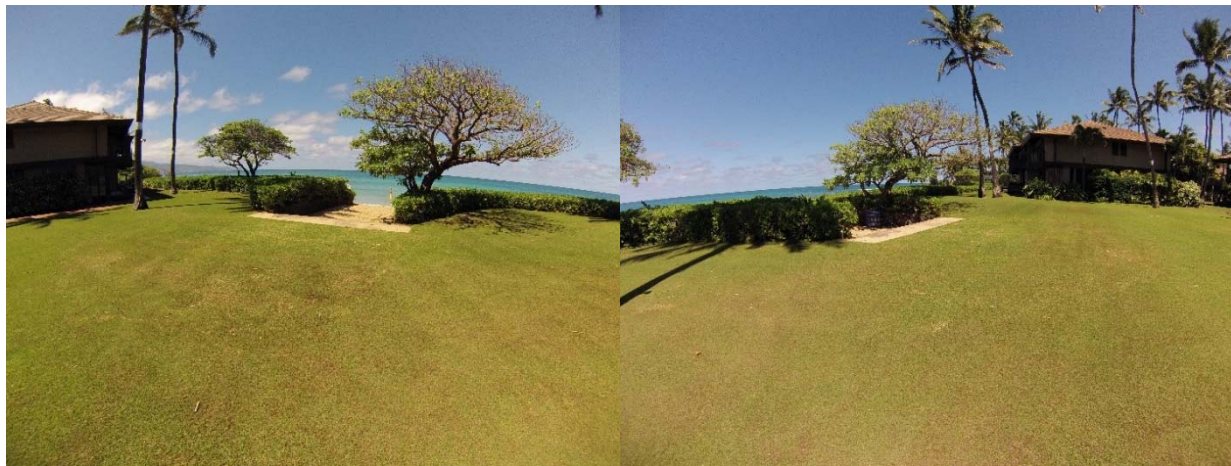
Figure 5-22 Typical backshore conditions at the site

Backshore conditions at the project are typified by a coastal lawn bordered by a naupaka hedge on the makai side. The Hayashi seawall is located beneath and makai of the naupaka hedge, extending seaward beneath the restored sand beach. Dwellings are built in the coastal lawn, adjacent to the mauka side of the Hayashi seawall.

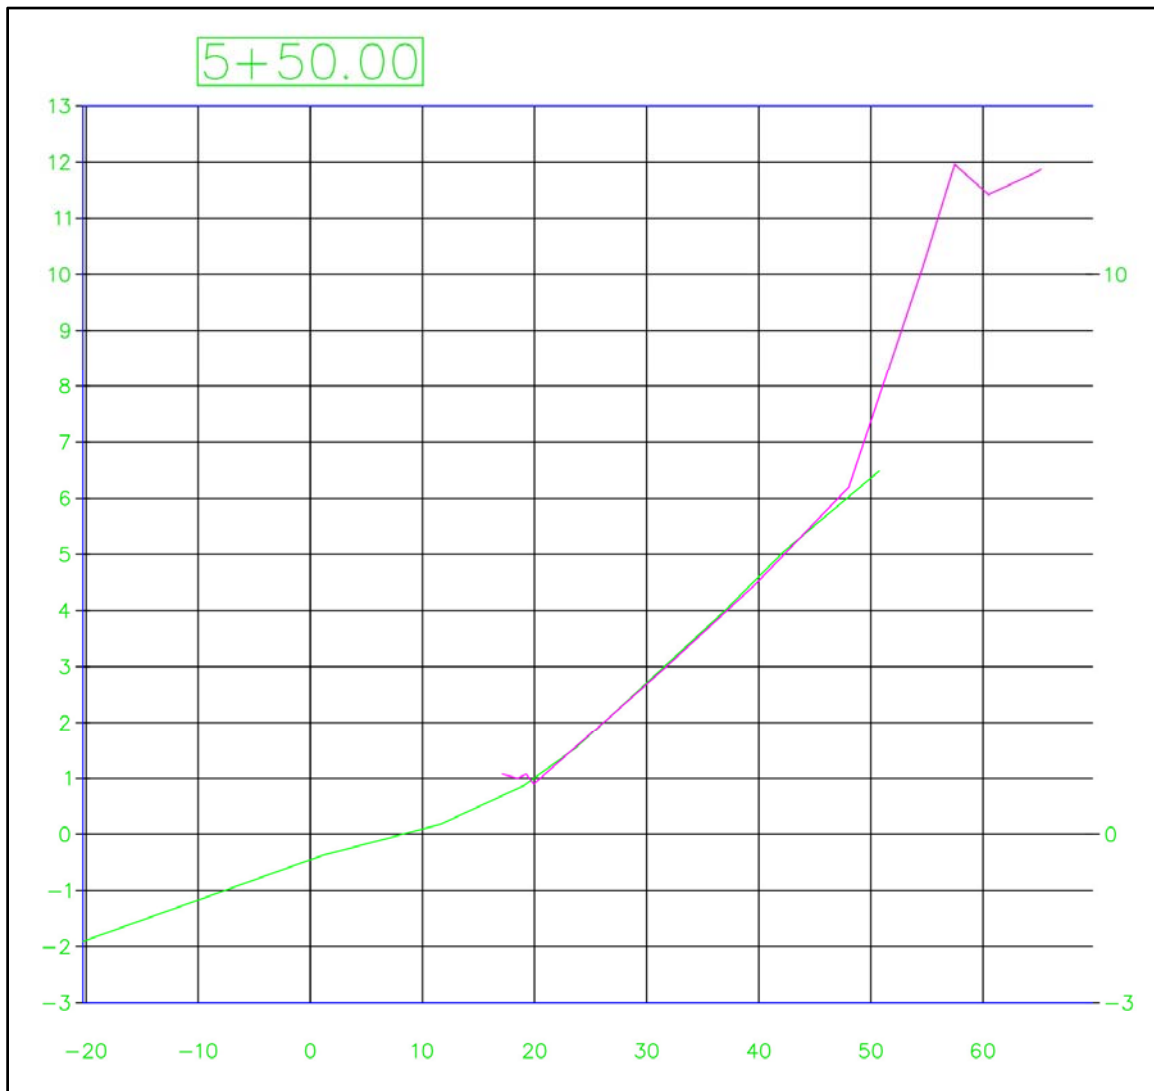
Figure 5-28 Profile 5 + 50. Green and pink lines represent November 09, 2015, and November 10, 2015, elevations respectively.

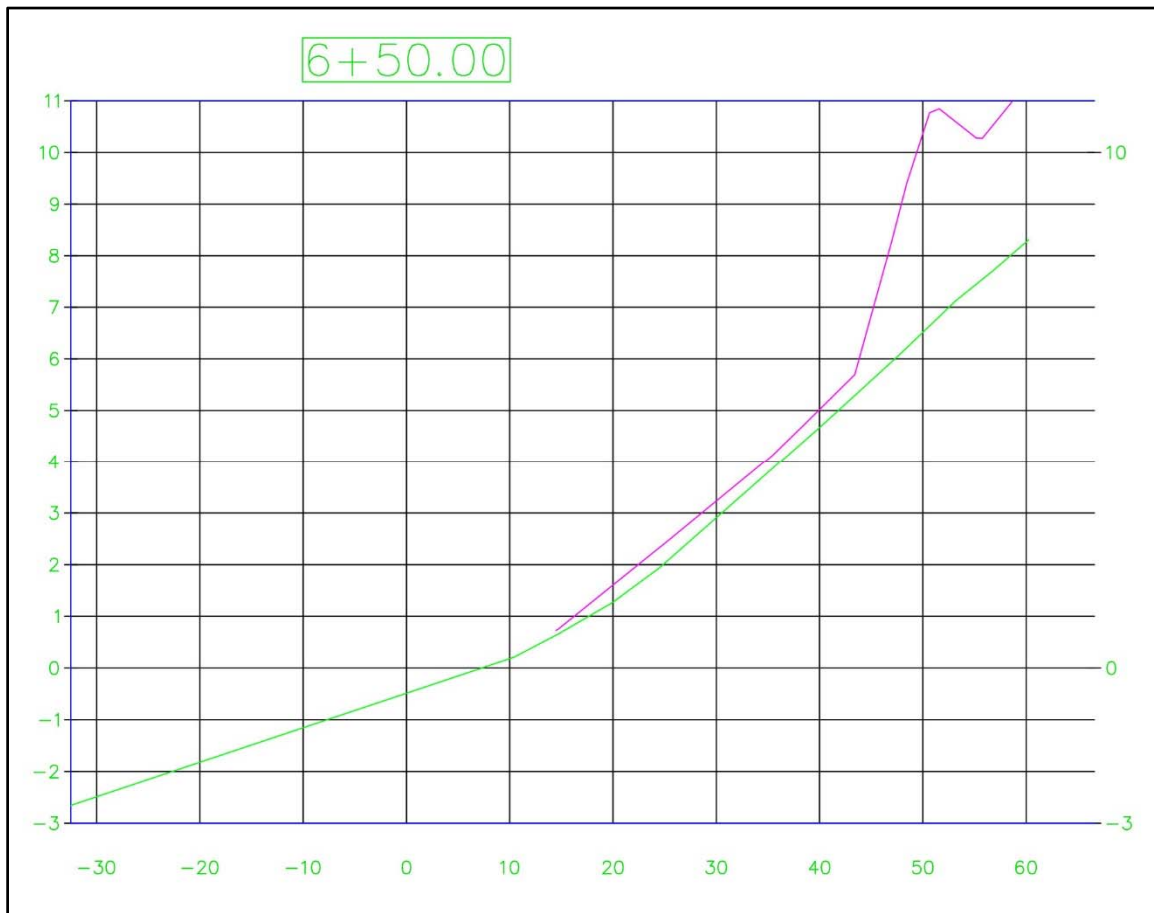
Figure 5-30 Profile 6 + 50. Green and pink lines represent November 09, 2015, and November 10, 2015, elevations respectively.

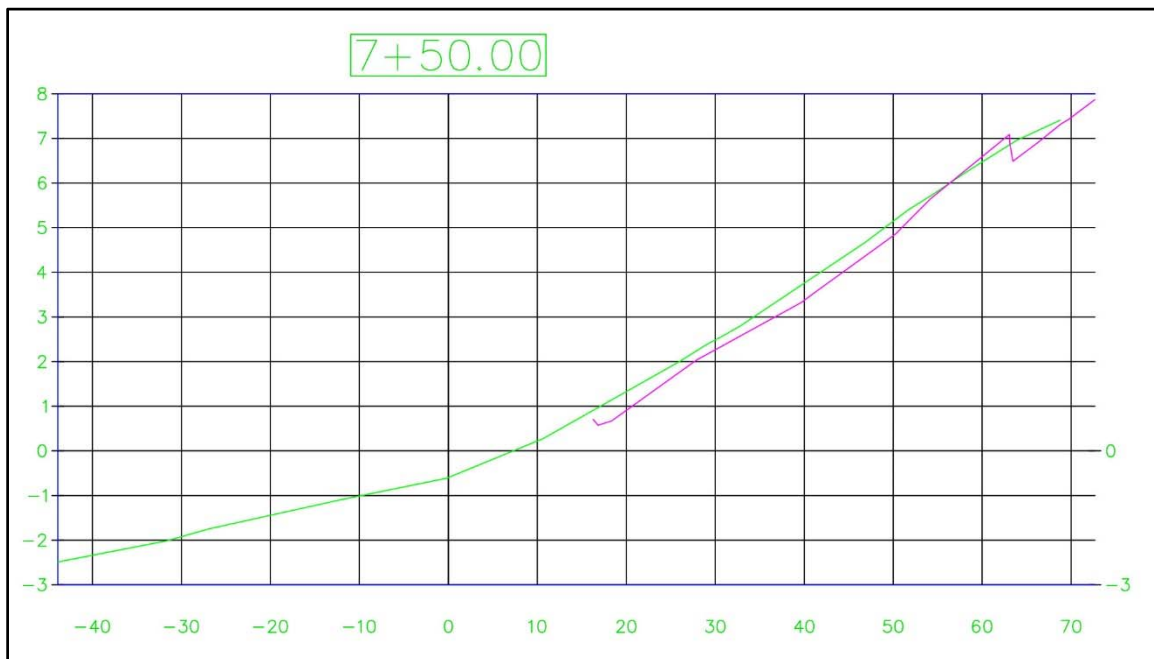
Figure 5-32 Profile 7 + 50. Green and pink lines represent November 09, 2015, and November 10, 2015, elevations respectively.
