SUBJECT: Proposed Waimea Deep Monitor Well Project Located at Lālāmilo, South Kohala,
Hawai'i, TMK: (3) 6-6-002:041

A DMW is a well that penetrates through the freshwater zone into the saltwater zone. The purpose of this project is to monitor aquifer health statewide to ensure the sustainability of groundwater resources. CWRM notes that the project consists of planning, design, and permitting of a DMW with a diameter casing of less than 12 inches (approximately between 6-8 inches), a 10'x20' concrete pad and related improvements inclusive of 15'x15' chain-link fence with barbed wire and a gate enclosure, and an 8 ft wide graded access road.

Well Site and Construction Staging Area
Field Photo

SOUTH KOHALA, HAWAII

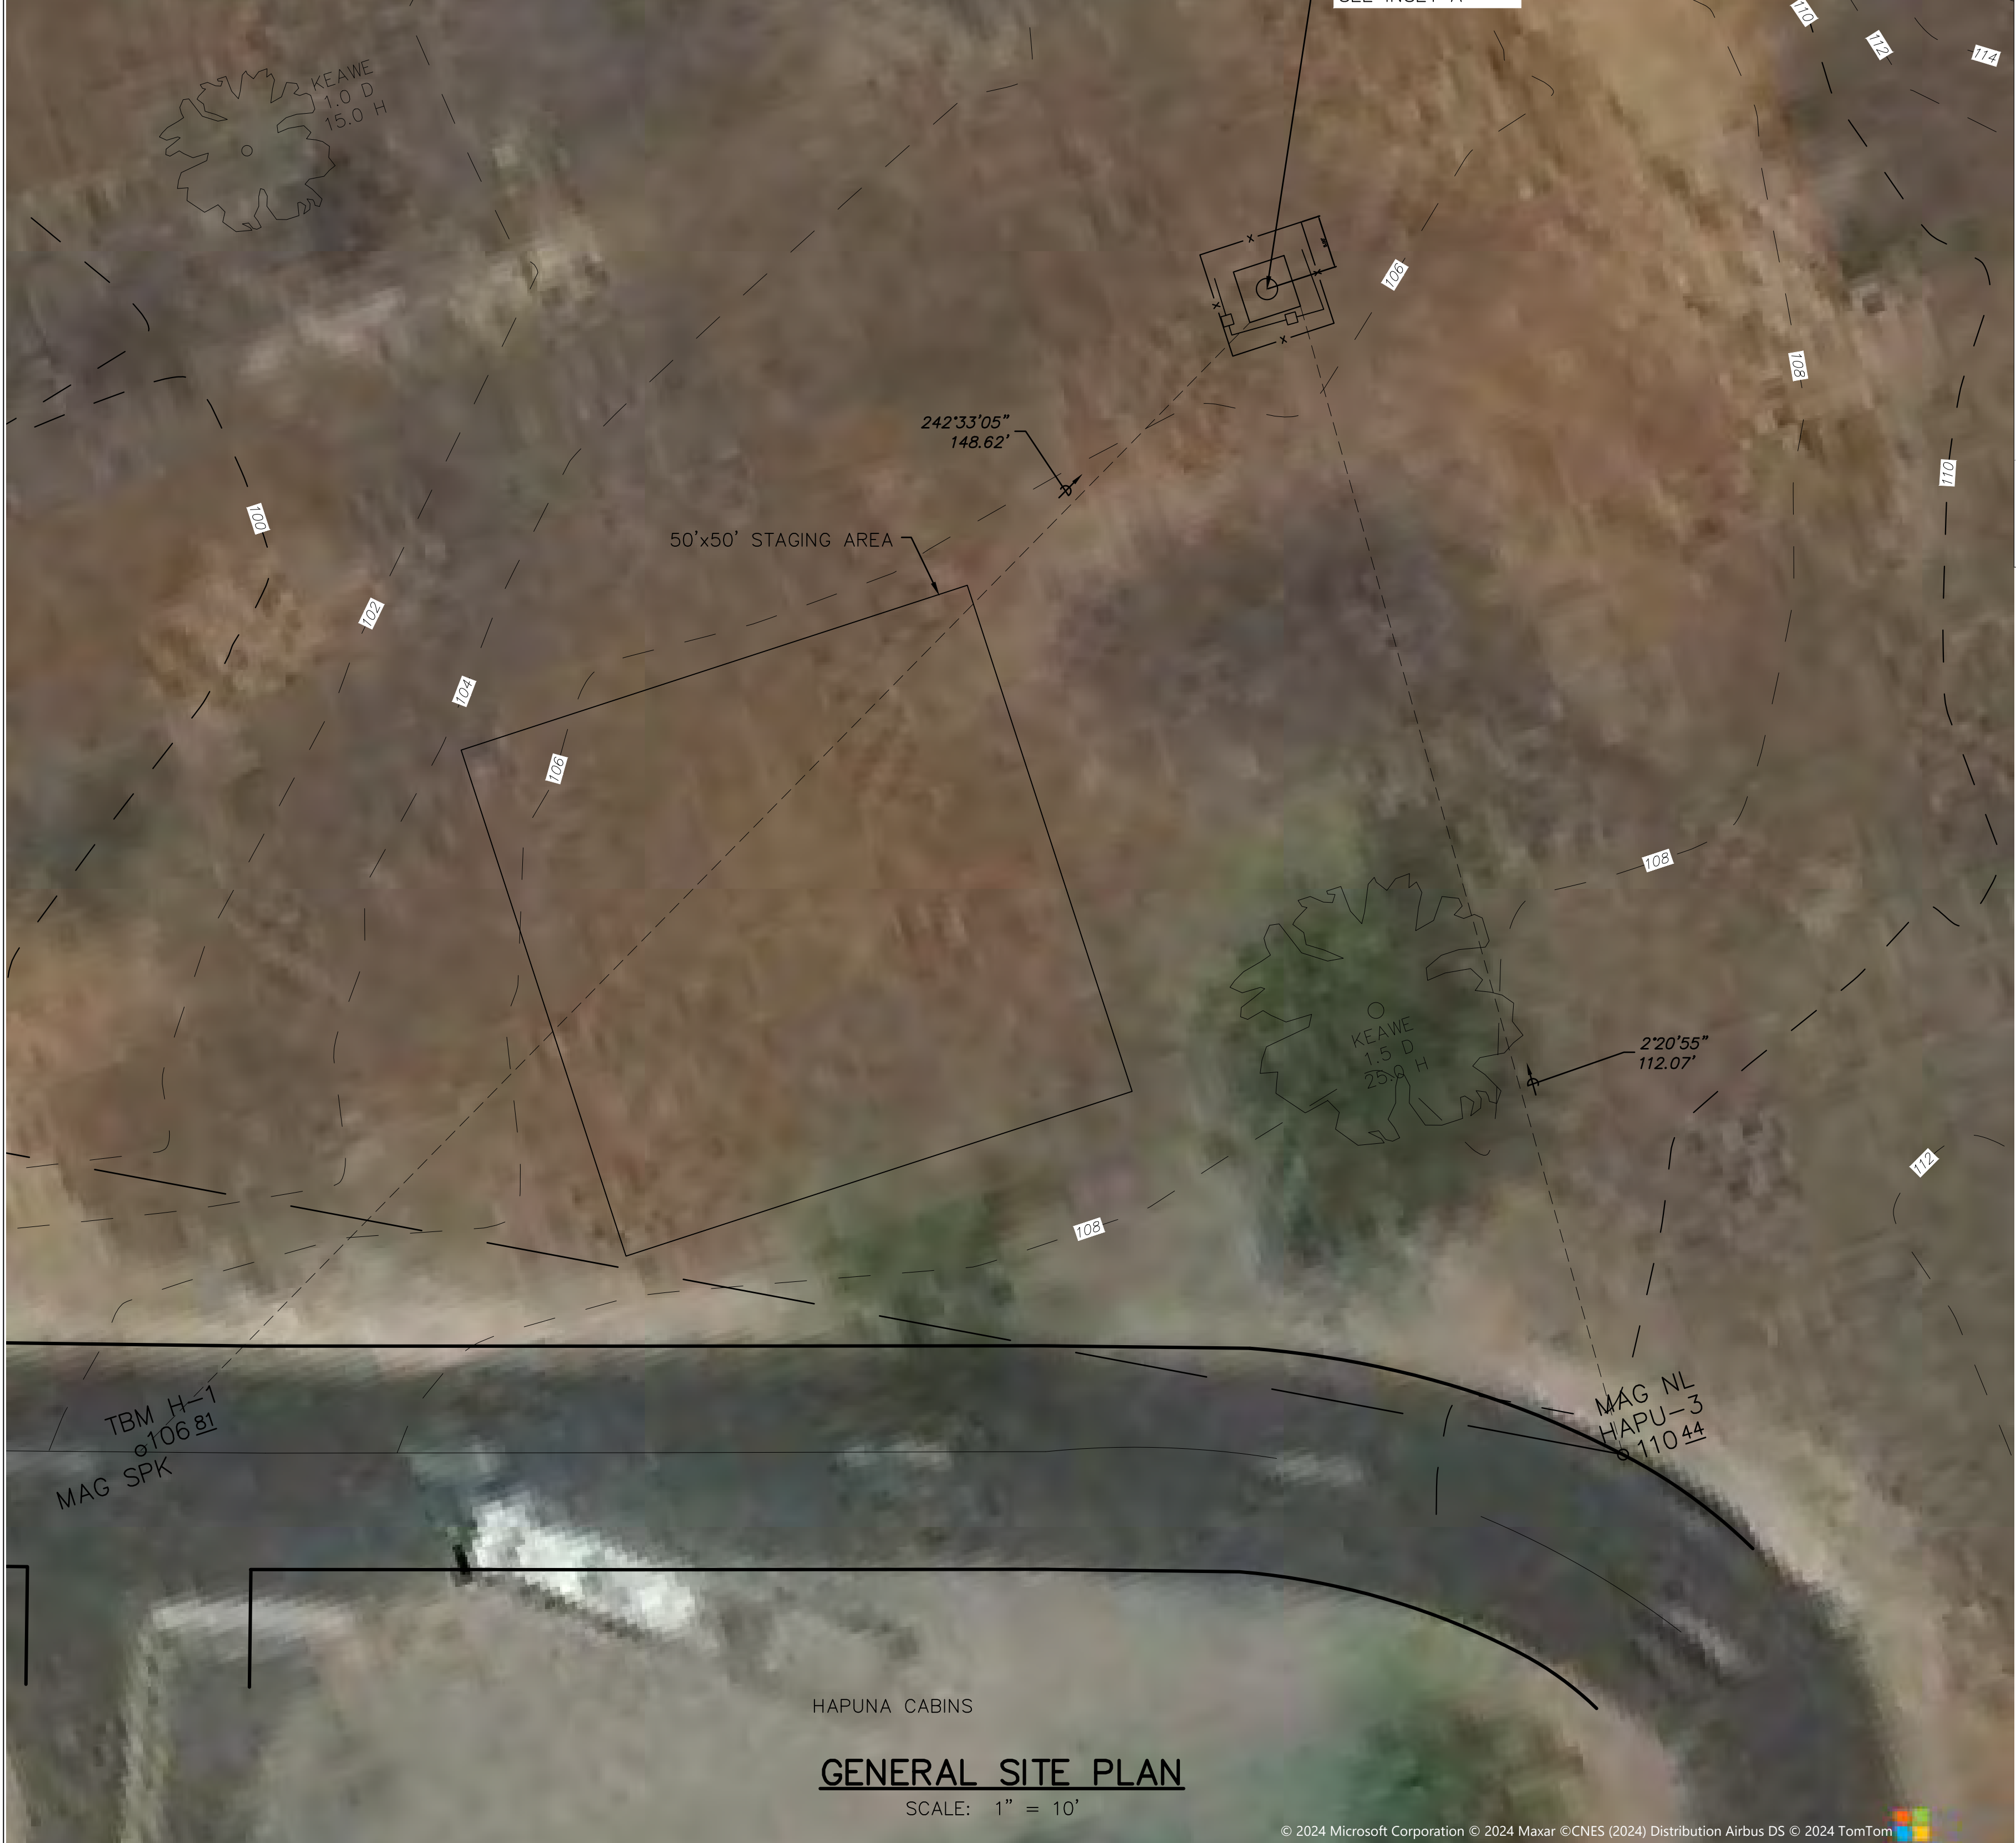
GENERAL SITE PLAN
 SCALE: 1" = 10'

INSTALL NEW WELL, CONC. PAD, AND FENCE SEE INSET A

NOTE:
 ALL POLLUTANTS WILL BE STORED AT THE MAXIMUM POSSIBLE DISTANCE FROM POLLUTANTS. IF POSSIBLE ANY POLLUTANTS WILL BE STORED HYDRAULICALLY DOWN FROM THE WELL.

NOTE:
 1. LOCATION OF THE WELL AND STAGING AREA SHALL BE CONFIRMED WITH ENGINEER AND ARE SUBJECT TO CHANGE BASED ON EXISTING SITE CONDITIONS.
 2. THE HAPUNA AREA WAS ONCE USED AS A TRAINING AREA FOR AMERICAN MILITARY FORCES. CONTRACTOR SHALL ENGAGE A QUALIFIED MUNITIONS CONTRACTOR TO PERFORM A PRE-CONSTRUCTION AND EVALUATION AND SURVEY AT EACH SITE OF TRENCHING, SHOULD ANY UNEXPLODED ORDNANCE BE UNCOVERED, ALL WORK SHALL CEASE IN THE IMMEDIATE AREA, CALL 911, AND THE ENGINEER SHALL BE NOTIFIED IMMEDIATELY. NO WORK SHALL RESUME UNTIL CLEARANCE HAS BEEN OBTAINED FROM THE ENGINEER AT NO EXTRA COST TO THE STATE.
