Project Description

Maunalua Boat Ramp Maintenance Dredging and Facility Improvements

**State of Hawaii Department of Land and Natural Resources (DLNR)
Division of Boating and Ocean Recreation (DOBOR)**

September 2024

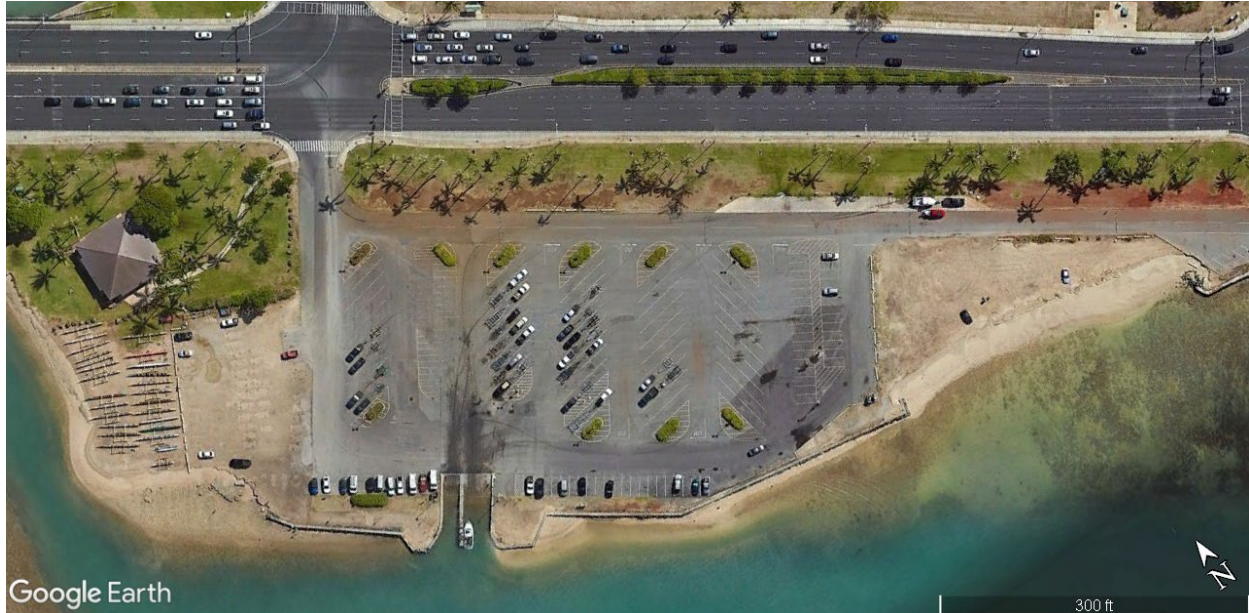
Figure 1. Satellite Photo of the Facility, Captured on May 21, 2015 (Photo: NASA)

The west side of the Facility is host to several canoe clubs who practice the traditional Hawaiian sport of outrigger canoe paddling from the site. Canoes are stored within a modern hale structure as well as in the upland area in the westernmost portion of the Facility, and are launched into the bay via the shoreline along the western edge of the Facility. A satellite photo showing an overview of the Facility is provided in Figure 1, below.

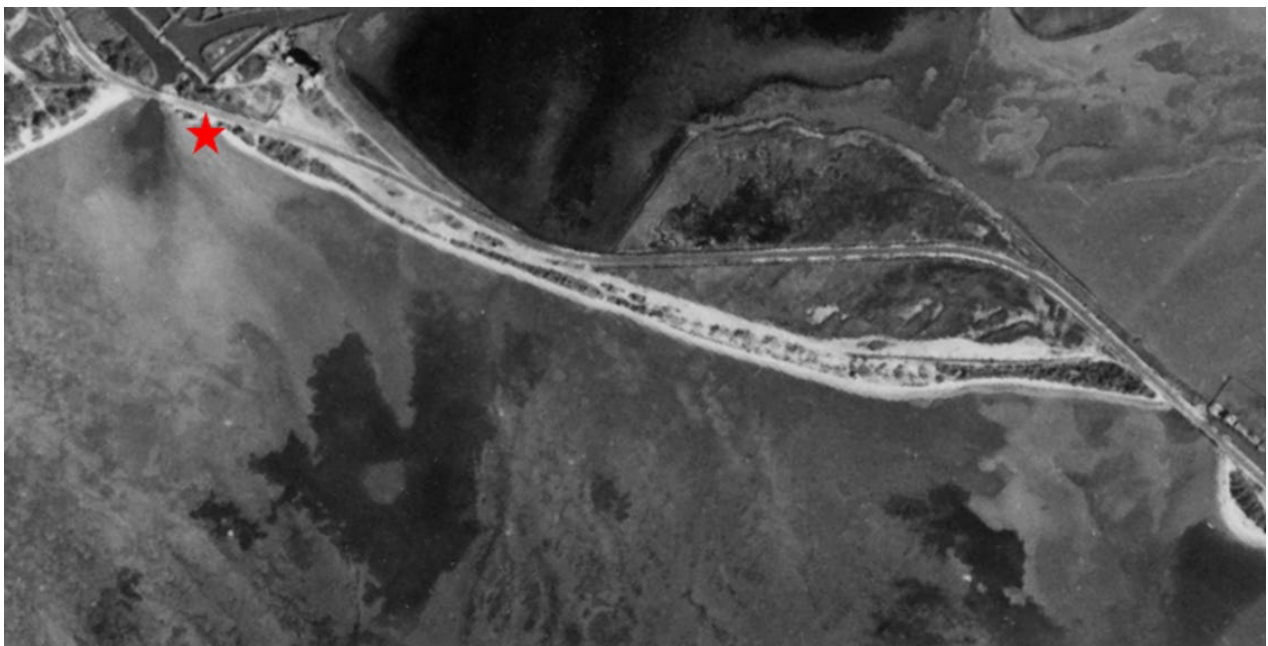
Figure 3. Aerial Photograph of the Project Site in Maunalua Bay with a Red Star Showing the Location of the Existing Maunalua Bay Boat Ramp Facility (Center Left) and Kuapa Pond in the Foreground, as It Existed in 1928.

Figure 1 provides a 1928 photograph of the narrow ribbon of land located between Maunalua Bay and “Kuapa Pond,” a brackish fishpond, which stretched inland, northeast of the site. The location of the present-day Facility is shown with a red star. The shoreline of Maunalua Bay consisted of carbonate sand beaches with a narrow, vegetated backshore/dune system. As evidenced in the photograph, no navigation channel connecting the present-day Facility location to Maunalua Bay existed at this time.

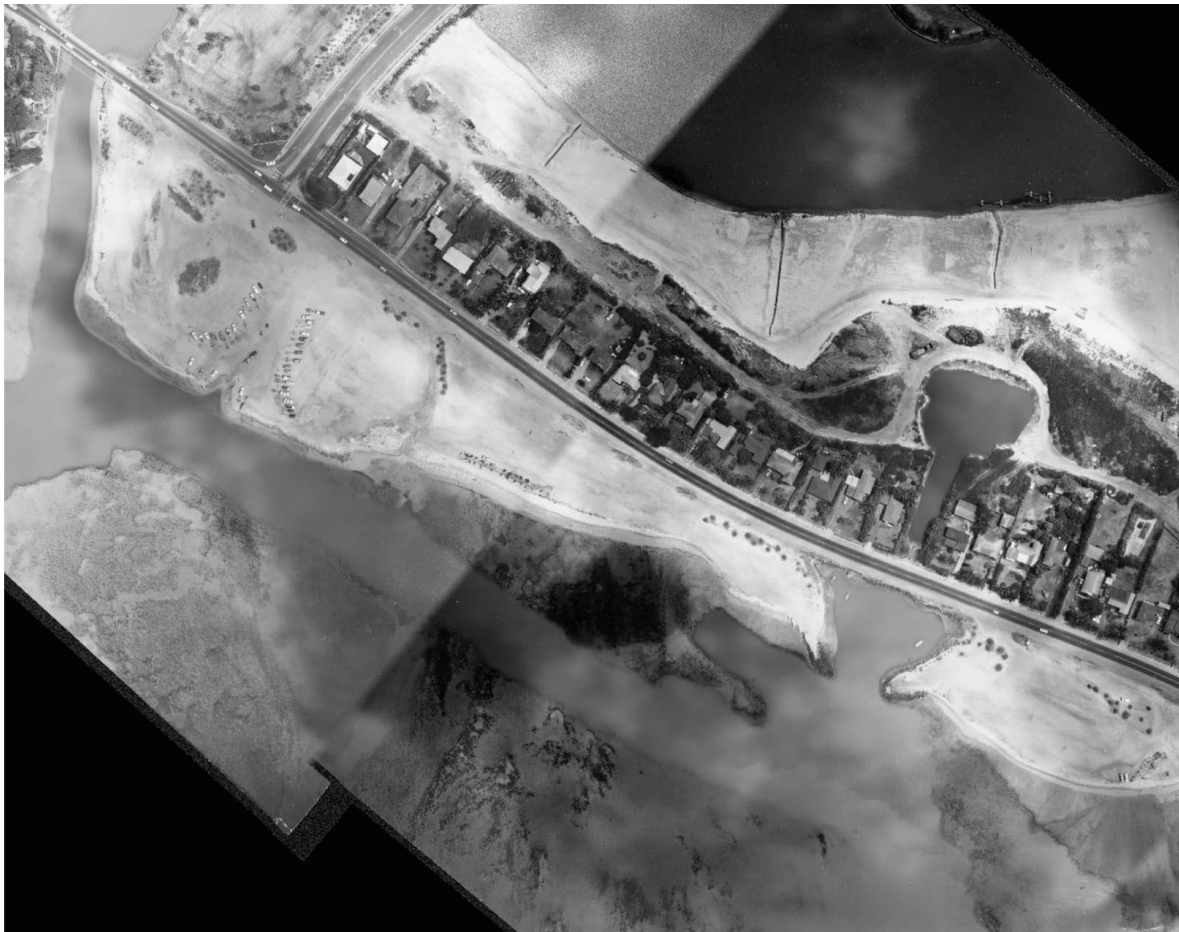
Figure 4. Historical Aerial Photograph of the Project Site in 1967.

Maunalua Bay and its vicinity underwent significant changes between the 1940s–1960s, with the creation of navigation channels as well as large-scale dredging and filling operations associated with the development of the Hawaii Kai Marina. Figure 3 presents an aerial photograph of the project site in 1967. The dredged navigation channel can be clearly seen running from the bottom right of the photograph towards the upper left at the site of the present-day boat launch ramp. Figure 4 provides a more recent satellite photograph from 2016. A white dashed line has been added to identify the location of the dredged navigation channel that provides vessel access to the Maunalua Bay Boat Ramp Facility from the Pacific Ocean.

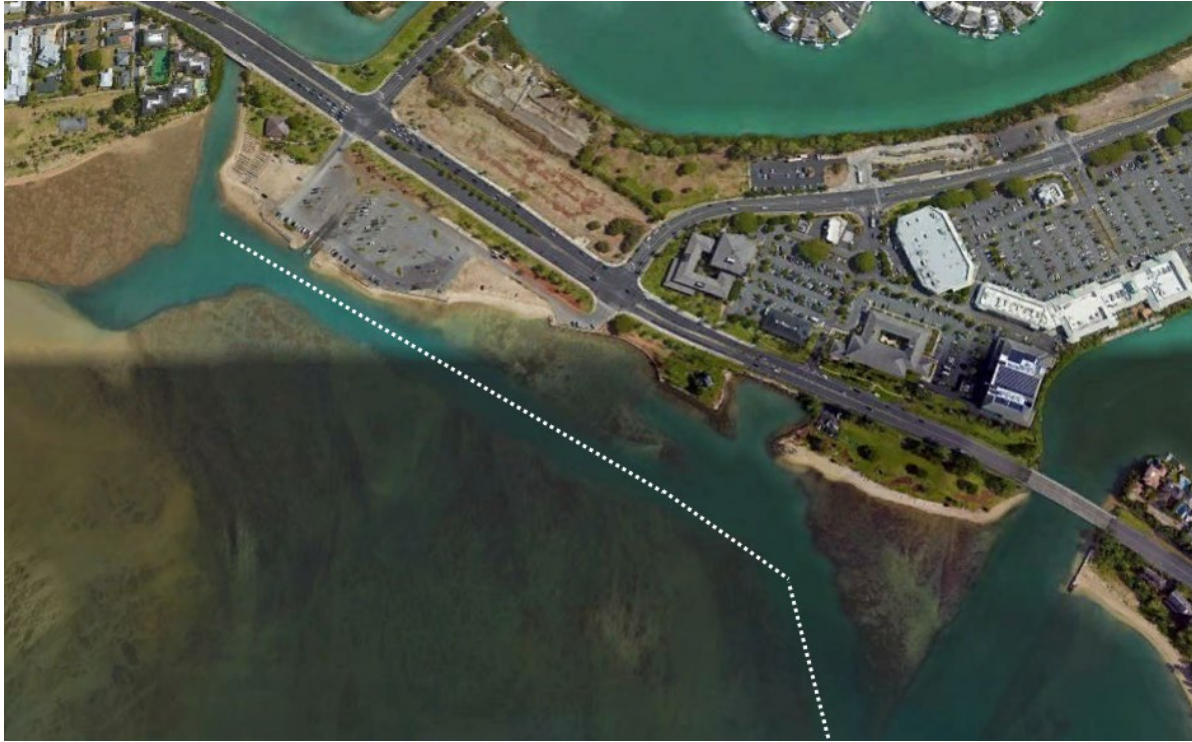
Figure 5. Satellite photograph of the project Site in 2016.

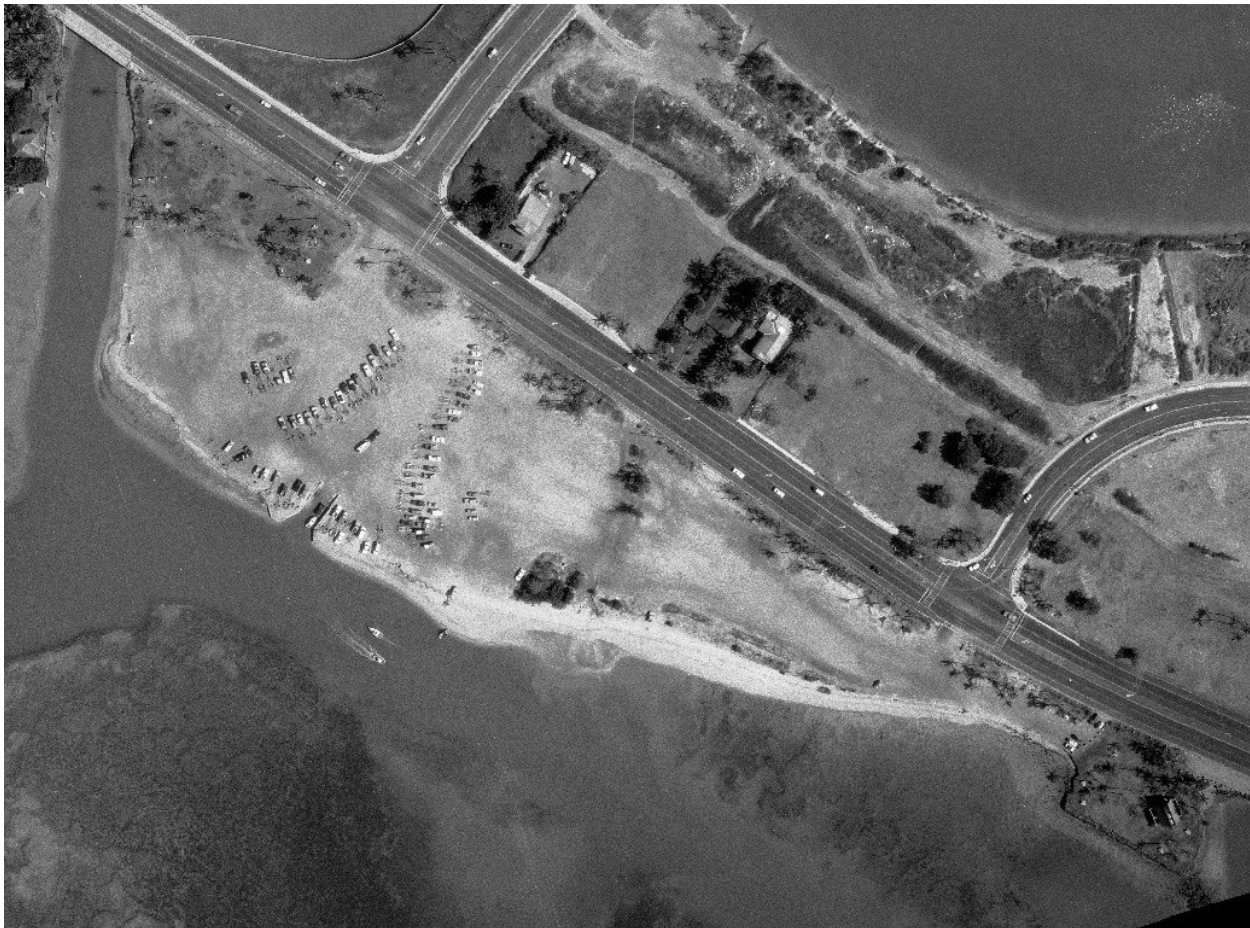
Figure 8. Historical Aerial Photograph of the Facility area 1975.

Between 1967 and 1975, a concrete boat ramp bordered by cement rubble masonry walls was constructed at the facility to prevent erosion and provide a safe launch facility for boaters. Shoreline hardening structures also began to be installed, starting with a rock revetment installed along the shoreline of the C&C Parks and Recreation-owned lot east of the site, makai of the restroom structure. Elsewhere the shoreline was not protected by shoreline armoring and subsequently experienced chronic erosion.

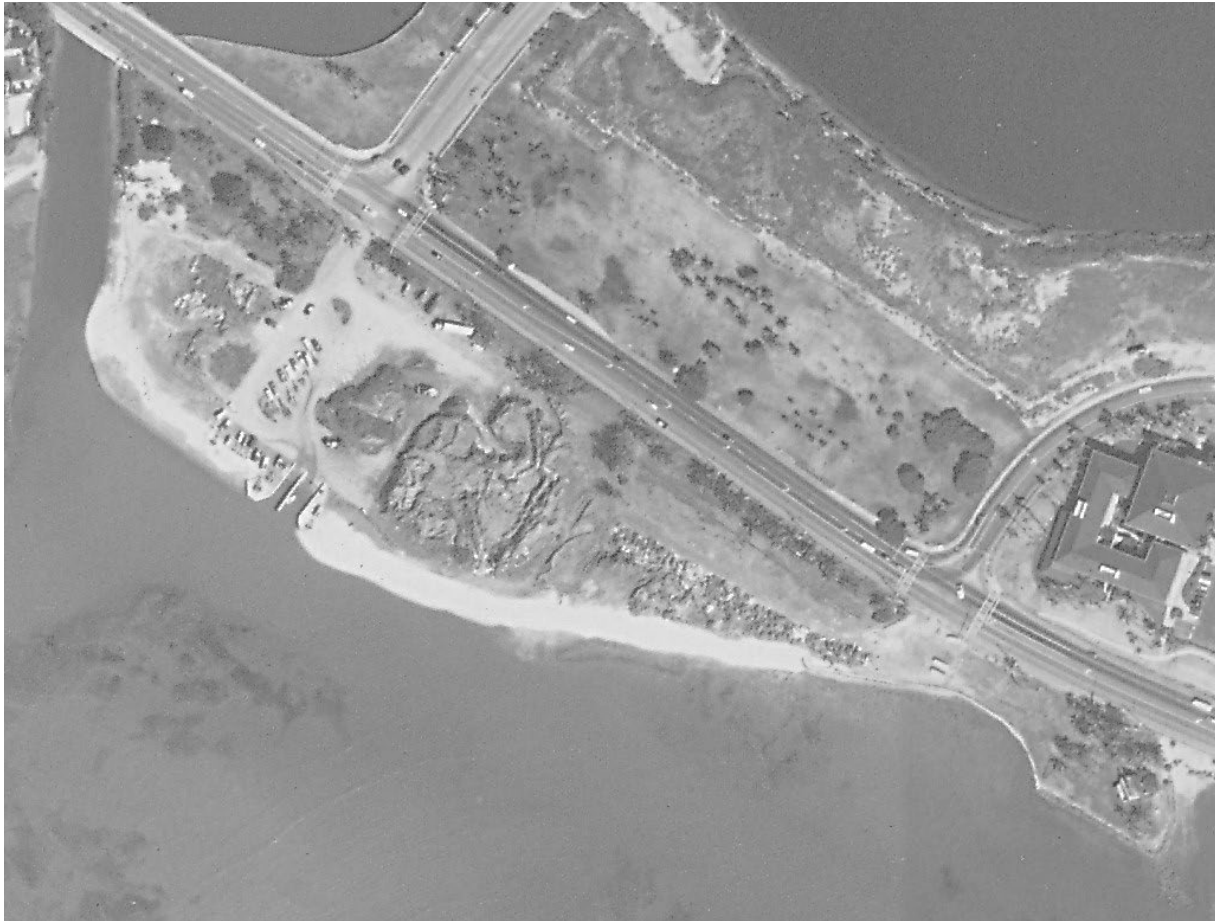
Figure 9. Historical Aerial Photograph of the Facility Area in 1988.

Further hardening was installed between 1975 and 1988, consisting of a seawall extending west from the west end of the existing revetment, and terminating at the current east end of east beach. The seawall can be seen in Figure 5, below.

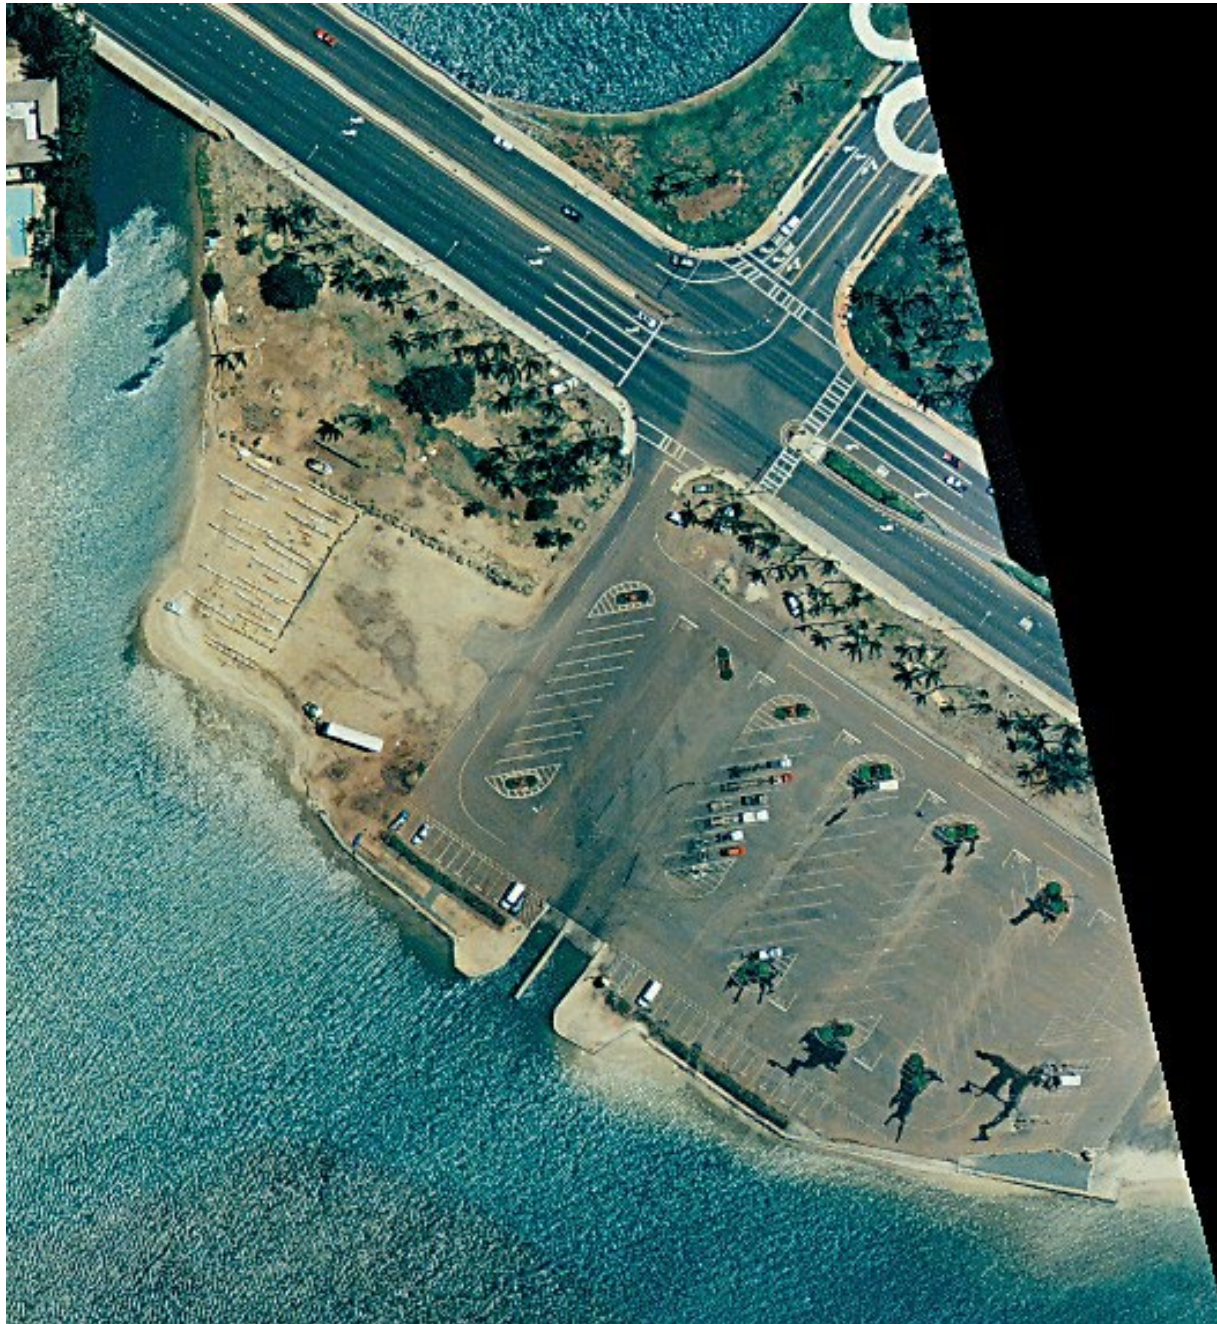
Figure 10. Historical Aerial Photograph of the Facility Area in 1996.

Finally, in 1993, the current extents of shoreline hardening were completed, with the installation of short, sloped walls extending east and west from the boat ramp, as can be seen in Figure 7, below. A cross-section from the project drawings is also provided in Figure 8, below.

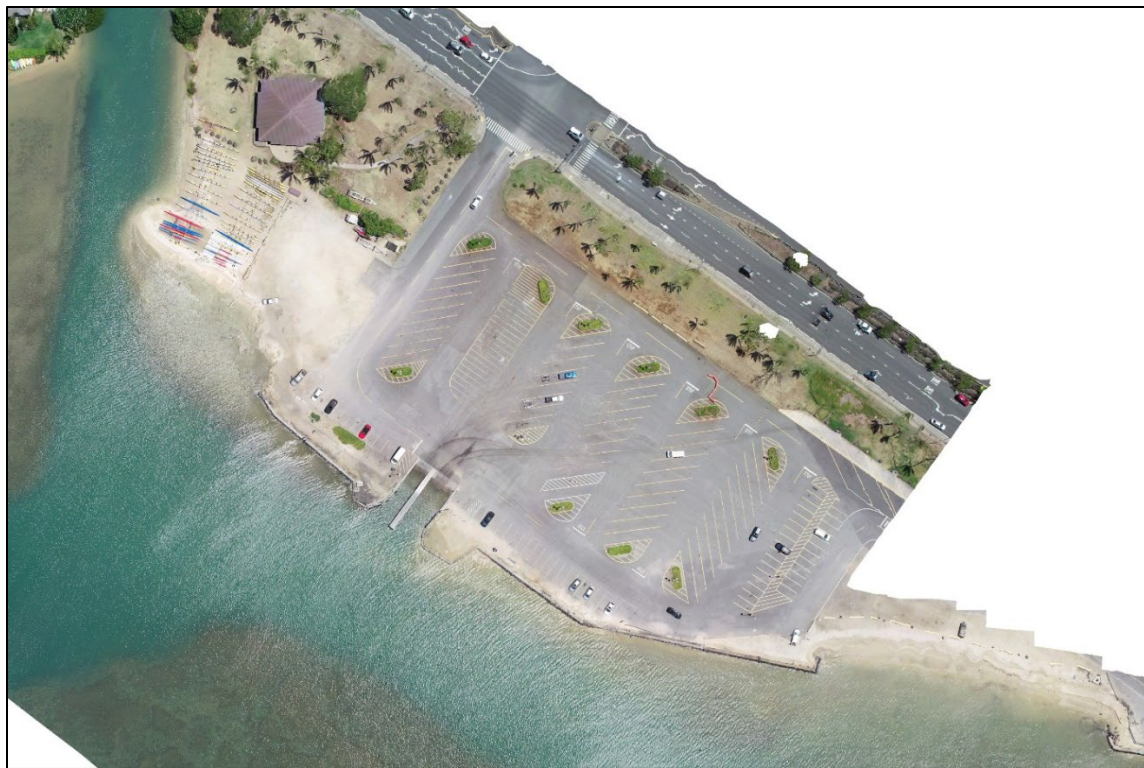
Figure 12. Orthomosaic Aerial Image of the Project Site as It Existed on July 14, 2023 (Shoreline Science & Engineering, LLC).

Areas without shoreline hardening have continued to erode since 1993. An aerial photograph of the project site collected in July 2023 is provided in Figure 9, below, showing severe erosion at the west end of the site, and moderate erosion at east beach.

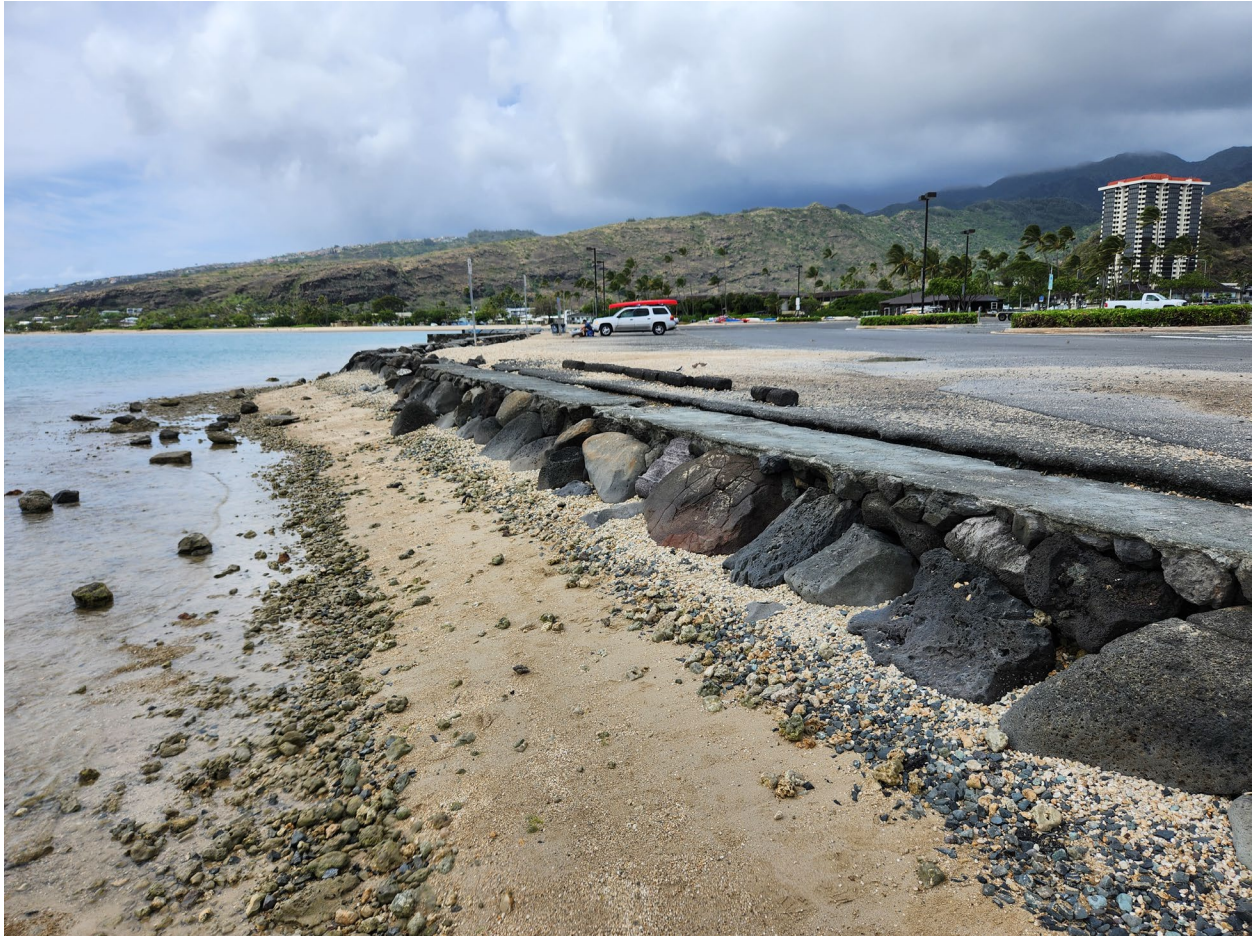
Figure 13. Photo of the Type B Wall East of the Boat Ramp, Looking West, on February 28, 2024 (Photo: Integral Consulting Inc.).

Small, un-grouted rock walls (Type B wall) located along the shoreline of the Facility have developed voids and have partially collapsed in some areas. This wall type is shown in Figure 3, below. Grouted CRM walls (Type A wall) adjacent to the boat ramp have also degraded and developed voids. This wall type is shown in Figure 4, below. The existing Type A walls will be repaired via filling of voids, repointing existing mortar, and forming and tremie pouring voids per the project plans and specifications.

The existing Type A and B walls may be partially re-built (as needed), by removing the existing un-reinforced concrete cap and all loose stones above grade, and re-constructing per the project plans and specifications. All voids will be fully grouted, and the walls will be topped with a reinforced concrete cap added as a part of this repair. Repairs to both wall types will include increasing the height of the walls (including the new reinforced concrete cap) by approximately 10 percent to a final post-construction top of wall elevation of +4.7 ft MLLW. The existing Type B wall at the east end of the site is taller, and consequently be repaired to a corresponding 10 percent increase in height to +5.2 ft MLLW.

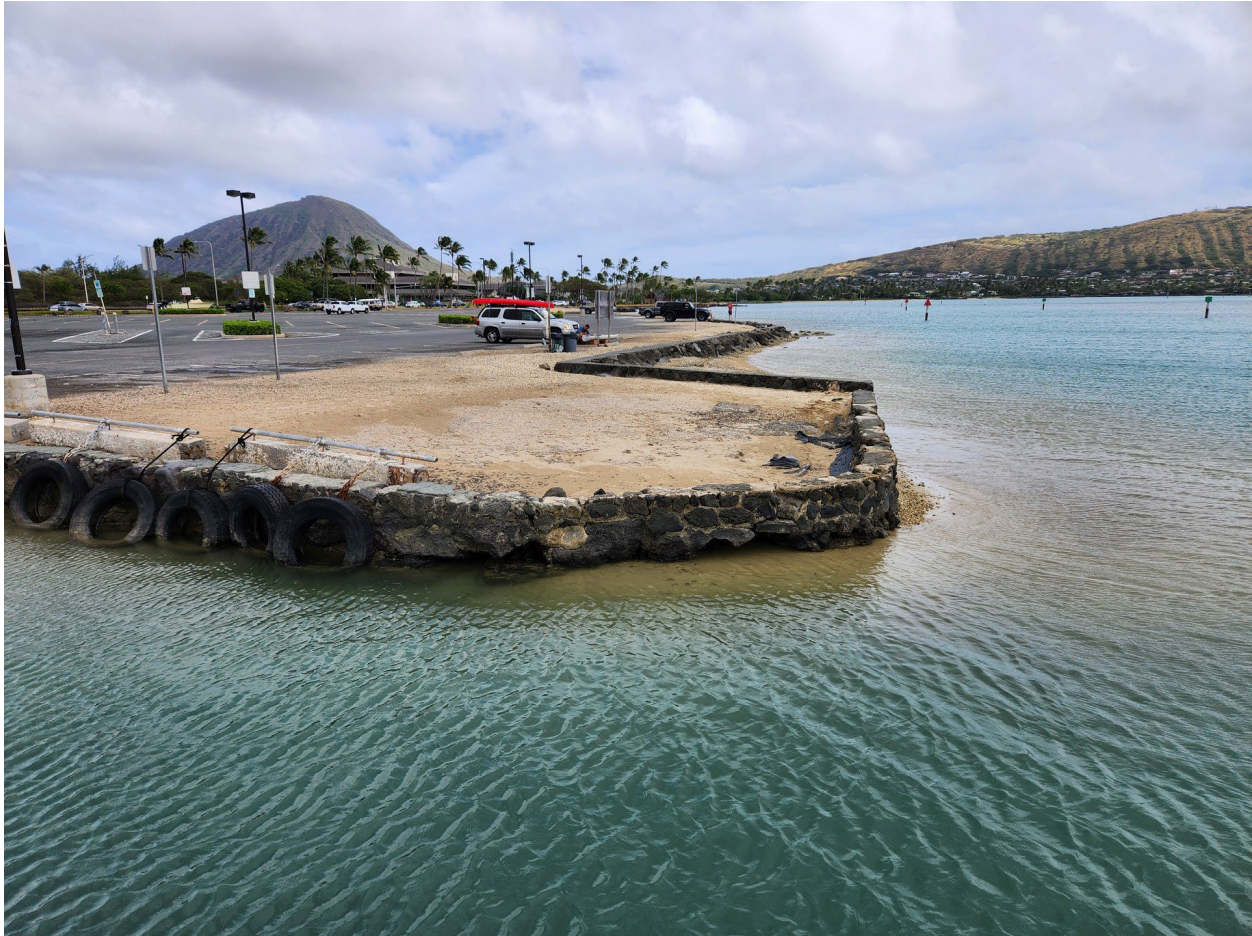
Figure 14. Photo of the Dilapidated Type A Wall along the East Edge of the Boat Ramp, Looking East, on February 28, 2024 (Photo: Integral Consulting Inc.).

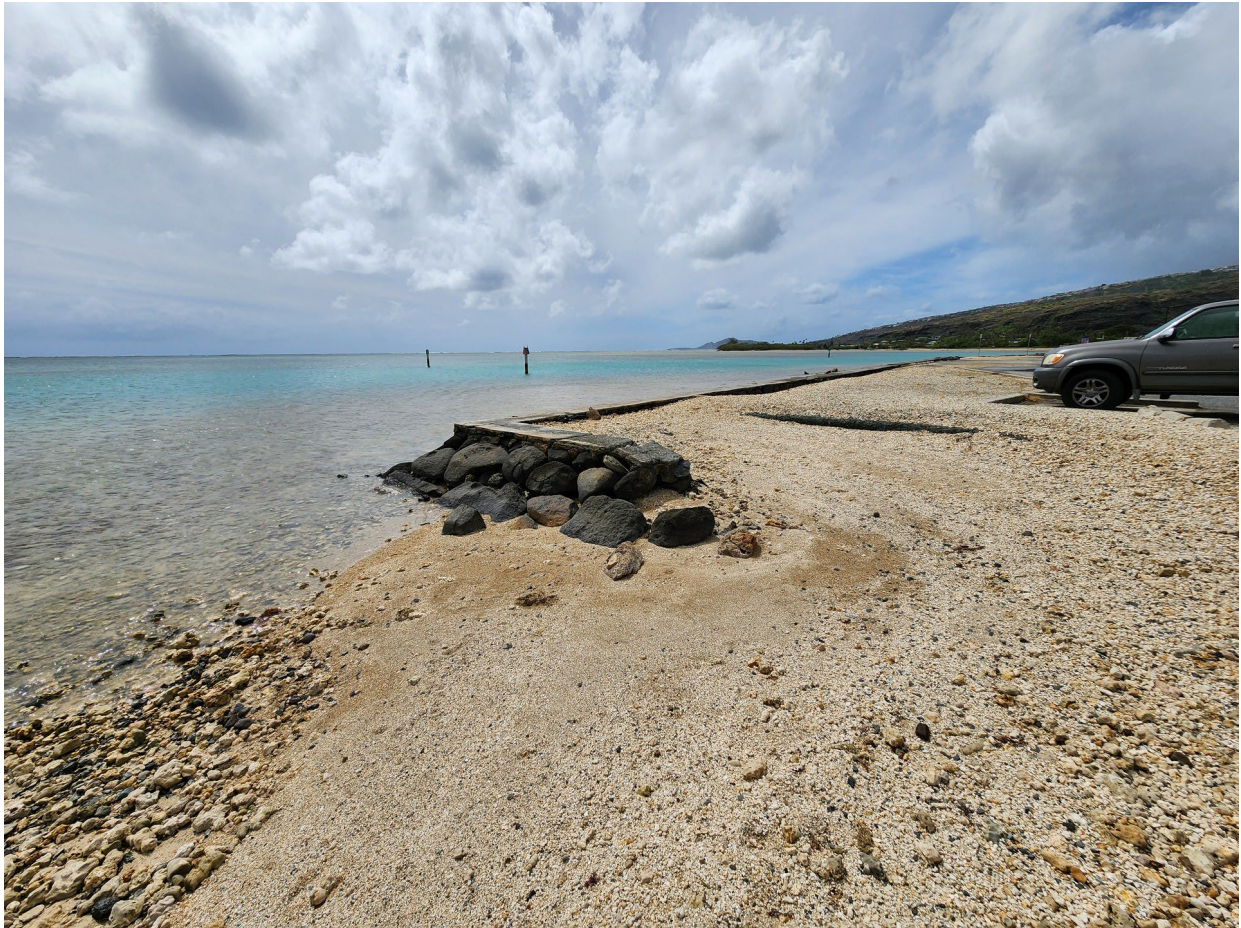
Figure 15. Photo of the Terminal End of the Type B Wall Located at the East End of East Beach.

Toward the east end of the site is a small beach area, approximately 300 feet in length (referred to as “East Beach”). Erosion at both ends of the beach has damaged existing shoreline structures and resulted in the collapse of a portion of the asphalt parking lot on the east end of the beach. This project includes extending the length of the existing Type B wall at the west end of the beach (after it turns towards the mauka direction) by 25 linear feet. A photo of the end of the existing Type B wall is shown in Figure 5 below.

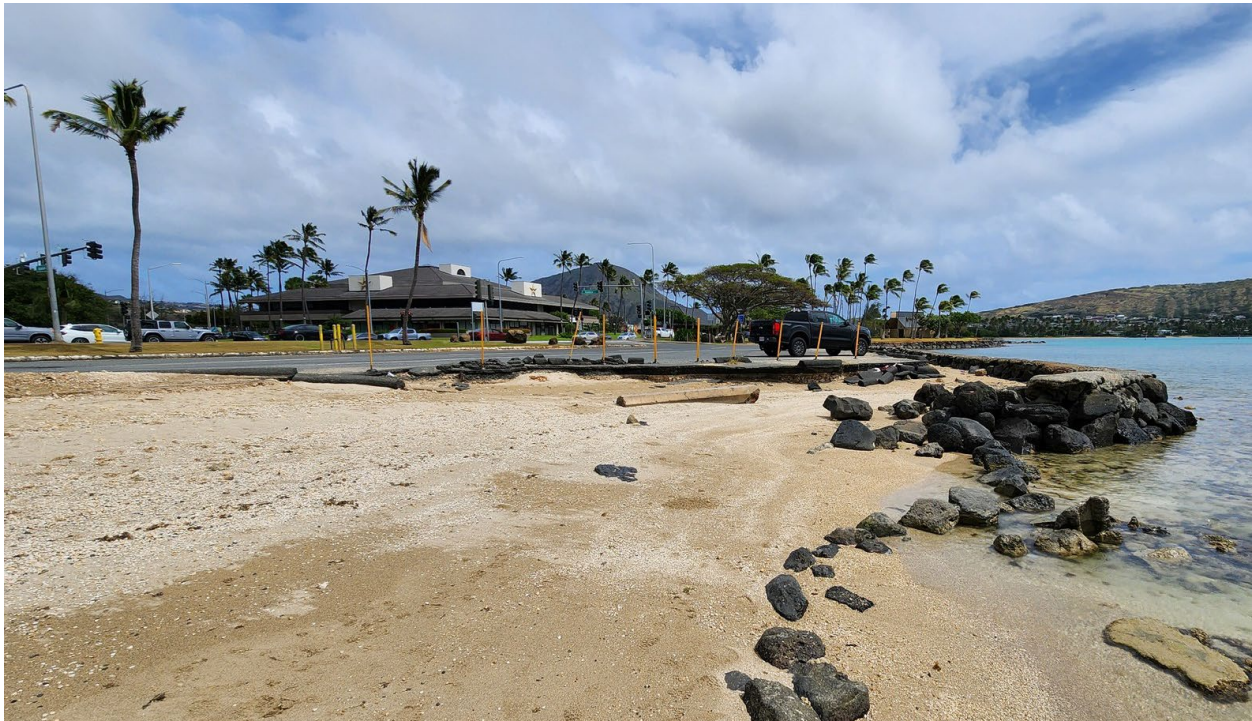
Figure 16. Photo of the Dilapidated Wall/Revetment Structure and Shoreline Erosion Area Located at the East End of East Beach.

At the eastern end of the beach, shoreline erosion has undermined the existing parking area and threatens the adjacent drive aisle. A new revetment will be constructed at this location, extending the length of the existing shoreline armoring in this area by roughly 45 feet. This area is shown in figure 6, below.

At the east end of East Beach, a new revetment structure is proposed to stabilize an eroding area and prevent further damage to the paved parking lot. Erosion control BMPs will be installed as required by the project plans and specifications. Loose stones and debris in the vicinity of the proposed revetment will be removed, followed by preparation of the subgrade behind the revetment, placement of geotextile fabric, placement of underlayer stones, and placement and grouting of the armor stone. This work will be done primarily by hand with the assistance of an excavator. Once complete, the area behind the new revetment will be filled using dredged material, and the subgrade for the parking area repair will be prepared. The parking area will be repaired to its original extents using asphalt. The eastern end of the proposed East Beach fill is intended to overlap with/bury the landward end of the proposed new revetment. As such, the revetment must be completed prior to placing beach fill in that area.

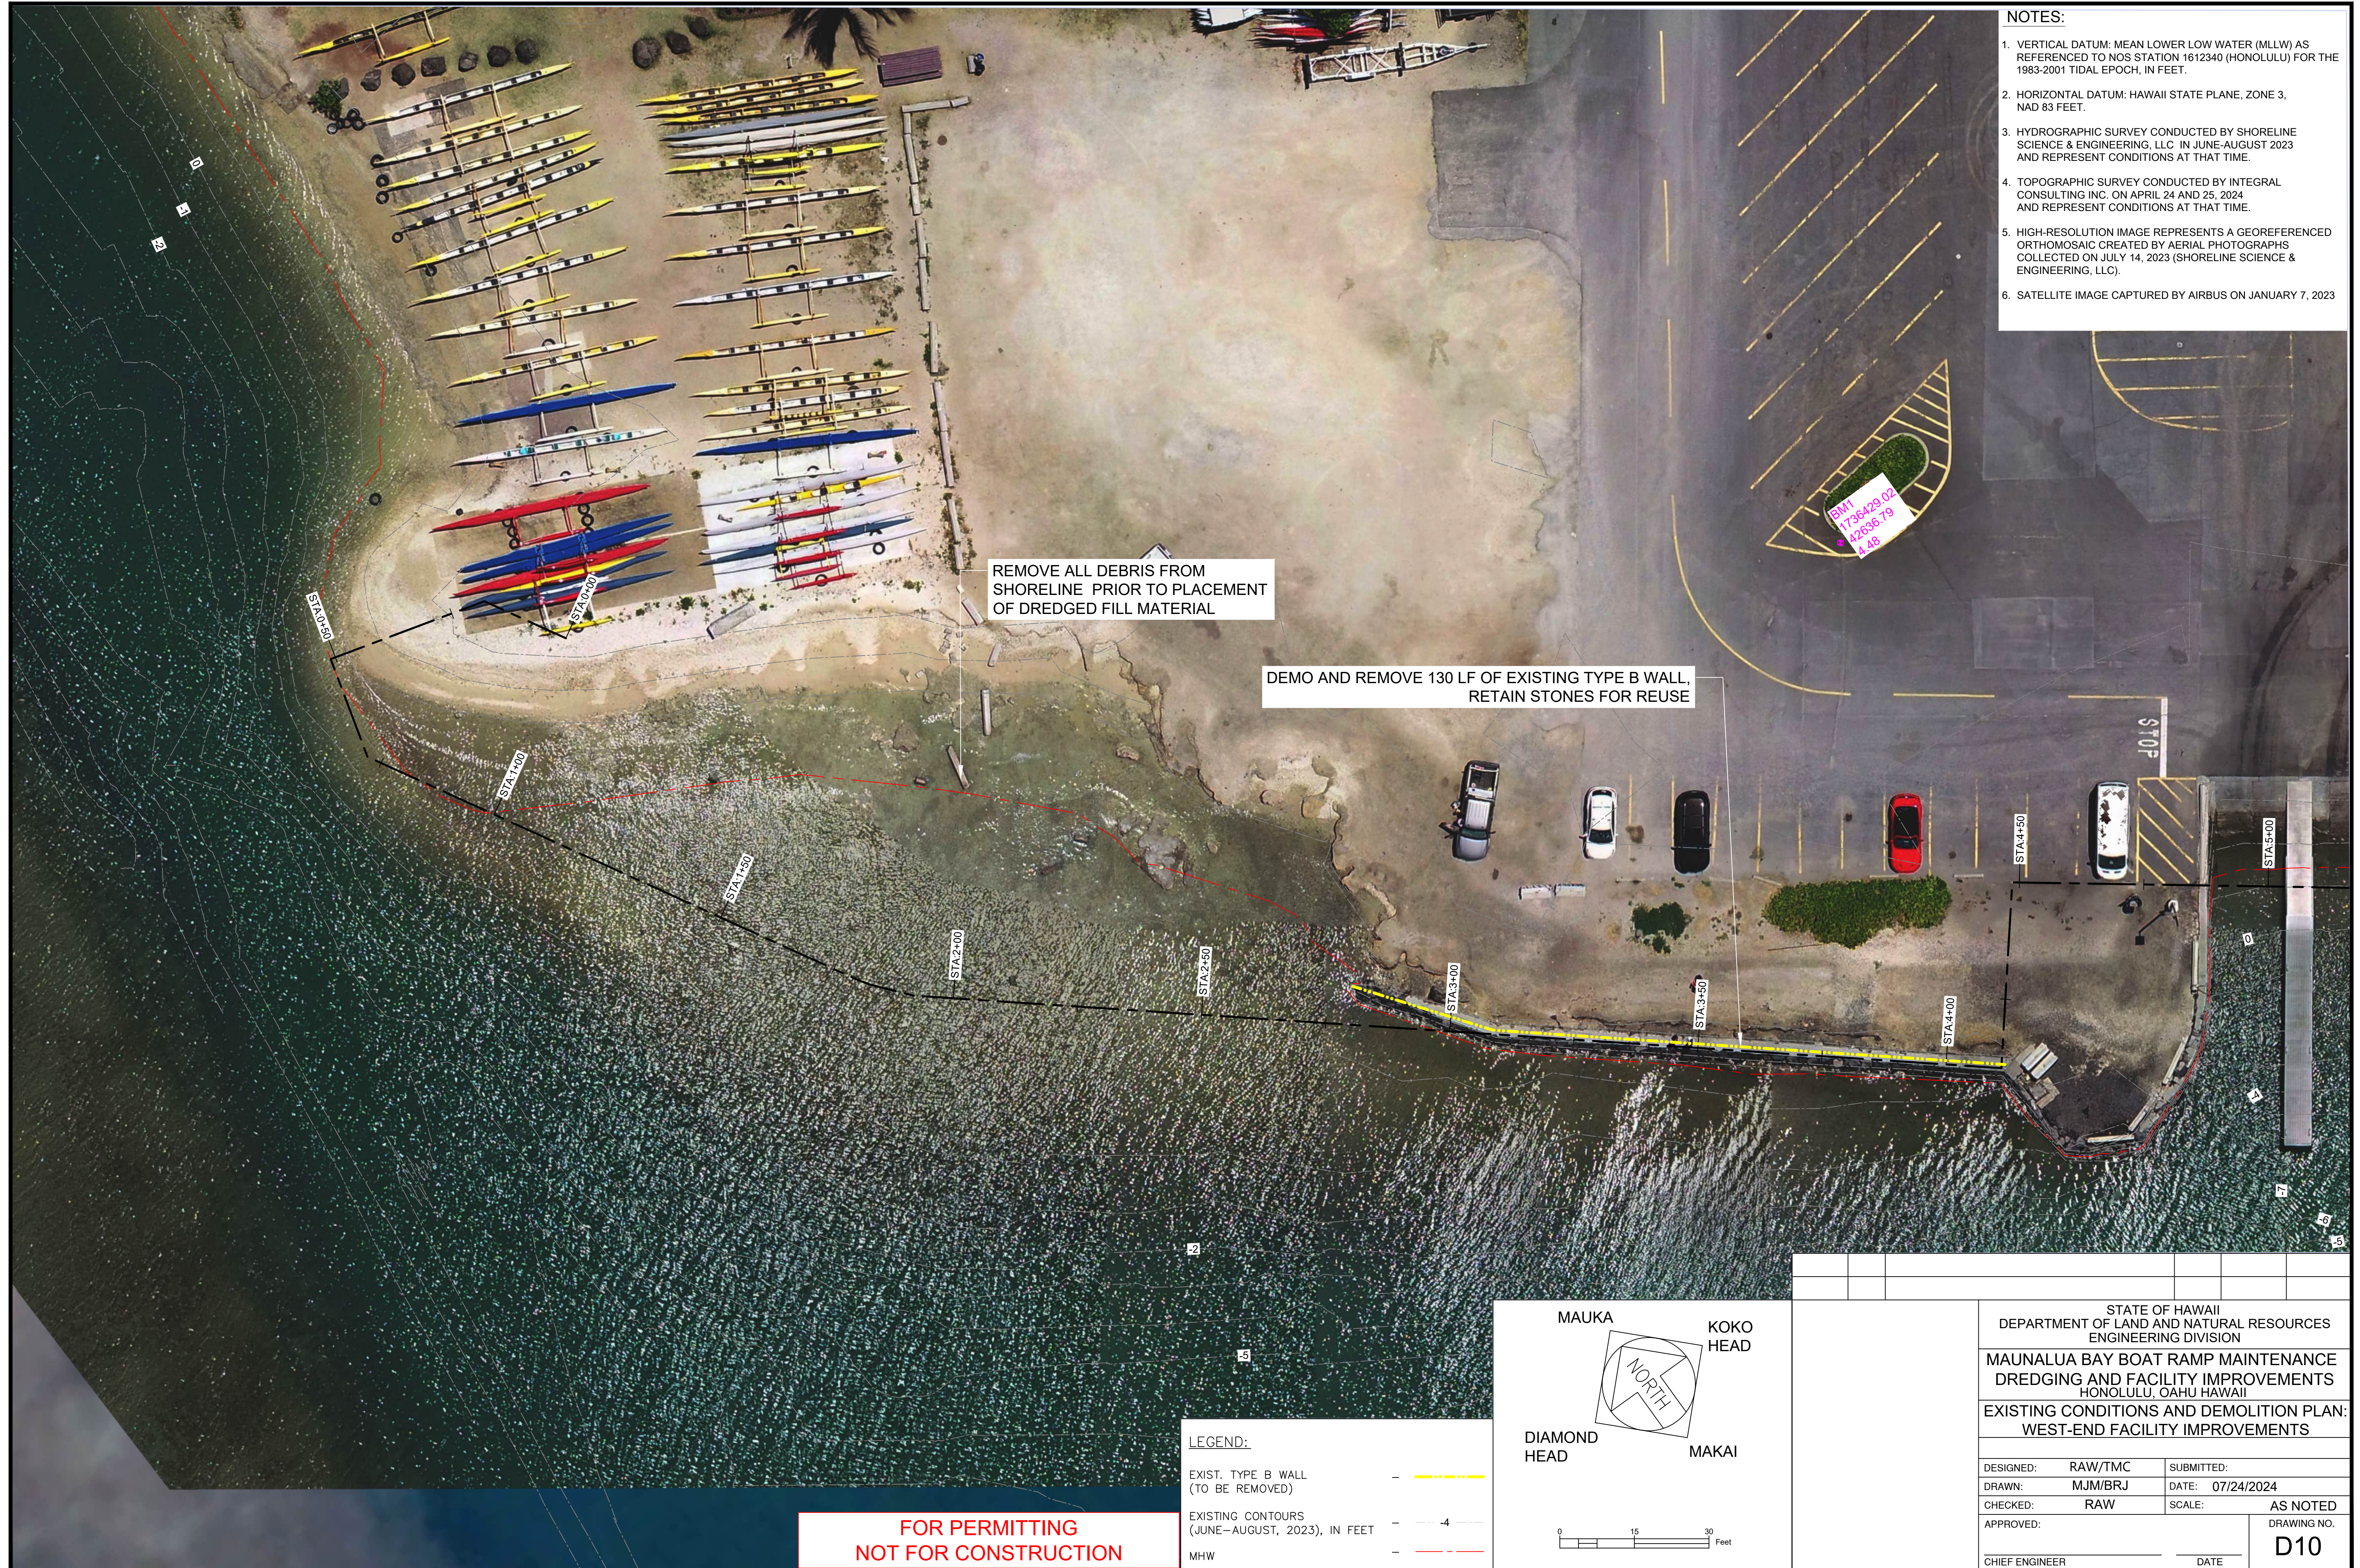
REMOVE ALL DEBRIS FROM SHORELINE PRIOR TO PLACEMENT OF DREDGED FILL MATERIAL

DEMO AND REMOVE 130 LF OF EXISTING TYPE B WALL, RETAIN STONES FOR REUSE

PROPOSED DREDGED MATERIAL CONTAINMENT STRUCTURE 439 LF SEE SHEET S-2

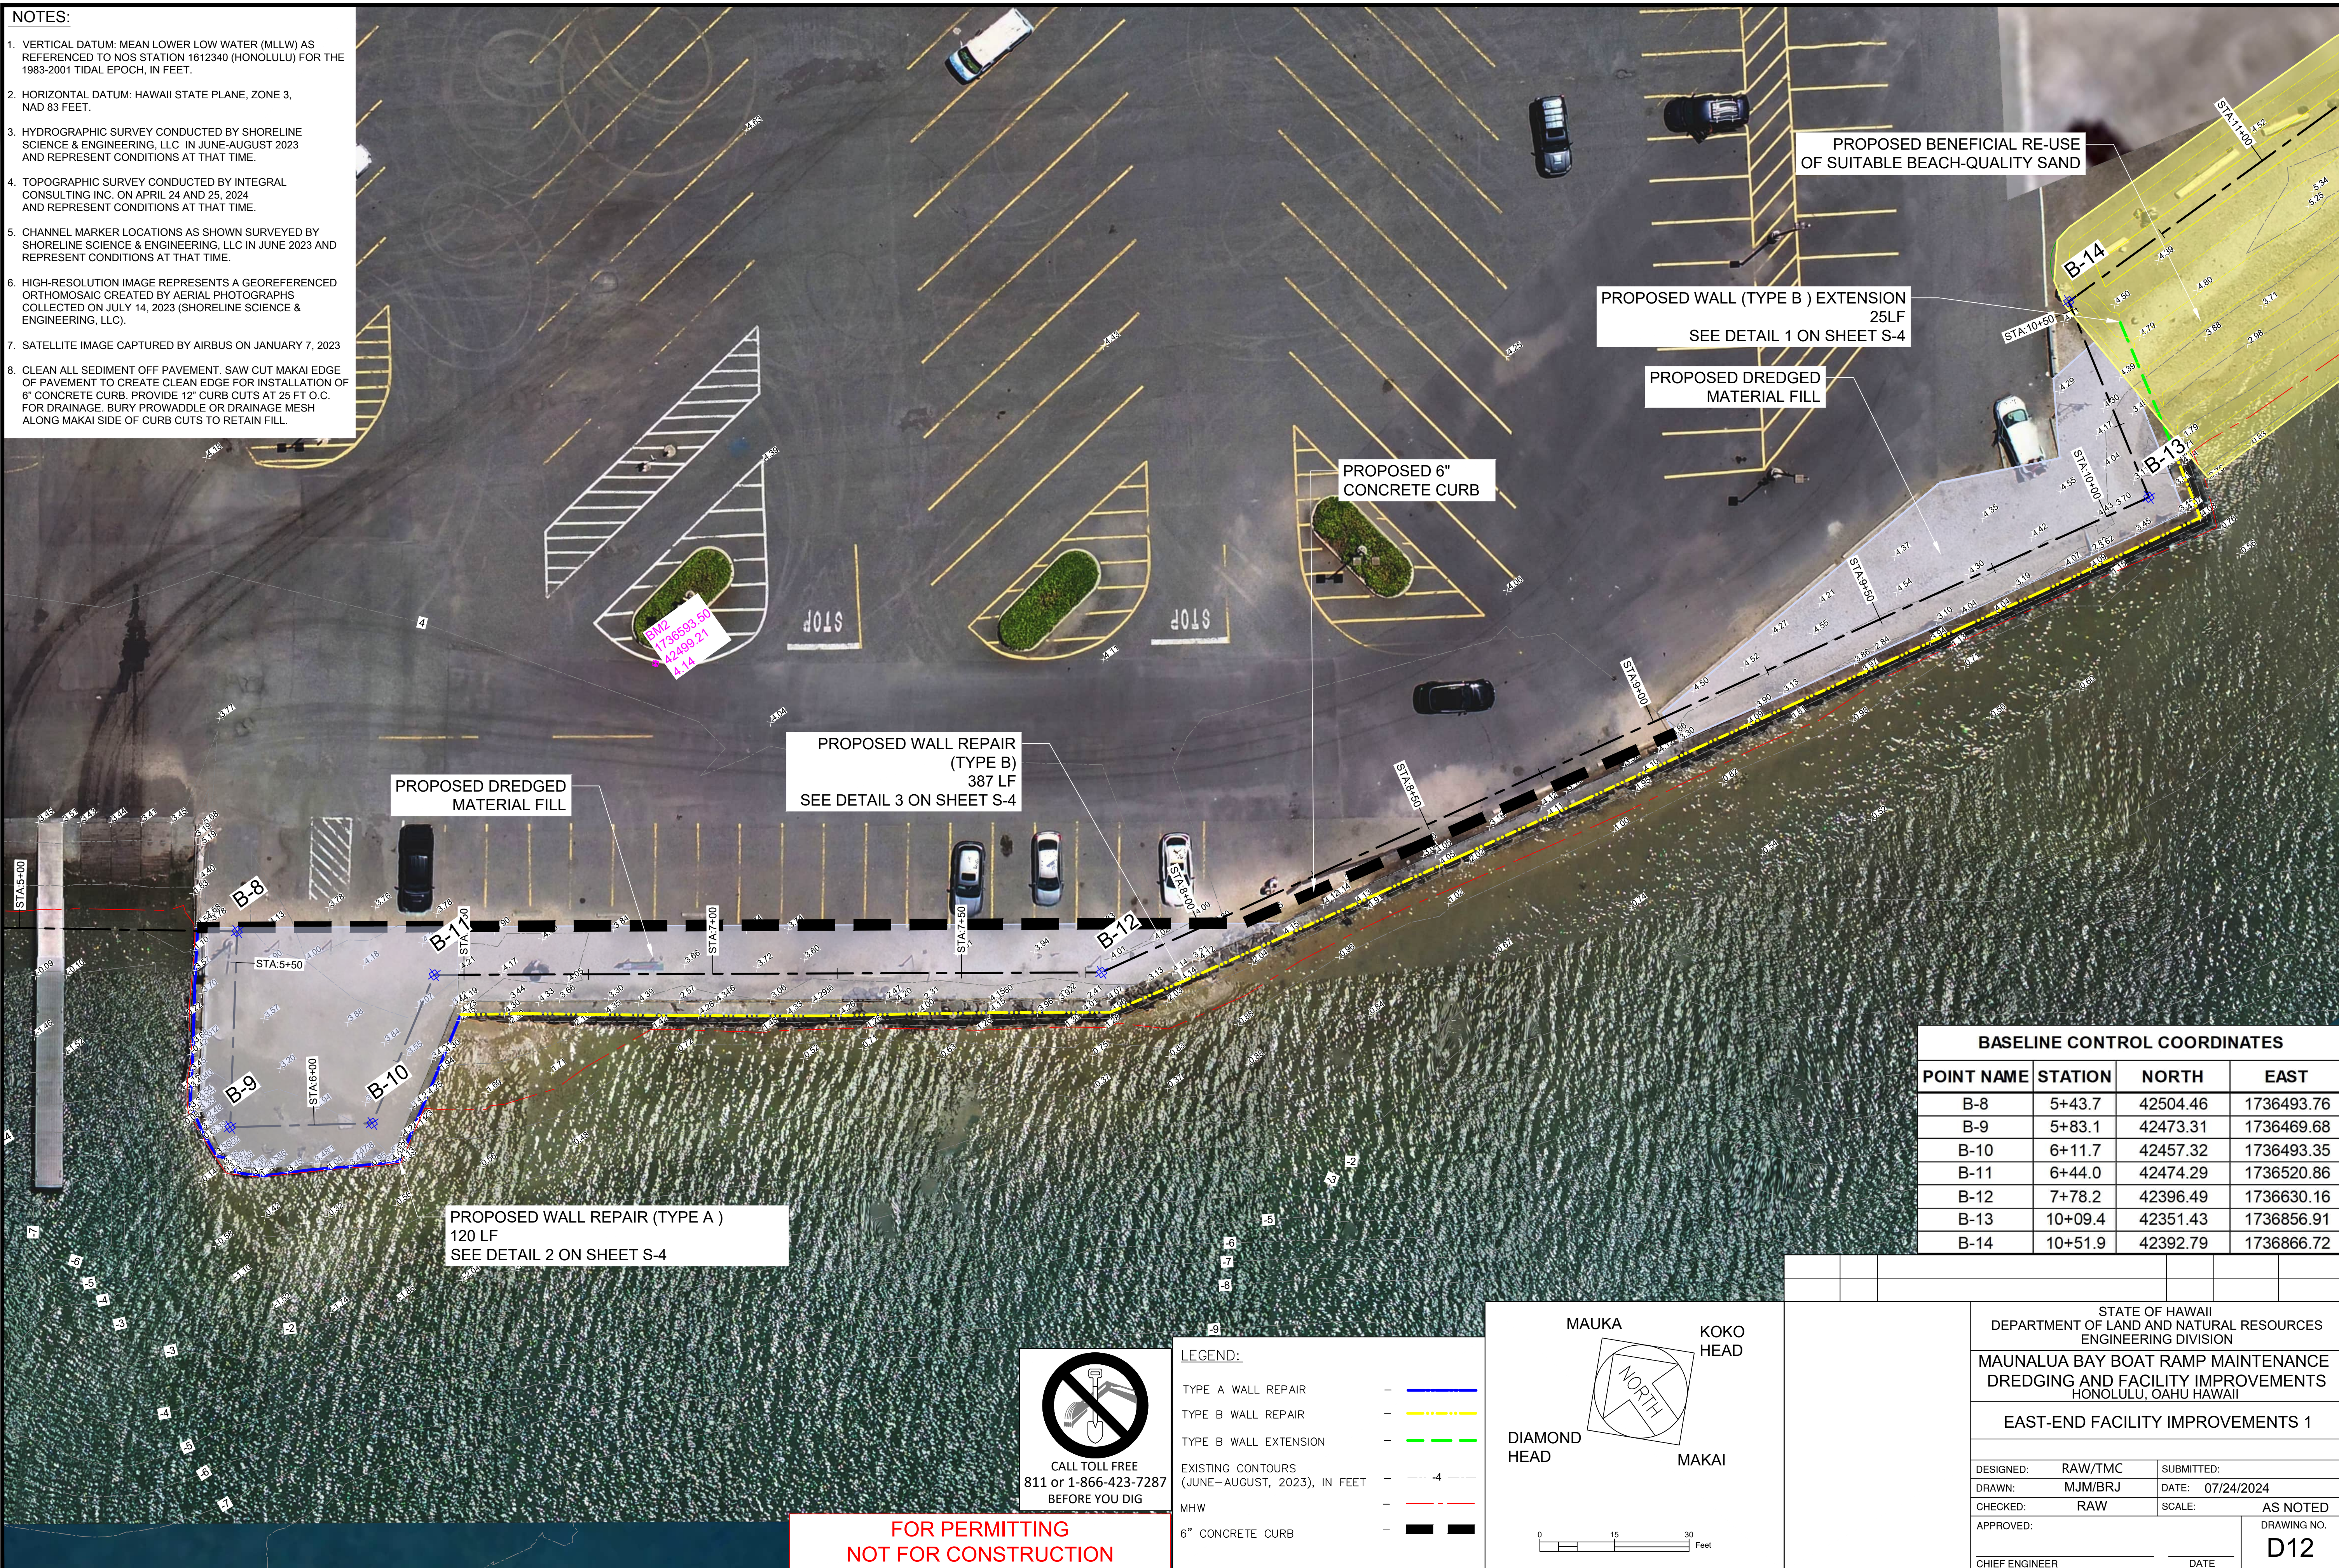
7. SATELLITE IMAGE CAPTURED BY AIRBUS ON JANUARY 7, 2023
8. CLEAN ALL SEDIMENT OFF PAVEMENT. SAW CUT MAKAI EDGE OF PAVEMENT TO CREATE CLEAN EDGE FOR INSTALLATION OF 6" CONCRETE CURB. PROVIDE 12" CURB CUTS AT 25 FT O.C. FOR DRAINAGE. BURY PROWADDLE OR DRAINAGE MESH ALONG MAKAI SIDE OF CURB CUTS TO RETAIN FILL.

PROPOSED WALL REPAIR (TYPE B)
387 LF
SEE DETAIL 3 ON SHEET S-4

PROPOSED WALL REPAIR (TYPE A)
120 LF
SEE DETAIL 2 ON SHEET S-4
