Project Description

Maunalua Boat Ramp Maintenance Dredging and Facility Improvements

**State of Hawaii Department of Land and Natural Resources (DLNR)
Division of Boating and Ocean Recreation (DOBOR)**

September 2024

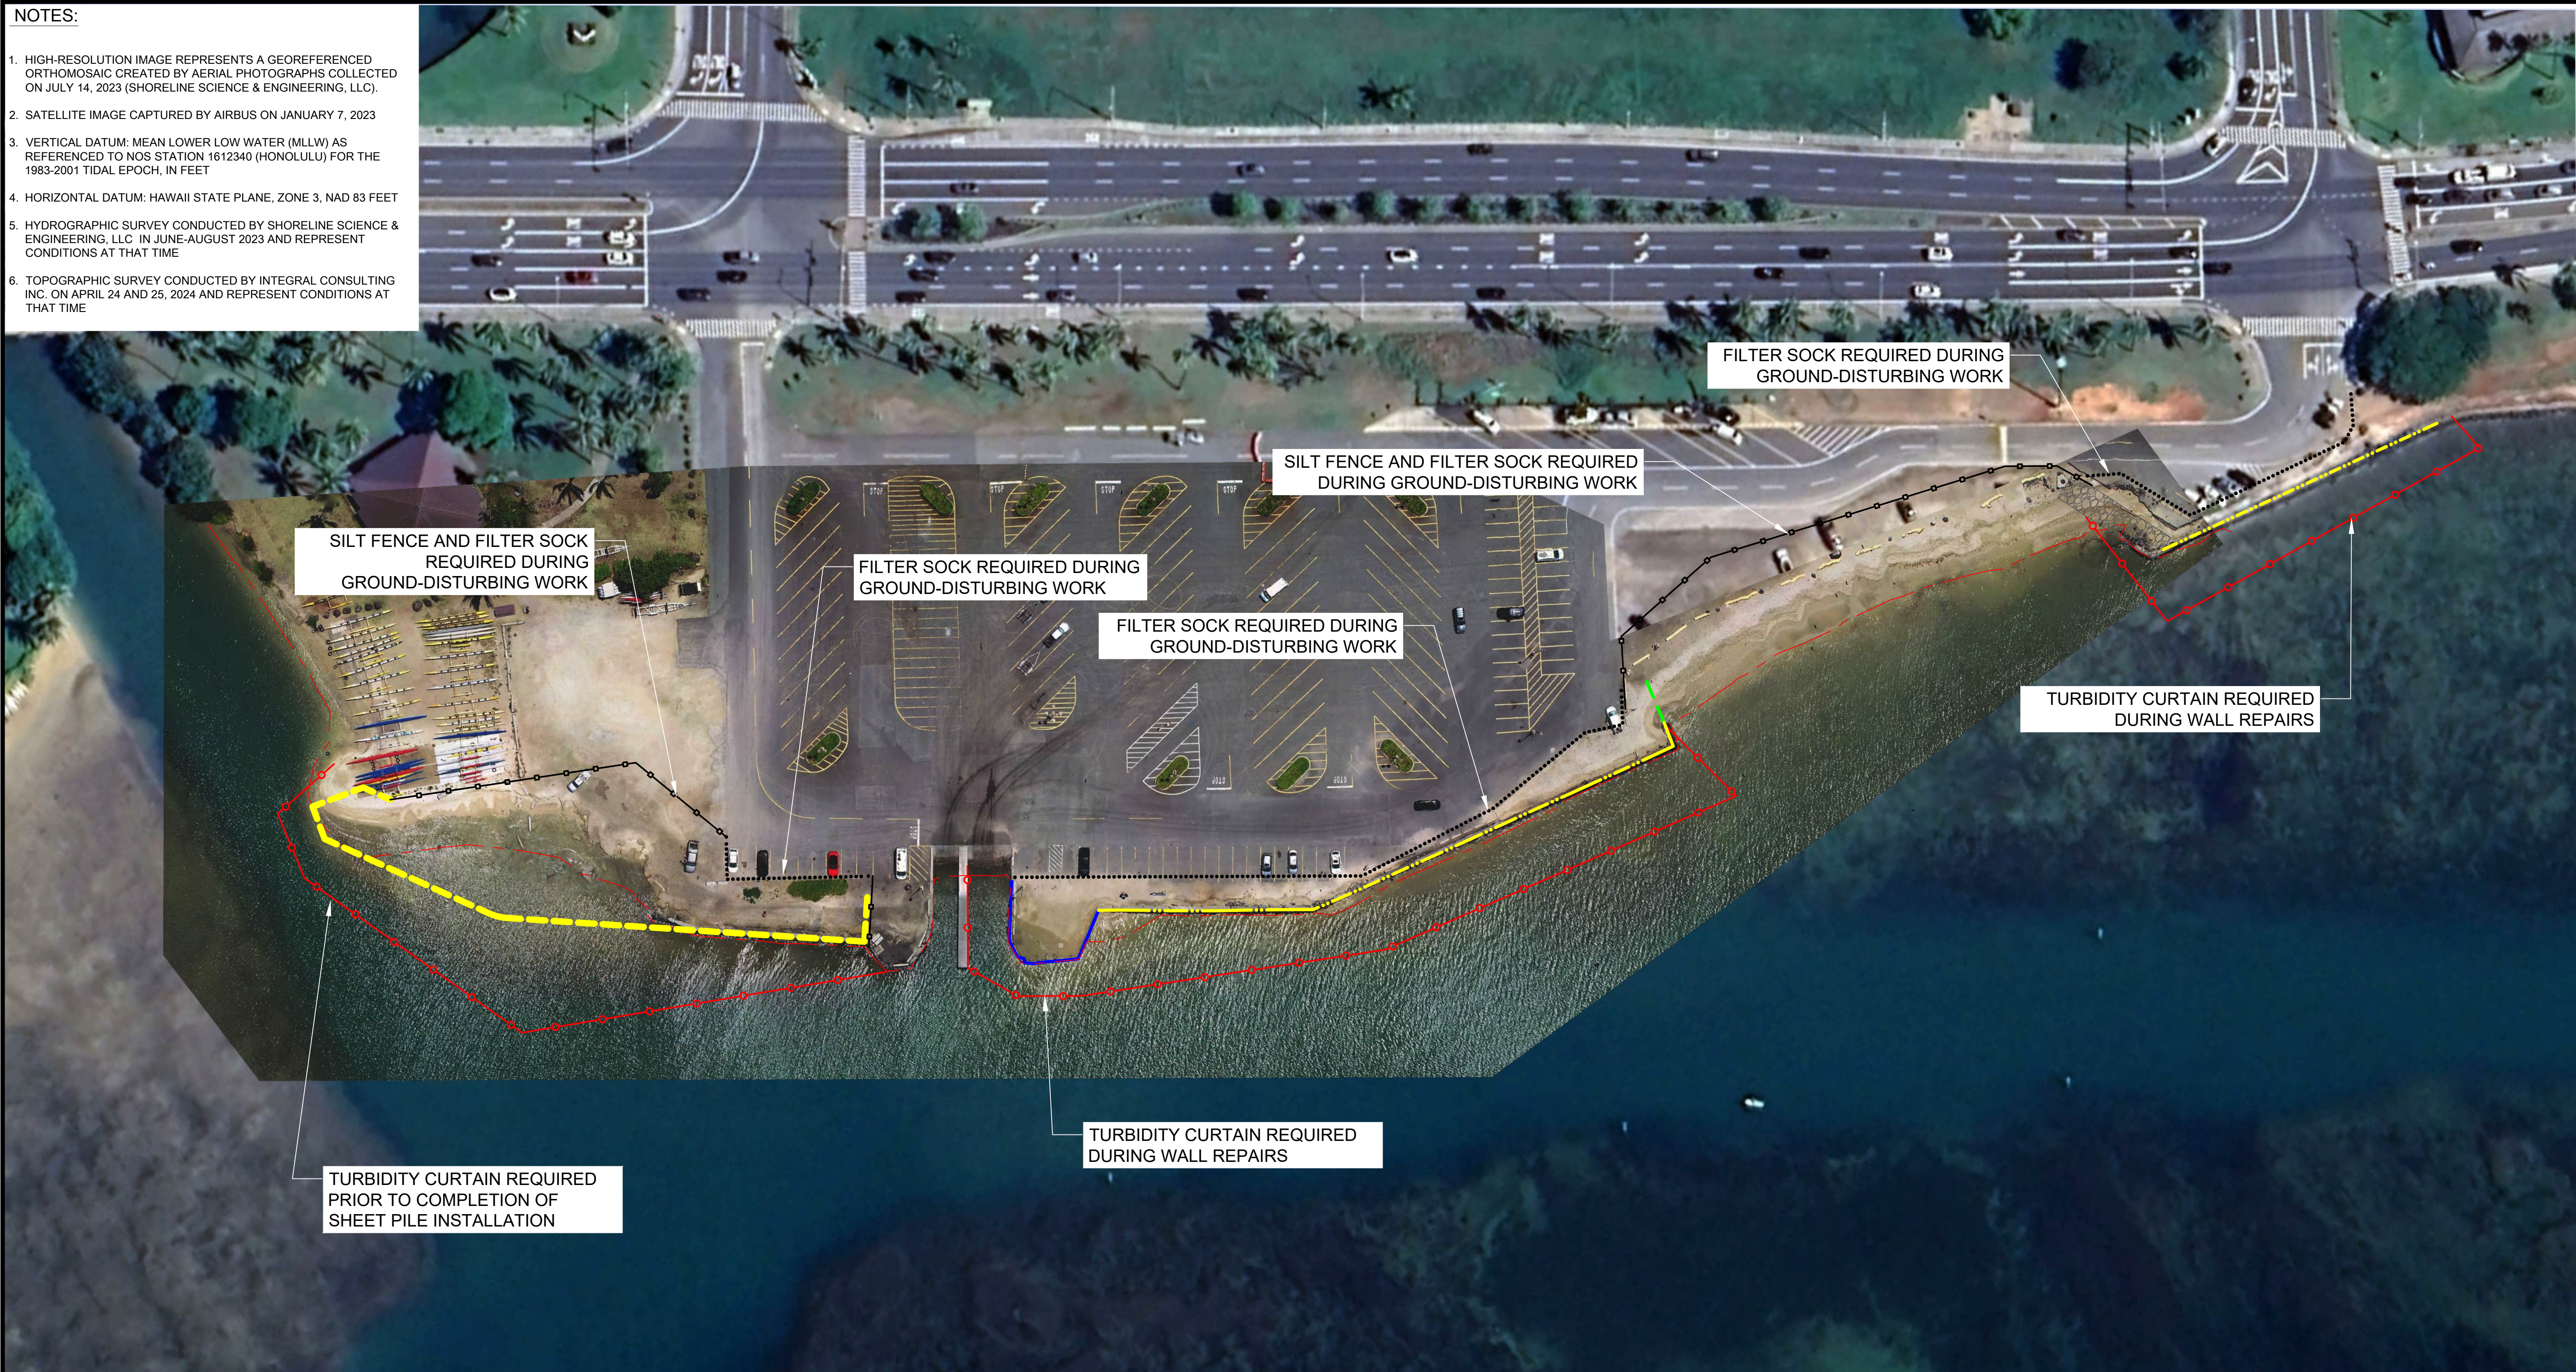
SILT FENCE AND FILTER SOCK
REQUIRED DURING
GROUND-DISTURBING WORK

FILTER SOCK REQUIRED DURING
GROUND-DISTURBING WORK

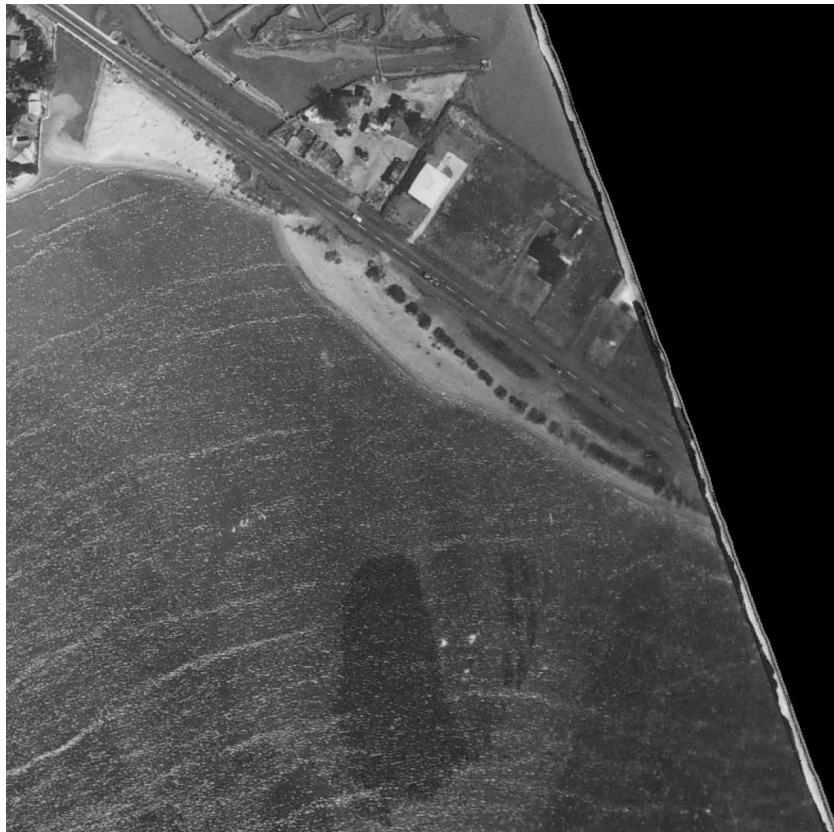
The Facility exists along the shoreline of Maunalua Bay, southwest of the Hawaii Kai Marina, and is made up of dredged fill material placed between the 1940s–1970s. The fill was placed atop the fringe reef that originally existed just makai of Kalanianaʻole highway. The site as it existed prior to fill being placed to create the facility is shown in Photograph 1, below.

Photograph 1, the aerial photograph of the shoreline in the project area as it existed in 1949.

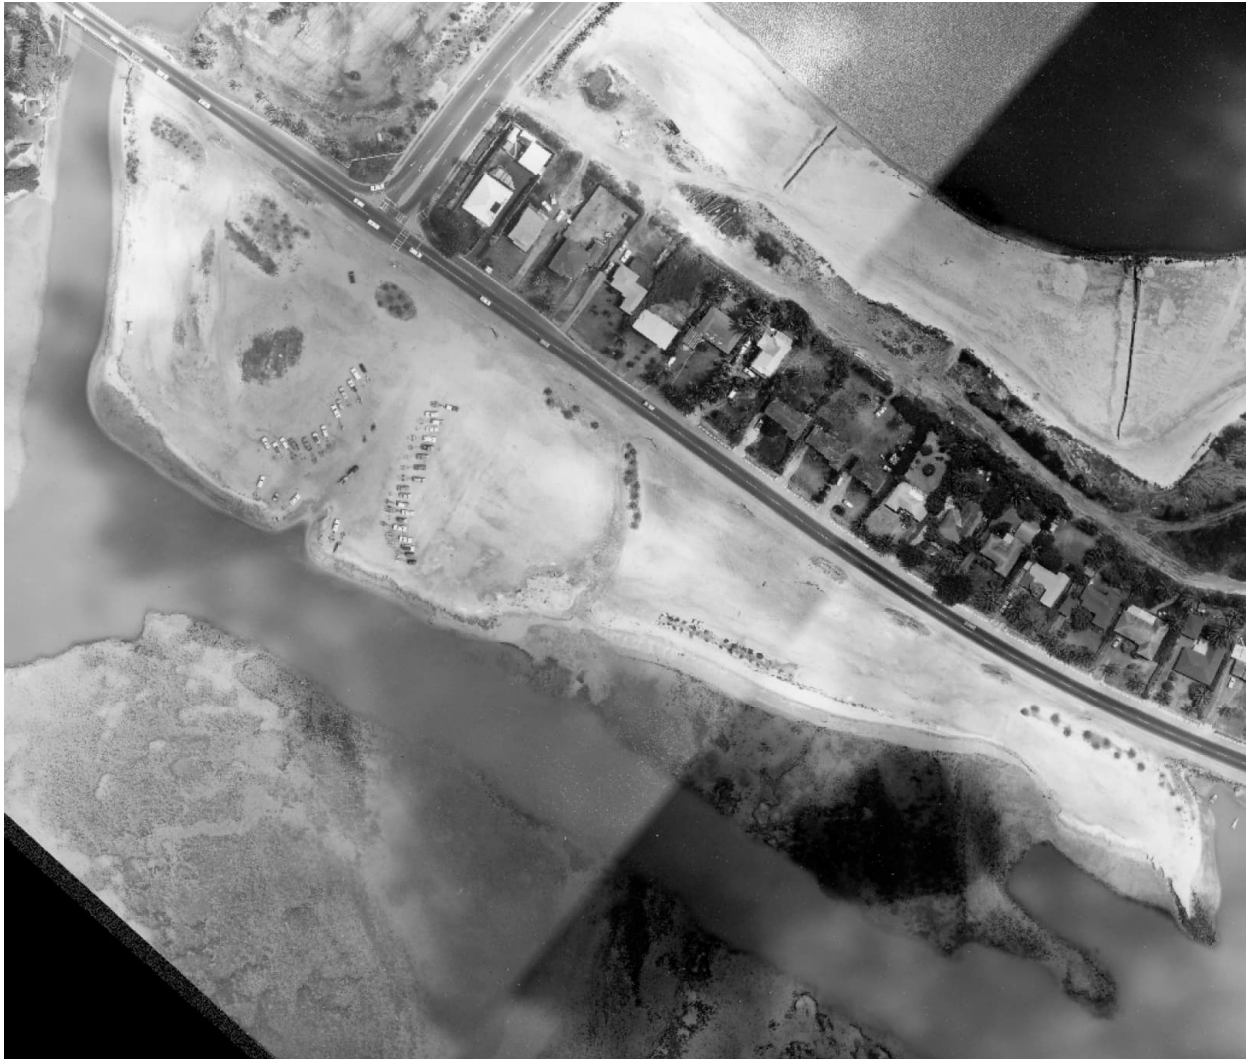
Photograph 2, the facility as it existed shortly after its original construction as shown in an aerial photograph captured in 1967.

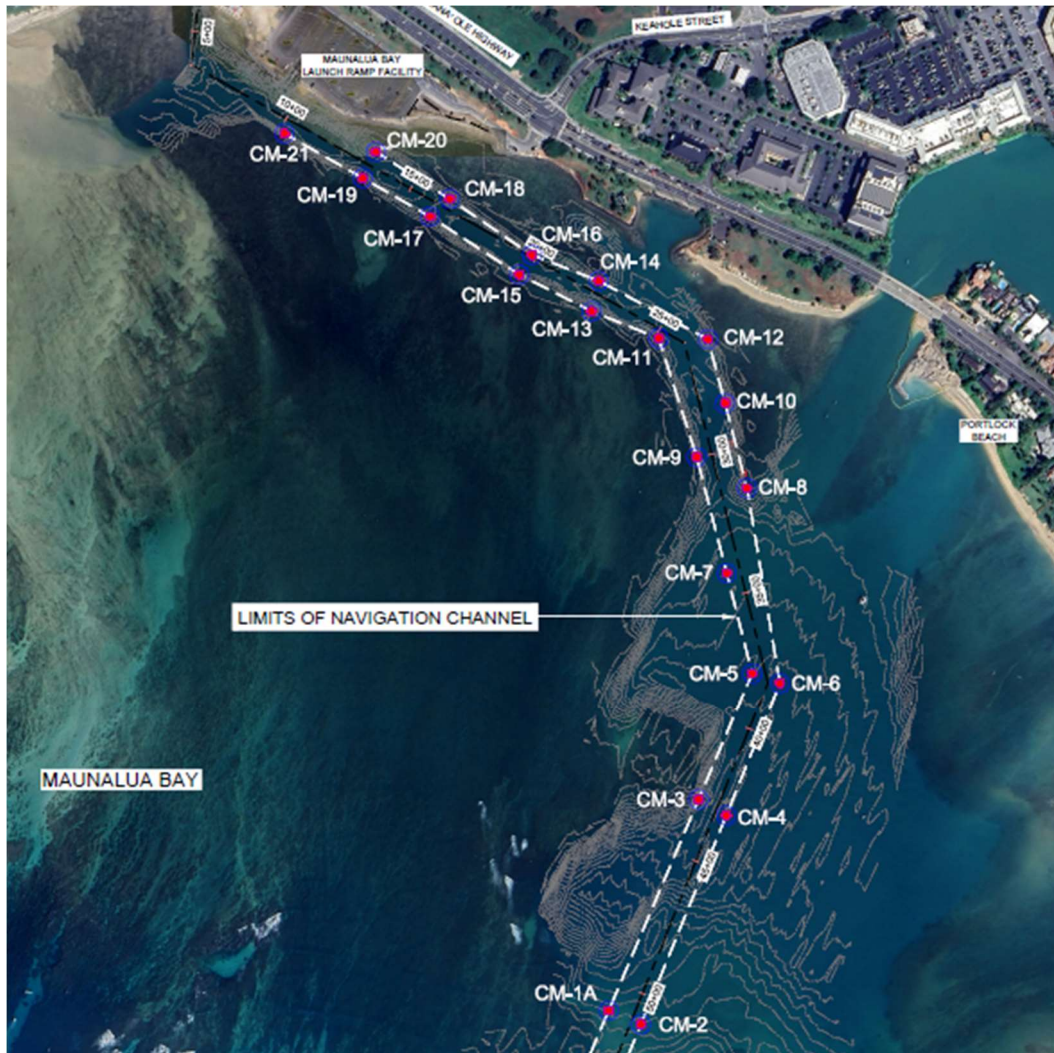
A dredged navigation channel, nominally 100 ft wide with depths ranging between 6 to 9 ft relative to mean lower low water (MLLW), provides access for vessels to transit between the Facility and the deeper waters of the bay to the southeast. Channel markers #8–#21, made of

concrete-filled galvanized steel pipes with reflective signage, are located along the edges of the navigation channels spaced at roughly 300-ft intervals. A dredged channel also exists at the outer edge of the fringing reef, roughly 1,300 ft long and 130 ft wide, to provide safe passage between the bay and the Pacific Ocean. The navigation channel is illustrated in Photograph 5, below. A single channel marker (#1) identifies the beginning of the channel as vessels approach from the ocean (not shown).

Photograph 5, Site Map of the Maunalua Bay Navigation Channel

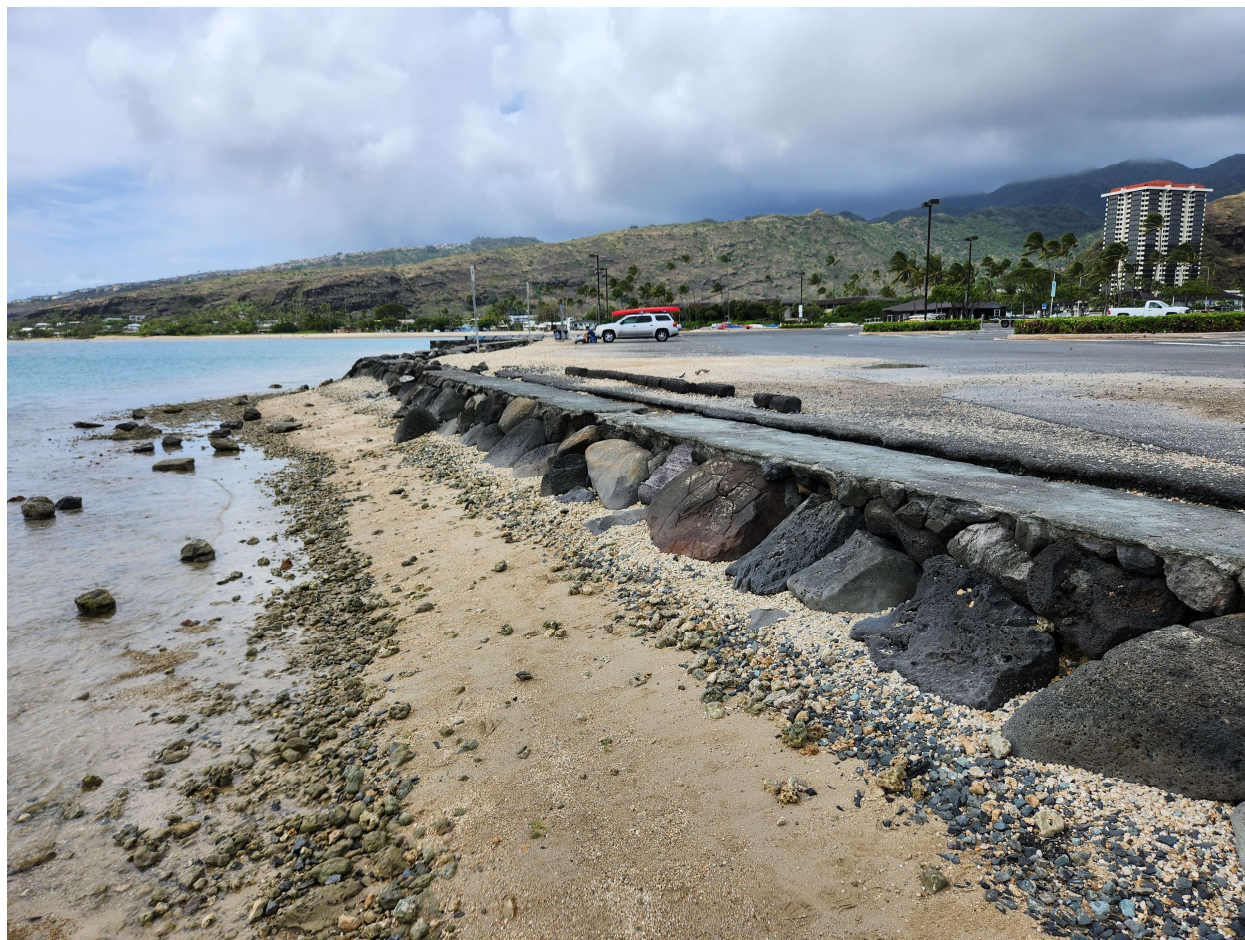
Photograph 6, Photo of the Type B Wall East of the Boat Ramp, Looking West, on February 28, 2024 (Photo: Integral Consulting Inc.)

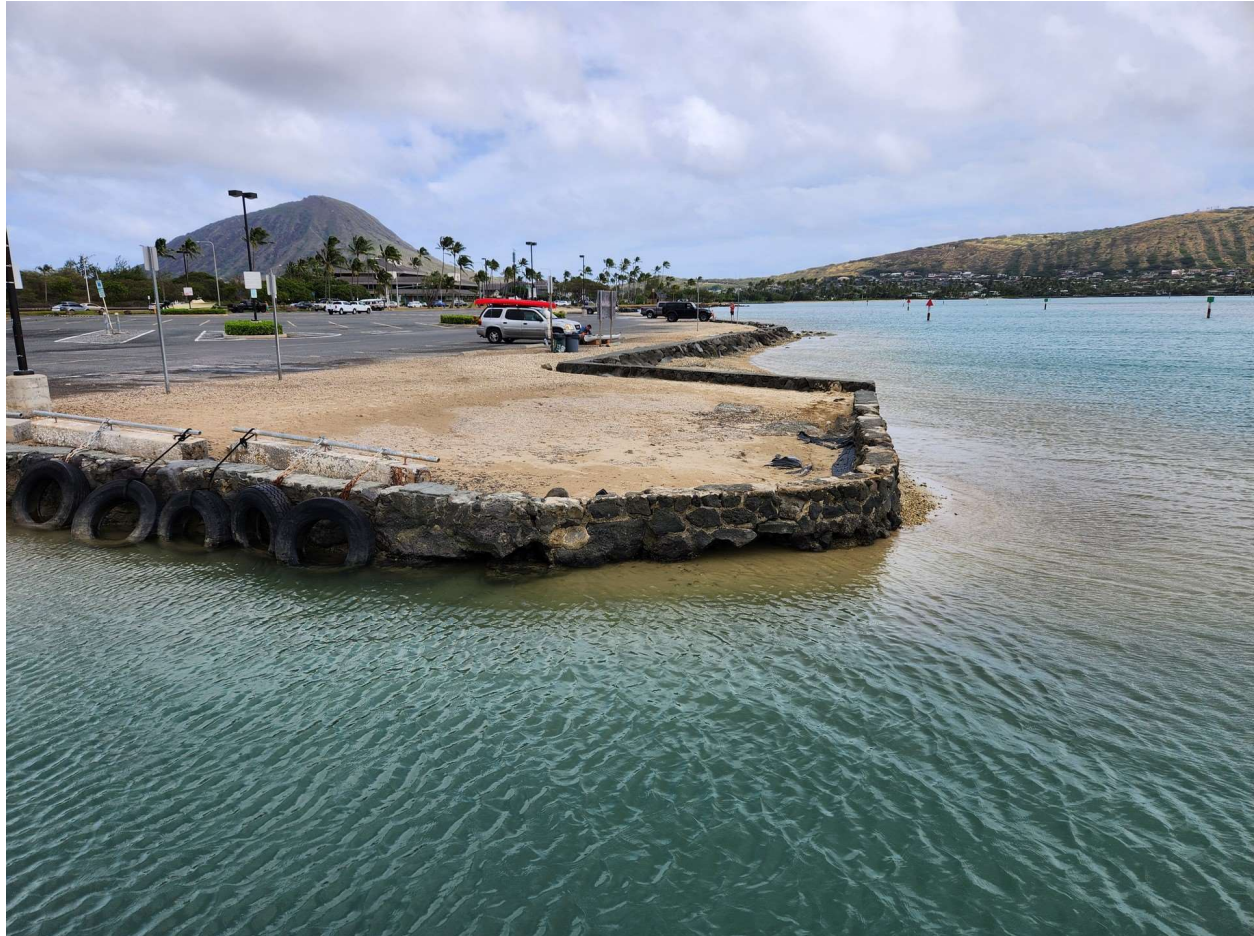
Small, un-grouted rock walls (Type B wall) located along the shoreline of the Facility have developed voids and have partially collapsed in some areas. This wall type is shown in Photograph 6, below. Grouted CRM walls (Type A wall) adjacent to the boat ramp have also degraded and developed voids. This wall type is shown in Photograph 7, below. The existing Type A walls will be repaired via filling of voids, repointing existing mortar, and forming and tremie pouring voids per the project plans and specifications.

Photograph 7, Photo of the Dilapidated Type A Wall along the East Edge of the Boat Ramp, Looking East, on February 28, 2024 (Photo: Integral Consulting Inc.)

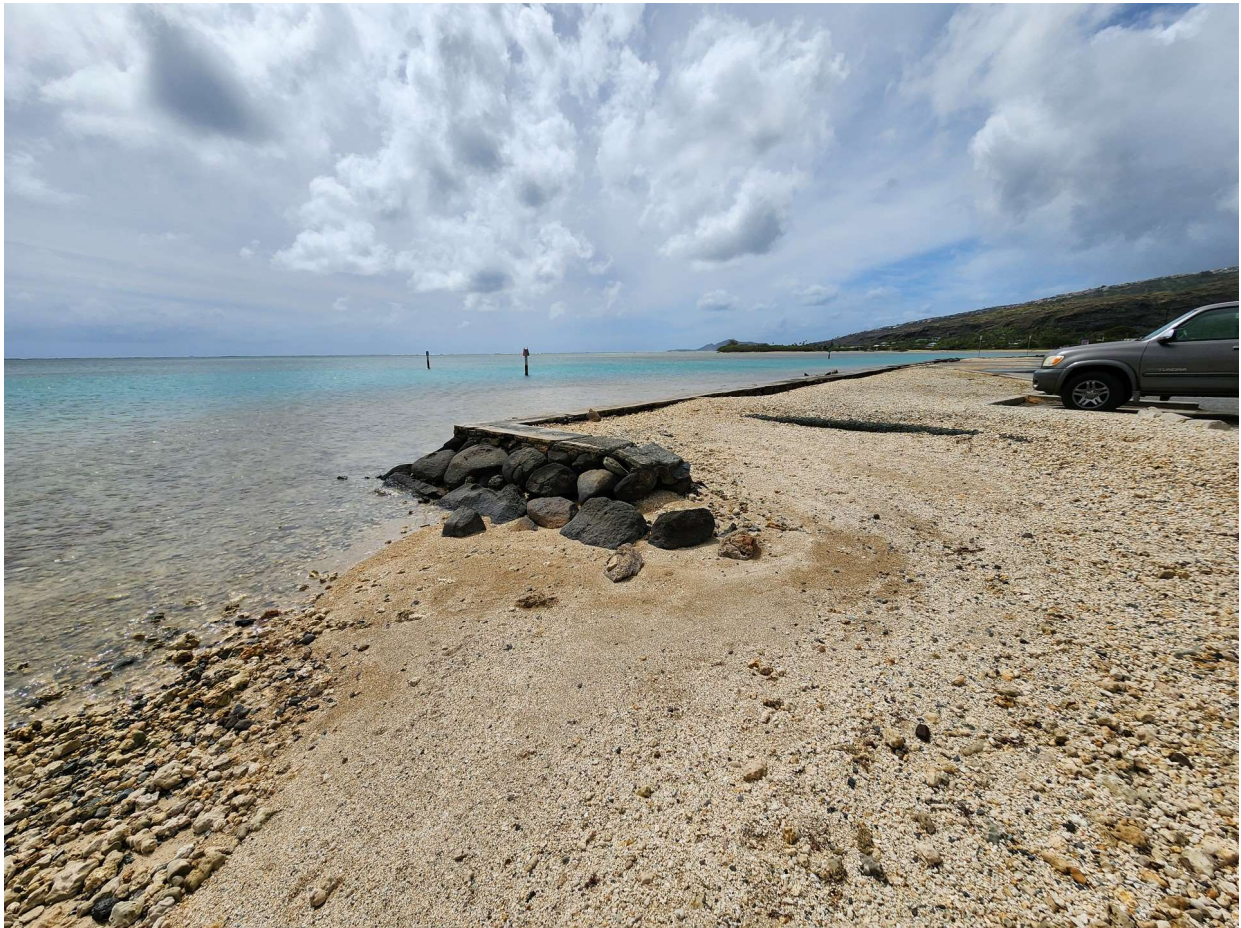
Photograph 8, Photo of the Terminal End of the Type B Wall Located at the East End of East Beach

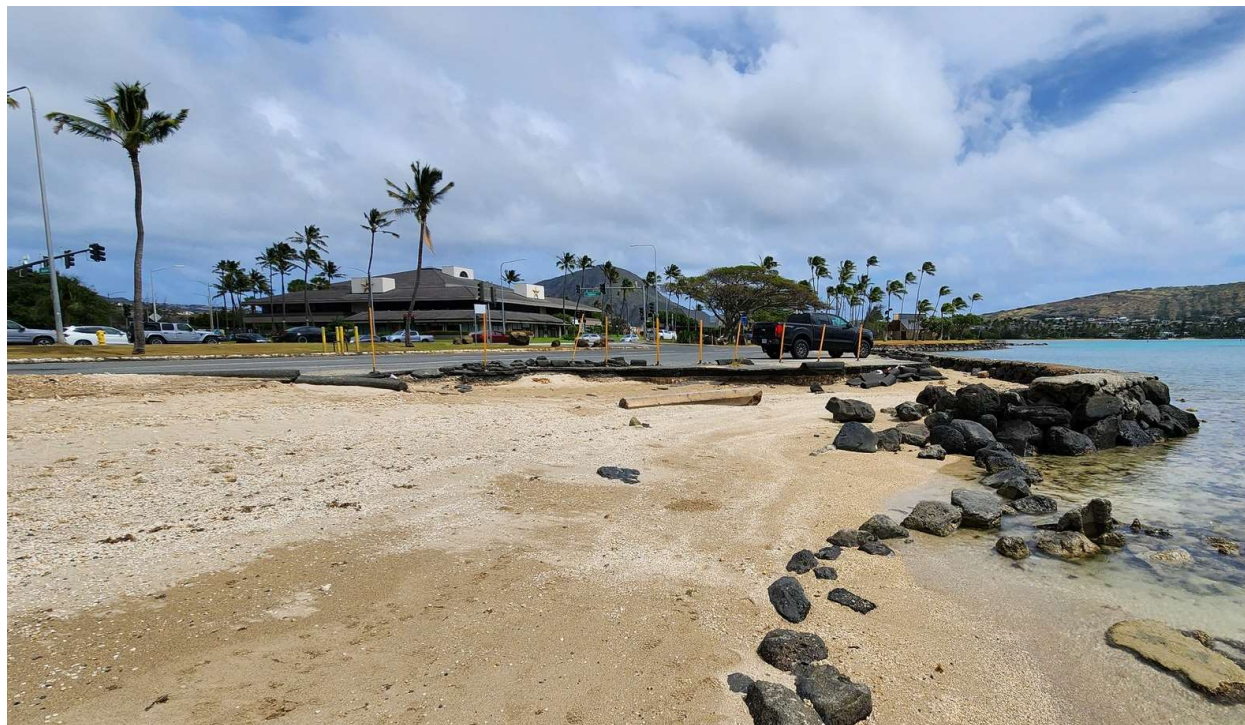
At the eastern end of the beach, shoreline erosion has undermined the existing parking area and threatens the adjacent drive aisle. A new revetment will be constructed at this location, extending the length of the existing shoreline armoring in this area by roughly 45 ft. This area is shown in Photograph 9, below.

Photograph 9, Photo of the Dilapidated Wall/Revetment Structure and Shoreline Erosion Area Located at the East End of East Beach

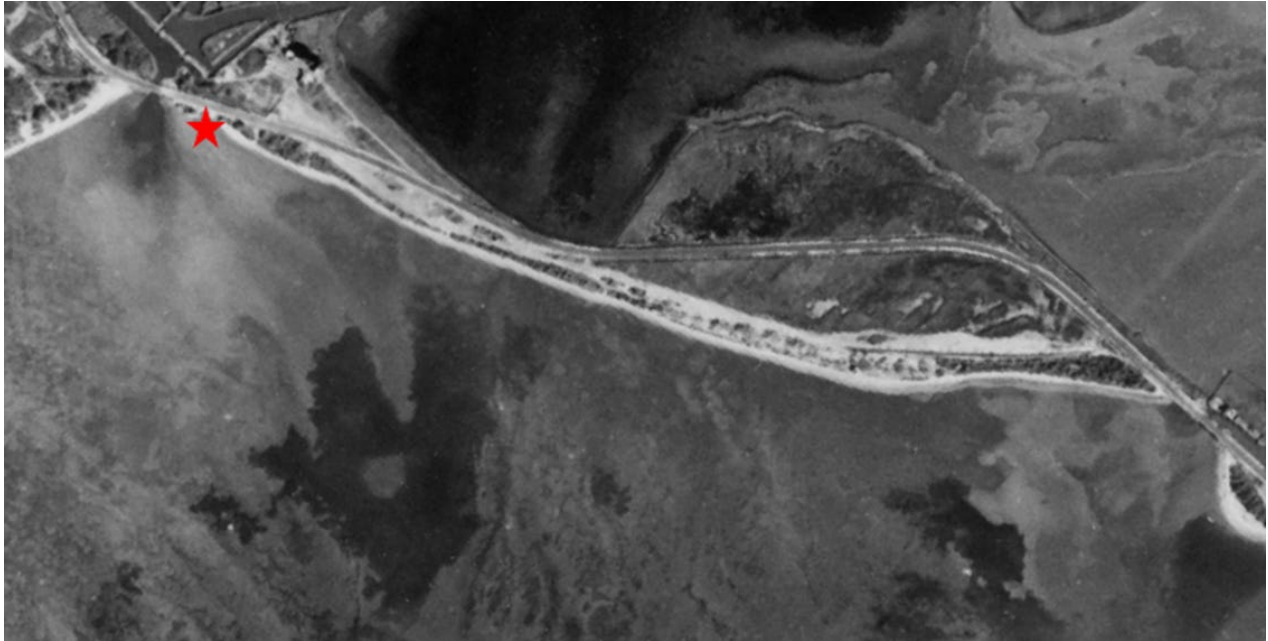
Figure 1 provides a 1928 photograph of the narrow ribbon of land located between Maunalua Bay and "Kuapa Pond," a brackish fishpond, which stretched inland, northeast of the site. The location of the present-day Facility is shown with a red star. The shoreline of Maunalua Bay consisted of carbonate sand beaches with a narrow, vegetated backshore/dune system. Sediment types, which would be typically found in this type of environment, would include sand near the bay's shoreline, transitioning to mostly silt in the furthest landward reaches of the pond. Further offshore, coastal sediment material would consist of coral rubble and ancient limestone reef.

Figure 1. Aerial Photograph of the Project Site in Maunalua Bay with a Red Star Showing the Location of the Existing Maunalua Bay Boat Ramp Facility (Center Left) and Kuapa Pond in the Foreground, as It Existed in 1928

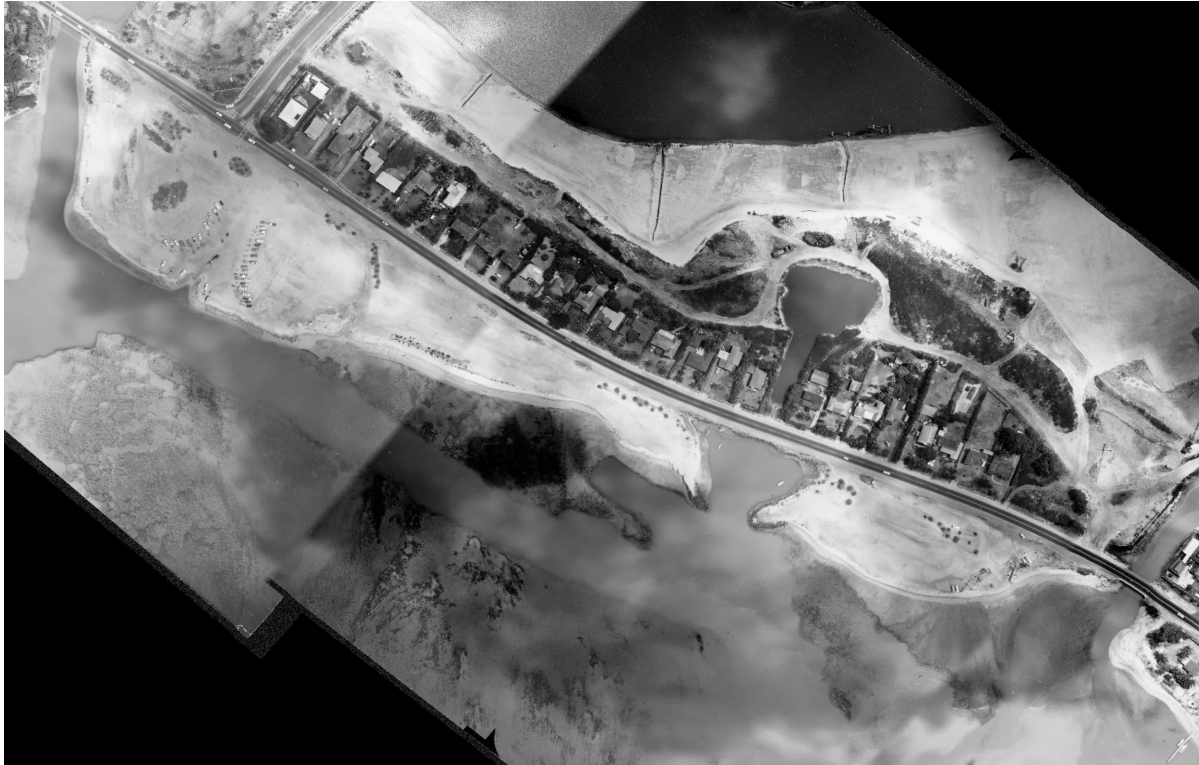
Maunalua Bay and its vicinity underwent significant changes between the 1940s–1960s, with the creation of the navigation channel as well as large-scale dredging and filling operations associated with the development of the Hawaii Kai Marina. The Maunalua Bay Boat Launch Facility was originally constructed in the late 1950s through the early 1960s. It is understood the landmass of the present-day Facility was constructed using material dredged from within Kuapa Pond to create the Hawaii Kai Marina, as well as coral rubble from construction of the navigation channel through limestone reef. Figure 2 provides an aerial photograph of the Facility as it existed in 1968.

Figure 2. Aerial Photograph of the Project Site (Left) and Similarly Filled Areas, as It Existed in 1968

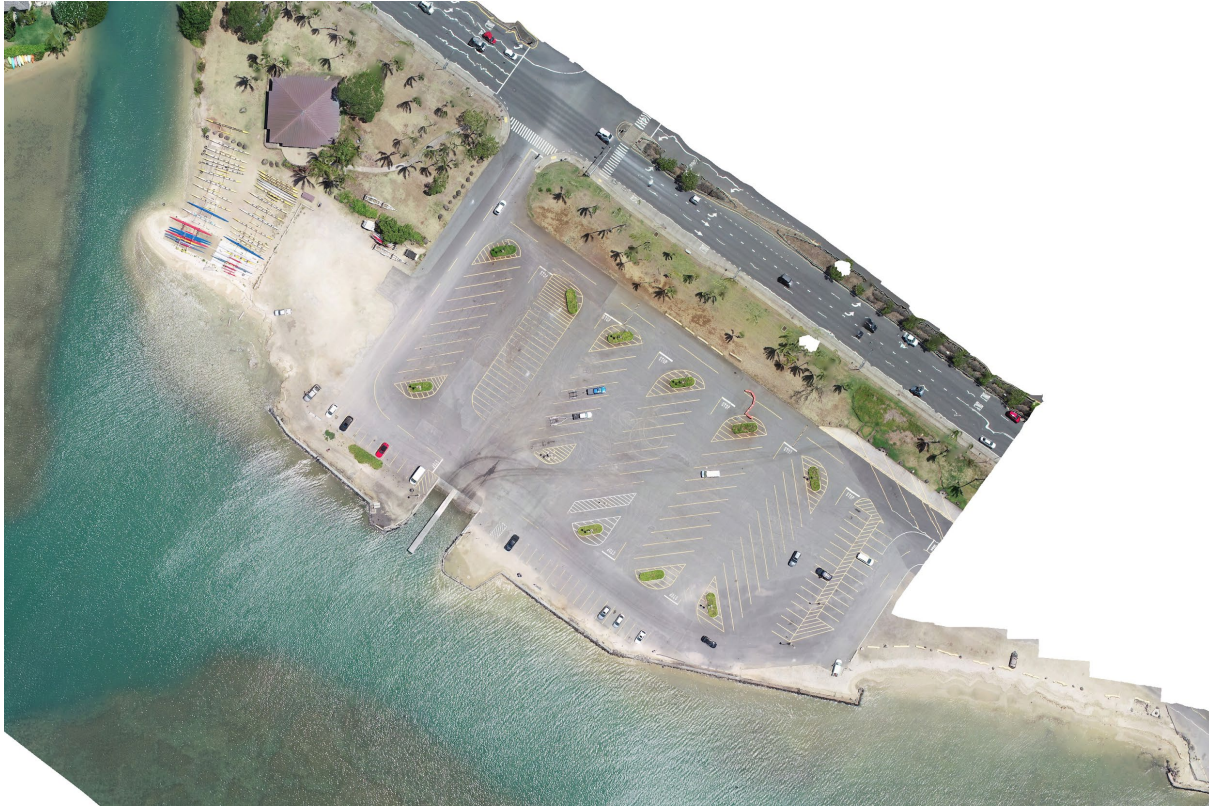
Today, shoreline structures have been installed along most of the Facility area to stabilize the shoreline. At the launch ramp facility, a concrete boat ramp and roughly 750 linear ft of cement rubble masonry walls were constructed to prevent erosion and provide a safe launch facility for boaters. Beyond the end of these walls on the east and west ends of the Facility are areas where the Facility was not protected by shoreline armoring; these areas have subsequently experienced chronic shoreline erosion over the years. An aerial photograph of the project site collected in July 2023 today is provided in Figure 3, below.

Figure 3. Orthomosaic Aerial Image of the Project Site as It Existed on July 14, 2023 (Shoreline Science & Engineering, LLC)

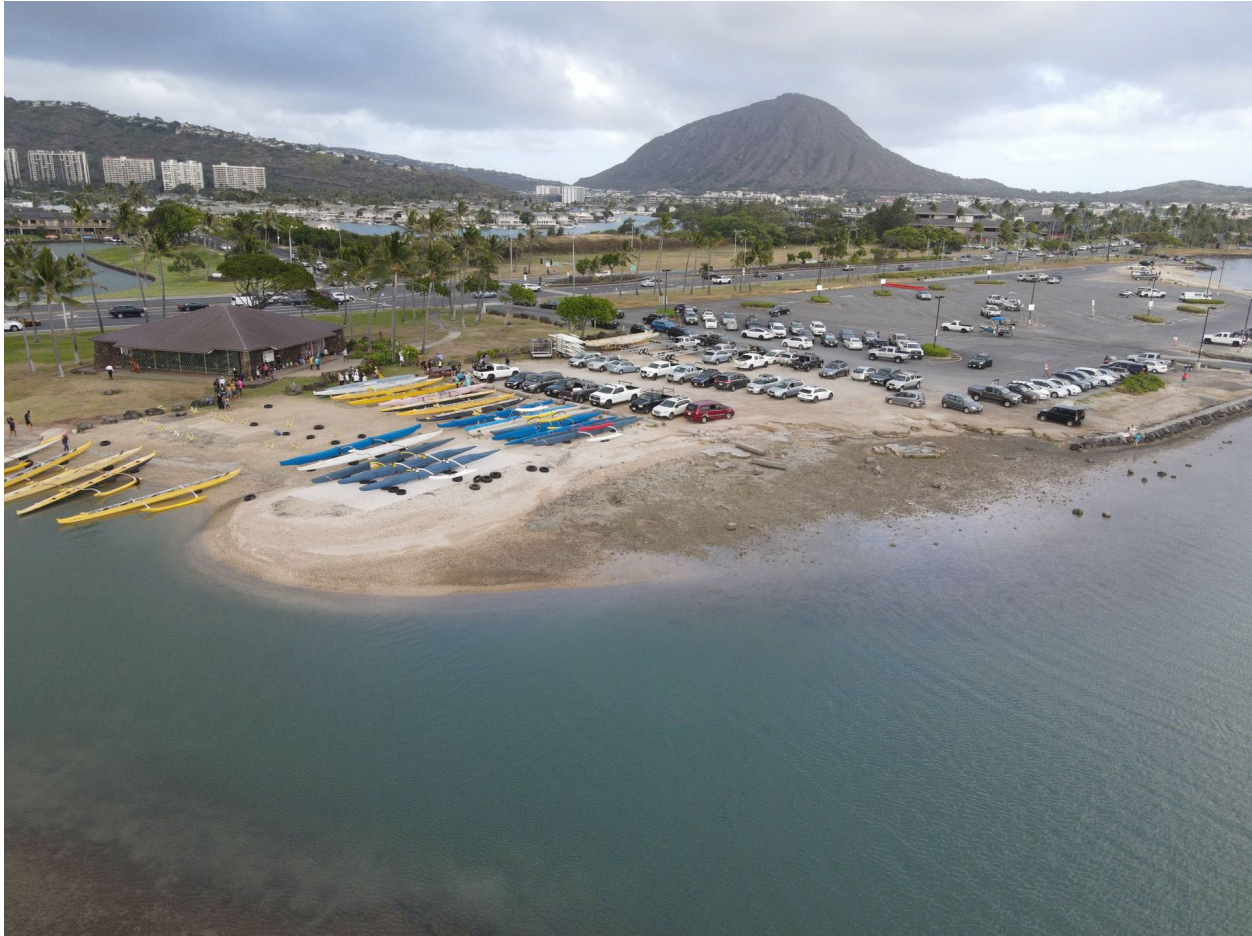
On the west end of the Facility, an area of the original Facility consisting of approximately 5,500 ft² has been eroded, resulting in the loss of usable space for recreational activities at the site. An oblique aerial photograph of this area is provided in Figure 4, below. This project proposes to restore this eroded shoreline by constructing a dredged material containment structure consisting of a steel sheet pile wall and filling the area behind with dredged sediment.

Figure 4. Oblique Aerial Photograph of the West End of the Facility as It Existed on April 13, 2022
(Photo: Shoreline Science & Engineering, LLC)

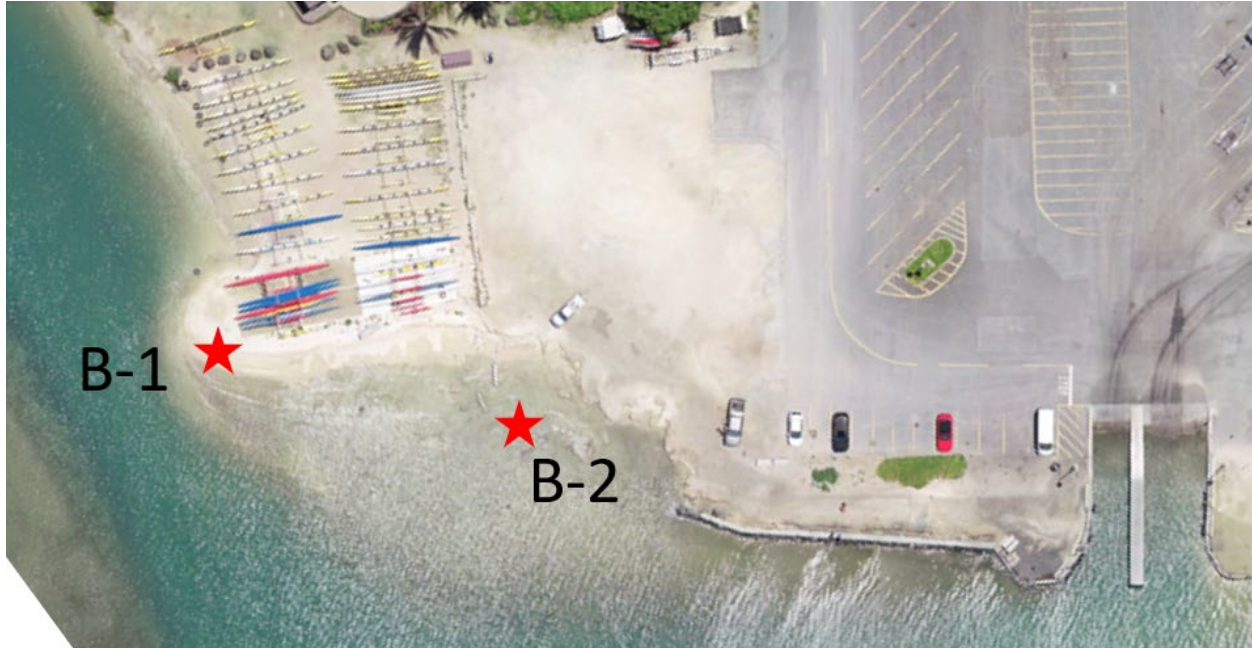
To determine the geotechnical design parameters of the proposed sheet pile wall, Integral retained Geotek Hawaii to drill two geotechnical borings along the proposed alignment with a tracked Geoprobe 6620DT rig with 6-in. diameter hollow-stem auger and auto-hammer. The borings, B-1 and B-2, extended to depths of 41.5 and 36.5 ft below ground surface, respectively. Boring B-1 was located at the west end of the Facility adjacent to the navigation channel, and Boring B-2 was located between the boat launch ramp and the west end of the Facility. The approximate boring locations are illustrated on Figure 5.

Figure 5. Approximate Locations of Geotechnical Borings Conducted at the West End of the Maunalua Bay Boat Ramp Facility

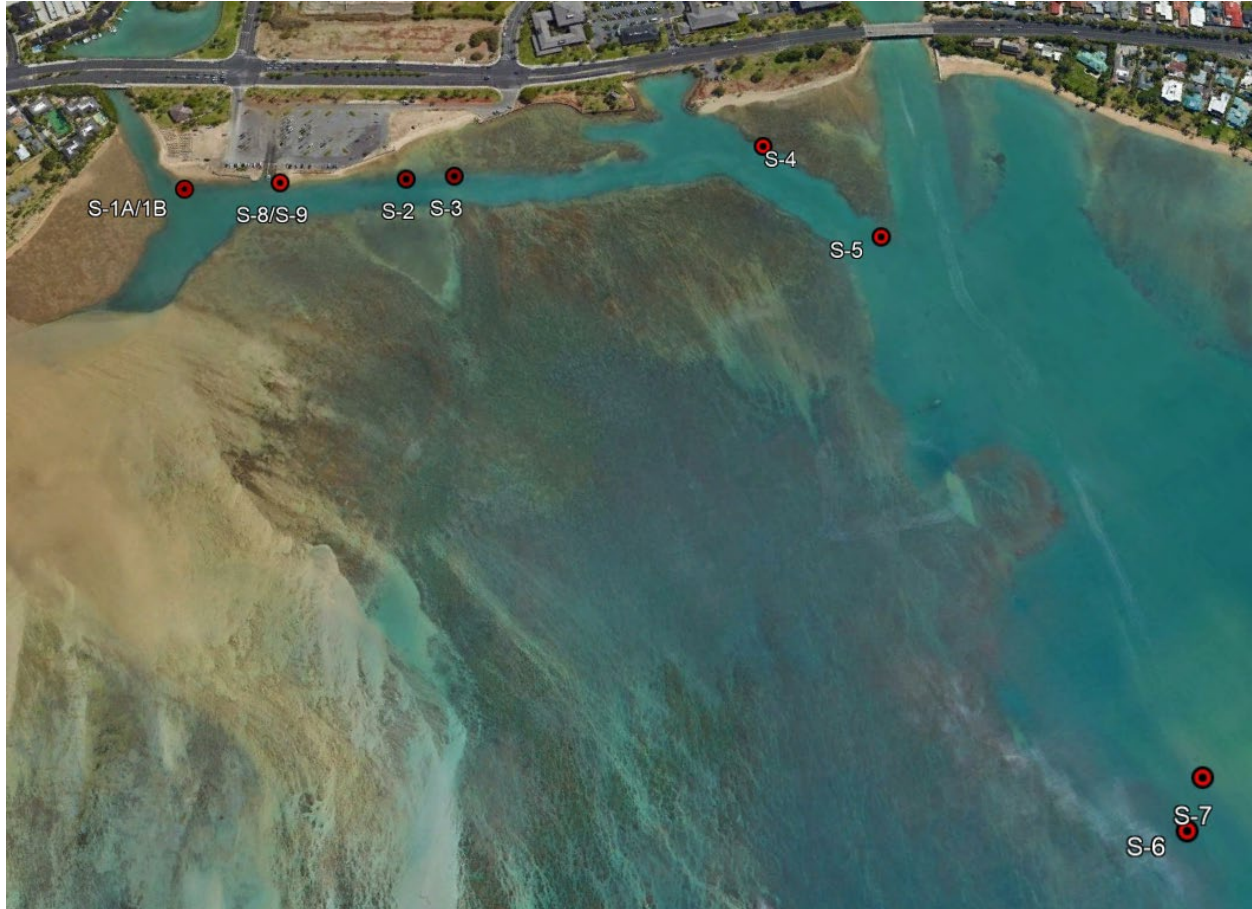
Figure 6. Locations Where Sediment Samples Were Collected on June 8, 2023, throughout the Maunalua Bay Navigation Channel

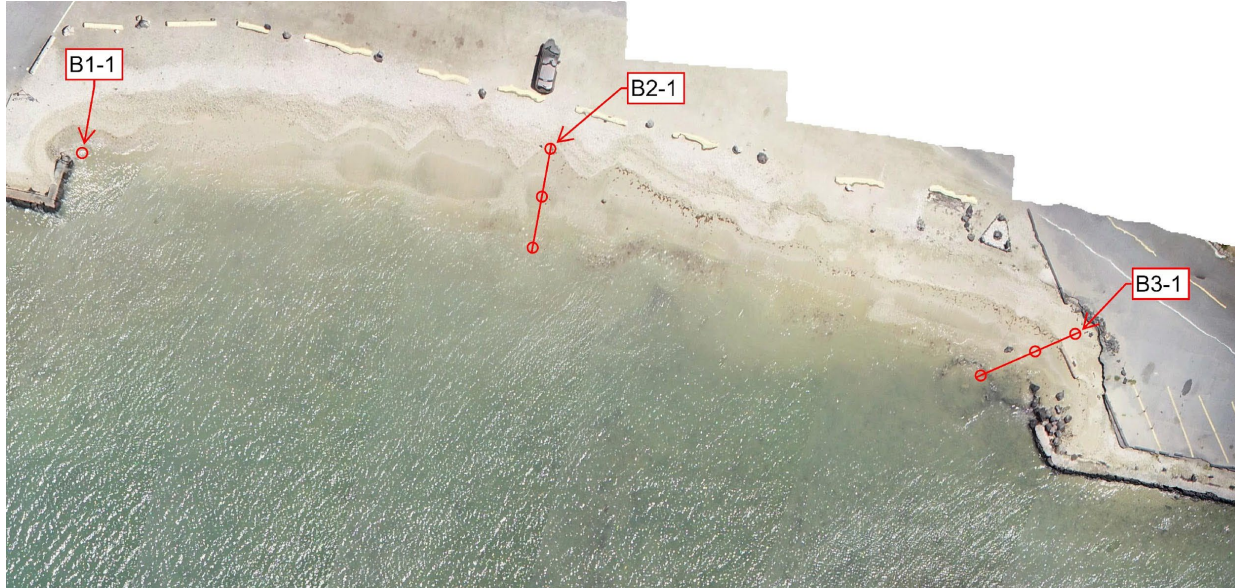
The material from Transects C1-1 through C3-1 at the western nourishment site (i.e., the “canoe launch area”) were combined into three composite samples for testing. Similarly, material from Transects B1-1 through B3-1 at the eastern nourishment site “east beach” were combined into three composite samples for testing. The material from the center cross section (B2-1) was submitted for testing, while the remaining two were archived to allow for future analysis, as needed. The locations from which these samples were collected are shown in Figures 8 and 9, below. The samples generally contained material from within the top 4 in. of the beach surface. The samples were then delivered to Geolabs, Inc., for analysis of grain-size distributions per ASTM C117, C136, and D1140.

Figure 9. Locations of Sediment Samples Collected at “East Beach”

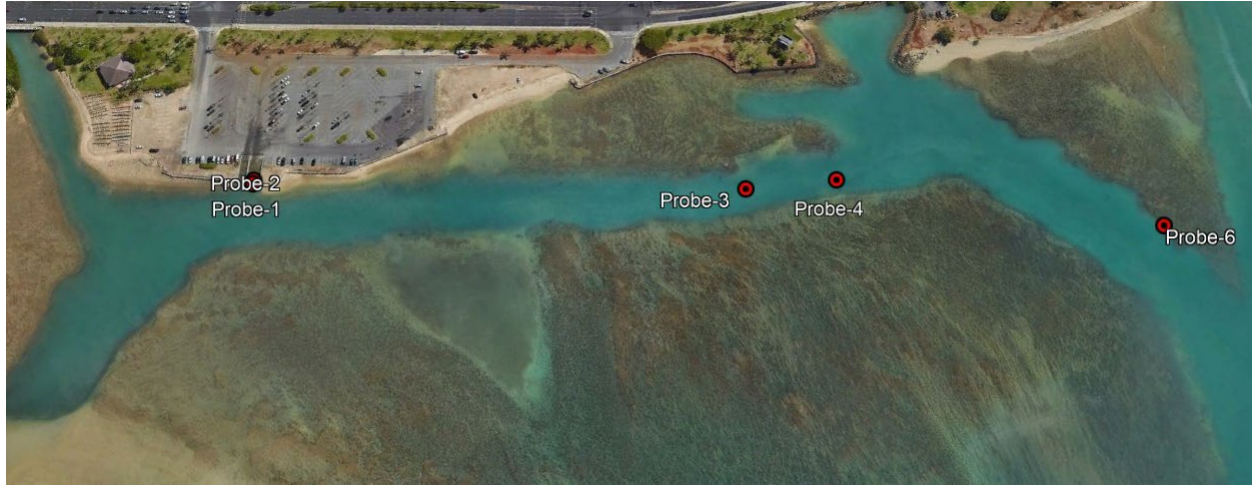
On October 3, 2023, two scientists from Shoreline Science & Engineering, LLC conducted sediment probing tests, to roughly characterize any variations in the density of the material below the layer sampled in June. The probing was performed using a 10-ft-long piece of $\frac{5}{8}$ -in. rebar, which was driven into the channel bottom by hand using a manual post driver. At each probing location, the rebar was driven to a depth beyond the proposed dredge elevation, to determine if the full extent of material was suitable for maintenance dredging. The scientists recorded the water depth at the probe location and the depth to which the rebar was driven. A GPS point was also recorded at each probing location using a handheld Garmin GPS 73. The probing locations are shown on the map in Figure 10, below.

Figure 10. Locations Where Sediment Probing Was Performed on October 3, 2023, throughout the Maunalua Bay Navigation Channel
