Draft Environmental Assessment

**Garrett Single-Family Residence and Farm
in the Conservation District at Maku‘u**

TMK (3rd): 1-5-010:009
Maku‘u, Puna, County of Hawai‘i, State of Hawai‘i

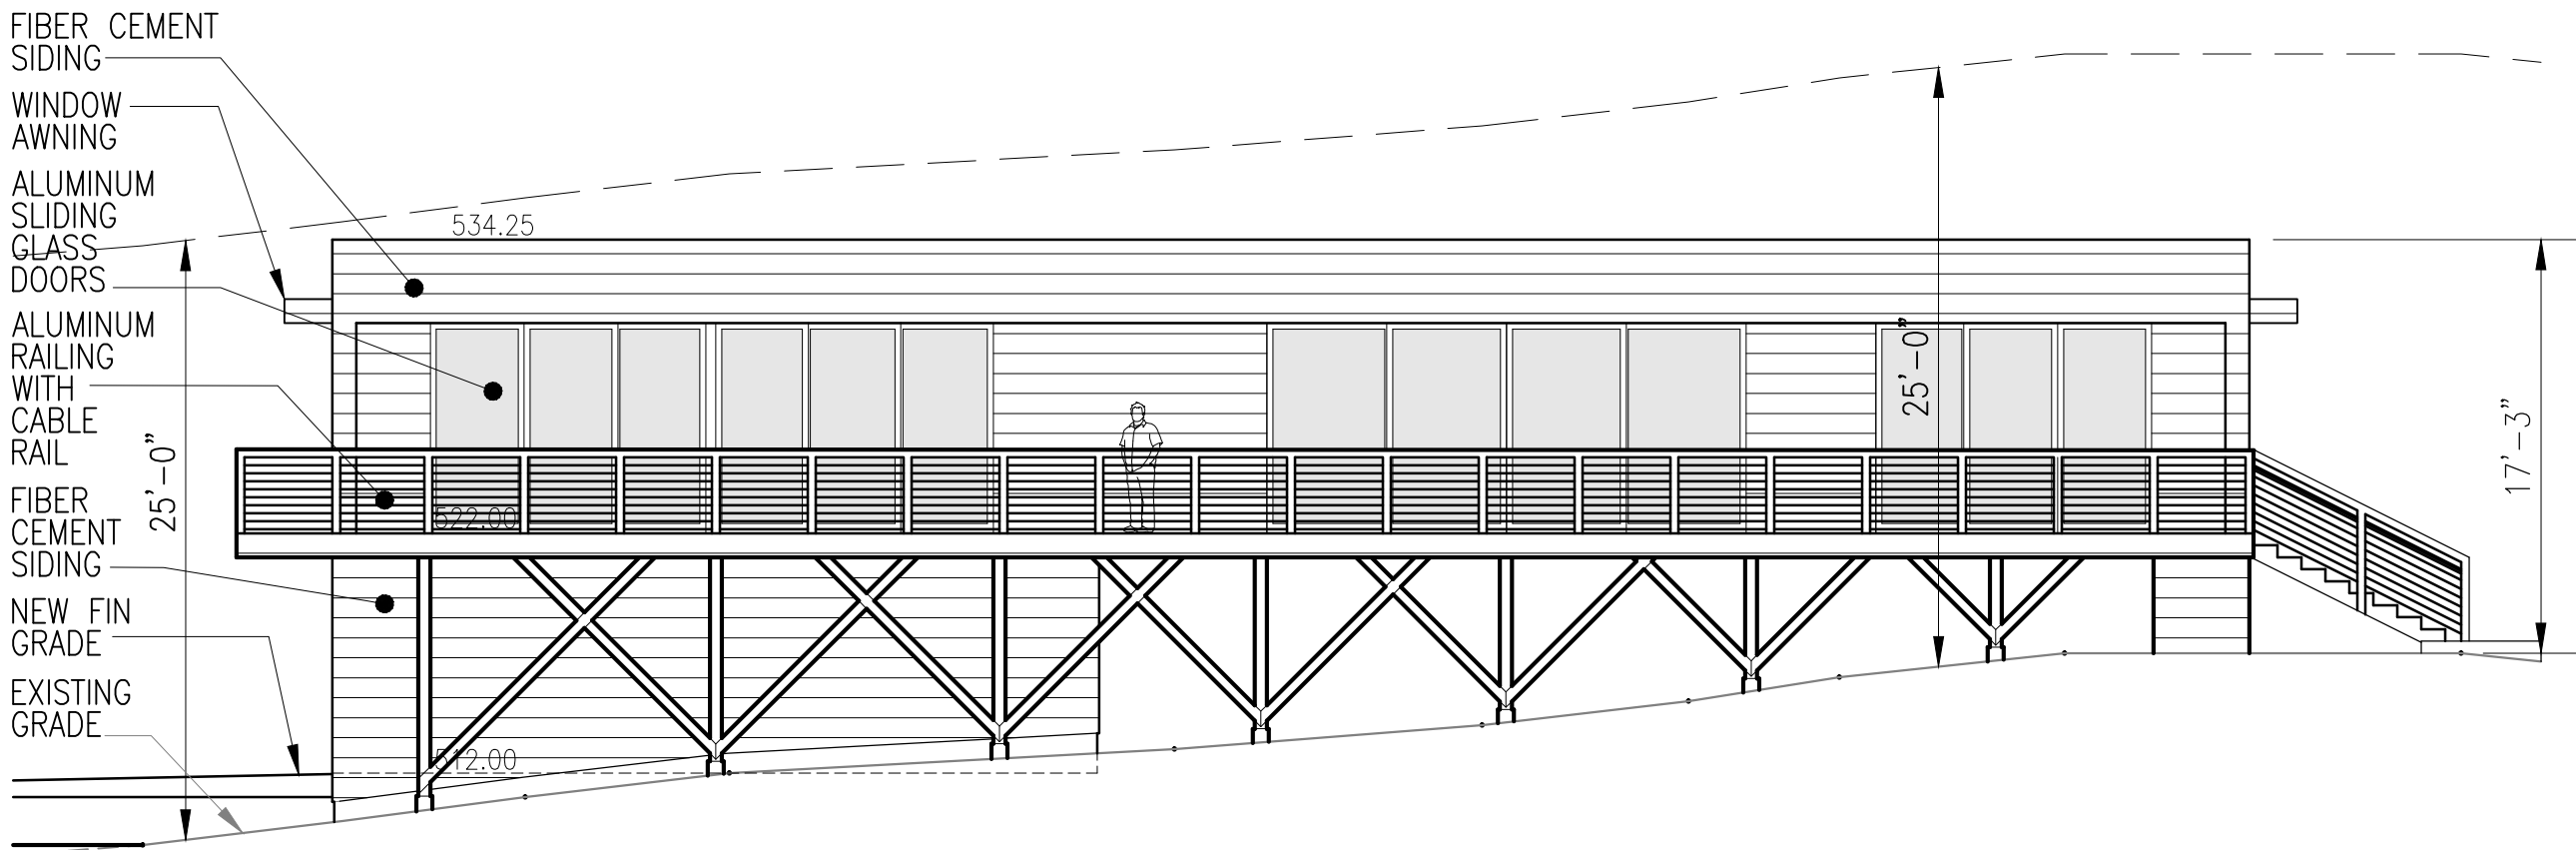
ENCLOSED AREA 2,560 SQ FT
LANAI AREA 1,239 SQ FT

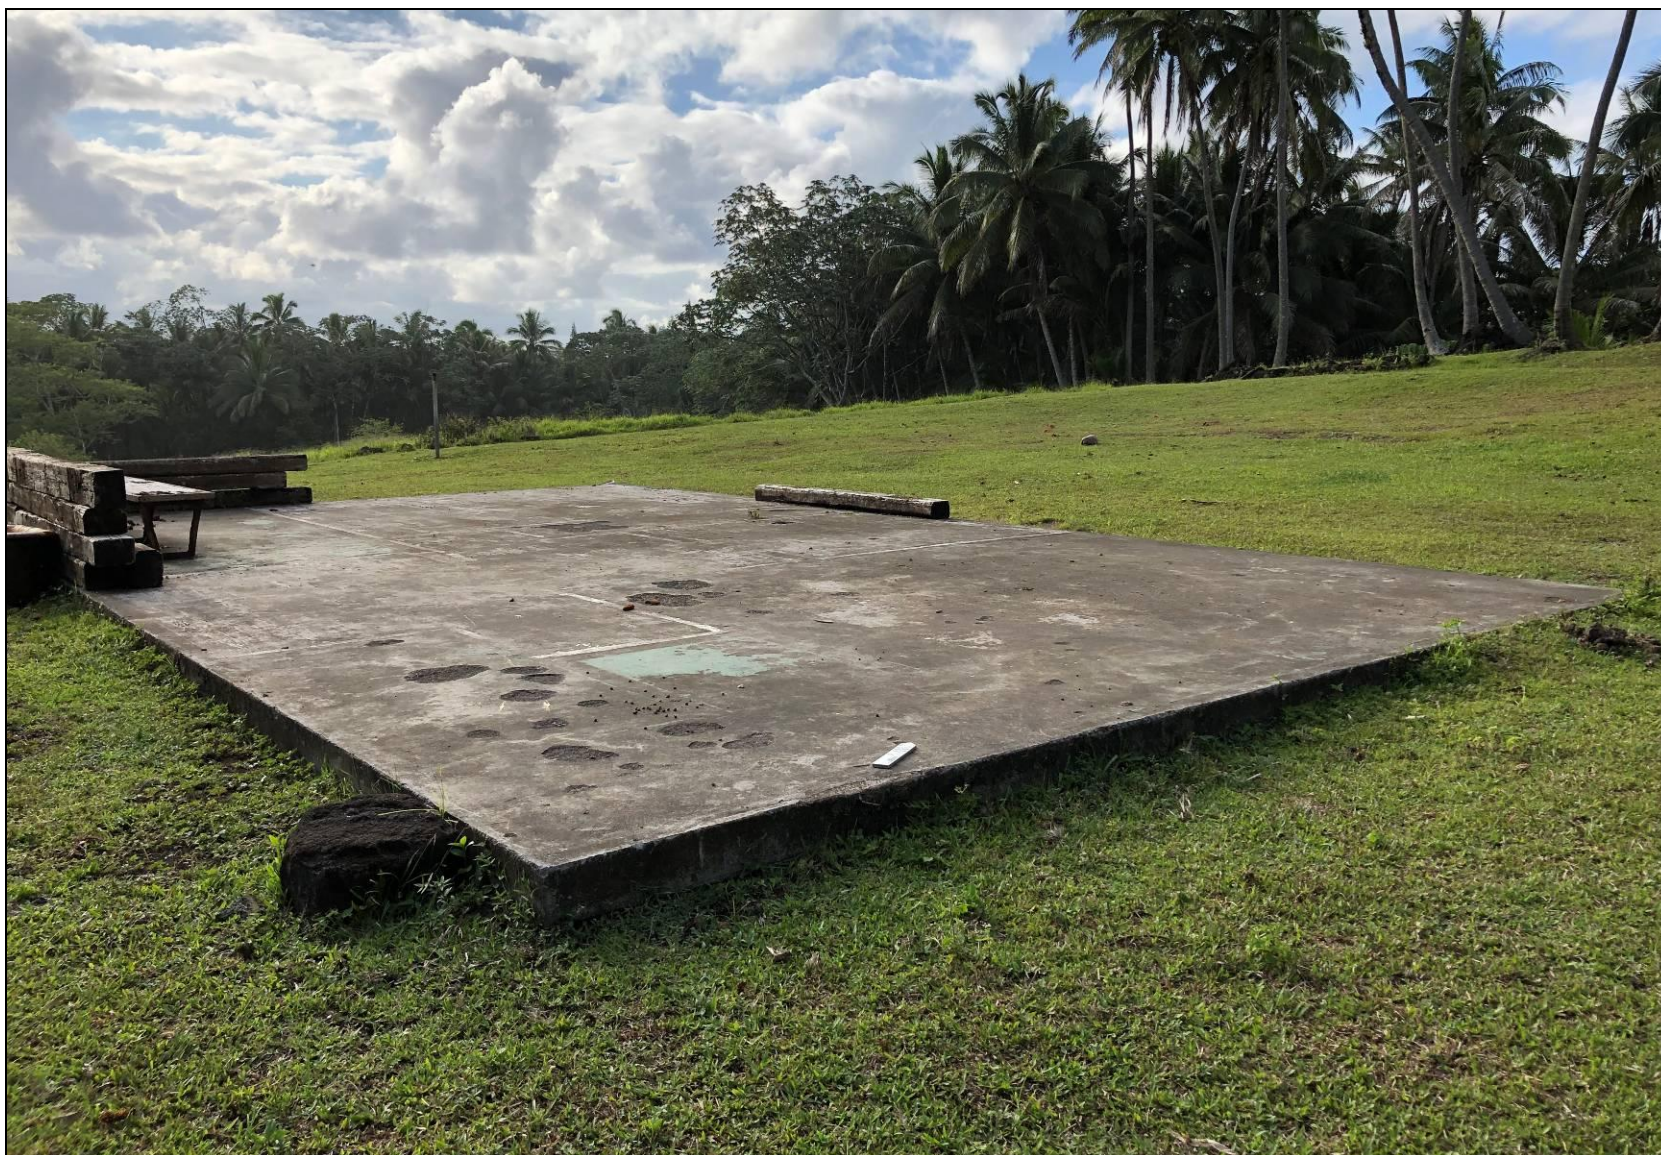
Figure 21: Photograph of Site 7476 Foundation Looking North.

Site 7476 is the foundation located where the Kamahele House once stood (see Figure 18). The foundation is toward the center of the project area in an area of mown grass, northeast of two avocado trees, and northwest of a large stand of Cook pines (Figure 19). The concrete foundation is 10.37 m (34 ft) long by 6.1 m (20 ft) wide and is raised approximately 16 cm (6.3 inches) above ground surface (Figure 20 and Figure 21). The house burned down in 2014 during Hurricane Iselle and is no longer present. Family members remembered the house was a post-and-pier wood structure with wood floors boards. They didn't recall a cement foundation and this might have been poured by the subsequent owner. Site 7476 was destroyed by an accidental house fire in 2014, is in poor condition, is no longer present and lacks formal integrity. No further work is recommended at Site 7476.

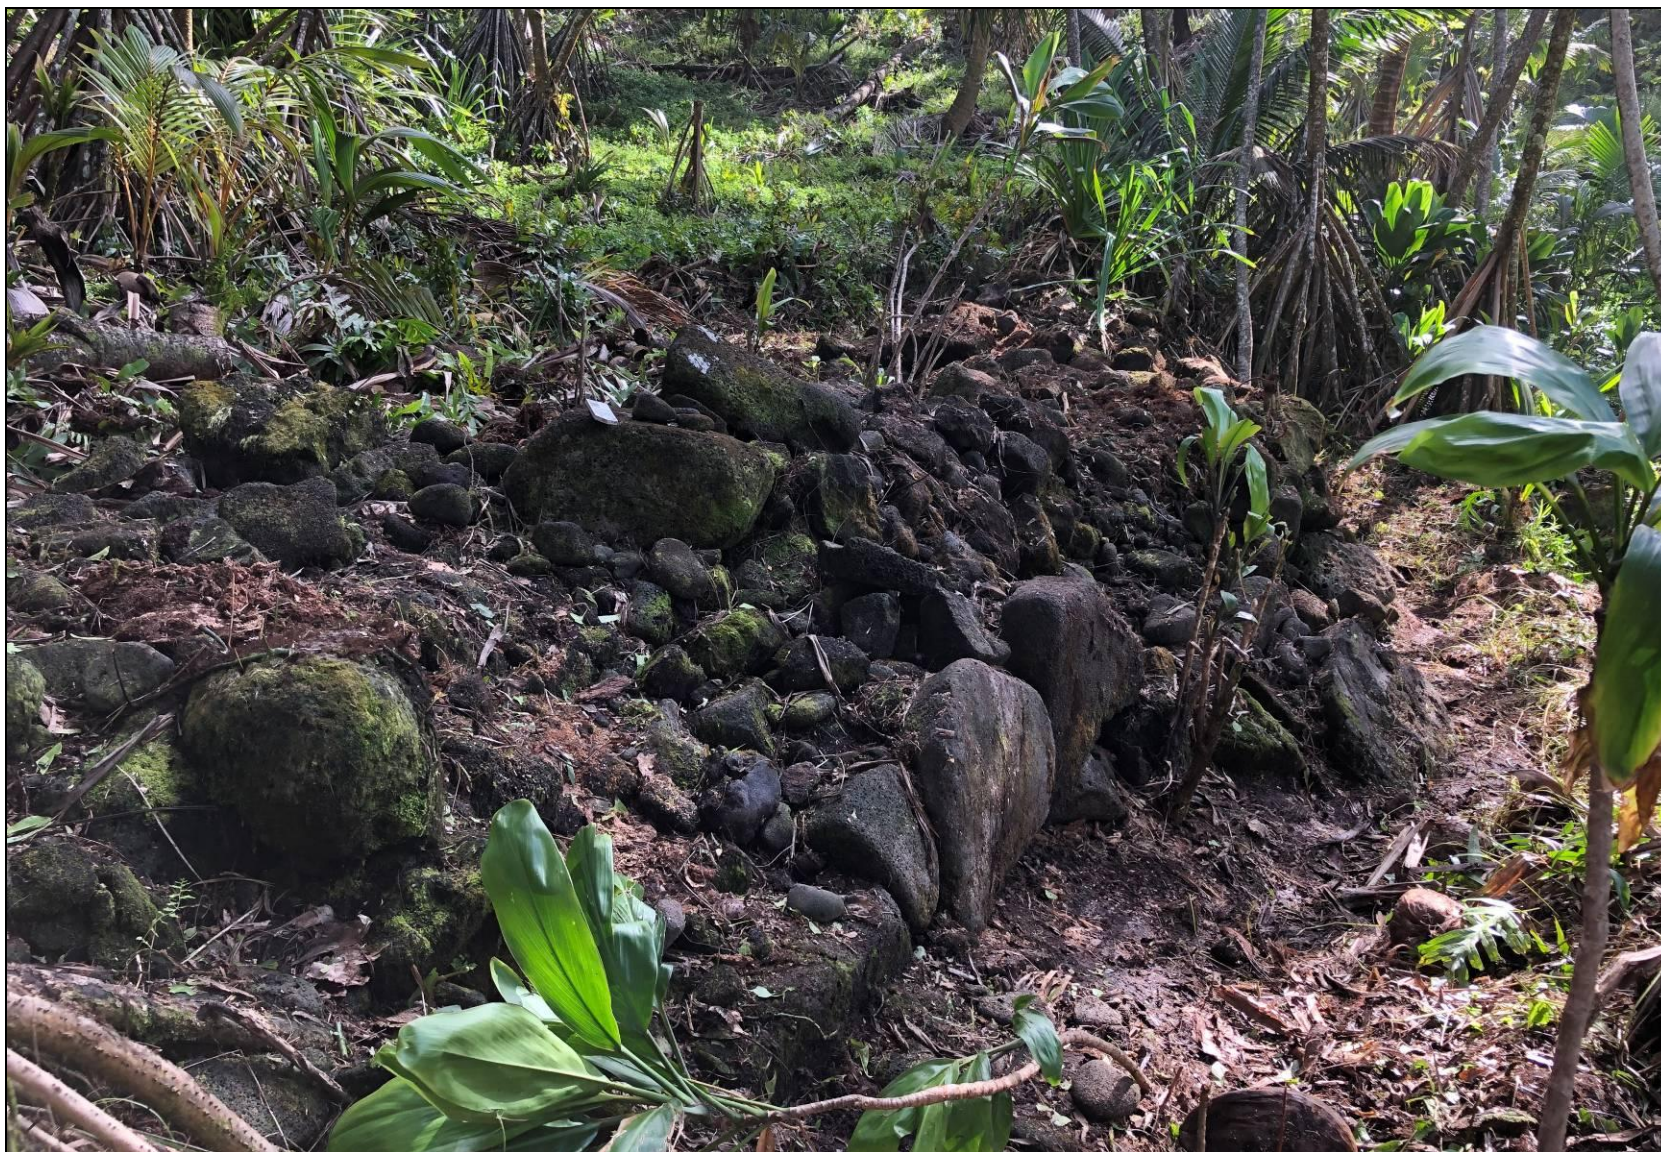
Figure 30: Photograph of Site 18980 Feature 6 Rock Wall Showing Partial Collapse, Looking West.

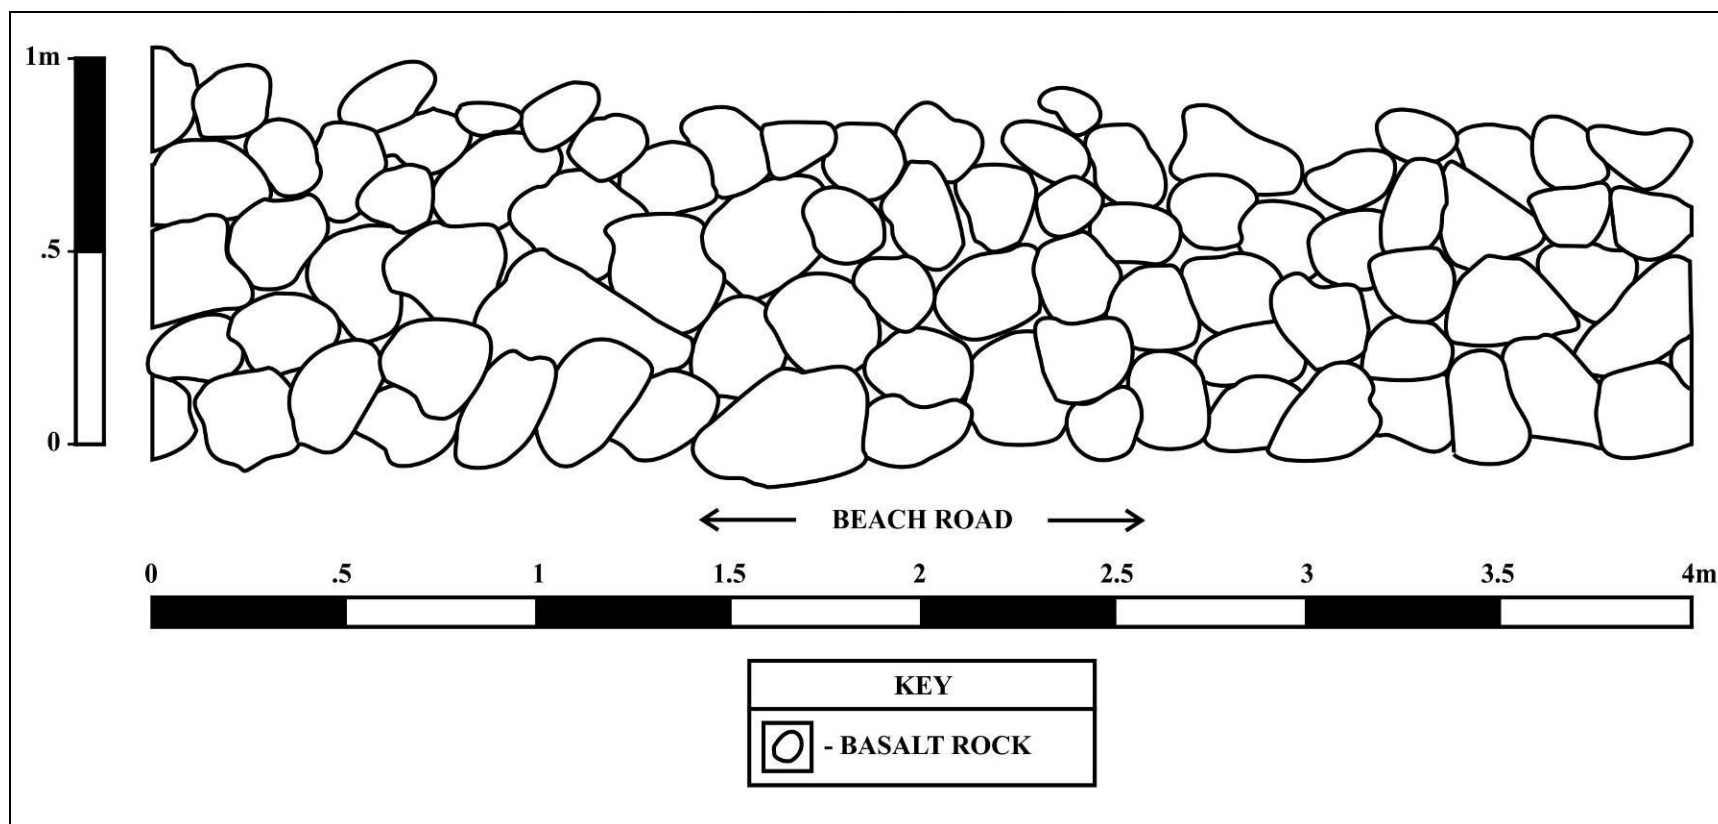
Figure 37: Site 31111 Southwest Rock Wall Profile Showing Typical Wall Construction.

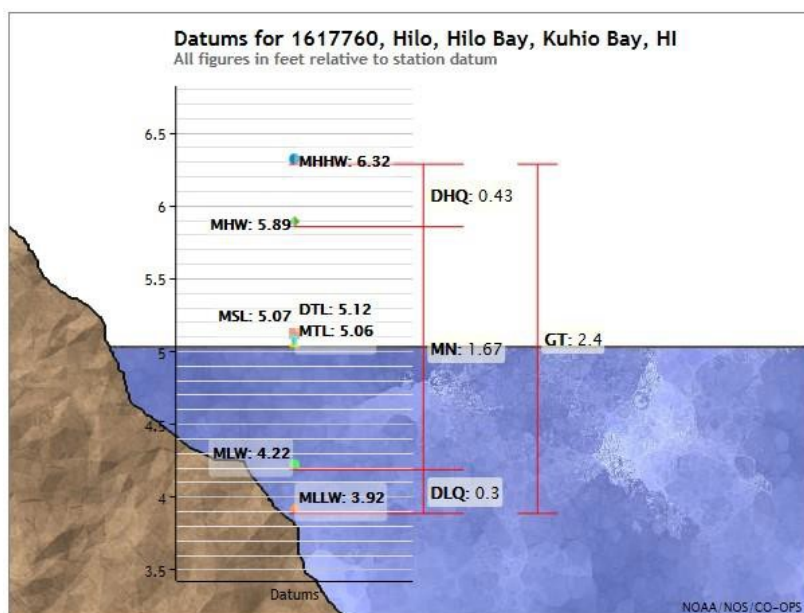
Figure 6 Tidal data for Hilo Bay (in ft.).
